**11 Eglinton Terrace, Ayr:  
Archaeological Mitigation**

Data Structure Report

by Alan Matthews

issued 7<sup>th</sup> December 2009

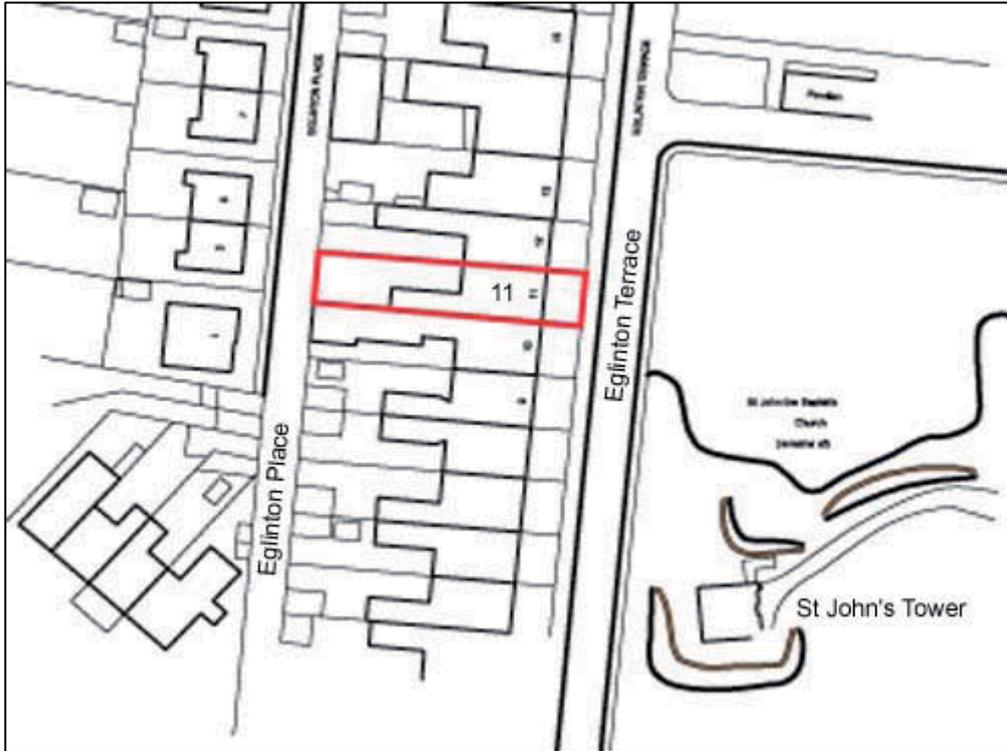
Figure 2a: Site location

2. The development site is situated to the rear of 11 Eglinton Terrace and can be accessed from Eglinton Place (NGR: NS 333 222) (Figure 2a). It consists of an urban back plot, partially paved and mostly retained as a garden. Three services are known to be in the area and more may be present at depth; these include a large drain and manhole, an electrical cable and a telephone line.

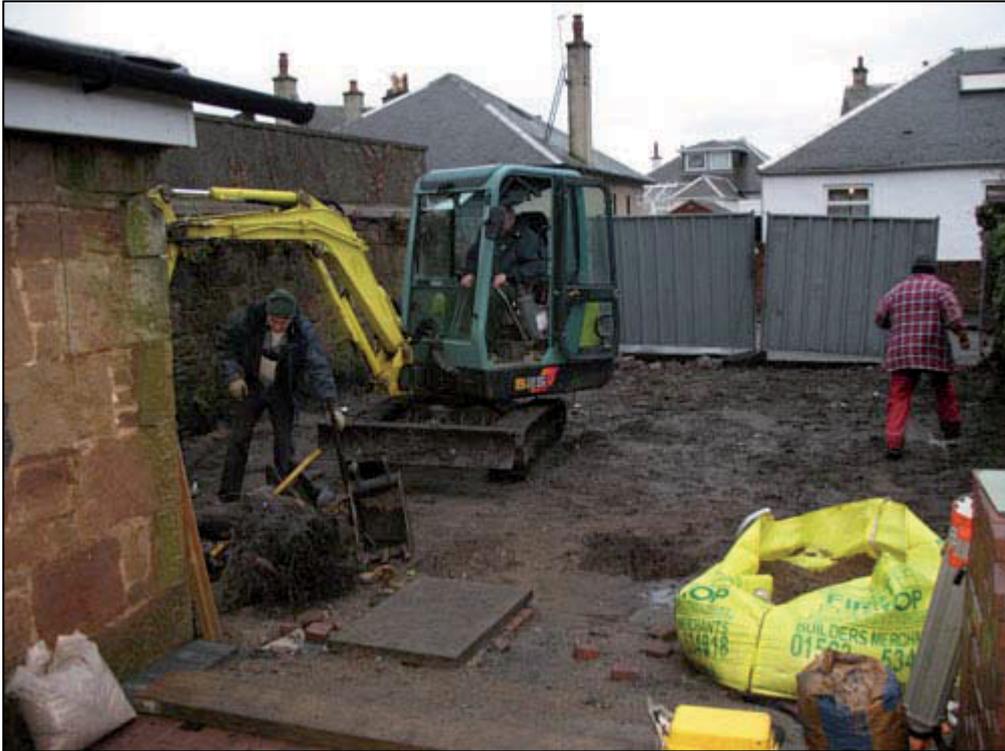
Figure 3a: Prior to excavation of the foundations

14. The archaeological monitoring involved all the ground breaking works associated with the proposed garage and interconnecting extension (Figure 3a). These works comprised a series of trenches excavated for the placement of foundations within the development area. These interconnecting trenches were located along both the boundary walls and across the centre of the development area in accordance with the building plans provided. In three places services were shown to be present within the development area; a large drain and manhole, an electrical cable, and a telephone line (Figure 2b). It is possible that additional services were present at depths not reached by the excavation works but the potential disturbance, even of those revealed, should be noted.

22. The electrical cable and the drain were both located in the centre of the development area. A manhole was associated with the drain (Figure 3a). It should be acknowledged that considerable disturbance had taken place within the centre of the development area as a result of the placement of these services. In the case of the drain and manhole, this disturbance continued to a depth not reached by the excavation works carried out here. It is likely that this disturbance has resulted in the removal of any significant archaeology from the centre of the development area.

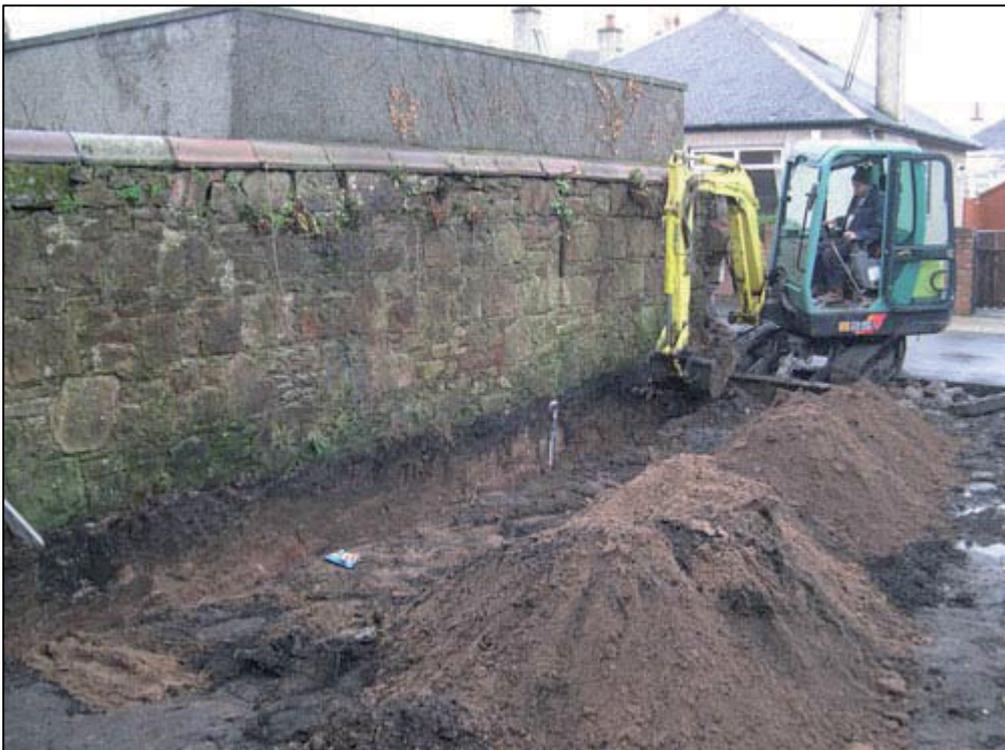
Figure 3b: Work in progress at south wall

15. Excavation works were undertaken using a mini-digger with hand excavation carried out in awkward areas given the tight space available to work in (Figure 3b). The foundation trenches were typically 900mm wide and excavated to a depth of 600mm. The first 200mm of excavated material was topsoil (001), which consisted of a very dark brown garden soil containing plant roots and modern rubbish. Immediately beneath the topsoil was yellow-orange, very loose sand (002). Deposit (002) continued to the base of the trenches showing some signs of disturbance by roots and the placement of services.

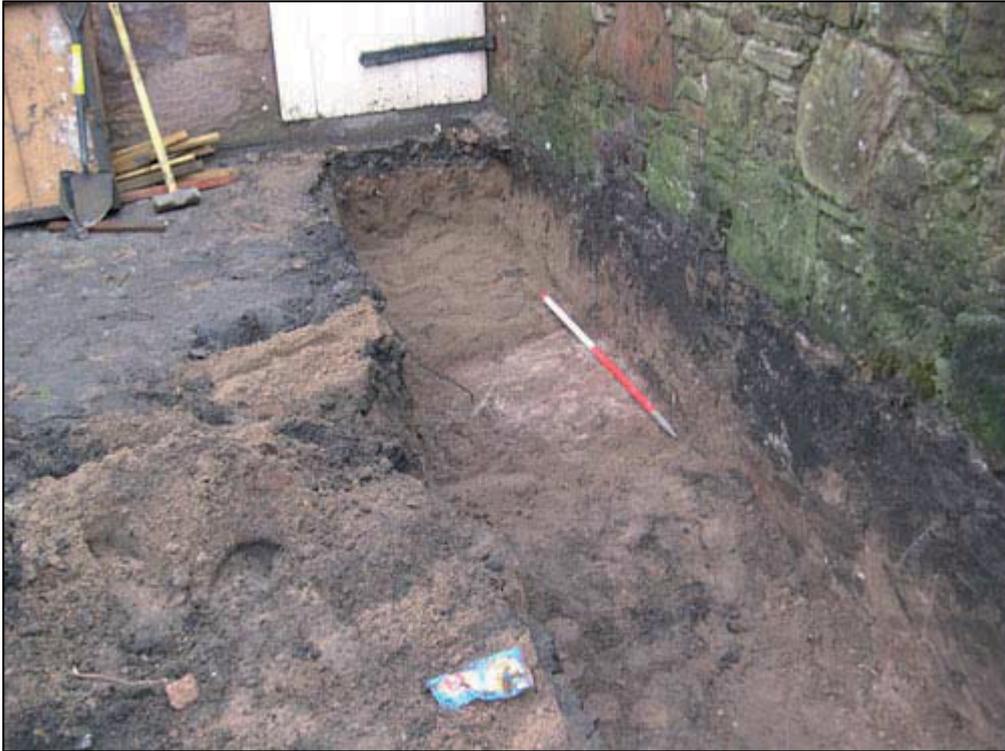
Figure 4a: (003) at south-east corner

17. The only potential archaeological feature observed during the works was a mass of mortar (003) lying adjacent to the south wall of the development area. Feature (003) (Figure 4a) proved upon excavation to be physically tied in to the foundation of the south wall of the development area. No artefacts were recovered in relation to this feature.

21. Services were noted in three places on the site; a large drain and manhole, an electrical cable (Figure 4a) and a telephone line. All ran east to west through the development area. The telephone cable was connected to a telegraph pole which had been recently moved from the north-west corner of the development area. Modern disturbance resulting from the movement of this cable was observable along the entire northern boundary of the site.

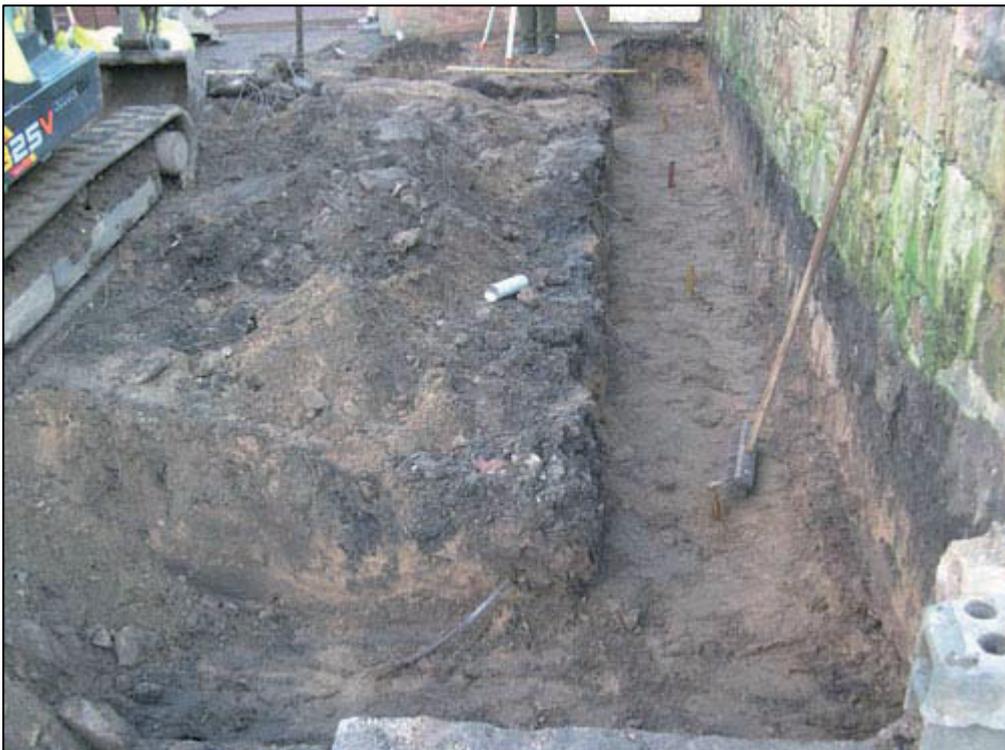
Figure 4b: Foundations at south wall

20. Feature (003) which consisted of a mass of mortar tied into the foundations of the south wall (Figure 4b) of the development area, may indeed have been an extension of the wall foundations. It was certainly an extension of the same structure and therefore contemporary. It is possible that it represents an extension of the foundations which would have further extended the outbuildings of 11 Eglinton Terrace. However, no further evidence was recovered to support this.

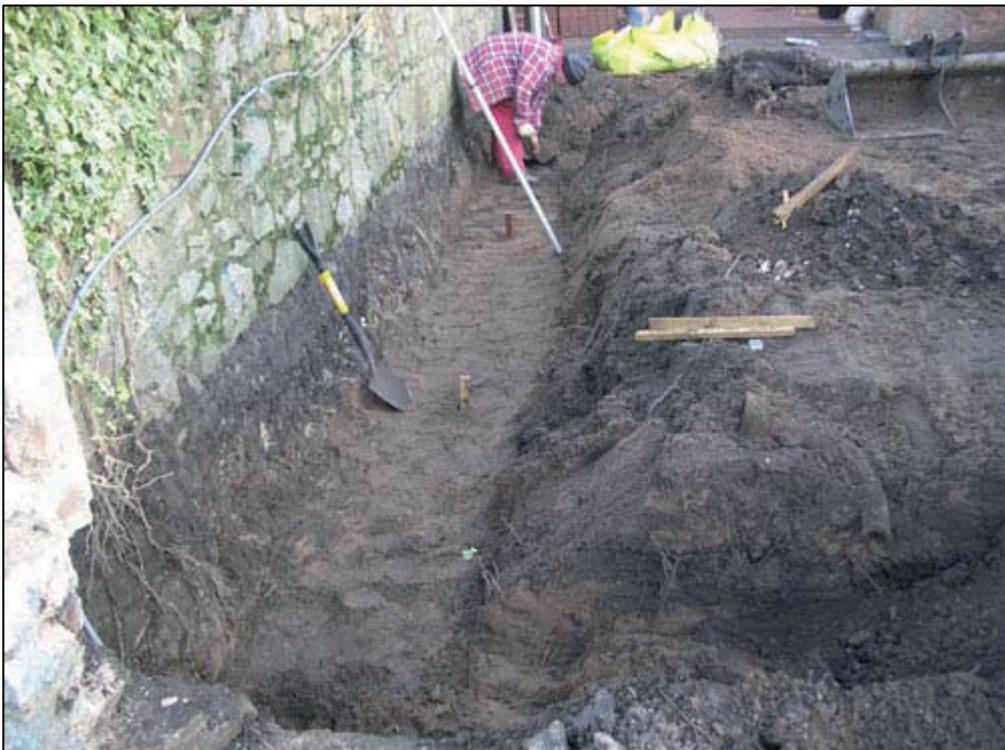
Figure 5b: Foundations along the north wall

18. Signs of disturbance along the northern boundary (Figure 5b) of the development area and additional modern artefacts in deposits (001) and (002) were attributed to disturbance resulting from the placement of a telephone cable. It was clear that the cable had been recently buried and that the associated telegraph pole had recently been moved.
