19 Culzean Road, Maybole: Archaeological Evaluation

Data Structure Report

by Alan Matthews

issued 11th June 2010

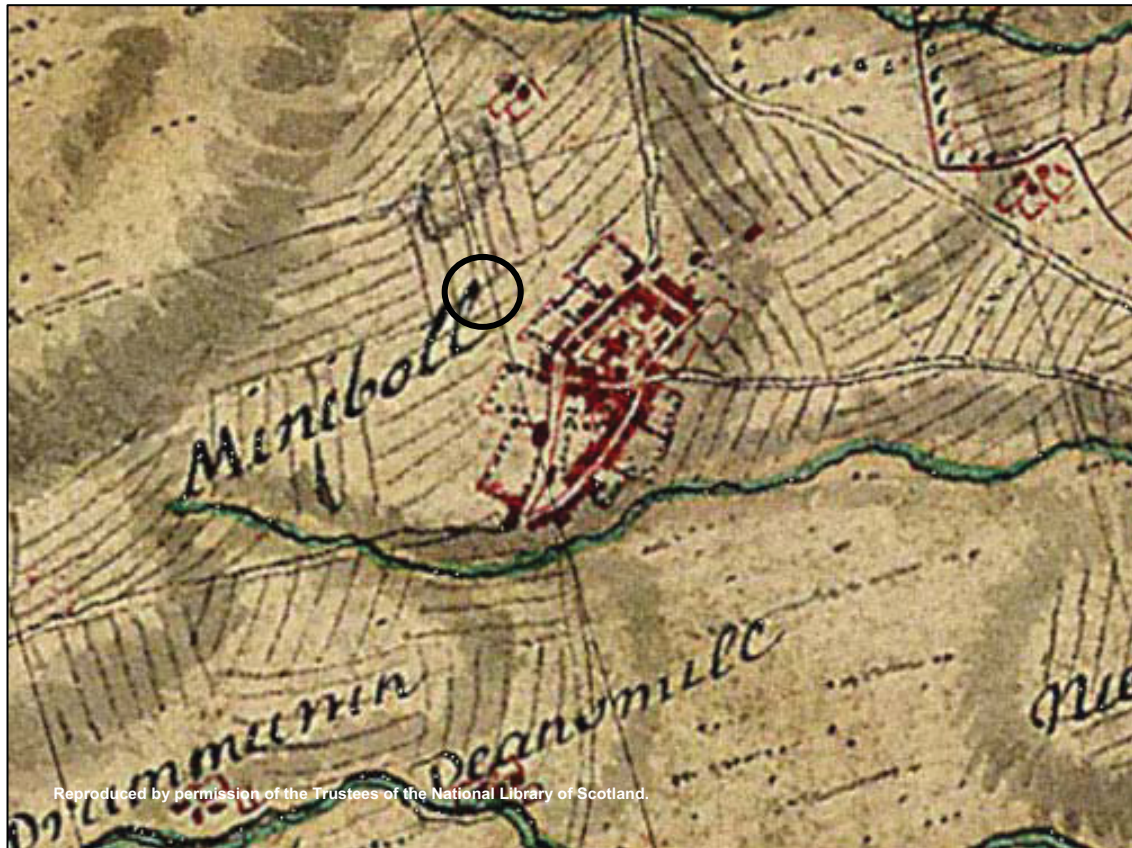
Figure 1a: Roy's Military Survey 1747-55

8. The earliest cartographic depiction of Maybole from which we may understand the layout of streets is Roy's Military Survey of Scotland (1747-55) (Figure 1a). This depicts Maybole as constructed around two roads running south-west to north-east bisected by a third running roughly east to west (Figure 1). The furthest north of these being in the same location as the modern High Street. Running along the north side of the High Street are several buildings with plots.

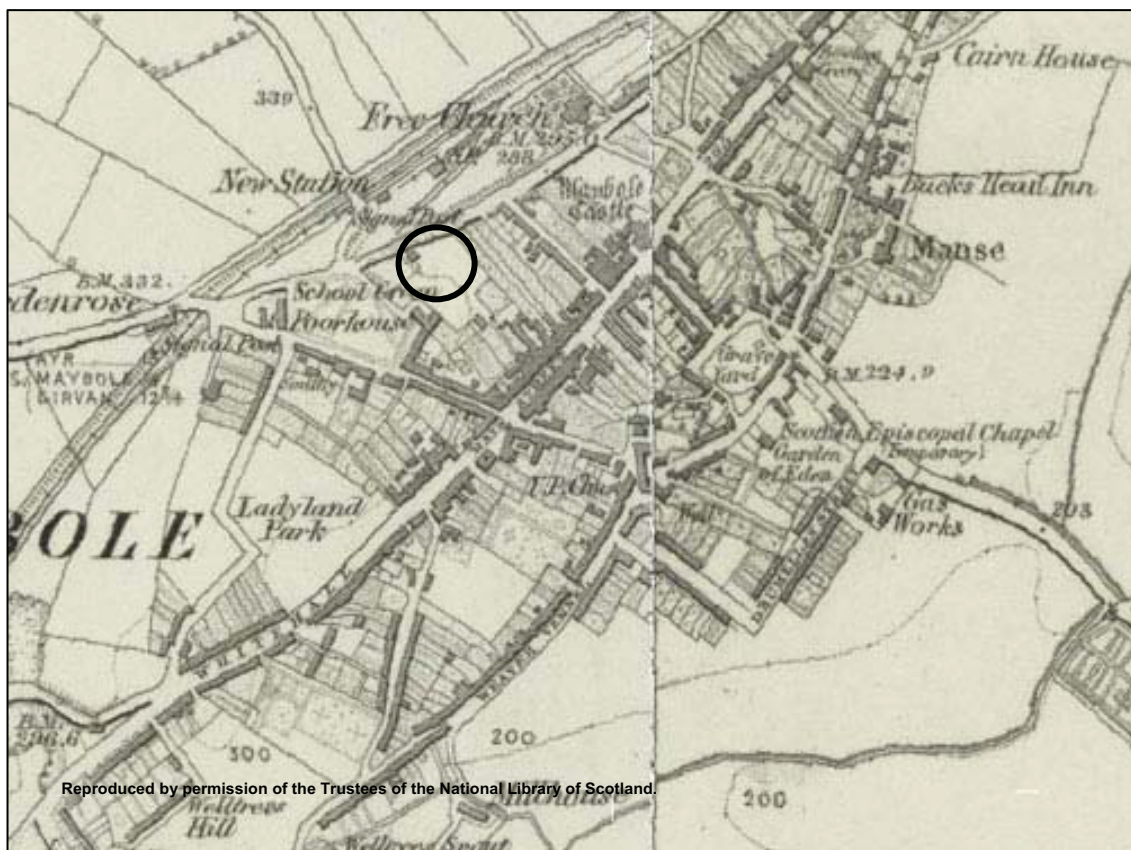
Figure 1b: 1st edition Ordnance Survey Map 1854-59

9. By the 1st edition Ordnance Survey map (1854-59) the town has been expanded north to include Culzean Road and the line of the railway. There has been a corresponding increase in the size of the town with the area between Culzean Road and High Street being developed. Frontages of buildings face onto the High Street (called Main Street in the Ordnance Survey map) with the plots stretching up to Culzean Road.

15. Cartographic sources suggest that the proposed development area is at the north-western limit of the town plots as shown on Roy and within the rear of the plots shown on the 1st edition Ordnance Survey map (Figure 1b). As such the possibility does exist for significant archaeological remains within the development area which have not been disturbed by recent development. However, it is uncertain, especially from modern depictions of the burgh expansion, if the rear most parts of the plots of the medieval town extend to within the development area.

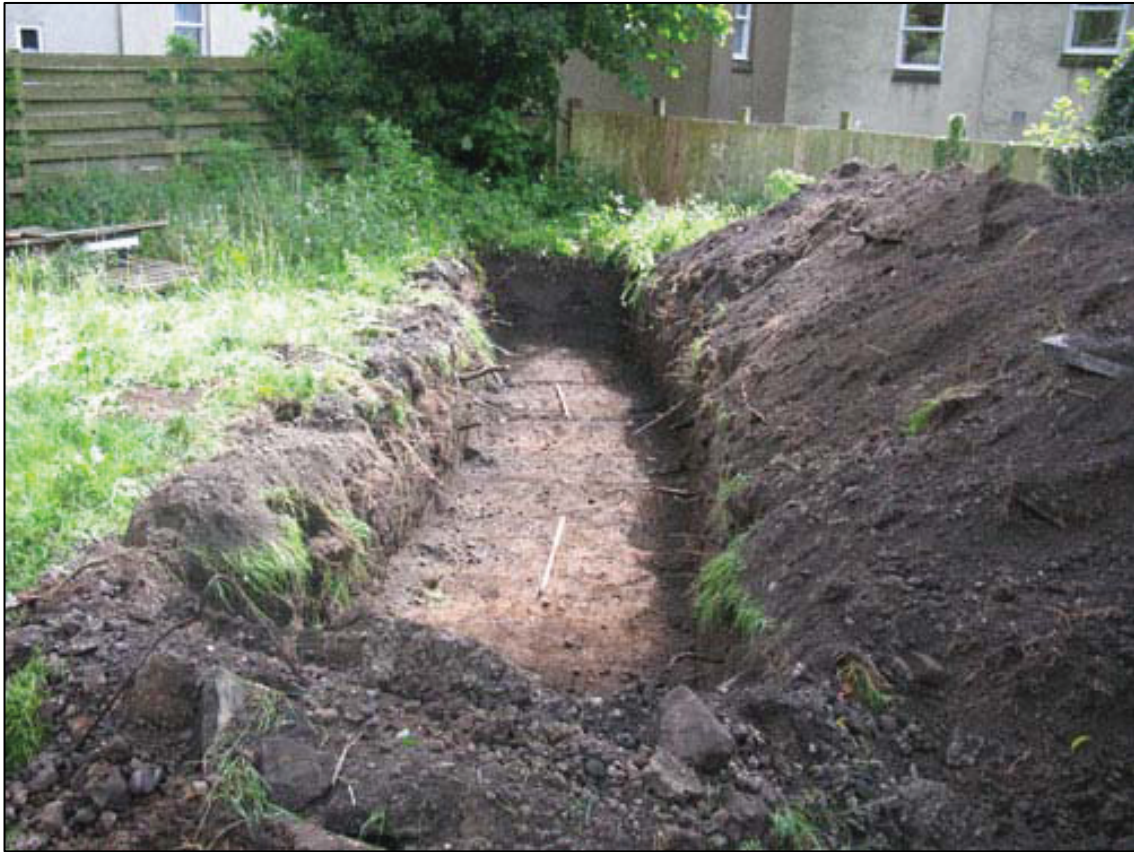
Figure 3a: Trench 1/2

21. Trench 1/2 (Figure 3a) was excavated to a depth of 900mm along its entire length. This surface in this area was partially paved and there was an initial depth of 200mm of topsoil (001) or bedding for paving (002). 700mm depth of deposit was composed of very humic silty sand with a large quantity of tree roots and small stones (003). This accumulation of material reflects the fact that beyond the south-eastern boundary of the development area the ground drops quickly into the back garden of other properties.

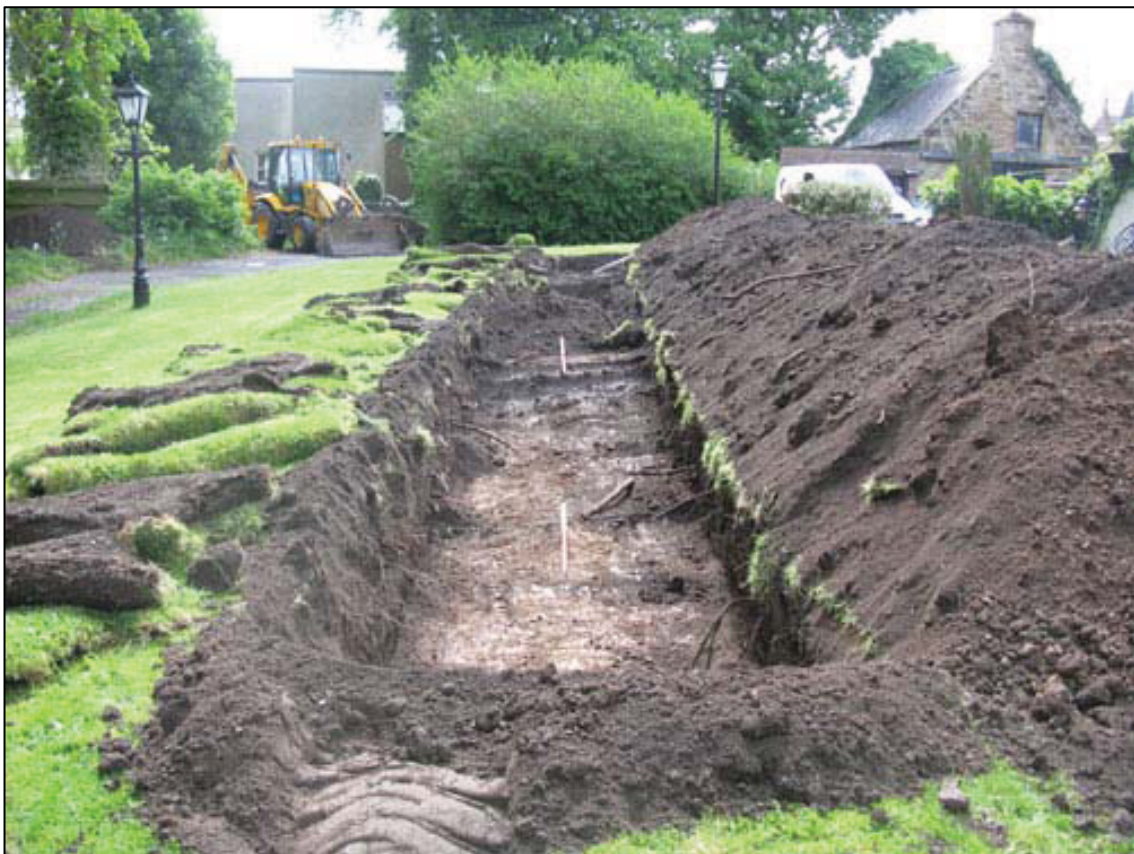
Figure 3b: Trench 4

19. All of the seven trenches excavated were reduced, where possible, to archaeologically sterile natural soil. The only exception to this was in Trench 4 where the presence of an electric cable and a spur water main prevented a short portion of the trench being excavated to the full depth. The depth of soil varied considerably across the site in correspondence with the natural topography.

27. The services uncovered in Trench 4 (Figure 3b), a spur water main and an electric cable, were located at a depth of 400mm and 200mm respectively. These services ran approximately north-east to south-west through the centre of the development area but were not deep enough to disturb the natural drift geology. Two additional unmarked services were located using a CAT scanner (presumably electric cables) (Figure 5a) running across the north-western third of the site from the main house to Culzean Road. In order to minimize the risk to the excavator and staff trenches in this area were moved to avoid the services. Given how shallow the topsoil was in this area it is very likely that these services are excavated into the natural drift geology.

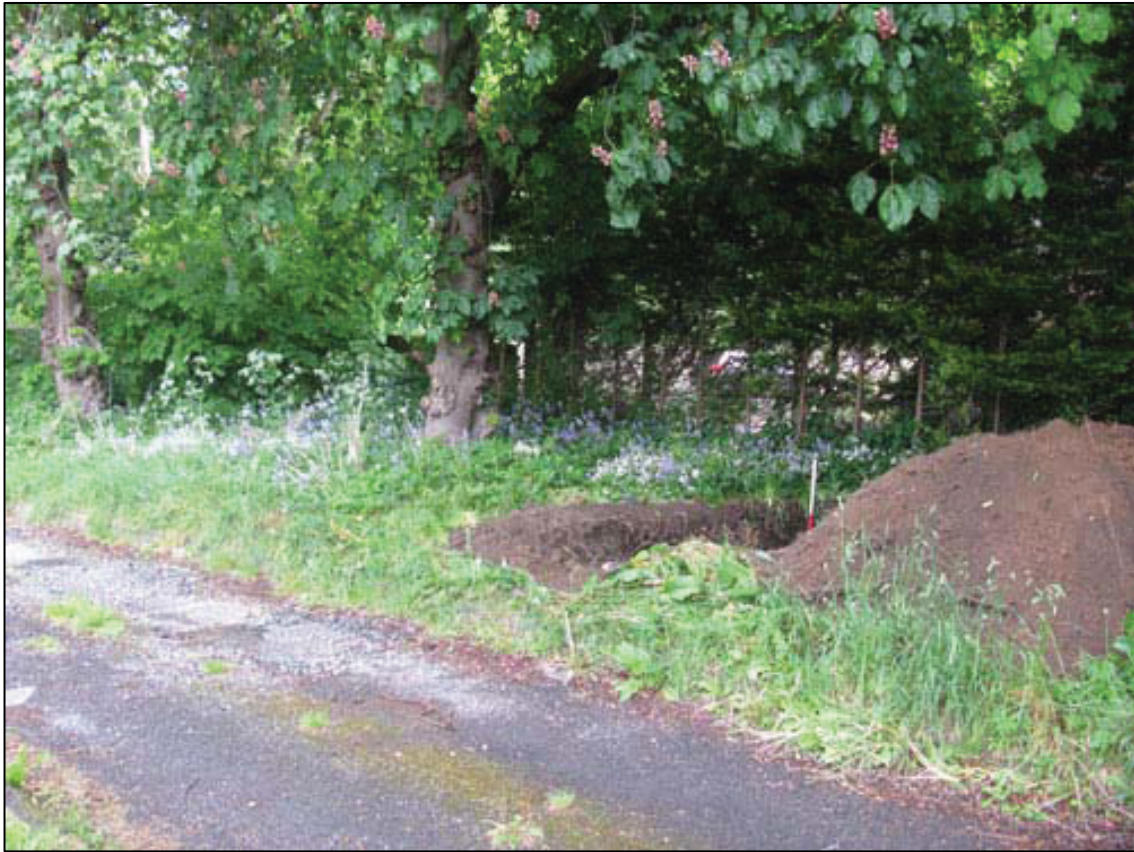
Figure 4a: Trench 5

22. Trenches 3, 4 and 5 were excavated to a similar depth in order to reach archaeologically sterile drift geology; light orange brown silty sand (004) or light orange sandy clay (005). Trenches 3 and 5 (Figure 4a) were excavated through a large quantity of tree roots. In contrast, Trenches 6, 7 and 8 (Figure 4b) were excavated to between 700 and 300mm depth. The shallowest being Trench 8 which was the furthest to the north-west.

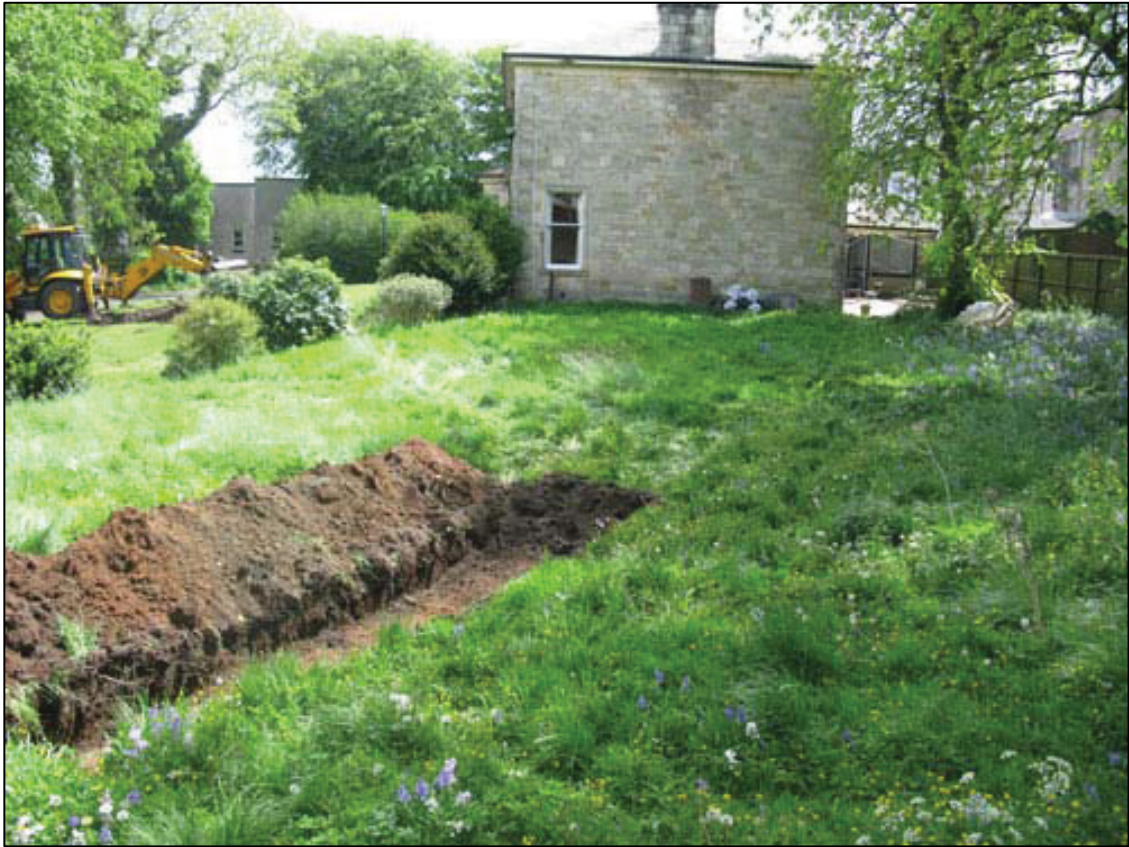
Figure 5a: Trench 6 and main building

31. Given the varied depth to subsoil across the development area it is difficult to be definitive about the potential disturbance to subsoil resulting from the buildings on site. Certainly it is likely that placement of foundations for the main house has resulted in disturbance down to the level of natural drift geology and so removal of archaeological potential. At the southern corner of the development area where the subsoil is presumably at a slightly greater depth (no greater than 900mm by comparison with the Trench 1/2) the extent of potential disturbance is less clear. However it should be noted that the loose and heavily root laden deposit (002) would likely prove unsuitable for the placement of foundations and therefore disturbance may well extend to the level of the subsoil.

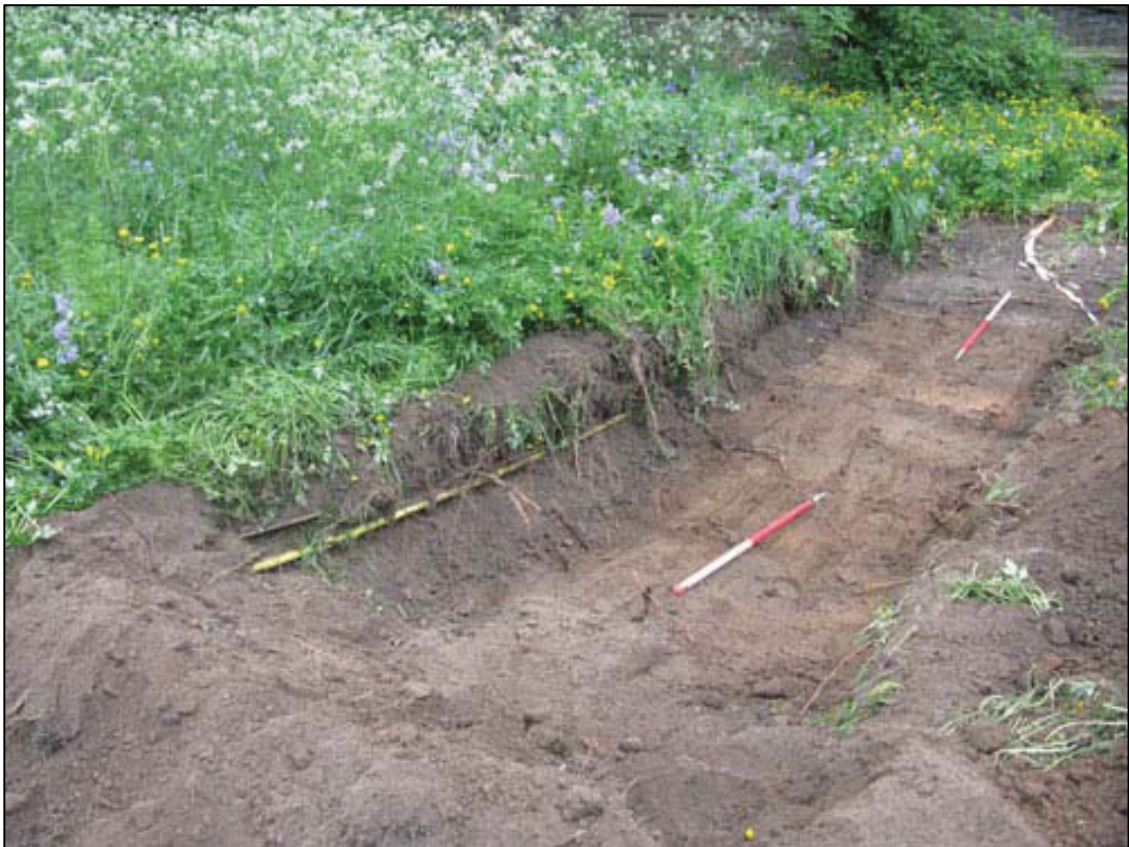
Figure 5b: Trench 8 showing gas pipe

25. Very few features were located within the natural soil. A ceramic pipe was uncovered in a linear cut at the north end of Trench 7. This was interpreted as being a modern waste water pipe. A metal gas pipe (coated in yellow plastic) (Figure 5b) was located along the south-western edge of Trench 8. This unmarked service was buried to a depth of no more than 200mm and so only disturbed the subsoil at the north end. Any additional disturbance was the result of tree roots and contained no anthropic material.
