LAND at INDIAN QUEENS ST COLUMB CORNWALL

Results of a Desk-Based Assessment &
Walkover Survey

Report No.: 150109
Date: 09.01.15
Authors: P.Webb
V. Hosegood

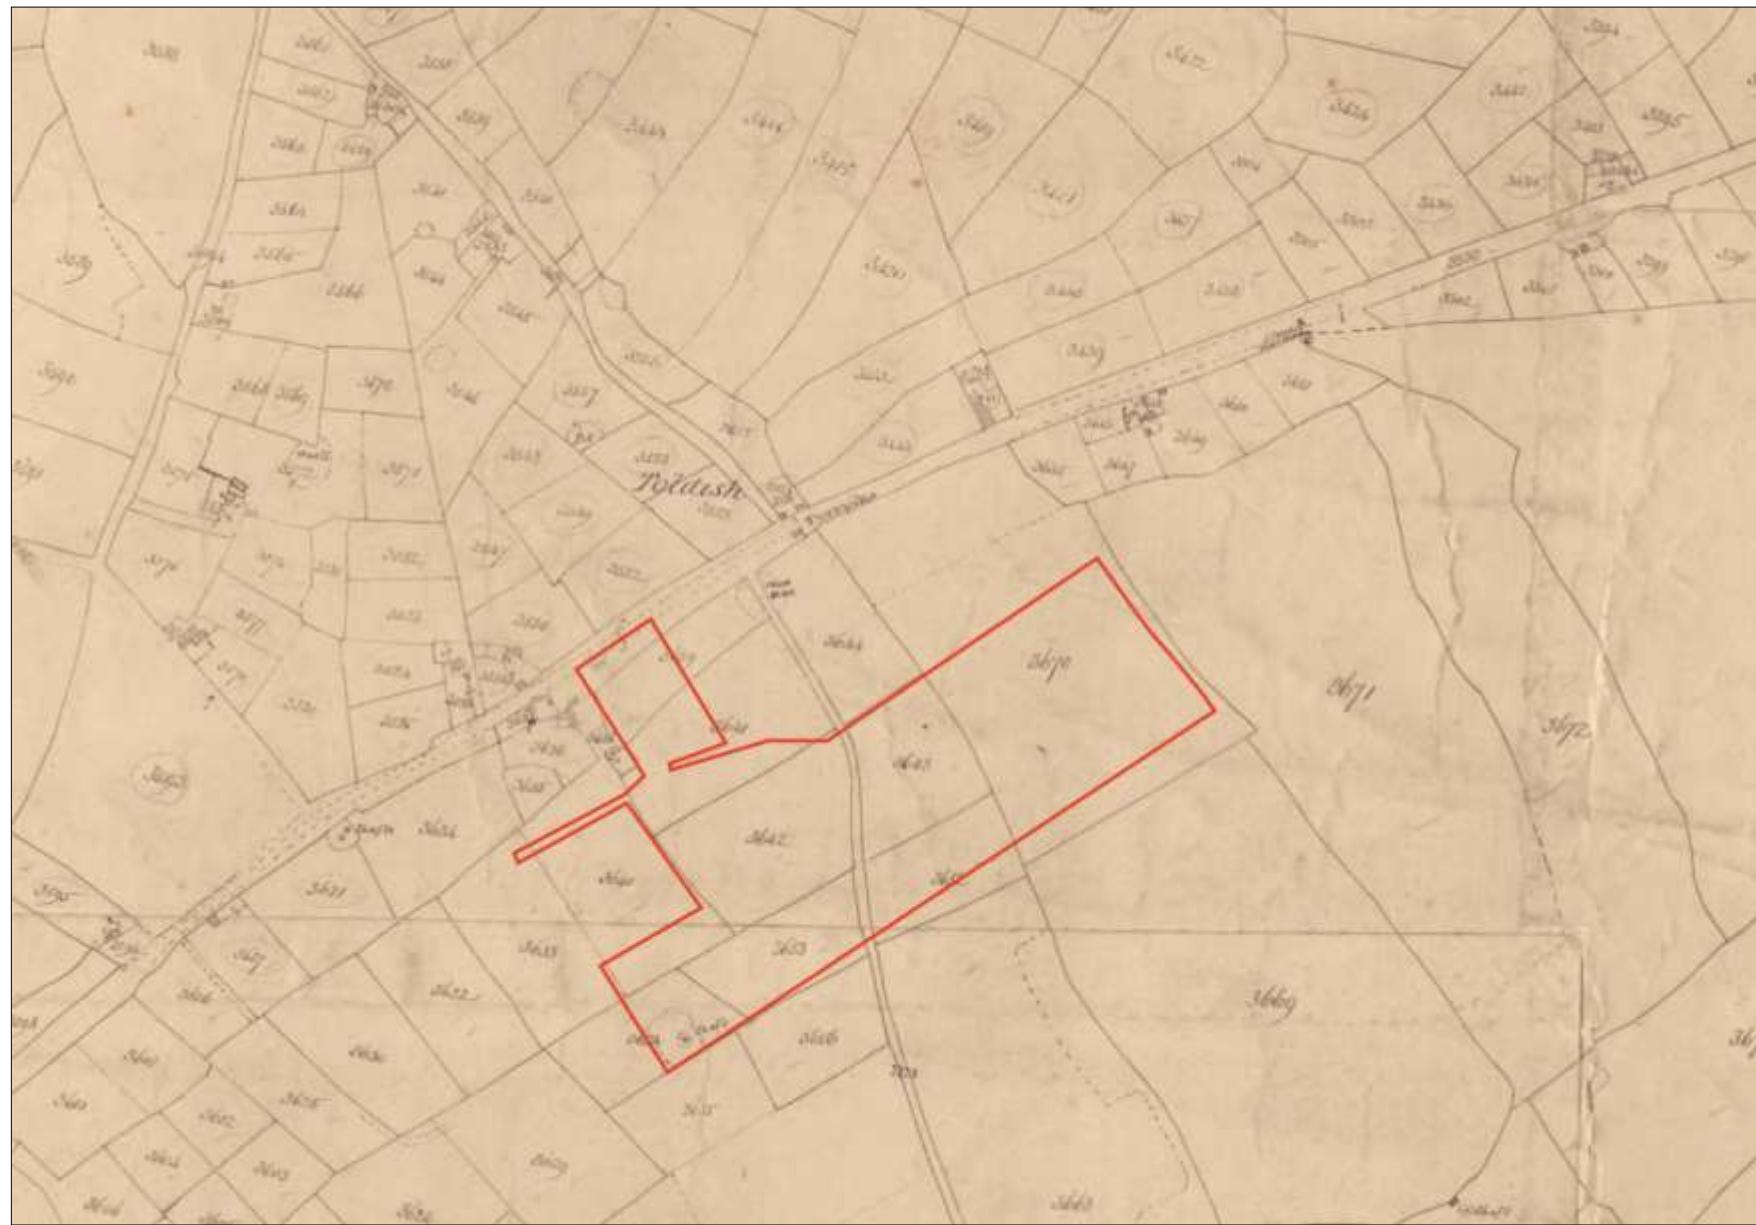
The first detailed cartographic source available to this study is the 1840 tithe map of St Columb Major. At this time, the proposal site was comprised of (parts of) nine separate fields and a track/road leading to the Turnpike Road (the Old A30) to the north. These fields are mostly large, relatively regular and are distinct from the fields to the north of the old A30, which are generally narrow, and more irregular with a number of curving boundaries, indicative of anciently enclosed land (AEL). The larger and regular nature of the fields apparent on the proposal site is suggestive of land enclosed in the post-medieval period probably of the rough upland or commons, hinted at on earlier maps.

The theory that these fields may have been rough common is further supported by the tithe apportionment (see Table 1) which indicates that some of the larger fields (e.g. 3669, 3670 and 3671) were part of a holding named as *Part of Castle Denis Common* and are described as *Rough Pasture*. These large fields probably represent the last phase of enclosure (associated with an 1821 enclosure award), with the other smaller fields to the west of these, probably enclosed at an earlier date on a more informal basis. The field-names are also largely prosaic for the most part, fairly straightforward, and indicative of late enclosure. Within and surrounding the area of the proposed development there are a few noteworthy field names, with the exception of *Barrow Close* (3633) adjacent to the western boundary of the site, especially given a cropmark identified in this approximate location on the HER.

Figure 4: Extract from the 1840 St. Columb Major tithe map. Site location is bounded in red. Note the *Shaft* indicated in the south-west corner of the proposal site.

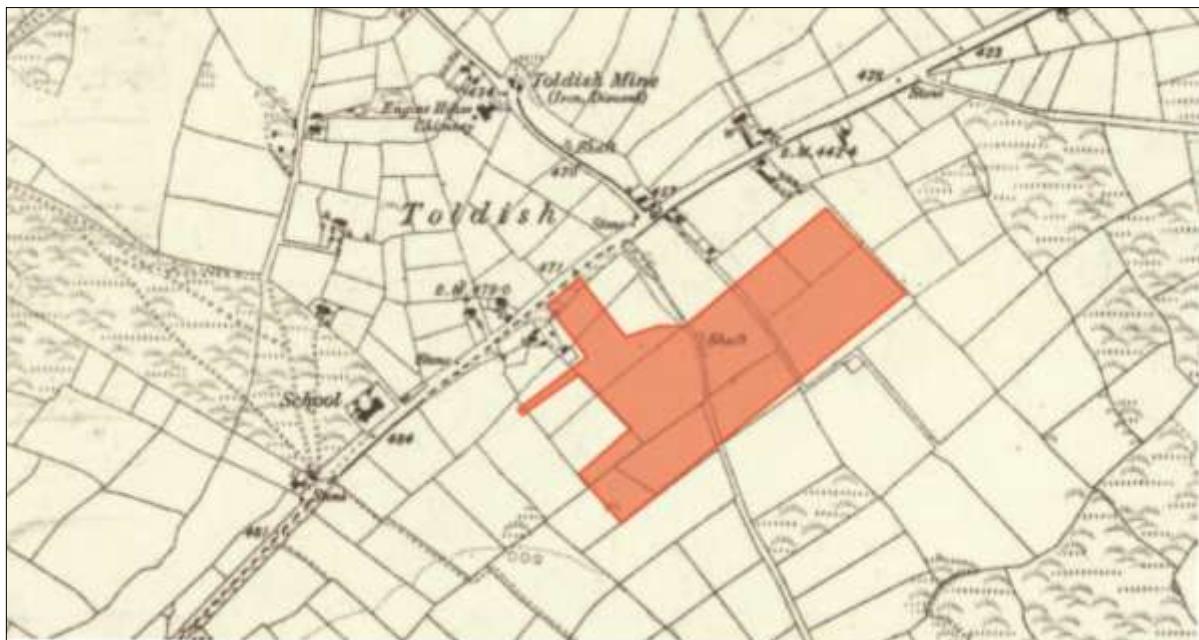
In terms of the historic fieldscape, only a few minor changes appear to have occurred between 1840 and 1888. A number of larger fields had been broken into smaller regular fields, including the eastern field which forms the proposal site, which had been sub-divided into three fields.

There is also an increase in the number of houses and buildings between 1840 and 1888. Two groups of buildings had been built to the north of the proposal site, along the old A30, the western group (Penrose Farm) are focussed upon a track, which formed a crossroads at Toldish to the north, and ran south bisecting the proposal site.

The only other aspect of note is that there is a mine shaft depicted flanking the track in the centre of the site, which was not shown on the tithe map. The shaft located in the south-west corner of the proposal site on the tithe map is in contrast no longer marked, although it is indicated as rough ground.

Figure 5: Extract from the OS 1st Edition Map, c.1888 (the site is indicated).

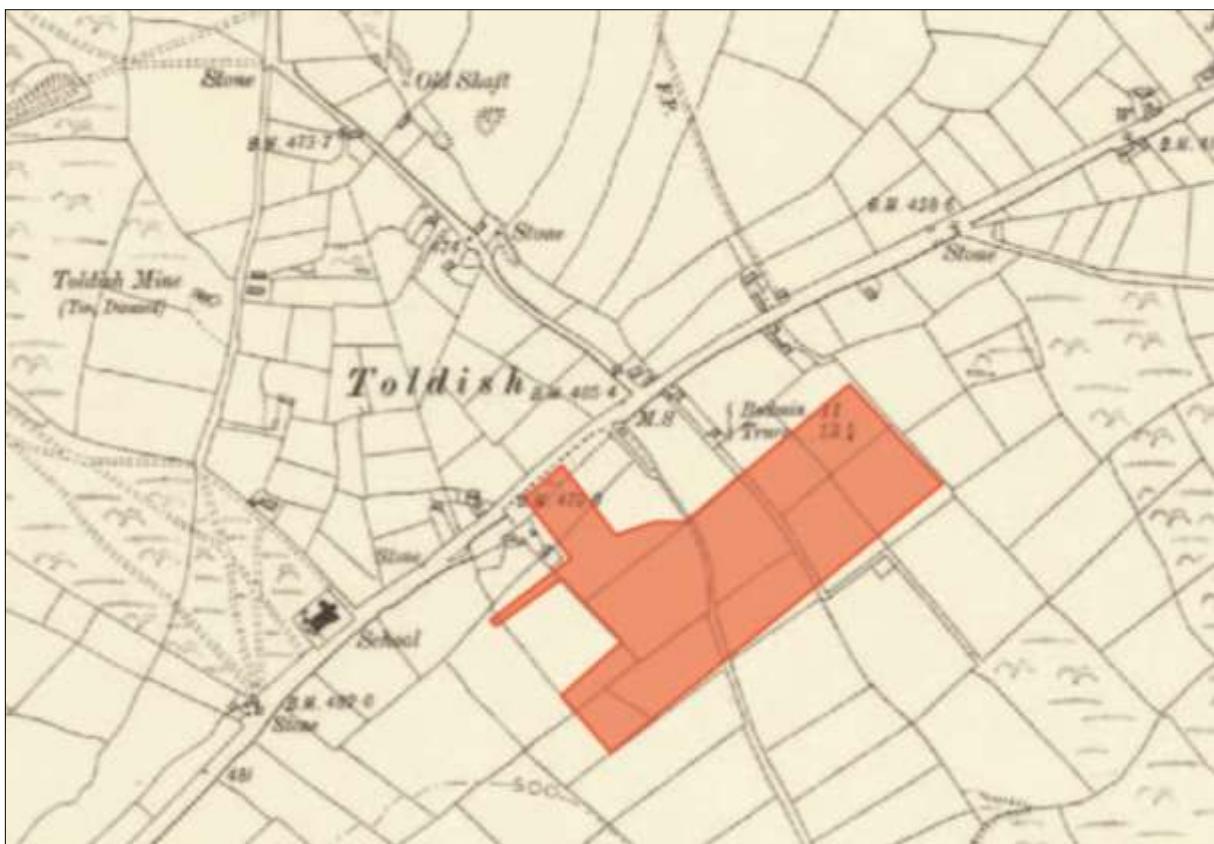
There are a few minor changes between the first and second edition OS map of 1907, with the two mine shafts on the tithe and 1st edition no longer appearing, and an additional boundary subdividing the southern of the three fields to the east of the proposal site.

Figure 6: Extract from the OS 2nd Edition Map, c.1907 (the extent of the site is indicated).

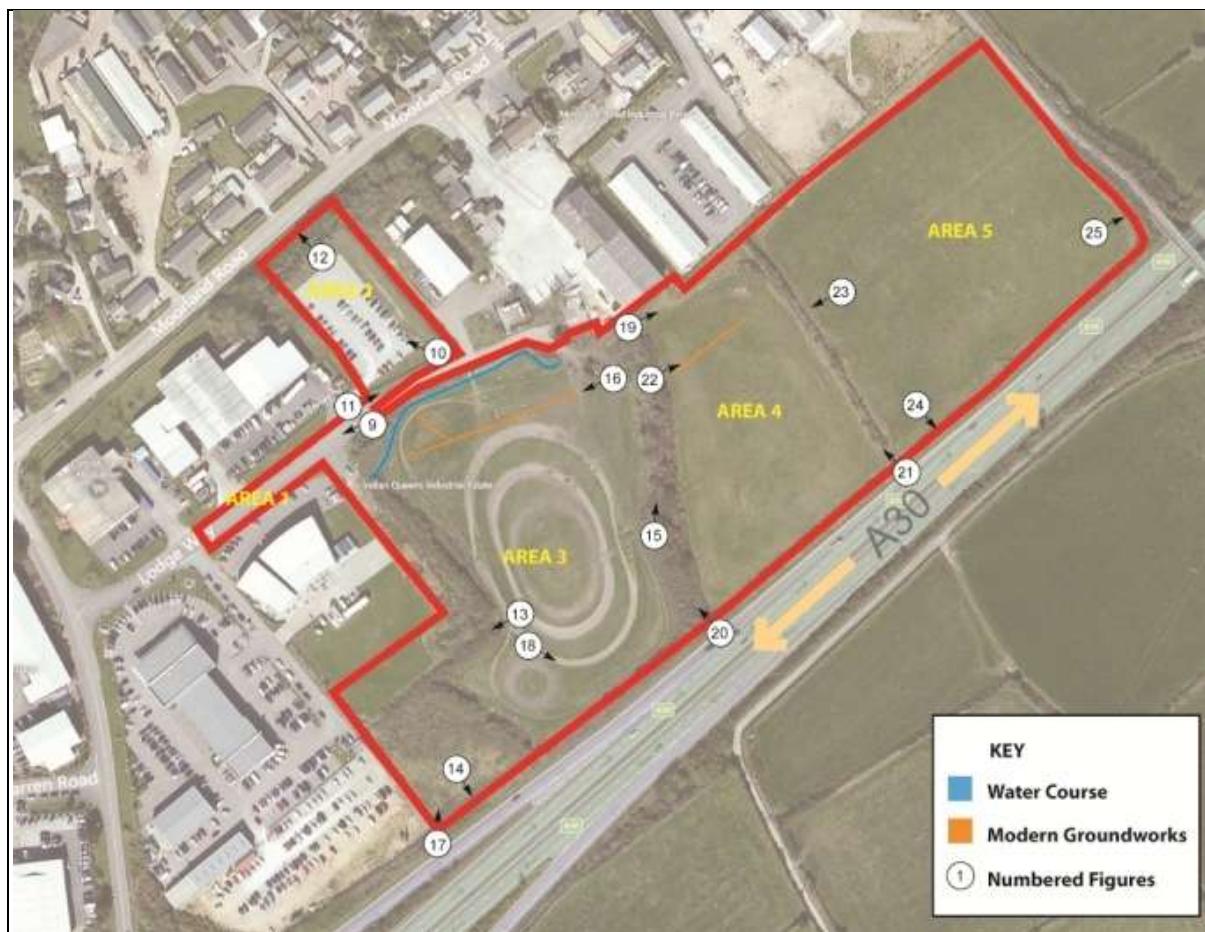
Figure 7: Walkover plan.

The site comprises three fields sloping gently down to the north-east. The fields were currently under pasture with signs of recent machine tracking activity, and were sub-divided by stone hedgebanks.

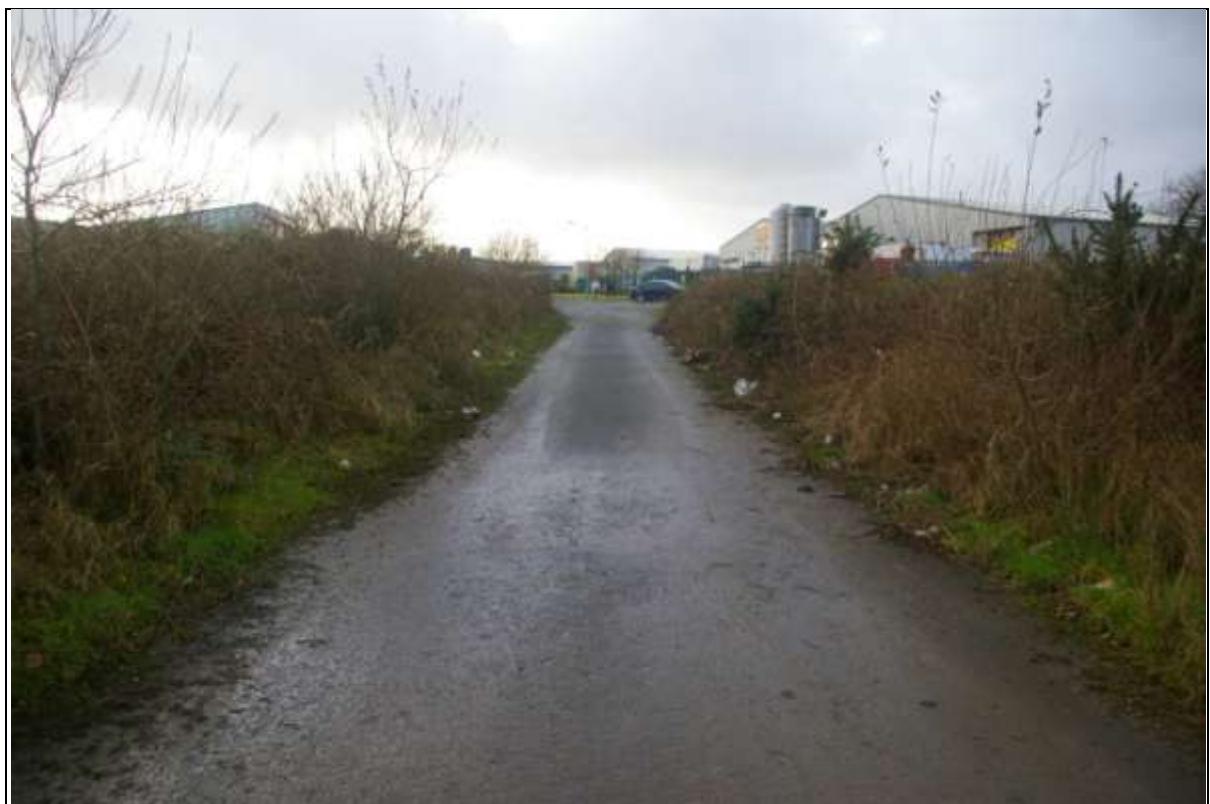
The site includes an access area (Area #1; Figure 9) running between industrial units at the western end of the current industrial estate, which currently comprises a tarmac road developing into a hardcore track before entering the main site at the north-eastern corner of Area #3. The northern boundary, between Areas #1 and #2, is an earthen bank c.1.5m high with overgrown shrubbery

including brambles. The southern boundary, with Area #3 consisted of a low earthen bank overgrown with brambles.

Figure 8: Access route, Area #1; viewed from the north-east (no scale).

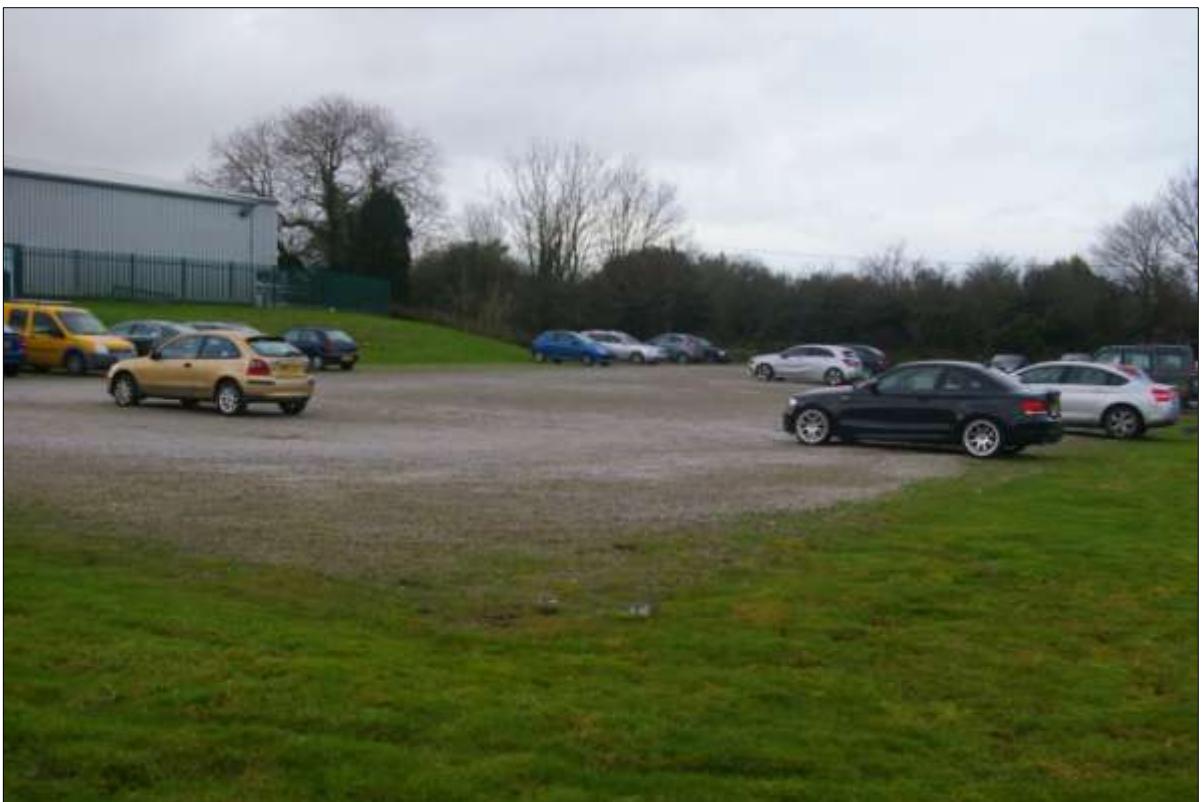
Area #2, to the north of Area #1 comprised a rectangular area currently in use as a car park with a compacted hardcore surface (Figure 10). It was bounded on the southern and eastern sides by an earthen bank c.1.5m high (Figure 11); whilst the western boundary gently slopes up to the west with a modern industrial unit standing on it. The northern boundary comprised a stone wall c.1m high (Figure 12) with an area of trees shielding it from Moorland Road (the old A30) to the north.

Figure 9: Car park Area #2; viewed from the south-east corner (no scale).

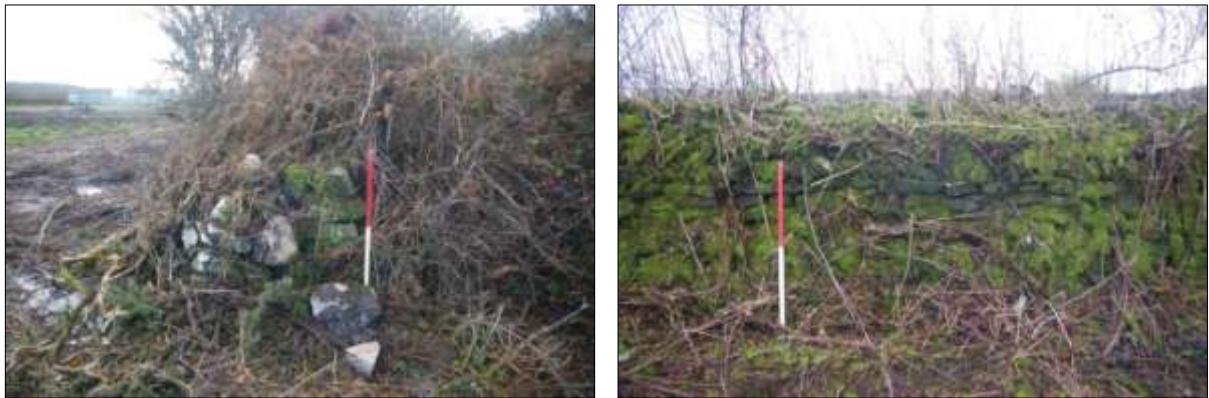
To the south of Area #1, forming the bulk of the western end of the site, is Area #3, a reverse 'L' shape in plan. It was under pasture with signs of recent machine tracking. The area was bounded to the north by a low earthen bank overgrown with brambles. The northern half of the western boundary was formed by a stone hedgebank c.1m high covered with earth and topped by a recently cut hedge and trees. The western return, forming part of the northern boundary of the western extension, similarly consisted of a stone hedgebank c.1m high and 1m wide, constructed of large stone blocks (Figure 13). The southern half of the western field boundary was composed of a c.2m high metal fence. The southern field boundary, which extended the length of the site, incorporating Areas #4 and #5 was a further stone hedgebank with flat facing stones, though with two upper courses in a herringbone pattern (Figure 14). The eastern boundary to Area #3 was composed of a curvilinear earth covered stone hedgebank c.1m high. This formed the western side of a double

Figure 12: East end of stone hedgebank forming the western half of the northern field boundary to Area #3; viewed from the north-east (1m scale).

Figure 13: Detail of stone hedgebank forming the southern boundary of Area #3; viewed from the north-west (1m scale).

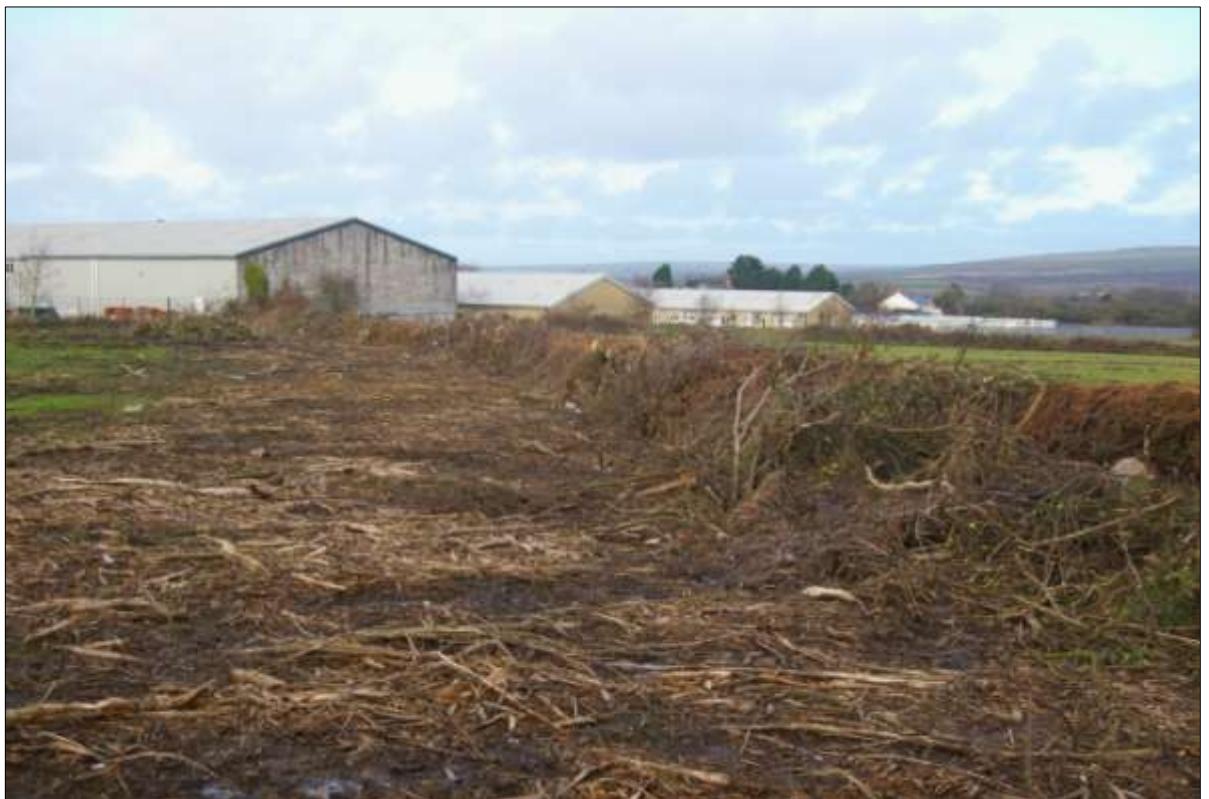
stone hedgebank which had previously had a number of trees growing between (Figure 15), and most likely represents the remains of a track/road.

Figure 14: Stone hedgebank forming the eastern boundary of Area #3; viewed from the south (no scale).

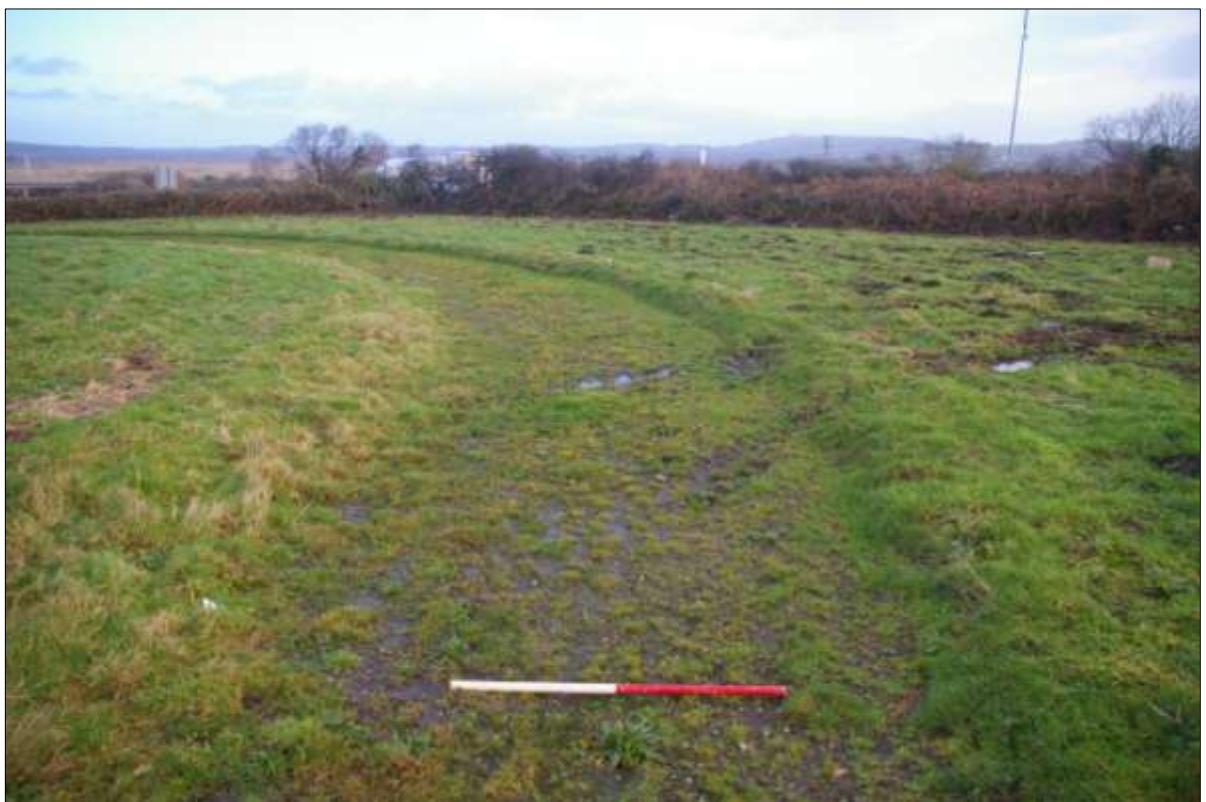
Despite being under pasture, Area #3 showed signs of recent activity. Immediately to the south of the northern boundary was a drainage channel c.0.5m wide. This had been supplemented very recently by the excavation of a further drainage channel several metres to the south, for which the ground disturbance was still visible (Figure 16). The western extension of the area, forming the foot of the 'L', showed further signs of recent disturbance of the ground (Figure 17) and is likely to relate

Figure 17: View of the outer 'track'; viewed from the north-west (1m scale).

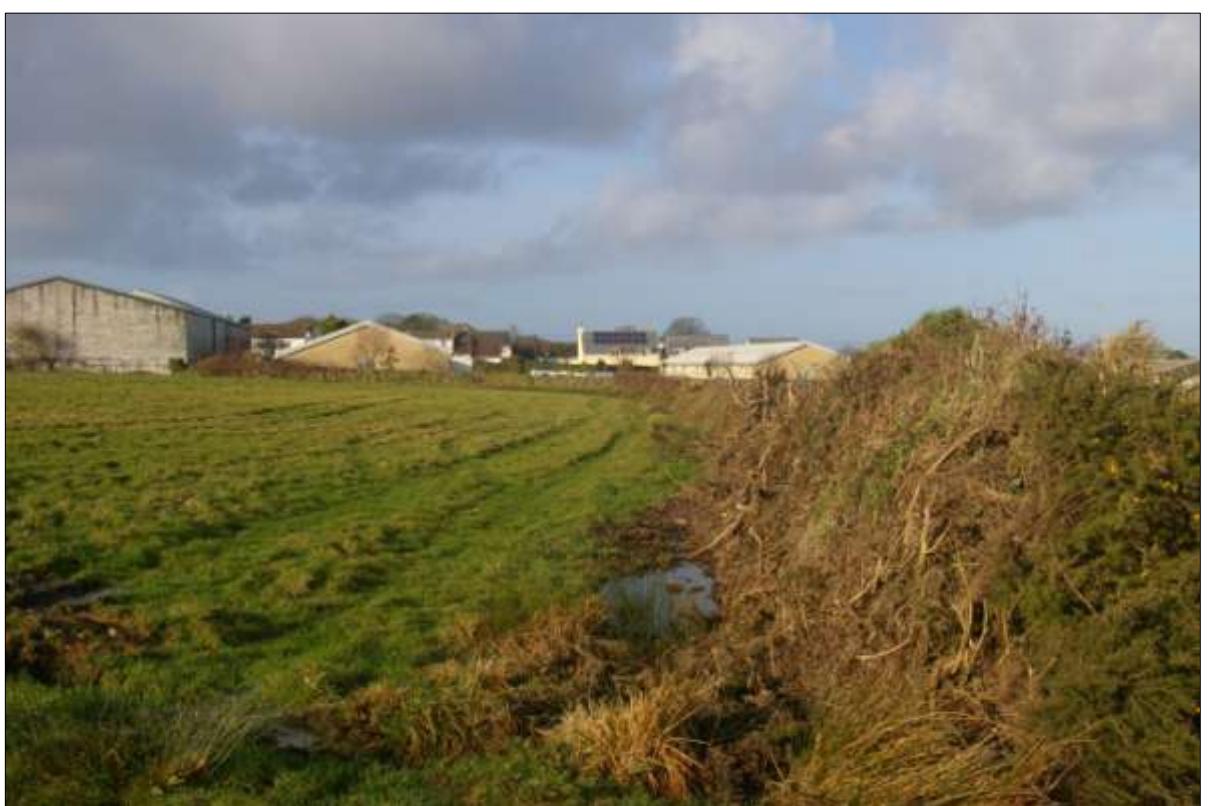
To the north-east of Area #3, on the north-eastern side of the double hedgebank was a rectangular field currently under pasture, Area #4. The eastern half of the northern boundary was composed of an earthen bank c.1m high. This had a return to the north which abutted a modern breeze block constructed building, which formed the remainder of the northern boundary (Figure 19). The western boundary was a stone hedgebank c.1m high, which itself formed the eastern boundary of a

Figure 20: The hedgebank forming the eastern boundary of Area #4; viewed from the south-east (no scale).

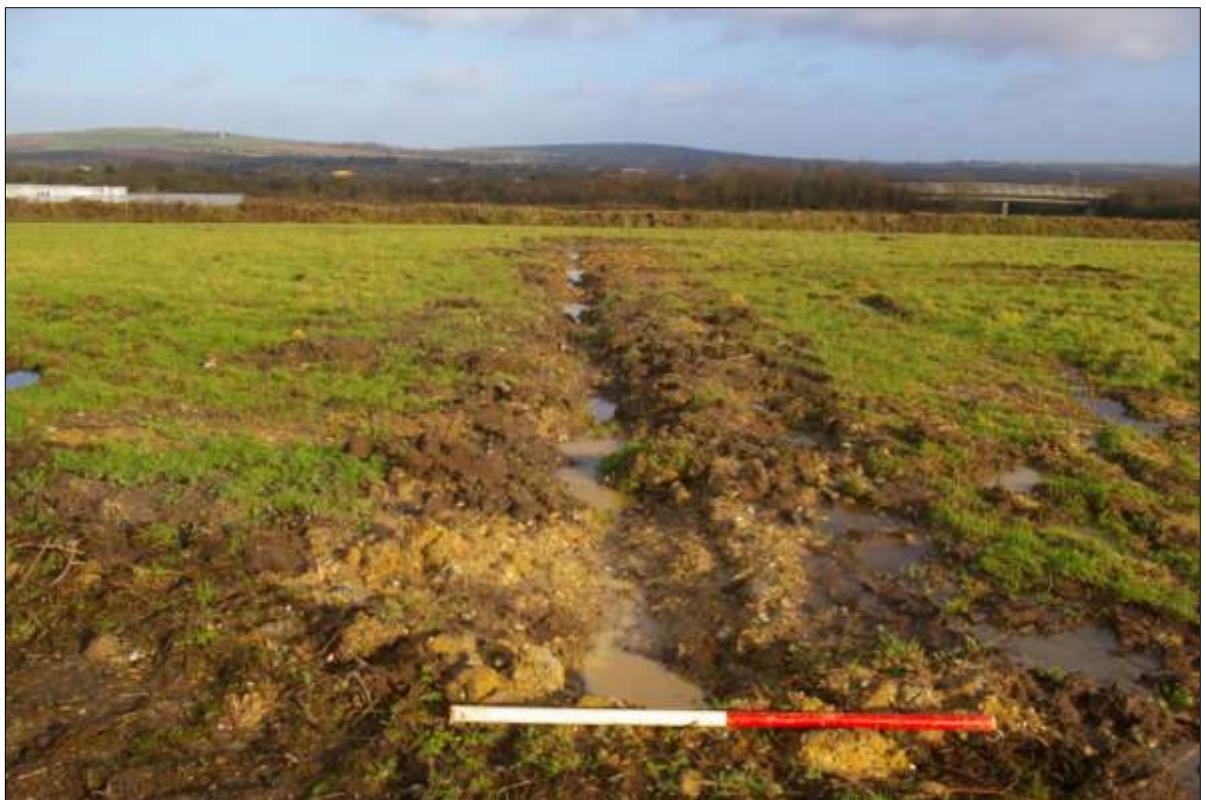
Internally, Area #4 comprised a field under pasture, though a drainage channel or pipe trench had recently been excavated approximately mid-way along its length (Figure 22).

Figure 21: View of recent ground disturbance in Area #4; viewed from the south-east (1m scale).

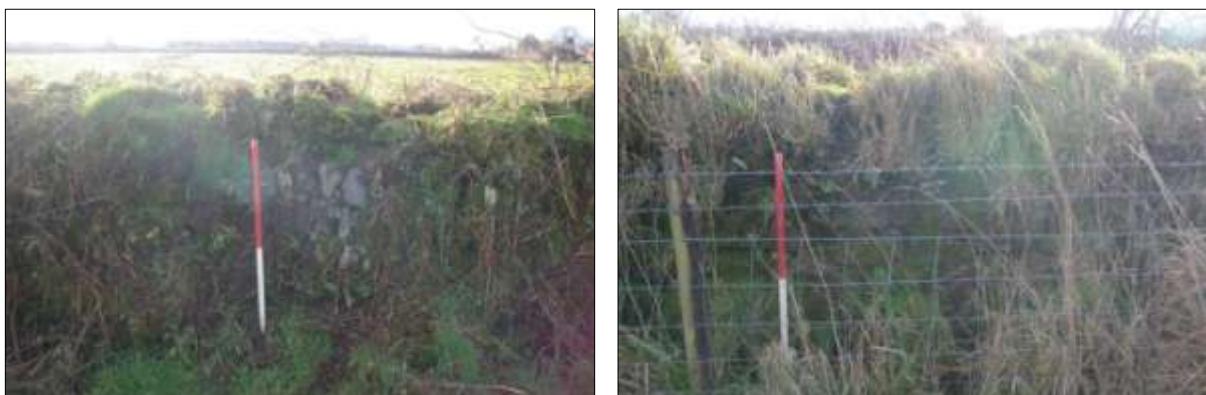
Area #5, forming the eastern limit of the site was rectangular in plan, and currently under pasture. The eastern half of the northern boundary comprised a c.2m high metal fence whilst the western half was a continuation of the northern boundary of Area #4. The western boundary was formed by the same hedgebank as the eastern boundary to Area #4 (Figure 23). The southern boundary was again a continuation of the southern boundaries of Areas #3 and #4, though a wire fence runs along its northern face (Figure 24). The southern half of the eastern boundary similarly comprised a flat faced stone hedgebank fronting an area of birch trees (Figure 25). The northern half of this boundary was formed by a wooden fence.

Figure 22: Detail of stone hedgebank boundary of Area #5; viewed from the north-east (1m scale).

Figure 23: Detail of the southern boundary of Area #5; viewed from the north-west (1m scale).

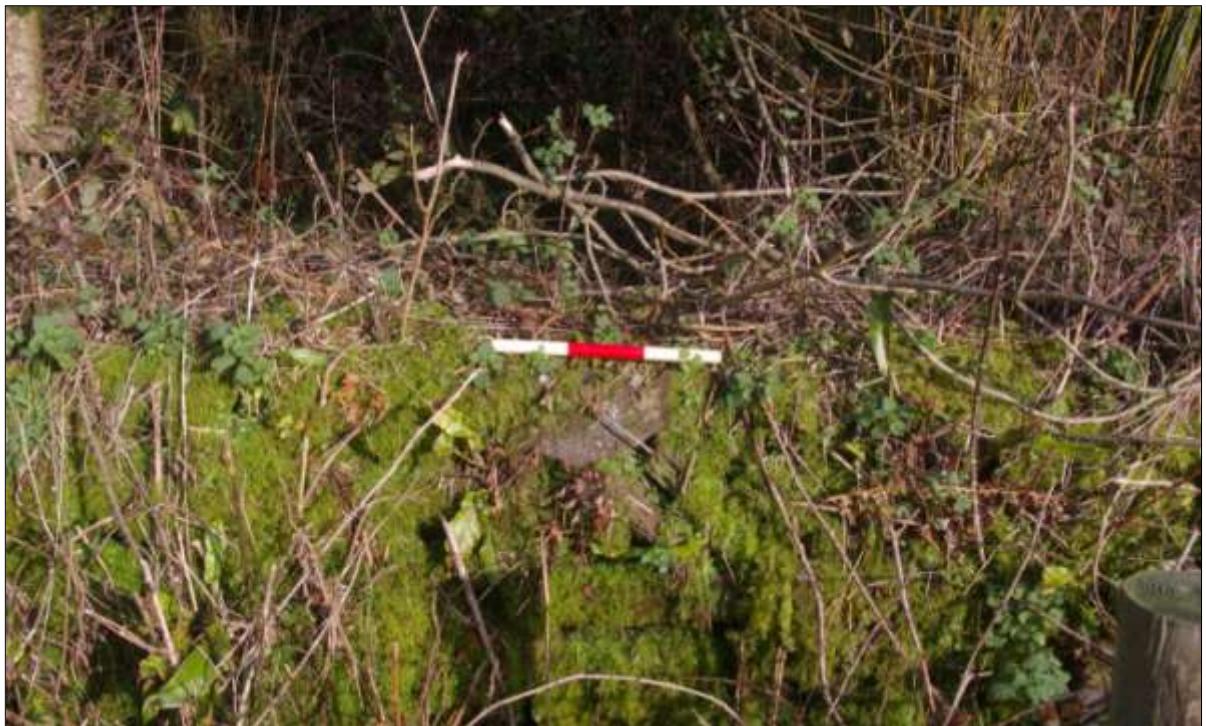
Figure 24: Detail of stone hedgebank forming the southern half of the eastern boundary of Area #5; viewed from the south-west (0.3m scale).

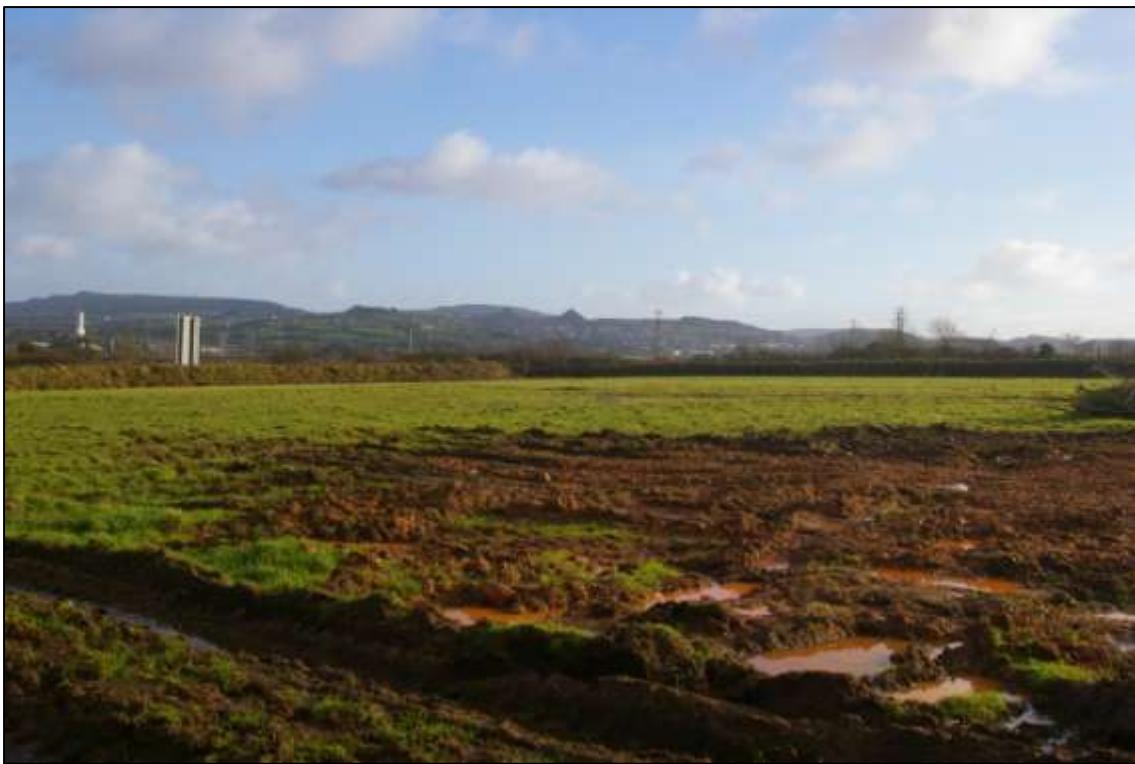
View of north-west corner of Area #4 showing disturbed nature of ground; viewed from the west (no scale).

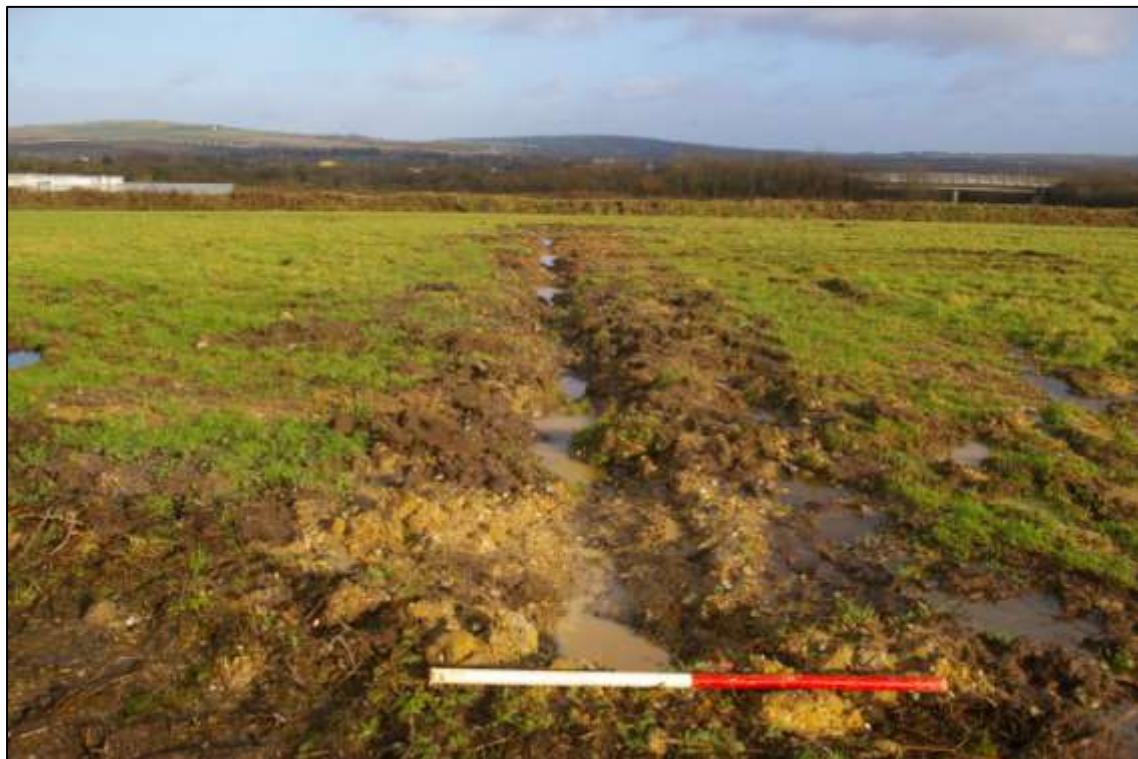
View of modern groundworks in Area #4; viewed from the south-west (1m scale).

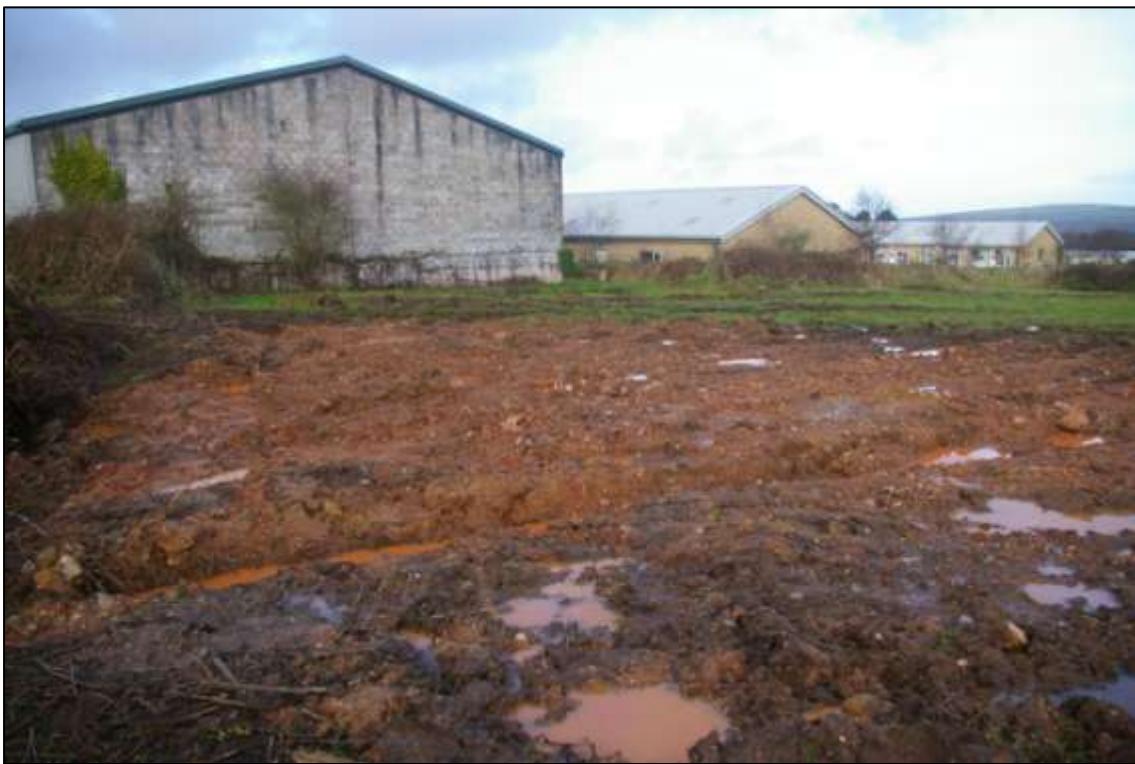
Detail of disturbed ground in north-west corner of Area #4; viewed from the south-east (no scale).

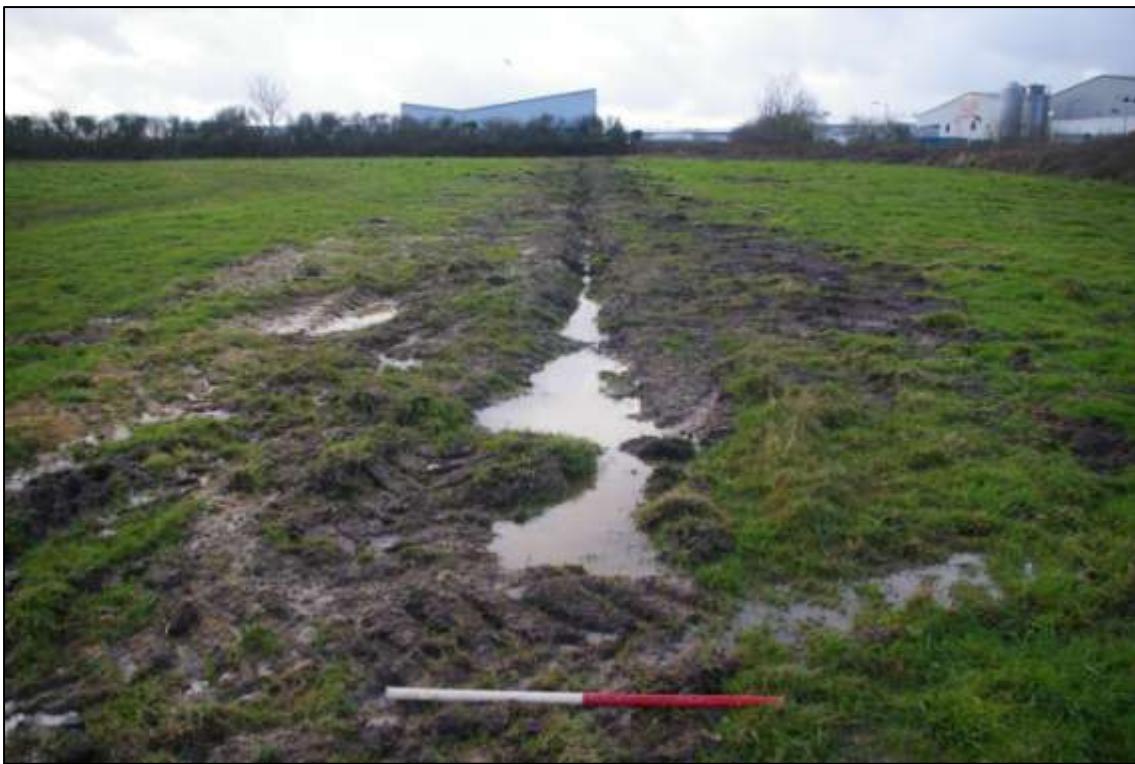
View of modern ground disturbance in Area #3; viewed from the north-east (1m scale).

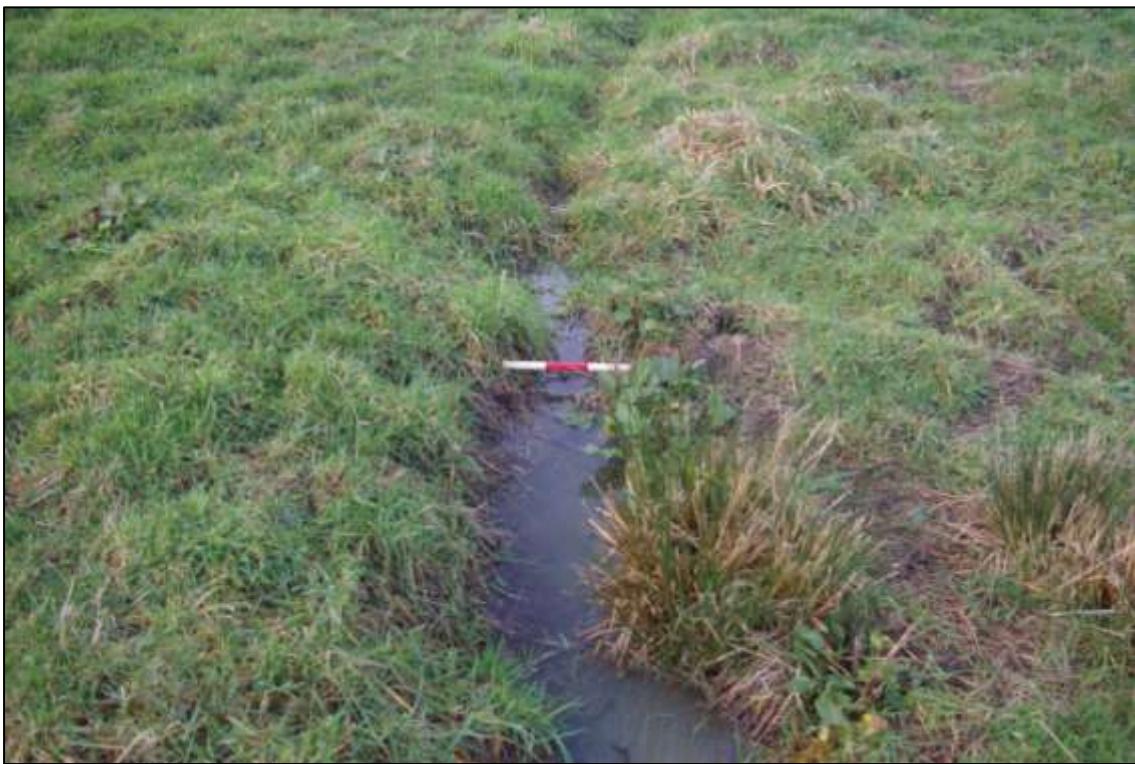
Detail of channel in Area #3; viewed from the south-east (0.3m scale).

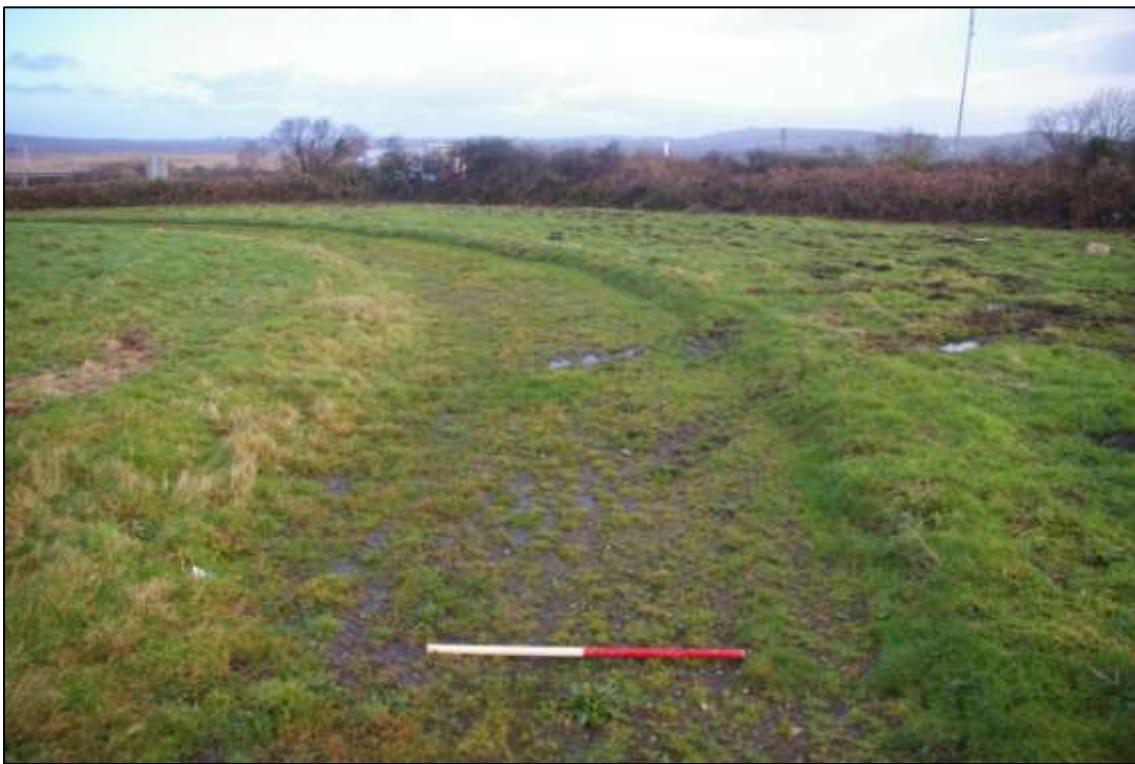
Detail of earthwork track within Area #3; viewed from the north-west (1m scale).

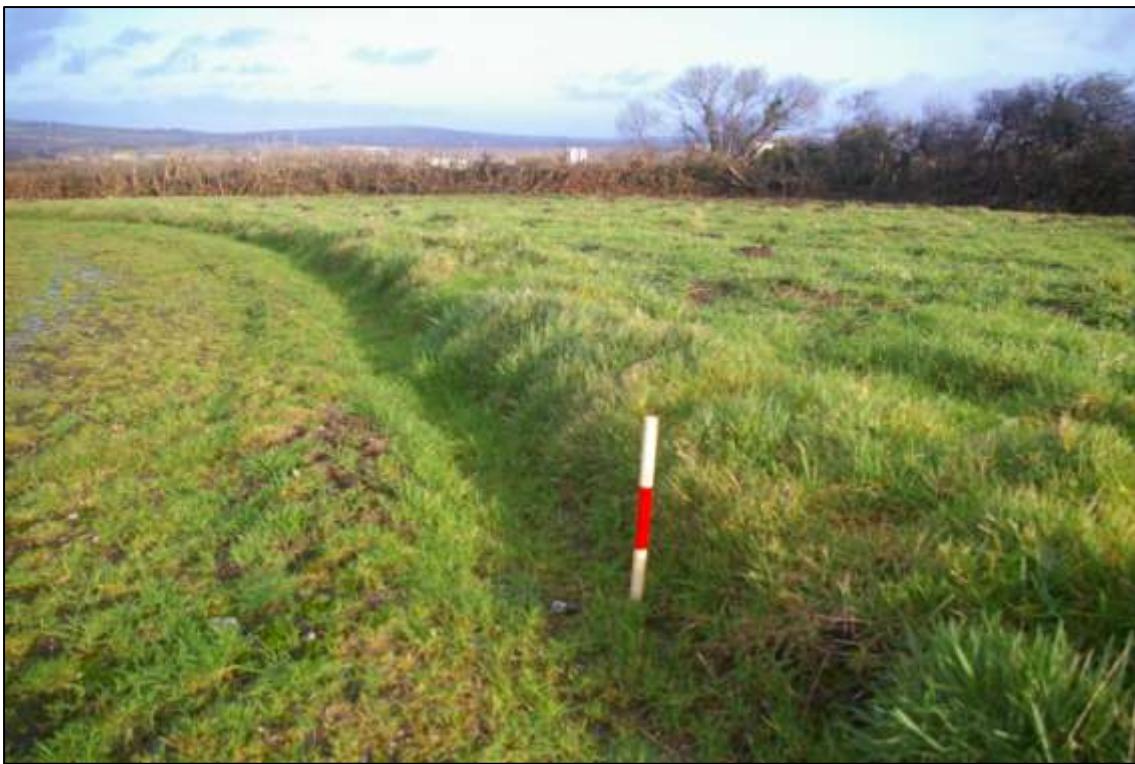
Detail of earthwork track within Area #3; viewed from the west (0.3m scale).

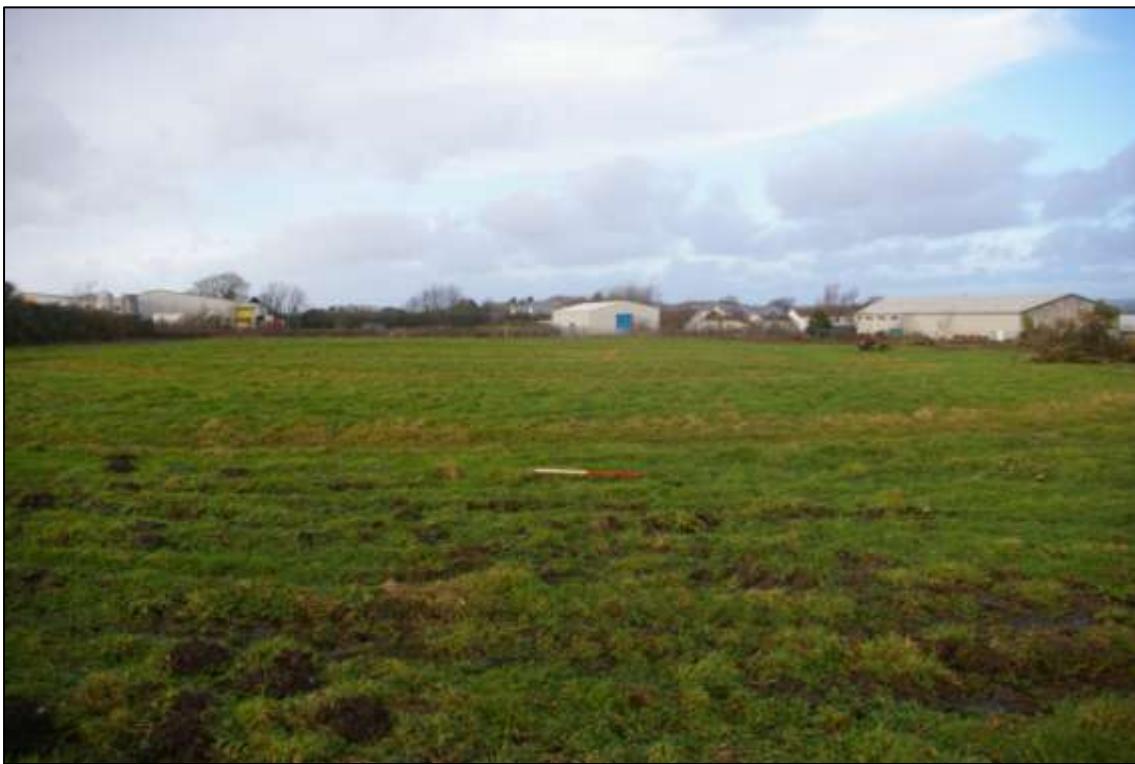
General view of earthwork track in Area #3; viewed from the south-east (1m scale).
