Devon County Council Historic Environment Record

Civil Parish & District: Hatherleigh, West Devon	National Grid Reference SS 5415 0485	Number:
Subject: Evaluation Trenches & Hedgebank Recording		Photo attached? N
Planning Application no: (H13) – 8461/2006/OKE and (H14) – 8462/2006/OKE	Recipient museum: Plymouth	
OASIS ID: Southwes1-36387	Museum Accession no: AR.2008.7	
Contractor's reference number/code: HOC06/HOC07	Dates fieldwork undertaken: Evaluation 12-18.12.2006 Recording 15.08.07/09.09.07/10.09.07/01.12.07	
<p>Description of works.</p> <p>South West Archaeology excavated 6 evaluation trenches over the three field site (see attached Fig.1 site plan), positioned to sample a range of slight earthworks visible on the ground and noted in an earlier desktop assessment (SWARCH Report 061115), but not shown on any 1880-90s OS maps.</p> <p>Trench 1. Two 1m wide gullies 2.5m apart were noted cut into the natural subsoil from beneath the dark brown topsoil. That to the SW [107] had a single clay fill that to the NE [105] contained a succession of brown silty-clay fills and irregularly stepped sides suggesting it had been re-cut or cleaned. [105] appeared to correspond to a slight, cur

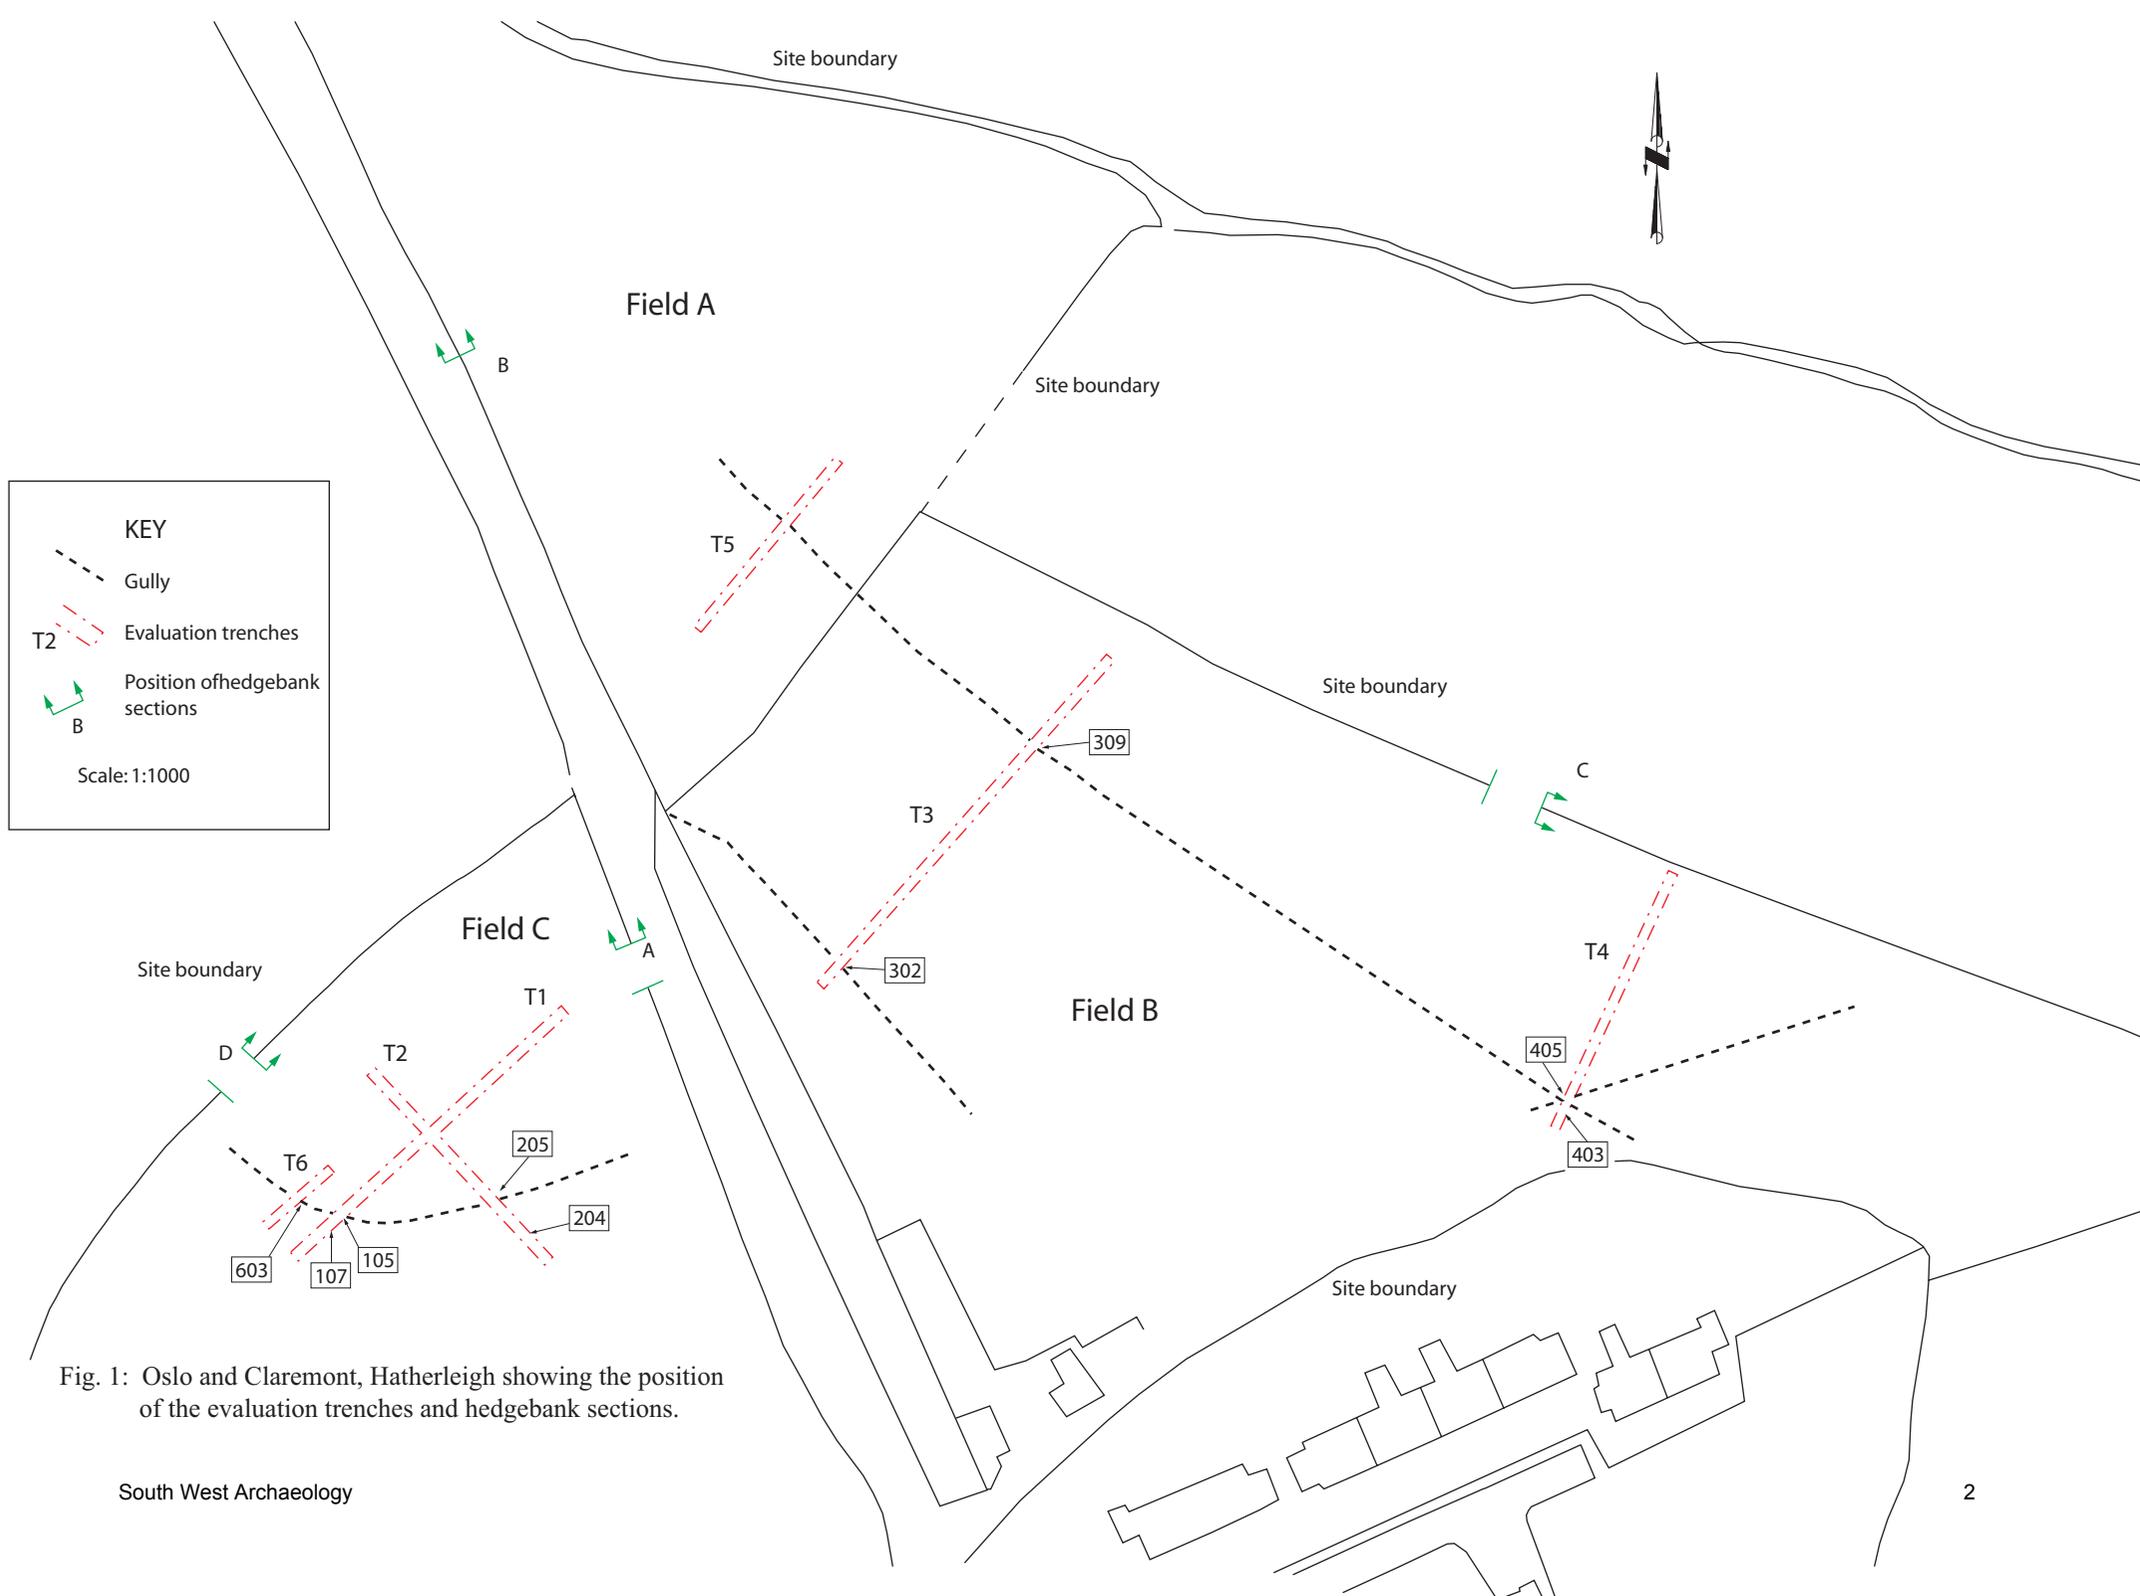
Fig. 1: Oslo and Claremont, Hatherleigh showing the position of the evaluation trenches and hedgebank sections.

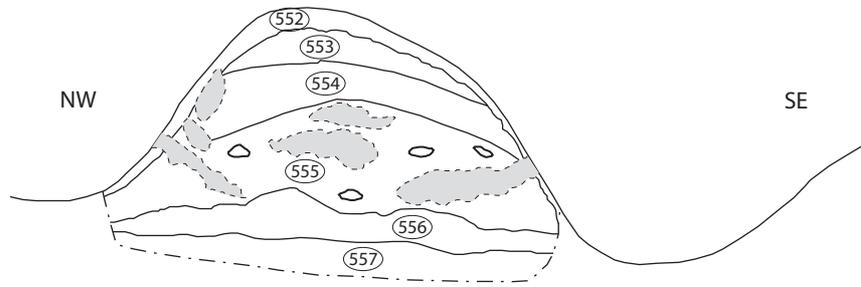
Hedgebank section D viewed from the southwest

Hedgebank section D

Context Number	Description
552	Root matter and humic soil
553	Firm pink clay
554	Reddish brown friable clay silt
555	Orange silty clay
556	Buried soil, grey orange/brown with mineralisation
557	Natural, dense red/orange clay

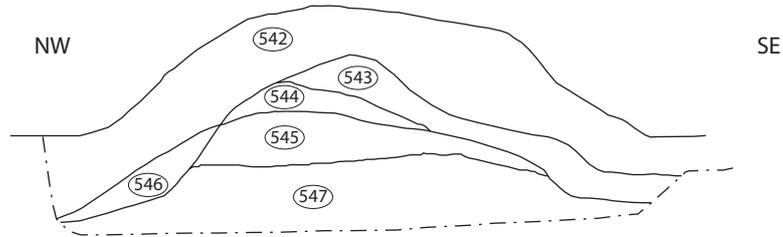
Hedgebank section C viewed from the northeast

Hedgebank section C

Context Number	Description
542	Topsoil
543	Reddish orange sandy clay
544	Friable orange clay, few inclusions (post med sherd)
545	Mid brown clay some small black stones (<5%)
546	Similar to topsoil – probably represents initial slippage to NW
547	Natural gritty red clay

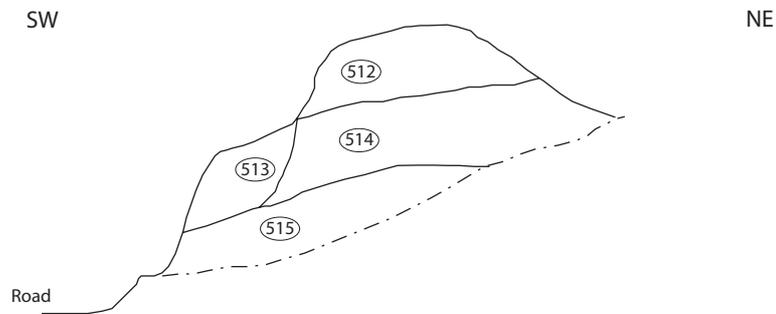
Hedgebank section B viewed from the southeast

Hedgebank section B

Context Number	Description
512	Topsoil
513	Topsoil - slippage
514	Mid-brown red clay, fairly compact
515	Natural gritty red clay

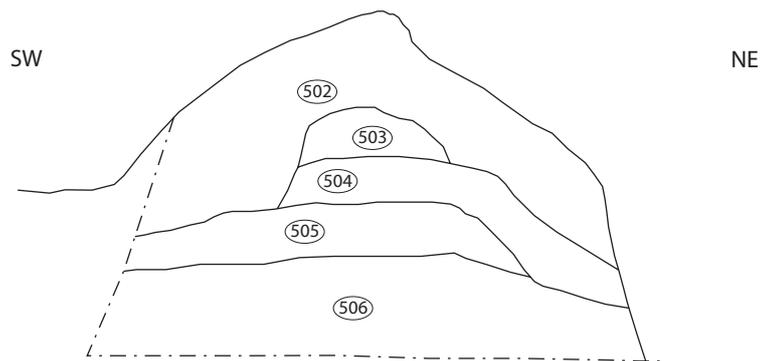
Hedgebank section A viewed from the southeast

Hedgebank section A

Context Number	Description
502	Topsoil
503	Reddish-beige to mid-brown sandy clay
504	Beige-brown clay with red flecks
505	Compact beige-red clay
506	Natural gritty red clay

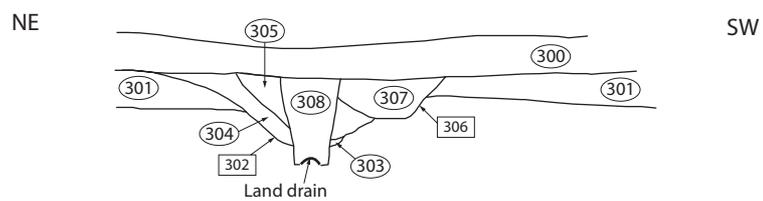
Gully 302 in trench 3

Gully [302]

Context Number	Description
300	Topsoil
301	Subsoil
302	Cut ditch/gully
303	Bottom fill of ditch/gully (302)
304	Fill over (303)
305	Fill over (305)
306	Cut (re-cut) to SW of (302)
307	Fill of (306)
308	Cut of land drain
309	Cut of shallow gully not on section drawing
