# COOMBE FARM BRIXTON DEVON

Results a Desk-Based Assessment  
&  
Historic Building Recording

Report No.: 110131  
Date: 31.01.11  
Authors: B. Morris  
E. Wapshott  
S. Walls

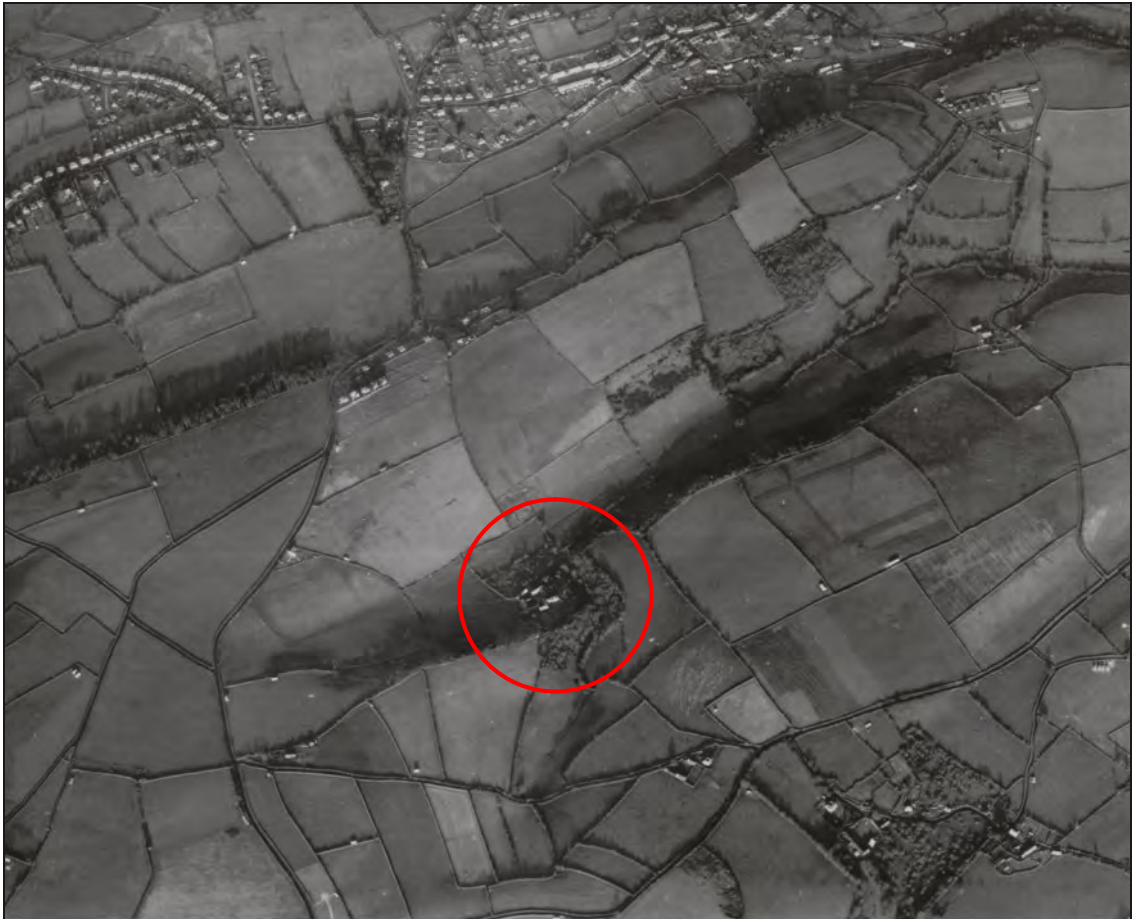
Figure 3: 1946 RAF aerial photograph of Coombe Farm and surrounding area (site is indicated). Note the rolling topography and the distinct linear comb the farm occupies (RAF).

While this incident makes no reference to the location of the said curtilage, the Augustinians do have something of a reputation as agricultural improvers (Fizzard 2008, 71-2). It is possible that, given the peripheral location of Coombe within the parish (and see Figure 3 and Figure 4), the original grant of two furlongs was of unenclosed common pasture which they then subsequently enclosed. Such a move would have enraged those people with an existing right to the land – including the manorial lord, the Abbot of Tavistock – and this could have prompted Ada's direct action.

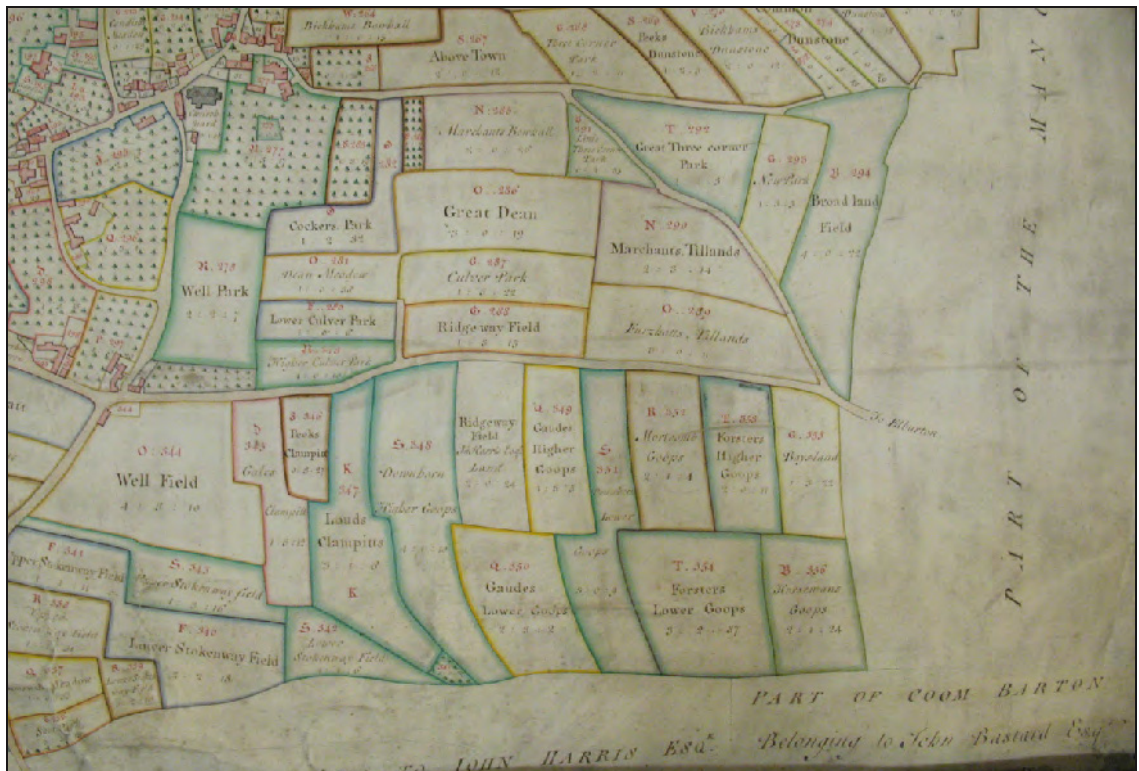
Figure 4: The south-east corner of the Manor of Plymstock, as depicted on the estate map of 1755 (DRO).

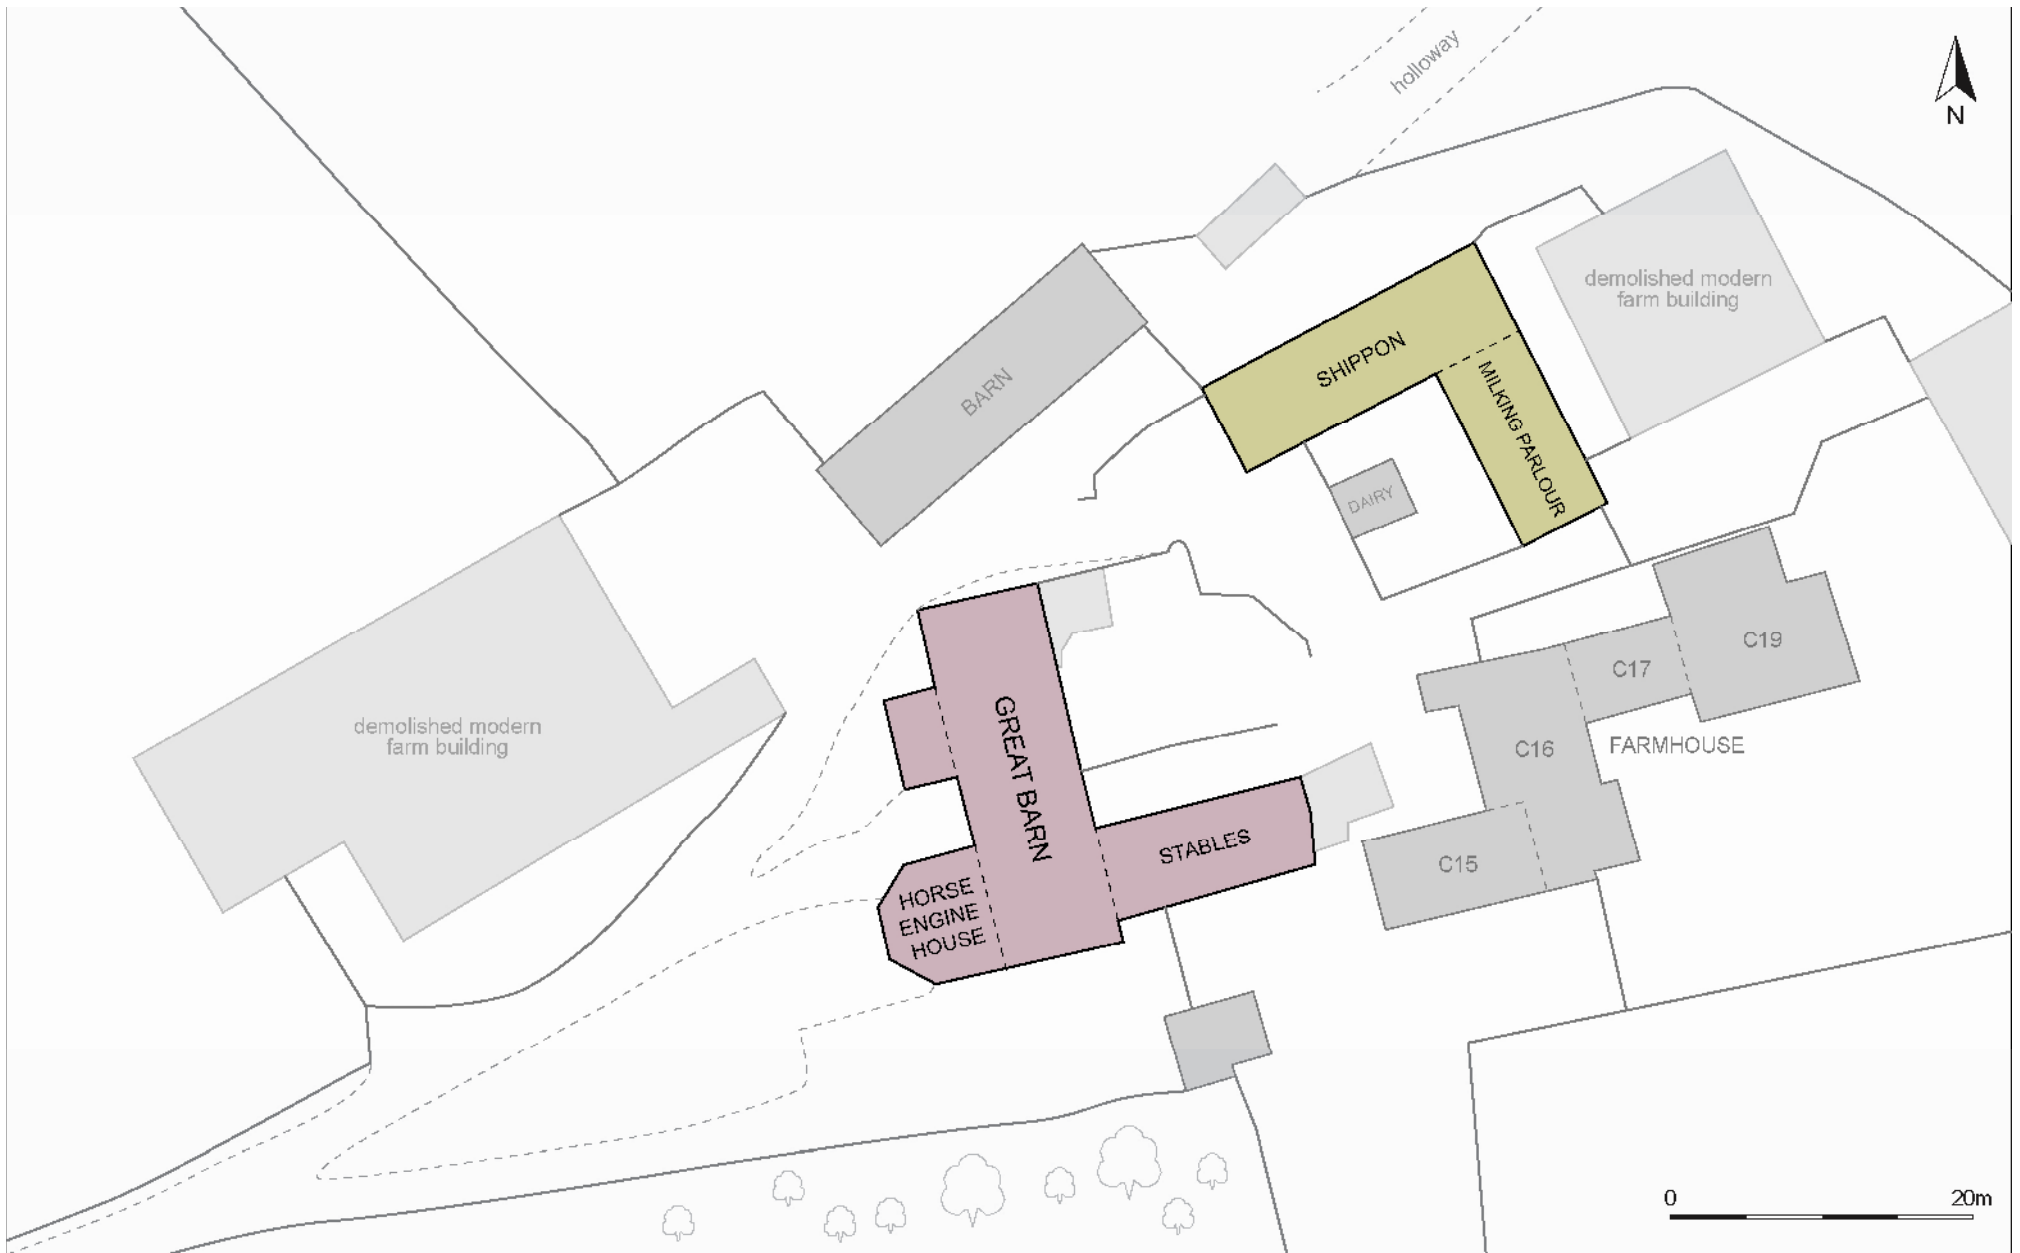
Figure 5: Coombe Farm, Plymstock, showing the layout of the farm and the location of the recorded buildings.

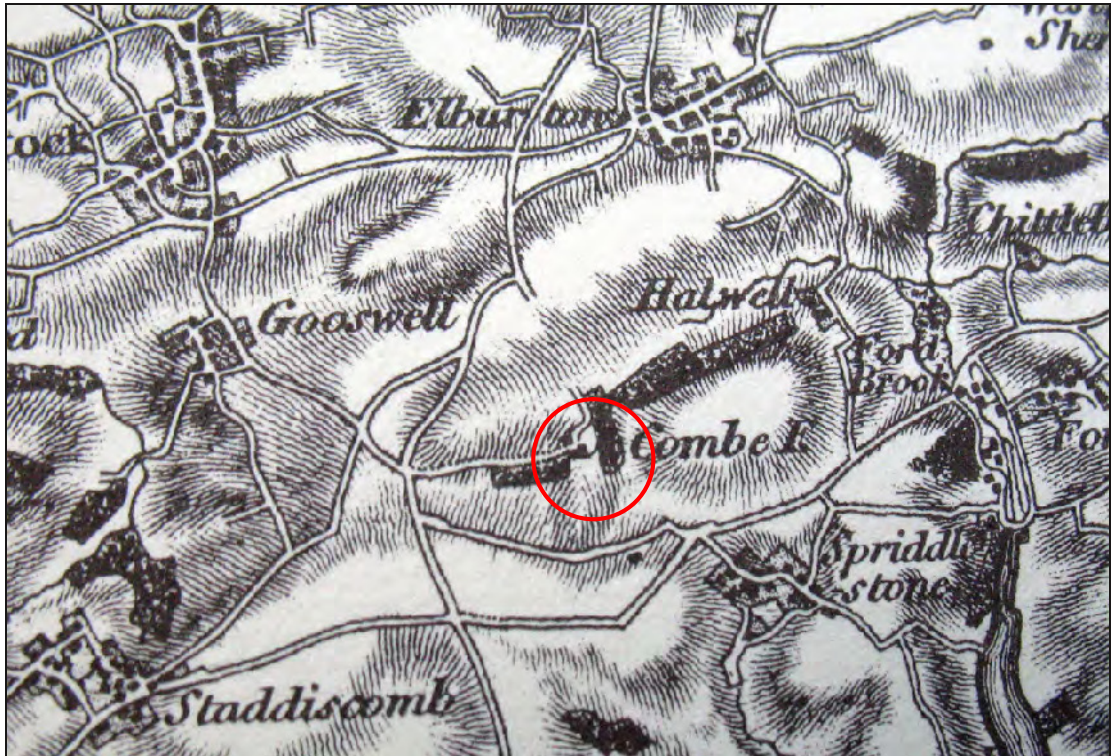
Figure 6: Extract from the Ordnance Survey 'Old Series' one inch map surveyed c. 1805, published 1809. The location of Coombe Farm is indicated (WCSL).

The 'Old Series' Ordnance Survey one inch map surveyed around 1805 and published 1809 (Figure 6) provides only the location of the buildings, but does not represent them with any accuracy.

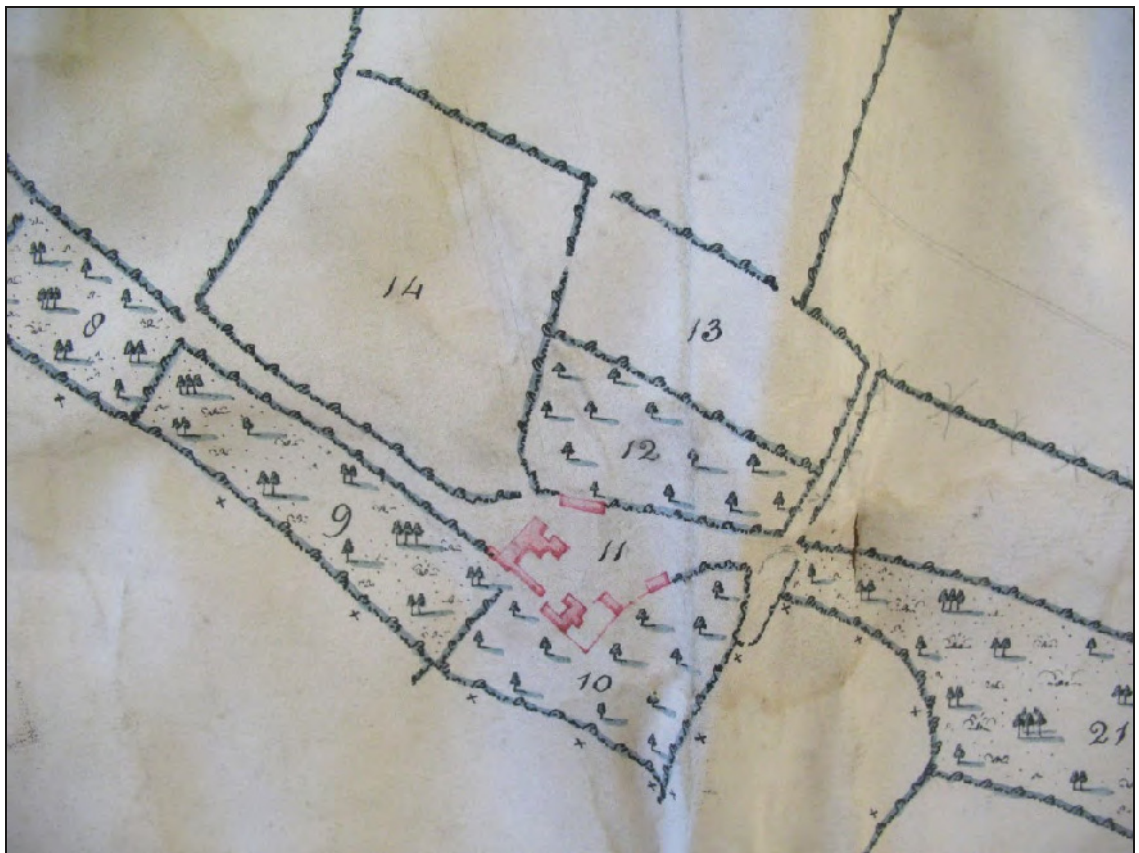
Figure 8: Extract from an estate map *c.* 1770 showing Coombe Farm (DRO).

The Brothers Greenwood map of 1820 is similarly sparing with useful information (Figure 7), and the earliest available map to show Coombe Farm in any detail is an estate map surveyed *c.*1770 (Figure 8), which appears to provide a relatively accurate depiction of five buildings. Figure 8 shows the Great Barn, with adjoining Horse Engine House (or perhaps a predecessor) and the Stables, but not the Milking Parlour or the Shippon. Other buildings are shown adjoining the Great Barn to the east, but these no longer survive.

At this date the domestic range (the southernmost building) had apparently already acquired additions to what the English Heritage listing document (see Appendix 5) records as a typical post-medieval farmhouse on the three-rooms-and-cross-passage plan. The map appears to show the house once possessed a north wing, a feature that disappeared by 1842.

Three other buildings are shown to the north and east of the farmhouse and Great Barn, one of which is still extant, but these do not correspond with the Shippon or the Milking Parlour.

evidence (see above) indicated it must have been built between *c.*1770 and 1842 (see Figure 8 and Figure 9). This building was converted into a modern milking parlour, and has lost all other period features. The Shippon retains its high quality late 19<sup>th</sup> century scissor-truss roof (as seen in the Stables), and first appears on the 1905 OS 2<sup>nd</sup> edition 1:2500 scale maps (see Figure 11). The Shippon was constructed with its presentation side to the courtyard, with more basic stonework to the north, east and west. Internally, this building is largely intact, apart from the removal of the horse stalls. Details such as chamfered timbers and recessed doorways to block drafts show a high level of consideration was put into its construction.

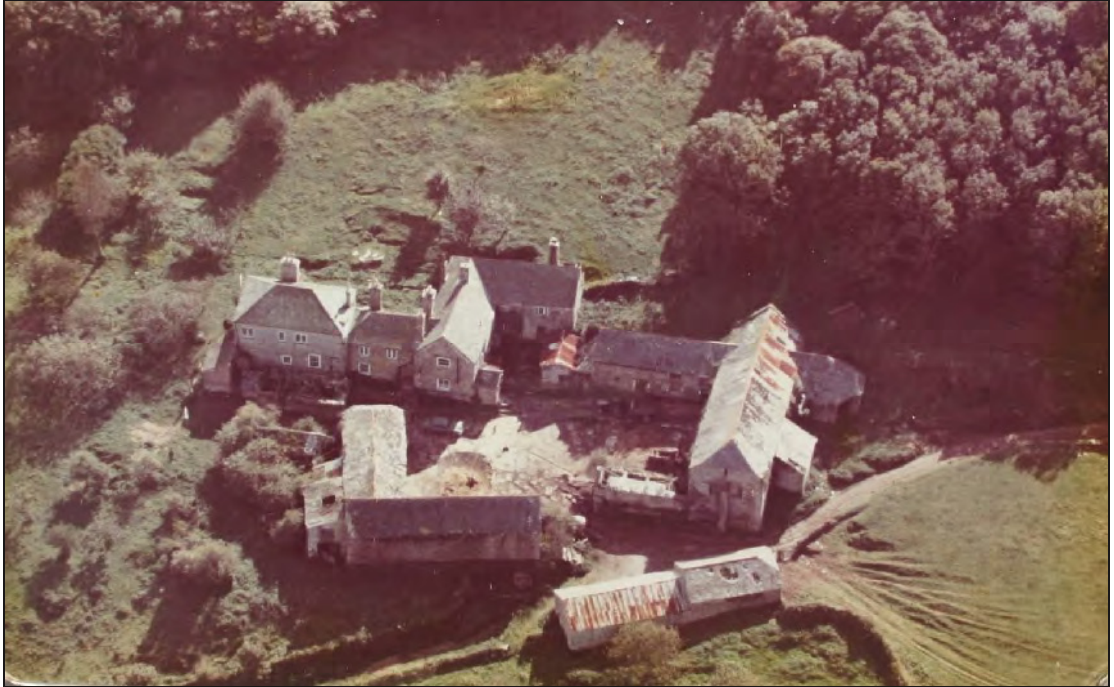
Figure 14: The farm buildings at Coombe Farm, during the later 1960s (MacBean family).

Later 20<sup>th</sup> century developments include the erection of a large double-pile building to the west and two buildings to the east. Some roofs have been replaced with modern materials. The historic core remains however essentially unaltered (see Figure 14 and Figure 15 ).

stonework. The concrete repair also features a window, with timber lintel and glazed with a single sheet of corrugated plastic. There are a few possible put-log holes to the north end of the elevation, but these are more likely to be the sockets for the rafters of earlier lean-to structures (see Figure 14). The wall of the Milking Parlour has been partially tied into the east elevation of the Shippon at the north end.

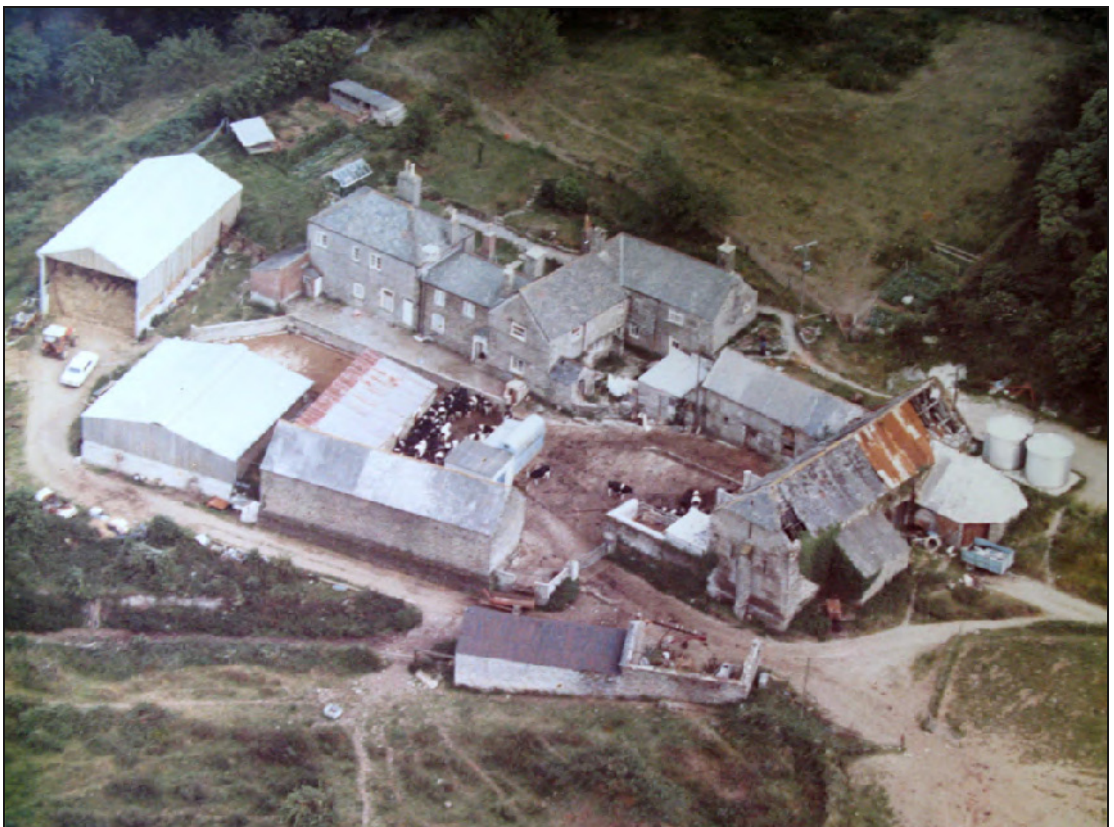
Figure 15: The farm buildings at Coombe Farm, during the early 1970s (MacBean family).

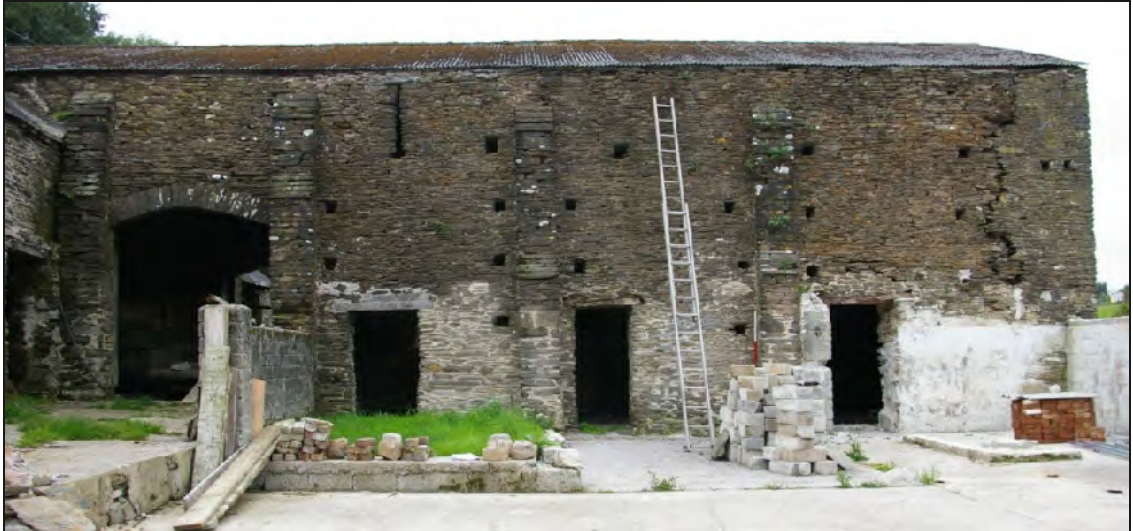
There is a projecting string course at wall-plate height (also found on the west elevation), although this survives only within the Stables. The elevation has a number of put-log holes

arranged in parallel lines along the length of the barn, either side of the buttresses. At the north end there are two small pigeon holes at the same height of those on the north elevation. The elevation is partly rendered and white-washed at the north end, where modern concrete block buildings, including a dairy, have been removed. There is a large vertical structural crack at the north end of the elevation, where the north gable was rebuilt.

Figure 16: East Elevation of the Great Barn, viewed from the east (scale 2m).

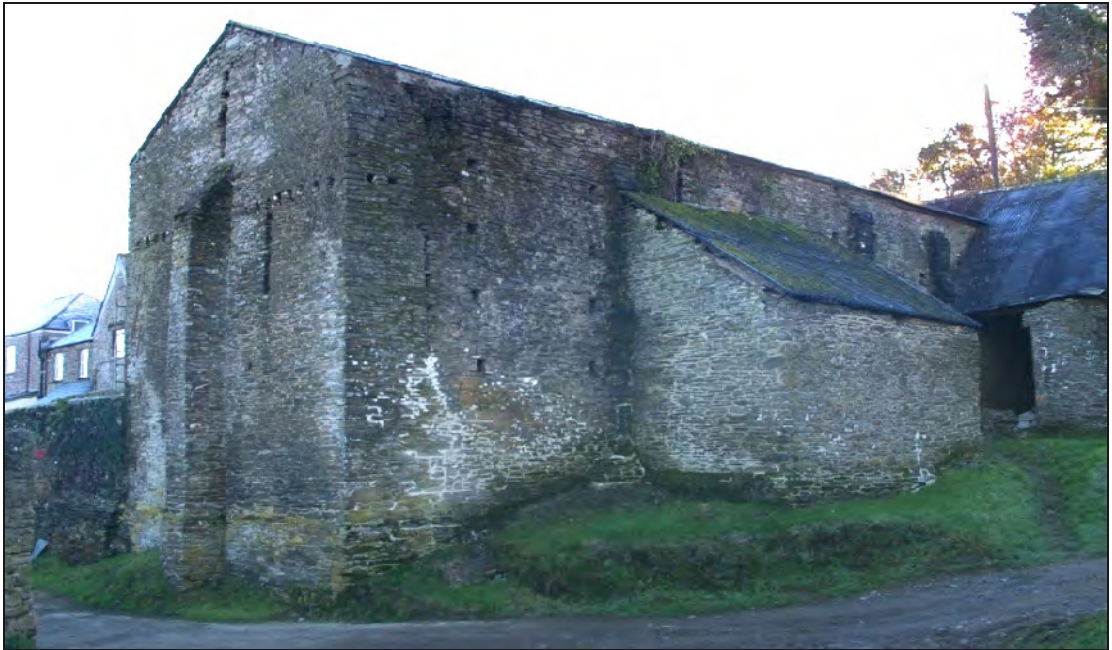
The gable-end elevation of the Great Barn, facing north (see Figure 17), fronts onto the modern driveway to the main farmyard and valley to the north. A rubble slate-stone elevation, stepped out at the base, under a corrugated asbestos roof, abutted by the farmyard wall to the east. Ground levels have been reduced to expose the rougher foundations of the gable at the north-west corner. With three slit air-vent openings, in a triangular arrangement, with a single row of 16 pigeon holes running above the bottom two openings. A large central buttress running out beneath the central upper opening, this is also stepped at its base. There is only one small possible put-log hole to the right of the main buttress. The obvious vertical structural cracks at the northern end of east and west elevations, the difference in stonework, the presence of pigeon holes, and the markedly different style of buttress indicate this elevation has been rebuilt. The rebuild of the northern gable indicates the Great Barn has either been extended (from 10 bays to 10.5 bays), or was reduced (from 12 bays to 10.5 bays). It is possible the vertical cracks on the west elevation belong to a second set of threshing doors in a much larger structure, but given the fall of the land this seems unlikely.

Figure 17: North and west elevations of the Great Barn, viewed from the north-west.

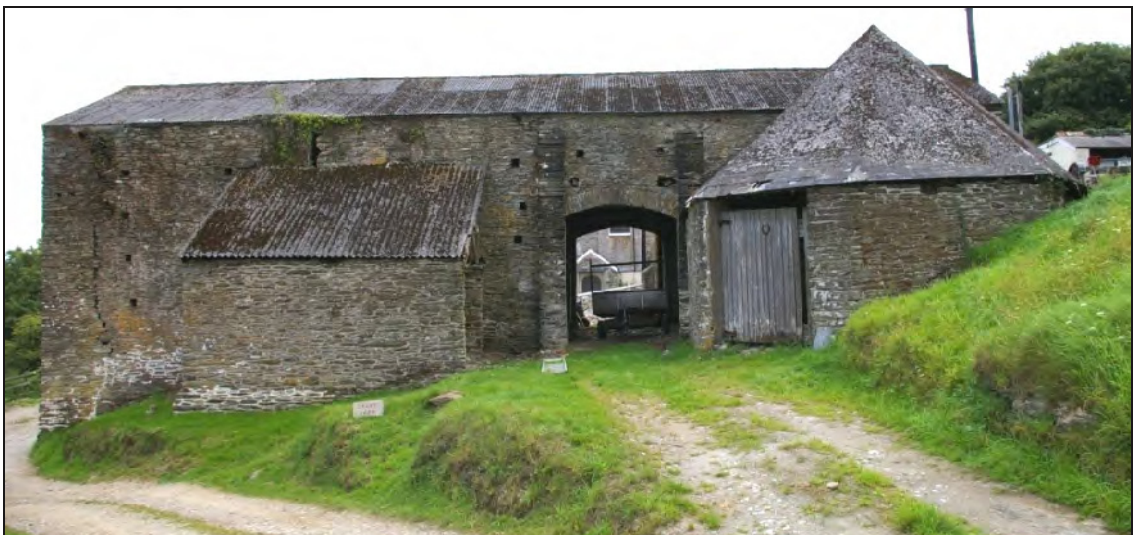
The elevation is buttressed, with stepped buttresses: the first buttress has been removed from the north end and the scar can be seen on the wall, the second is built into the north wall of the Lean-To and the third is located within the Lean-To, its top portion having been removed above the roof-line. The fourth and fifth buttresses flank the threshing door. The elevation has a number of put-log holes arranged in parallel lines along the length of the barn, either side of the buttresses, and there are two pigeon holes at the north end at the same height as those on the northern elevation. There is a large vertical structural crack at the north end of the elevation, this appears to show some evidence for quoins, and the straight join is poorly tied into the rest of the wall.

Figure 18: West elevation of the Great Barn, viewed from the west.

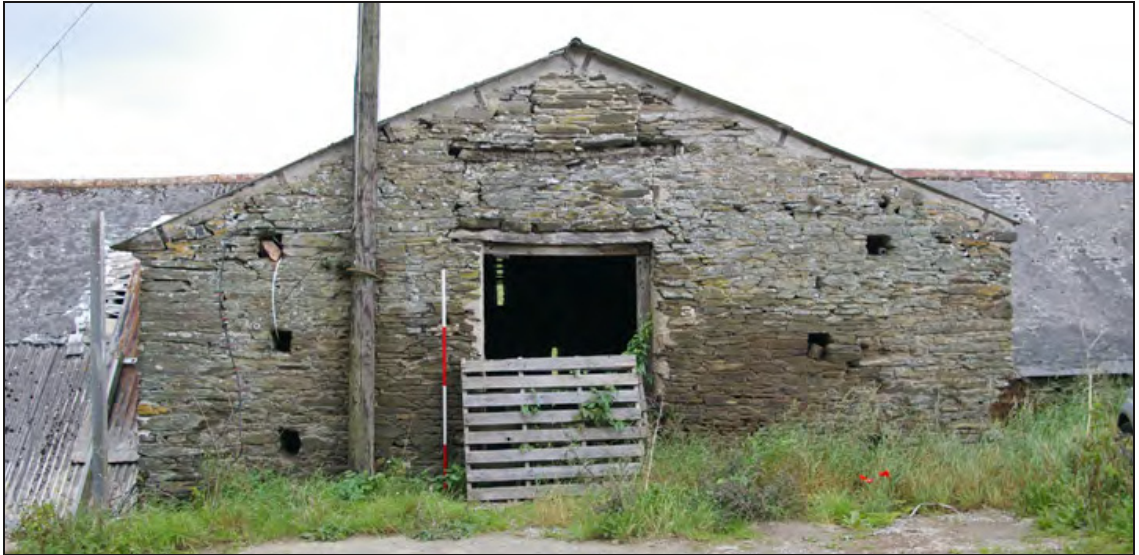
A gable-end elevation of the Great Barn, facing south (Figure 19), built into the slope of the hillside, fronting onto a small levelled upper yard area. A rubble slate-stone elevation with lime mortar, showing repairs towards the apex of the roof, with substantially larger more blocky stone quoins to the western corner and a large central opening with timber lintel, which is partly blocked above, with a secondary timber lintel. The roof is corrugated asbestos. This elevation has a number of put-log holes arranged in parallel lines either side of the door. The ground level appears to have been artificially raised.

Figure 19: South elevation of the Great Barn, viewed from the south (scale 2m).

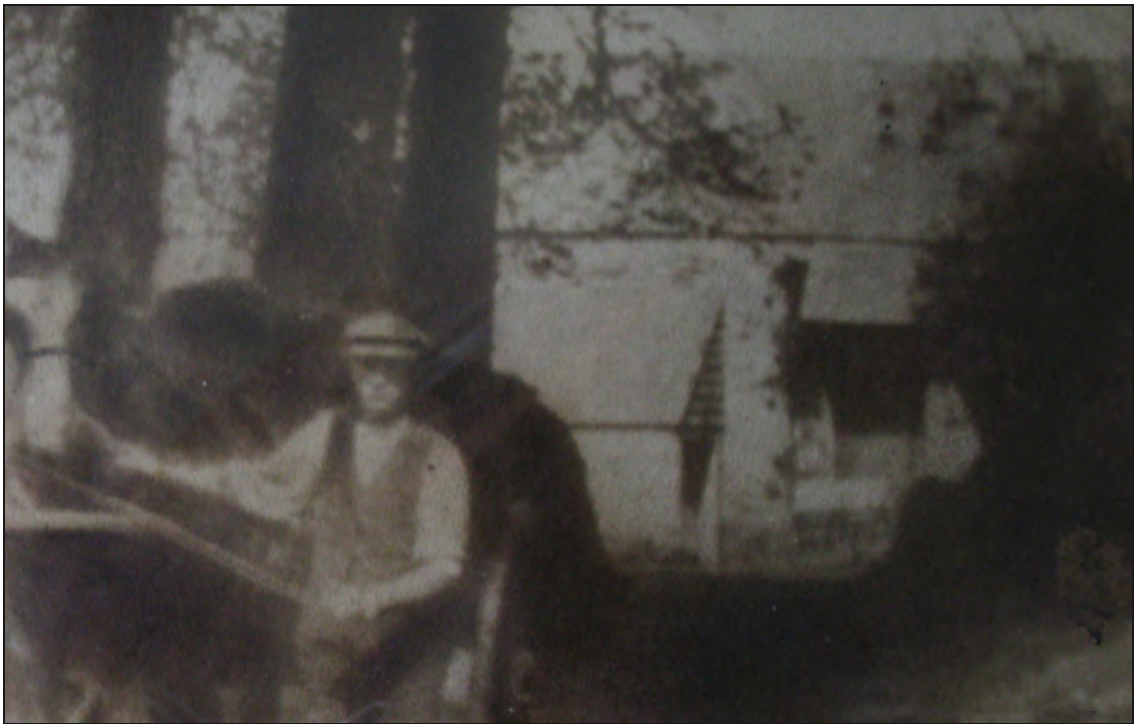
Figure 20: The west elevation of the Great Barn, from an early 20<sup>th</sup> photograph (MacBean family). Note the porch projecting over the threshing door.

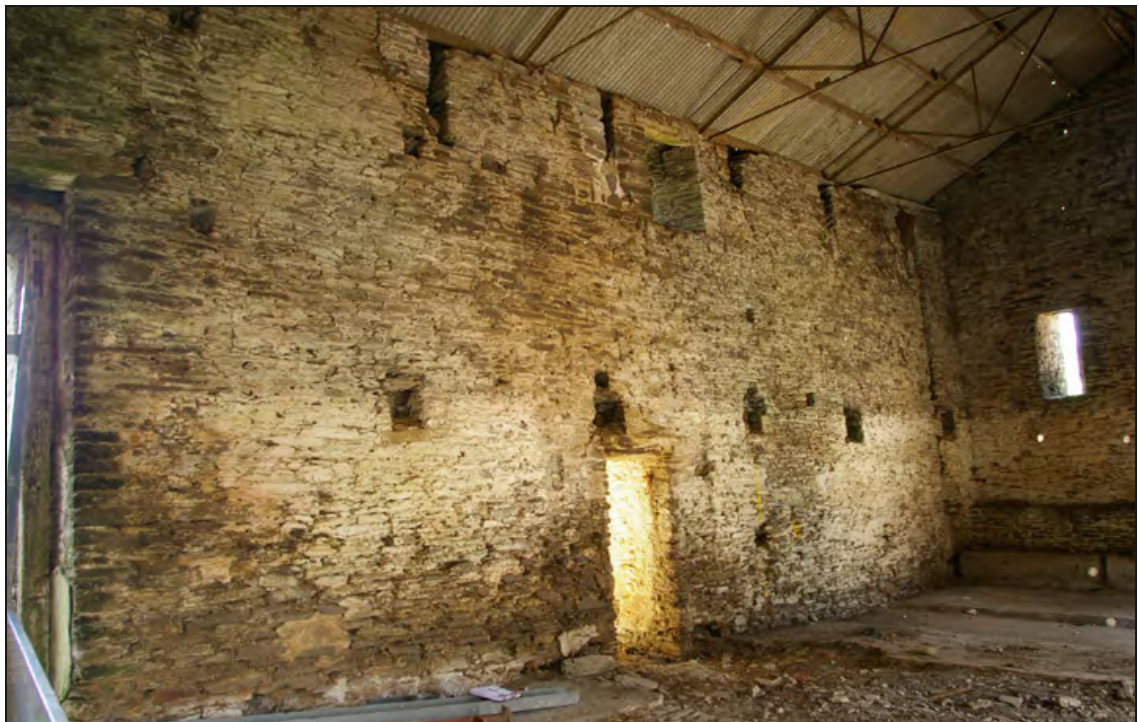
The interior of the Great Barn forms a single open space 22.5m long by 6m wide (see Figure 21). The roof structure is modern, with steel bolted struts and trusses and corrugated asbestos sheeting. The internal floor surface slopes down from south (where bedrock is exposed) to north (where the internal floor level is *c.*1.5m above exterior levels). The northern wall steps in *c.*0.2m at *c.*1.2m above the floor, and there is a small blocked opening in the middle of the wall just below the step. There are large vertical structural cracks between the east and west walls and the northern gable. The floors to the north of the threshing doors are concrete over rough cobbling and to the south they are earthen over bedrock.

Above the cattle stalls, five corresponding beam slots in the east and west walls held substantial oak beams (*c.*0.4×0.4m) that supported a hay loft. This floor collapsed and was removed in the 1970s (MacBean *pers. comm.*). There is no visible evidence for a floor at the southern end. Put-log holes, corresponding to those visible externally, are visible on the west and east walls, approximately half of which are blocked.

Figure 21: The interior of the Great Barn, the north end of the west wall, viewed from the south-east.

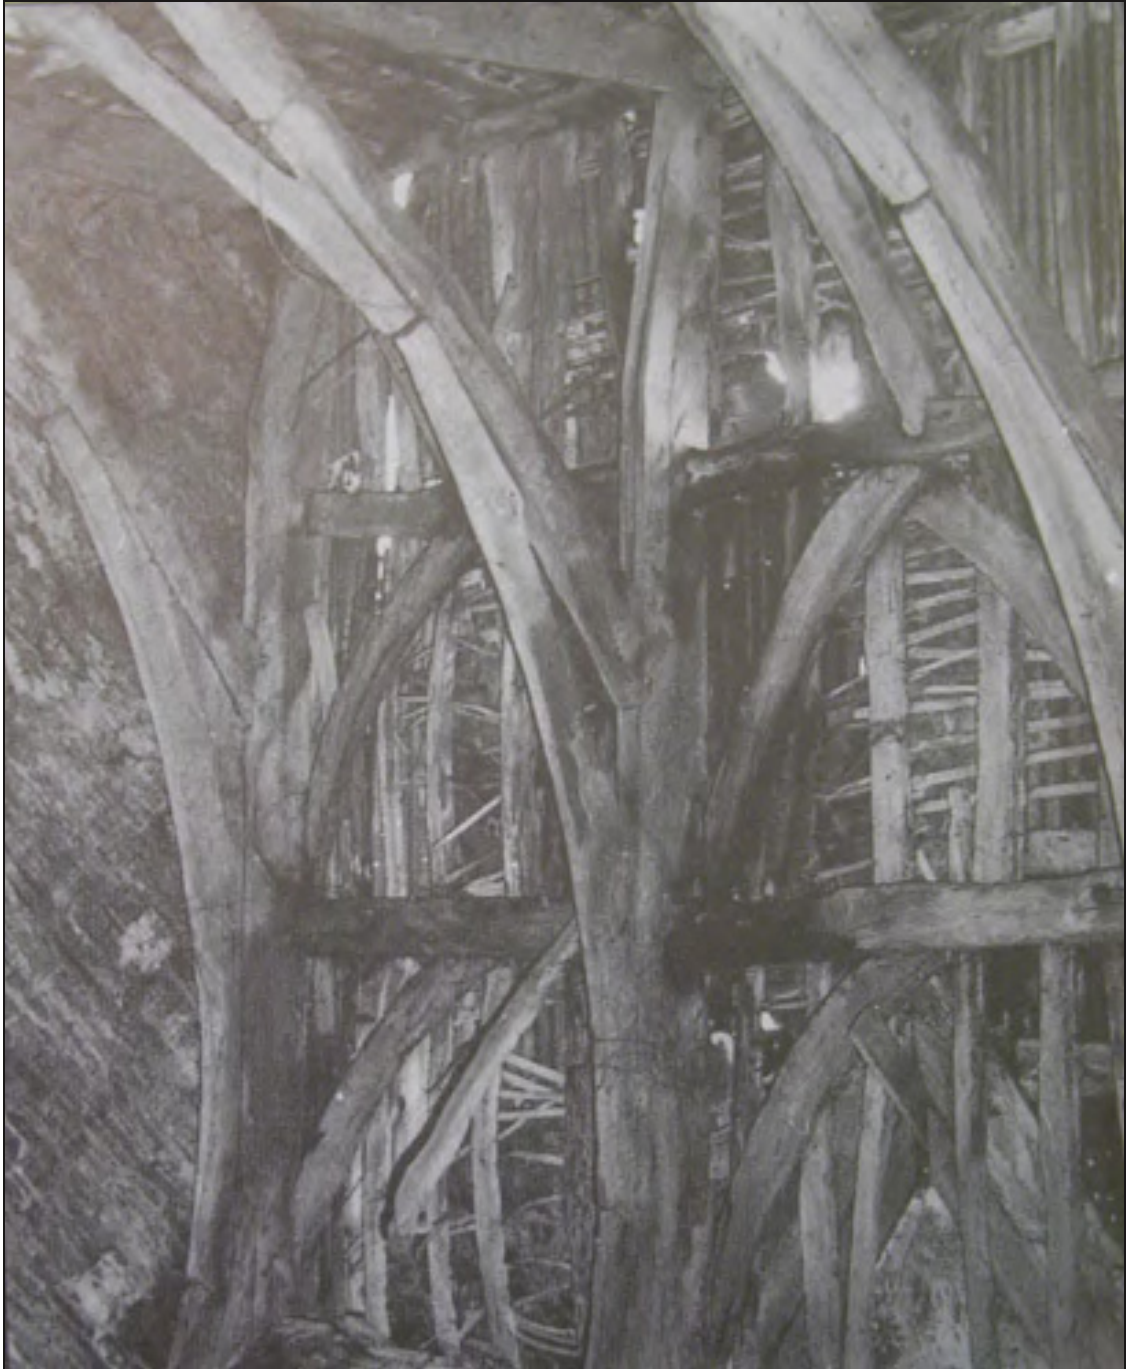
None of the original timber trusses remain *in situ* (see Figure 22), although the stubs of two lower arch-braces, and three truss-pad timbers, do survive. The roof was pitched, but with a half-hip at the northern gable. The sockets indicate the trusses were set *c.* 1.4m into the tops of the wall, and that the bays were *c.* 2m wide. In most instances, the sockets are asymmetric, with a vertical northern edge and a concave or sloping southern edge. In eleven instances the asymmetric edge, and often the cavity left by a truss-pad timber, has been infilled with mortared stonework. This unusual morphology could relate to how the trusses were originally raised (i.e. built, then slotted into the truss sockets and raised), but more probably indicate that the original roof racked to the south, displacing the stones of the wall in this distinctive manner, and was later pushed upright again and the cavities infilled.

Figure 22: The original roof of the Great Barn, the western truss-blades at the southern end, viewed from below and to the north-east. This photo was published in Langdon (1995), and shows the 15<sup>th</sup> century arch-braced roof was in a poor state of repair by the early-mid 20<sup>th</sup> century.

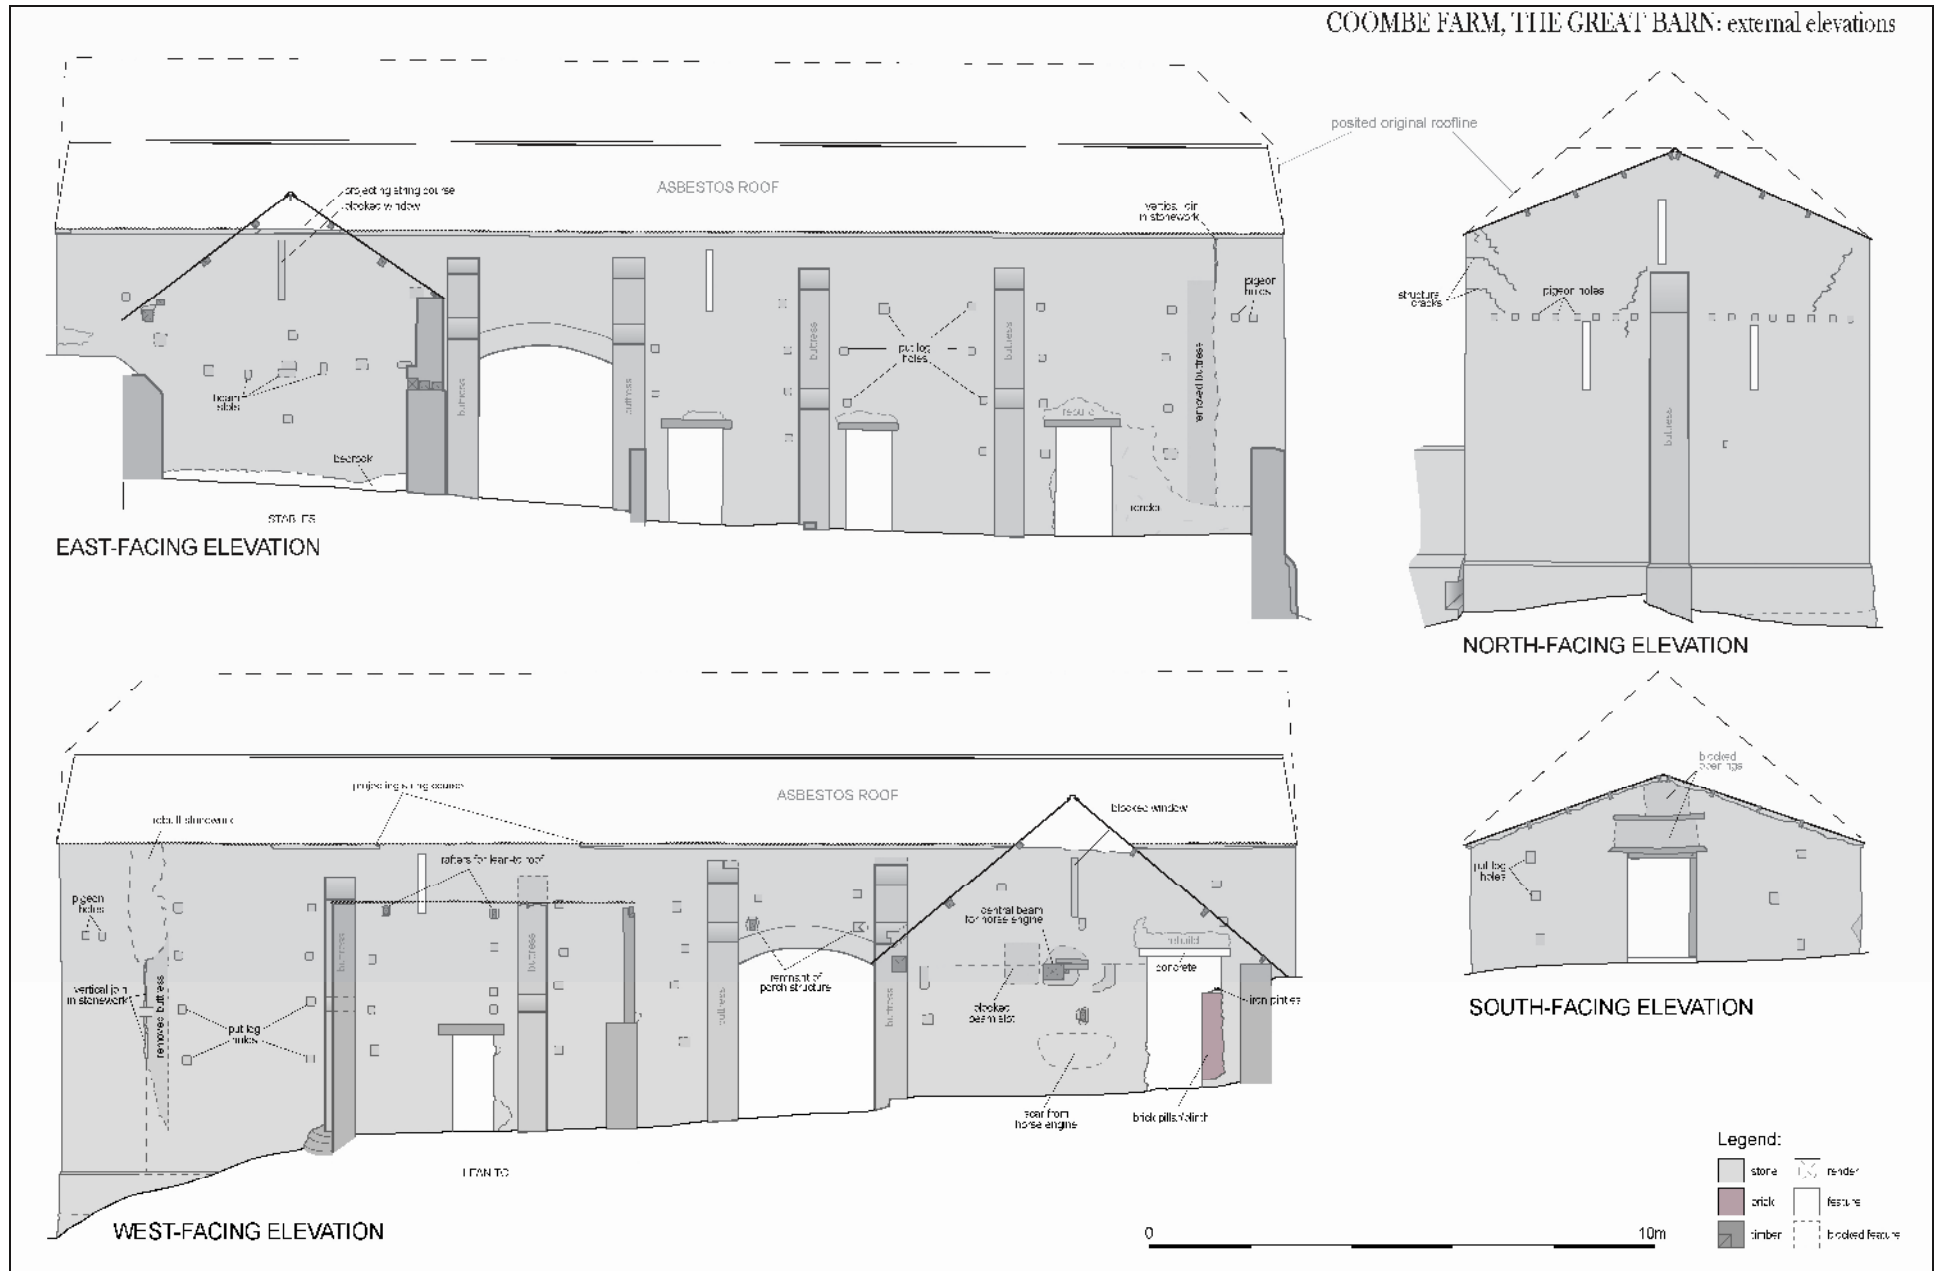
COOMBE FARM, THE GREAT BARN: external elevations

Figure 23: The external elevations of the Great Barn.

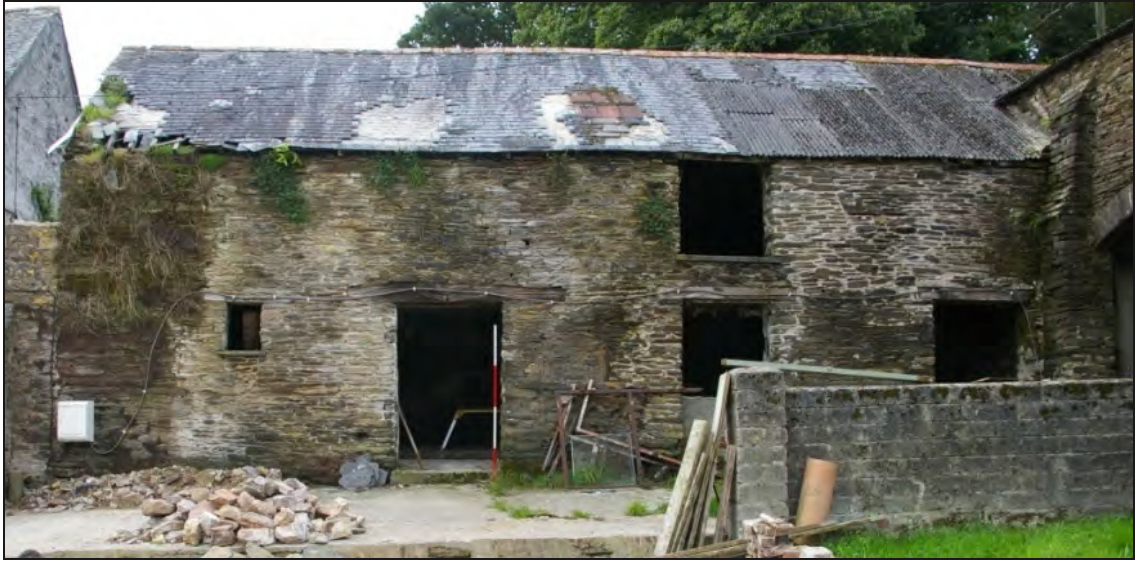
The north elevation (see Figure 26 and Figure 27) of the Stables fronts onto a large yard now surrounded by a wall. The north elevation is constructed of roughly-coursed rubble slate-stone, with stepped base to wall with shale ledge at the west end. There are six openings: a small window to the east end with timber lintel and slate sill, a large doorway with long timber lintel, a blocked slate-framed opening in the centre, a tall narrow forced doorway with timber lintel, partly blocked, with loading door with slate sill and timber lintel above, and at the west end a large (?)forced opening with timber lintel abuts the east wall of the Great Barn.

Figure 26: North-facing elevation of the Stables.

Figure 27: North elevation of the Stables, viewed from the north (scale 2m).

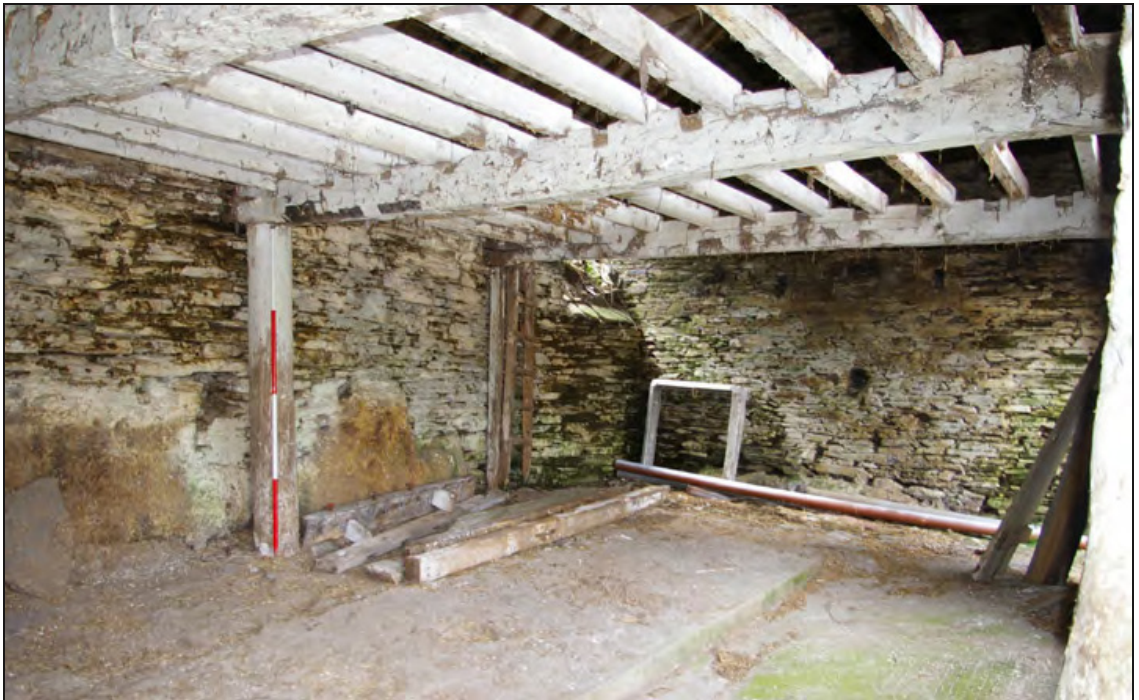
Figure 28: The ground floor interior of the Stables, viewed from the north-east (scale 2m).

Internally, the Stables form a single space with hay loft over (see Figure 28). The floor is of concrete, with cobbles and/or bedrock showing through where the concrete has failed. The step in the floor indicates stalls for eight cattle originally lined the northern wall, with a manure passage to the north. Scarring on the floor indicates the presence of a feed passage along the north wall. The walls and ceiling of the ground floor are white-washed, and the lower part of the north wall is plastered, suggesting this building has been used as a cowhouse/dairy in the past.

The first floor is supported on five chamfered oak beams with simple run-out stops that cross the building north to south. These beams rest on a step in the northern wall. The current joists run on top of the beams or lie in shallow sockets, but there are further joist sockets on all of the main beams, suggesting that either the joists have been renewed, or that the beams may be reused. Four of the beams have failed at their southern end, presumably because raised external ground levels left them vulnerable to rot; three of the beams are now supported by lengths of re-used telegraph pole. No floorboards remain from the hay loft at first-floor level.

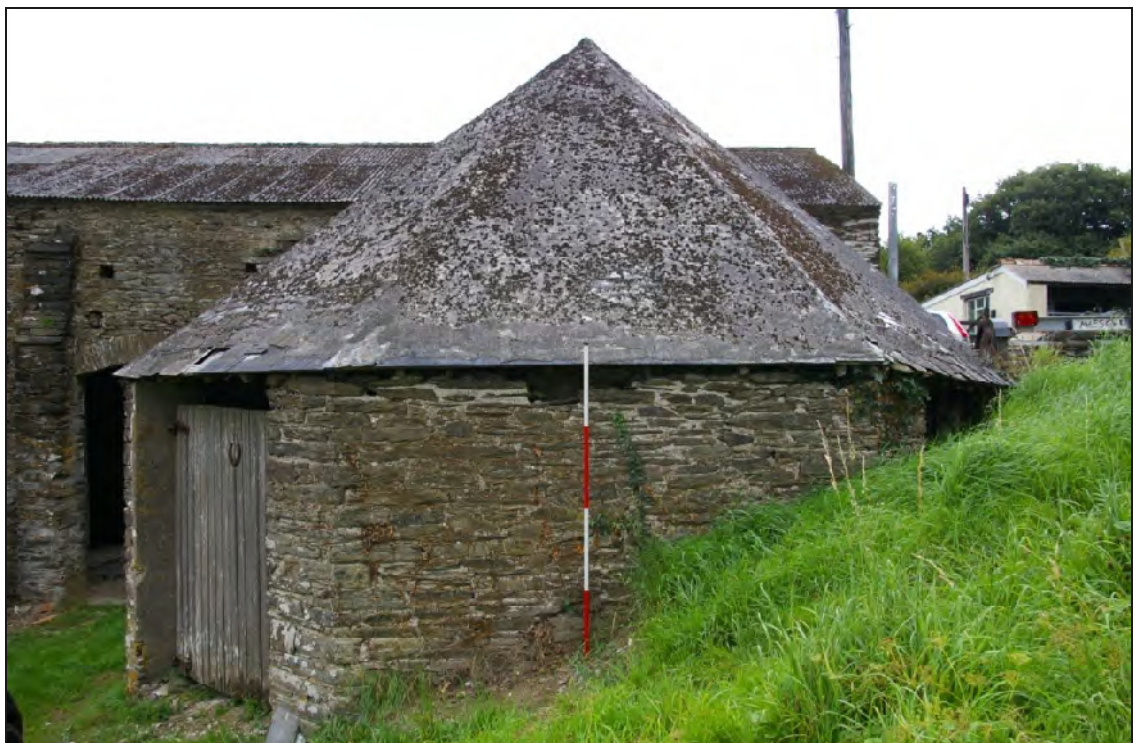
A polygonal Horse Engine House is attached to the south end of the Great Barn, fronting onto grassy area to the west of barn complex and drive to the farm (see Figure 29). The rubble slate-stone elevations under a hipped 'slurred' slate roof were built into the slope of the hillside. There are four openings: a large opening abutting the west wall of the Great Barn with (failing) timber lintel, a large opening on the north-west angle with modern planked door, a partly blocked opening in the south-west angle, and an opening forced through into the Great Barn to the east. The partly blocked opening in the south-west angle was originally a doorway, blocked to *c.*1m by stone, and by concrete blocks to *c.*2m. The original blocking may have taken place immediately after the construction of the Engine House, being the adaptation of a set design to the awkward location.

Figure 29: The Horse Engine House, viewed from the north-west (scale 2m).
