# COOMBE FARM BRIXTON DEVON

Results a Desk-Based Assessment  
&  
Historic Building Recording

Report No.: 110131  
Date: 31.01.11  
Authors: B. Morris  
E. Wapshott  
S. Walls

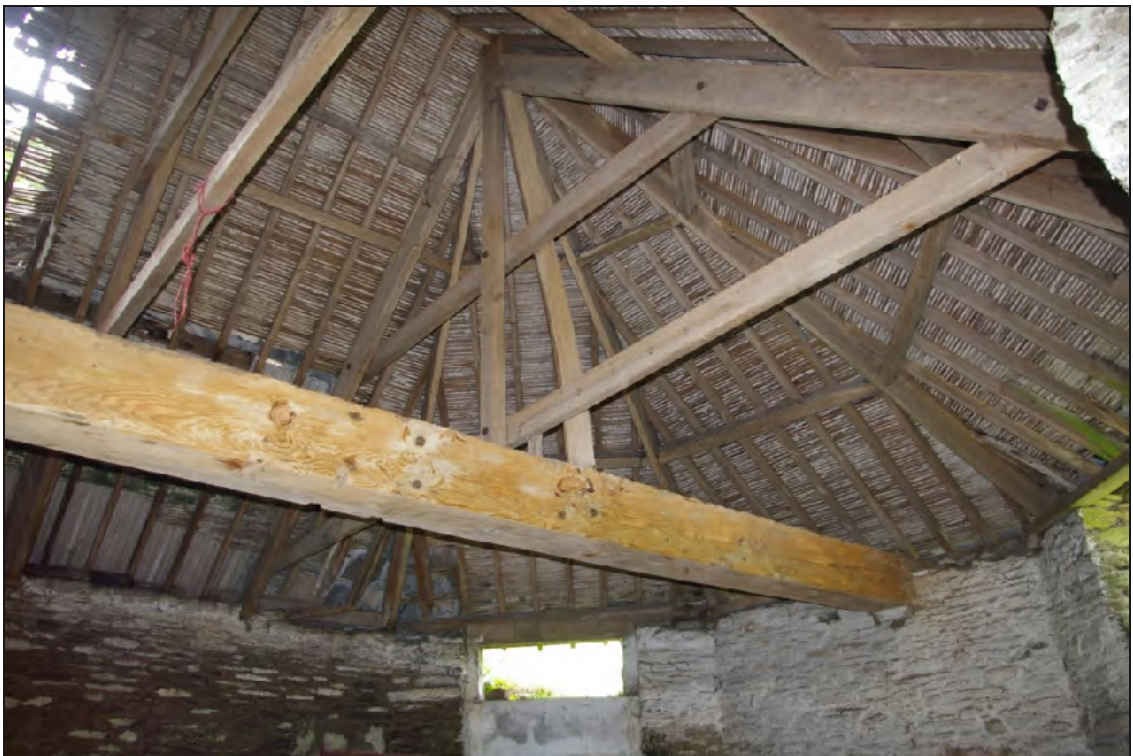
Internally, the floor has been extensively disturbed and appears to lie directly on the bedrock. A large (c.0.4×0.4m) and heavy oak beam with chamfered sides and run-out stops spans the Engine House from east to west (Figure 30).

This beam also bears the scars of many pintles/bolts and sockets, indicating its main function would have been related to the horse engine that would have sat in this room. None of the original machinery survives, although the blocked opening adjacent to the main beam suggests shafting originally went through the wall into the Great Barn at this point, later diverted or superseded by the forced opening with the brick pillar and pintles (see above) to the south. There is an irregular oval patch of damage on wall of the Great Barn where the horse would have passed when driving the horse engine, and there are numerous sockets and blocked sockets in this wall.

Figure 30: The interior of the Horse Engine House, viewed from the north-east.

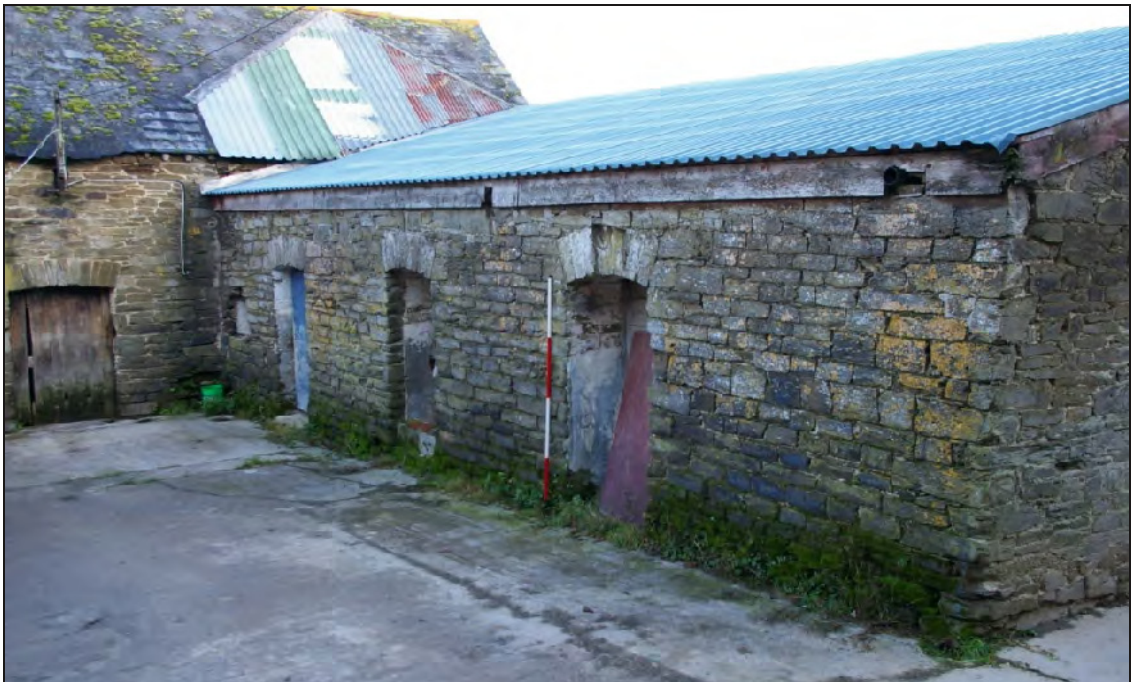
The presentation side of the Milking Parlour faces west onto the farmyard, and features dressed coursed stone walls with three symmetrical doorways with dressed stone segmental arches and stone reveals (Figure 31 and Figure 35). This elevation has been reduced in height following the collapse of the roof. The two doorways to the south have been blocked with concrete blocks, although the blocking is set back flush with the interior face of the wall, revealing white-washed uppers and part-rendered lower walls to the depth of the door splay. A small window opening has been forced through the elevation at the north end immediately adjacent to the south wall of the Shippon. This opening has ragged edges and missing stones and has been partially rendered and cemented.

Figure 31: West elevation of Milking Parlour, viewed from the south-west (scale 2m).

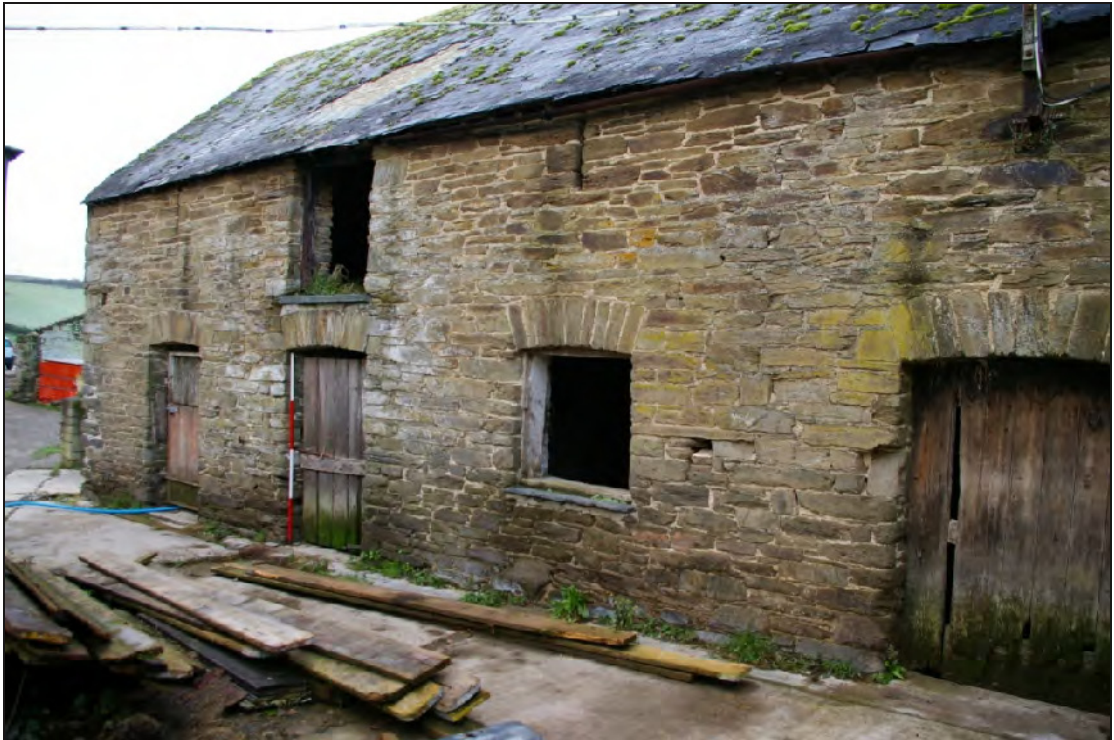
There are four openings, all with segmental stone arches and internal timber lintels, on the ground-floor, with a loft loading door and ventilation slits above (see Figure 32 and Figure 35). All of the openings have stone reveals; the loft door has a replacement slate sill and the window on the ground floor has an earlier slate sill. The two ground floor doorways to the west are wider on the outer face of the wall, with a projecting inner wall to the left; on the stable door to the east, the inner wall is recessed behind the projecting outer face of the wall on both sides. This would have ensured a wind-tight seal to the doors and protected the animals within from unnecessary drafts.

The ventilation slits are narrow to the outer face of the wall, with roughly dressed stone reveals, with a wide splay to the interior and an interior timber lintel and slate sill. All three doors retain timber boarded doors (with beading to the stable door), and while they feature uneven width planks and strap hinges and thus may date to the 19<sup>th</sup> century, they appear to have been re-used. The loft loading door has no *in-situ* door, and the ground floor window has an existing frame only, which is also a replacement. There is some surviving cast-iron guttering to the centre of the elevation with ovolo moulded brackets, but no downpipes or hoppers survive.

Figure 32: South elevation of the Shippon, viewed from the south-east (scale 2m).

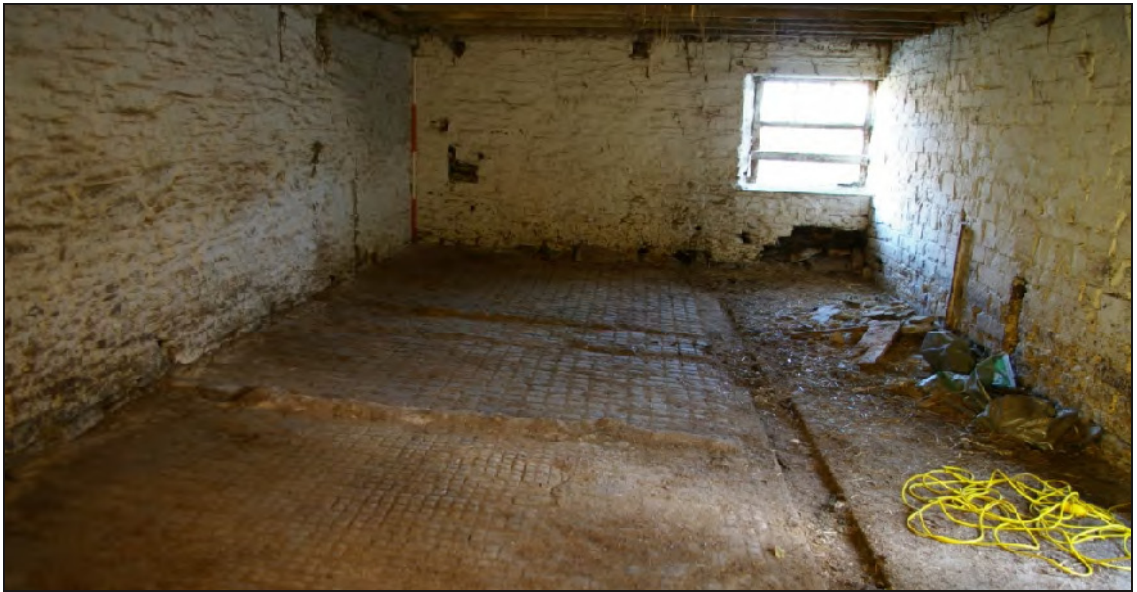
The loft is accessed by a wooden ladder to the left of the door into the stable. The majority of the loft floorboards have been removed except for a strip along the south wall for access. There is a projecting course of stones along the north wall at first-floor height into which the joists are set, possibly being a supportive plinth for the loft floor above, or perhaps a draft-exclusion measure. All of the joists, support beams, posts and lintels are chamfered.

Figure 33: Floor of the stable in the Shippon, viewed from the west (scale 2m).

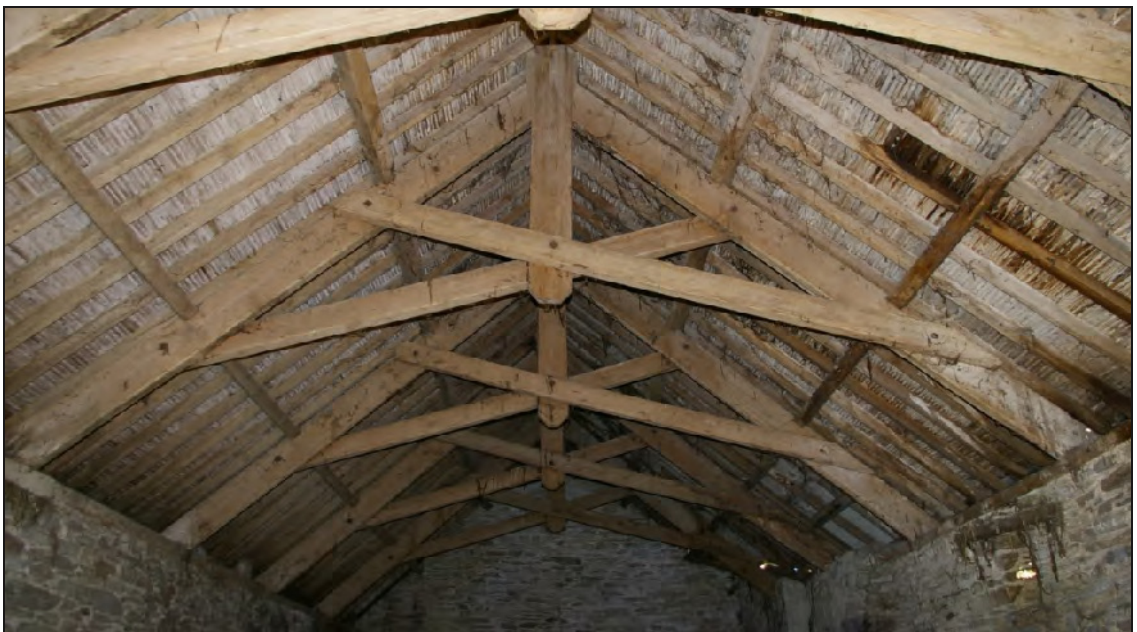
Figure 34: Roof structure of the Shippon, viewed from the west.

The roof structure is of pitched scissor-truss construction, with ‘mortice and tenon’ to the apex and bolted joints; the purlins are set into the back of the truss blades with two to each pitch (Figure 34). The underside of the slate is torched, with lathes lying directly on the rafters.

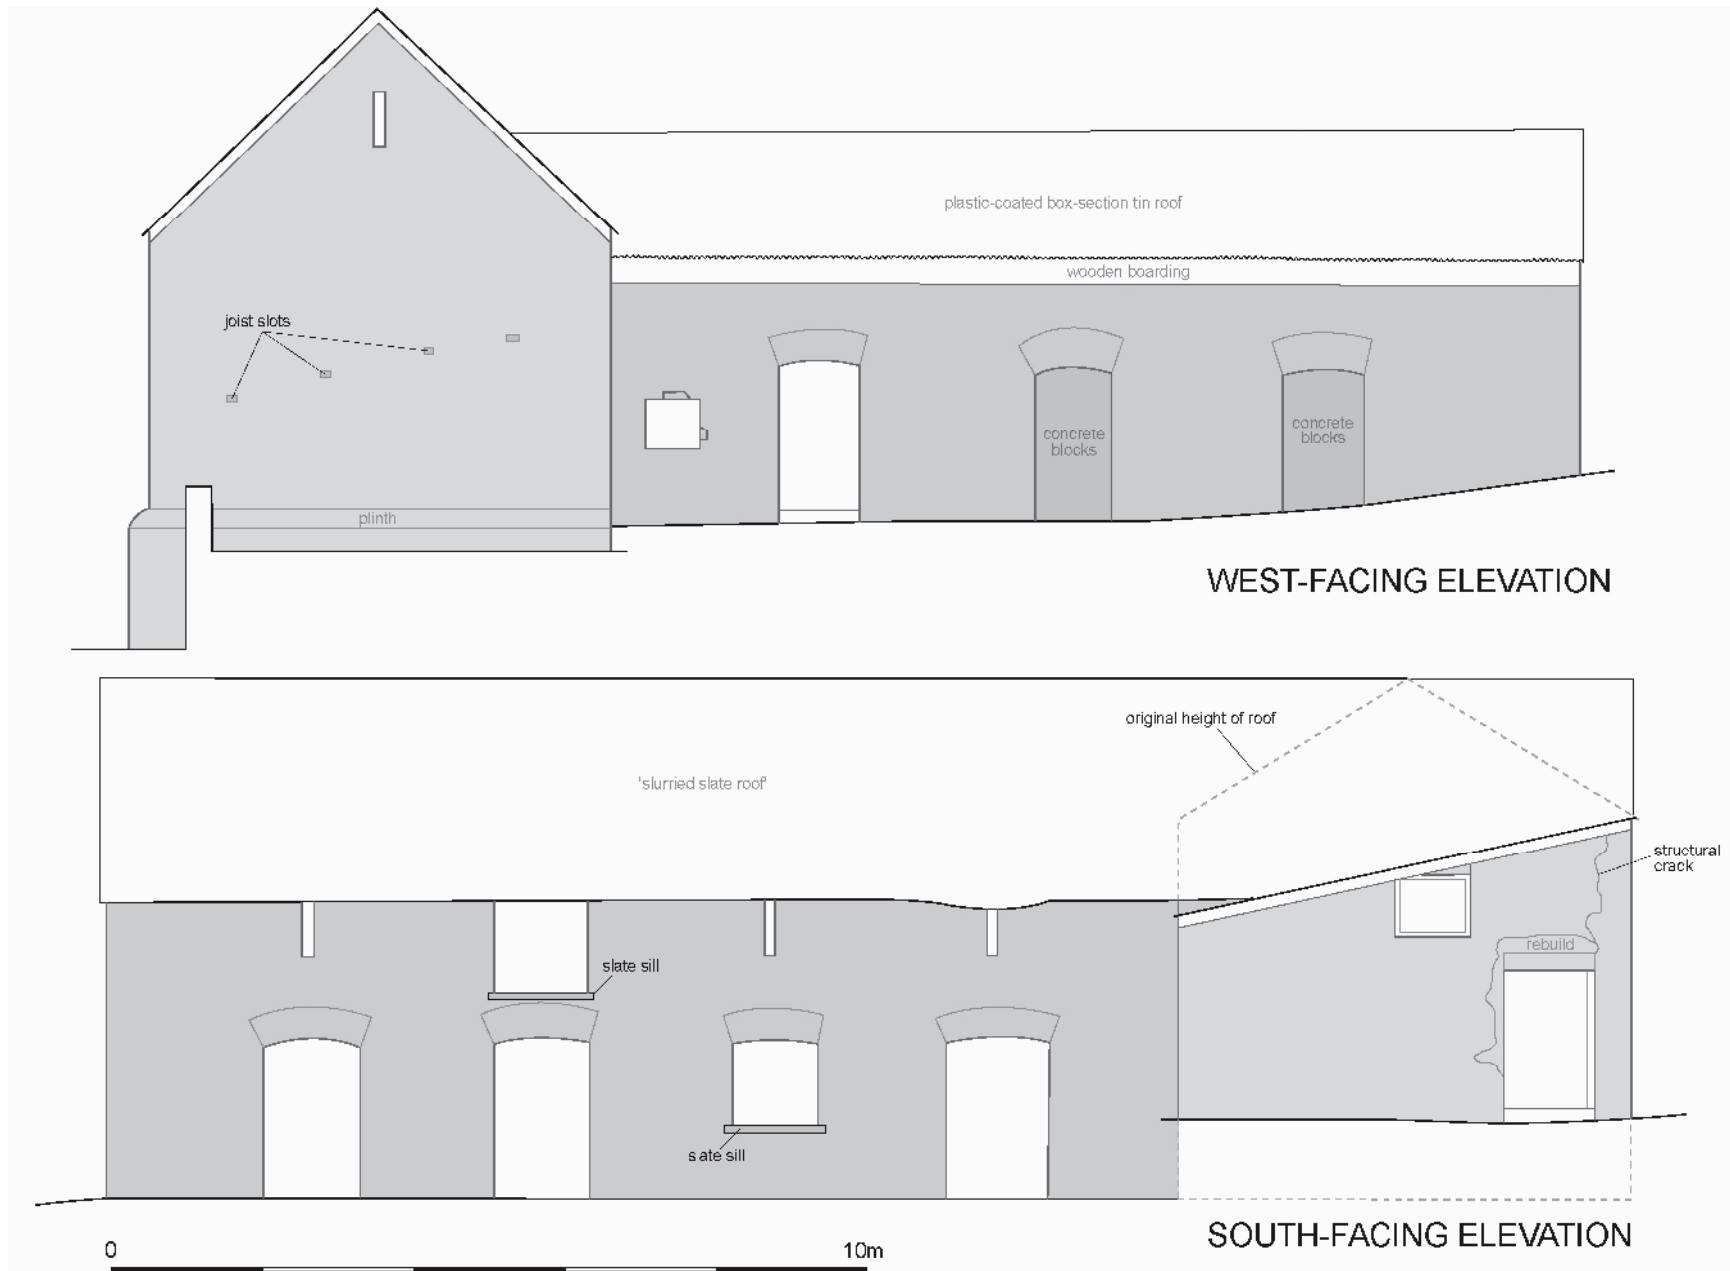
Figure 35: The west- and south-facing elevations of the Shippon complex.
