Archaeological Investigations at Kitchen Garden

Preston Park

Stockton-on-Tees

TA10/04

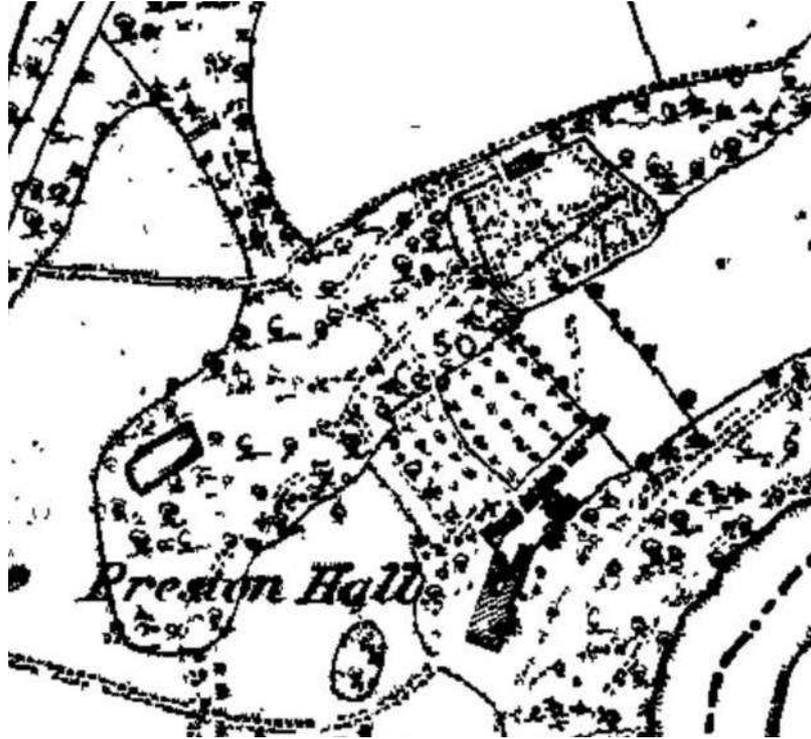
Fig 2: Ordnance Survey Map of 1856 (Crown Copyright. All rights reserved. 100023390. 2008)

First Edition Ordnance Survey Map 1856 (Fig 2)

This shows the garden quite clearly. It is oriented north-west to south-east, but for ease of description the north-west wall will be referred to as the north wall and the other orientations will be taken from this. The north wall has a building mid way along it which projects both sides of the wall, there is an opening through the wall beyond the west end of the building. The north-east corner of the wall is a sharp angle, while the south-eastern corner is rounded; there is no indication of an opening in the east wall, a path approaches it from inside the garden but does not continue beyond the wall. No opening is depicted in the south wall, however there are paths on both sides about two thirds of the way along and this probably indicates an opening.

The south-west corner seems quite angular and has two walls meeting it from the north. The outer wall follows a curve up to the north-west corner, while the inner runs directly to the corner. This creates a curved annexe to the garden. The north-western corner describes a right angle to the inner wall, while the outer wall curves away quite gradually. There may be a structure of some sort set into the gap between the inner and outer walls at this corner.

Paths approach the curved and straight western walls and appear to go through both.

The interior of the garden is divided into unequal quadrants with the north-south path being offset to one side, following the line from the opening next to the building in the north wall. The east-west path is approximately mid way along the walls. Paths are depicted along the side of all the walls, but no minor paths are shown. The plan appears

to show vegetation of some description in all but the north-eastern quadrant. There may also be a wall linking the south-west corner of the garden to the orchard to the immediate south.

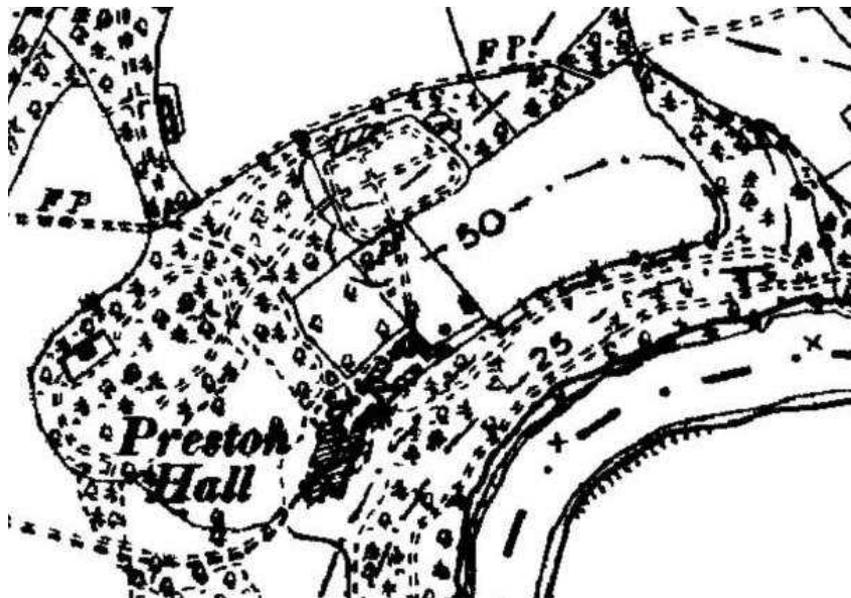
Fig 3: Ordnance Survey Map of 1898 (Crown Copyright. All rights reserved. 100023390. 2008)

Second Edition Ordnance Survey Map 1898 (Fig 3)

The basic layout of the garden appears to have changed little by 1898, although no internal vegetation is shown. Some building work had however taken place. The building on the north wall had been extended to the west, beyond the passage through the wall, it may also have been widened. This building is presumed to be a greenhouse.

A new building had also been constructed at right angles to the east wall. This is still extant and was probably for the head gardener, it was provided with gardens front and back.

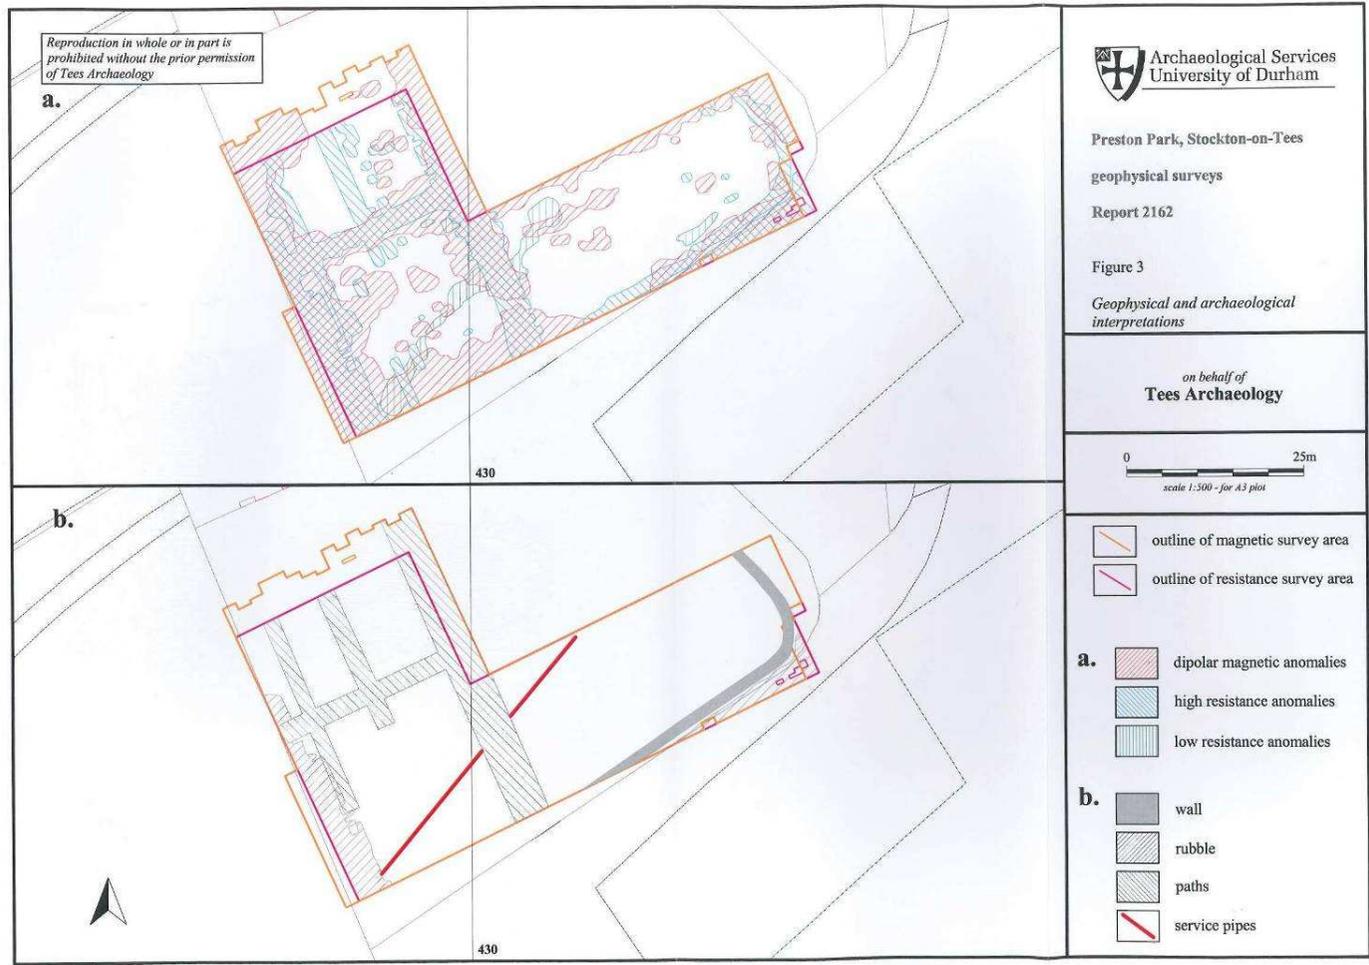
Fig4: Archaeological Interpretation of Geophysical Survey

Geophysical Survey (Fig 4)

A geophysical survey of the walled kitchen garden was commissioned from Archaeological Services, University of Durham. This was intended to identify the location of paths, the now demolished south wall and any indication of beds or other features.

The survey took place in March 2009 and comprised both geomagnetic and electrical resistance survey of the available area. The north-eastern quadrant of the garden was unavailable due to numerous low brick walls constructed in the 1980s, while an area c 5m wide adjacent to the north wall is paved and therefore not available for survey. The full report 'Kitchen Garden, Preston Park, Stockton-on-Tees, Teesside, ASUD Report 2162, March 2009' is held in the Tees Archaeology Archive and what follows is a summary of the results.

In addition to the main quadrant paths which are still visible and in use the survey identified two additional paths running north-south within the north-west quadrant, both seem to run the full length of this quadrant and continue into the next, but do not run the full length of the next quadrant.

The survey identified a curving feature in the south-east corner, which was interpreted as the remains of the southern boundary wall.

In addition to these features a service pipe was identified running from the south-west corner towards the middle of the east wall and extensive deposits of rubble were indicated along the west wall.

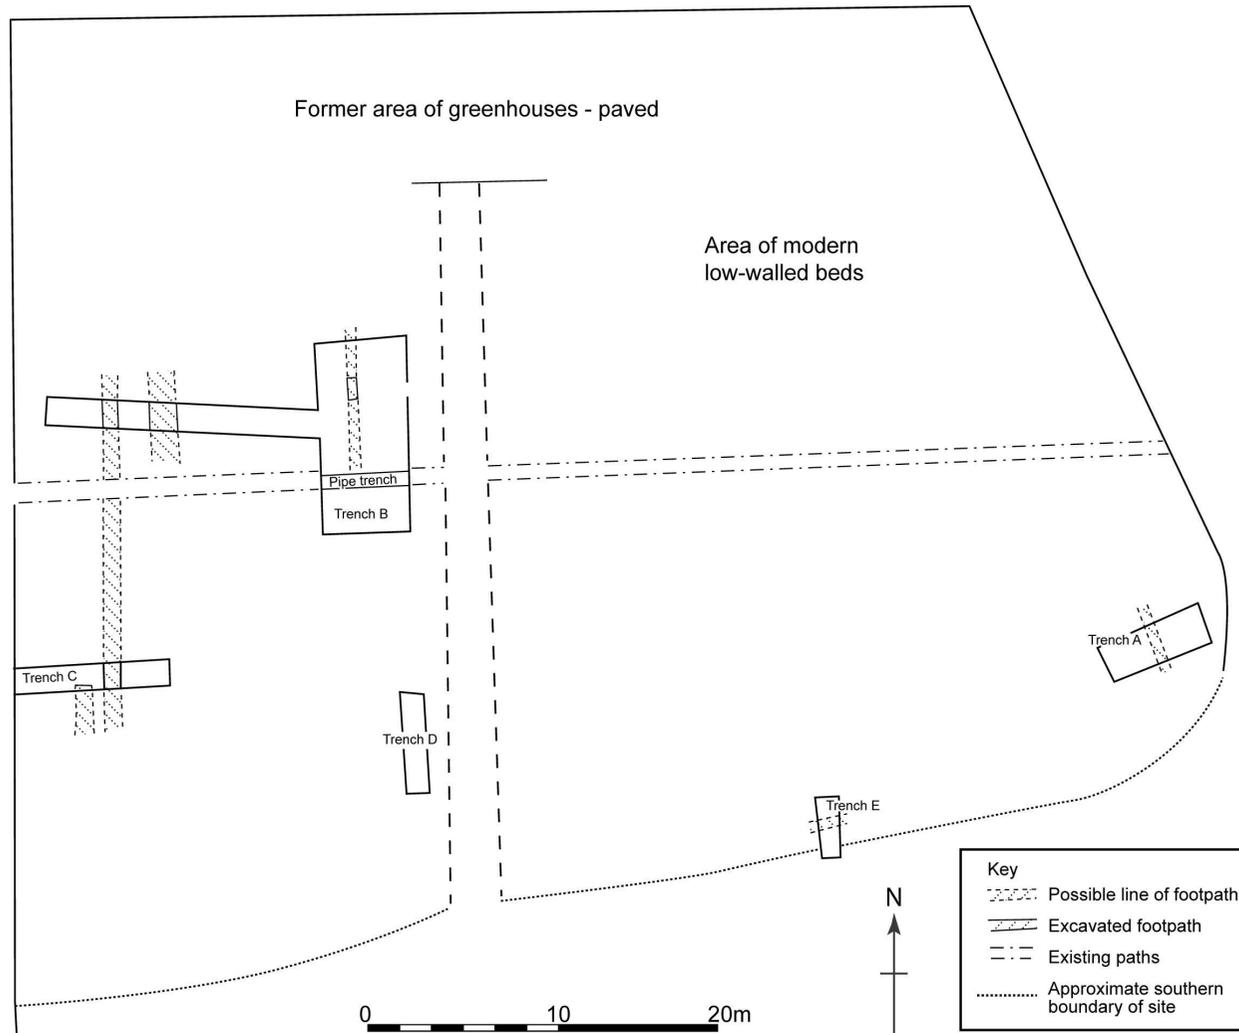
Fig 5: Location Plan showing position of trenches A – E and lines of footpaths

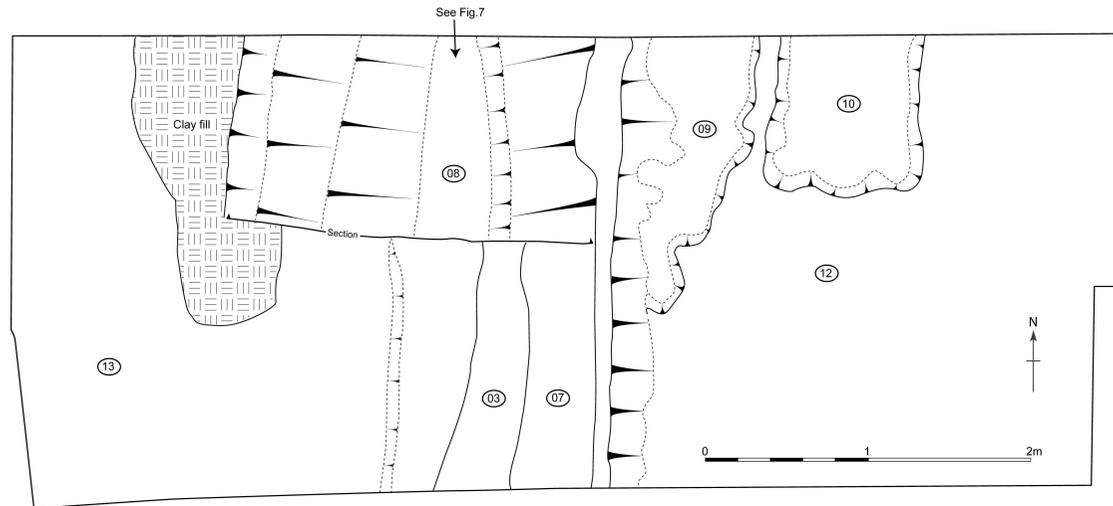
Fig 6: Plan of Trench A

Trench A (Figs 6 & 7)

Trench A was sited in the south-east corner of the garden over a curving geophysical anomaly which was interpreted as the demolished south wall. This area had intensive rabbit burrowing through and around it. The trench measured 5.9m x 2.8m and was oriented east – west. The following phases run from the earliest to the latest.

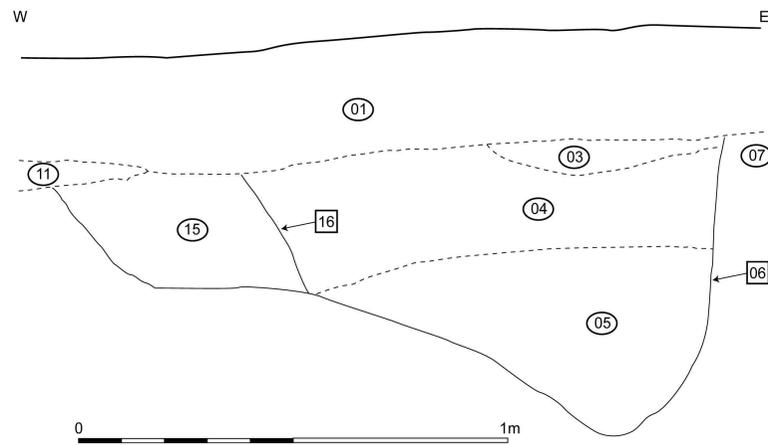
Fig 7: Section drawing of Ditch 06, Trench A

A north-south ditch (A06) was dug across the site (Fig 7). This was c250mm deep and at least 0.6m wide. It was filled with a light brown clay (A15) which contained flecks of coal and brick. This may have been intended as a drain.

The ditch (A06) filled up and was re-cut slightly to the east as ditch A16, in doing so it cut through the path (A07). This reduced the path to a width of c.250mm.

Ditch A16 was c.1m wide at the top, with a vertical edge to the east where it cut through the path (A07) and a 45 degree slope to the west. The very bottom of the ditch was a clearly defined 'U' shape and the widening of the profile to the west may have been the result of periodic digging out of the ditch to clean it.

The bottom fill of the ditch was a light brown silt (A05), overlain by a grey-brown clay (A04) and the topmost fill (A03) was a light brown soil with numerous fragments of brick and mortar.

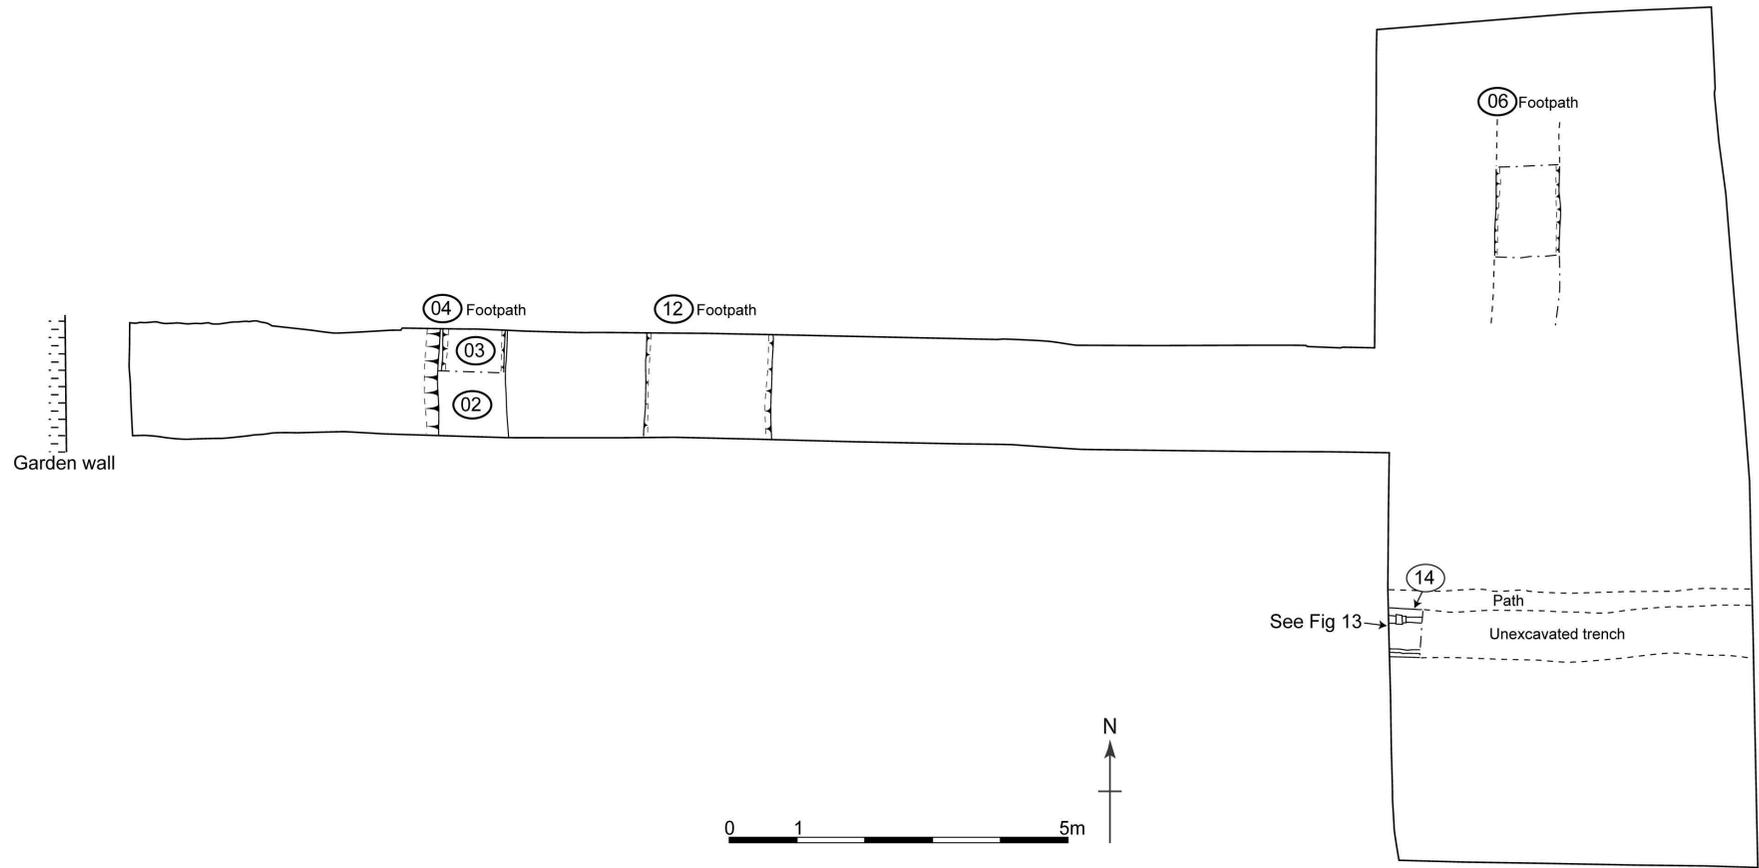
Fig 8: Plan of Trench B

Trench B/B ext_(Figs 8 – 13)

Following the removal of the topsoil, B01, four features were identified, three of these were probably north-south paths and the fourth was a service trench containing water pipes.

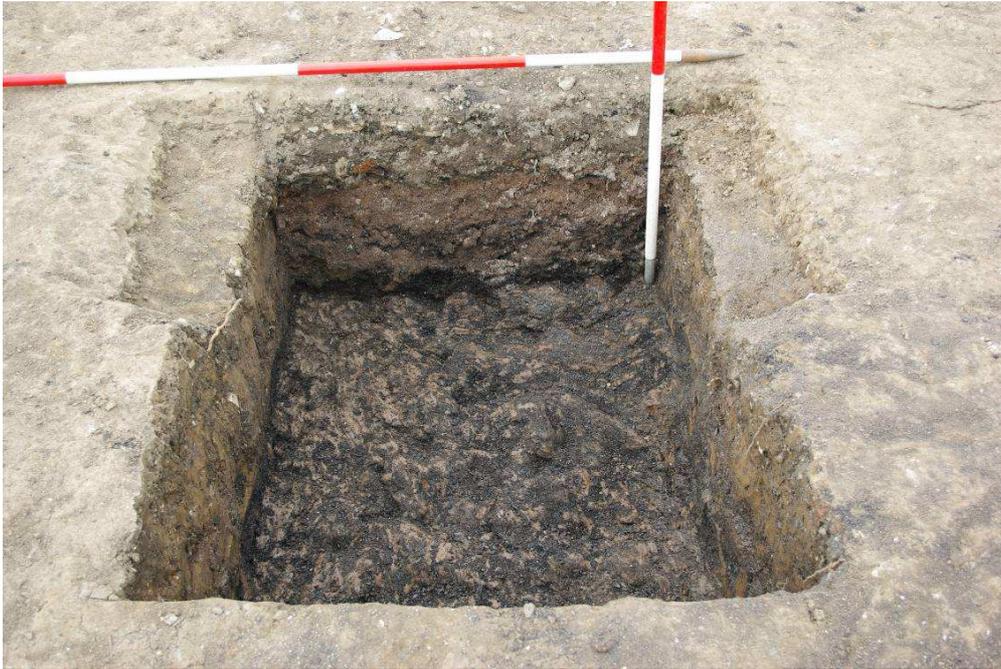
Fig 9: Construction trench for footpath B06, showing ashy fill, Trench B, view from the north

B06 was created by digging a trench 0.8m wide at the bottom, 1m wide at the top and 0.5m deep (Fig 9). This trench was first filled with an ashy brown/black soil which contained charcoal, clinker and some clay pieces (B11). This layer was 180mm deep. Overlying it was a light brown sandy soil 120mm thick (B08), which again contained charcoal, clinker and other burnt material. Overlying this in turn and forming the surface of the footpath was B07 a layer up to 200mm thick, comprising a dark-grey sandy soil containing pieces of charcoal, brick and mortar.

The trench for this footpath was unexpectedly deep and the depth and the loose character of the fill suggests that the provision of drainage was as much a consideration as the provision of a hard wearing surface.

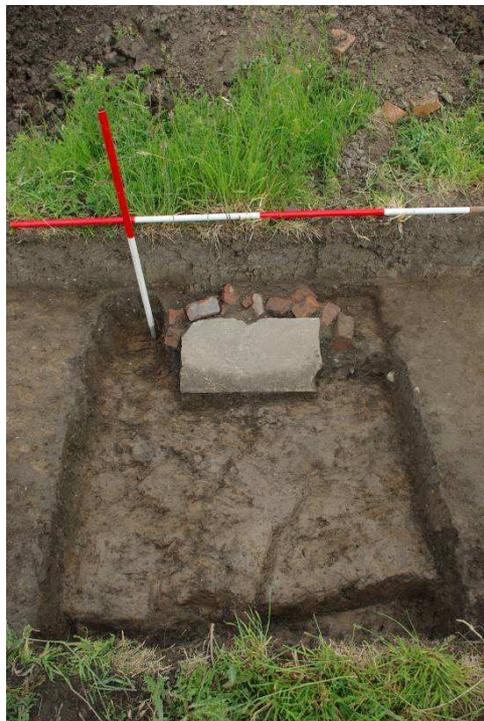
Fig 10: Construction trench for footpath B12, Trench B, view from the south

Footpath B12 lay c.10.6m west of B06 and ran north-south, parallel to the latter. A trench 2.05m wide and up to 250mm deep had been cut into the natural clay, the content of this trench varied (Fig 10). In part it contained grey/brown clayey soil containing pebbles (B10) and in the northern part of the excavated section there was a large stone slab and a deposit of loose rubble (B09). It is not clear why the make up of the footpath should vary so much.

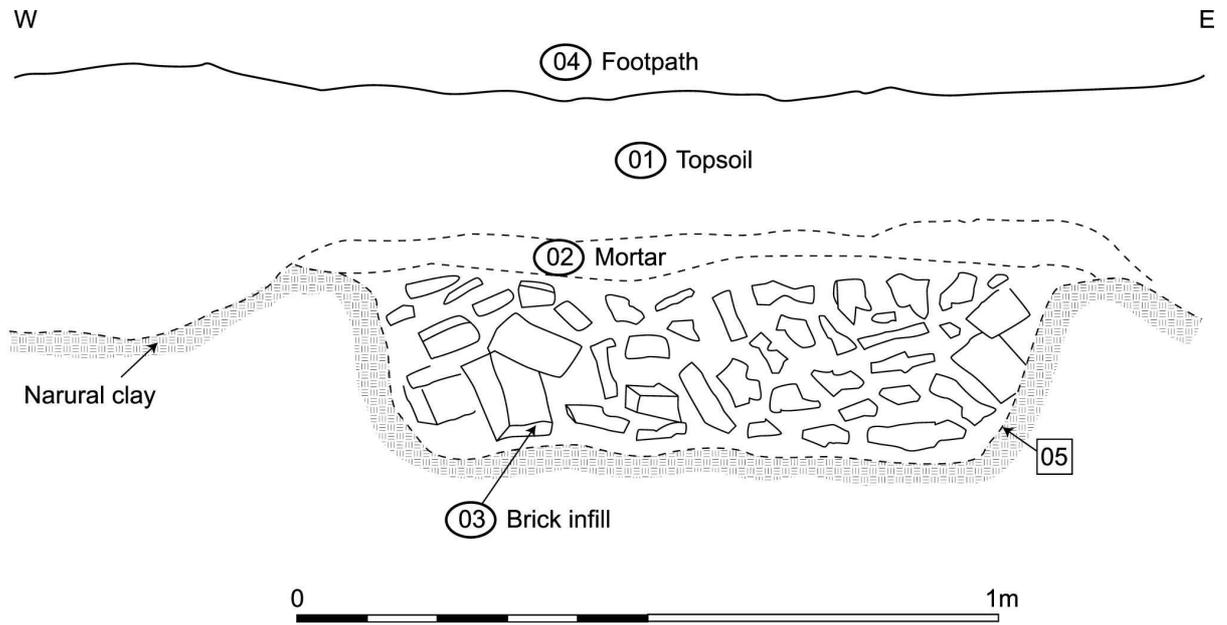
Fig 11: Section Drawing of footpath B04, Trench B

Footpath B04 lay 2m west of B12. Again a trench had been dug into the natural, 0.8m wide at the base and 1m at the top (Figs 11 & 12). It had a maximum depth of 340mm. The trench had a single fill of broken bricks (B03). The latter were handmade and probably of the same type as used for the construction of the wall. This fill was quite loose and again drainage seems to have been as much a factor as a good surface.

Overlying the brick fill was a dirty mortar layer (B02) 8 to 11mm thick which provided a hard, compact surface.

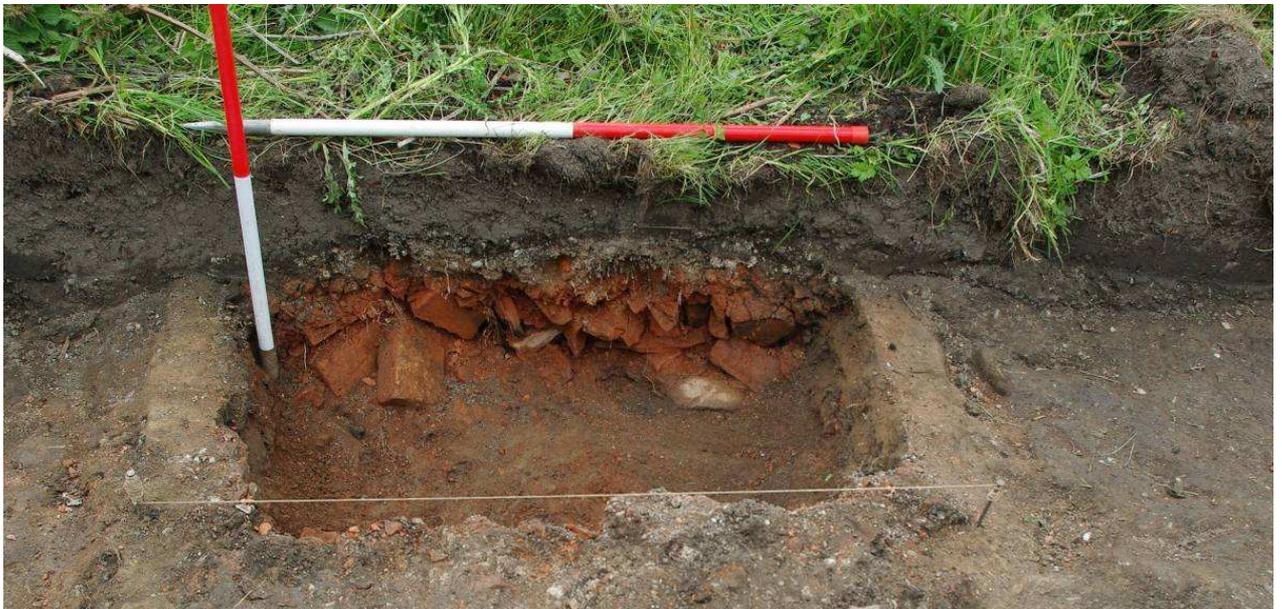
Fig 12: Construction trench for footpath B04 showing brick rubble fill, Trench B, view from the south

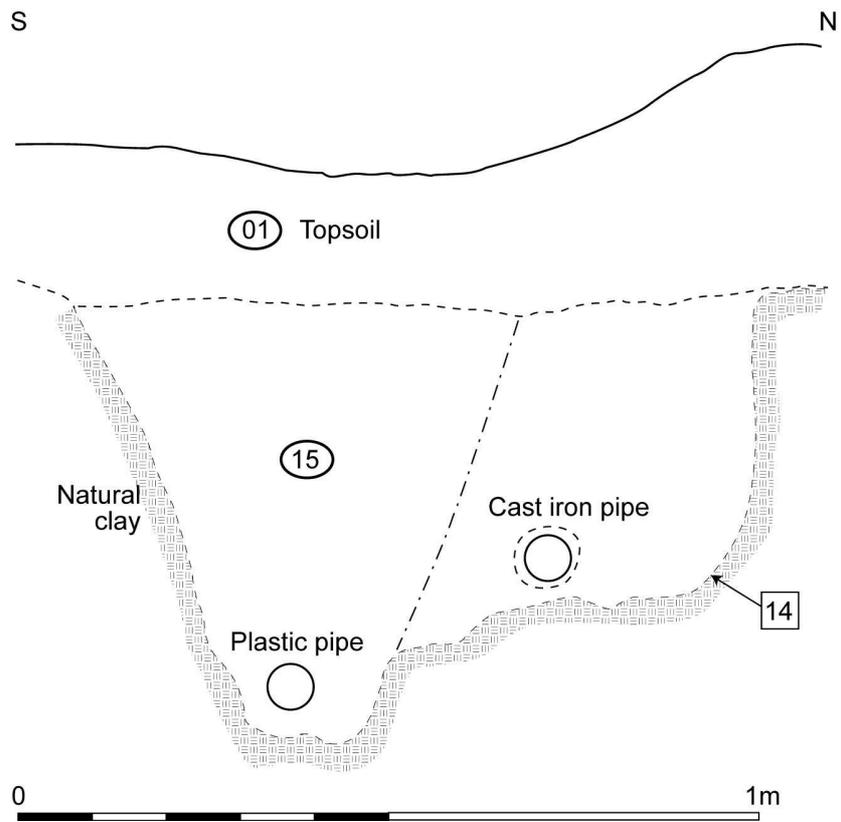
Fig 13: Section drawing of Water Pipe trench B14, Trench B

Service Trench (Fig 13)

A trench 0.9m wide at the top and a maximum 0.6m deep (B14) was noted running east-west across the site, beneath the main east-west path. This contained a dark brown clay fill with some pieces of brick (B15). The trench also contained two water pipes, one made of cast iron, the other, in a slightly deeper cut, was plastic. It is presumed that these provided and provide the water to the garden.

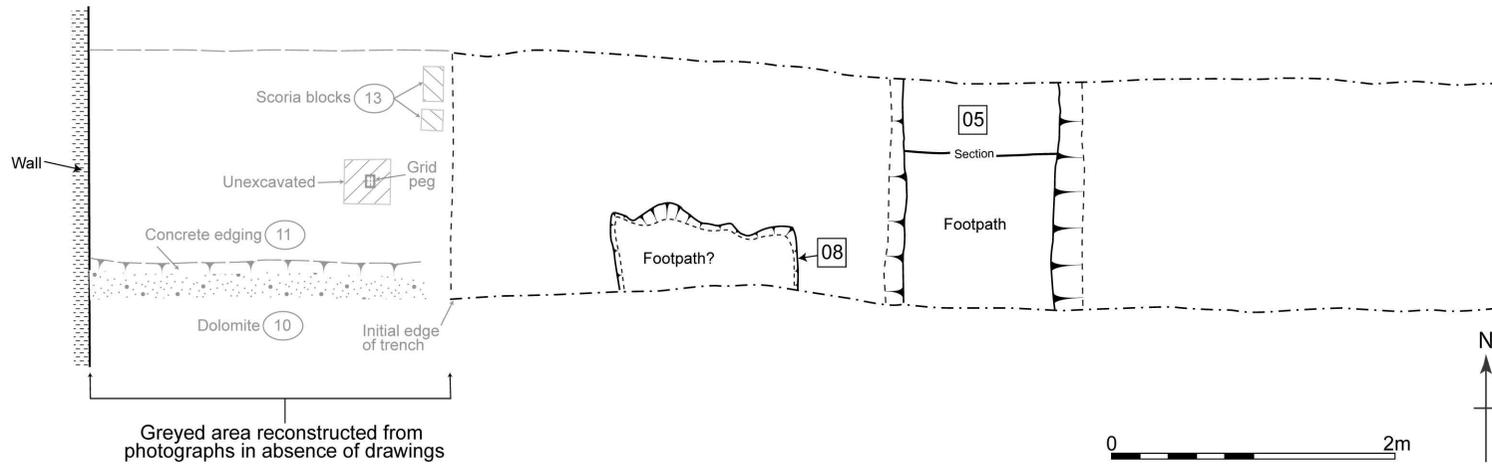
Fig 14: Plan of Trench C

This footpath was sited 0.7m east of the previous and 5.8m east of the boundary wall (Fig 14). It ran north-south through the trench and appears to be a continuation of that seen in Trench B (B04). A trench (C05) 0.9m wide at the base and 1.05m wide at the top was cut a maximum of 280mm into the natural clay. This was filled with loose brick rubble (C04), comprising different sized fragments of hand made brick. Overlying the brick was a surface up to 60mm thick of a dirty grey-white mortar.

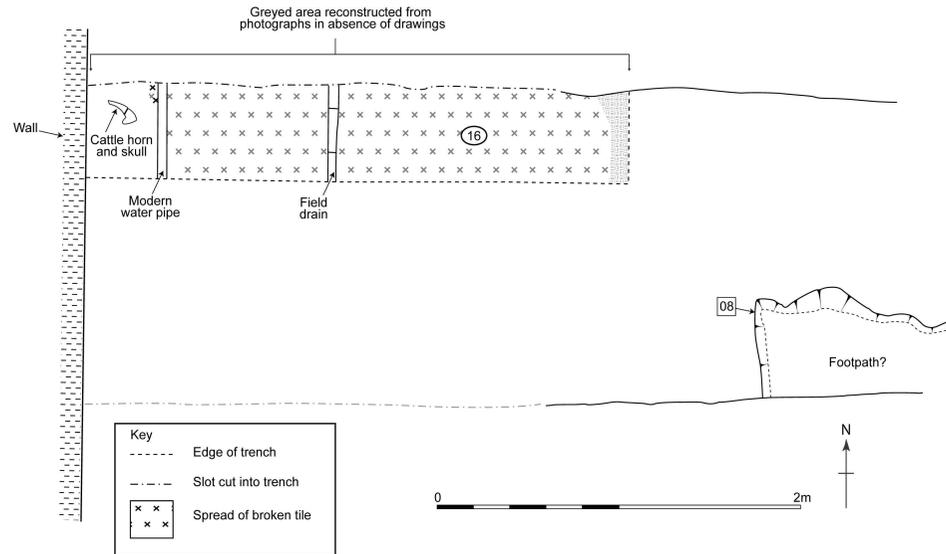
Fig 15: Plan of Trench C extension

The first activity comprised the insertion of a an early type clay field drain (C18), at the western end of the trench, cut into the natural grey clay (C06) and an overlying dirtier clay (C17) (Fig 15). This was the only formal drainage encountered within the garden, however there may be others yet to be identified. Overlying the field drain and only excavated over a small area was a large spread of broken tile and field drains (C16) (Fig 16). This might occupy the full width and a significant length of the bed. The broken tiles were presumably laid down to assist drainage in these very heavy soils; a number of the pieces had the name 'Lambert' on them.

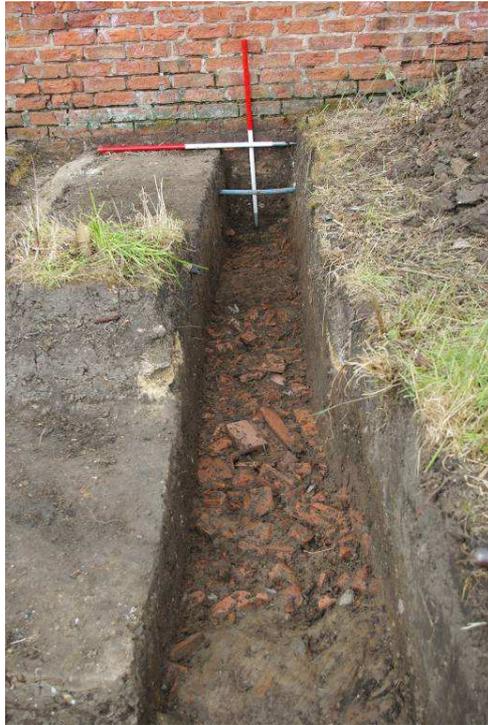
Fig 16: Spread of broken tiles, C16, Trench C, view from the east

The trenching of the paths and the loose fill placed in the trenches will also have helped. Excavations in Trench C showed that extensive use of broken tile was also made to try to improve drainage. It is however intriguing that only one intact drain run was encountered, it may be that more await discovery and that the site had an extensive system of field drains laid in it, but this does not appear to be the case.

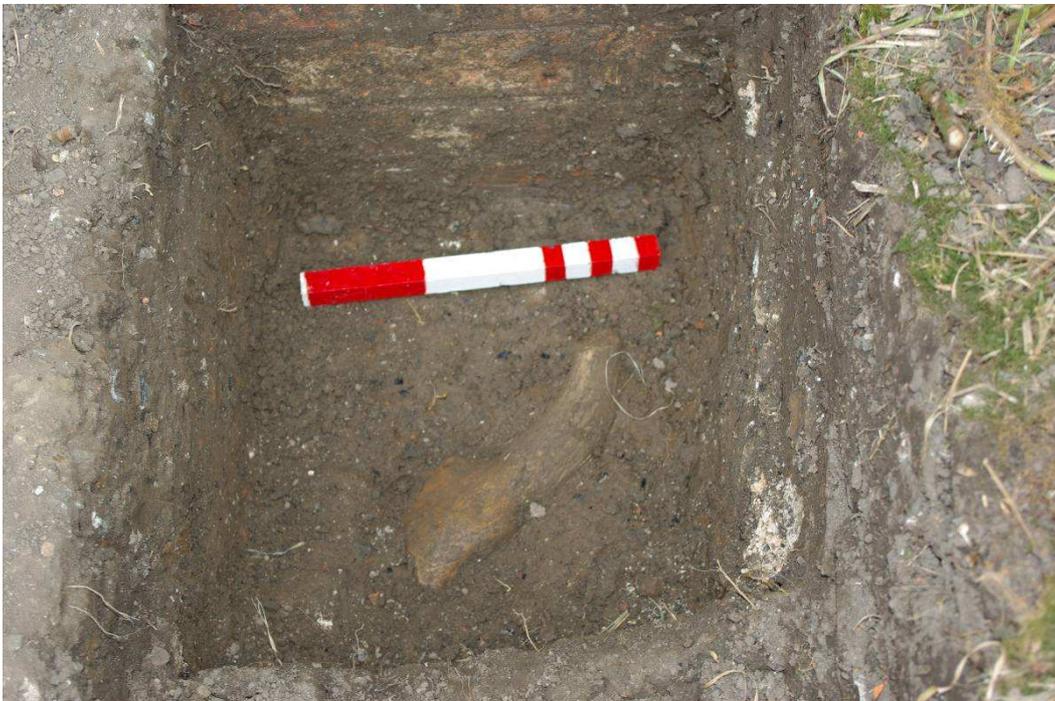
Fig 17: Cow Horn 'in situ', Trench C

The quantity of horn cores found in trench C is more intriguing - six partial skulls and horn cores from both sides of the skull and three parts of horn cores. The partial skull remains and absence of jaws together with the chopping and cutting marks indicate that only part of the skull was being obtained and that this was then being processed to remove the horn. Presumably the horn was then being worked. At least four animals are represented by the remains, however without more information on the total numbers of bones involved it is difficult

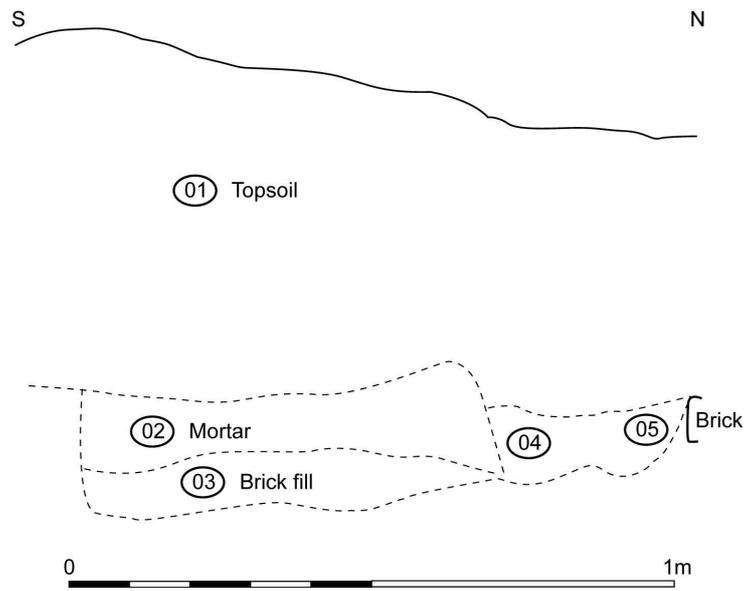
Fig 18: Section through footpath in Trench E

There was a footpath running east-west through the trench. A trench at least 0.7m wide and probably 1m originally was cut 0.22m into the natural clay (E06). The trench was filled with a deposit (E03) of broken hand made bricks about 100mm thick and this was overlain by a dirty grey mortar (E02) again about 100mm thick.

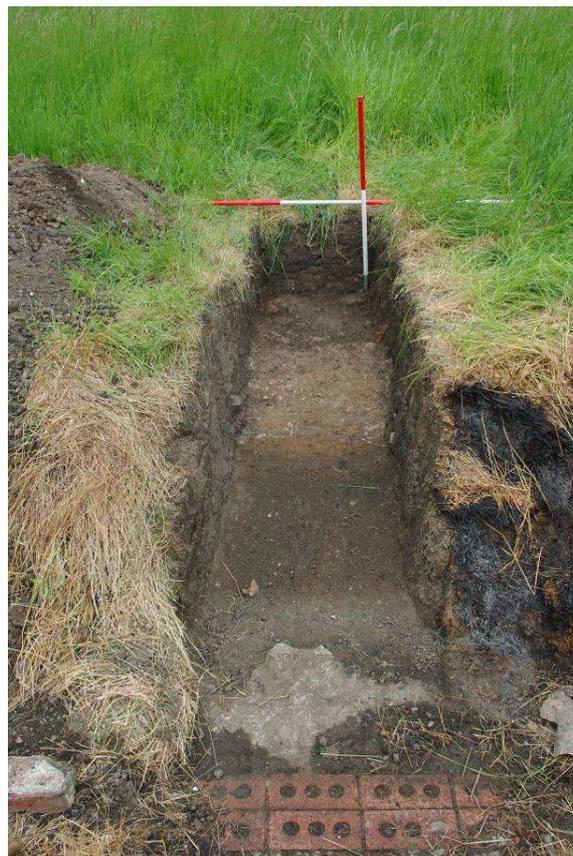
Fig 19: Trench E from the north

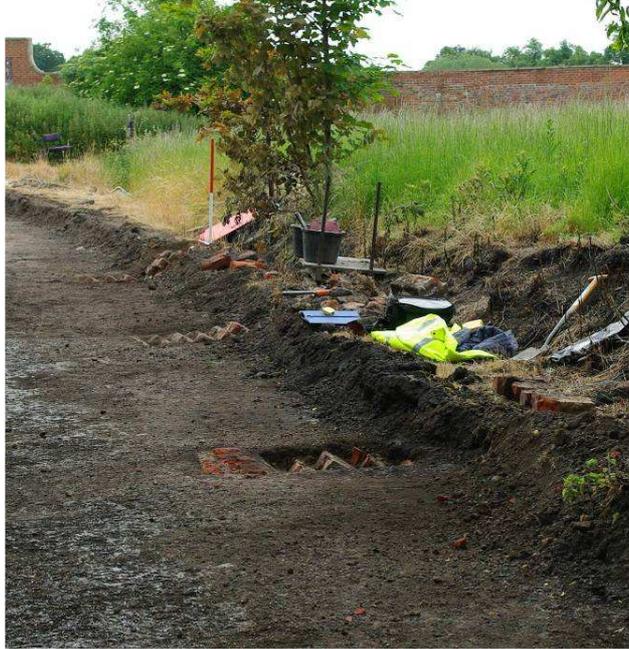
Fig 20: External, angled buttresses of the former south wall, from the east

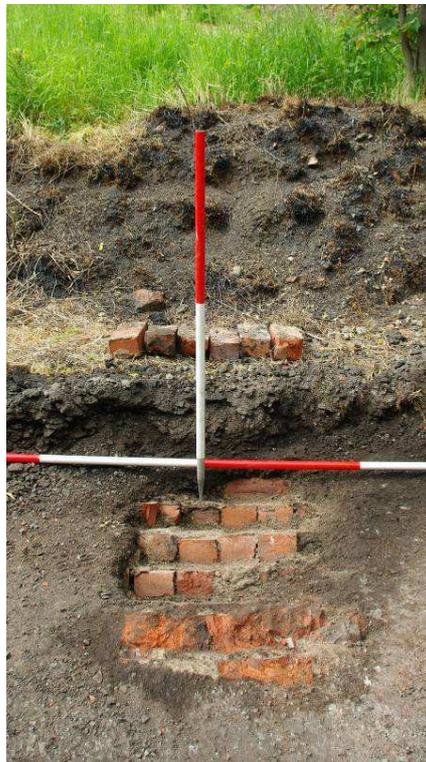
Fig 21: South Wall Buttress 1, from the south

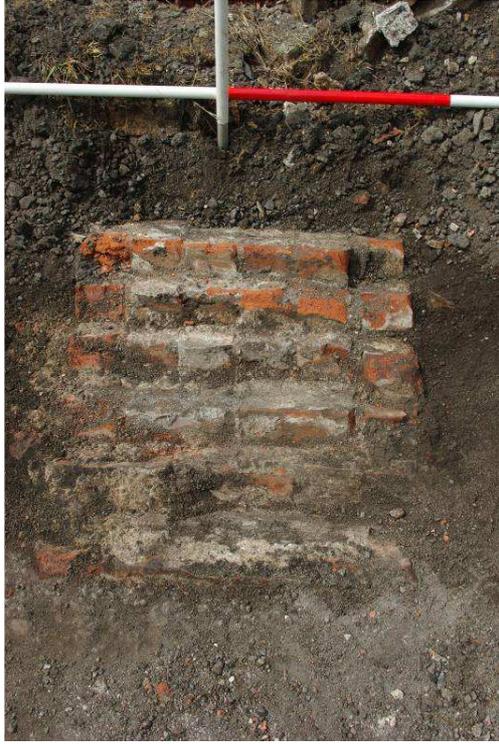
Fig 22: South Wall Buttress 2, from the south

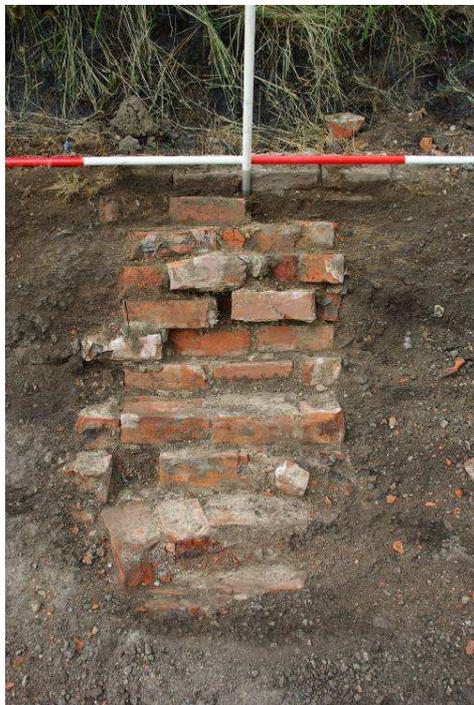
Fig 23: South Buttress 3, from the south
