HISTORIC BUILDING RECORDING FORMER WHITE & CO SHOE FACTORY STATION ROAD, EARLS BARTON NORTHAMPTONSHIRE

on behalf of Bellway Homes

July 2005

ASC: 689/EBS/2

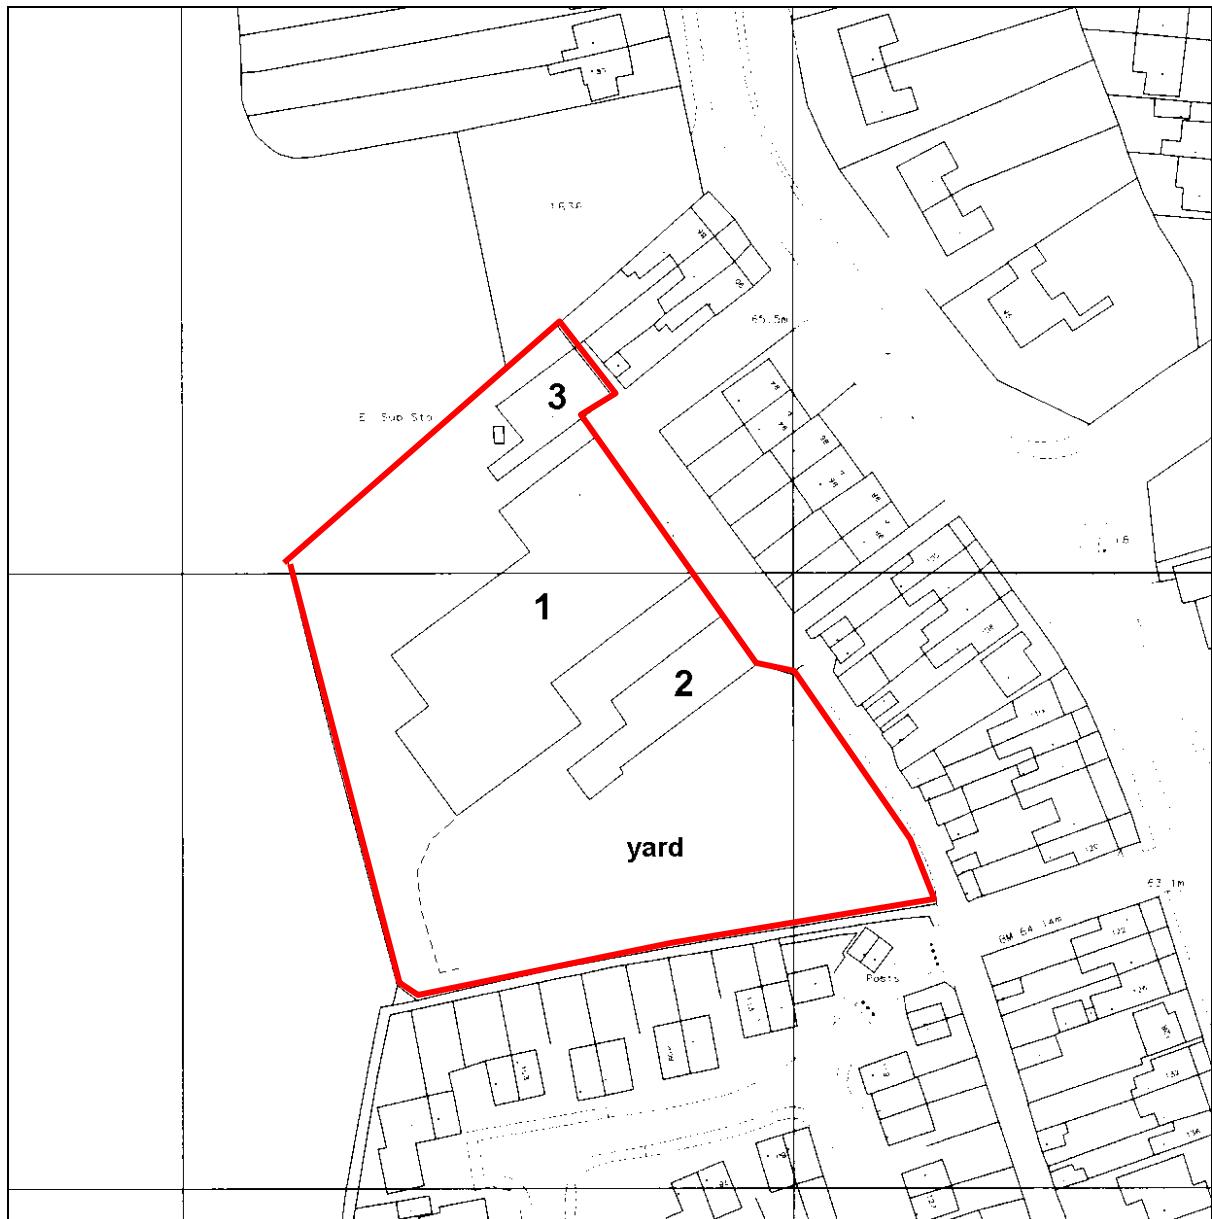
Figure 2: Site location (*scale 1:1250*)

The three buildings surviving on the site were the remnants of a much larger boot and shoe complex belonging to White & Co, and were thought to date from the 1950s or early 1960s. The larger building (Fig. 2: 1) occupying the centre of the site, was the main factory. It comprised two linked structures. To the north-east was a two-storey, flat-roofed brick building, housing both offices and production areas. At its south-west end was a modern steel-framed unit with a pitched roof, housing additional production facilities. South-east of the main structure was a single-storey building of brick and concrete block construction (2). To the north-west of the main building was a corrugated iron-clad building (3), which is shown as belonging to the site in Fig. 2, but was not accessible to the survey team. The gate between this structure and

Building 1 appeared not to have been used for some considerable time. Between Buildings 1 and 2 was a narrow yard, with a gate at its north-east end. To the south-east of Buildings 1 and 2 was a large concrete yard area: around the rest of the building was rough grass. Access to this was by a gate at the east corner of Building 2.

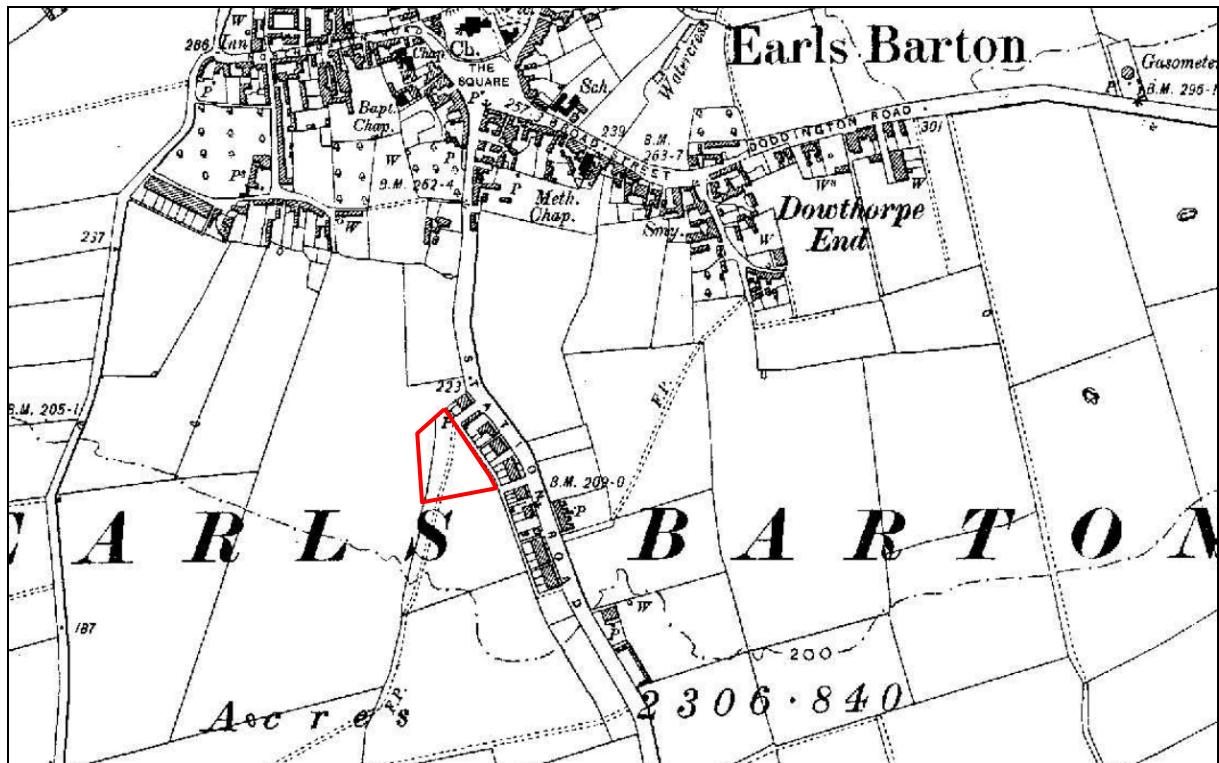
Figure 4: The site in 1901 (*not to scale*)

The precise date for the construction of White's Station Road factory is not known. The Ordnance Survey 6" sheet issued in 1901 (Fig. 4), shows a long narrow building set at right angles to Station Road, in the area now occupied by 94 Station Road. A separate L-shaped building stands at the south end of the plot. A trackway crosses the undeveloped site of the later factory building in a north-south direction.

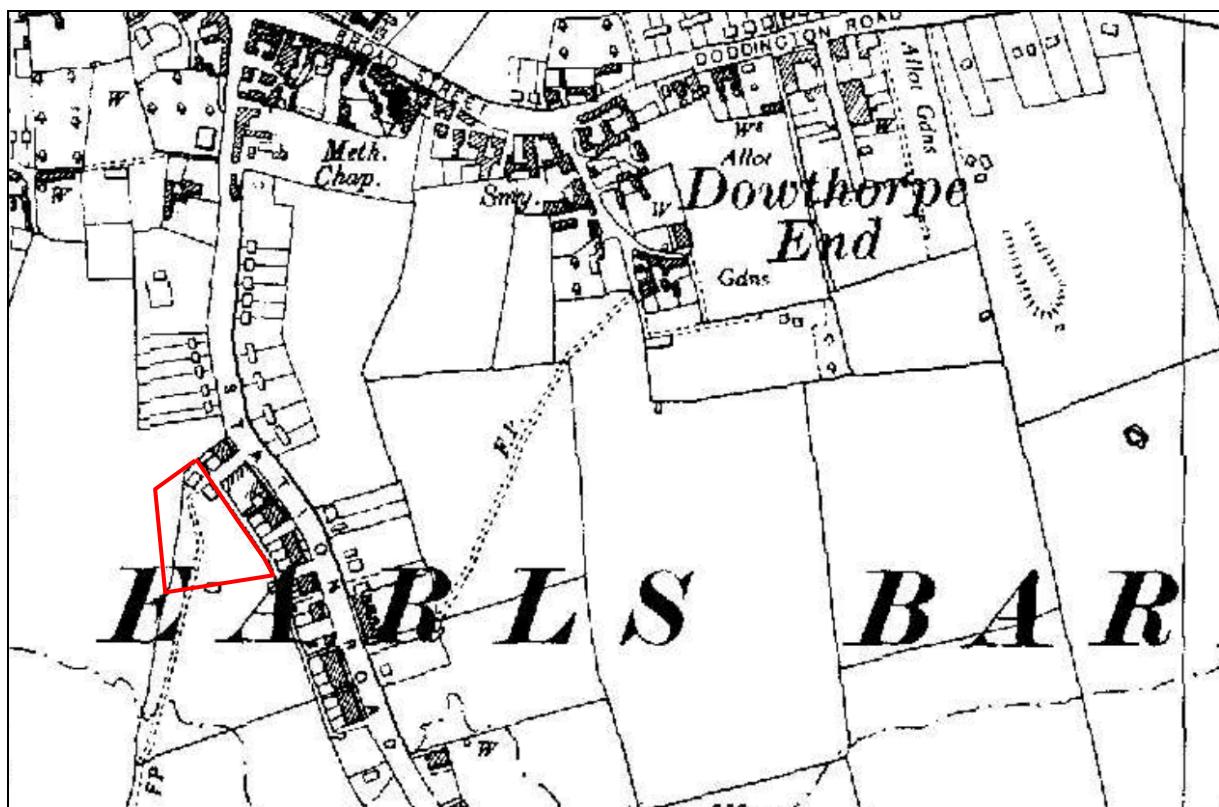
Figure 5: The site in 1958 (*not to scale*)

The Ordnance Survey 1:10,560 sheet for 1958 (Fig. 5) shows the original factory had expanded southwards, across the area now occupied by 94-98 Station Road. At this time the site of the later factory building is still shown as undeveloped, though there are two buildings at the north end of the site, and two towards its south end. None of these structures bear any relationship to Buildings 1-3, demonstrating that the present factory buildings must have been built after this date.

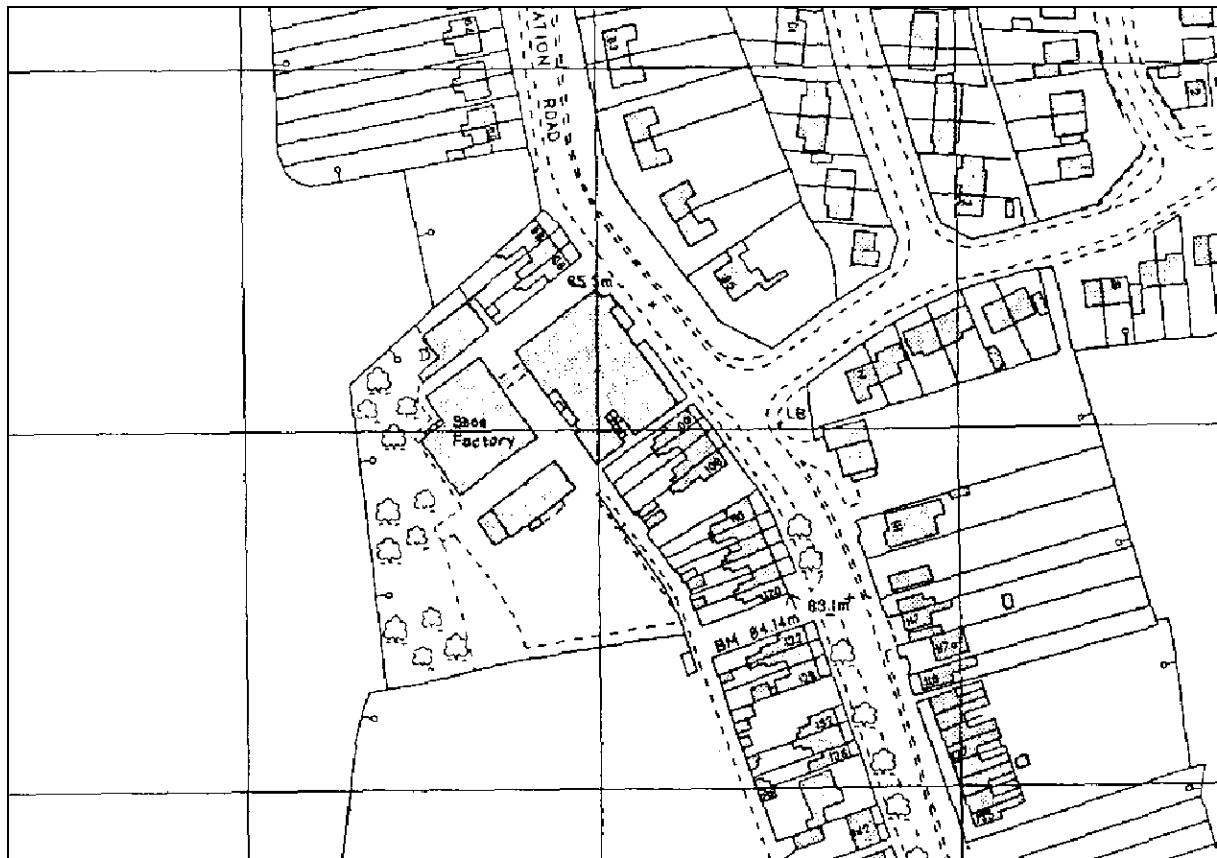
Figure 6: The site in 1974 (*not to scale*)

By the later 20th century the present factory buildings had been constructed. The 1974 Ordnance Survey 1:2500 sheet (Fig. 6) shows the north-east part of Building 1 (labelled 'shoe factory'), linked by a bridge to the original factory building. At this time the west part of the site is shown as wooded, with mainly mature trees. Buildings 1 & 3 are also shown for the first time.

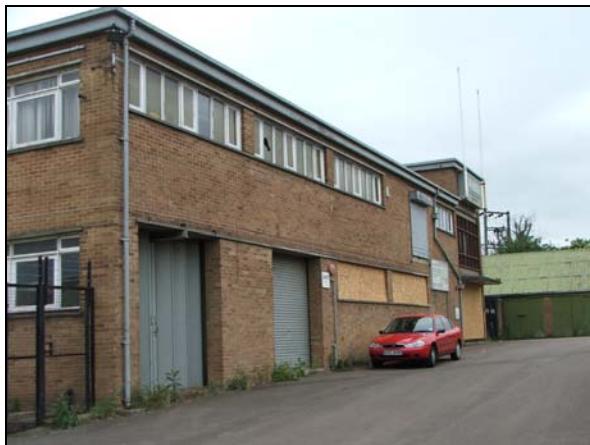
Plate 1: Building 1, north-east elevation

The north-east elevation was the front of Building 1. At its north end was the main entrance to the factory, with full-height glazing on both floors, and a sign identifying the building above. Two flagpoles surmounted the squat tower above this part of the building. At the south end of this elevation was a large concertina door, giving access for large plant to the boiler room. Above the door a substantial 'I' beam projected: presumably this was intended to carry a hoist. Adjacent to the boiler room door was a loading bay (Room 4) with a roller shutter door. At first-floor level was a door marking the location of the former bridge to the original factory building.

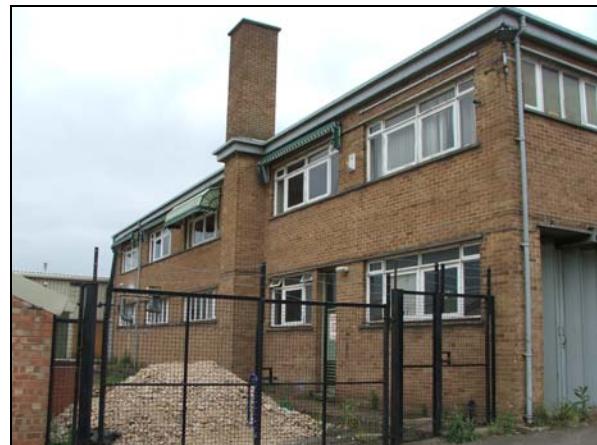
Plate 2: Building 1, south-east elevation

The south-east elevation was dominated by a square-section brick chimney, rising from the south corner of the boiler room. There were three doors at ground level: one to the boiler room; the second, adjacent to the chimney, being the main entrance for production staff; the third, at the junction between

the two buildings, being a fire exit. The office windows on the first floor were fitted with striped canvas fold-down awnings.

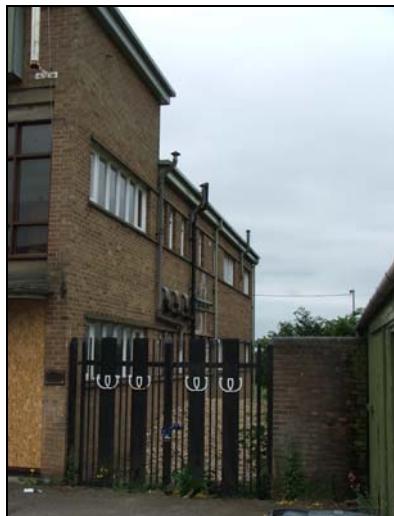
Plate 3: Building 1, north-west elevation

The north-west elevation was pierced by many small windows, due to the presence of toilets in this location on both floors. The presence of soil pipes and external waste plumbing also relates to this. The gap between the north corner and the adjoining corrugated iron building was closed by a pair of iron gates, bearing the company monogram.

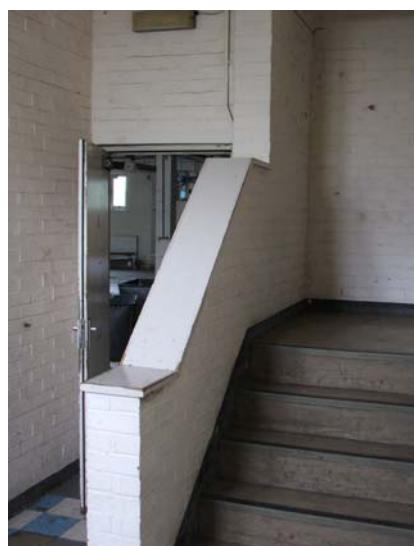
Plate 6: Room 1 (back stairs)

The main entrance for production staff was a door in the south-east side of the building. This led into a small foyer (**Room 1**), from which a door provided access to the ground-floor production area. A dog-leg concrete staircase led up to the first-floor production area.

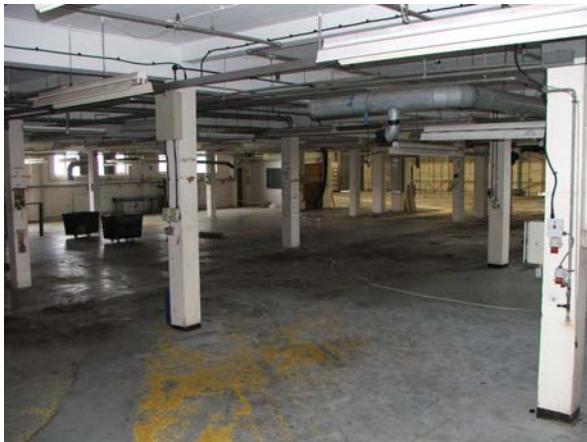
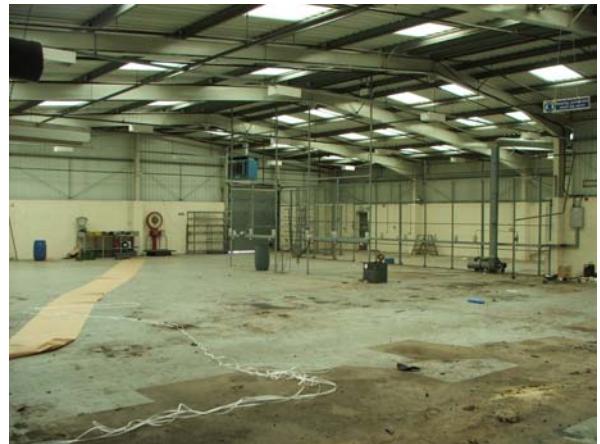
Little remained in the production areas (**Rooms 2 & 3**) to give an idea of the processes carried out there. The only evidence for machinery was provided by holding clamps bolted to the floor in Room 2, and power points throughout. Part of Room 3 was divided off by steel-framed caging, possibly as a store. On the north-east side of Room 2 was a small office (**Room 6**), presumably for shop-floor management, such as a foreman or production supervisor. On its rear wall was a large board with samples of leather in different colours and finishes. On the north-west side of Room 2 were ladies' and gents' WCs.

Plate 7: Room 2 (Production Area A)

Plate 8: Room 3 (Production Area B)

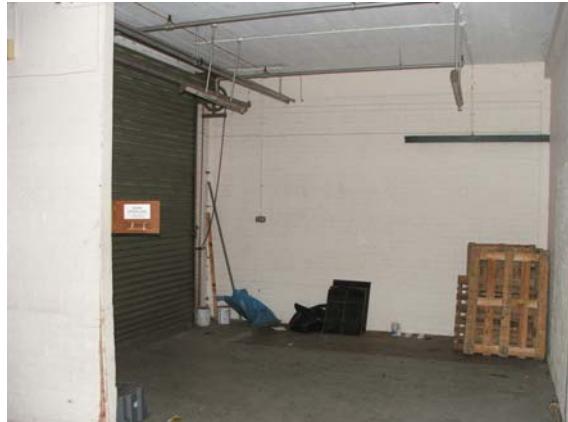
Plate 9: Room 4 (loading bay)

As has already been noted, the east corner of the ground floor was occupied by the boiler room, which could not be entered. Adjacent to this, on the north-east frontage, was a loading bay (**Room 4**). The adjoining **Room 5** provided access to the production area. On its north-west side was the lower part of the brick shaft which had contained the hoist or lift to the upper floor. All the machinery related to this had been removed, so the type of hoist could not be determined. From Room 5 a corridor ran north-westwards to Room 7, passing behind Room 6 and the hoist.

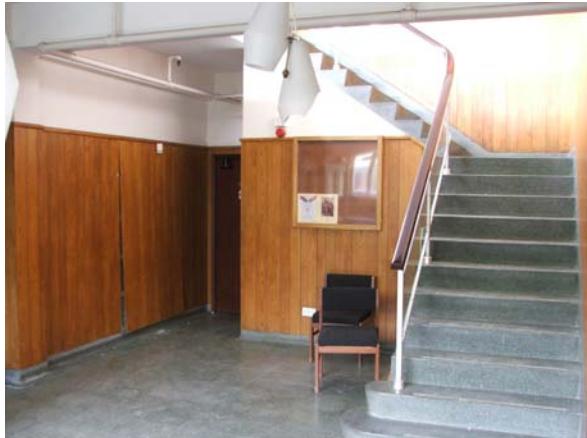
Plate 13: Room 7 (entrance foyer)

Room 7, the foyer inside the main entrance to the factory, provided a contrast to the areas described above. Its floor was tiled, its walls were panelled in dark wood, and the stairs leading to the upper floor had a marble finish. Inside the double entrance doors was a glass-panelled porch, with a second set of double doors leading into the foyer. In the wall opposite, a door led to the production area. In the south corner, stairs rose to the upper floor, turning through 90°.

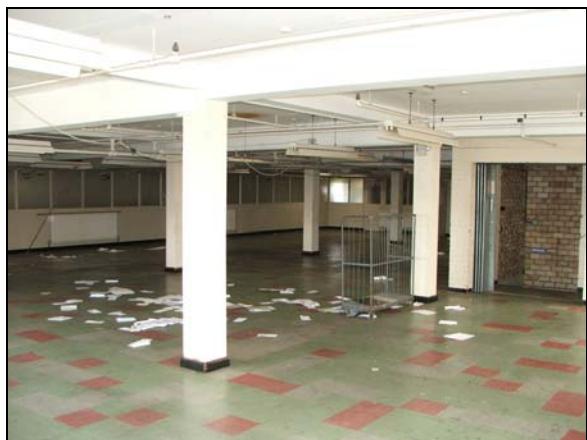
Plate 17: Room 12 (Production Area C)

The first floor production area (**Room 12**) covered an area of c.290 sq. m. Its floor was laid with heavy-duty lino tiles, unlike the bare concrete floor of the ground-floor production areas. While there was evidence of ample power supplies along the south-west side of the room, there were no marks or fittings indicating the presence of heavy machinery. On the north-east side were the three small offices mentioned above. Two (**Rooms 13 & 14**) opened onto the production area. On the south-east side was a landing and stairs (**Room 15**) leading to the staff entrance (Room 1). Beside the entrance to Room 15 was a time-clock. The south-west and north-west sides of Room 12 were half-glazed partitioning. A doorway in the south corner led to the offices, as did two doors in the north-west partition. A double door in the same partition was blocked by a radiator.

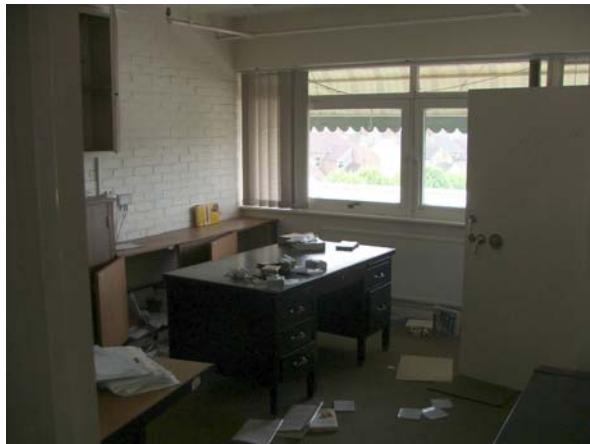
Plate 21: Room 16

Access to the offices was provided by **Room 17**, a corridor running almost the full width of the building, on a NW-SE alignment. At its south-east end was an office, **Room 16**. The presence of a large Chubb safe built into its south corner suggests this may have been the accounts office. Also at this end of the corridor, **Room 20**, a second corridor, ran south-westwards, giving access to Rooms 18 and 19. At the junction of the two corridors was the entrance to Room 21 and the main suite of offices. On the south-west side of the corridor was a doorway, leading into Room 23, closed on the corridor side by a counterweighted sliding door, identical to and directly aligned with that in Room 10.

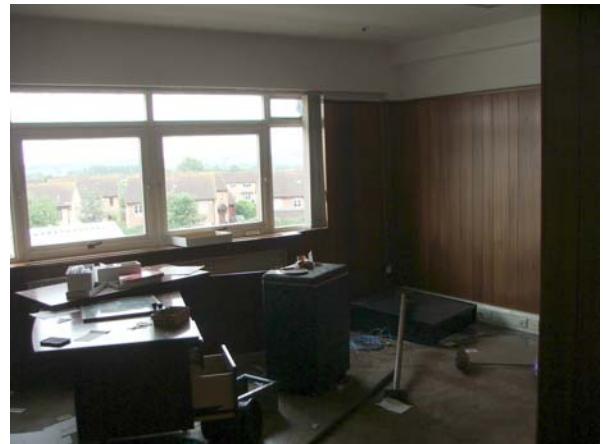
Plate 22: Room 18

On the south-east side of Room 20 was the entrance to **Room 18**. The panelled walls and surviving fixtures and furnishings in this office suggested that its occupant was a senior manager. Its north-west wall was occupied by a large built-in cupboard. At the south-west end of Room 20, occupying the south corner of the building, were two interconnected offices. **Room 19** was

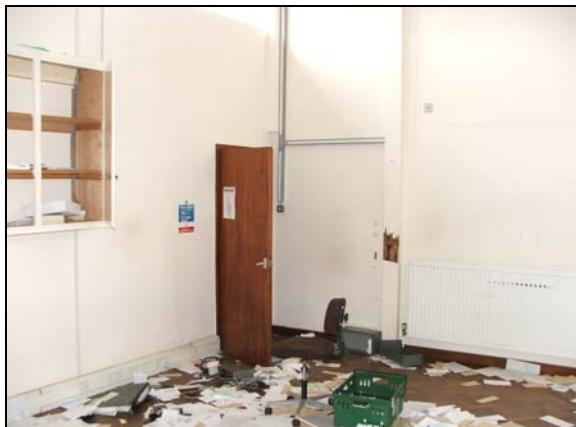
Plate 23: Room 21

Room 21 appears to have been the administrative office. Built-in cupboards on its north-east wall were evidently used for storing office stationery. **Room 22**, to the south-west, may have served a similar purpose. A door from Room 22 provided access to the aforementioned balcony at the rear of the building. To the north-west of Rooms 21 and 22 was **Room 23**, the largest of the offices, measuring $9.0 \times 5.6m$. The large suspended wood-finished lighting unit above the centre of the room suggests that this may have been a meeting / board room.

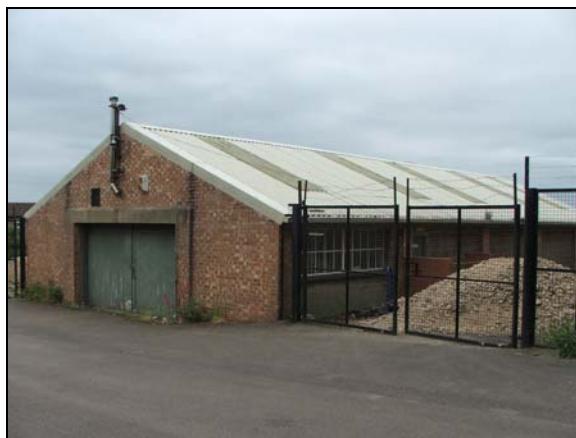
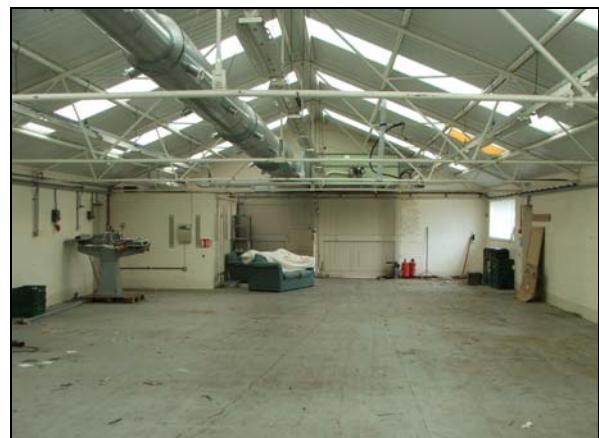
Building 2 was a five-bay single-storey building of stock brick (stretcher bond) and concrete block construction, measuring $26 \times 10m$. Its pitched roof was carried on steel trusses. At its north-east end were large double doors: pedestrian access was by a door on its north-west side, opposite the staff access to Building 1. The interior was lit by translucent roof panels, and windows in the north-east bay. The interior layout of Building 2 comprised a single working area, with a small office partitioned off in the north corner, and a storage area also partitioned off at the south-west end. As in Building 1, all production machinery had been removed, apart from one machine of indeterminate function, and it was not possible to determine what function the building had served. At the south-west end of Building 2, a single storey extension measuring $c.12 \times 6m$ appears to have been a garage. Building 2 first appears on the available OS maps in 1974 (Fig. 5).

Plate 29: Building 2, north-east end

Plate 30: Building 2, interior

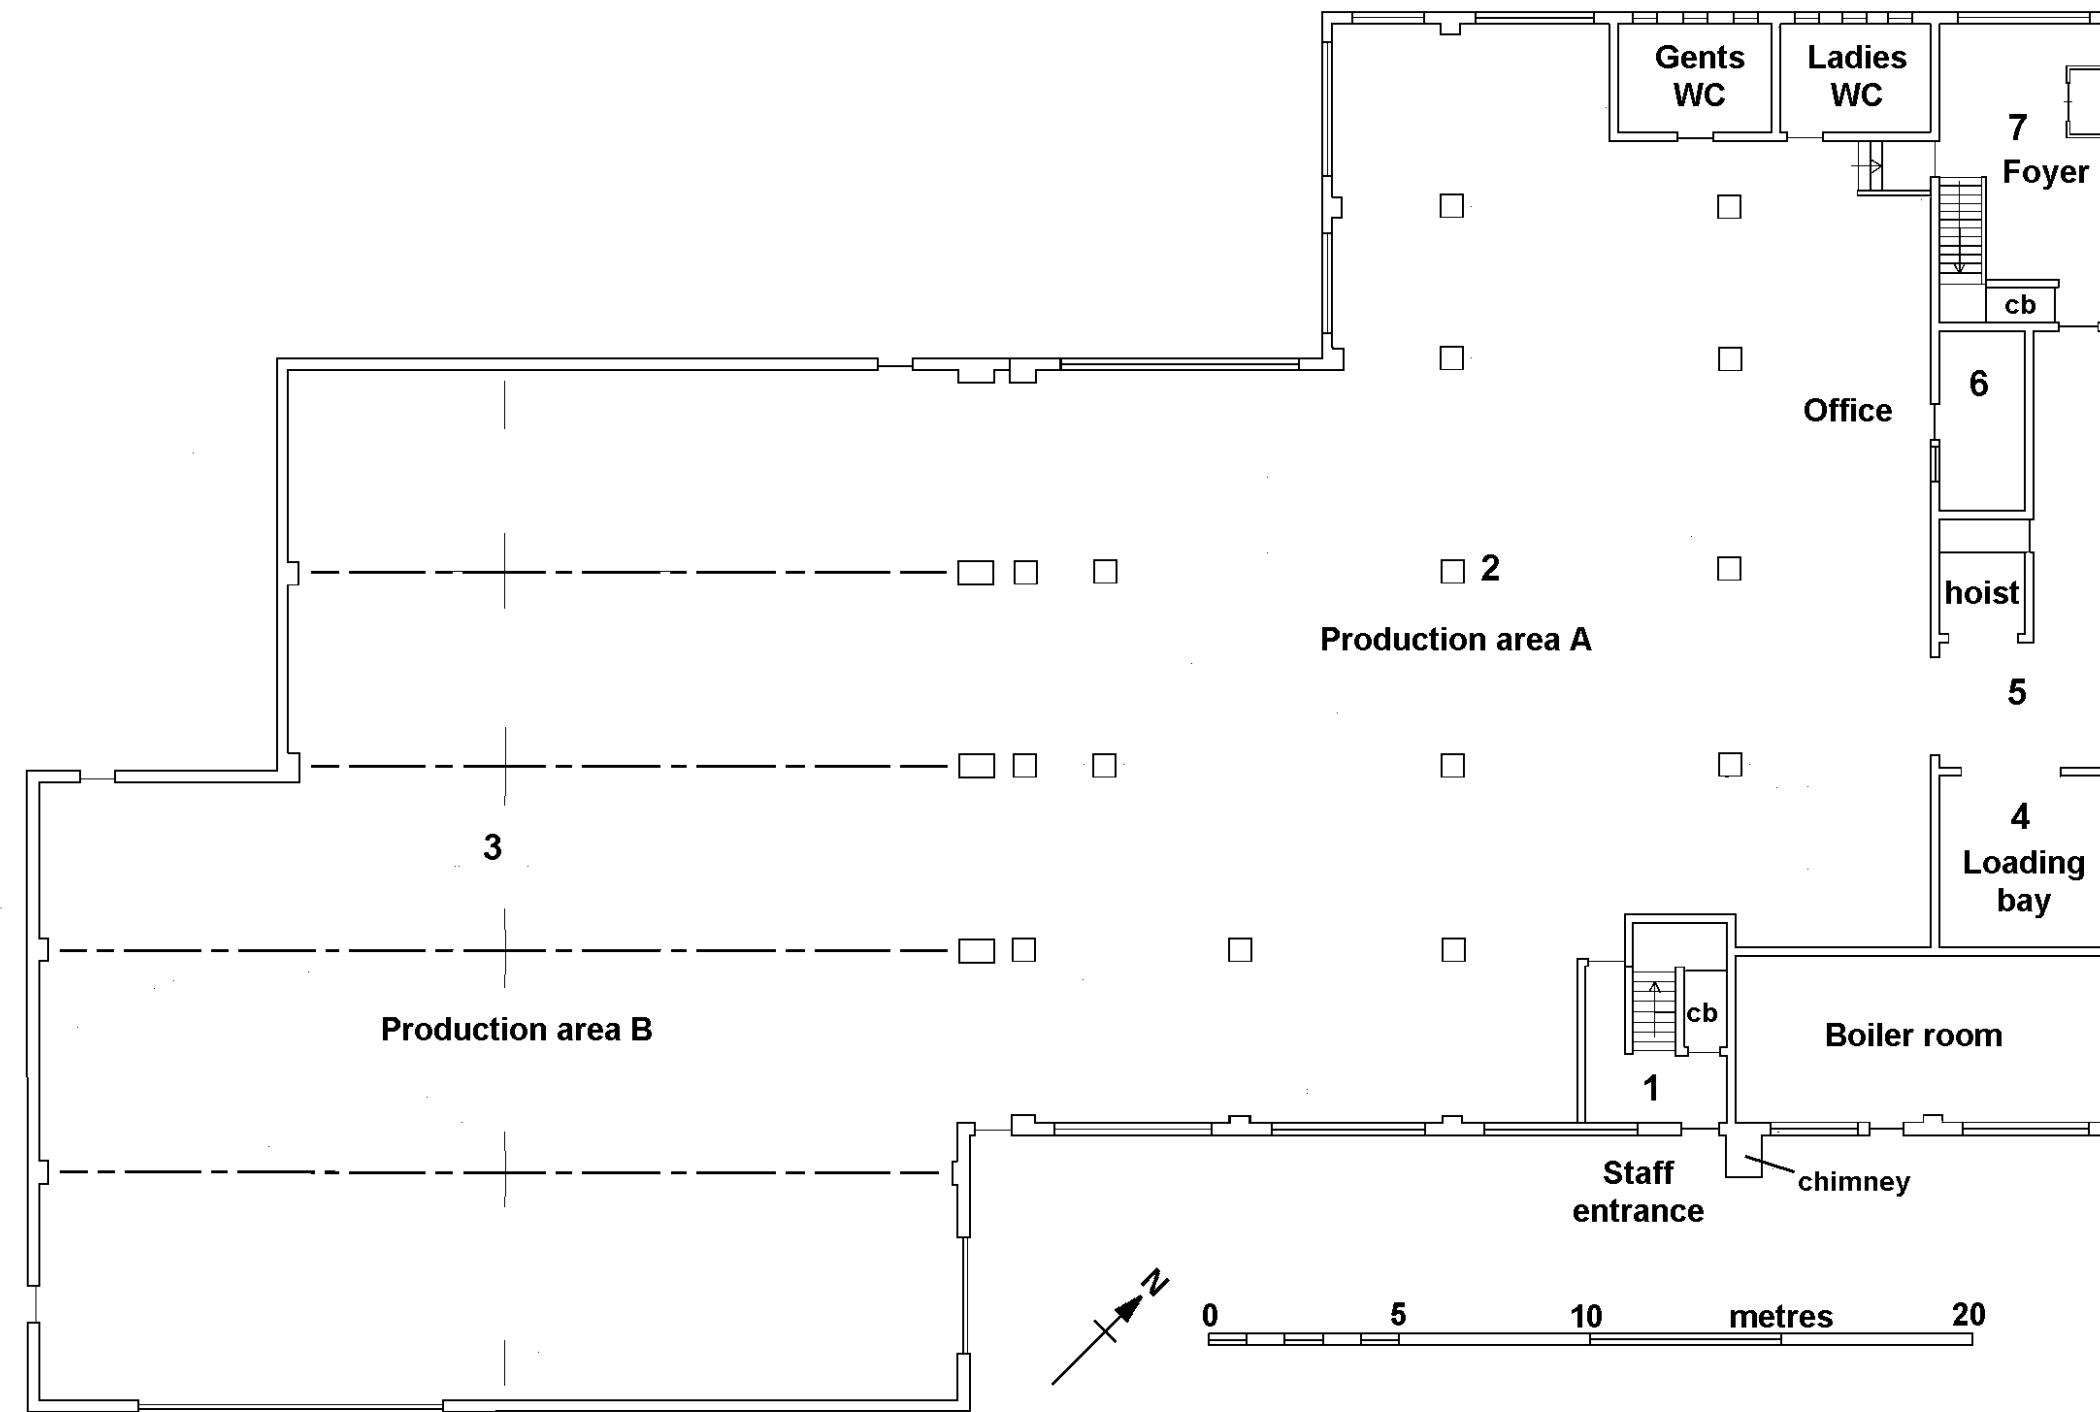
Figure 7: Building 1, ground floor plan (*scale 1:200*)

Almost all of the ground floor of Building 1 was taken up by two production areas, located in the rear part of the original building (A) and occupying the whole of the later extension (B). The remainder, comprising the north-east side, was taken up by access arrangements for staff, visitors, goods and equipment, and services.

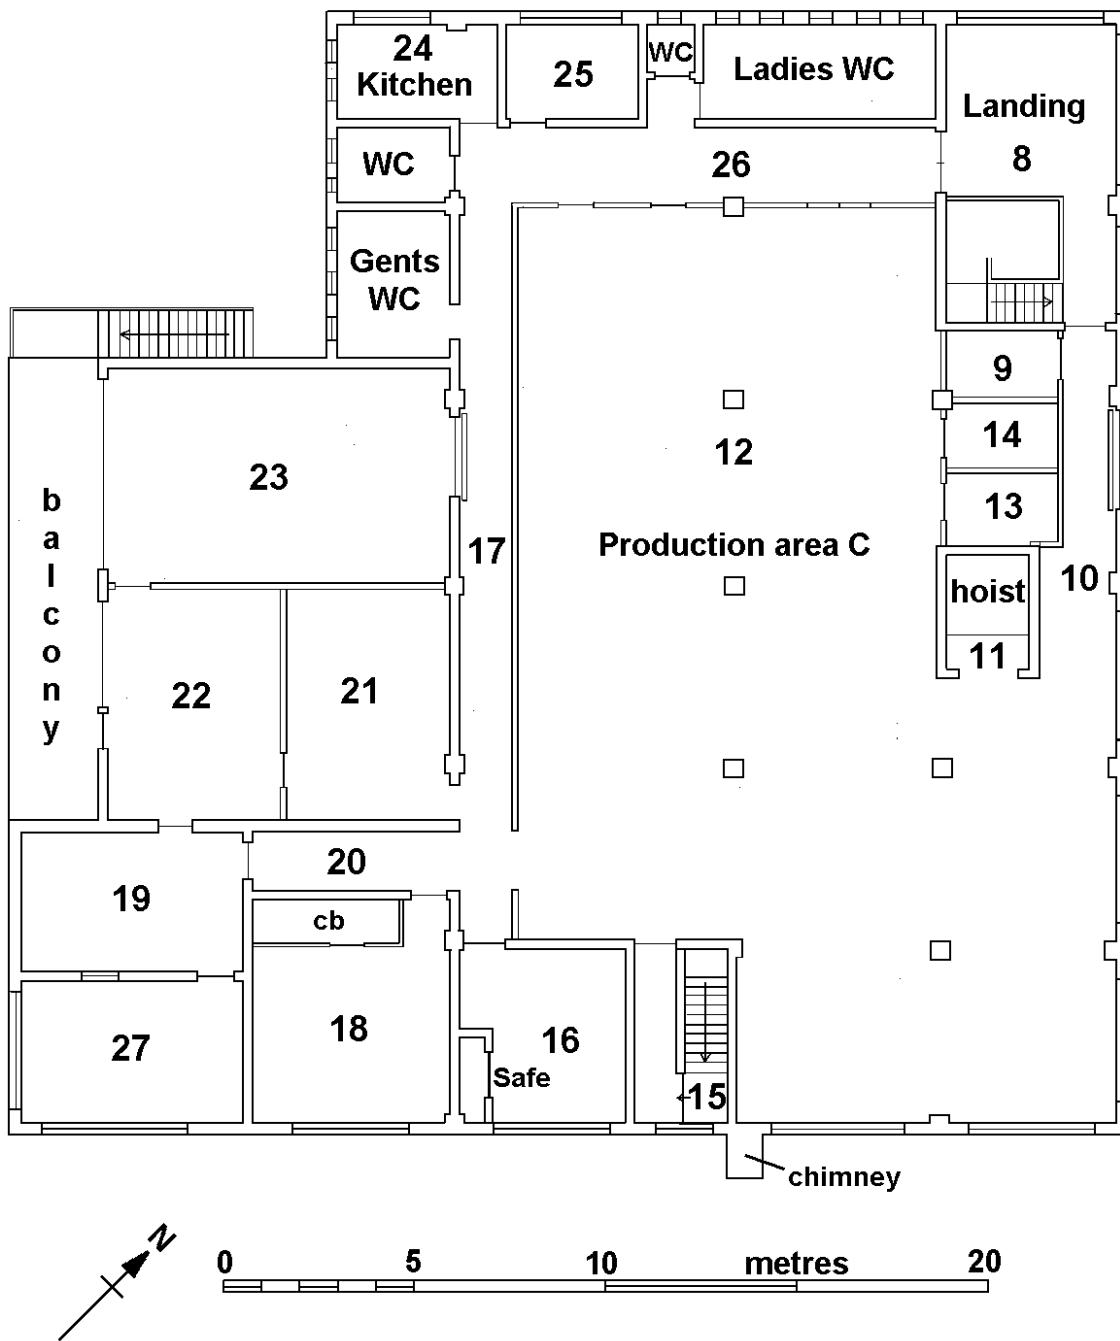
Figure 8: Building 1, first floor plan (scale 1:200)

Like the ground floor, the upper floor plan of the factory was simple and functional. The front of the building was taken up largely with a third production area (C). On the north-west side, separated by a corridor, were toilets and a kitchen. To the south-west, also separated by a corridor from the production area, were the company's offices.
