6. Route ways and watercourses

6.2. Route ways

6.2. Colne Valley River System

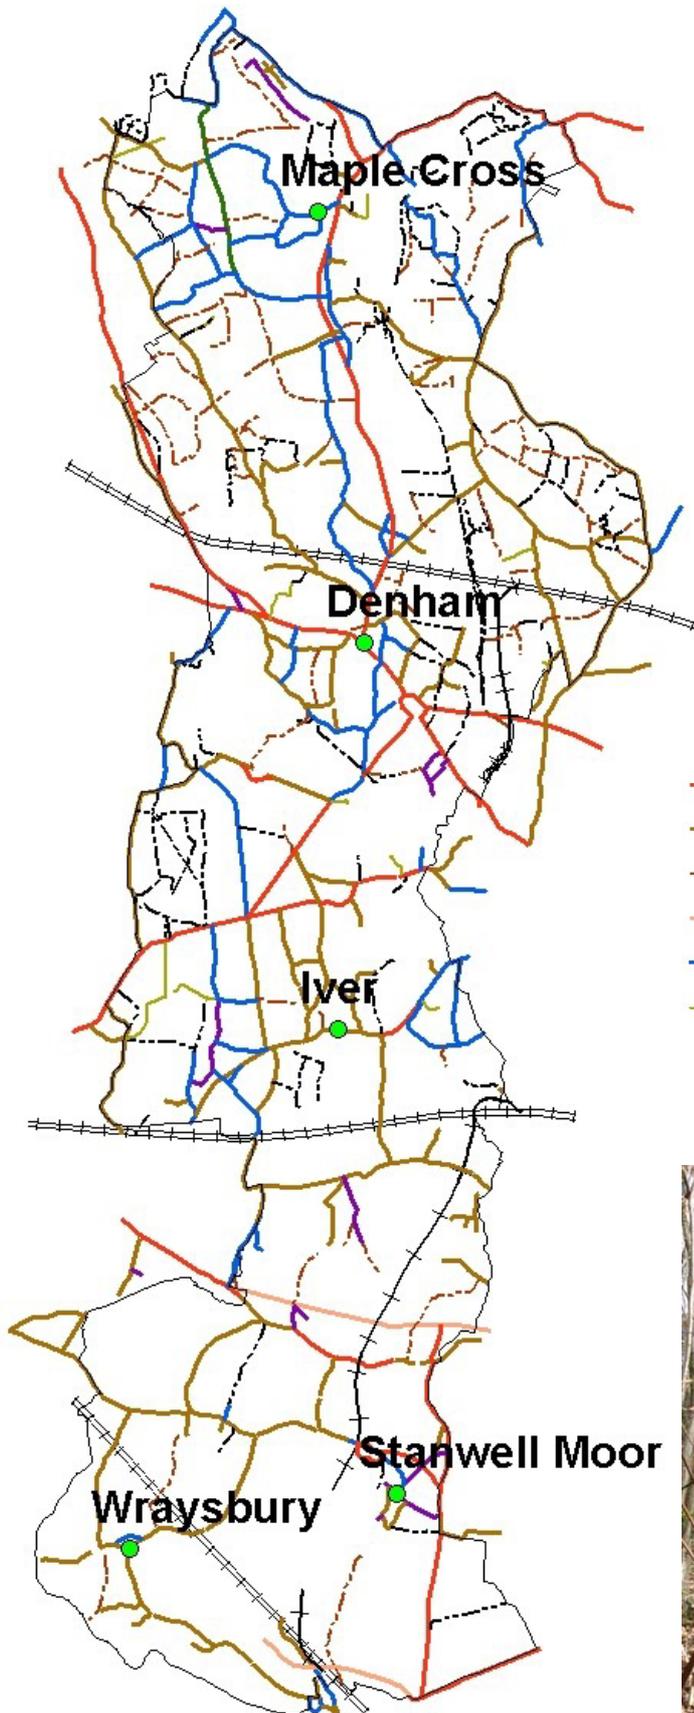
Figure 68: The present day route ways

Route ways in the Colne Valley have remained remarkably intact in comparison to the level of growth and urbanisation. The essential historic framework of roads and paths continue as a backbone to the modern transport network with the vast majority of old medieval and pre-map source roads are now used as modern B-roads. Some introductions have been made including the Colnbrook bypass, several historic railways and the motorways that dissect the Valley, while most of the modern A-roads also have historic roots as roman roads and toll roads. The greatest level of loss is recorded with the footpaths and trackways as a high number of these disappeared throughout the century.

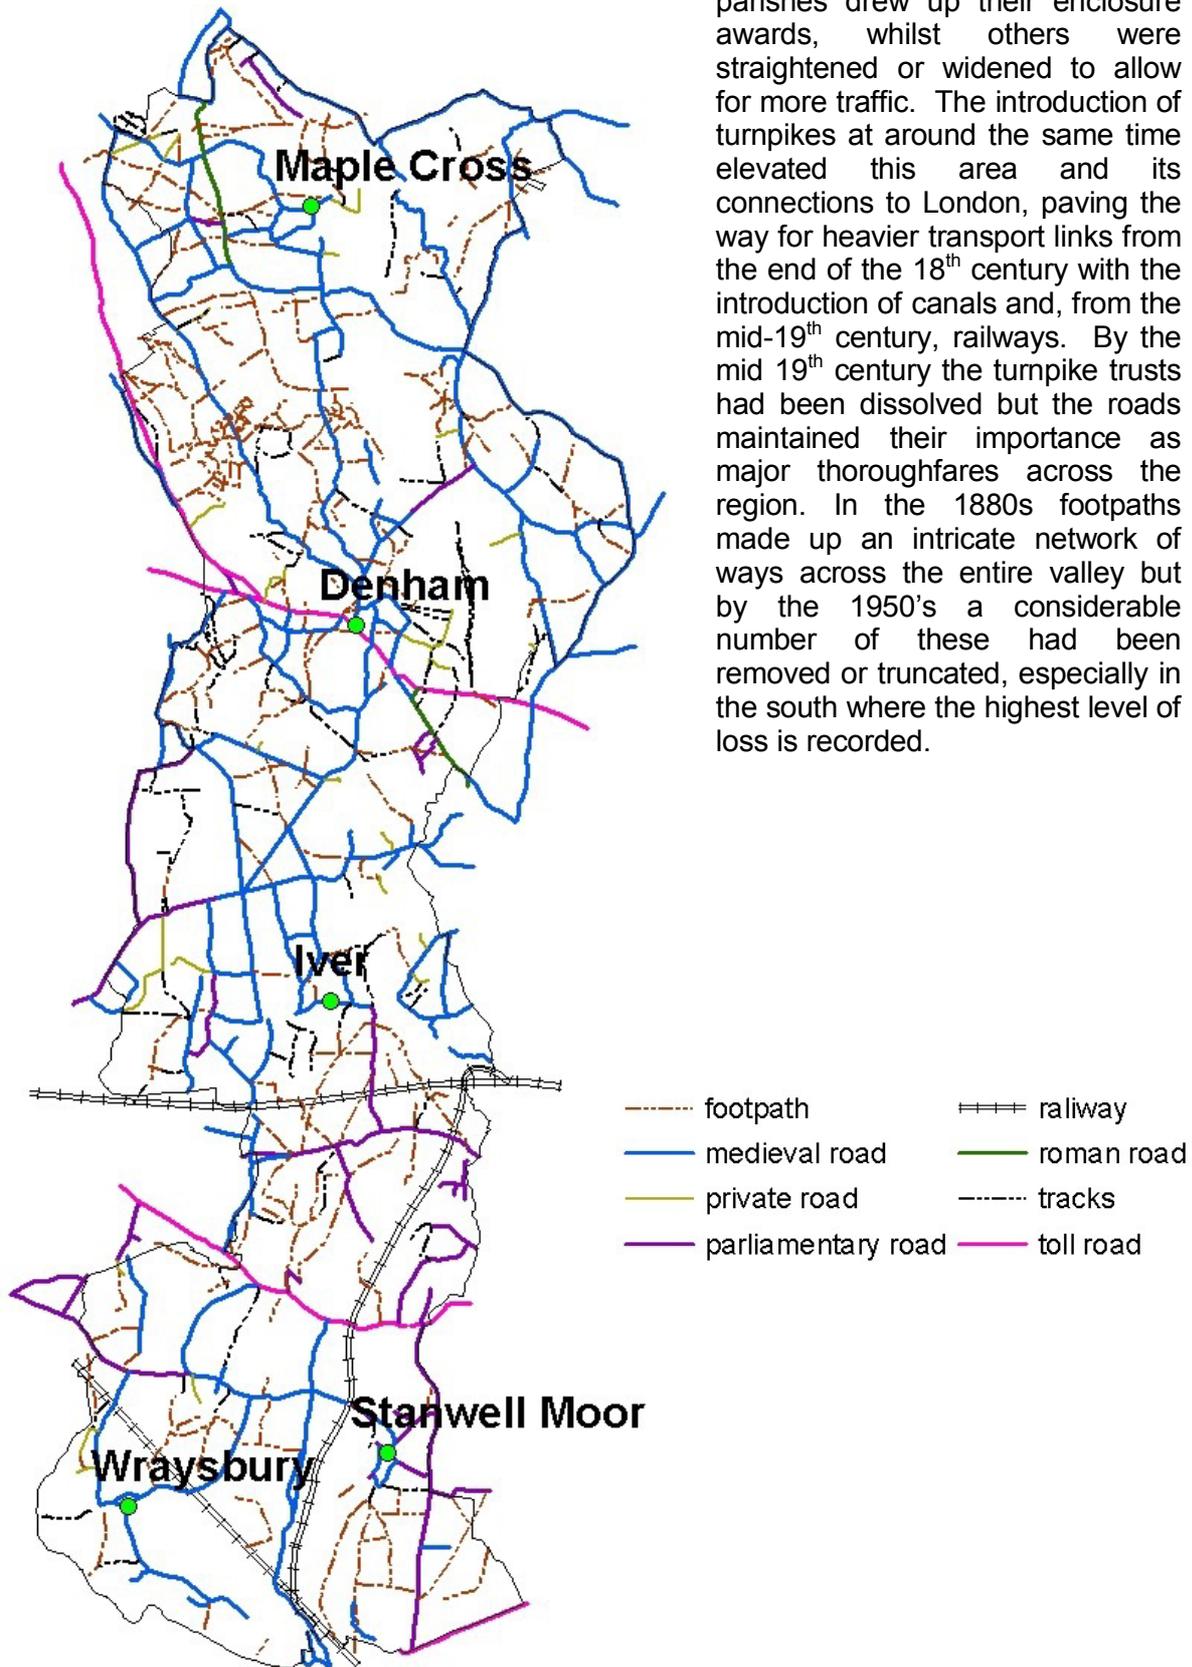
Figure 72: Routes network. OS 6" 1st edition. (1876-1886)

Railways were introduced by the mid to late 19th century and further increased the urbanisation of the area. Links between the major railway lines, settlements and other sites were provided by short sections of railways. Several sections of temporary tramways were also constructed between various extraction sites and the railways and canal ways

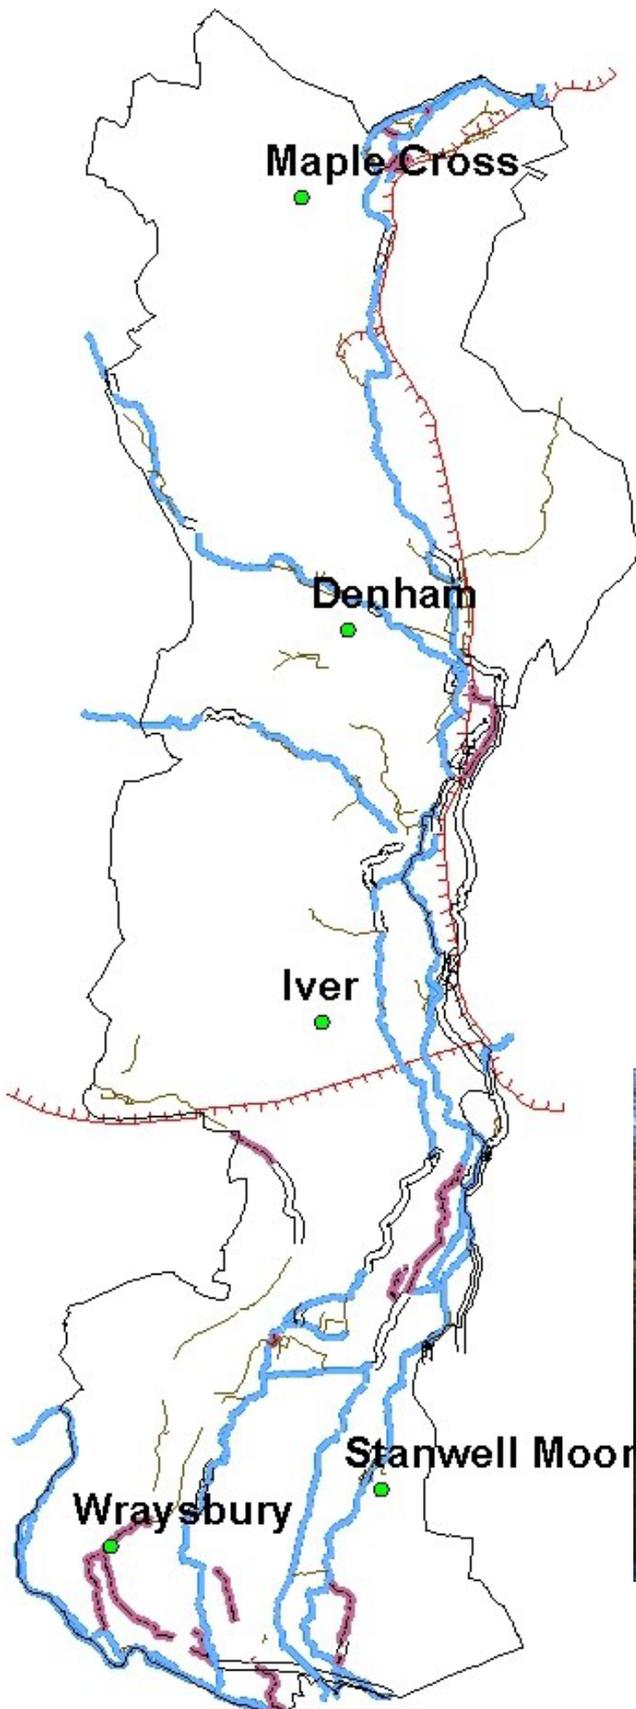
Figure 74: The present day water network

The Colne Valley river system shown in Figure 74 exhibits an intricate pattern of natural and constructed watercourses. Natural river channels for the purposes of this document are defined as stretches of the river course that have not been artificially constructed from the medieval period onwards. The courses of the waterways that run through the Colne Valley Park have been heavily altered over many centuries as new river stretches have been cut, channels straightened and widened and ditches and leats added to channel water for watercress farming and millworks. The present day network, shown in Figure 74, highlights the extent to which the river network has been altered through the addition of wholly artificial sections along the course of the river channel, surviving sections of medieval boundary ditches, modern canal ways as well as surviving sections of leats.

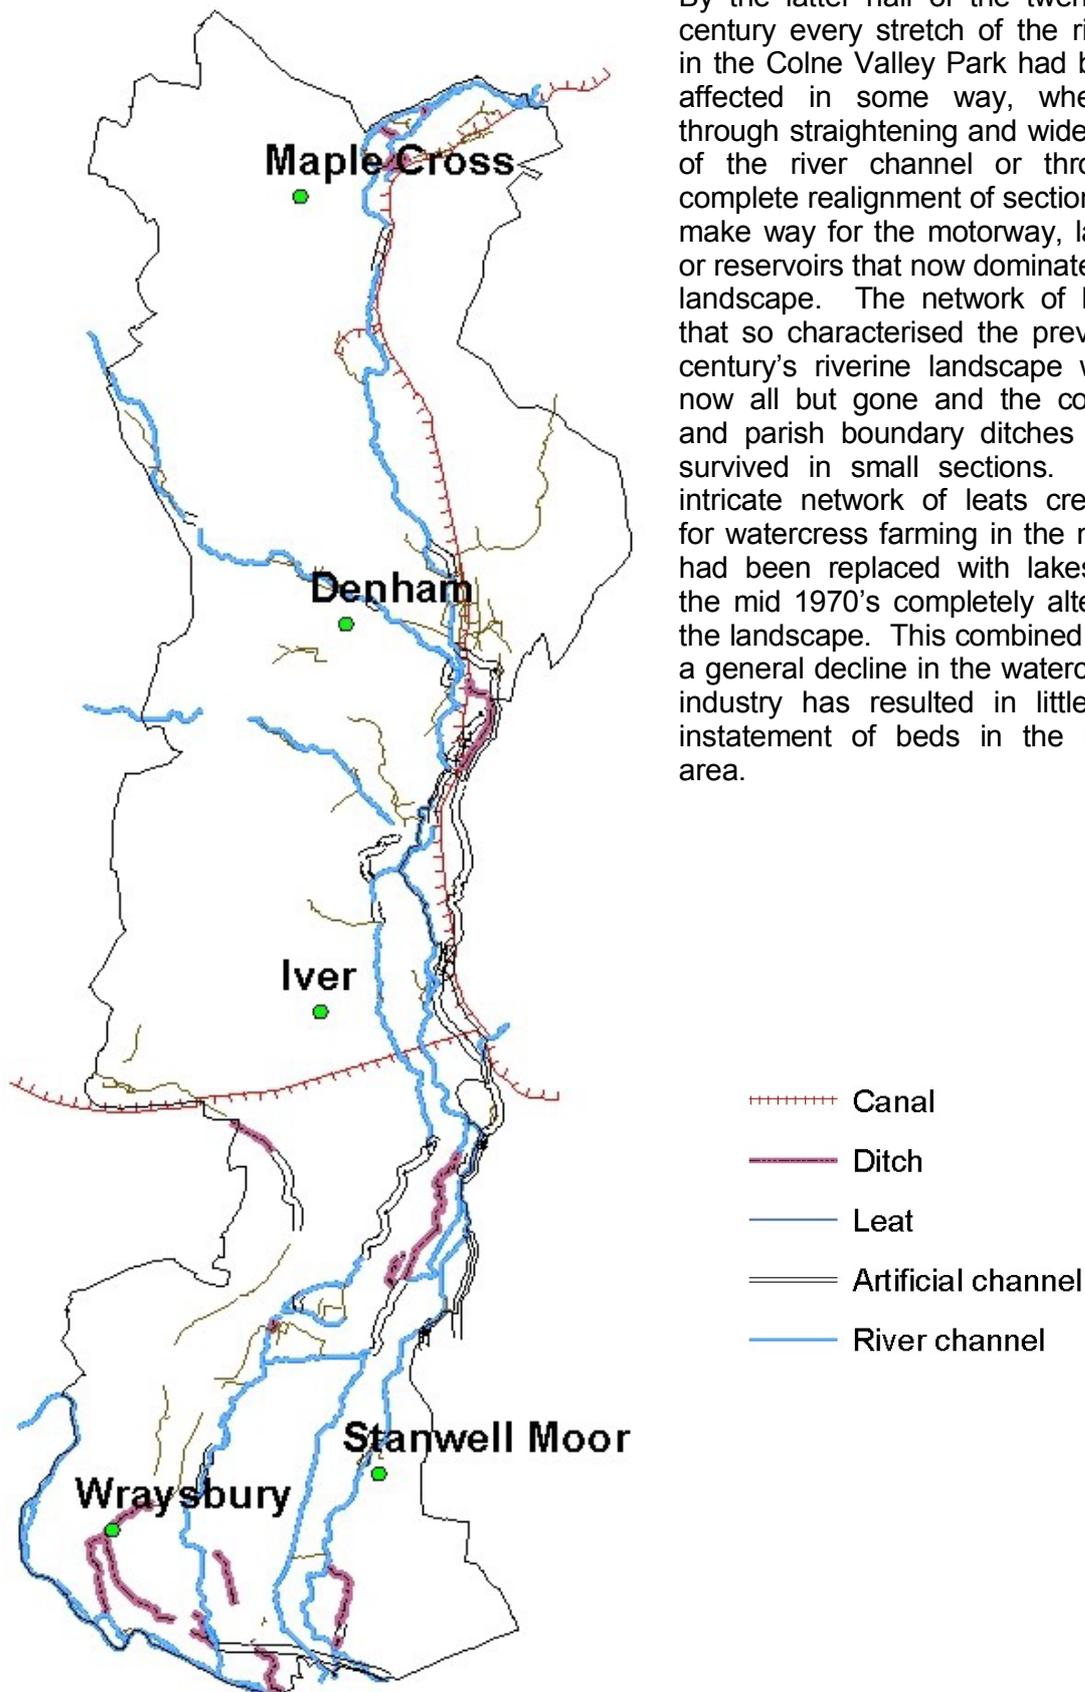
Figure 76: Water system. NG 10k edition (1972-1990)

By the latter half of the twentieth century every stretch of the rivers in the Colne Valley Park had been affected in some way, whether through straightening and widening of the river channel or through complete realignment of sections to make way for the motorway, lakes or reservoirs that now dominate the landscape. The network of leats that so characterised the previous century's riverine landscape were now all but gone and the county and parish boundary ditches only survived in small sections. The intricate network of leats created for watercress farming in the north had been replaced with lakes by the mid 1970's completely altering the landscape. This combined with a general decline in the watercress industry has resulted in little re-instatement of beds in the local area.

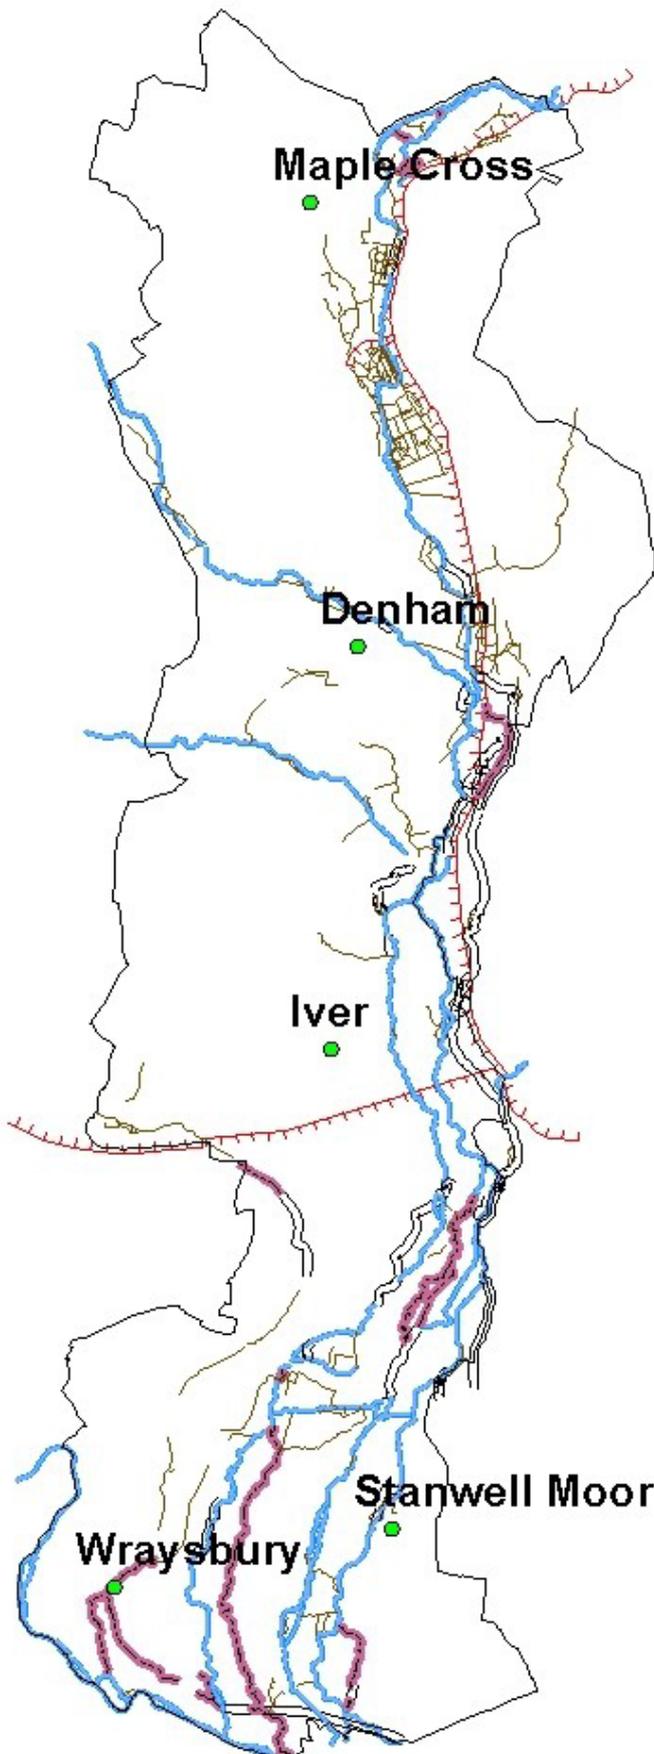
Figure 77: Water system. NG 6" provisional edition (1955-1962)

By the 1950's the pattern of water ways had already been greatly reduced as a great many of the previous centuries leats and ditches were no longer in use, in the Rickmansworth area, the mining and later construction of lakes in the Stockers farm area meant the loss of large areas of watercress beds. Around Wraysbury, also, there was extensive loss to ditches and leats as the large reservoirs were constructed. Figure 78 shows a highly intricate web of leats leading off from the river Colne, it is located under what is now the Pynesfield lakes. This area of the Colne Valley Park was intensively utilised for watercress farming until the early twentieth century.

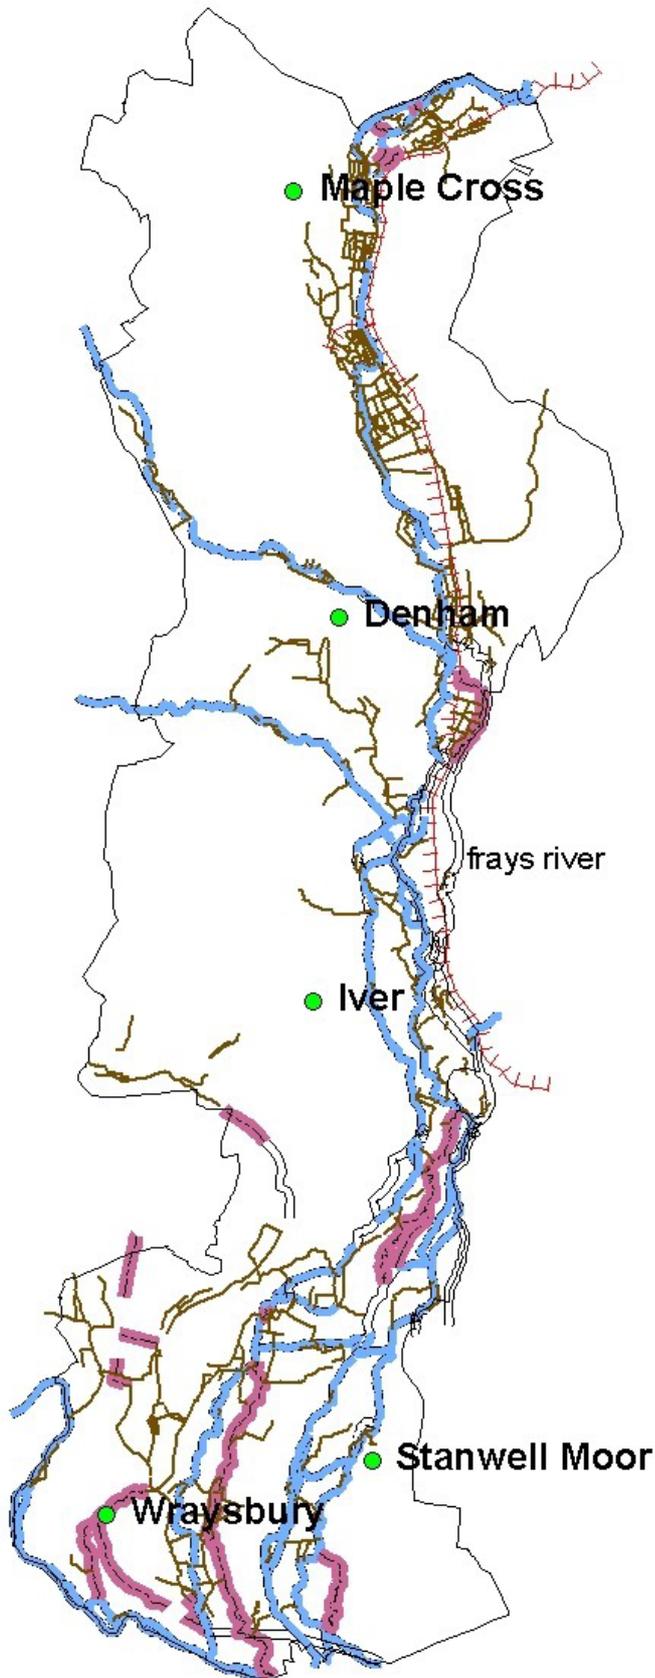
Figure 79: Water system. OS 6" 1st edition. (1876-1886)

The most extensive addition to the historic river system was the cutting of Fray's river in the 15th century, although details of this remain scarce it is thought to have been cut by John Fray, the Baron Lord Chancellor to the Exchequer in order to power mills in the Uxbridge area. Further artificial branches to the Colne River include the Duke of Northumberland's river, cut in the 16th century and the Queens or Cardinals river dating to the 17th century (Baker et al: 1962). The early medieval county ditches only survive in small sections due to later construction of motorways, reservoirs and to some extent the extractive industry. Included in county ditches are fragments of Shire ditch, Bonehead ditch and the Bigley ditch. Trade along the Grand Junction canal was flourishing by the early 1800's with flour and coal as the main resources transported on the new canal. The late construction of the Slough branch of the Grand Union Canal in 1882 constituted one of the last canal ways in England with the aim of promoting the brick industry in the area and in particular the sites at Langley.

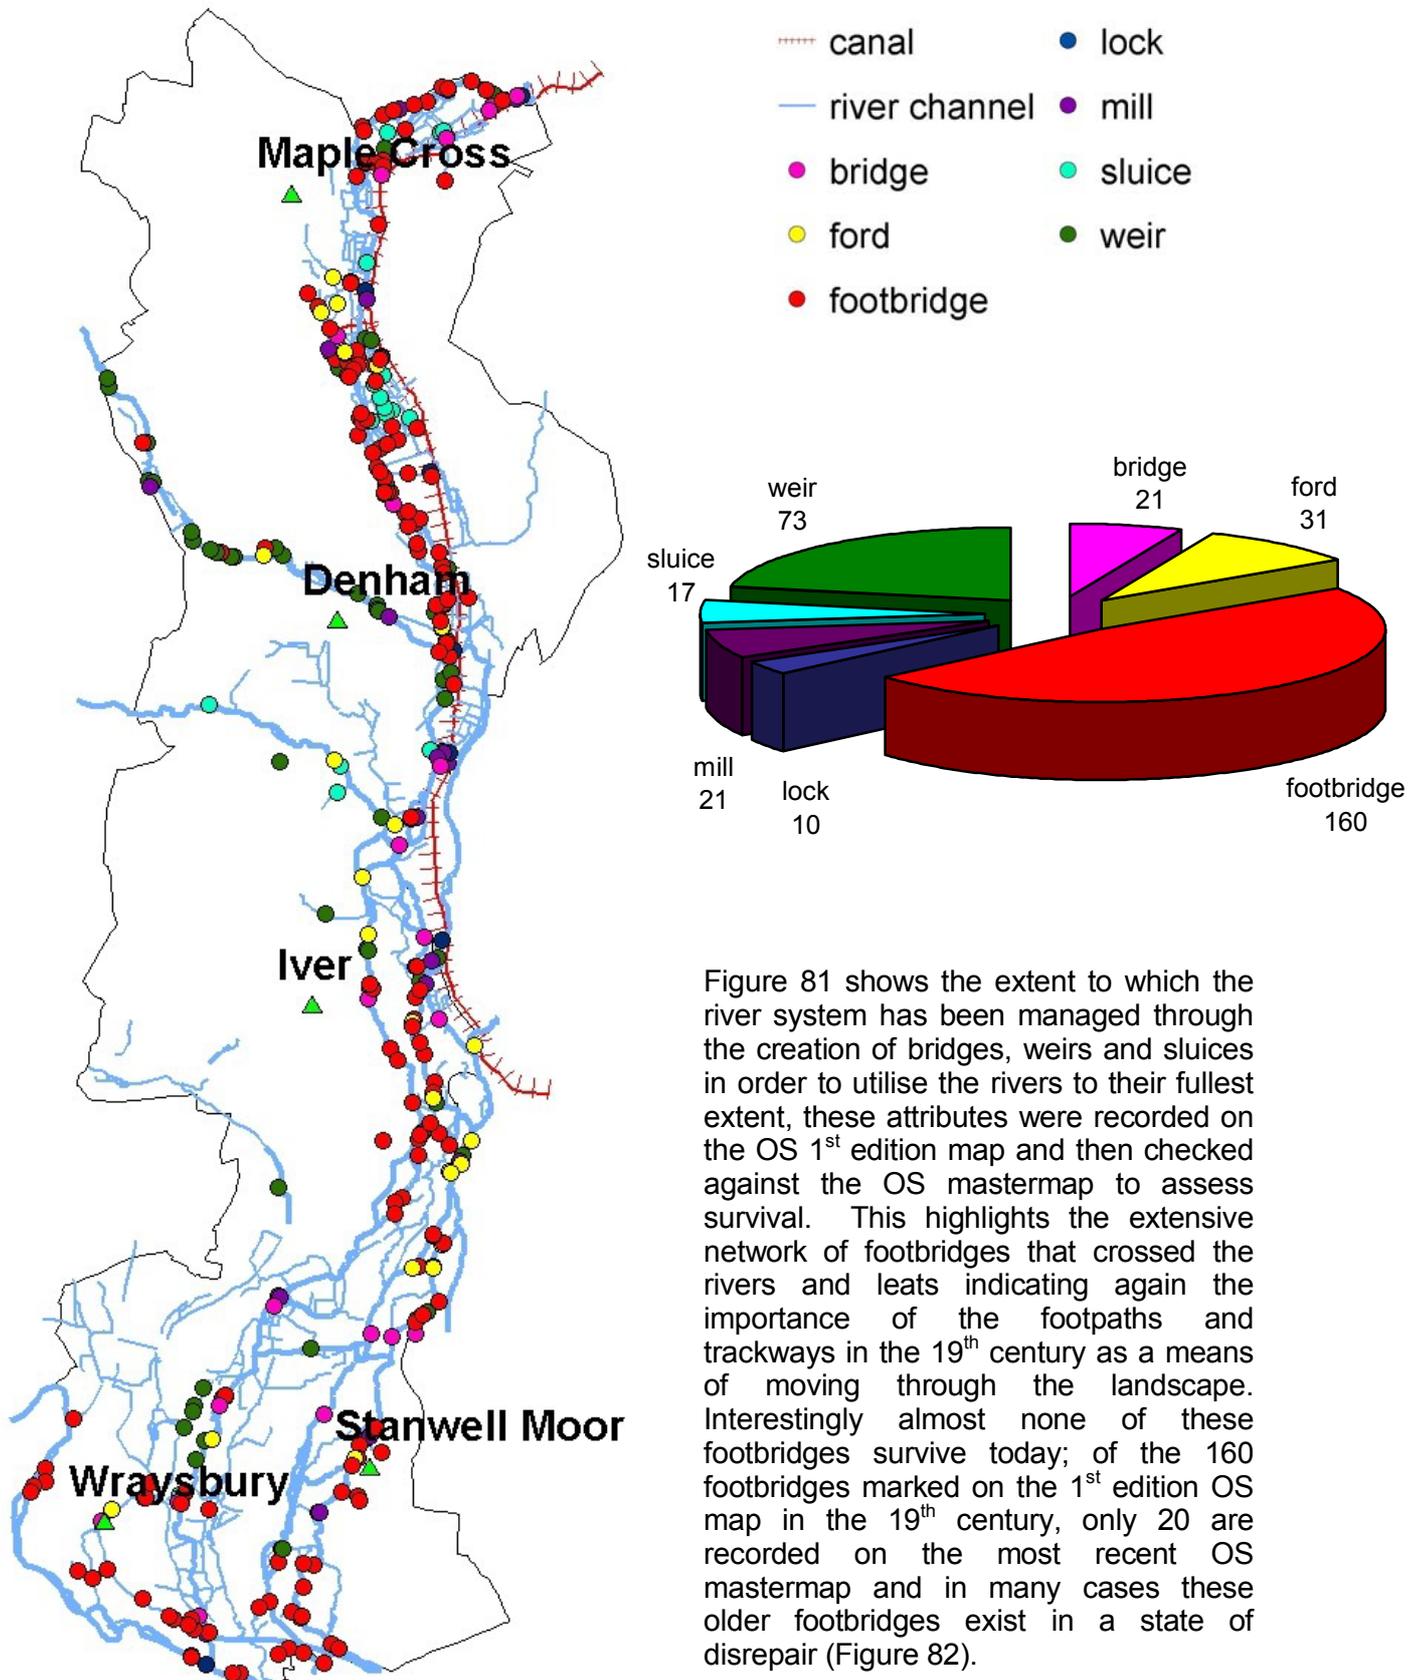
Figure 81: Structures on the river network OS 1st edition 1880.

Figure 81 shows the extent to which the river system has been managed through the creation of bridges, weirs and sluices in order to utilise the rivers to their fullest extent, these attributes were recorded on the OS 1st edition map and then checked against the OS mastermap to assess survival. This highlights the extensive network of footbridges that crossed the rivers and leats indicating again the importance of the footpaths and trackways in the 19th century as a means of moving through the landscape. Interestingly almost none of these footbridges survive today; of the 160 footbridges marked on the 1st edition OS map in the 19th century, only 20 are recorded on the most recent OS mastermap and in many cases these older footbridges exist in a state of disrepair (Figure 82).

The creation of so many weirs and sluices give an indication of the level of management of the rivers for industrial purposes as most often they were used to divert and channel the water towards mills and fish farms. In the 1880's 19 mills were recorded on the OS 1st edition map as being on or near the river Colne whilst a total of 90 weirs and sluices were recorded. Weirs were most commonly used to direct and increase the power of the river over short distances in order to increase the function of a nearby mill whilst sluices were more commonly found at the point where a leat coincided with the main river.

A high number of fords also indicate the level of wheeled traffic using the road network in the area; some 31 fords were recorded on the OS 1st edition map in comparison to 21 bridges, but while 18 bridges remain today, only 3 of the fords have been converted into bridges in their own right.

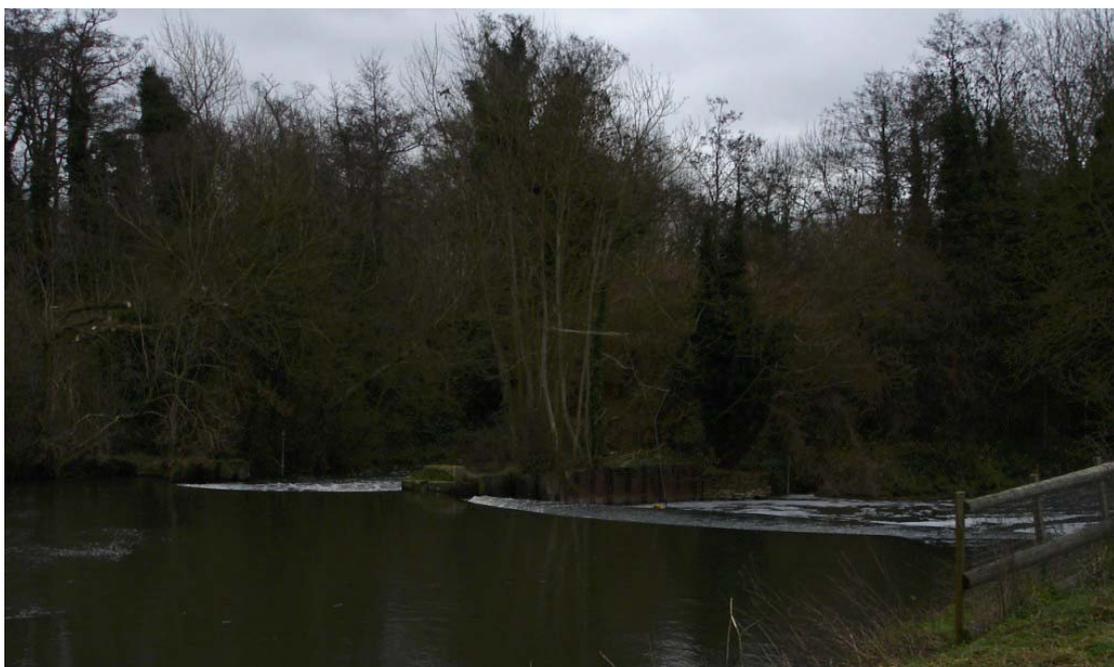
Figure 83: Two surviving weirs on the river Colne

In the 18th and 19th centuries the river was heavily utilised for a number of industries. Weirs and sluices concentrated the force of the river in order to power a number of mills built along the course of the river, many of which were corn mills built to process the produce from the local farms. Entire river channels were also constructed to power even more mills in the Uxbridge and Hillingdon areas, use of the river for mill power was primarily concentrated in this area. Leats and ditches were also cut in order to feed a significant industry in watercress farming in the north of the Colne Valley. This database also records a myriad of footbridges, fords and bridges crossing and re-crossing water channels at all point along the course of the rivers.
