The Great Hall of the Bishop's Palace at Hereford

By S. R. JONES

J. T. SMITH

THE GREAT HALL.

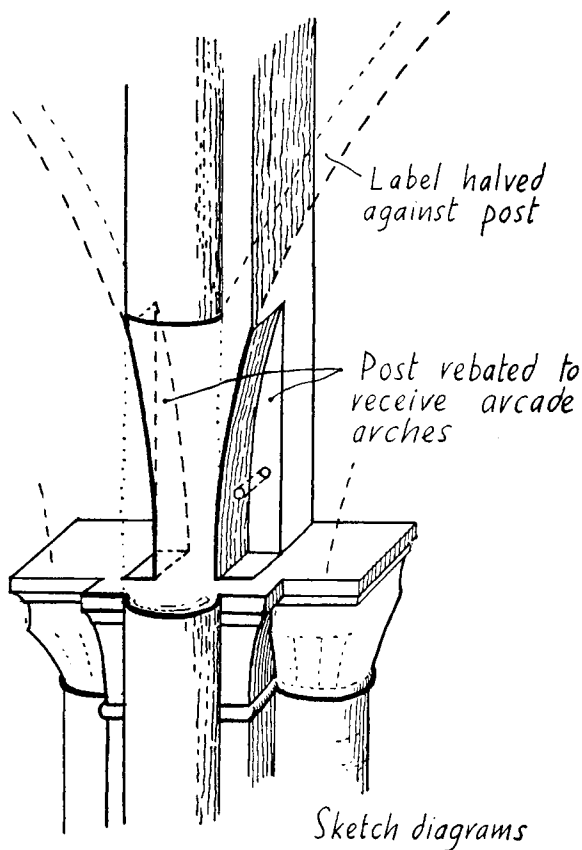
FIG. 24

Method of jointing capital and arch-brace to post (pp. 73 ff.)

The Commission's observation that the middle and side aisles were originally spanned by semicircular arches accords perfectly with the evidence of the attached shafts and capitals (PL. XII, A). A minor point of construction we have not observed elsewhere is the use of a large dowel driven from the back of the post into the arch-brace spanning the nave to steady it (FIG. 22).

in the early middle ages,⁵ is never found in buildings of the fourteenth and fifteenth centuries where wooden pegs would be expected to perform such a function, as they do at the palace in fastening the capitals to the posts (PL. XII, A). Here perhaps, the length required for the inserted pin led to the use of wood. The two parts of the label butt against a chock projecting horizontally, whereas the arch-braces butt against each other. There is yet another contrast with later practice, where the braces almost invariably butt against a chock that projects from the

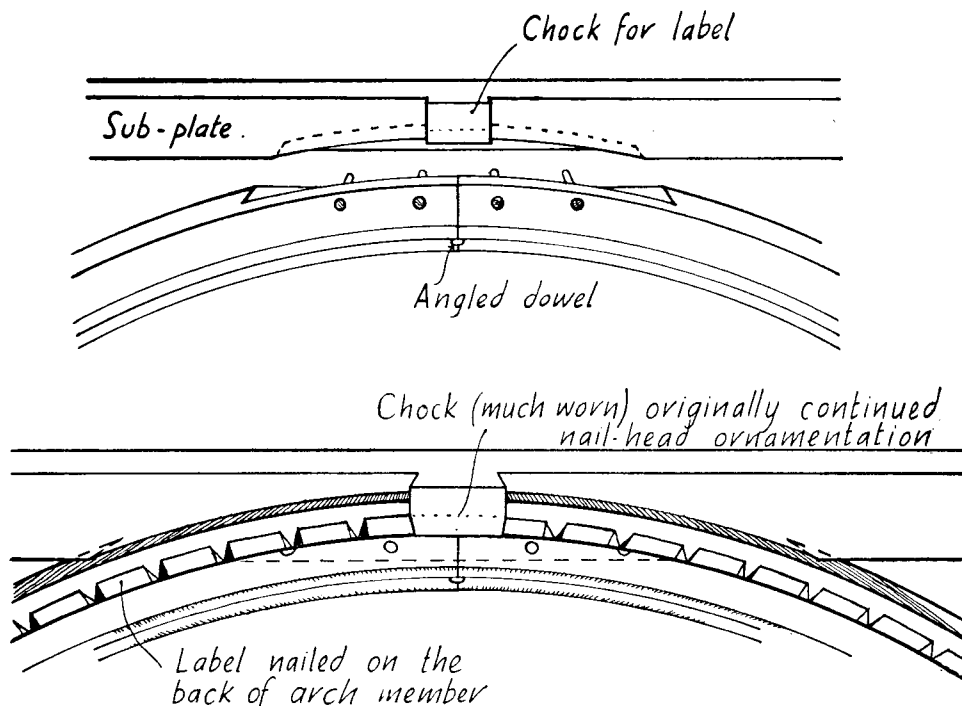
FIG. 25

THE BISHOP'S PALACE, HEREFORD
Details of jointing arch-braces and sub-plate (p. 74)

The technical details of the timber joints are interesting. The mortise-and-tenon, pegged through, is used only to fasten the sub-plates to the posts, where, perhaps, a halved joint might have been thought likely to part in the event of any lateral movement in the structure. Whatever the reason, this sparing use of what is the commonest form of joint encountered by students of English timber buildings presents a striking contrast to later practice. To fasten the arch-braces to the posts and sub-plates halved and pegged joints were used; their construction is shown by diagrams (FIG. 24). The use of this type of joint for this particular purpose either does not occur, or has not been specifically mentioned in later timber buildings. Certainly it is not used in any of the other timber houses we

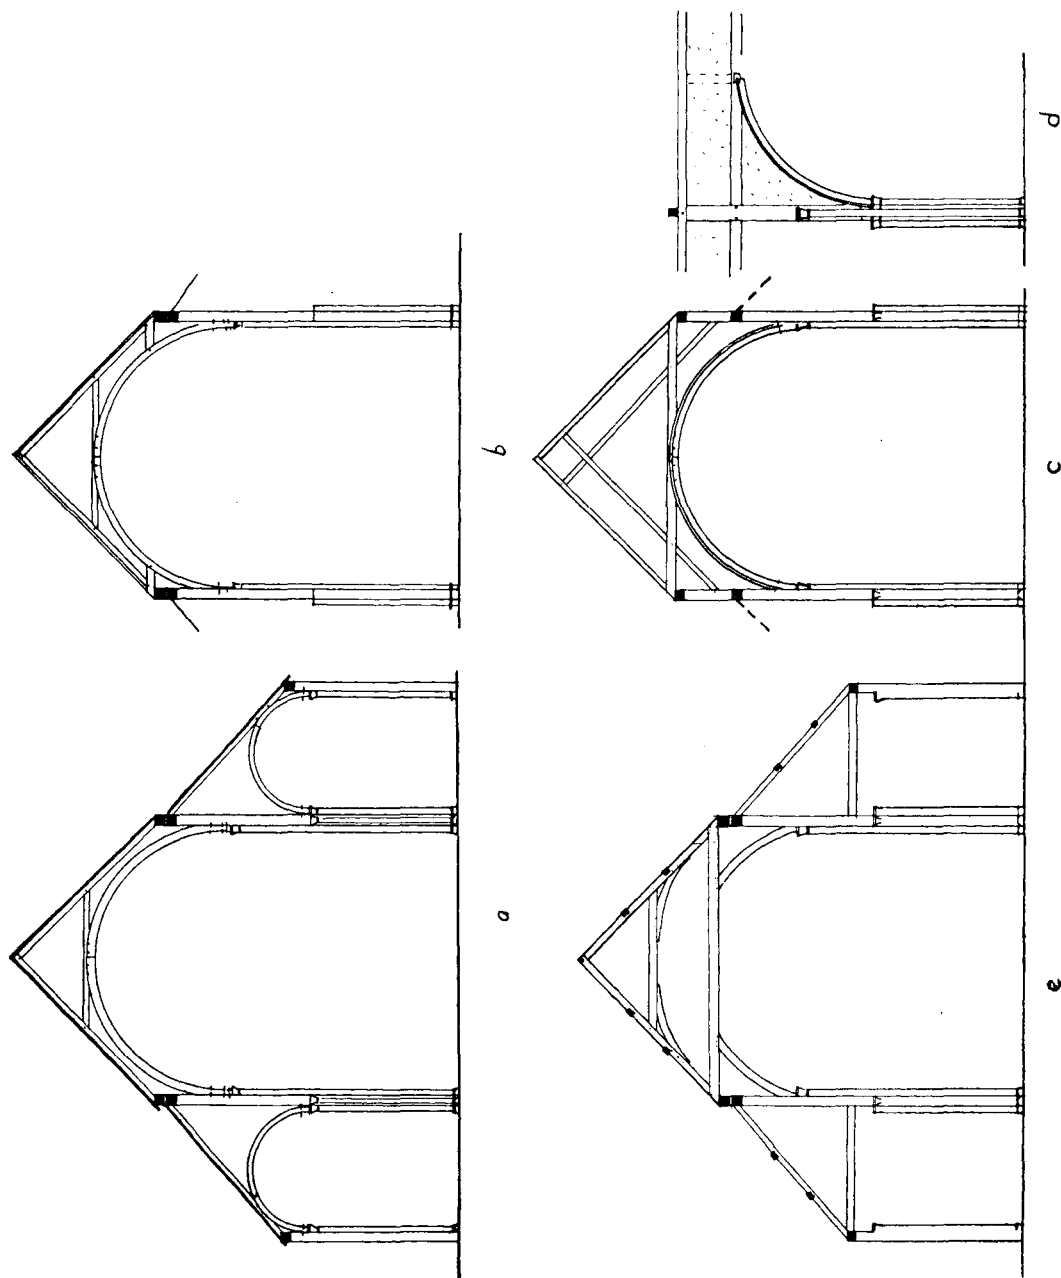
FIG. 26

Possible reconstructions of the twelfth-century hall. (c) shows the existing roof (pp. 77 ft.)

The simplest solutions are those without a tie-beam. The one that involves least speculation (FIG. 26a) has transverse arches kept stable principally by their own weight but helped also by the dowels driven through the posts from the back and perhaps by being joined in some way to the collar of the relevant pair of common rafters. The posts would in this case be tenoned into the arcade-plates that sit immediately above the sub-plate. The precise form of the arches spanning the aisles and their associated roofs is of much less importance, since it could not affect the general stability of the building very much. For this reason no detailed conjectures have been attempted in any of the proposed solutions.

A variant of the method (FIG. 26b) uses a spur-tie to link the arcade-plate securely to the arch-brace in the manner common in halls of the fourteenth-century.

Next we will consider a more complicated reconstruction (FIG. 26, *c, d*), where the posts are carried upwards about four feet above the sub-plate to the arcade-plate; these are joined by a tie-beam into which are tenoned the two braces forming the transverse arch. The other timbers are not based on any evidence but are inserted as one of several forms of trussed-rafter roof.²² This reconstruction, implying a clerestory above the arcade, has one very serious drawback. The sub-plate shows no sign of any superstructure, neither peg holes for mortise-and-tenon joints nor rebates for halved joints, yet the bay-width of 24 ft. (to centres) demands some fairly substantial wall. The later intermediate truss perhaps conceals some evidence, so the solution is not ruled out entirely. The first floor great hall of Taunton castle, built between 1107 and 1129, has been reconstructed in a rather similar way,²³ unfortunately without reference to the evidence it was based on. One further theoretical possibility was mentioned above, that the spur-ties to the arch-braces were placed directly on the posts without the interposition of a plate. No analogies exist for such a method, so the matter cannot be pursued; the possibility is remote.

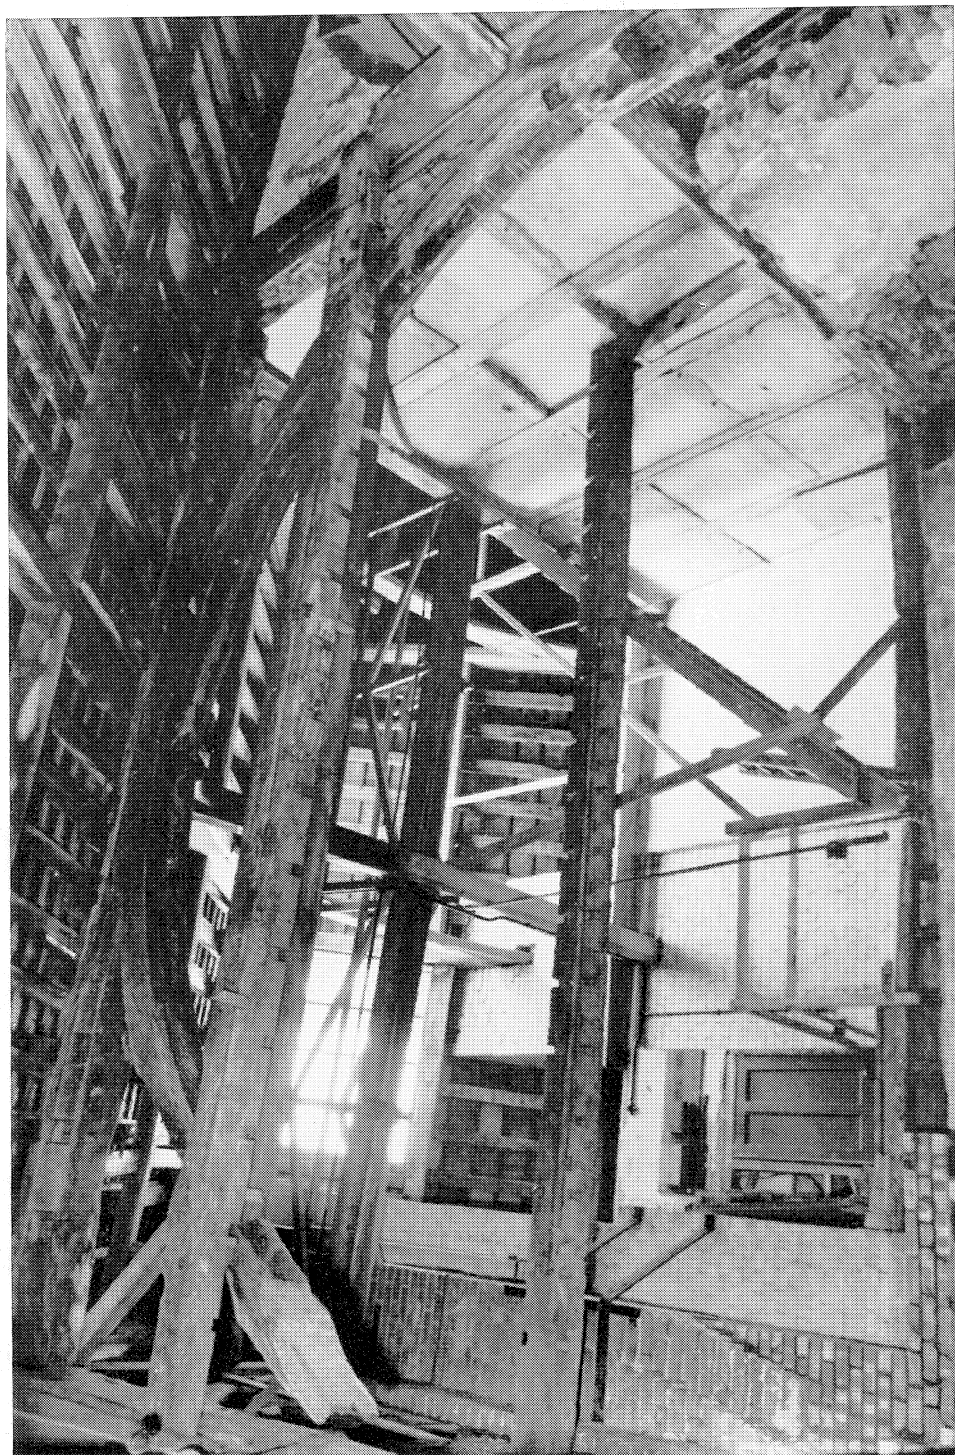
A bay of the arcade in the great hall exposed during repairs (p. 70)

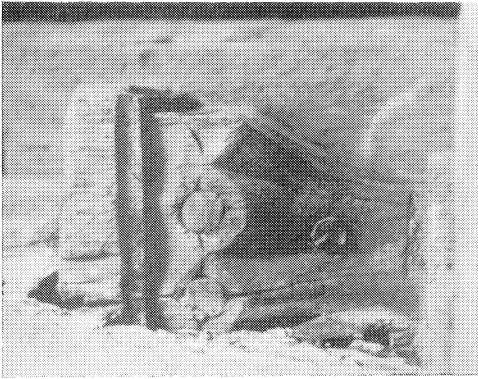
A

- A. Capital pegged to post (p. 74)
- B. Detail showing, nail-head ornament and original in-filling (pp. 74-75)
- C. After alteration (p. 75)
- D. Before recent alterations showing original wattle-and-daub in-filling (p. 75)

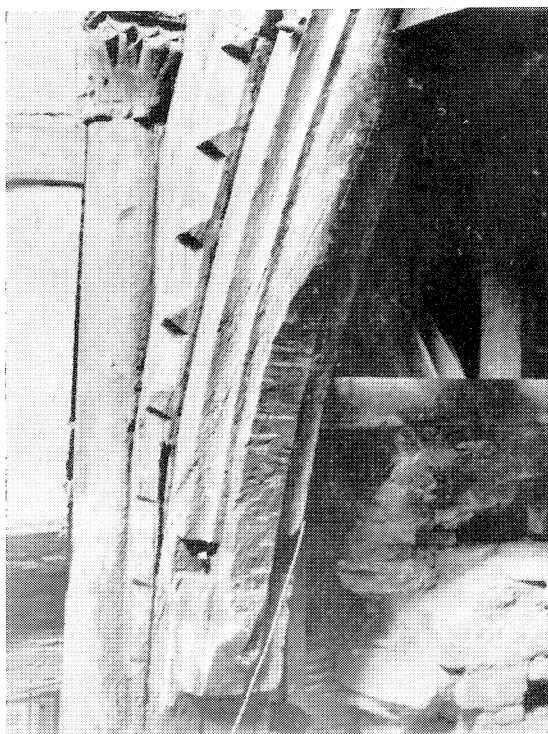
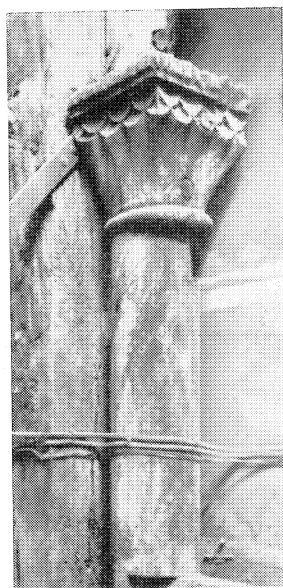
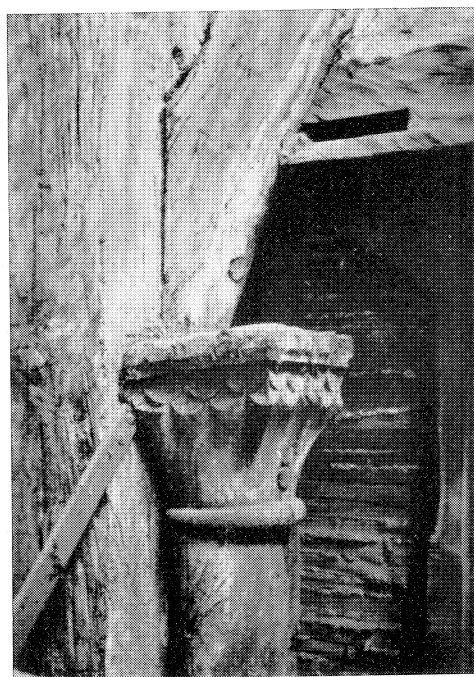
PLATE XIII

Capitals and other details of the woodwork in the middle bay of the great hall (pp. 73-4)

Even more surprising, though not without a certain appropriateness, is the use of nails to fasten the label, ornamented with nail-head (PL. XIII, A), to the arch-braces. The use of metal to join sizable pieces of timber, though it can be inferred
