Three Deserted Medieval Settlements on Dartmoor: A Report on the late E. Marie Minter's Excavations

By GUY BERESFORD

HOUNDTOR, HUTHOLES AND DINNA CLERKS are three deserted medieval settlements on the granite uplands towards the eastern side of Dartmoor Forest, Devon. Houndtor and Hutholes were small villages comprising eleven and six buildings respectively; Dinna Clerks was an isolated homestead. Extensive excavation at these sites by the late Mrs E. Marie Minter revealed a long sequence of superimposed houses, divisible into two periods. Those of the first were built of turf. Although their remains were few, and in some places confusing, they provided much information on the construction of this type of building in the South-West of England. During the second period commencing in the middle of the 13th century, the houses of turf were gradually replaced by those of stone. The excavation of the well-preserved remains of the long-houses and their associated barns and corn-driers and the recording of the gardens and some of the open fields have given a clear insight into the ecology of a community dependent upon mixed farming at altitudes between 1100 and 1300 ft above sea level. T

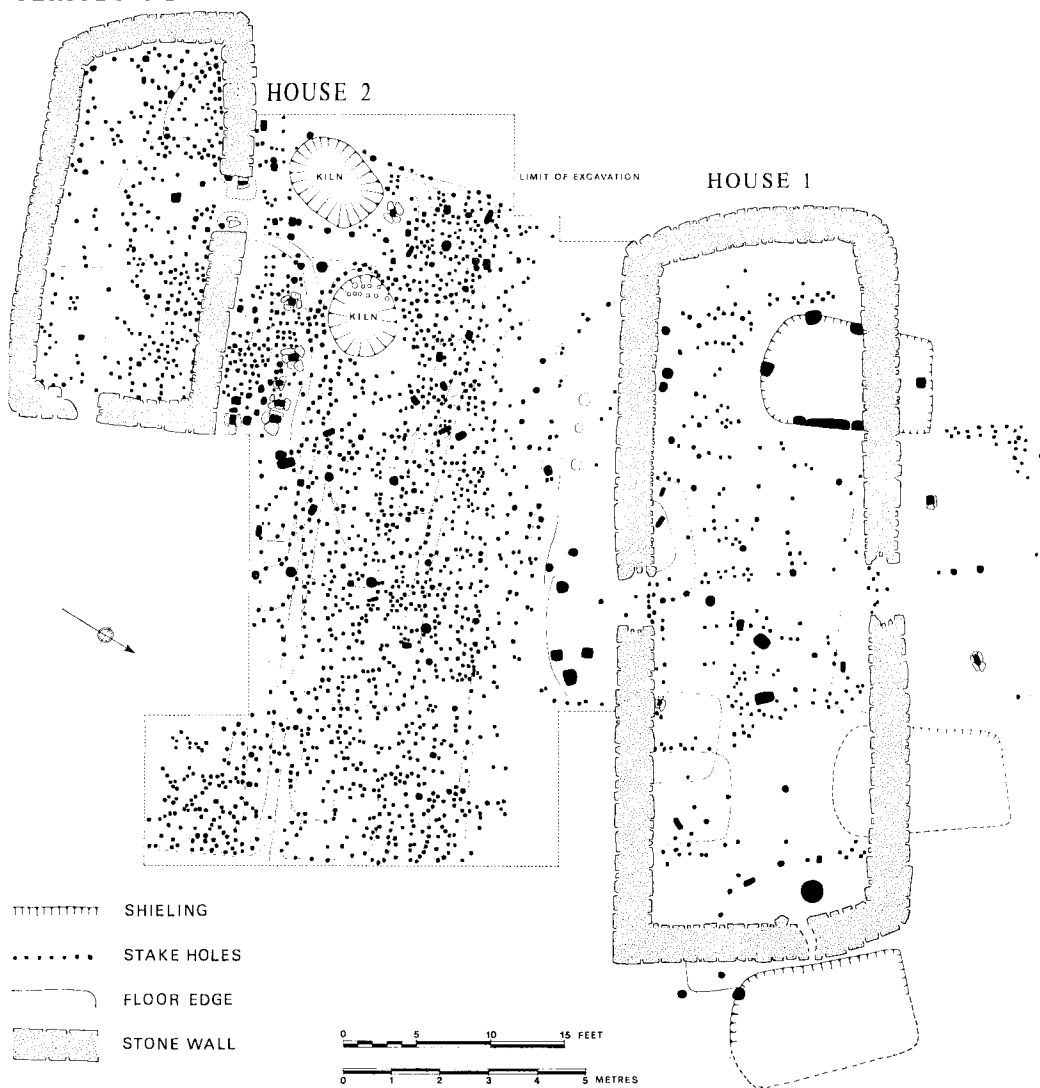
FIG. 7

Houndtor Village, Periods 1-2. 13th-century stone buildings, Houses 1 and 2 with underlying shielings and turf-walled buildings

The stake-holes are grouped together marking the position of house sites — their limits are clearly shown in Fig. 7 and in some of the unpublished plans. The stake-holes cannot be interpreted as the work of moles, which never burrow through an iron-pan¹⁰¹ or deeply into the subsoil, as their food comprises earthworms, grubs and insects, all of which live in humusy soil. Further, moles do not dig blind vertical shafts evenly spaced in straight lines! Only at Hutholes, where the growan is softer, had some larger stake-holes been damaged by moles. Mrs Minter also found evidence of mole activity in a modern garden plot lying immediately to the north of House 3, at the same site. However, where mole interference occurs the interpretation is usually clear.¹⁰² Nor could the stake-holes be interpreted as geological involutions, which are rare on Dartmoor.¹⁰³

The excavation of the area between Houses 1 and 2 at Houndtor Village revealed the remains of a long sequence of superimposed houses built of turf. Their positions were clearly defined by remnants of turf walls, lines of stake-holes, the wear of the floors and the remains of nineteen hearths.¹⁰⁸ It was not possible to elucidate all the stake-holes found in this area, but three phases of turf buildings could be recognized (Figs. 8 and 9). These houses were identified by the lines of stake-holes connected with the hard edges of the floors. Although the remains of many other houses could be recognized, only those which could be identified in this way are shown on the individual plans. The houses of the last phase are clearly defined by the walls of the stone long-houses by which they were replaced.¹⁰⁹ Remains of a turf wall some 2-3 ft high, built with a rough facing of stone, were found between Houses 1 and 2 (Fig. 9). The construction suggests that there was probably a short intermediate phase in the middle of the 13th century when the turf walls were faced with stone, as at Hutholes (Fig. 11).

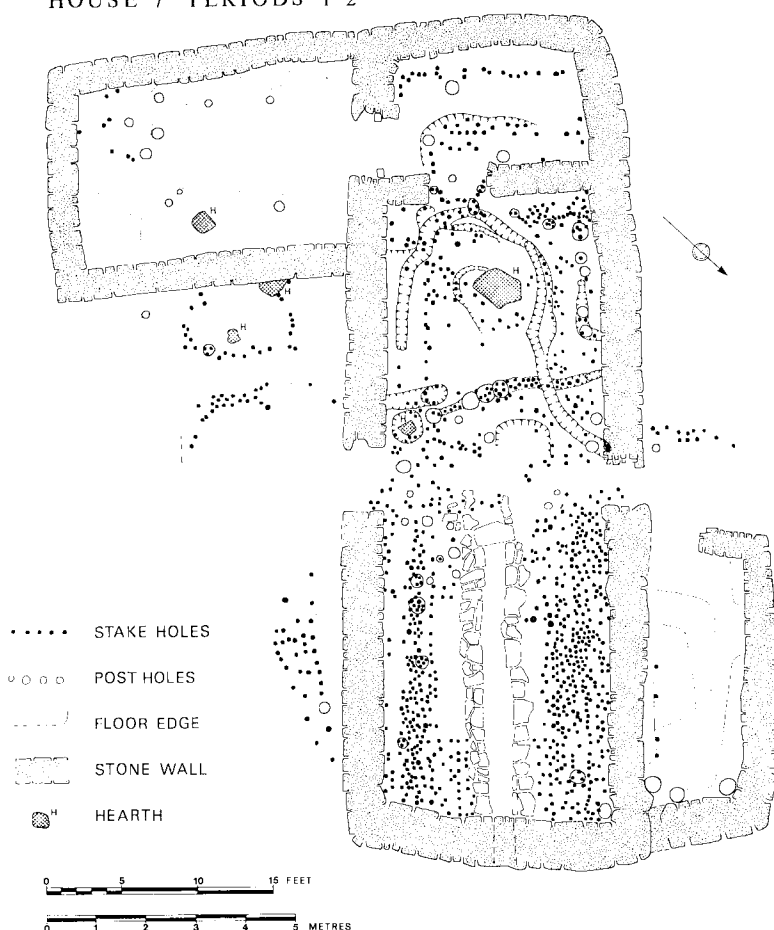
FIG. 10

Houndtor Village. House 7, Periods 1-2. Plan of 13th-century stone long-houses with underlying turf-walled buildings. Many of the stake-holes in the byre of the long-house are those of mangers and cow-ties

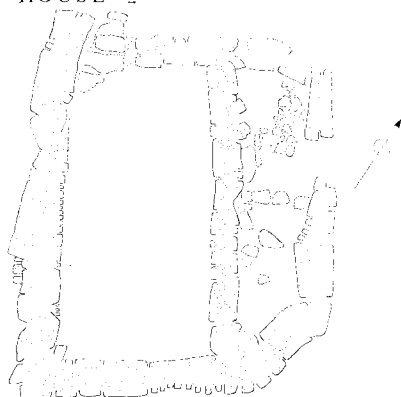
Hutholes Village. Period 2. Houses 1, 2, 4 and 6. Cf. Fig. 24 (House 6);
Pl. viii, A (House 1)

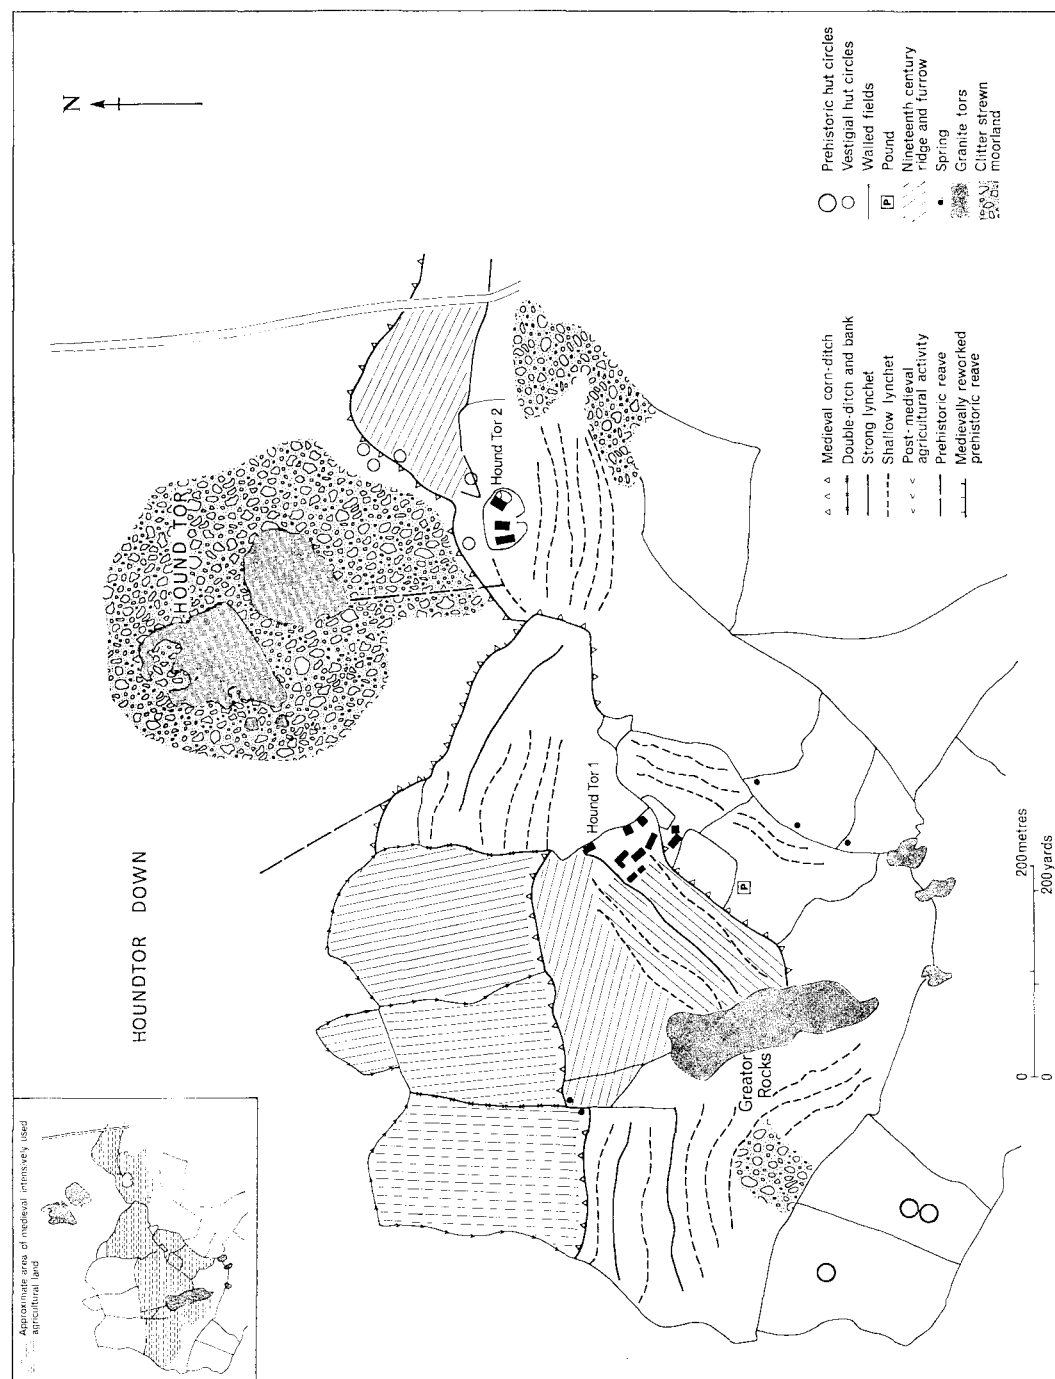
FIG. 27

Houndtor. Interpretative plan of medieval field layout. Sites A and B lie immediately SSE. and NNE. of Houndtor respectively. Sites C and D lie W. and NW. of the site of Houndtor 1 respectively
