The Pageant of History: A Re-interpretation of the 13th-century Building at King John's House, Romsey, Hampshire

By RUTH ALLEN¹

STRUCTURAL Analysis coupled with archaeological excavation at King John's House, Romsey, has revealed a mid-13th-century chamber block which probably stood within a precinct of adjoining buildings. The discovery and extravagant claims subsequently made for the building illustrate how far interpretation may be conditioned by the circumstances of the time.

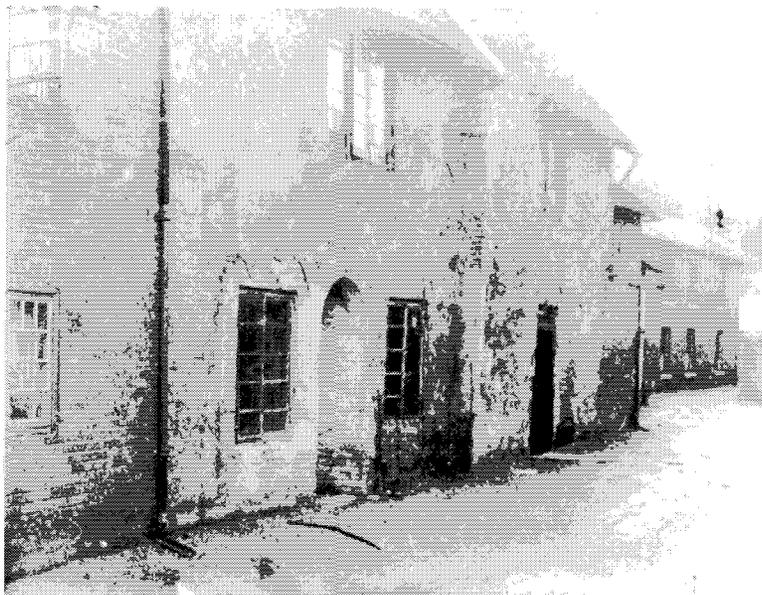
FIG. 2

Photograph taken c. 1900:
north side of stone building, showing render (Abbey church faintly visible in Background)

In 1928 Church Court was considered a slum, 'divided into fifteen residences, mostly of two small rooms' and 'containing a population of seventy-five persons'.²² A photograph (Fig. 2) of the north side taken at about the turn of the century shows

the render which hid the true character of the building for so many years.²³ Hence a building which, in the 13th century, was constructed in stone to the latest fashion and the highest contemporary specification, declined so far that it was in danger of demolition as a slum, had not the 'chance' discovery of its extreme age occurred.

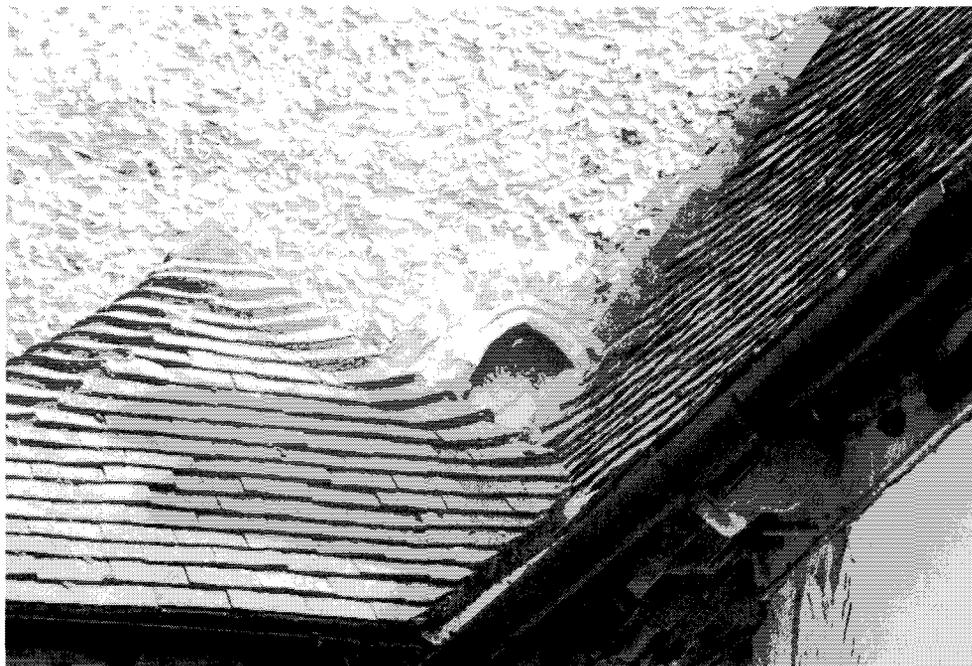
FIG. 6

Exterior view of head of west window, between roofs of lobby and Tudor Cottage

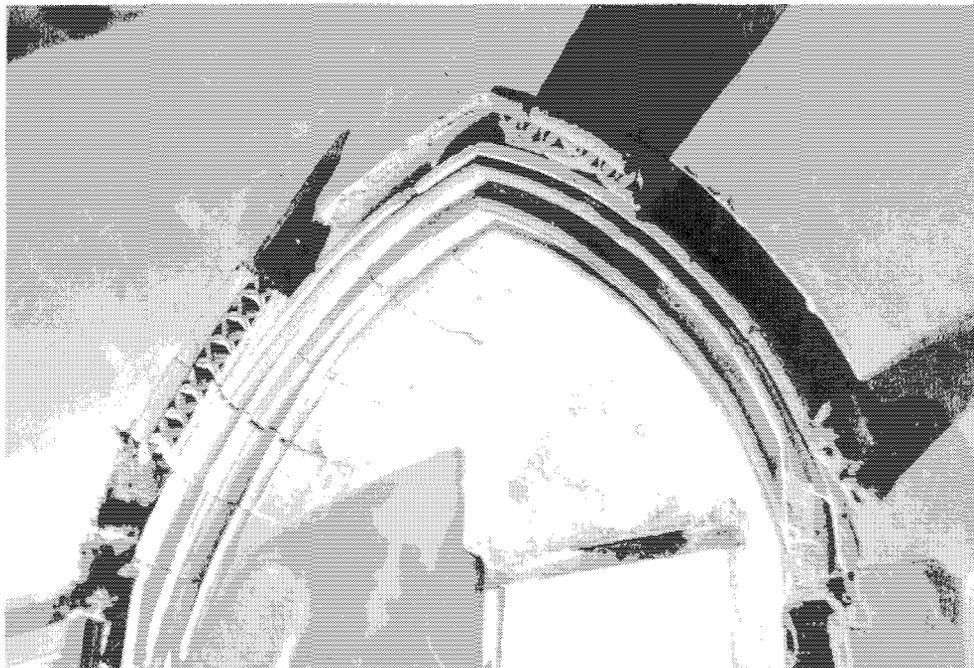
FIG. 8

Interior of west window, showing stilted arch, keeled mouldings and dog-tooth decoration

The mid- to late 13th-century date for the stone building was at one time claimed because of the style of the keeled internal mouldings of the W. and NW. windows, and the way in which the inner orders of the window arches merge on the outer to produce the effect of a stilted arch (Fig. 8). These features have been

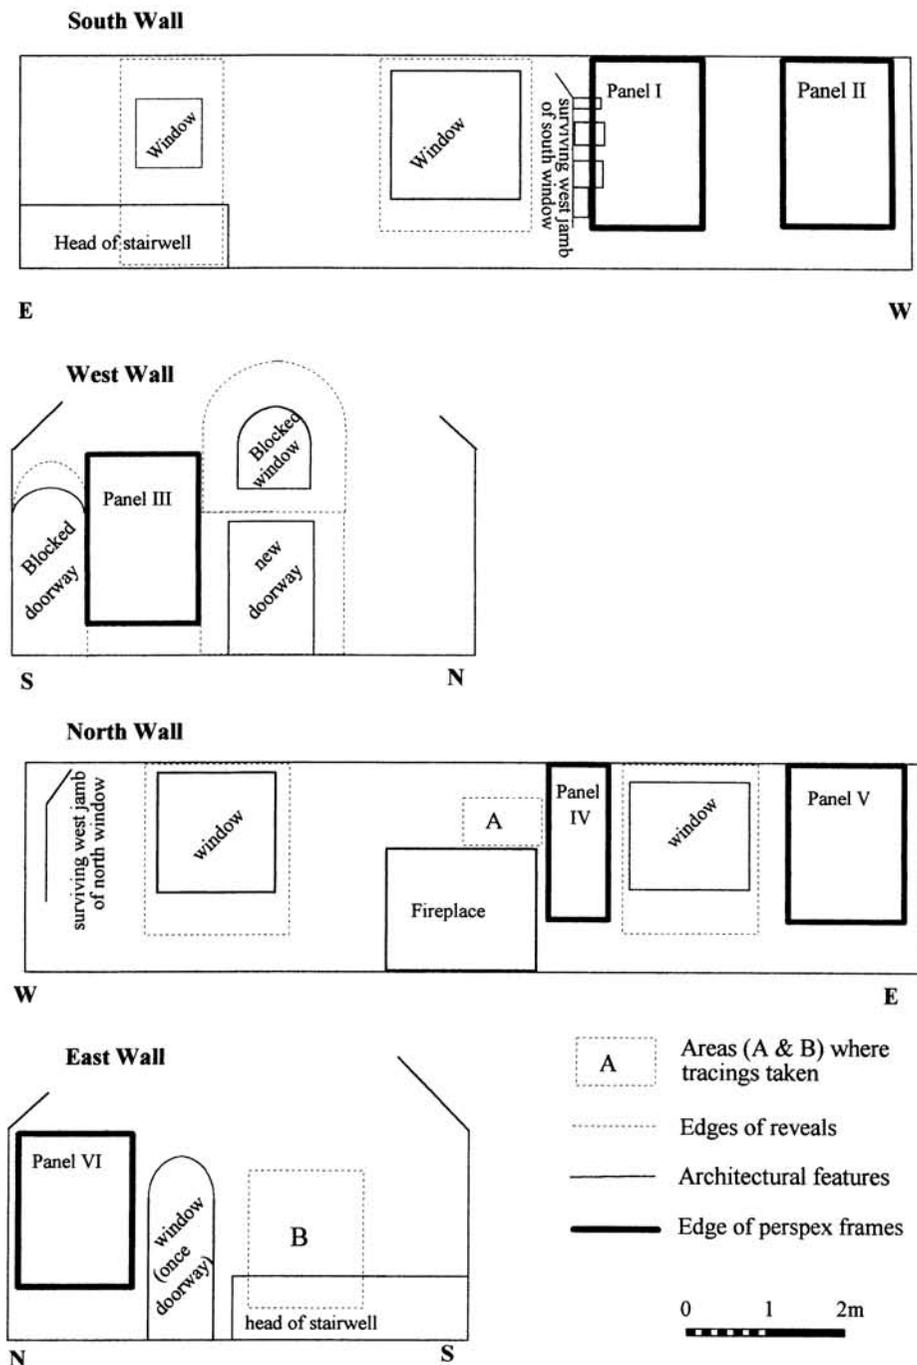
FIG. 14

Diagram of graffiti: positions of panels on the walls

³⁶ It was not possible to gain permission to remove the panels to make rubbings. A selection of graffiti behind the panels has been drawn at 1:1 with the aid of a 2 cm grid affixed to the perspex, and a similar grid beneath tracing paper on the drawing board. Rubbings of marks incised in the stone jamb of the south window have, with permission, been taken, together with tracings above the fireplace and above the stairwell (areas shown as A and B).

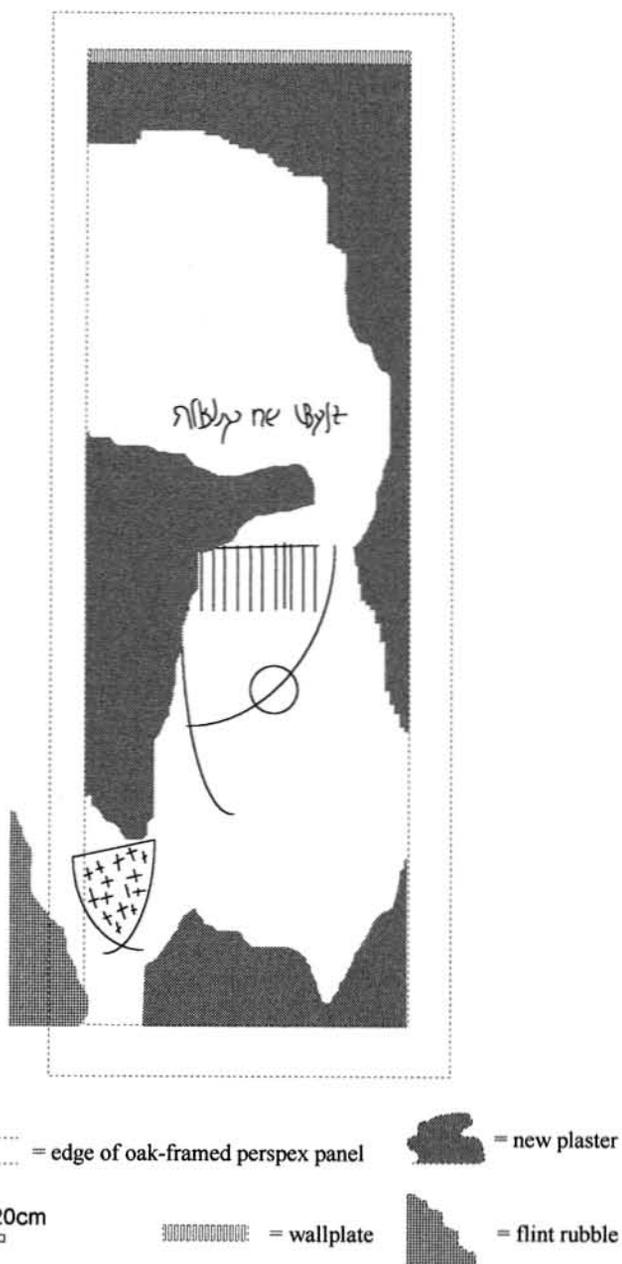
FIG. 18

Sketch of graffiti: north wall, panel IV

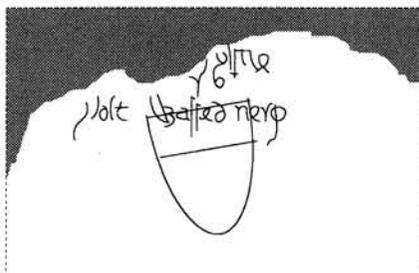
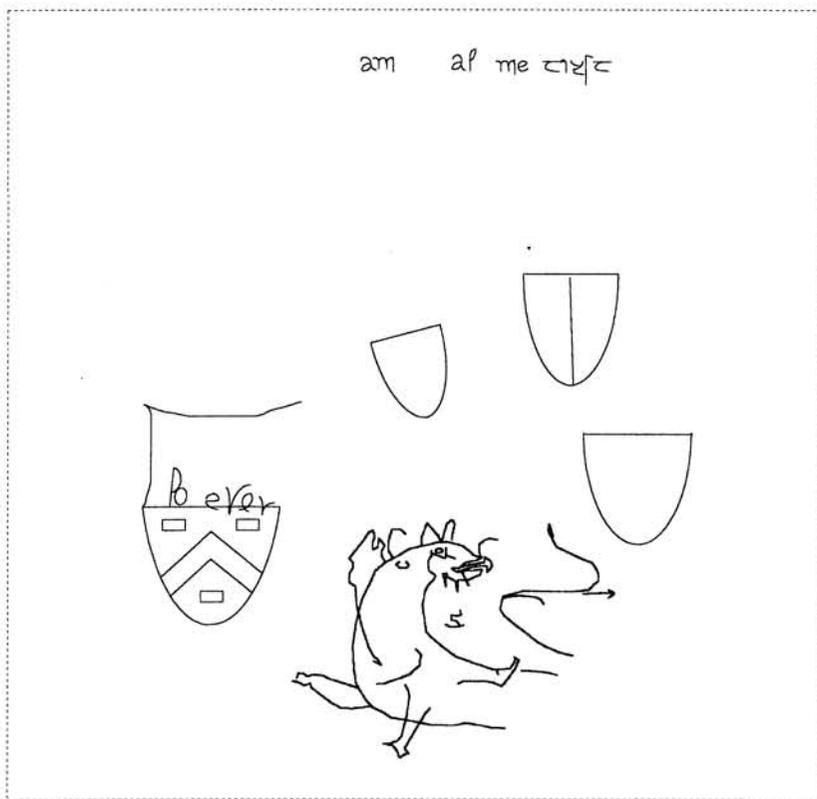
FIG. 21
Sketch of graffiti: areas A and B

Area A: Above Fireplace, North Wall

Area B: Above Stairwell, East Wall

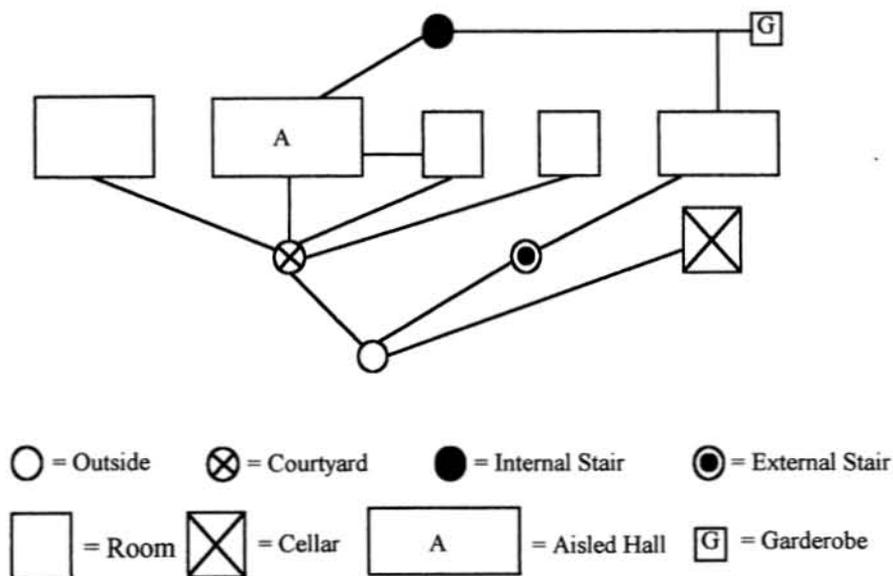
FIG. 23

Spatial Analysis Diagram: Phase I, medieval

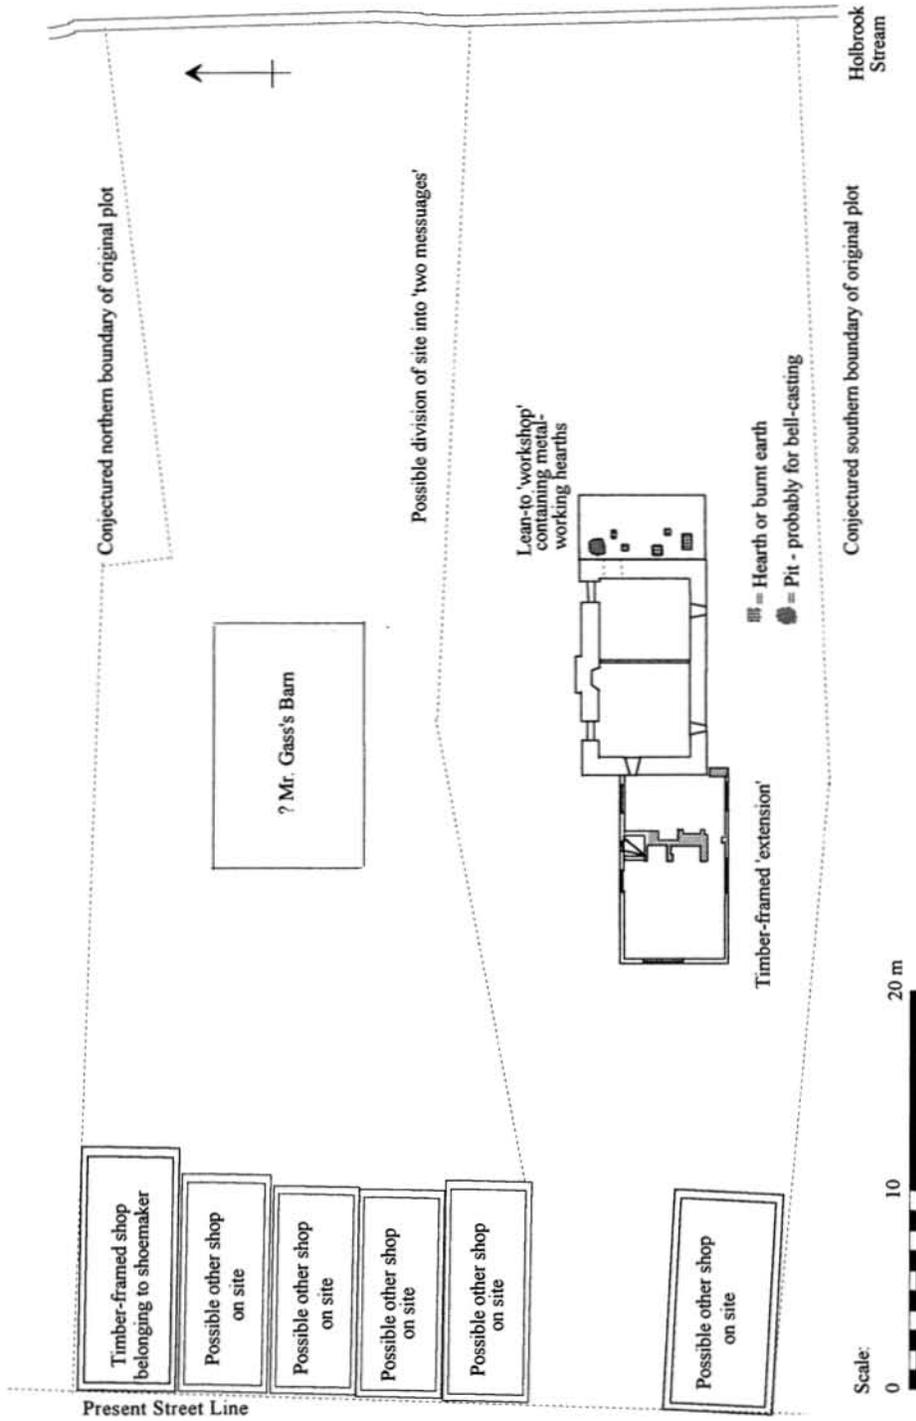
FIG. 22

Phase plan: medieval
