Glastonbury Abbey: The NE Crossing Pier

Archaeological Survey of the standing fabric - 2005

Jerry Sampson

Caroe & Partners Architects

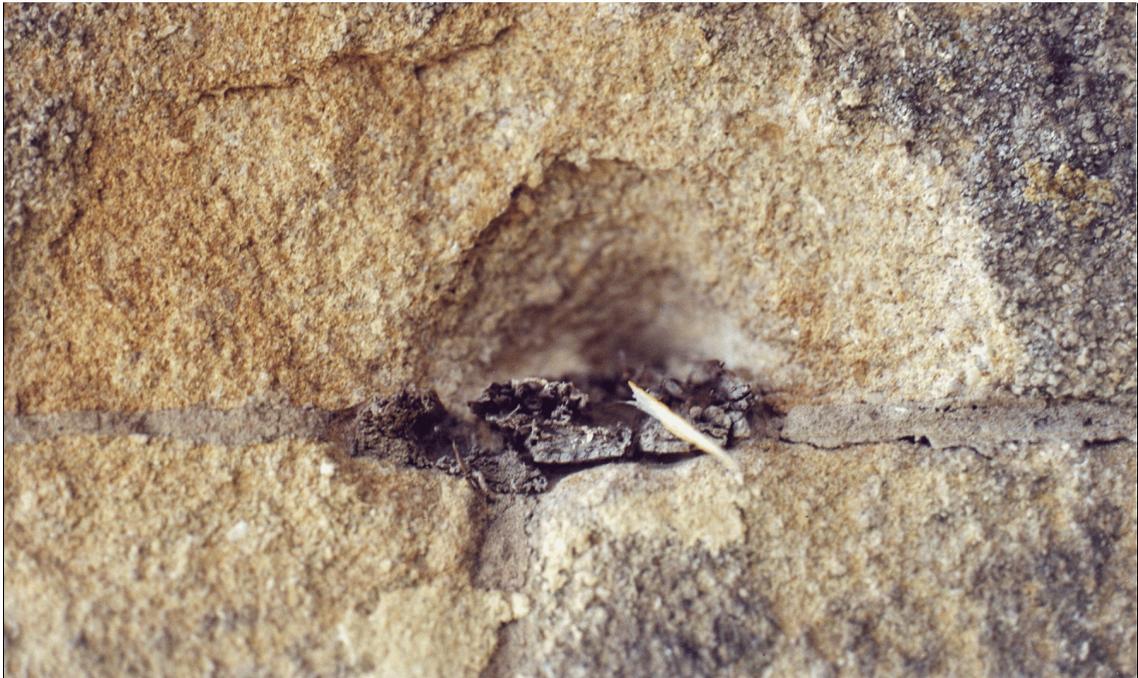
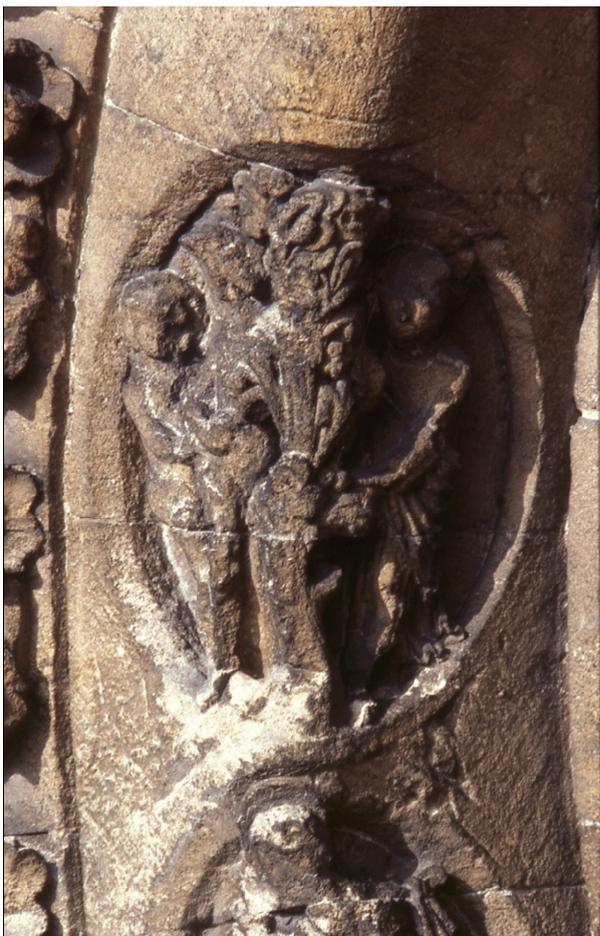
Signs of the hiatus reported by the chronicler Adam of Domesday following the death of Henry II in July 1189.

The carving of the south door of the Lady Chapel (left) remains incomplete - with only two (of the eight projected) figural vesicas nearly completed in the second order, and the foliate spandrels between them just begun. It gives the impression that the carver simply packed up his tools and left.

The small wedges at the level of the base of the clerestory of the south transept (above) appear to be those put in by the fixer masons when the stones were laid, but they were never taken out after the mortar set. In both cases the masons leaving the site after the money for wages ran out in 1189 could be the cause.

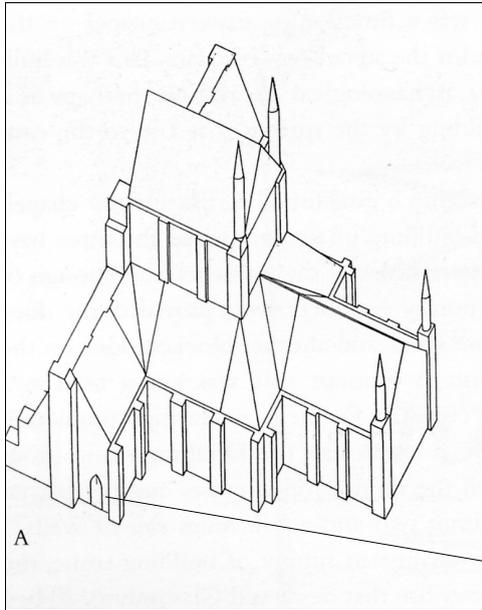
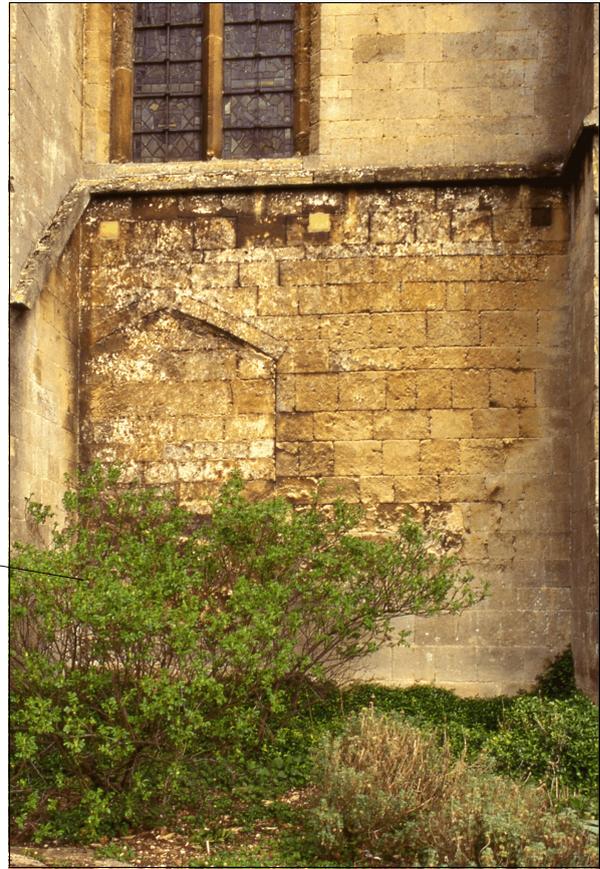
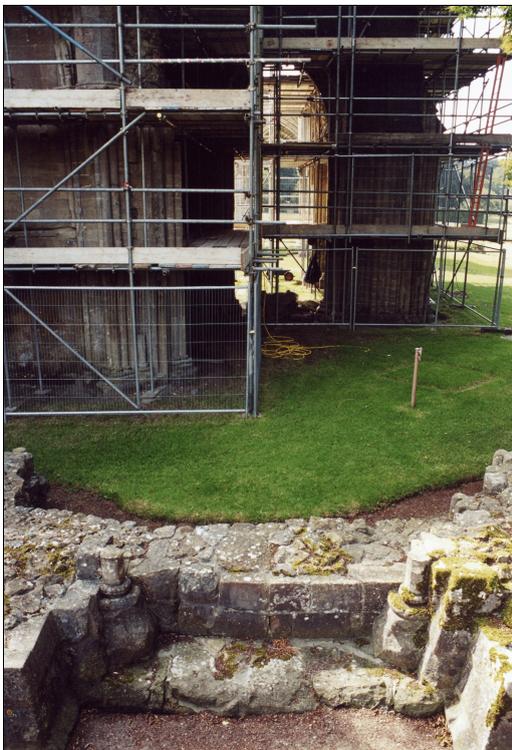
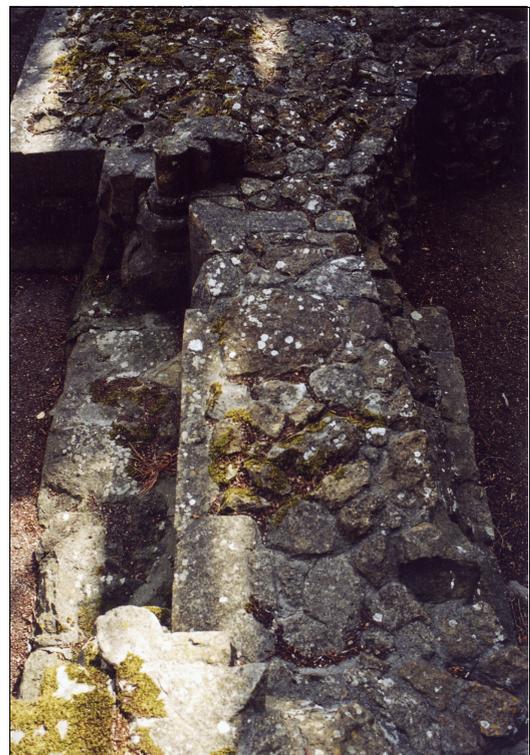
The blocked processional doorway at Wells (above and right), and in the N transept of Glastonbury Abbey (below), used while the choir was complete and before the transept was finished.

2.1.3.5.3.5 A photograph of the excavations published in the report, looking west along the north wall of the transept, shows the doorway as found with its blocking of finely cut ashlar in relatively shallow courses such as might be expected of a late twelfth or thirteenth century masonry.

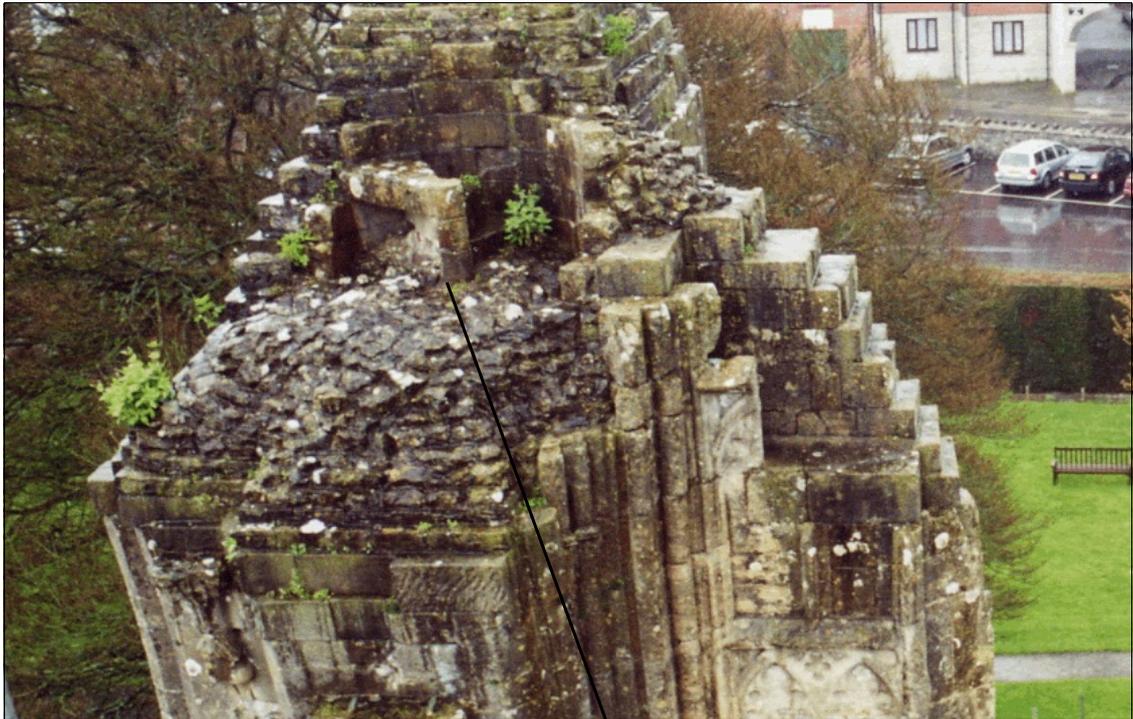
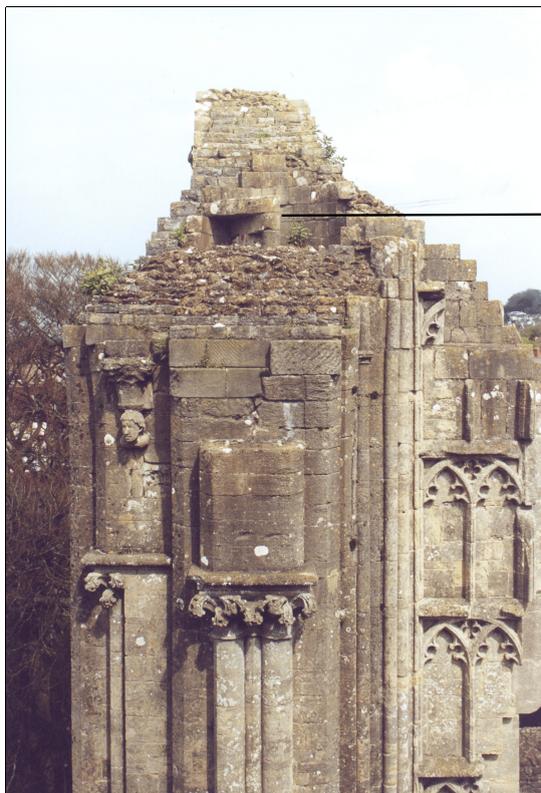
The spiral stair to the central tower in the North-East crossing pier.

Only three treads of the counter-clockwise stair still remain exposed above the Caroe period capping of the wall top. This stair was approached from the clerestory wall-passage, but also gave access onto a wall passage in the choir, which can be seen in the upper view from the top of the SE pier. The choir passages were probably blocked off when the elevation was remodelled under Abbot Monington.

2.2.1.3 The transept wall-walk, with its floor at the level of the lower clerestory string-course was noted in the previous report for the south transept, and is present also in the north transept, likewise being blocked at the southern end of the south bay with bricks set in a dark grey Portland cement. This passage must have given access to the stair in the north-eastern pier of the crossing, of which seven courses, including the newel and three steps, are still preserved at the top of the ruin.⁹

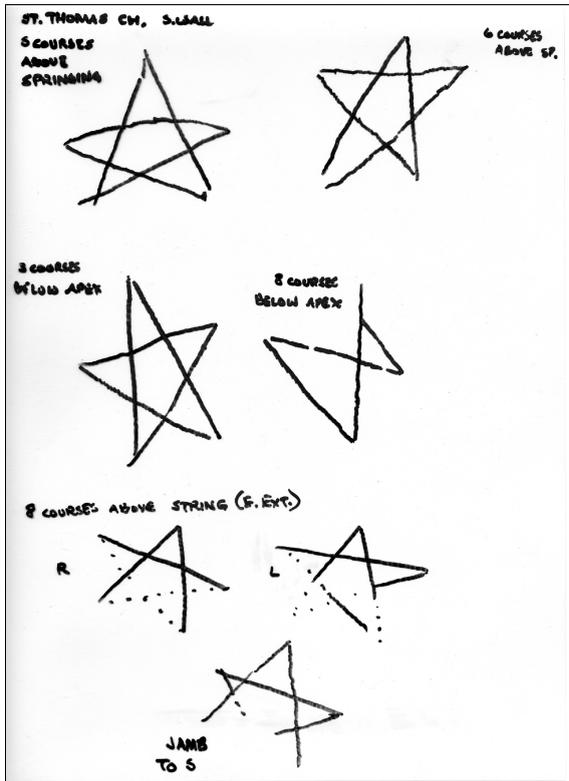
Above: five-pointed star mason's mark found on the choir aisle / St Thomas's Chapel, suggesting a date in or shortly after 1185. A mark very similar to this is found at Wells prior to the (1184) switch from Doulling stone to Chilcote stone, but this mason does not appear to mark any stone in the 1184-99 Chilcote phase of construction at Wells.

chapel south of the window head, and three on the south wall within the tympanum of the arch, suggesting that they were all laid during the same season of construction. A similar mark is found at Wells cathedral in the choir and transept, reappearing briefly in the nave in the first decade of the 13th century. Marks at Wells are rare in the earliest fabric of the choir - only 4 have been reported for the three bays of the late 12th century arcade; it is in the triforium that five-pointed star marks first appear, in all three bays on the north (7 marks) and the eastern bay of the south elevation (1 mark); in the clerestory this mason marks stones in the two eastern bays on the north (7 marks) and the eastern bay on the south (3 marks). In the pre-1184 fabric of the transept he leaves marks in the eastern part of both transepts at and below triforium level. He appears to be absent from the Chilcote period fabric (1184-1199) of the north transept and eastern nave, re-appearing in the Doulling stone masonry of the south transept clerestory and the nave west of the 1199 break. Thus the distribution of his marks at Wells would fit with a period of absence between 1184 and 1199 during which he appears to have worked at Glastonbury.

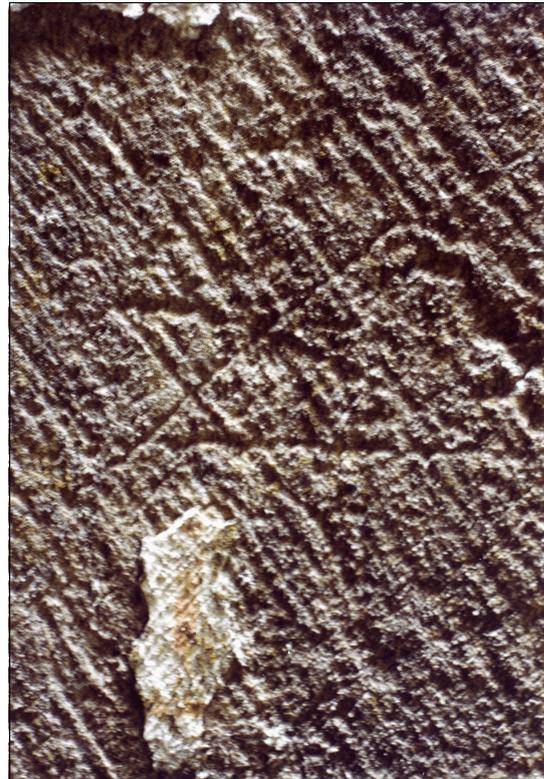
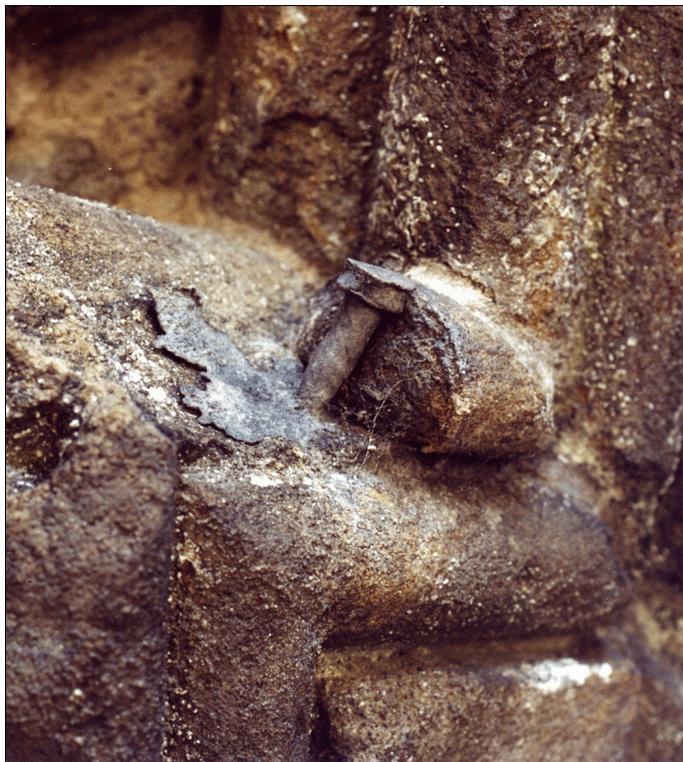
Left: Leaded repair to the zig-zag mouldings of the arch from the north choir aisle into the north transept's eastern aisle, west side of south elevation.

- 2.2.3.2 Medieval repairs
- 2.2.3.2.1 On the western zigzag mouldings of the arch into the north transept's eastern aisle from the west bay of the north choir aisle there are the remains of a lead-grouted repair to the southern margin of a roll-moulding. The attached piece has been lost, together with the lead-work which held the western end of the repair, leaving the eastern poured lead dowel and the associated lead which has spread into the joint. At the western end of the parent stone the mark of the drilling for the western poured dowel remains in the end of the stone.

- 2.2.3.2.3 Like the repair reported on the south nave aisle corbel table [SNA 2004 Section 2.9.1.3.] the form of the lead suggests that the repair was made before the stone was fixed.

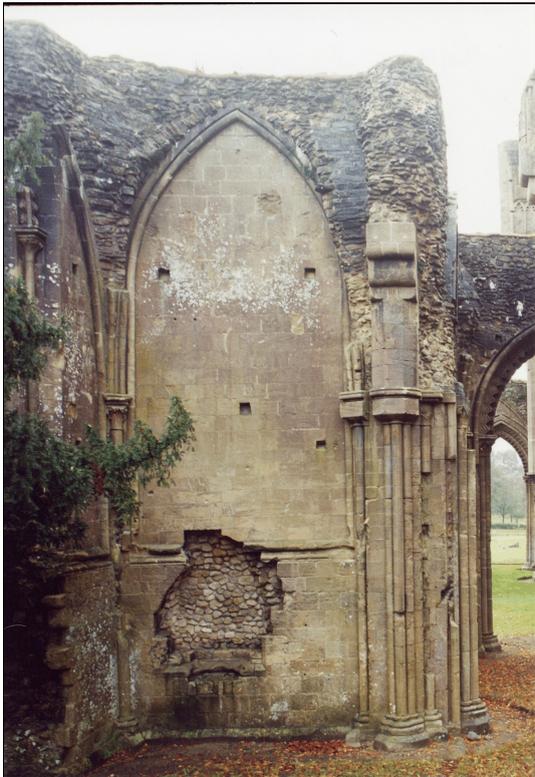
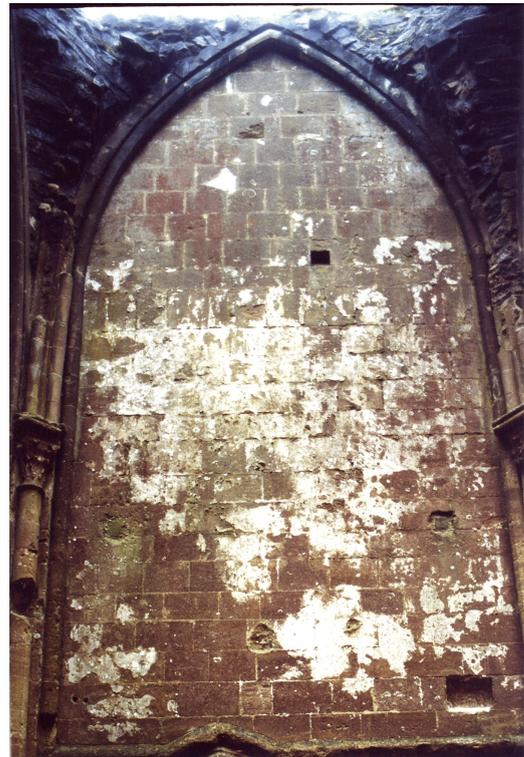
The N transept chapels' south walls, the northern (left) with the scar of the piscina; the southern (right) with extensive traces of lime plaster bearing ashlar lining.

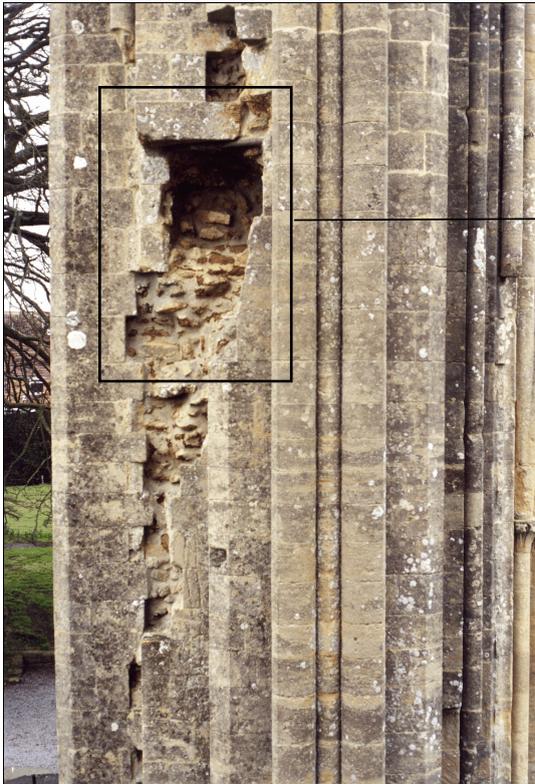
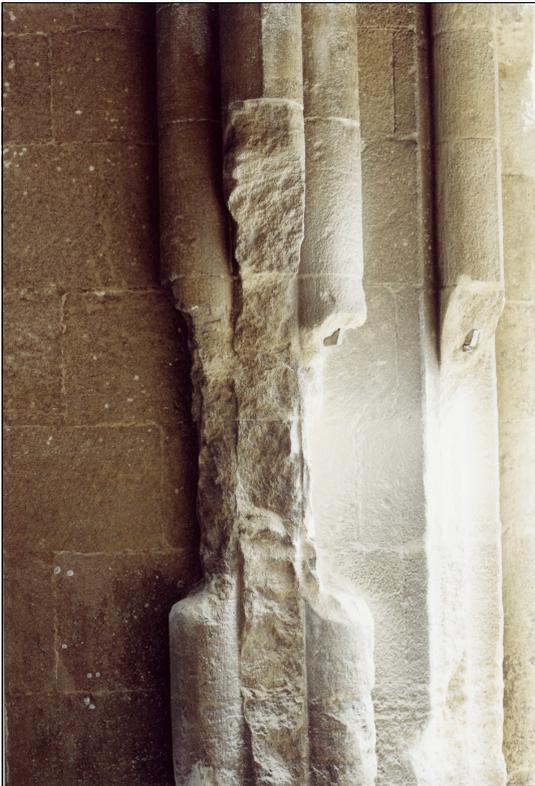
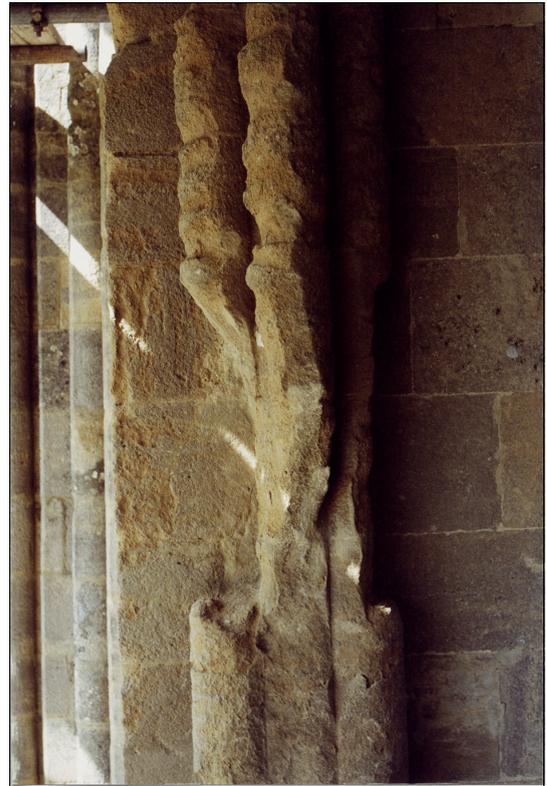
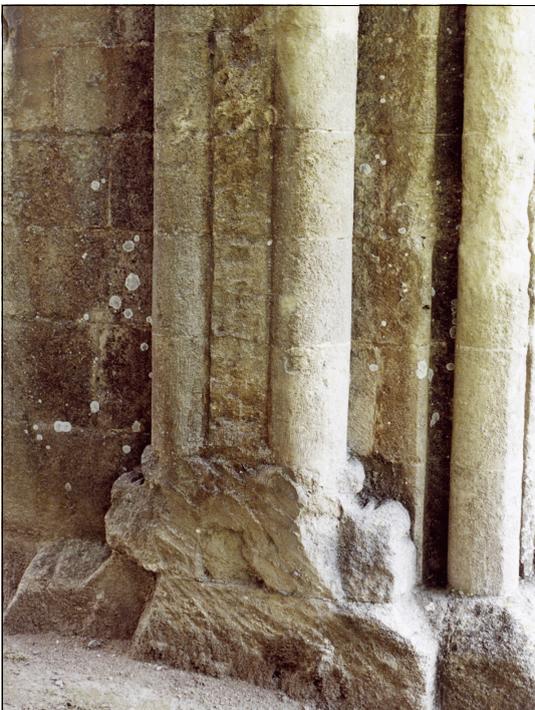
The cut away mouldings of the arch into the N Choir Aisle - the central roll moulding and base removed and the two side moulds cut back at parapet level to fix the C14 screen.

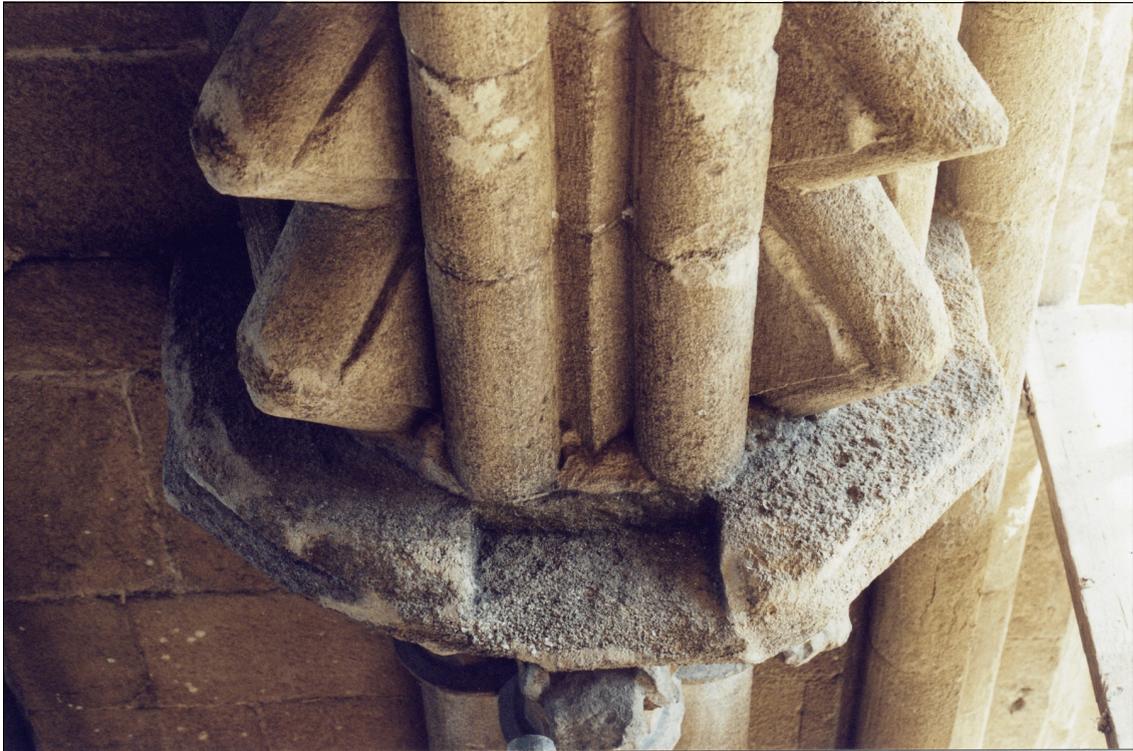
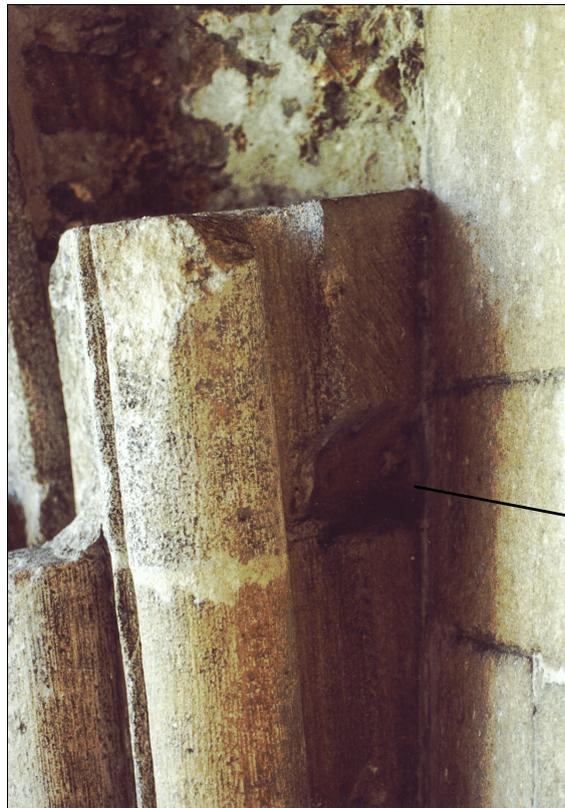
There are seatings for two lost transverse elements above the screen closing off the north choir aisle from the crossing.

Above is one of the two slots cut into the C12 abacus which housed a beam, either for the top element of the predecessor to Monington's screen, or for a beam to support sculpture.

- 2.4.2 Fixings above the north choir aisle screen
- 2.4.2.1 On the east face of the western arch of the north choir aisle, at approximately 60 cm above the springing of the arch, a shallow semi-circular

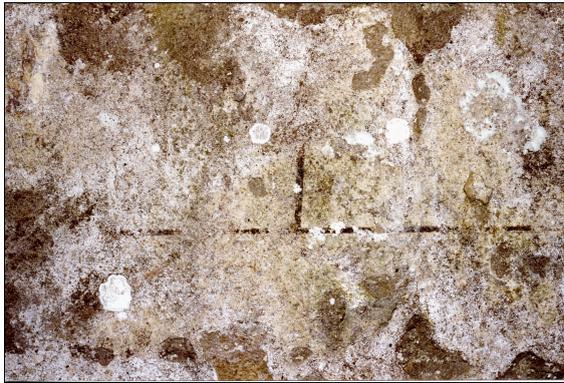
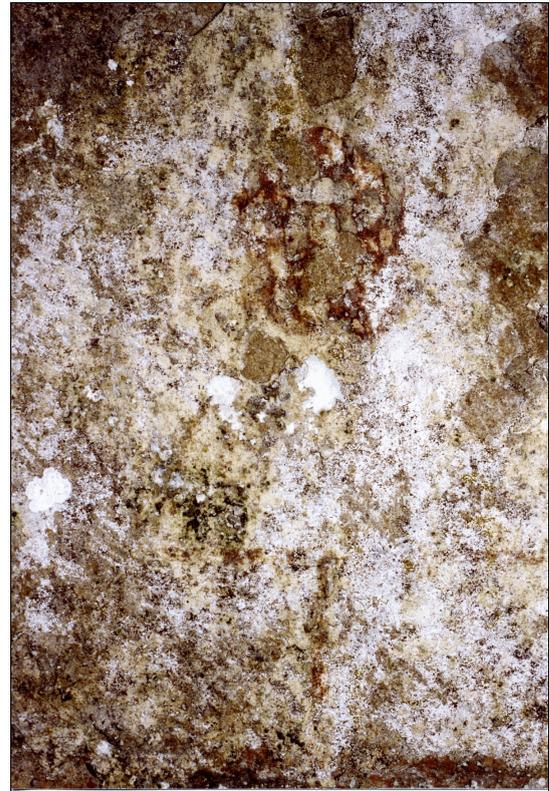
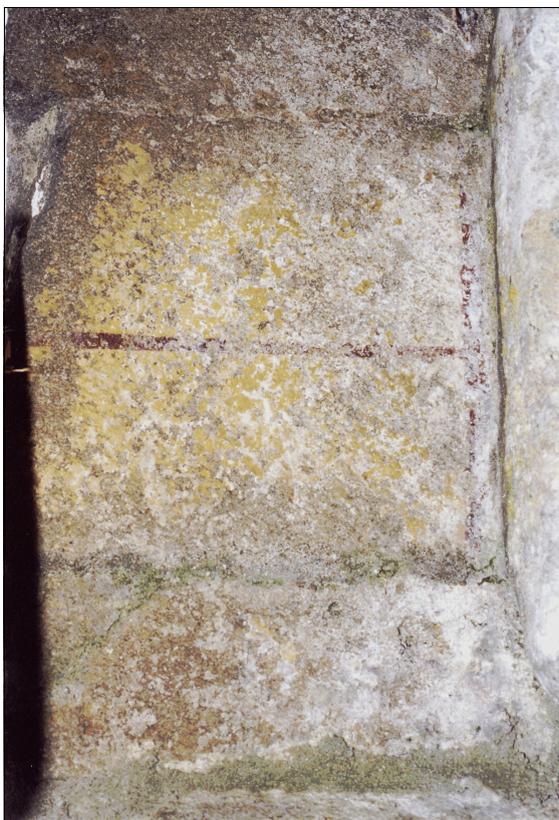
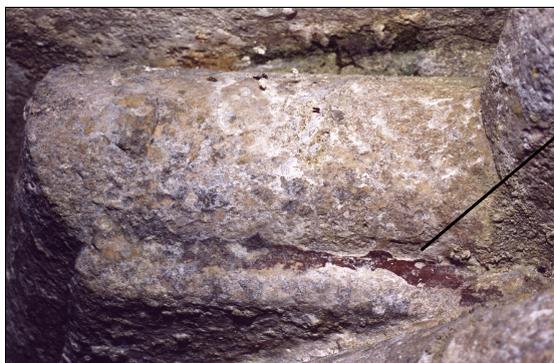
Paint traces in St Thomas' Chapel

Above: S wall, showing extensive traces of white painted plaster with ashlar lining in red (left), and remnants of red semée ornament (above).

Left: the soffit of the entrance (west) arch of the chapel has yellow ochre paint with red ashlar lining

Bottom left: the zig-zag moulding of the east window retains significant areas of red paint, usually preserved in the angles.

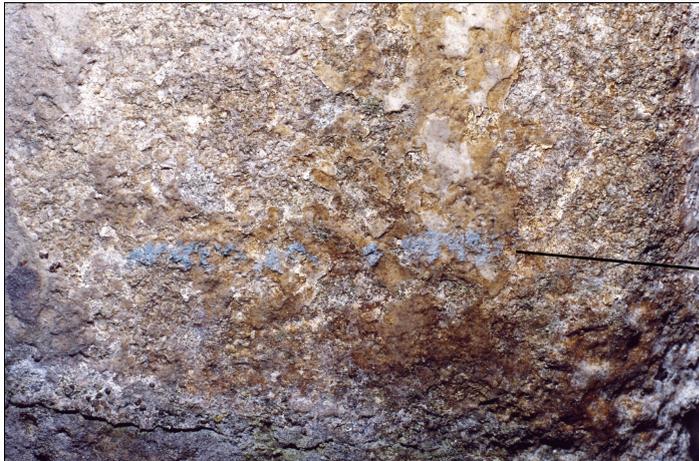
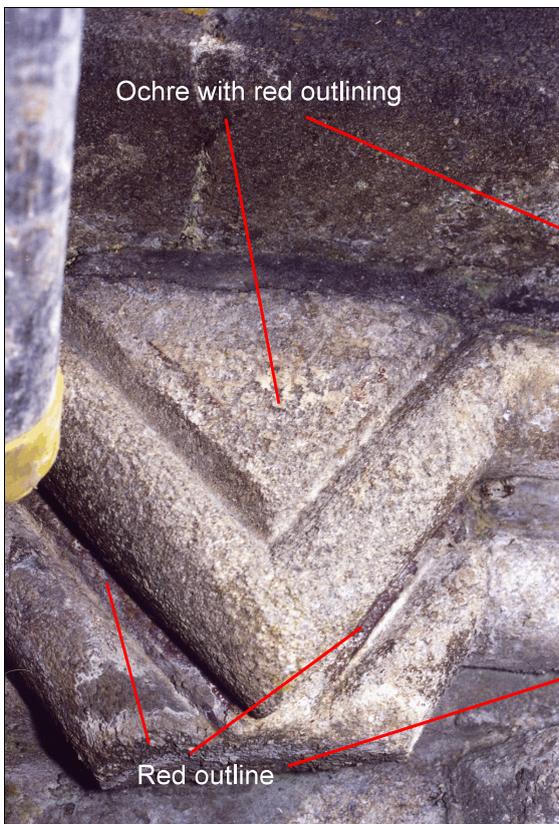
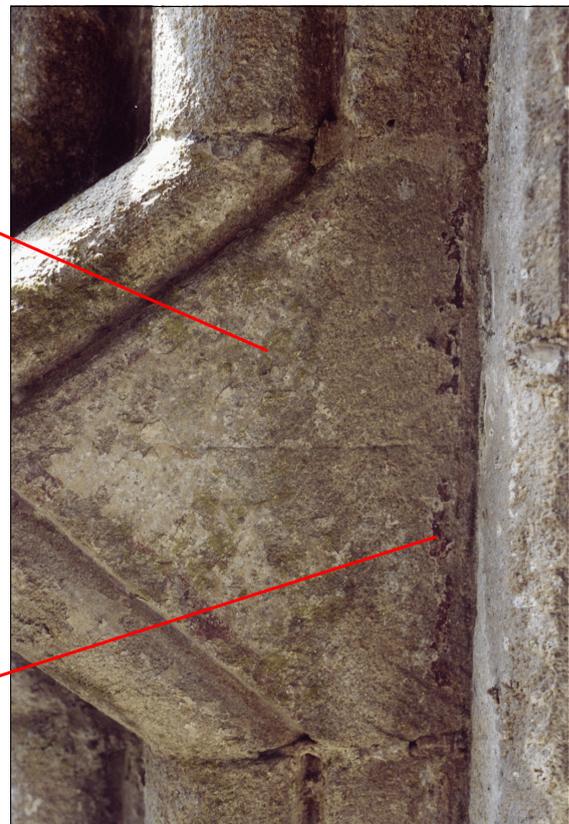
Paint traces on the West elevation of the western arch of St Thomas's Chapel

Left: trace of a blue line on the soffit west of the mouldings, south side of arch.

Below: paint traces on the zig-zag mouldings of the arch. The triangular grounds occasionally retain traces of yellow ochre with red outlining just inside the angle with the roll. The deeper mouldings between the latter and the outer rolls usually retain traces of dark red, and there are dark red lines along the margins of the moulding against the wall-face.

Ochre with red outlining

Red outline

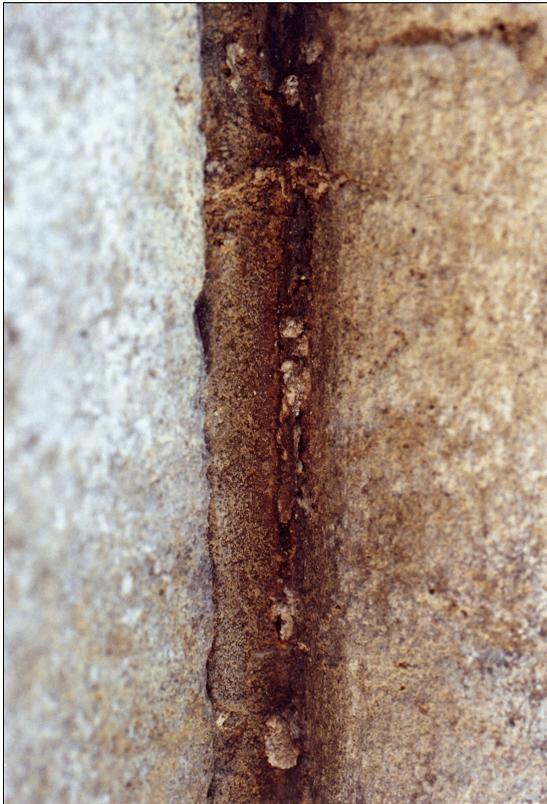
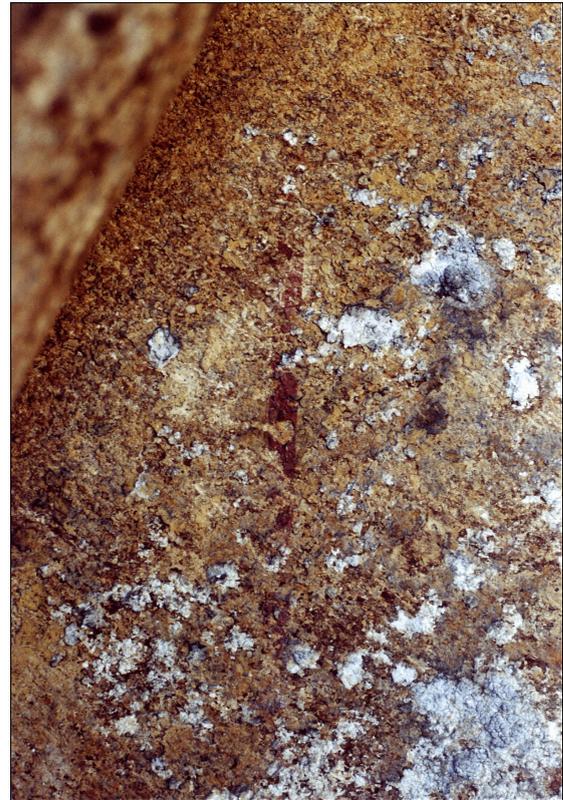
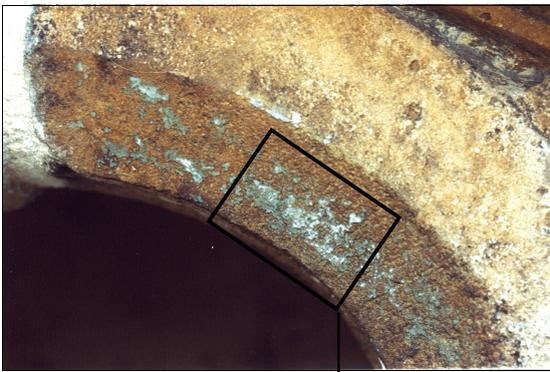
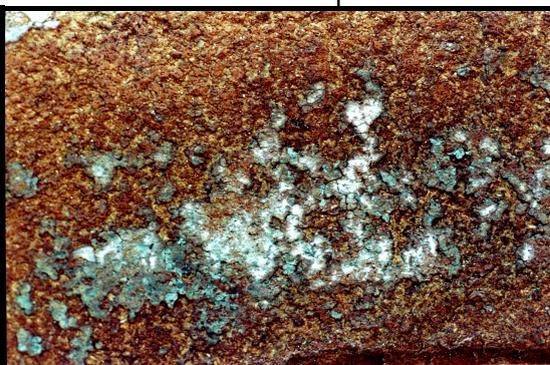
NE Crossing Pier - paint traces

Above left: W elevation, red paint in the angle of the southern wall-shaft between transept and crossing pier at clerestory level.

- 2.7.2.3 The southern opening of the triforium arcade bears a single fragment of what appears to be ashlar lining on its southern jamb. The arched head of the same opening retains green paint on the chamfer at the base of the foliate spandrel (cf. SCP2005 Section 2.7.7.).

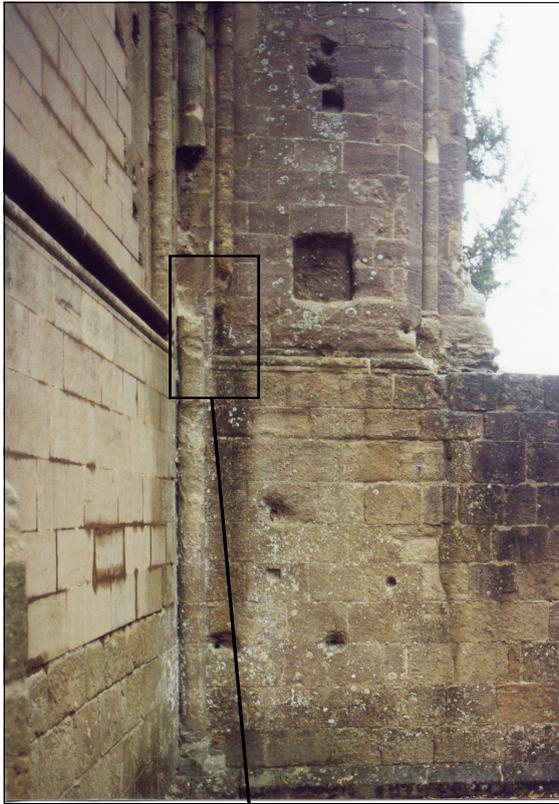
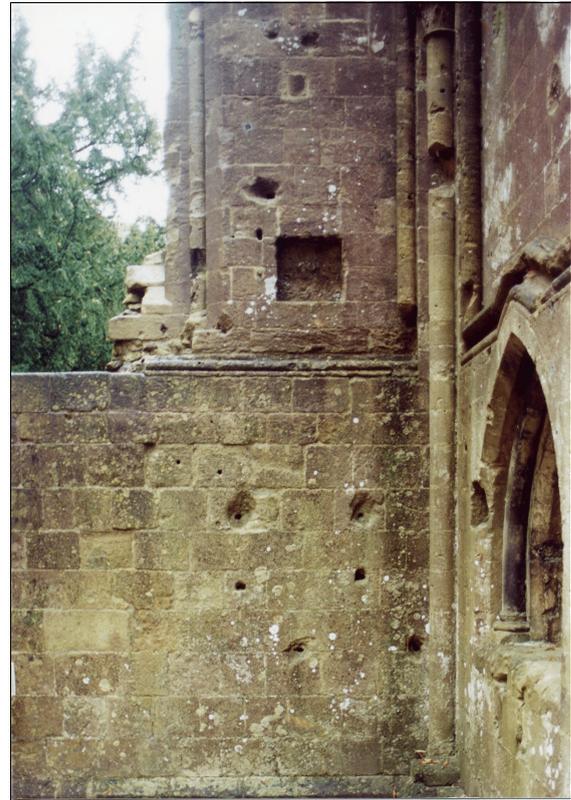
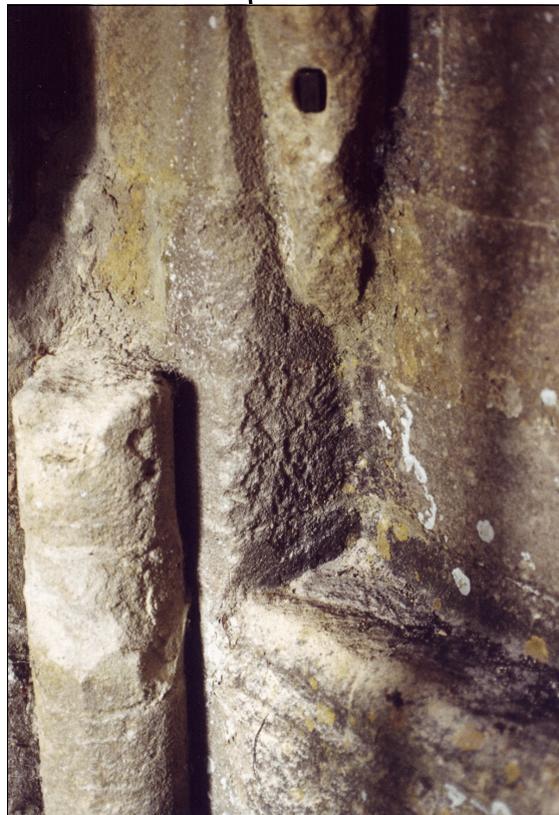
East wall of St Thomas' Chapel - marks of the lost reredos

The two large rectangular cut-outs were probably for corbels beneath life-size sculptures; below them the string-course has been cut back to locate a course of the stone reredos, and there is a symmetrical set of fixings to either side of the lost mensa (its position indicated by the absence of fixings). Symmetrical slots cut into the angle roll-mouldings of the window and the side wall-shafts also indicate the position of elements of the structure.

- 3.2.2.8 The cutting back of the horizontal sill-level string-course implies the intention to place a fairly heavy superstructure upon the prepared seating, and, since

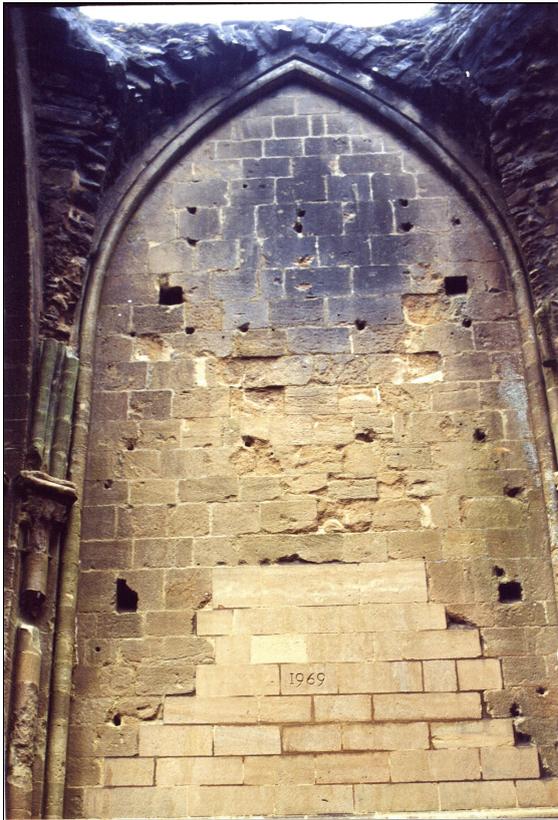
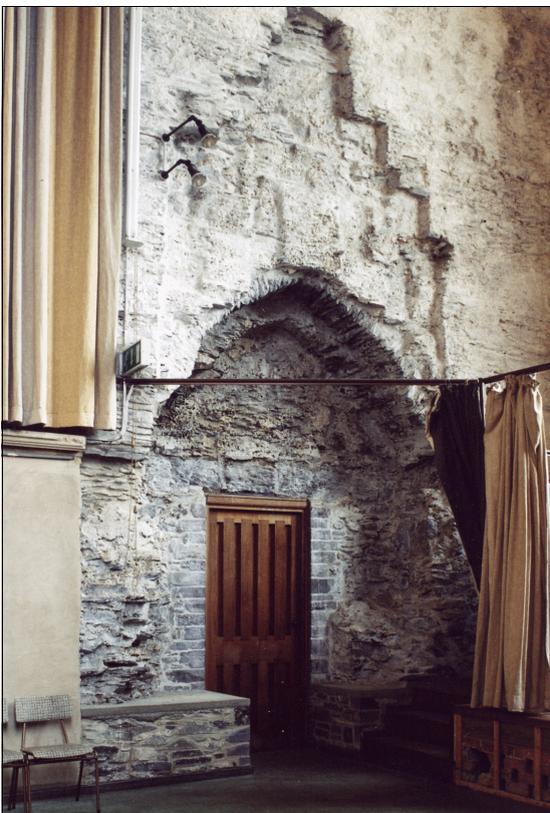
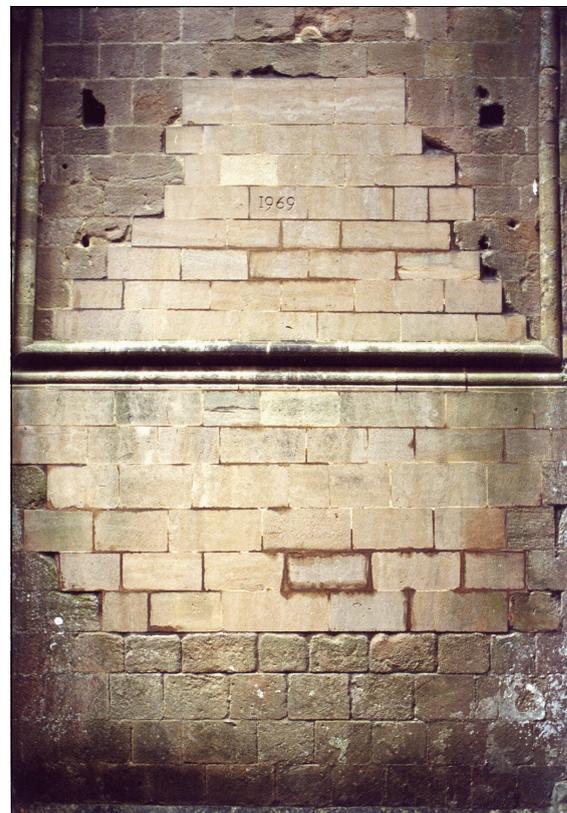
North Wall of St Thomas' Chapel - monument of ?John of Taunton (d.1291)

Left: Sockets of lost iron cramps which may originally have held decorative stone panelling above the monument (the four large holes are constructional putlogs).

Below left: the comparable scar of the lost monument of Bishop Adam Houghton (d.1389) in St Mary's chapel at St Davids Cathedral (Pembs.).

3.2.3.4 The scar from the destruction of the similar arch and gable wall monument of Bishop Adam Houghton (d.1389, tomb by ?1372) at St Mary's College Chapel, St Davids Cathedral (Pemb.) shows a similar overall form, but,

because the monument was built up with the wall, the form of the lost ashlar can be seen, giving a much more complete idea of the shape and construction of the tomb. In St Thomas's Chapel the only clue as to the form of the superstructure of the monument is provided by the presence of a series of seatings for iron cramps. The majority of these lie in three horizontal registers, each roughly a metre apart, at 2.95, 3.9 and 5 metres above the sill-level string-course, and rather than being associated with the triangular superstructure of the gable, they appear to relate to courses of applied stone panelling fixed to the wall above and to either side of the tomb canopy.

- 3.2.3.5 Of the horizontal registers of cramp-holes the uppermost set is the most irregular, there being a group of eight rectangular slots (one of which, centred on an incised 'X', has been filled) forming two lines. Below this is a single register of five rectangular holes, with seven smaller holes roughly on the same line and two below. The third horizontal line consists of four rectangular holes, with five smaller drilled holes at a similar level. These lines lie roughly a metre apart, and it is important to note that further rectangular holes exist in the spandrels to either side of the arch scar: two a metre down at a point coinciding with the top of the repaired scar, and another pair (with an outlier at east) a metre further down the wall, probably lying at the point where the arch diverged from the pinnacle. Five regular tiers of cramps suggests the fixing of five courses of metre-high stone panelling bearing decorative carving - though whether diaper-work or richer architectural or sculptural decoration cannot be inferred. It is of interest to note, however, that the putative tomb chest (which at this date may have borne weepers or saints) would have been of approximately the same height as each course of the panelling.¹⁴

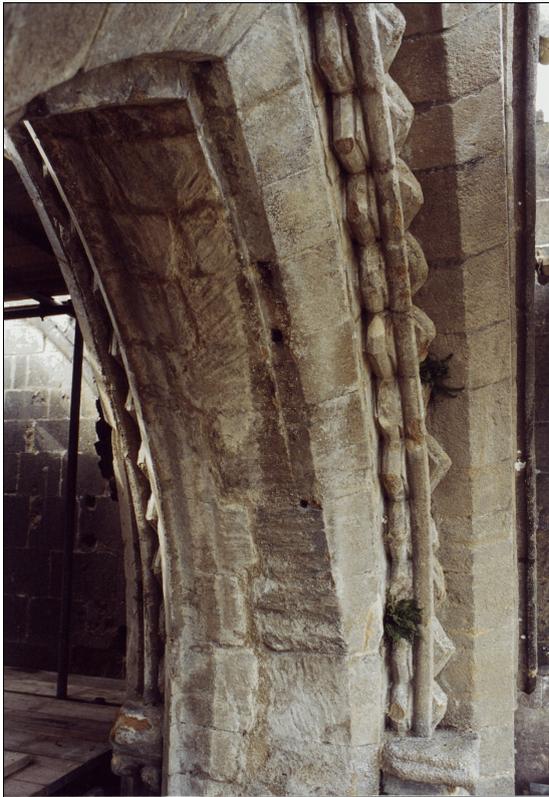
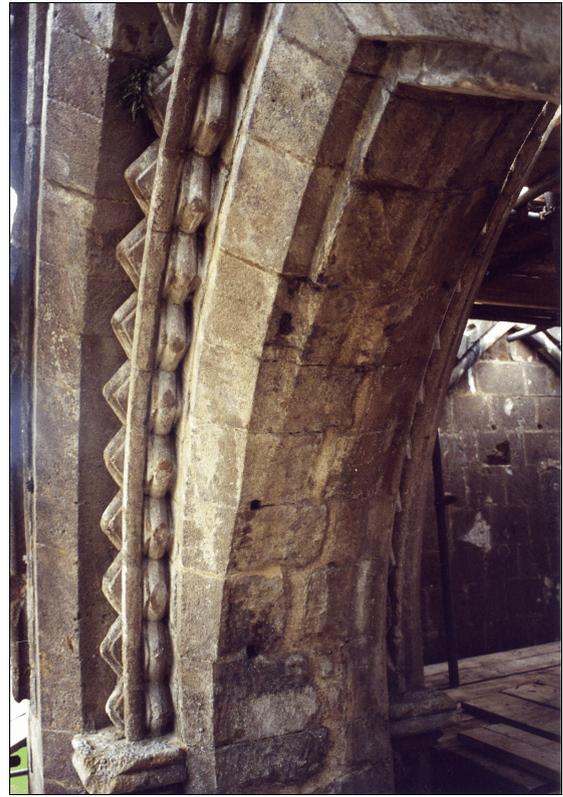
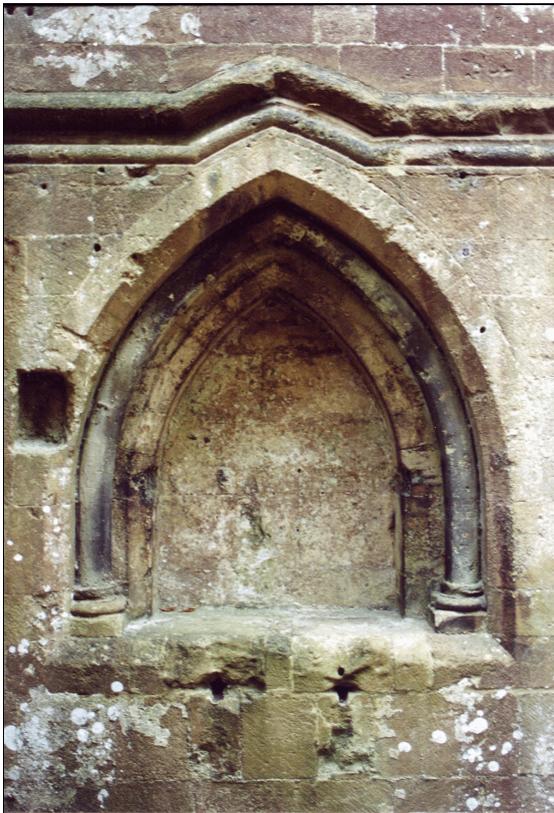
Above: The late twelfth century east window of the chapel of St Thomas, like the windows of the south nave aisle, shows signs of having been adapted to receive tracery at a later date, with the trimming-off of the chamfer towards the outer elevation removing much of the original step into which the early glazing was secured.

Left: the surviving piscina in the south wall of St Thomas's Chapel (retaining plentiful traces of painted ashlar lines on the background) has had its projecting drains cut back exposing the drainage channels. The scar of a similar piscina survives in the chapel to the north.

3.2.5.4 The arched recess retains plentiful traces of medieval paint, with green pigment remaining on the north face of the inner moulding of the arch

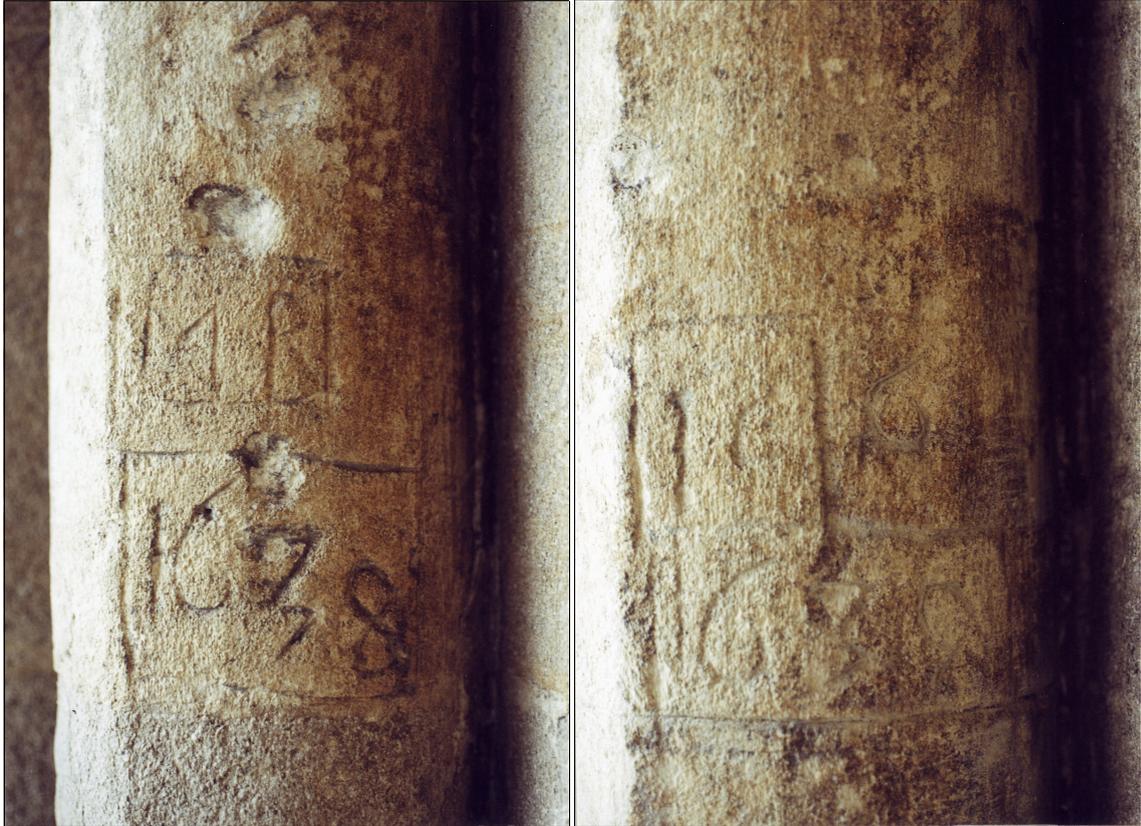
Three graffiti dated 1638 survive on the north-eastern crossing pier well above the height which could be reached from the present ground-level. Could they have been cut by men who were working on the demolition of the ruin?

The remarkable symmetry of the surviving ruin suggests that this is the result of the deliberate 'farming' of the stone in the great church while it was being used as a quarry, probably during the mid to late sixteenth and early seventeenth centuries - Hollar's distant prospect of the abbey in the mid-seventeenth and the early eighteenth century drawings of the ruins show that the greatest part of the destruction had already taken place.

4.1.3 The fact of the inscriptions all being cut in the same year of 1638 tends to support the idea that a scaffolding may have been present, since, if the pier were simply surrounded by collapsed masonry, more varied dates might have been expected to have been cut into the stonework.
