Glastonbury Abbey: The NE Crossing Pier

Archaeological Survey of the standing fabric - 2005

Jerry Sampson

Caroe & Partners Architects

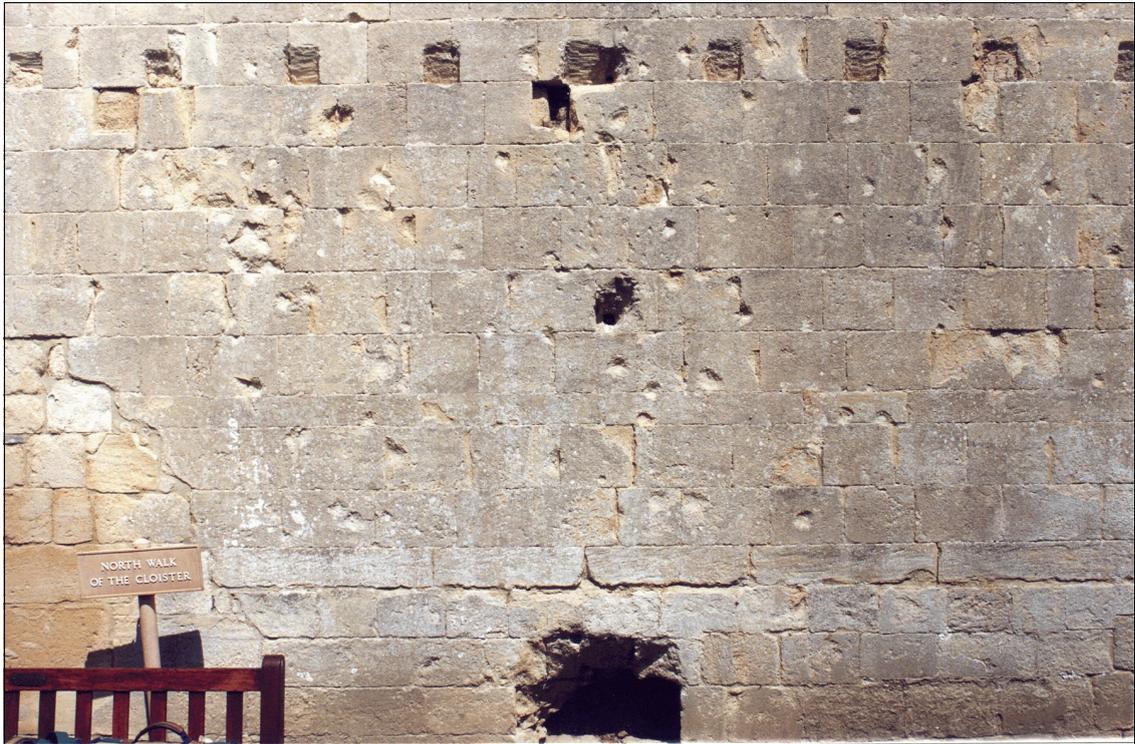
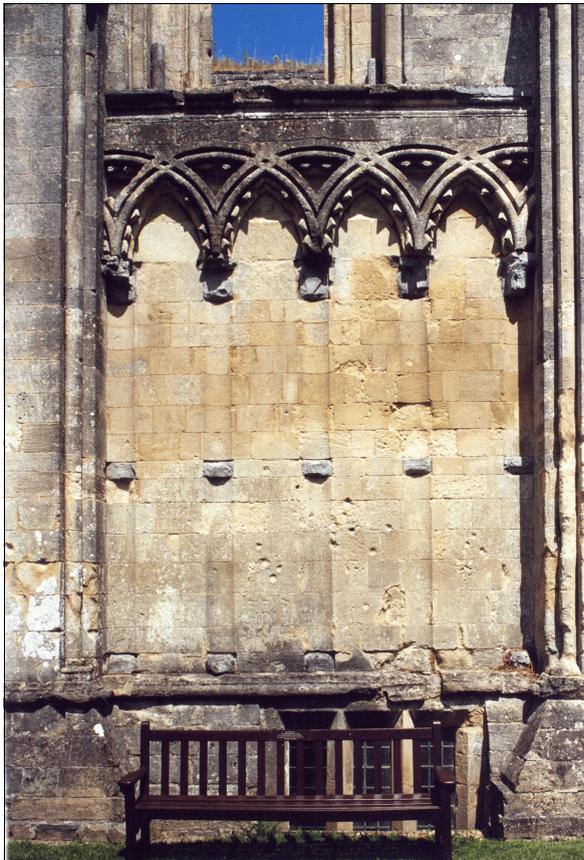
Marks of musket fire

Small hemispherical indentations in the ashlar of the south elevation of the nave aisle (above) and Lady Chapel (left) are very similar to those at Malmesbury Abbey, where a skirmish took place during the Civil War, and are probably the result of musket fire.

The situation on the south side of the Lady Chapel is similar. Here there are shallow circular depressions in the ashlar of the bay to east and west of the south door, with more occasional marks on the buttresses to either side of the doorway. Both here and on the south nave aisle the marks are generally between 1.5 and 3 metres above the present ground level. The shots are not apparently concentrated in one particular area, but rather
