Glastonbury Abbey

The Lady Chapel

Polychrome Survey:

(1) The Arcading

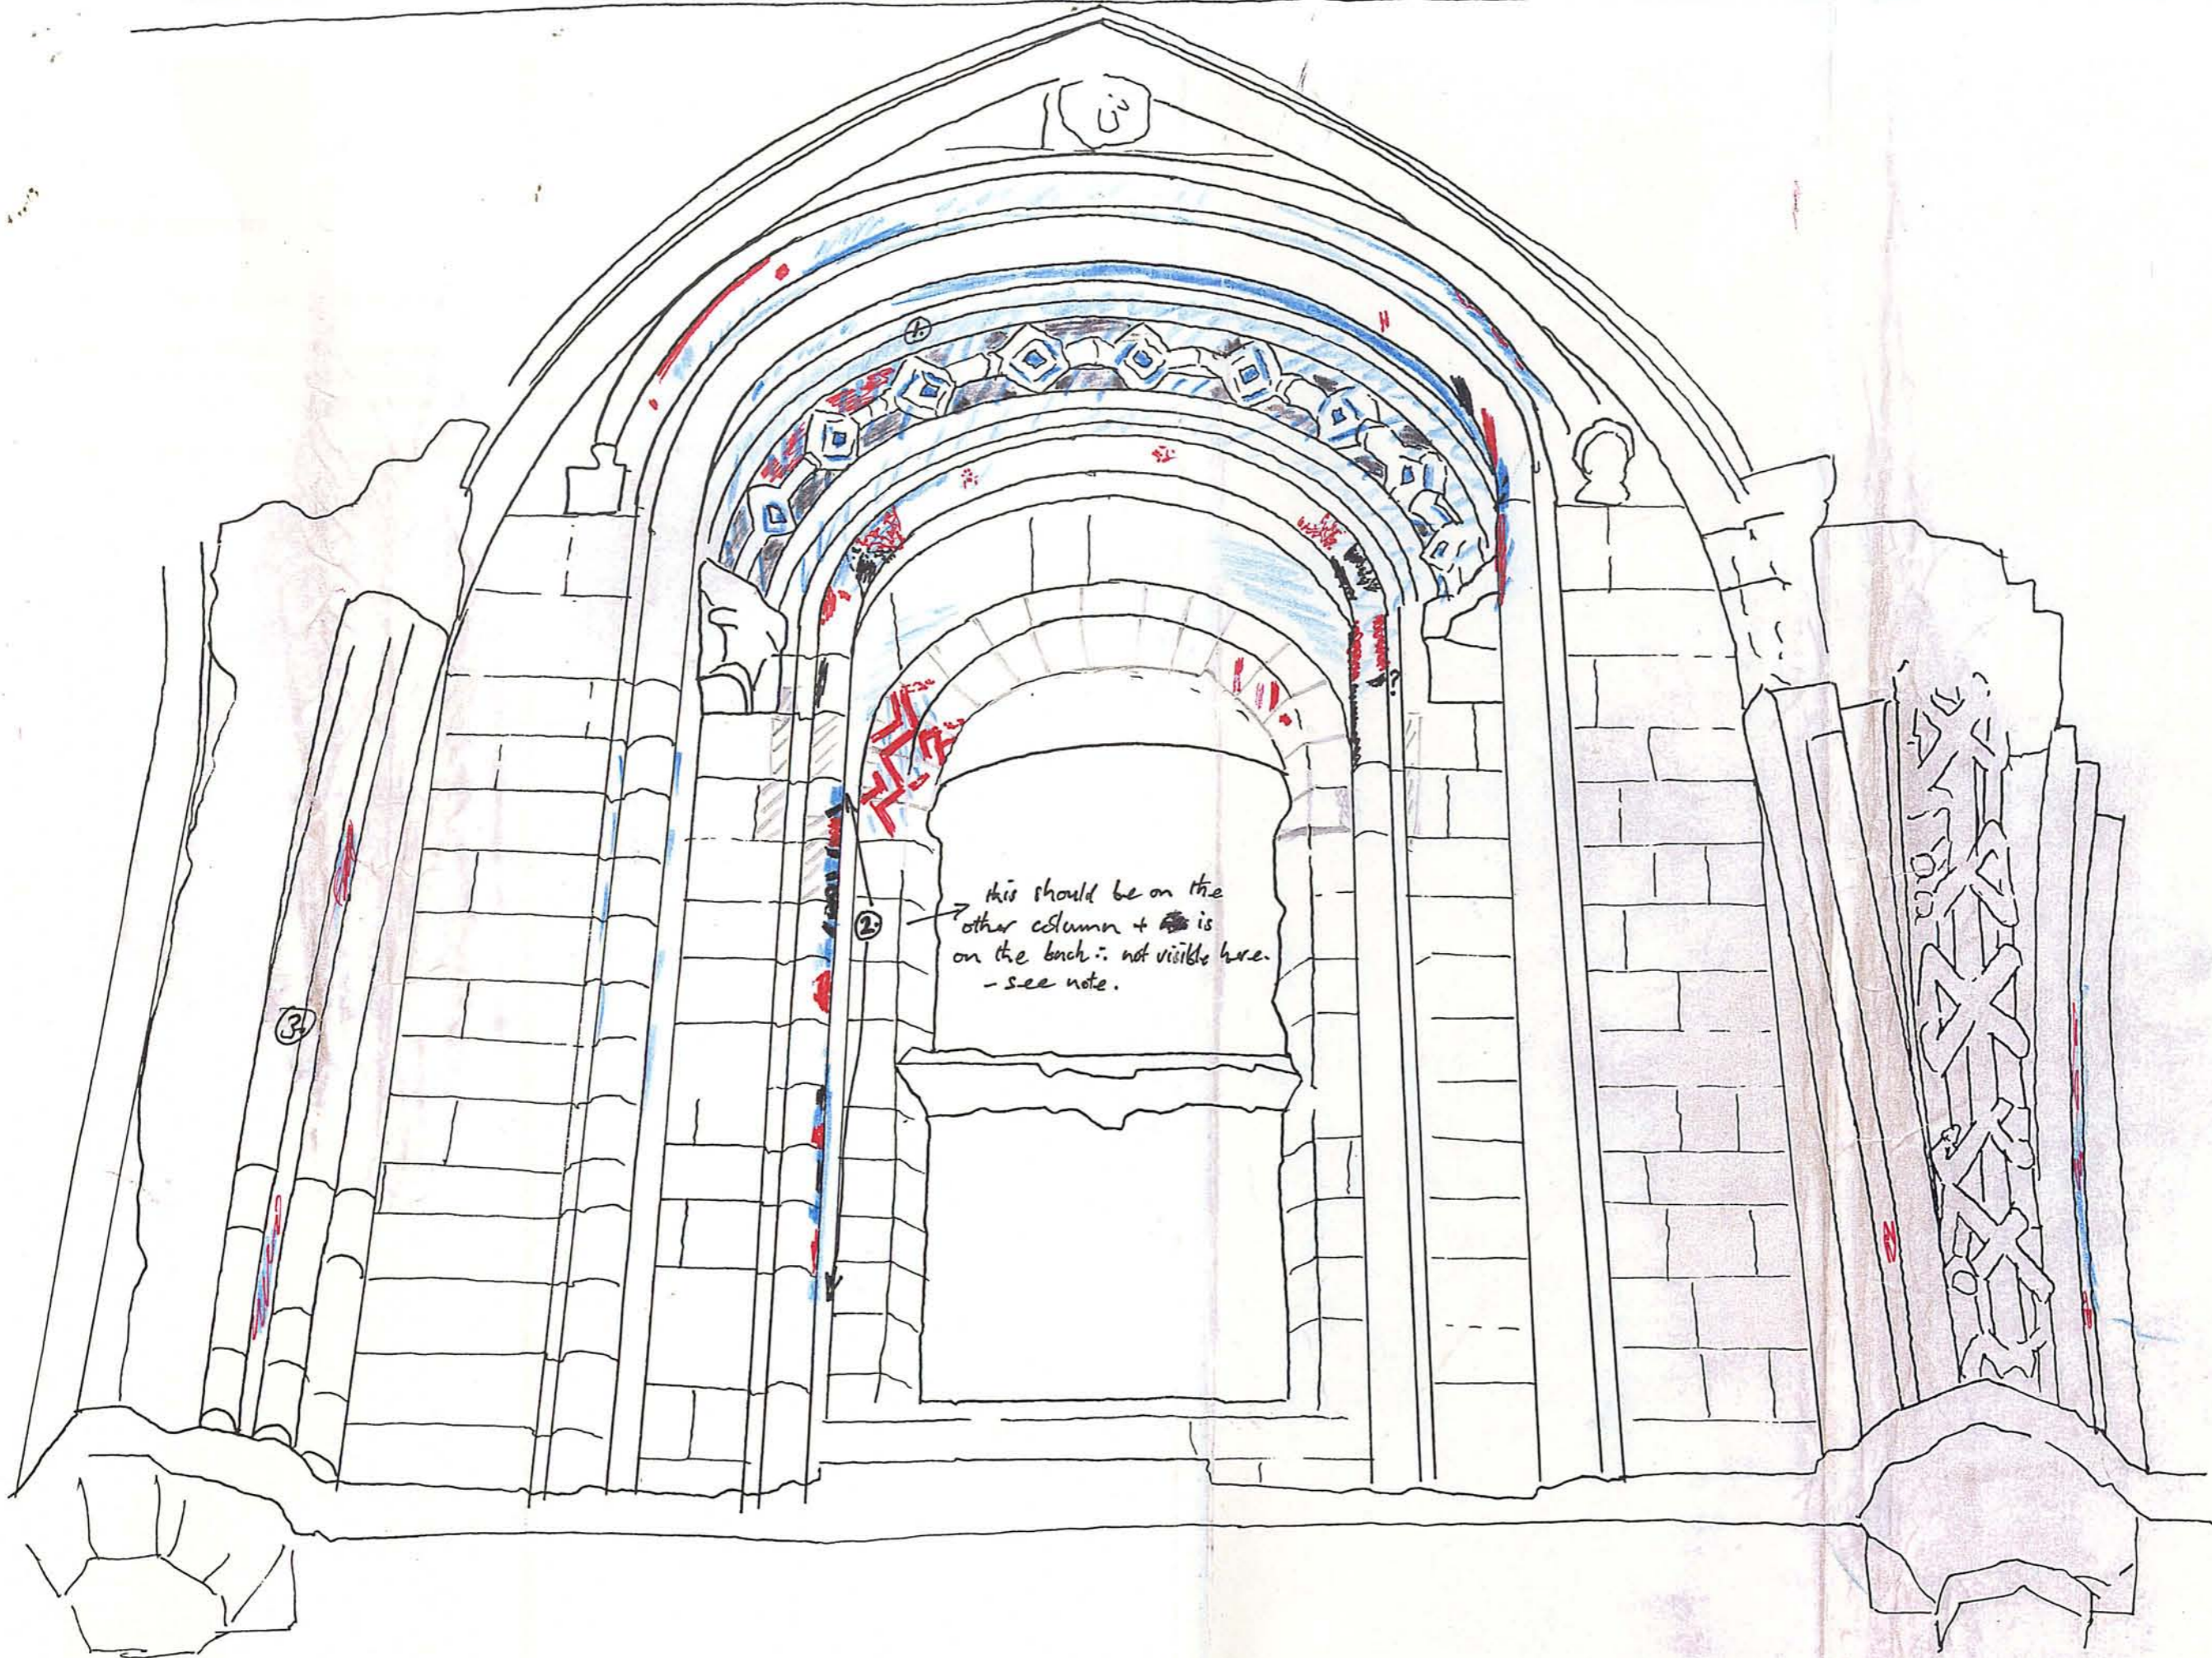
- ① White ground is on inside of roll (not drawn on)
- ② White in grooves of moulding
- ③ Wide band of red up back of moulding
- ④ Red under white
- ⑤ Pink
- ⑥ Chouning runs round back of shaft
- ⑦ White continues down head of arch
- ⑧ red on this moulding is pink
- ⑨ Thick white inside moulding

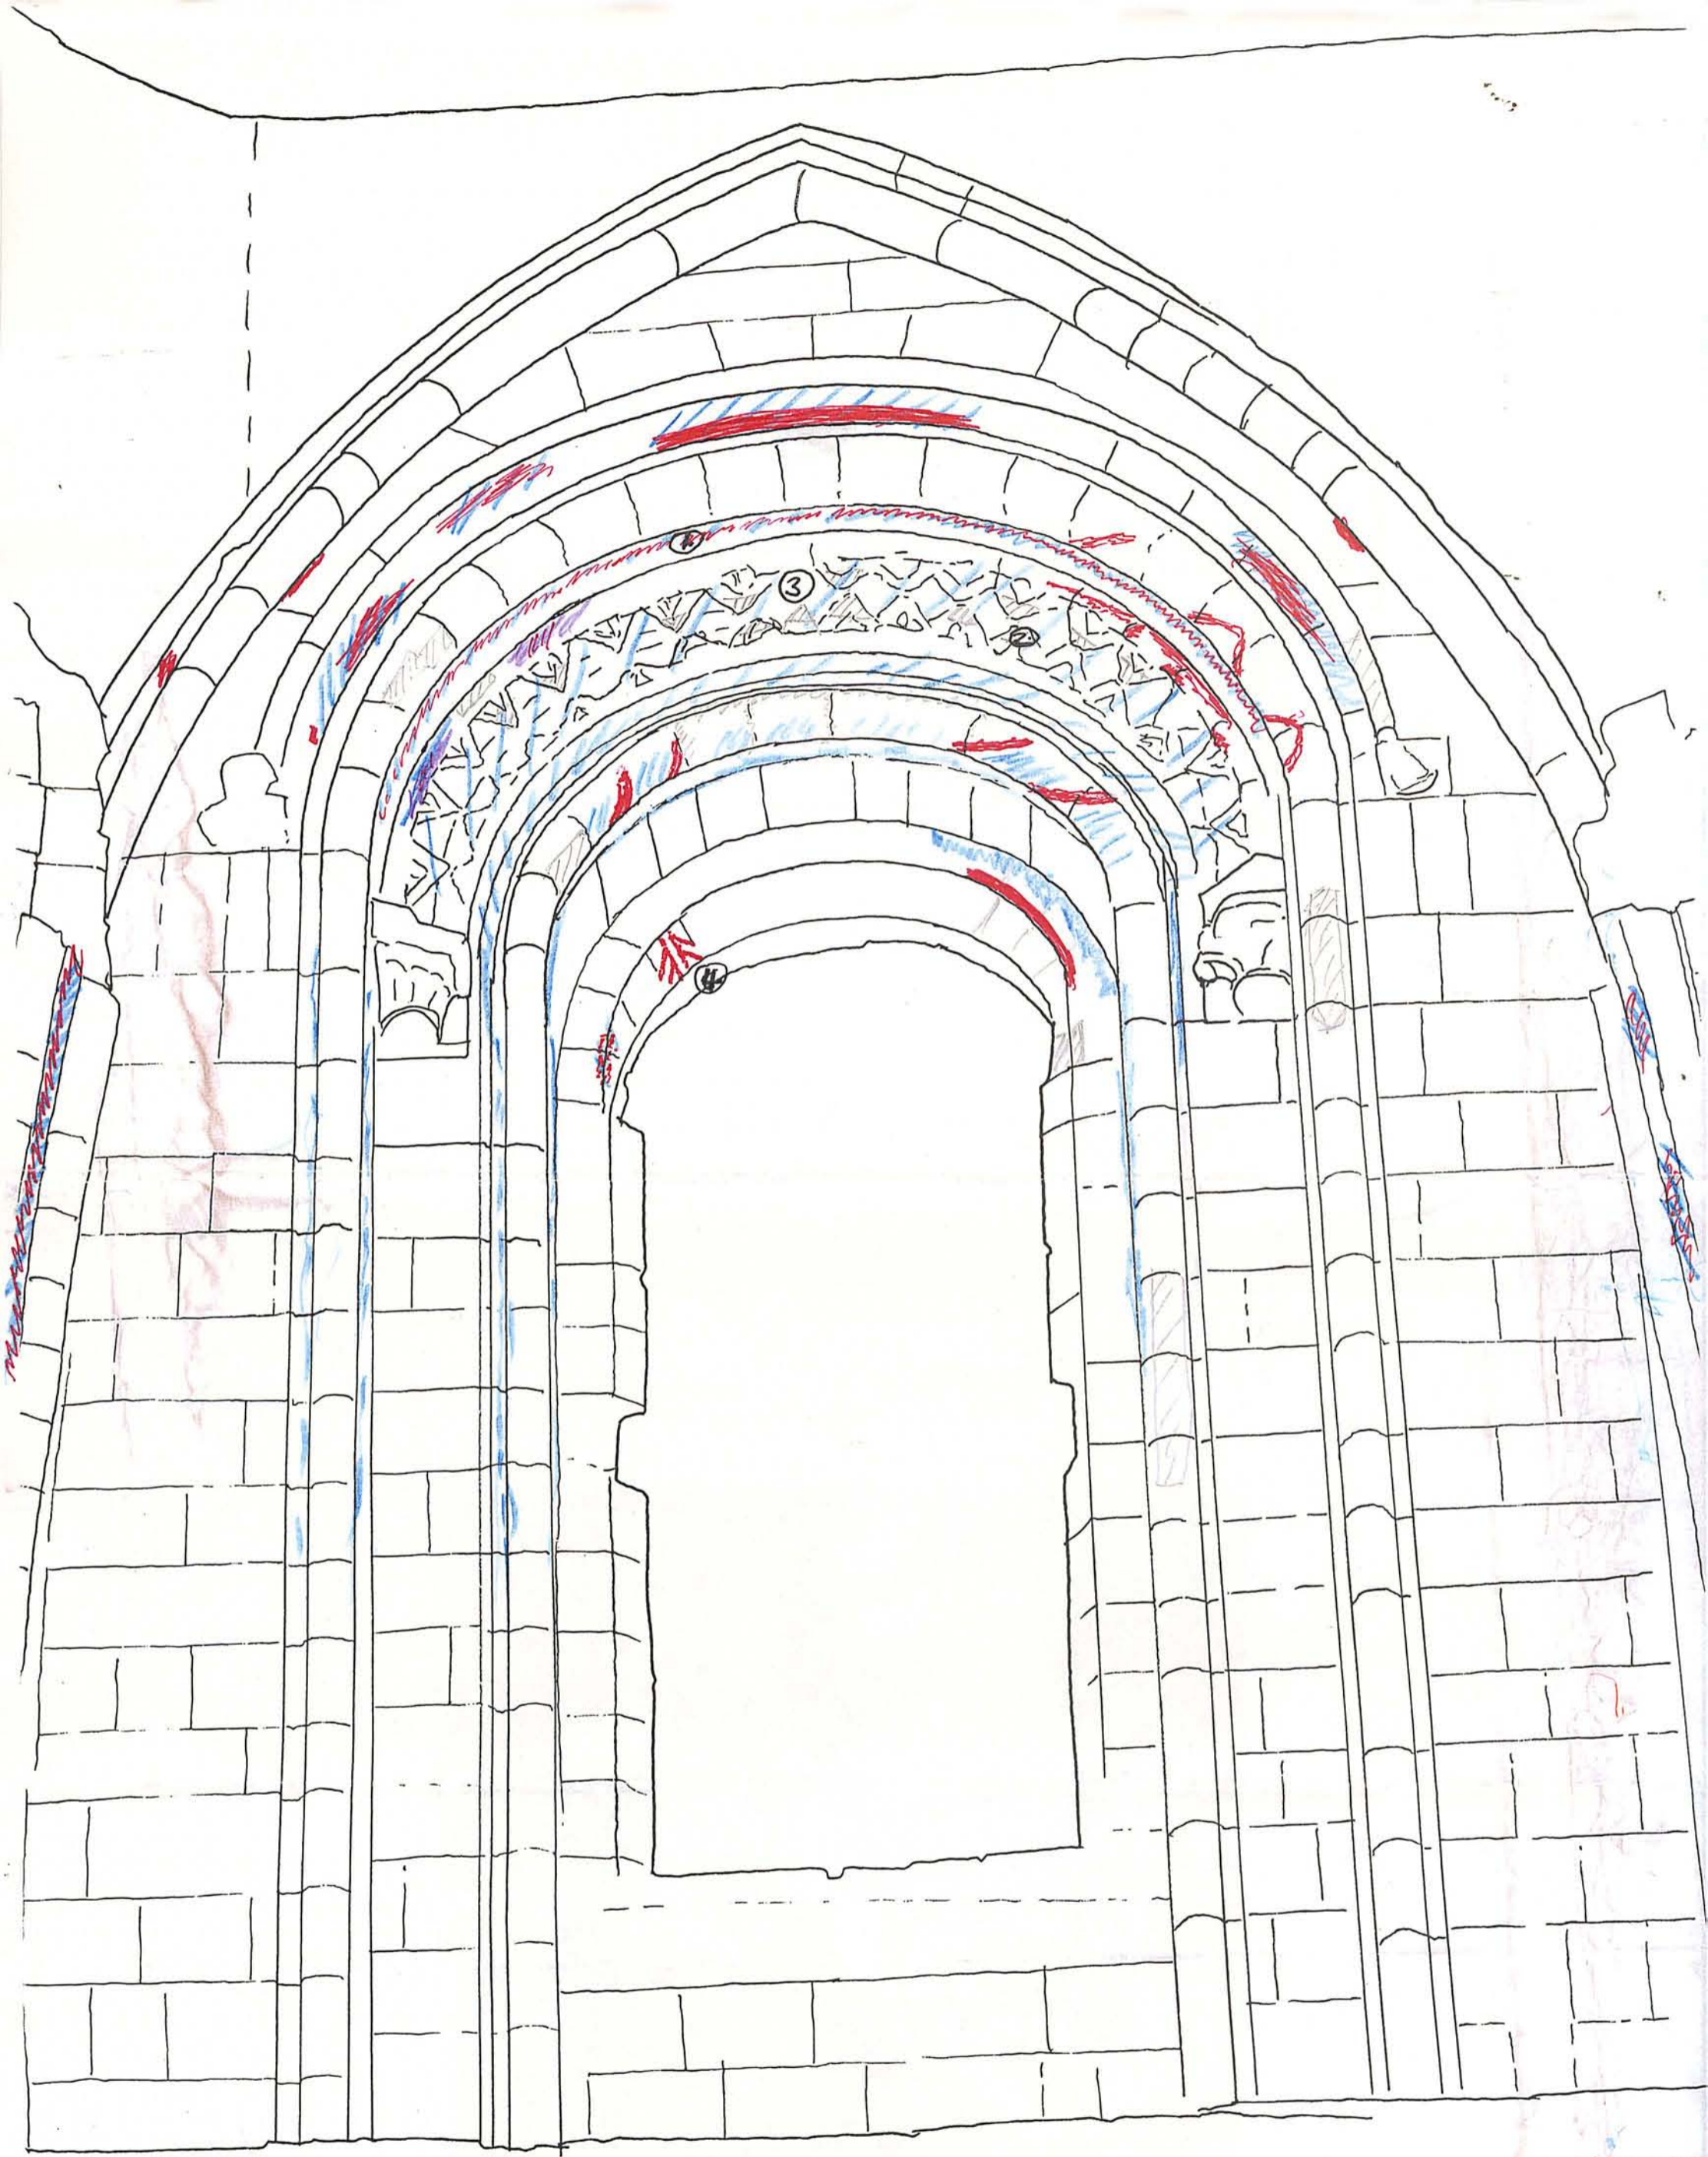
Bay 4N clerestory

1. Red with white over on flat face of small inner moulding (not shown on drawing).
2. Two ends of a copper pin (green only showing) here.
3. White over calcining throughout this chevron work.
4. This interpretation of the pattern was made only after long examination, and may not be very reliable – it exists only as a collection of dots and semi-lines of red.
