Castle Cottage, Wigmore, Herefordshire  
building recording and archaeological monitoring

Huw Sherlock, PJ Pikes and Robert Williams  
2002

*Castle Cottage, Wigmore, Herefordshire: building recording and archaeological monitoring  
2002*

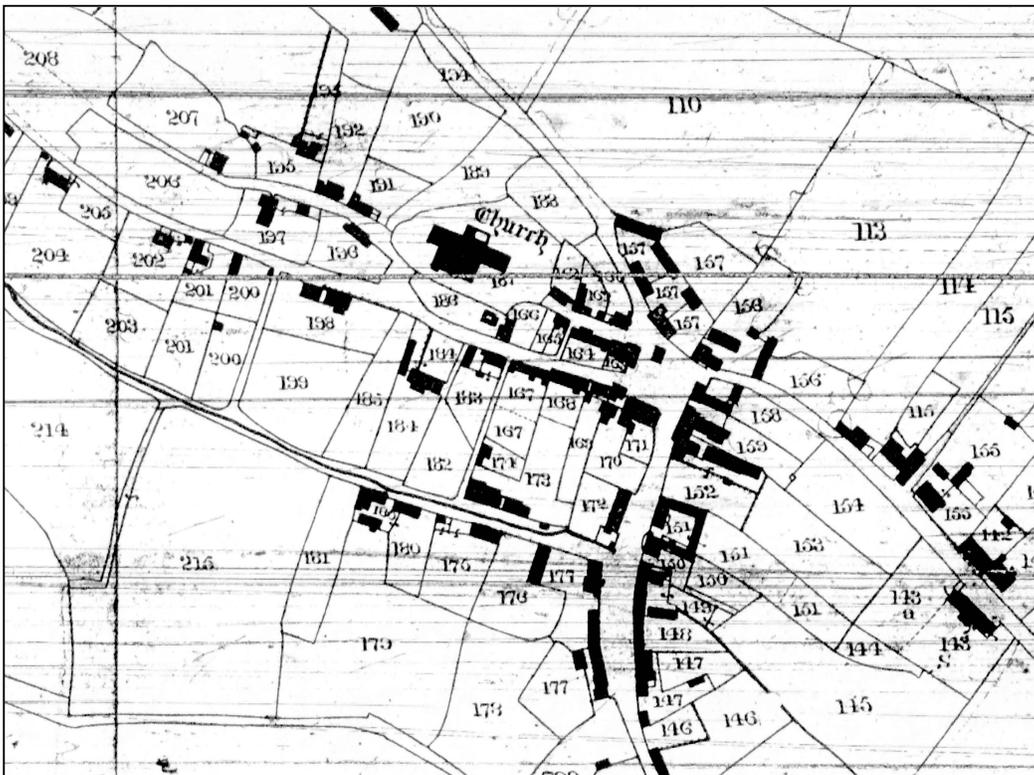
Figure 2: Extract from the 1841 tithe map of Wigmore.

Castle Cottage is marked as number 167 on the 1841 tithe map of Wigmore (see figure 2). The apportionment records that it was owned by Henry Prince and occupied by Thomas Owens.

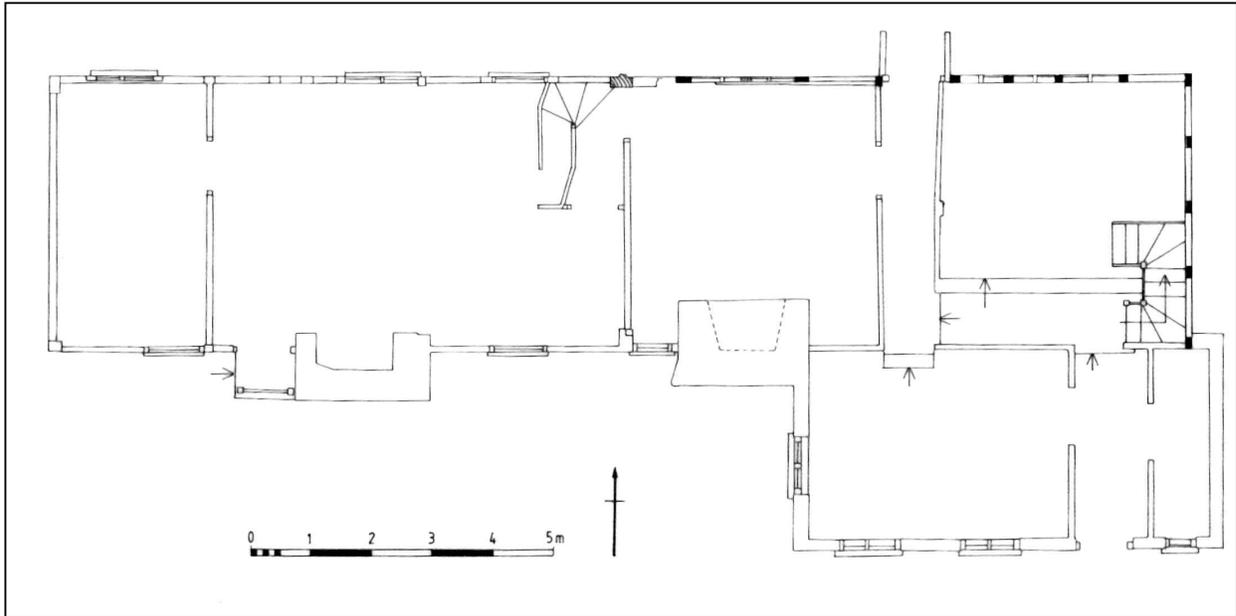
Figure 3: Ground plan of Castle Cottage, Wigmore

A plan at a scale of 1:50 based on the architect's drawing was annotated to include archaeological details mainly to areas where alterations were to be made to the house (see figure 2). This was mainly on the north façade where the sill beams were being replaced.

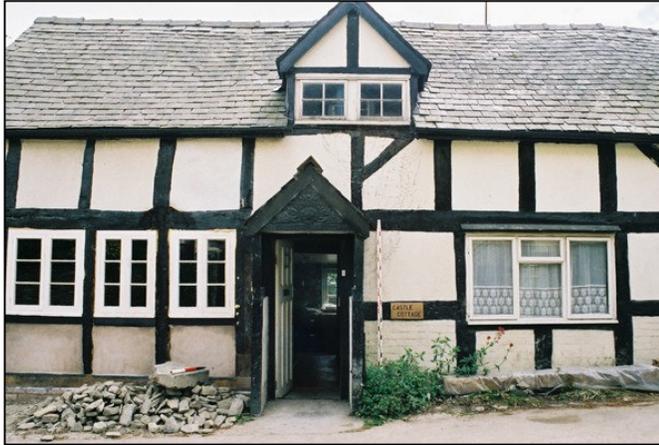
The external timbers have been heavily painted and many details of the original construction (such as the position of peg holes) are obscured. Many of the original timbers have been replaced with re-used or modern ones.

**Plate 1: The front entrance. The beam that was inserted is in the foreground.**

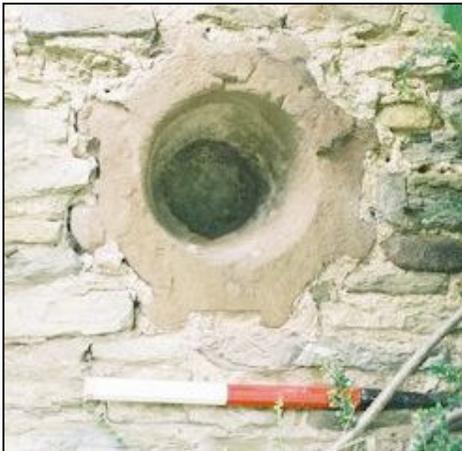
There are two externally placed stone rubble chimneys with offsets situated along the south rear wall and have brick upper stacks. Set within the stonework on the west stack is a moulded architectural stone (Plate 3).

**Plate 2: Inserted architectural fragment in base of western chimney stack.**

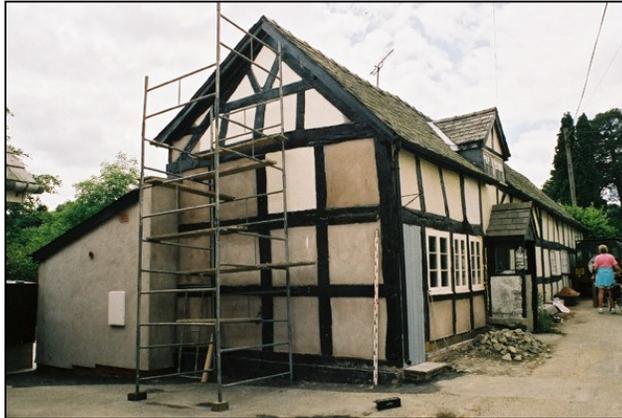
**Plate 3: The western gable end.**

The west gable frame has had modern repairs or replacement of selective timbers and the in-fill of the panels have been replastered and painted over recently.

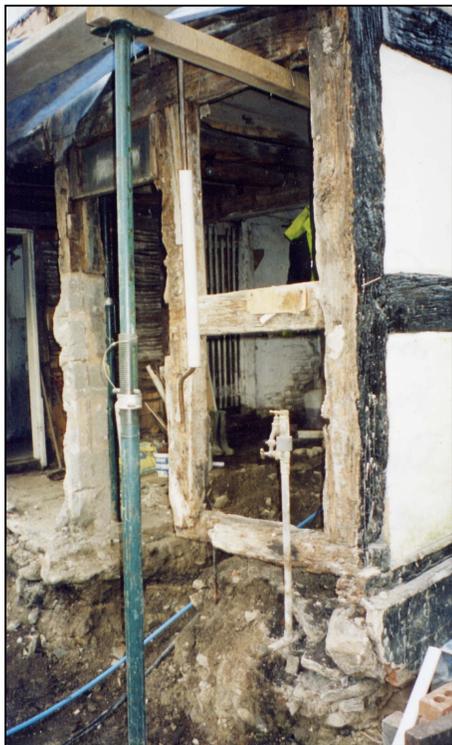
A new extension situated at the south east corner of the building has been built. This extension overshoots an earlier extension that has now been demolished. Much of the timber framing on the south elevation has either been replaced or the timbers are re-used. Plate 4 shows the exposed timbers at the south east part of the building.

**Plate 4: The south east corner of the building exposed during a previous phase of renovation work, The photograph clearly shows a raised sill beam on a stone plinth and a door entrance slightly west. The floor in this part of the building was formed by cobble stones (see plate 5).**

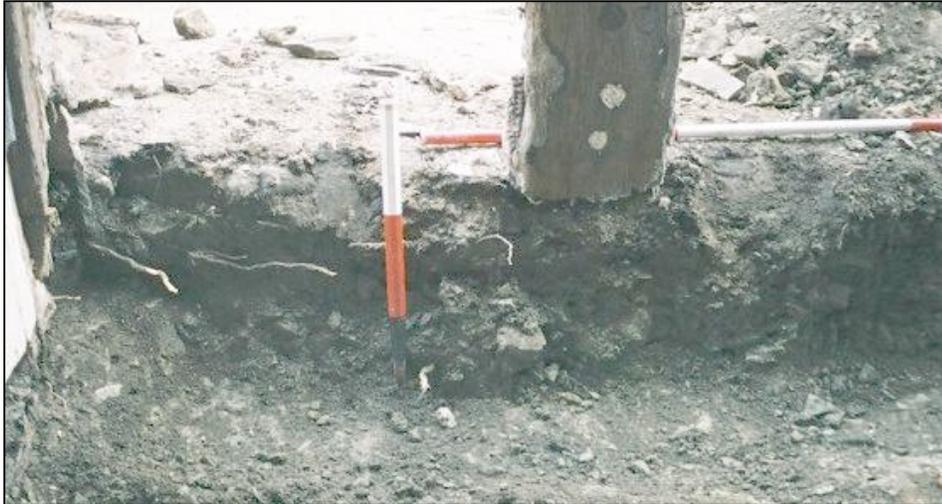
A shallow trench was excavated by the contractor, under archaeological supervision, along the line of the northern elevation to the immediate west of the main front entrance. This trench was 400 millimetres deep and 500 millimetres wide by 3.2 metres long and was excavated to allow the insertion of the new sole plate (the base of the trench was at 142.57 OD). The fill of this trench was a very loose, dark humic soil with frequent inclusions of small stones, brick, decayed wood and mortar. A number of nineteenth and twentieth century glass bottles were recovered from the trench, which have been retained. No archaeological features or deposits were recorded during the excavation of this trench.

**Plate 6: The base of the trench excavated in order to remove the old sill beam and insert the replacement beam.**
