Swan House, Tarrington, Herefordshire:
archaeological monitoring and building recording

Swan House, Tarrington, Herefordshire: archaeological monitoring and building recording 2001

Archenfield Archaeology were commissioned by Mr. and Mrs. Parry to carry out an archaeological building survey and watching brief during work carried out at Swan House, Tarrington, Herefordshire, in March and April 2001. The building survey showed that, in its current form, Swan House is typical of a late eighteenth or early nineteenth century building, although a number of features tend to support the Royal Commission inspector's thesis that it has a seventeenth century origin.

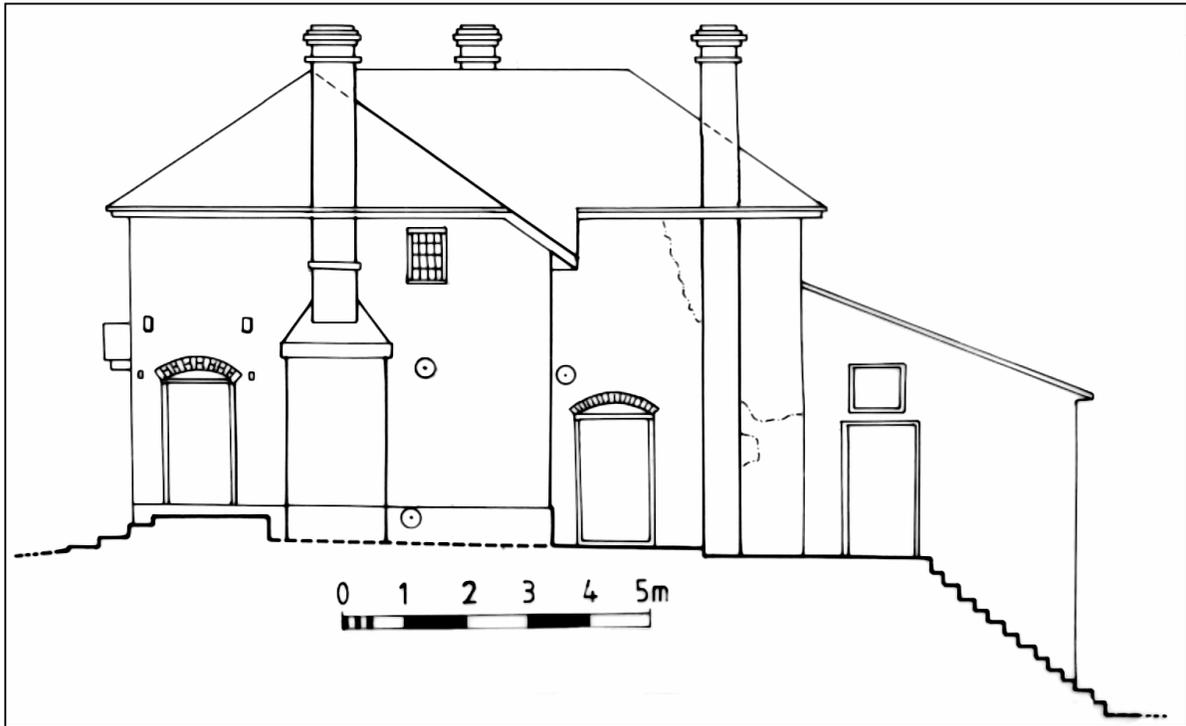
Figure 6: Swan House – East Elevation

The far eastern corner of the northern part of the house contains the third stack. Originally there was a fireplace associated with this but as it is now blocked the true width cannot be assessed. Refurbishment occurred in the corner of this part of the building, probably associated with the addition of the lean-to building running from the main house northwards. Construction breaks on the external east wall face (Figure 6) show a mix of stonework and later brickwork.

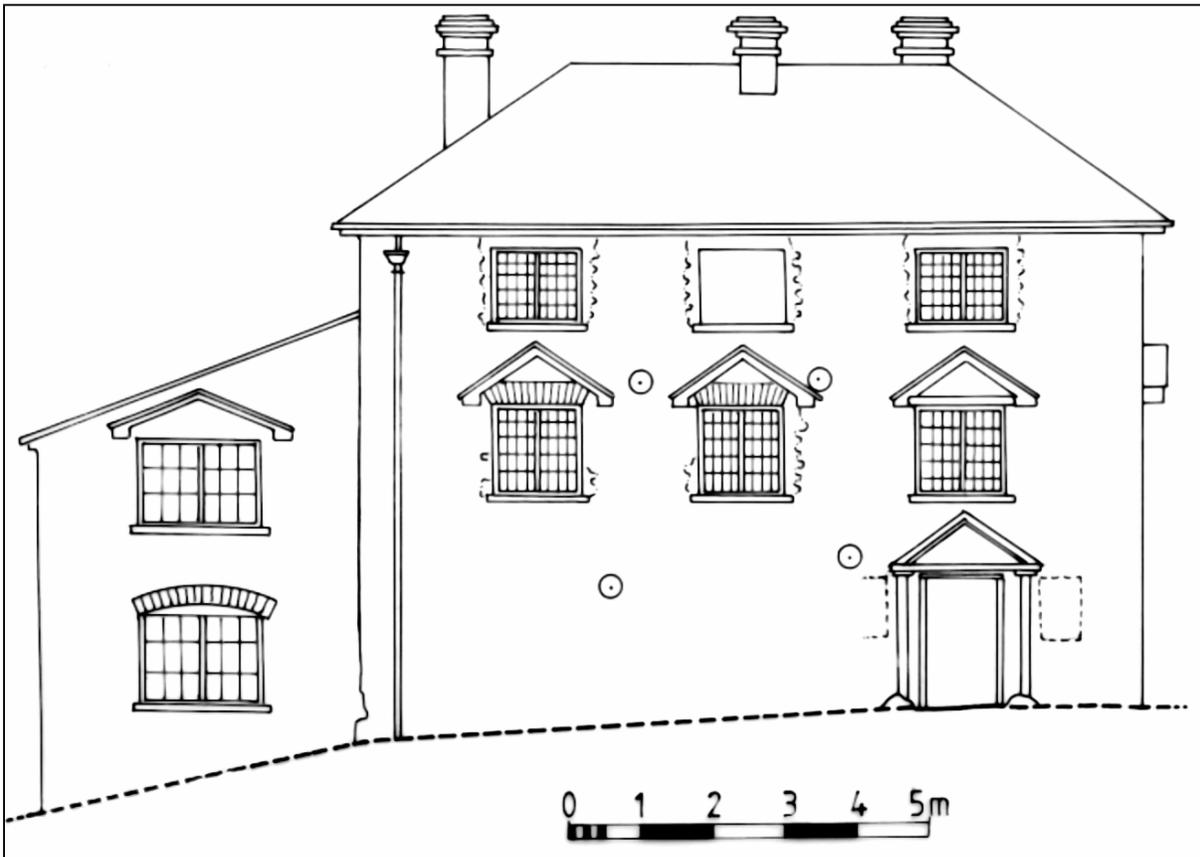
Figure 7: Swan House – West Elevation

The west elevation of the property faces the main road, while the main entrance to the house is at the rear.

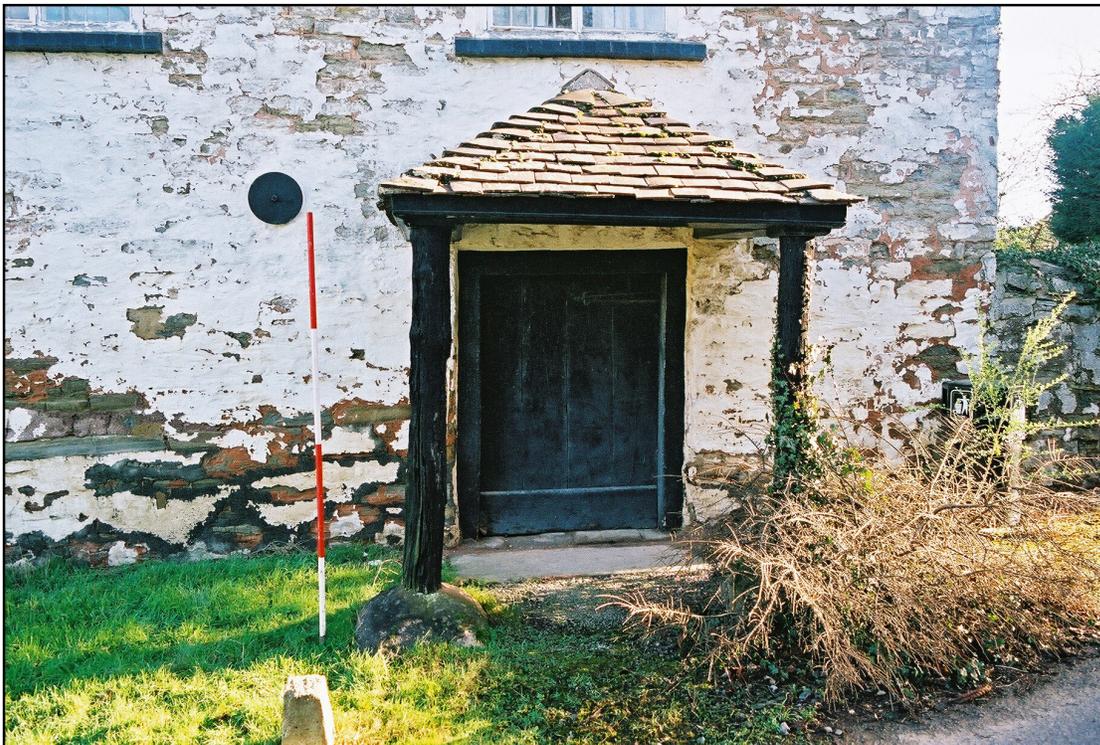
Plate 2: The West Porch.

The wooden porch which was attached to this elevation was removed by the client, Mr Parry, during the course of these latest renovations. Two stone corbels set within the brickwork to support the roof of the porch were revealed, and two further holes which once supported the fabric of the porch were apparent at a lower level either side of the door.

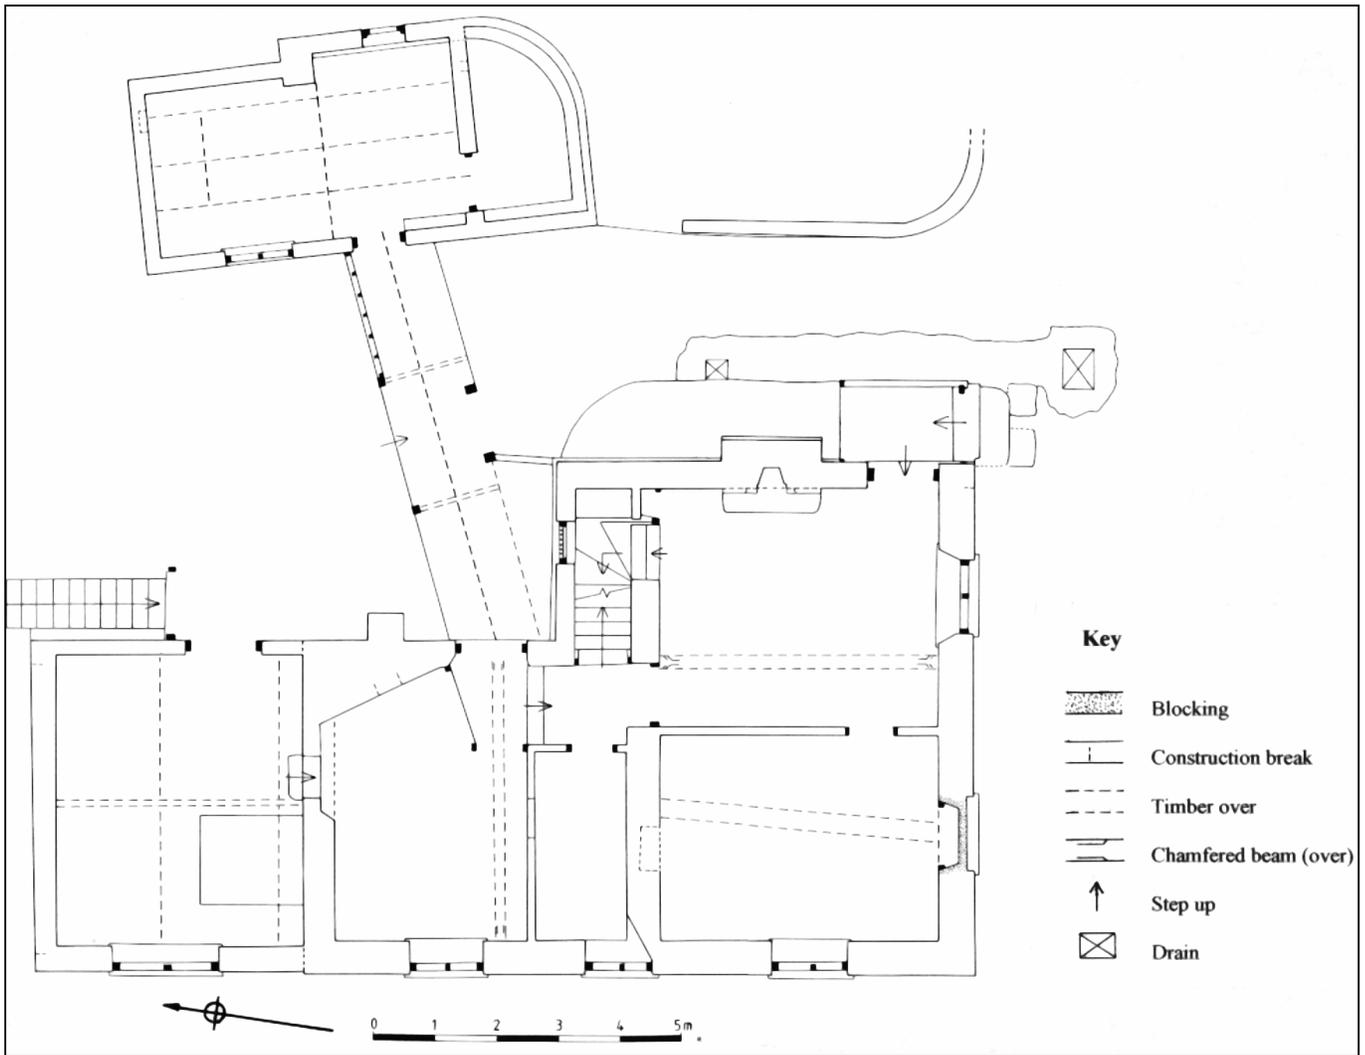
Figure 8: Swan House – Ground Floor Plan

Swan House is L-shaped and of two storeys with a basement. There is a later lean-to attached to the northern elevation and an outhouse containing the bathroom, which is joined to the main house by a covered passageway. There are two rooms plus a kitchen and pantry on the ground floor, and four bedrooms. There is visible evidence both internally and externally for the re-modelling which was carried out to the house.

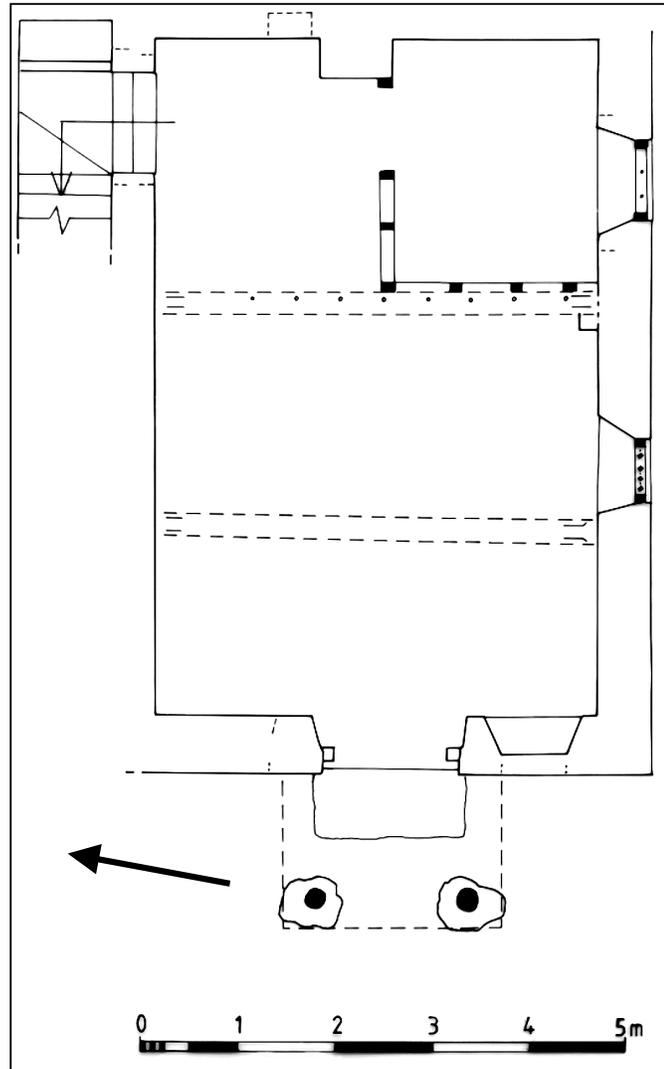
Figure 9: Plan of the Basement

There are several windows within the basement, some of which are blocked. These include two blocked windows at either side of the door in the west wall. The southern window shows signs that the reveals were splayed; the sill of this window is 1.16 metres from the basement floor. The northern one, which is completely blocked, is visible from a scar in the stonework from the internal face. There is no indication of its northern edge, which means that this entire corner has probably been re-built.

Two smaller windows on the southern wall light the basement. These also have splayed edges and wooden frames. The west window had four diamond-shaped mullions, three are still intact, one is missing. In-between the mullions are thin vertical metal bars. The eastern window has construction breaks on either side of its internal face but these are not apparent on the external face. This window

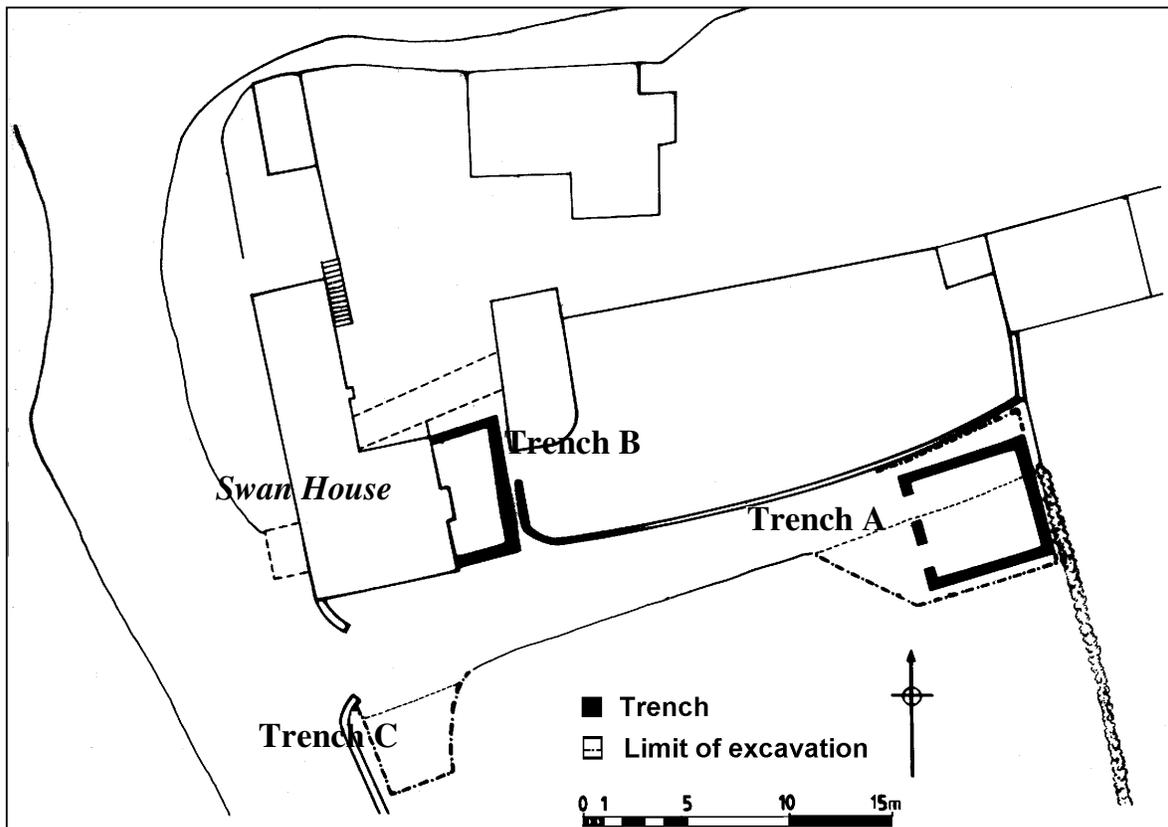
Figure 10: Trench Plan

There were three areas of excavation. The first two trenches (A and B) were excavated ahead of building construction while the third area (trench C) was excavated for use as a storage area for building materials.

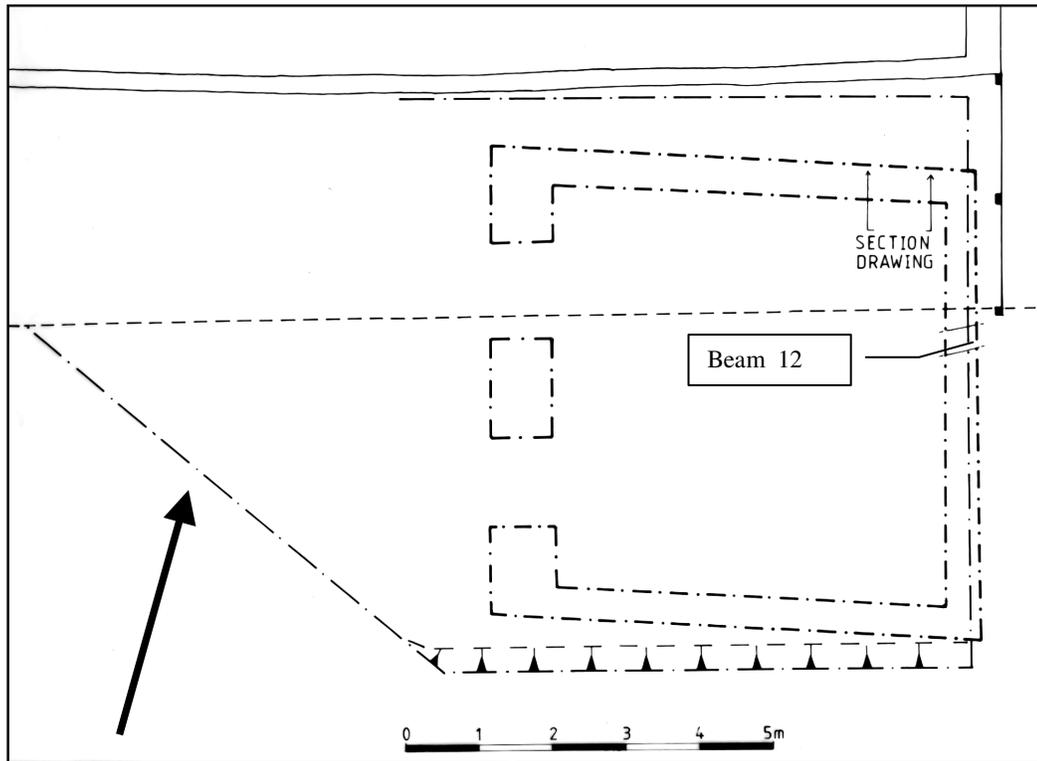
Figure 11: Plan of Trench A

This trench was situated within the garden area to the east of the house and was excavated for the insertion of footings for a new garage. As the garden was uneven, the first phase of this operation was the levelling of the area by machine in order to achieve a level surface from which the footing trenches could subsequently be dug. Initially the topsoil was stripped from an area measuring 8m north-south by 7.20m east-west using a JCB.

From the south-western extent of this area the ground sloped off to meet the edge of an existing driveway or path and from there it levelled out to meet its surface. This was observed before any topsoil was removed at the northern edge of the trench. The path extended outside the trench in both directions. After this initial phase the original southern boundary of the path was seen.

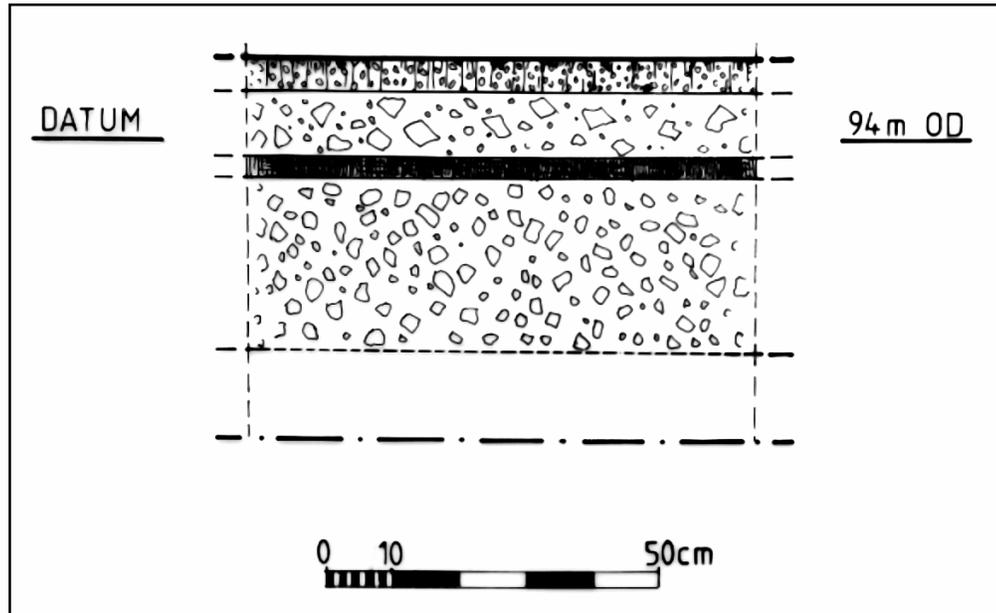
Figure 12: Trench A - section

Beneath this a burnt layer 9, (0.03m thick) was seen and directly below this was 10, a 0.26m thick layer of hard-core consisting of stone scalplings.

Natural red-brown clay (11) was seen immediately beneath this at 0.49m down from the top of the driveway.

The second phase of work for this area was the digging by machine of the footing trenches themselves. This consisted of a squared area within the lowered portion described above. The trenches were 0.45m wide and were taken down to a maximum depth of 1.04m from the present ground level at the southern side of the trench. The whole area was also stripped by machine during this second phase and on the north-east side of the excavated area the depth changed to a maximum depth of 0.52m (93.61 OD at the north eastern corner).

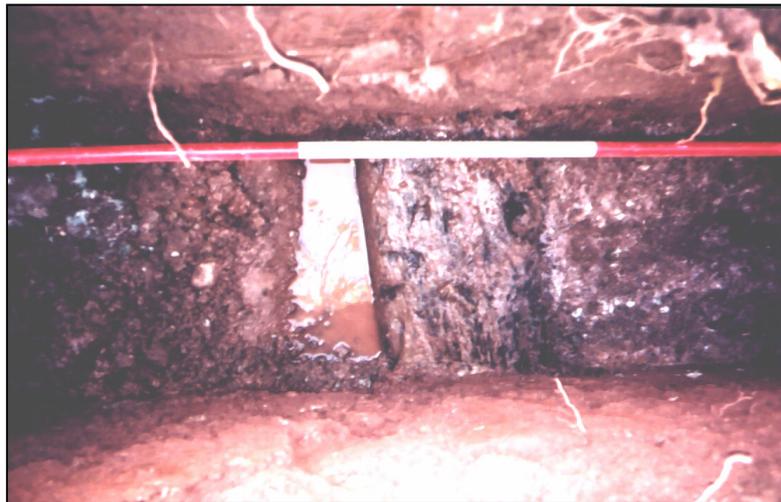
Plate 3: Beam 12 found in Trench A

In the eastern trench, running north-south, a worked section of timber (12, see Plate 3) was encountered. This lay directly at the limit of the depth of the excavation. The length was not determined but the width was 0.28m by 0.18m. The sides of this timber had been squared off. There was a nail on top of the

The only feature that may relate to an earlier phase of occupation of the site was found in trench A during the excavation of the footings for the new garage. The timber beam that was observed in-situ could possibly be the sill beam of an earlier timber-framed building. It was not possible to identify any cut in the section of the trench for the insertion of this beam, and no dating evidence was found. An iron nail was retrieved from the beam, and this has been retained for further analysis.

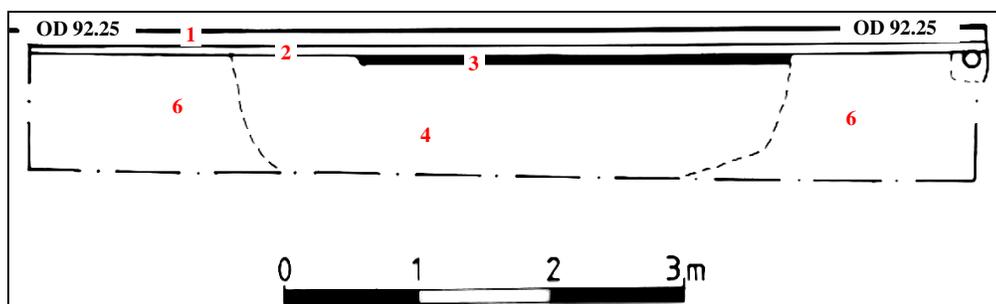
Figure 13: Trench B - section

Directly beneath concrete layer 1 a trench 7.15m in length by 0.50m wide, running in a north-south direction was dug by machine to a depth of 1.05m (91.02 OD) at its northern end and 1.18m (91.07 OD) at its southern end.

Below a layer of hard-core (2), which was 0.13m thick, was a thin burnt layer (3) 0.04m thick. Directly beneath this lay natural heavy red-brown clay (6). This had been cut by pit 5, measuring 4.20m in length and centrally positioned within the east section of the trench. The burnt layer lay directly on top of this pit although it did not cover its entire length.

The pit was not seen in the west section and the bottom was not determined as it carried on past the limit of excavation of this trench. The fill of the pit (4) was a silty, mid-brown soil with frequent charcoal flecks, stone, animal bone, and fragments of pottery and mortar/plaster fragments. A selection of these finds was retained.
