Pugh's Yard, Weobley, Herefordshire:
archaeological monitoring and building recording

P J Pikes, Huw Sherlock and Robert Williams
2003

Archenfield Archaeology carried out a programme of archaeological building recording and monitoring at the site known as Pugh's Barn, Weobley, Herefordshire, between March and October 2002. The buildings were analysed, and it was concluded that they were originally constructed as two separate barns, dating from the 17th Century. The main building was constructed for use as a threshing barn and the secondary building was used for cattle with storage space above. No major archaeological features or deposits were observed during the monitoring of ground disturbance associated with the construction work.

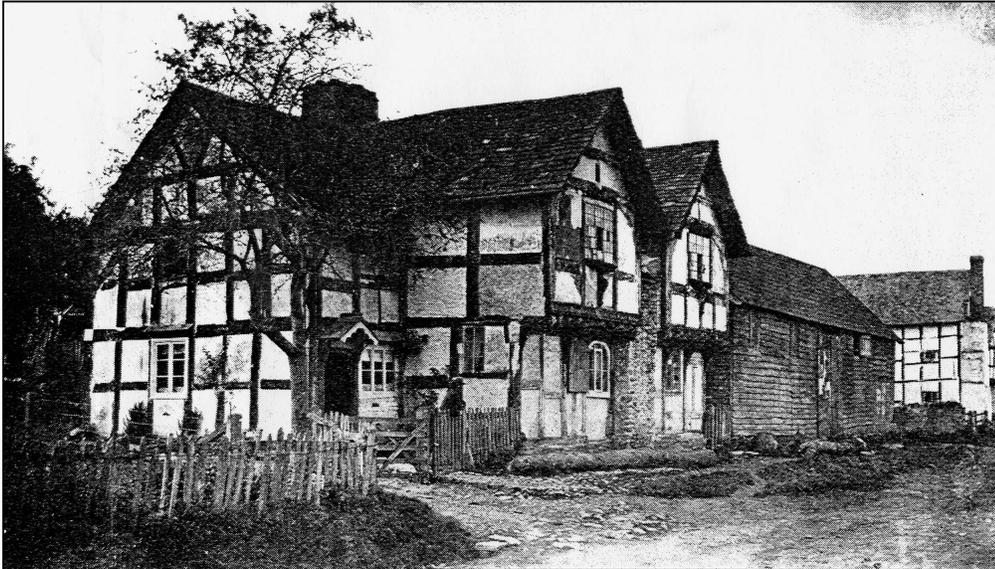
Plate 1: The Old Vicarage and the barns looking north-west. Reproduced from a photograph taken by Alfred Watkins in 1875.

A photograph in the Transactions of the Woolhope Naturalist's Field Club shows both barns covered in weather boarding in 1875 (see Plate 1).

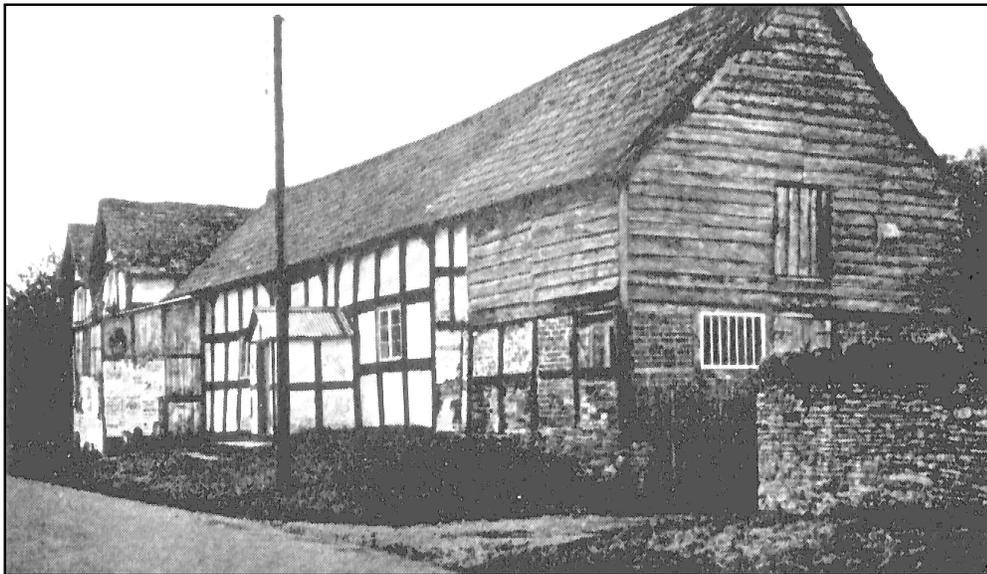
In the 1930s the barn was used as Recreation Rooms.

Plate 2: The barn in the 1930s looking south west (from RCHME)

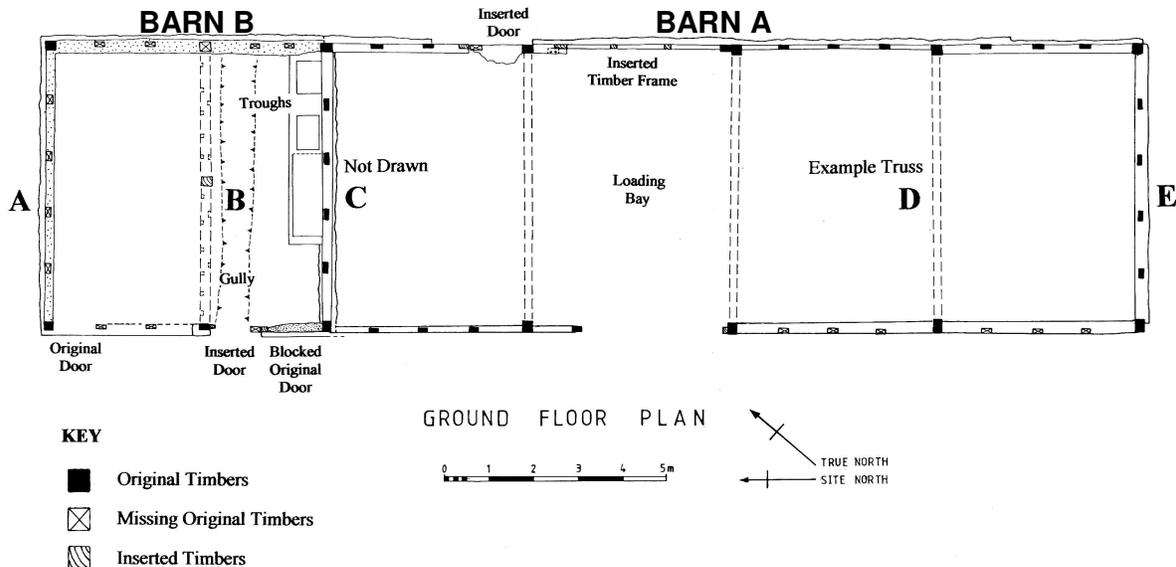
Figure 6: The ground floor plan of the barns.

This grade II listed timber framed building lies in a north-west/south-east orientation and consists of two distinct structures – barns A and B. For ease of description within this report, site north indicates that barn A is directly south in relation to the barn complex and barn B is at the north end. Both site north and true north can be seen on the ground floor plan (see Figure 6).

The threshing or loading bay of barn A is off-set to the north having two storage bays to the south and a single bay to the north. Barn B is of two bays of different widths and was used for cattle with storage space above.

The southern barn A has four bays and seems to be built first and the two bay barn B, was added slightly later. Both buildings are set on a stone rubble plinth and originally both were timber framed down to the wall plate

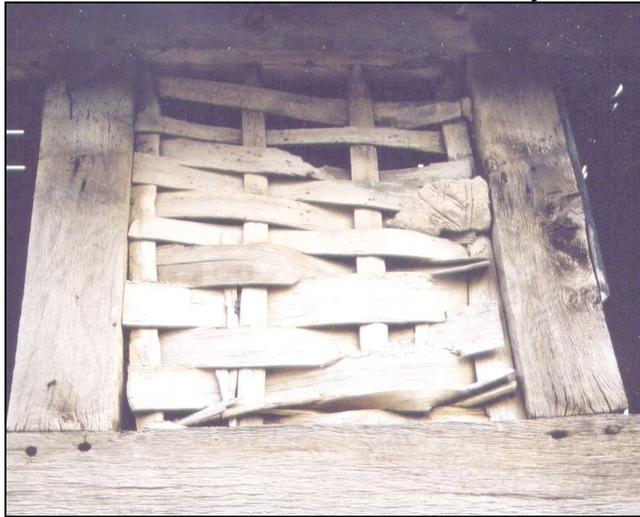
Plate 4: detail showing the cleft oak panel infill surviving in one of the panels.

Towards the southern end of this elevation the lower sections of wall has been replaced with modern breezeblocks but redundant pegs and mortices on the remaining timbers indicate that this was originally boxed-framed to the sill beam. Also at this southern end within the top panels are two inserted windows and an original cleft oak panel still survives *in situ* (see Plate 3).

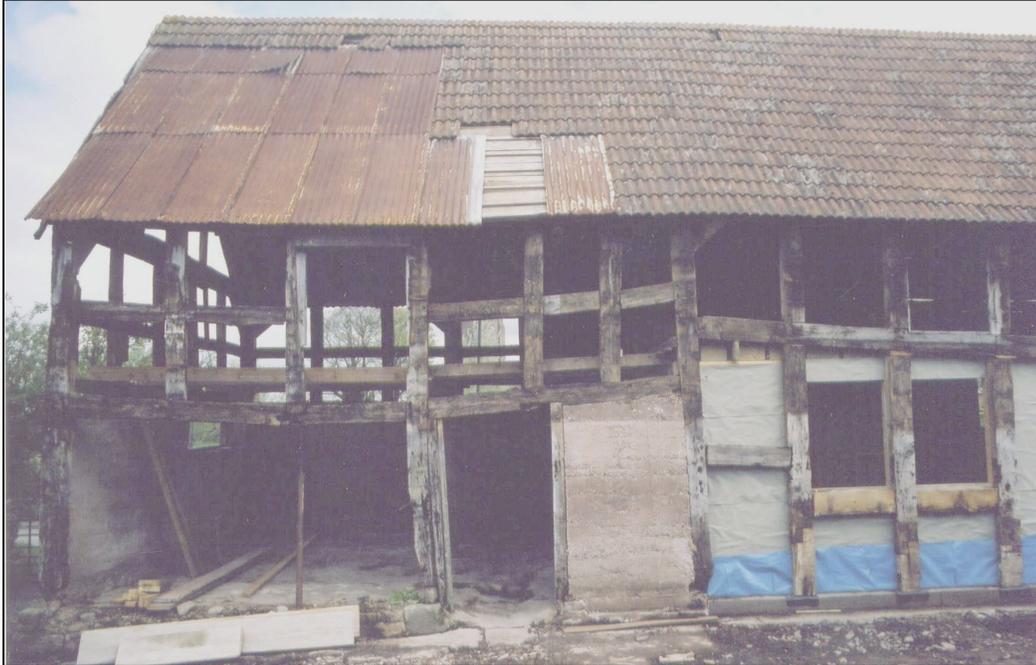
This two bay barn seems to have been attached awkwardly to the north elevation of barn A. The widths of the panels get smaller on both the east and west elevations as they run southwards. The panel widths go from an average size of 1m, to 0.56m at the point where the two buildings meet. The bay widths in this barn are also irregular. The northern bay is 3.30m wide whilst the southern bay is 2.50m wide.

Plate 5: The northern end of the western elevation. The irregular size of the panels can be clearly seen.

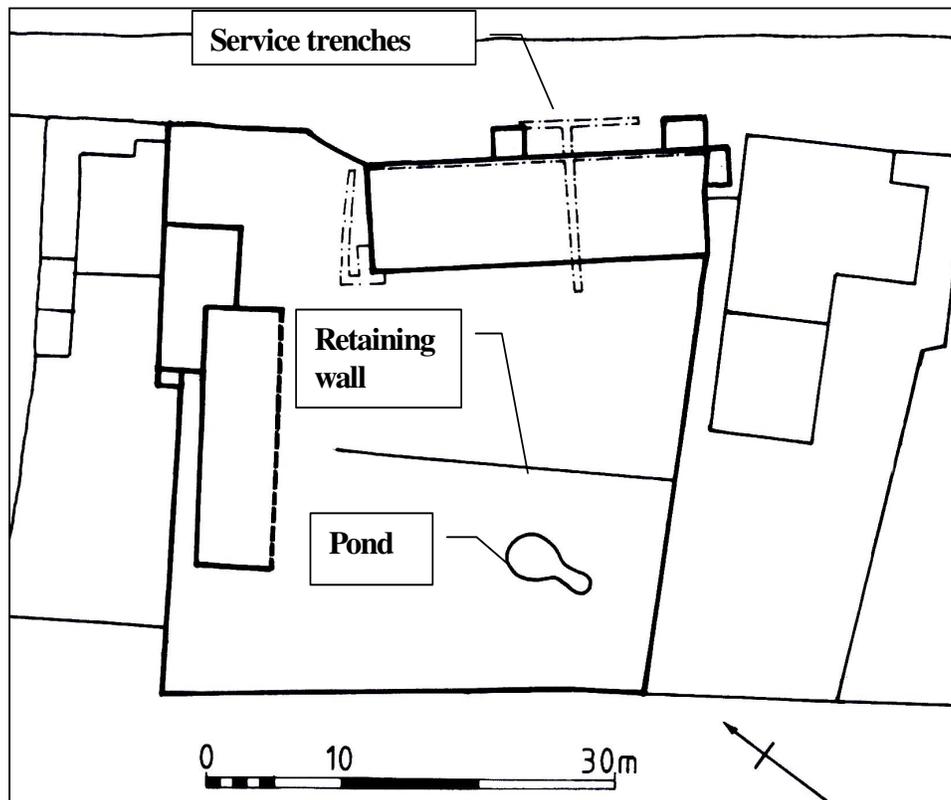
Figure 14: Site plan showing the position of the principal trenches observed during archaeological monitoring

Suitably qualified archaeological staff observed the excavation of trenches for the insertion of services and a pond. The lowering of the ground surface in the yard and inside the building was also monitored. No archaeological features or deposits were recorded, and only one sherd of medieval pottery was found in the area excavated for the pond.

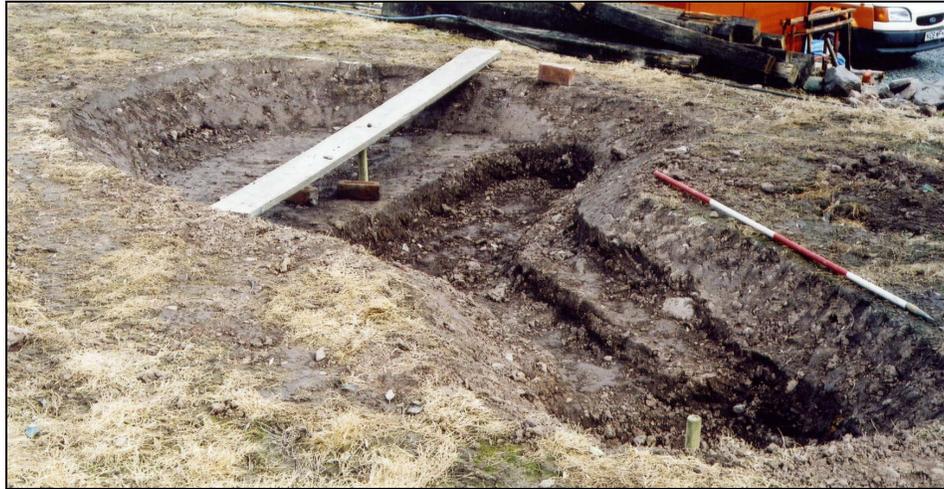
Plate 6: The newly excavated pond looking north east
