Former Davis Brooks soft drinks factory, Catherine Street / Coningsby Street, Hereford:
building survey

Huw Sherlock and P J Pikes
2001

*Former Davis Brooks soft drinks factory, Catherine Street/Coningsby Street, Hereford:
building survey
2001*

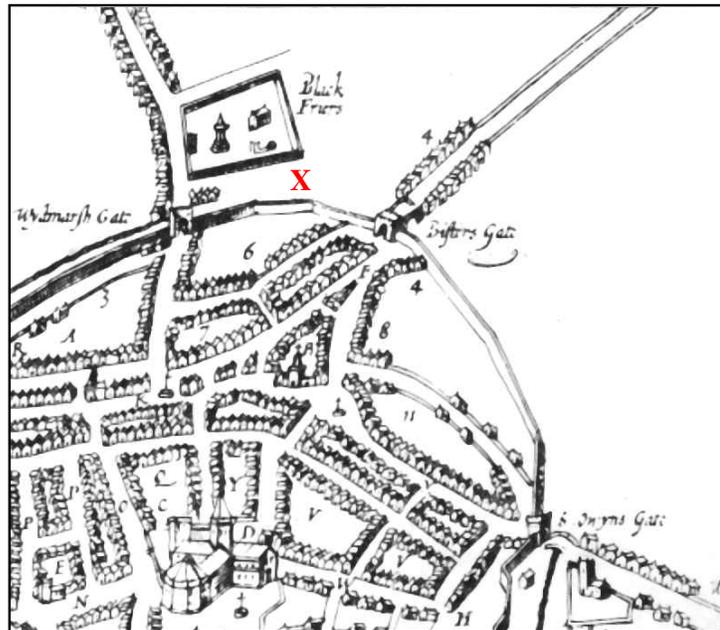
Figure 3: extract from John Speede's inset plan of Hereford 1610. The red X marks the approximate position of the site.

The use of this area as gardens may, in turn, have encouraged gradual housing development and, as D. Lewis indicated in 1998, John Speede’s map (figure 3) seems to show development running east from Widemarsh Street at a point between the gate and the Blackfriars precinct. Apart from a street south of the river, running east from St Martin’s Church, this is the only location where Speede shows extra-mural housing other than ribbon development along the roads approaching the city gates.

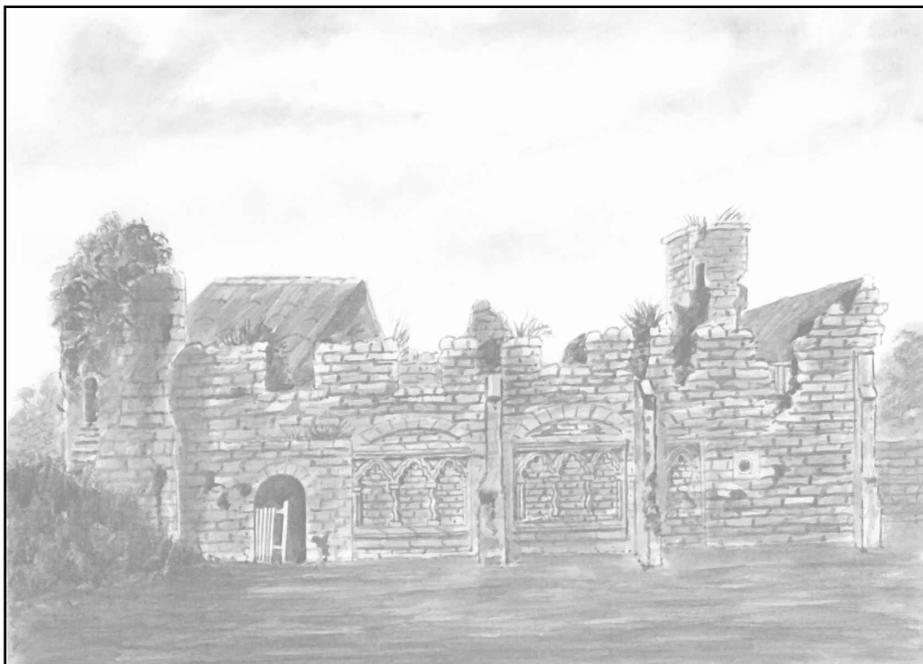
Figure 13: the ruins of the Blackfriars from the east in the 1790s. Again the setting is basically rural.

These are copies of two of a series of drawings by S Fisher in the 1790s. Jonathan Nield of Great Russell Street, London, published them in 1903. They are taken from a copy of the volume – 'HEREFORD CITY, after a collection of old drawings by S Fisher in the British Museum' - in the Walter Pilley Collection in Hereford City Library. We are grateful for the library's permission to use them.

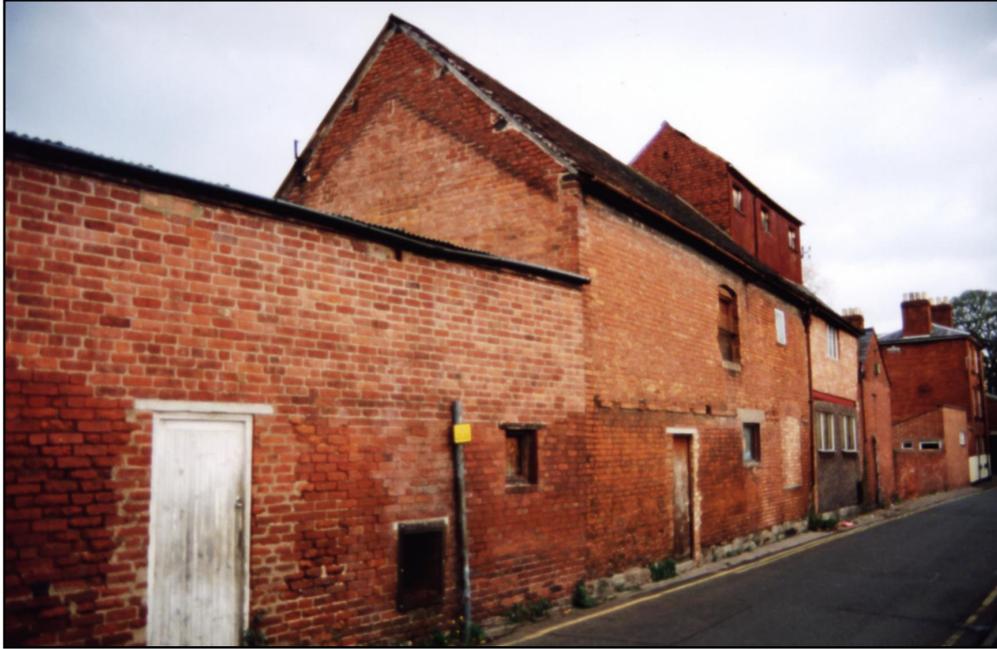
Plate 1: buildings 1 and 2 from the south-west. The sole remaining wall of building 2 is to the left of the picture.

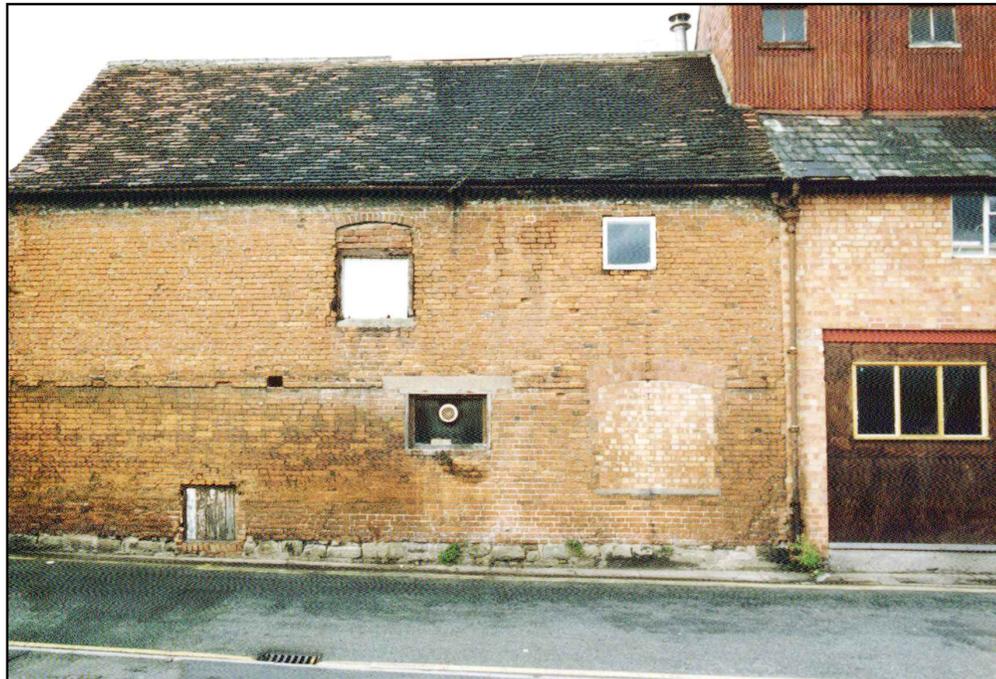
Plate 2: building 1 from the south

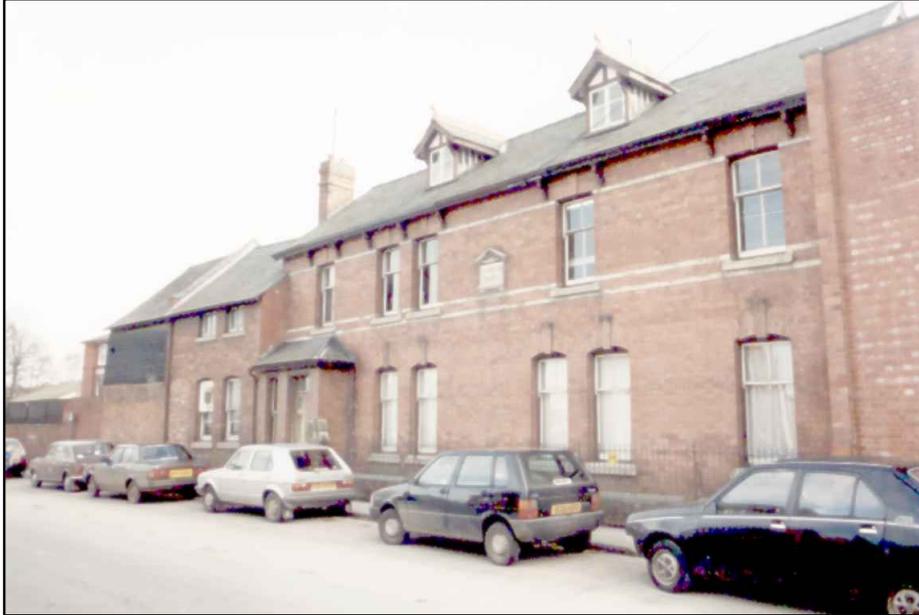
Coningsby House, designed in 1888¹, is situated at the north end of the complex, the north façade set back slightly from Coningsby Street. It is rectangular in shape with the longer axis being orientated east-west. It is of two storeys with attic and cellar and the fabric of the building is largely local red brick in Flemish bond.

Plate 3: Coningsby House from the north-west (1989)

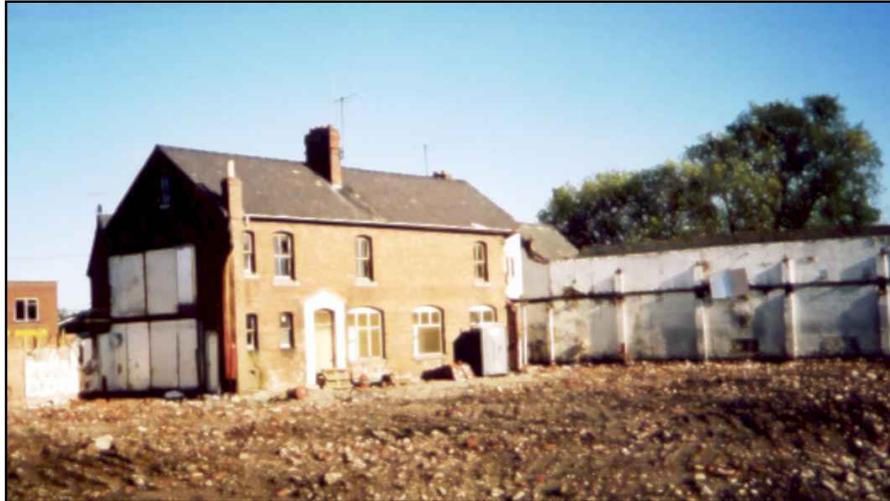
Plate 4: Coningsby House from the south-west (December 2001)

Designed in 1888 in Hereford as a domicile for Messrs Davies & Co. Coningsby House first appears on the 1886 OS map (figure 10) on land used by the family soft drinks business. It appears to have been constructed between two previously existing factory buildings used by Messrs Davies & Co. but was integrated into the factory in a way that would seem strange to later industrialists. From the ground floor, direct access to the east range of the factory was gained by means of a doorway on the south-east corner of the house situated beneath the stairs. This doorway also served as access to the cellar. There are two doorways on the first floor leading into the factory. Both of these are situated at the eastern end of the corridor. One takes you into the factory in a southern direction and the other leads you in at an eastern direction. Latterly much of the building, including the attic rooms, (originally servants quarters) has been converted into office space, although structurally the building has altered little from the original architects plans (figures 32-35). The company relocated in the 1990s and the site and buildings were sold.

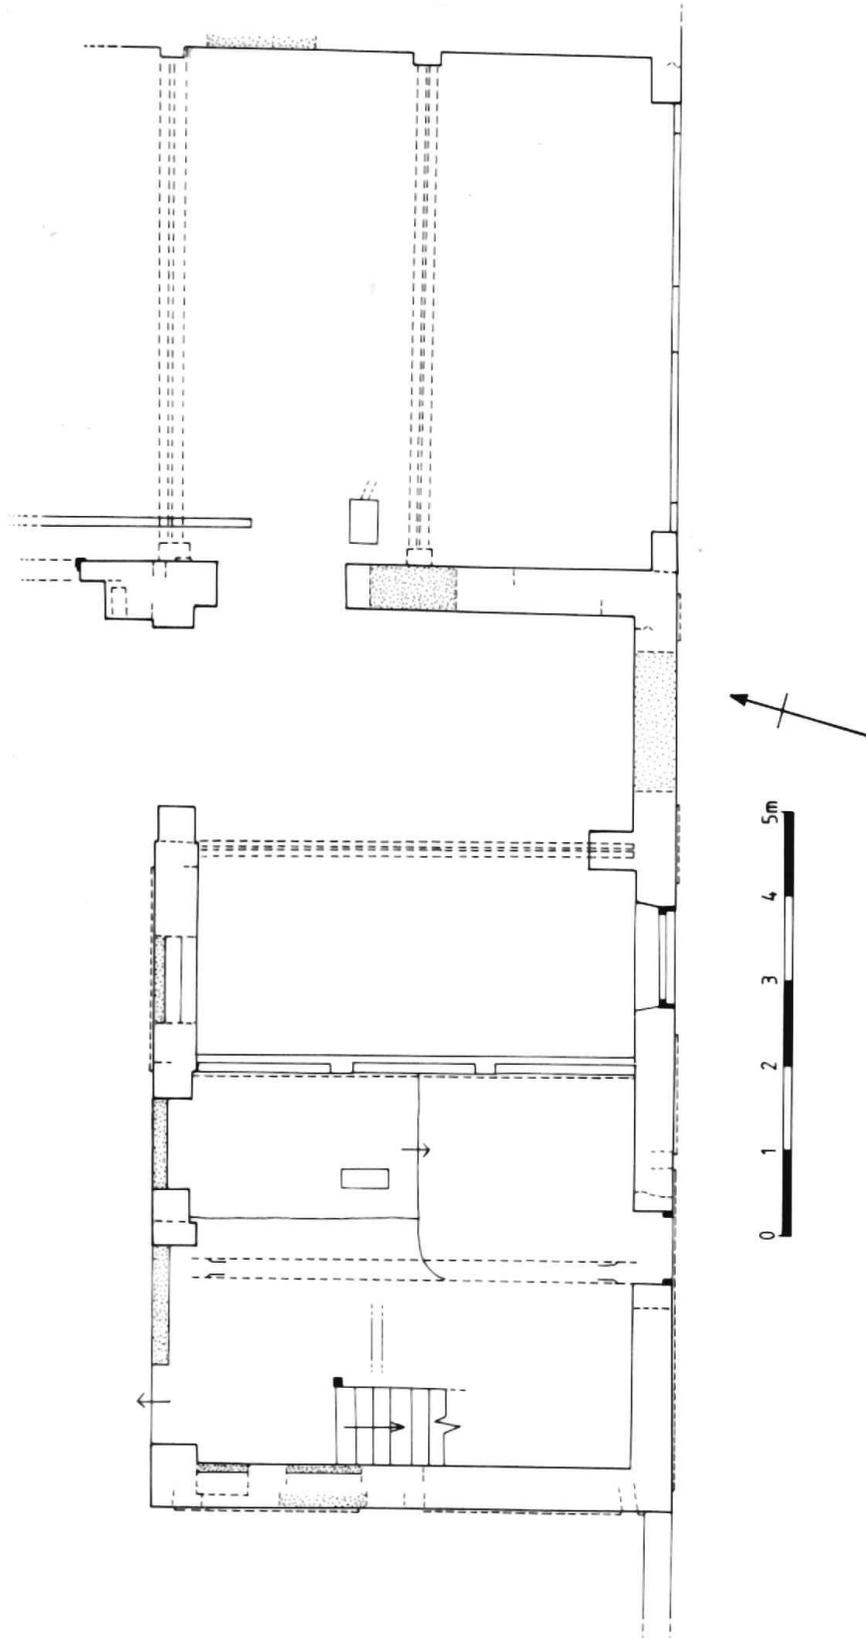
Figure 17: building 1 - ground plan

The building has two storeys. The ground floor is divided into two halves by an inserted brick wall that runs north-south. The internal faces of the walls have at some stage been plastered and where this is evident it is in a very poor state of repair.

The ceilings in both rooms are un-plastered, and the first-storey floor joists and undersides of the floorboards are exposed. The main floor beams supporting the upstairs floor joists in the western room have chamfered edges with run-out stops and have mortises for an earlier floor that has now completely gone. Corresponding repair work on the internal east and west walls where the original floor joists were once recessed can be seen. The main floor beam in the eastern room has been replaced with two modern timbers.

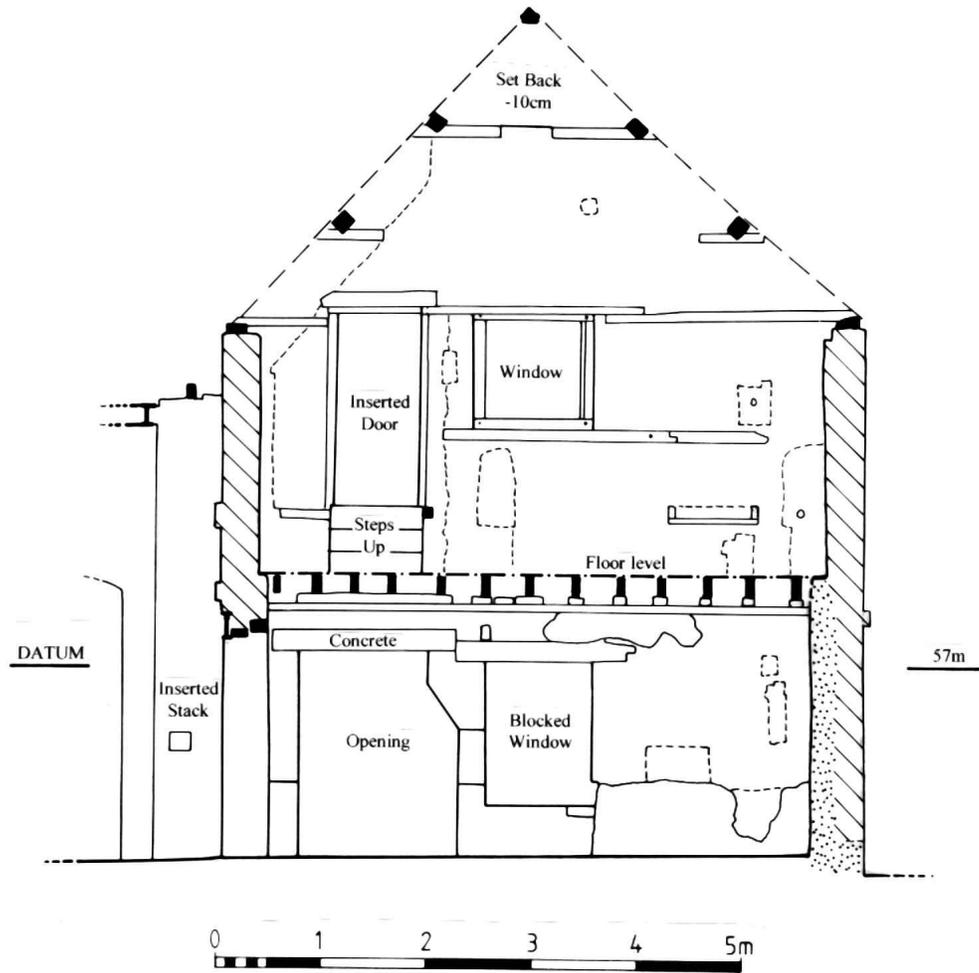
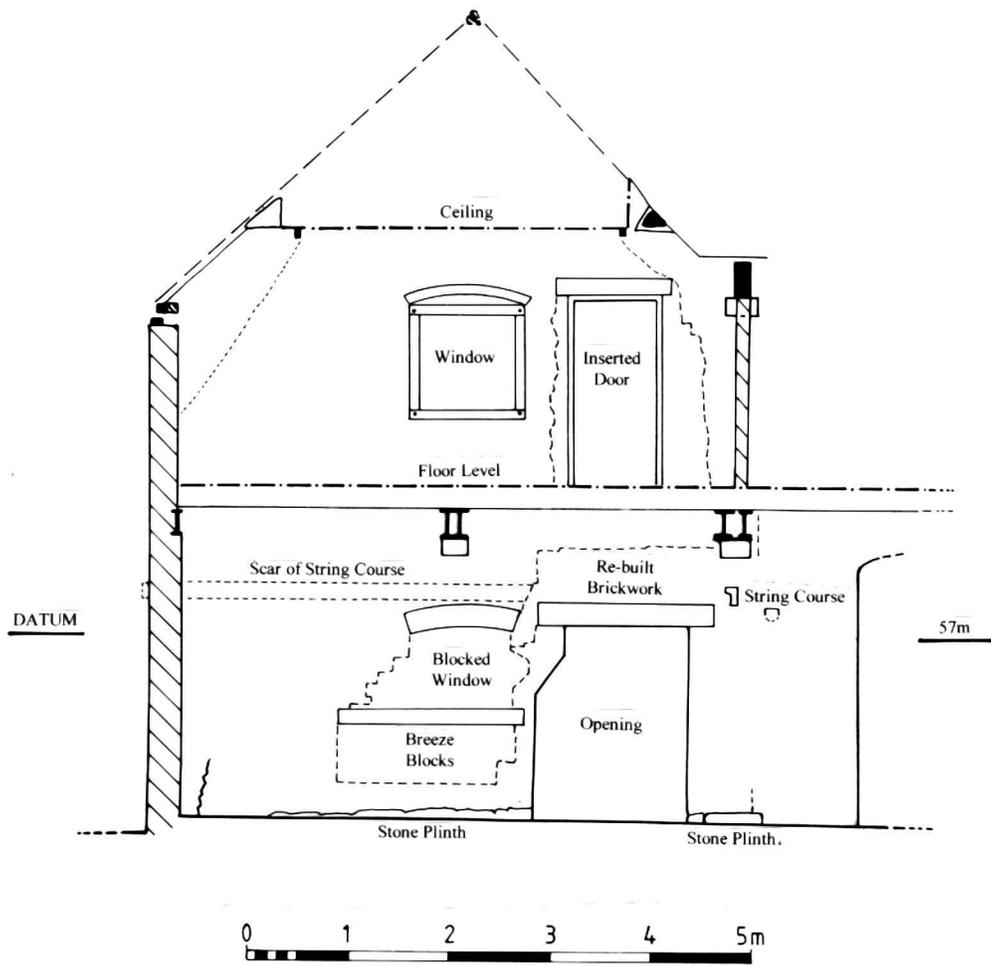
East Elevation (figures 20 and 21)

The shallow stone plinth can be seen running along the bottom of the wall, although a doorway interrupts it. This odd shaped opening provides ground floor access to the adjoining structure running east. A concrete lintel forms the head, and above this the brickwork has been replaced and the string-course is missing within this section of wall. Just south of this opening is a blocked segmental headed window. Just above the window head are the remains of the string-course. To the far north is an inserted external stack, and a construction break in the wall shows the original edge of building 1.

Figure 20: building 1 - east internal elevation

Figure 21: building 1 - east external elevation

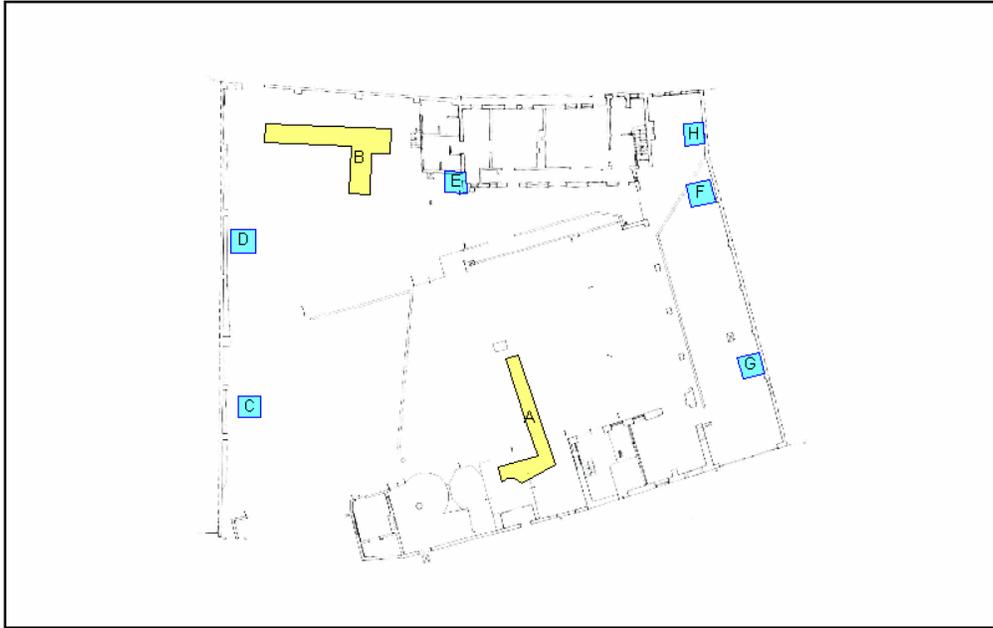
Five trial pits around the periphery of the site were excavated by the contractor, under archaeological supervision, before any demolition work was undertaken. Each of these trenches was approximately 2 metres square (figure 27, trenches C-H).

Figure 27: the 1999 trenches (A and B) and the 2001 trial pits

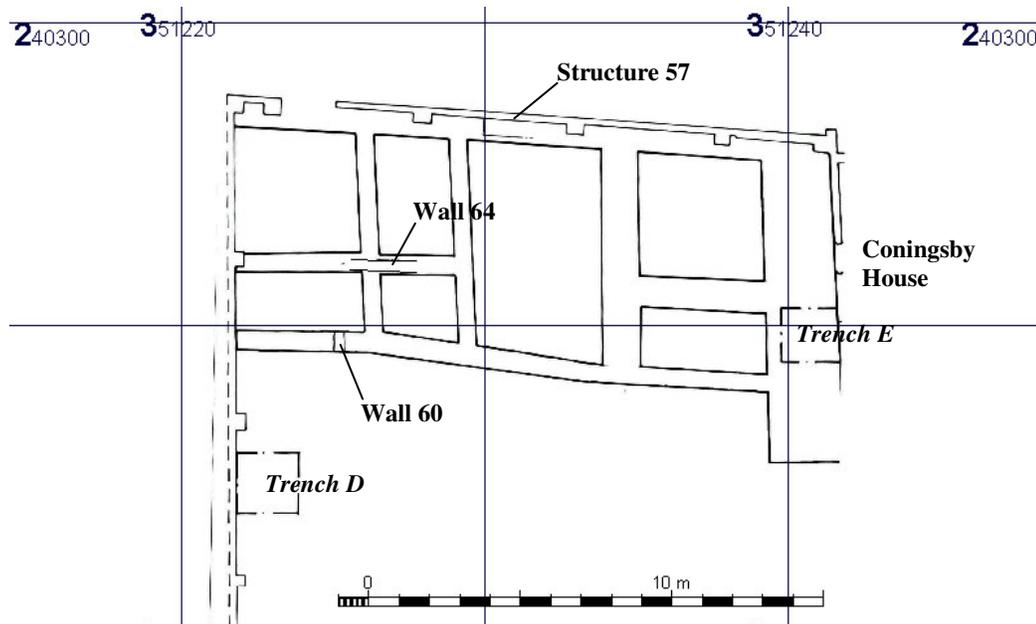
Figure 29: area 1

The northern foundation trench of this range ran along the Coningsby Street frontage, immediately inside the boundary wall. It was 1 metre wide and 1.75 metres deep. The section showed that a layer of gravel and modern brick 0.7 metres thick (context 55) overlay mid brown silty soil. This would seem to correspond with layer 15 found in trench B in the 1999 excavation. Natural gravels were visible at the base of the trench. The upper deposit was very loose and the sides of the trench were collapsing. To the north-west of this was a very loose layer of broken roofing slate and occasional pieces of stone in a matrix of decayed mortar (context 56). A stone-lined cellar-like structure (context 57 - see plate 5) lay 10 metres from the western edge of Coningsby House. This was constructed of roughly coursed rubble stone blocks measuring approximately 0.45 metres by 0.3 metres. The base of the wall was not visible, and it was not possible to see if this structure had a floor. One wall of the structure (context 58) ran north-south across the trench and a return (context 59) was also found running parallel to Coningsby Street. The height of the walls was approximately 1.75 metres with the top at 54.56 metres OD.

The position of this cellar corresponded with the north-east corner of the westernmost of those buildings on the site which faced Coningsby Street in the 1850s (see Curley's plan, Figure 9). 5.5 metres to the south-west of the cellar was a brick wall (64) running east-west. This would have been the rear (south) wall of this building.

One other feature was found in this area. This was another brick wall (context 60), which ran north to south across the southern foundation trench at a distance of 3.9 metres from the eastern boundary wall. This feature represented the rear wall of the building which originally stood on the western side of the site. The boundary seems to have moved to the west in the intervening years.

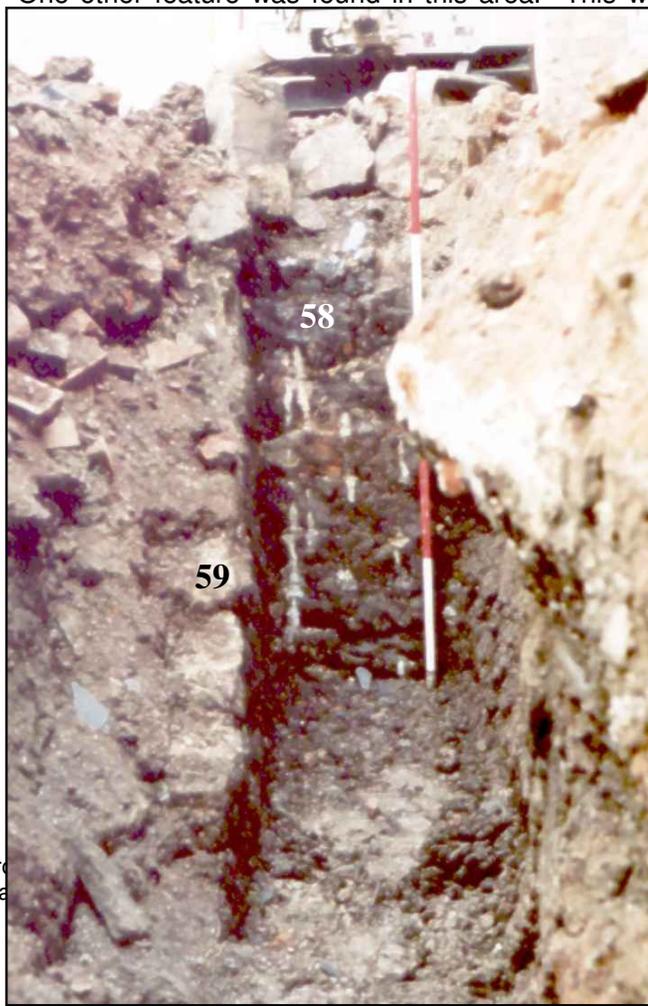
Plate 5: Structure 57 at extreme northern edge of the site.

Viewed from the east, the southern wall (59) of the cellar-like structure is visible on the left.

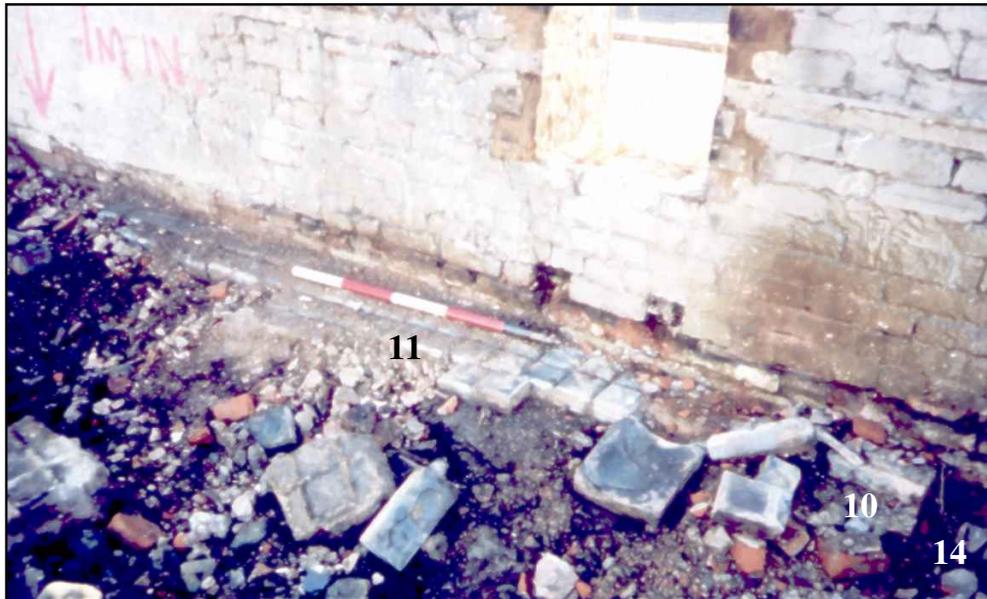
Plate 6: the remains of the stable flooring in the eastern end of building 2

There were stable bricks, of the 2 squared brick type, to the west of the site of the barn (building 1). These corresponded with brick floor 11 found in trench A during the 1999 excavation. These would have formed the floor of the eastern part of building 2 and were divided from the cobbled floor (14) in the western part of building 2 by an internal north-south brick wall, 10.

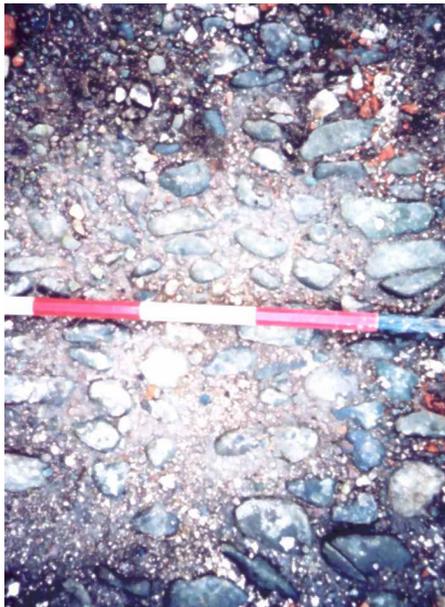
Plate 7: cobbled floor 13 in building 2

To the west of these bricks were intermittent remains of cobbled floor 14, much disturbed by the slab removal. No traces of internal wall 10 or the northern wall 9 of building 2 were observed at this stage. Just to the west of the position of wall 10 was the remains of a drain, which would have run parallel to the wall here.

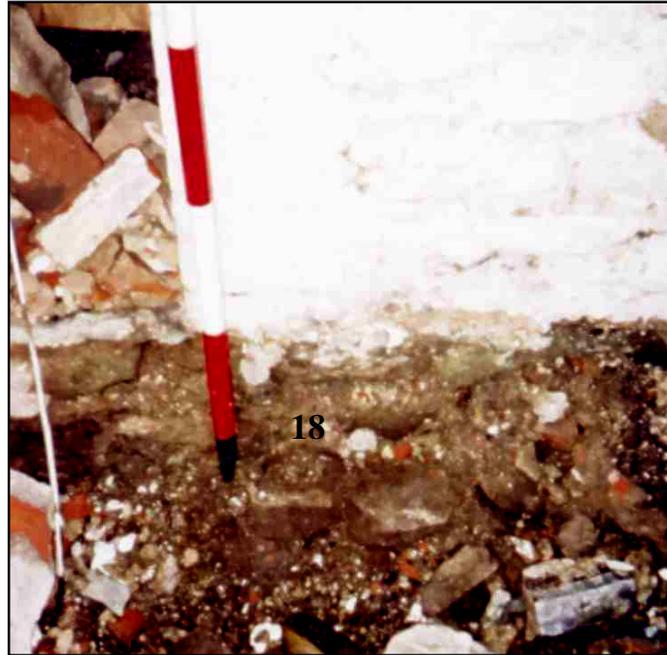
Beneath these bricks were the remains of an earlier floor formed of large cobbles (18). These cobbles were 250mm down from the doorstep, which would suggest that they formed part of an earlier floor of the building. The stonework on the internal faces of the barn continued down beneath the old floor level for at least 380mm from the step at the door.

Plate 8: cobbled floor 18 in building 1

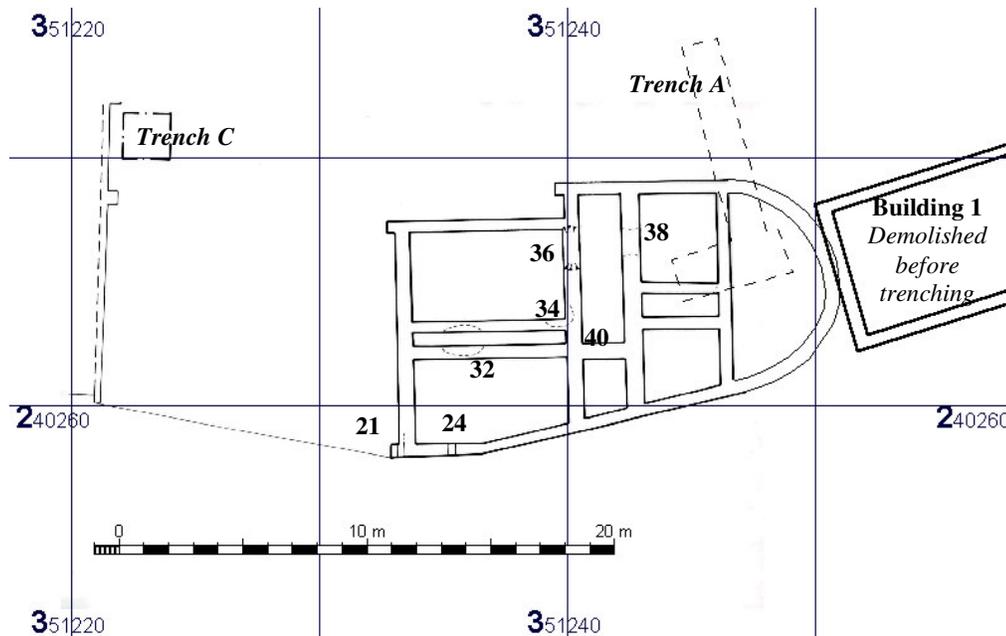
Figure 30: area 2

1.5 metres to the east along the Catherine Street frontage from wall 21, another wall (24) marked the edge of floor 25. This survived as two courses of brick above what appeared to be a stone and brick rubble foundation. This wall was the western wall of building 2.

To the east, this wall was butted by small cobbles 27. These appear to have been part of the floor of the eastern end of building 2 and may be identified with cobbles 14 found in 1999. Beneath these was an orange clay layer (28), about 100mm thick, which was probably bedding for the cobbles. Layer 29 rested on an ashy layer (30) about 50mm thick, which in turn, lay on soil 31. At the western end, there was no visible stratification within 31, which lay above the fluvioglacial gravel natural. Further to the east, layer 31 could be seen to overlie a dark greyish-brown loam which was up to 0.4 metres thick.

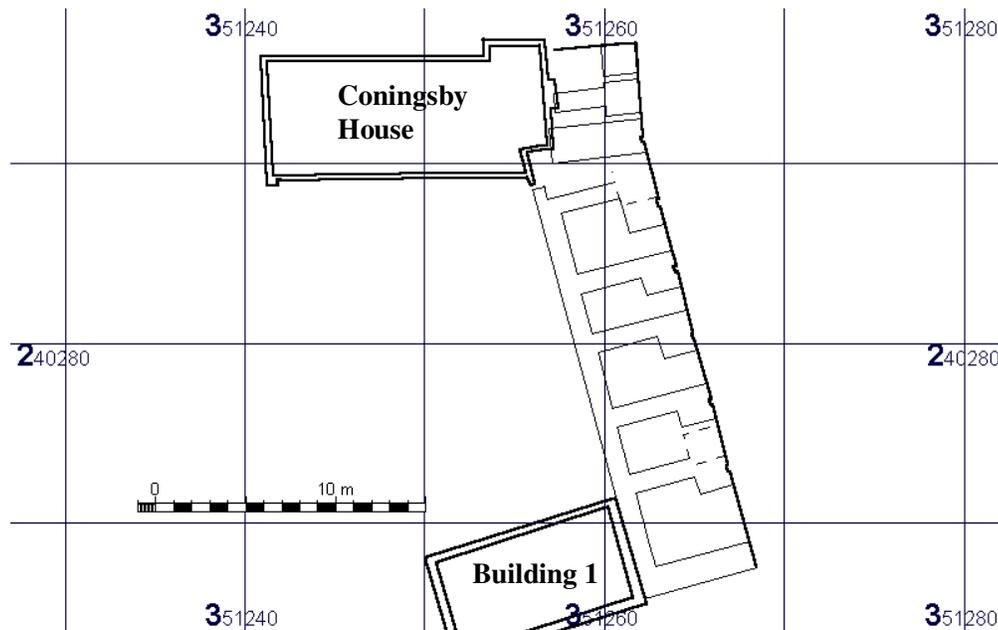
Figure 31: area 3

Area 3 was a series of foundation trenches for the range of buildings planned for the eastern edge of the site. It ran from Coningsby Street in the north to Catherine Street in the south.

At the northern extremity, underlying the brick wall by Coningsby Street, was a wall (20) constructed of very large sandstone blocks. This was presumably the foundation of the northern wall of the building which stood here before the eastern factory range (3) was constructed in the mid-late 19th century. This seems to have been the western part of a building which was on this site in the 1850s and is marked on Curley's plan (Figure 9).

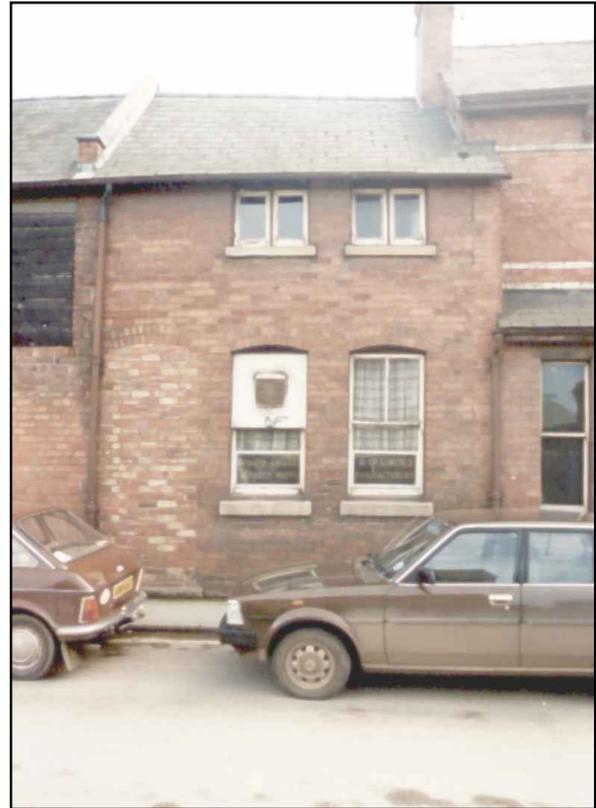
Plate 10: the southern wall (63) of the house which originally stood to the east of Coningsby House

The trenching to the south of wall 63 exposed no identifiable archaeological features. The lack of traces of earlier buildings presumably reflects the absence of structures here until the factory range was built in the later 19th century.
