Bastion Mews, Hereford:
archaeological monitoring of bore hole surveying

*Bastion Mews, Hereford: archaeological monitoring of bore-hole survey
1998*

Client: Mr Z Dutton -Thompson, the site owner

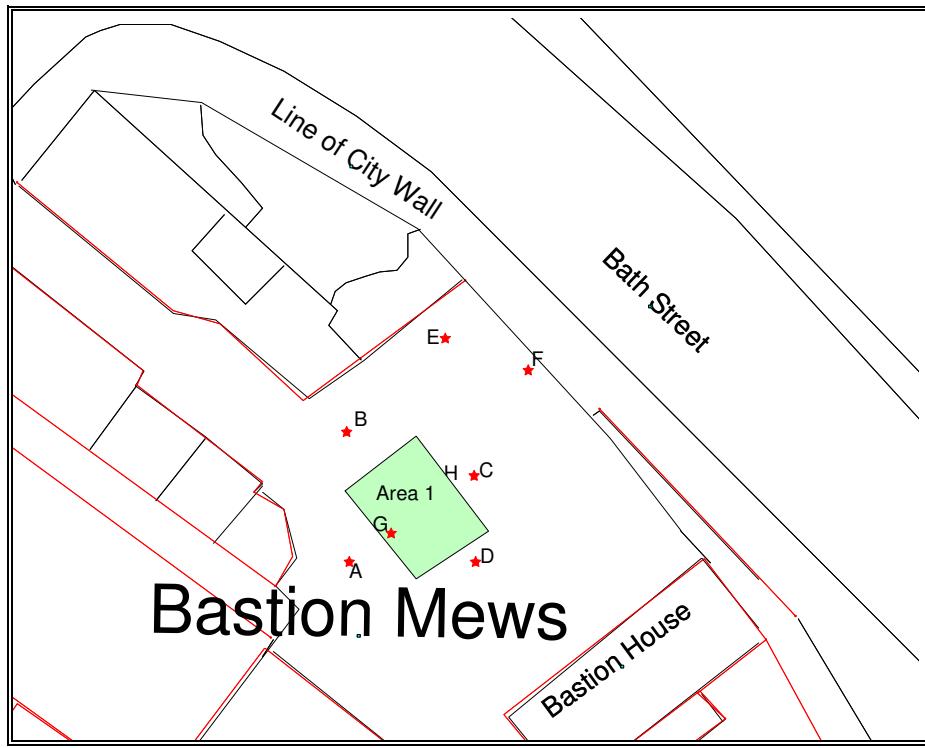
Figure 1: Plan of the site today showing the area in which the fuel tanks and hydraulic lift are located, and the location of the boreholes (A-H). See appendix for extract at 1:500 scale.

Mr Z. Dutton-Thompson (the client), wished to identify the extent of any possible soil contamination that may have arisen from the presence of buried fuel tanks on the site (within 'Area 1' in fig.1). To achieve this a borehole survey was necessary, but given the proximity of the site to a Scheduled Ancient Monument (S.A.M. Hereford 124), and that it lies within the Area of Archaeological Importance (as defined by the Area of Archaeological Importance (Hereford) Order 1984), Mr. Dutton-Thompson commissioned an archaeological watching brief in order to assess the likely survival of substantially undisturbed archaeological remains in the area of potential disturbance (marked as Area 1 and Boreholes 1,2 and 3 in fig.1). The Boreholes were sunk with a percussion cap rig after removal of the concrete yard surface. The cores retrieved from the boreholes were analysed, drawn and sampled. They showed that substantially undisturbed and potentially important archaeological remains survive below the modern yard surface to a maximum depth of 3m in places.

The current proposals involve the conduct of a borehole survey to determine the extent and nature of any soil contamination resulting from leakage of fuel oils held within two underground fuel tanks on the site (within Area 1 on fig.1).

Mr. Dutton Thompson engaged the services of Geotechnical Engineers Ltd (of Rock House, Lower Tuffley Lane, Gloucester) to drill eight boreholes (see fig 1 for location of bores). The concrete yard surface was first removed with a cylinder-cutting device. A Competitor Rig (see illustration on front cover) was then used to remove cores to a depth of three metres by means of a percussion driver. Each core was removed in 1m sections, which tapered progressively. The initial core was of 6" diameter and the final core of approximateley 4" diameter. Each core was removed intact and stored inside a clear plastic sleeve, allowing for visual inspection and recording of the cores. Once the core is removed from the rig and the clear plastic shield split open samples of the core material can be retrieved at any depth required, and stored separately in heavy gauge plastic sample bags. Samples were taken from cores C, D & B and sequentially numbered. The location and depth of samples taken were noted in the site log book and on section drawings. Soil samples retrieved will be retained for further analysis, and the results of this included in the final publication.

Eight boreholes were sunk, and three cores removed (A-H on fig.1) in metre sections from each one. The condition of the cores indicated that beneath the concrete yard surface (**Context 2**) (an average 40cm thick) the ground has remained substantially undisturbed. Clear stratigraphic horizons were observed in all the cores retrieved and these were drawn at a scale of 1:10 and a full description made in the site logbook. A full description of the soil matrices is included in the appendix.
