Blocks 6 and 11, The Moor, Sheffield

Archaeological Excavation

Oxford Archaeology North

September 2009

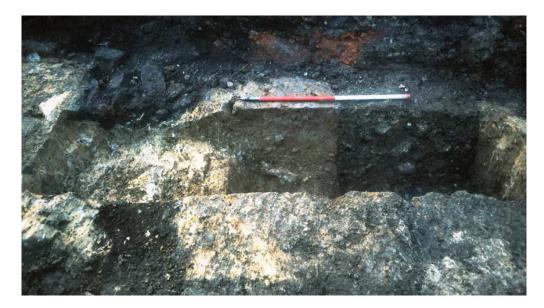
Plate 6: The truncated remains of ditch 543 (left) following sectioning

- 4.2.2 Ditch *543* was the more westerly of the two and a *c* 15m length of this feature was exposed. This ditch was found to be aligned north/south, running along the approximate line of the former route, known as Porter Street, and had been filled with a deposit of clay (*544*) (Figs 3 and 6; Plate 6). However, due to later truncation by an eighteenth- or nineteenth-century drain only the western edge of this ditch survived, and it was not, therefore, possible to determine its complete profile or extent.

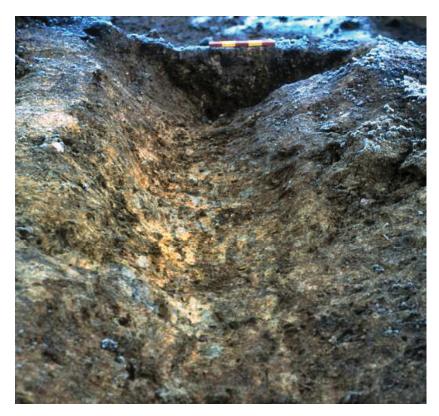
Plate 7: Ditch 483 following excavation

4.2.3 Ditch 483 was located c 8m to the east of ditch 543, and a 3m length survived between the basements of a late eighteenth-/early nineteenth-century public house and the basement of a late twentieth-century building (Figs 3 and 6; Plate 7). However, in a similar manner to ditch 543, the upper portions of this feature had been destroyed, and only its base survived. This basal section measured c 0.8m wide, was c 0.2m deep, with a broad V-shaped profile, and contained a deposit of silty-clay (484).

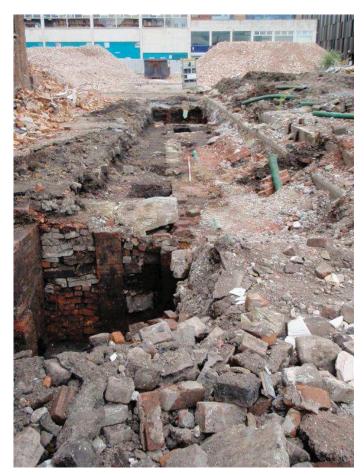
Plate 9: General view of the remains in Trench 3, Block 6, following excavation, viewed from the south-west

4.3.1 Industrial premises fronting Well Lane: potentially, the earliest structural remains uncovered during the excavations were located in Block 6, particularly as one area of this site, examined by Trench 3 (Fig 4), is known from the cartographic sources to have been developed by 1797. The remains of a building were uncovered that would seem to have originally fronted Well Lane, which correlated with a building plotted on the large-scale First Edition 1850-1 OS map (*ibid*). This building comprised four linear ranges, enclosing a central courtyard, which could be accessed via a covered passage leading from Well Lane (Plate 8). The layout suggests that this building functioned as an industrial premises and it is possible, based on the excavated remains, that it was one of the early buildings plotted on Fairbank's 1797 survey of this area of Sheffield. The below-ground remains comprised principally the building's exterior walls fronting Well Lane, along with an internal partition wall and the remains of a passageway, allowing access into the interior courtyard of the premises. In addition, a small subterranean room was also discovered, which originally lay beneath Well Lane (Fig 4; Plate 9).

4.3.2 The passageway leading into the interior courtyard of the building was located at the northern end of Trench 3. It measured 2m wide and beneath its surface ran a drain (6017). This drain was constructed of stone slabs and was found at a depth of 2m below the present ground surface. Either side of the passageway, the remains of the exterior walls of the building were discovered, which were constructed partially of brick and partially of stone. The exterior walls (6000 and 6001) exposed to the north of the passageway were constructed of handmade bricks, laid in a stretcher bond, two bricks wide, and bonded with lime mortar. To the south of the passageway, the portion of the building was also partially defined by brick walling (6003 and 6004). This

again was two bricks in width, constructed of handmade bricks, bonded with a lime mortar, and laid in a stretcher bond. A stone wall (6006) was also discovered forming a continuation of the exterior wall fronting Well Lane, and butted the southern end of the exterior brick wall (6003). It was 0.3m wide and was constructed of stone blocks, with an average size of 0.3m x 0.3m x 0.8m. Within the interior of this portion of the industrial building one internal partition wall (6005) was identified constructed of stone blocks with an average size of 0.35m x 0.28m x 0.8m, and along with the exterior brick walls, defined a 3.2m wide ground floor room located at the northern end of Trench 3. A deposit of ash and clinker (6021) was also discovered within the room, which in turn sealed two made ground deposits (6022 and 6024). Unlike the majority of the excavated site, there was no evidence for a basement within this part of the building.

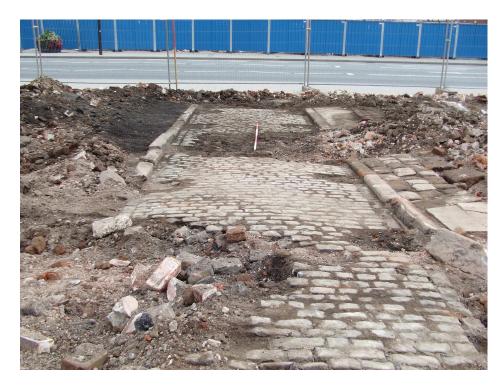
Plate 11: Earl Lane following excavation, viewed from the west

- 4.4.5 *Earl Lane:* in the northern half of Block 11 the remains of Earl Lane were uncovered (Fig 2; Plate 11) comprising cobbled paving (*108*) and cobbled road surface (*105*), beneath which ran a drain capped with sandstone slabs. It is possible that these remains date to Period 3, particularly as the historic map sequence (*Section 3.2*) indicates that this lane had been established during this phase.

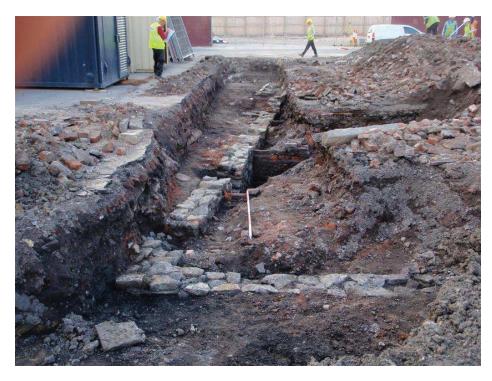
Plate 12: Remains of the Jessop Street dwellings exposed in Trench 1, Block 6, following excavation, viewed from the west

- 4.5.3 The excavation indicated that the interior of the four terraced dwellings contained four basement rooms (Rooms 6039, 6041, 6040 and 6049), located at the front of the properties. Each basement room was c 3m wide and, within the limits of Trench 1, these rooms were defined by the exterior stone wall (6032) of the dwellings, and three separate lengths of brick walling (6033, 6034 and 6037). These walls were only a single-skin thick and were constructed of handmade bricks, measuring 0.23m x 0.11m x 0.07m, joined with a lime mortar and laid in a stretcher bond. Each of the basements had also

been provisioned with a cellar light, positioned towards the western side of each of the rooms, facing onto Jessop Street. The lights were defined by a c 0.8m wide gap discovered on the exterior wall of the terraces (6032). The demolition rubble contained within the interior of one the basement rooms (6041) was completely removed in order to establish the depth and character of the basement. This revealed a flagstone floor (6045), located over 2m below the modern tarmac surface.

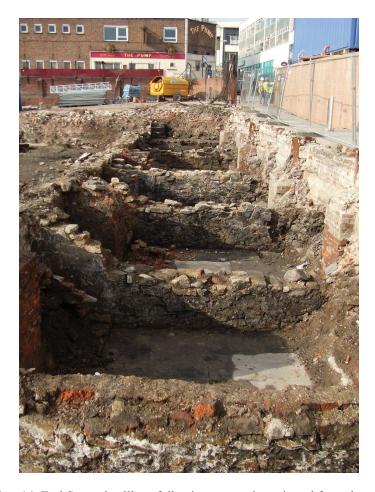
Plate 14: Earl Street dwellings following excavation, viewed from the east

- 4.5.6 *Earl Street dwellings*: the large-scale First Edition OS 1850-1 map indicates that the properties fronting Earl Street comprised a range of small, single-depth, dwellings, and the partial remains of eight of these were uncovered by the excavation (Fig 2; Plate 14). These remains comprised the rear portions of the basement rooms (Rooms *121*, *161*, *122*, *132*, *139*, *175* and *191*) of these dwellings. Significantly, the excavated remains also indicated that these dwellings had been built during two separate phases of construction.

- 4.5.7 One phase of construction entailed the establishment of six terraced dwellings, which were visible in the eastern half of the excavation trench as six adjoining basement rooms (122, 132, 139, 175 and 191). These rooms were all of a similar size and layout, and were also all constructed of similar materials. Therefore, each room was c 3.2m wide, and all shared the same rear wall (192/176/142/135/124), which was aligned parallel with Earl Street. This wall was c 0.6m wide, and was constructed of medium-sized sandstone blocks, laid irregularly, and bonded with mid-grey-brown mortar. At its western end, this wall also turned through 90 degrees to form the end wall (123) of this block of terraces. Similarly, the walls used to separate each individual basement (193, 177, 143, 136 and 125) were also c 0.6m wide and were constructed of medium-sized sandstone blocks, bonded with mid-grey-brown mortar. The interiors of each of these six basement rooms contained sandstone flagged floors which, when removed, were found to overlay a series of thin bedding layers composed of mortar (148) and deposits of silty-sand (146, 149 and 150). Each of the basement rooms was also accessed from the ground floor of the dwellings, via a brick staircase positioned in the south-eastern corner of the basement, which supported a series of sandstone steps (194, 179, 141, 134 and 120). Within one room (175), the bases of two small rectangular brick structures (180 and 181) were also encountered, butting its eastern wall, though the function of these structure could not be discerned from the surviving remains.

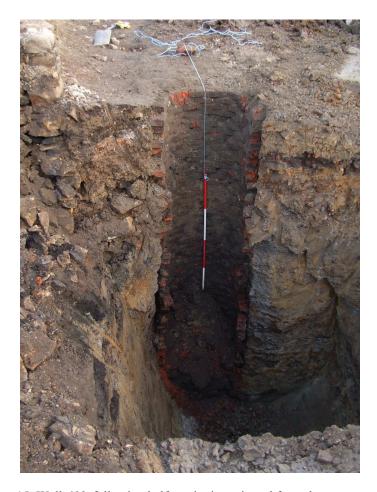
Plate 15: Well 603, following half-sectioning, viewed from the east

- 4.5.9 To the rear of the properties fronting Earl Street a c 0.5m wide stone wall (152) was discovered, and this originally enclosed and divided a yard area associated with both the Earl Street and Earl Lane properties. Within the yard area associated with the Earl Street properties, a short section of right-angled brick walling was discovered, which corresponds with the position of a structure depicted on the large-scale First Edition 1850-1 OS map, together with a brick-lined well (613). This had a c 1m diameter and extended for a depth of at least 4m below the original surface of the yard (Plate 15).

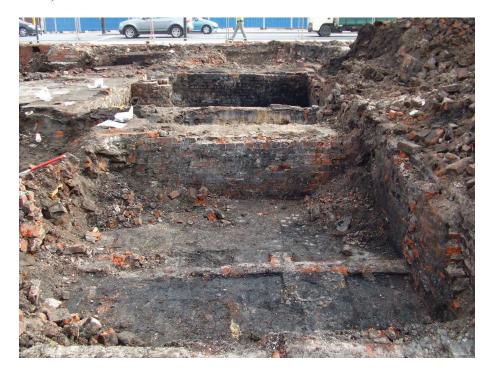
Plate 16: The basement rooms of the Earl Lane dwellings found to the west of the passageway, viewed from the west

- 4.5.11 Those rooms positioned to the west of the passageway (246-8) were all of comparable size, measuring 2m wide by 4m deep, and comprised handmade brick exterior and interior partition walls (250, 263, 264 and 266), which were all two bricks in width (Plate 16). The interiors of the rooms were paved with sandstone-flagged floors (265 and 267), whilst the position of a fireplace, or the foundations for a chimney which also served a fireplace in a room above, also survived in one of the basement rooms (246). This feature was defined by two small protruding brick piers spaced 0.8m apart.

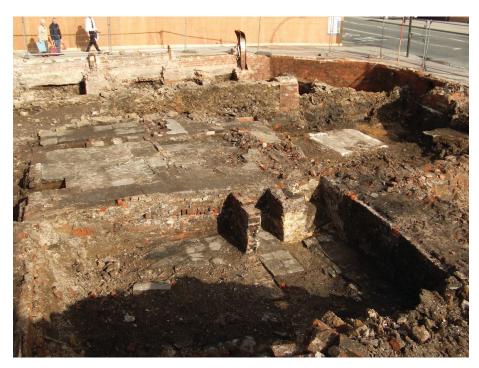
Plate 17: The basement rooms of the Earl Lane dwellings found to the east of the passageway (foreground), and the associated outshut (background), viewed from the south-west

- 4.5.12 The remains of the three basement rooms (244, 245 and 602) sited to the east of the passageway were similarly composed of handmade brick exterior and interior partition walls, and they had all been provisioned with sandstone-

flagged floors (Fig 2). The internal size of these rooms did, however, vary. Although all were c 4.8m deep, two of the rooms (244 and 245) measured 1.9m wide, whilst the remaining room (602) was only 1.4m wide. One of the rooms also contained the remains of a handmade brick staircase, supporting stone steps, which was positioned at the north-eastern corner of the room (Plate 17).

4.5.14 The remains of an outshut, linked to the properties fronting Earl Lane, was also discovered immediately to the east of the passageway (Fig 2; Plate 17). It abutted the rear walls of these properties and it was defined by one and two brick wide, handmade brick walls (164, 211, 213, 216 and 218). The outshut had a sandstone-flagged floor and contained two separate rooms (214 and 219), measuring c 4.4m by 2.4m and c 3.6m by 2.4m respectively. Access into its interior was through a 0.6m wide doorway positioned on its north-western side, whilst the outshut also had an internal c 1m wide doorway allowing access between its two rooms. A small ceramic drain cover was also observed in the south-eastern corner of the outshut. Following removal of the outshut flooring a number of subterranean structures were also exposed. These included a brick-lined drain (251), capped with sandstone, which led from the drain cover within the outshut and linked with a system of drainage features discovered immediately to the west. These latter features included two linear drains (268 and 269). Apart from the drainage system a small square structure (271) was also located beneath the flagged floor of the outshut (Plate 18). This measured c 1.2m sq and was constructed of handmade brick walls. Although

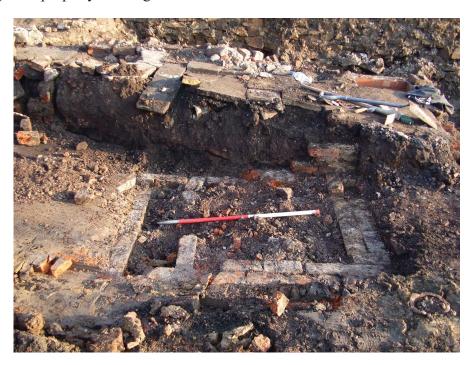
Plate 18: The structure discovered beneath the outshut floor, viewed from the south-west

4.5.13 To the east of the basement rooms (244, 245 and 602), positioned to the east of the covered passageway, the fragmentary remains of a further property, fronting Earl Lane, were also exposed (Fig 2). This property incorporated a basement room (242), which was defined by handmade brick walls (252-4), though due to later truncation it was not possible to determine the size, form or character of this room. Immediately to the rear of this property, a sunken handmade brick rectangular structure (243), measuring 2.1m by 1.6m, was also discovered. Although it was not possible to determine the function of this structure, it enclosed an area of flagged flooring, and presumably formed a small subdivision located within a possible outshut found to the rear of the adjacent property fronting Earl Lane.

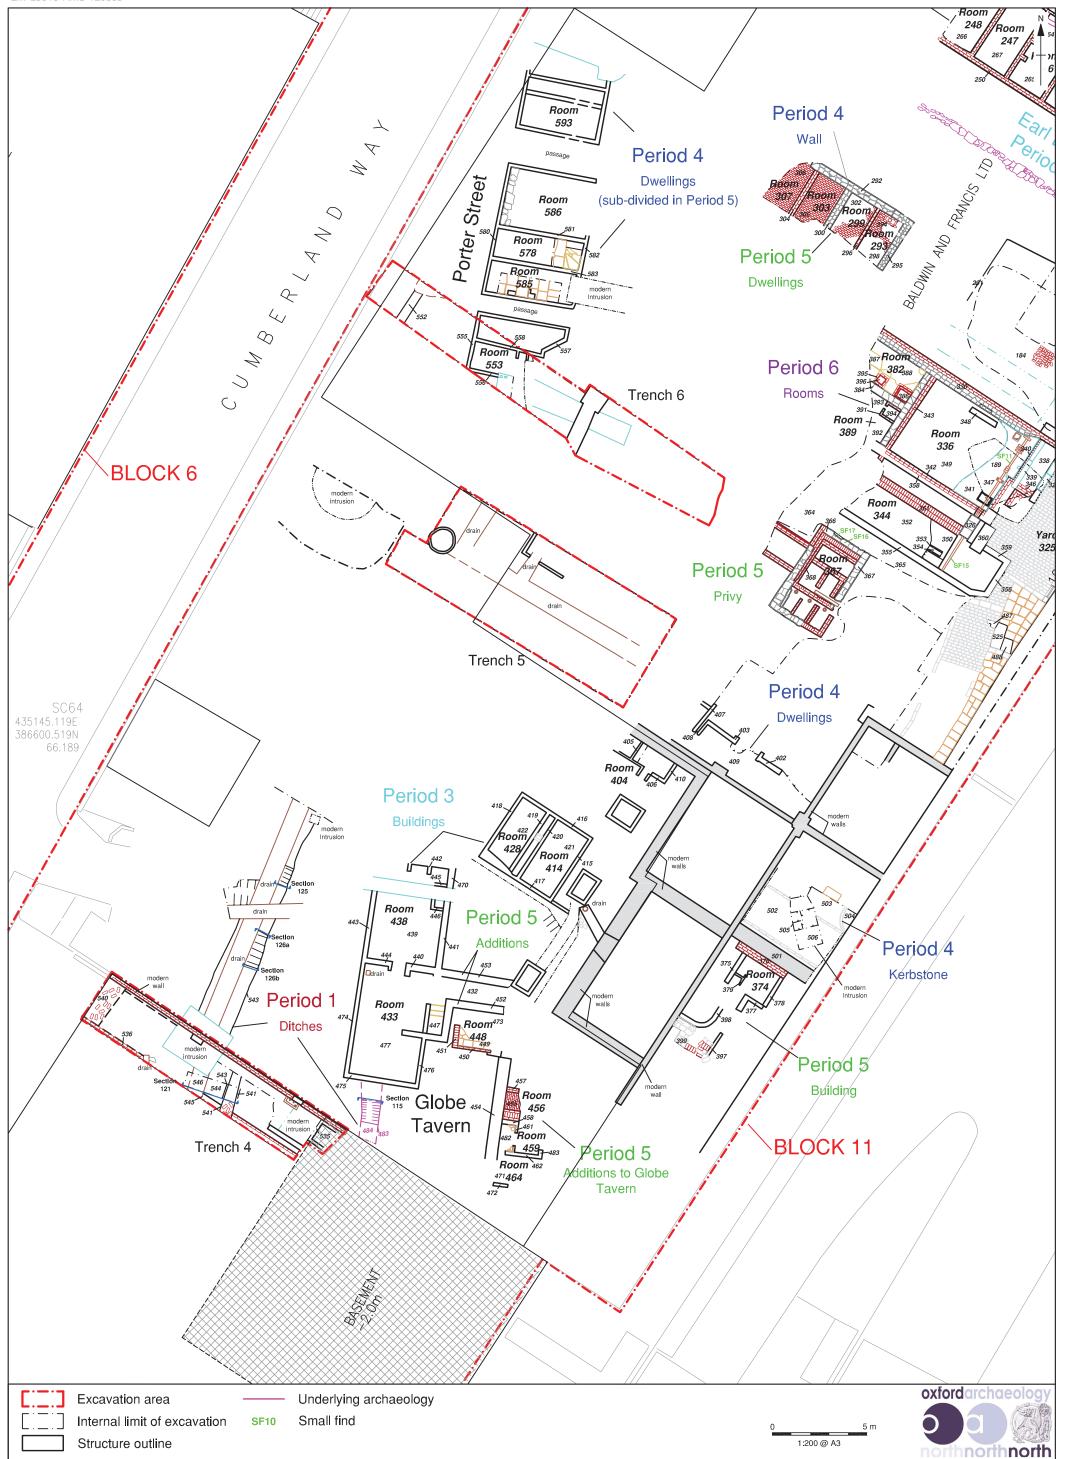
Figure 3: Plan of southern end of Block 11

- 4.4.4 **Room** 414/428: to the north of the Globe Tavern a further basement was exposed (Fig 3), which probably formed part of a small property constructed during Period 3, fronting Jessop Lane. This basement measured, in plan, c 4m by 3.8m, and was defined by four brick walls (415-8) composed of handmade bricks, measuring 0.12m x 0.24m x 0.07m, which were bonded with a midbrown/grey mortar. The interior of the cellar contained a sandstone-flagged floor (429) and also two parallel handmade brick walls (419 and 420), spaced c 0.4m apart. These walls appear to have been inserted in order to subdivide the cellar into two smaller rooms (414 and 428), which measured 1.4m and 1.8m wide respectively, and that were also separated by a narrow cavity.

- 4.5.18 **Dwellings fronting Jessop Lane:** the fragmentary remains of two probable Period 4 dwellings were discovered, which originally fronted Jessop Lane (Fig 3). These remains included short sections of handmade brick walling (402-3, 405-7 and 410), bonded with mid-brownish-grey mortar, forming elements of the ground floor rooms of these properties. Where examined, these walls were found to extend for a depth of c 0.4m, which indicates that these dwellings were not provisioned with basements.

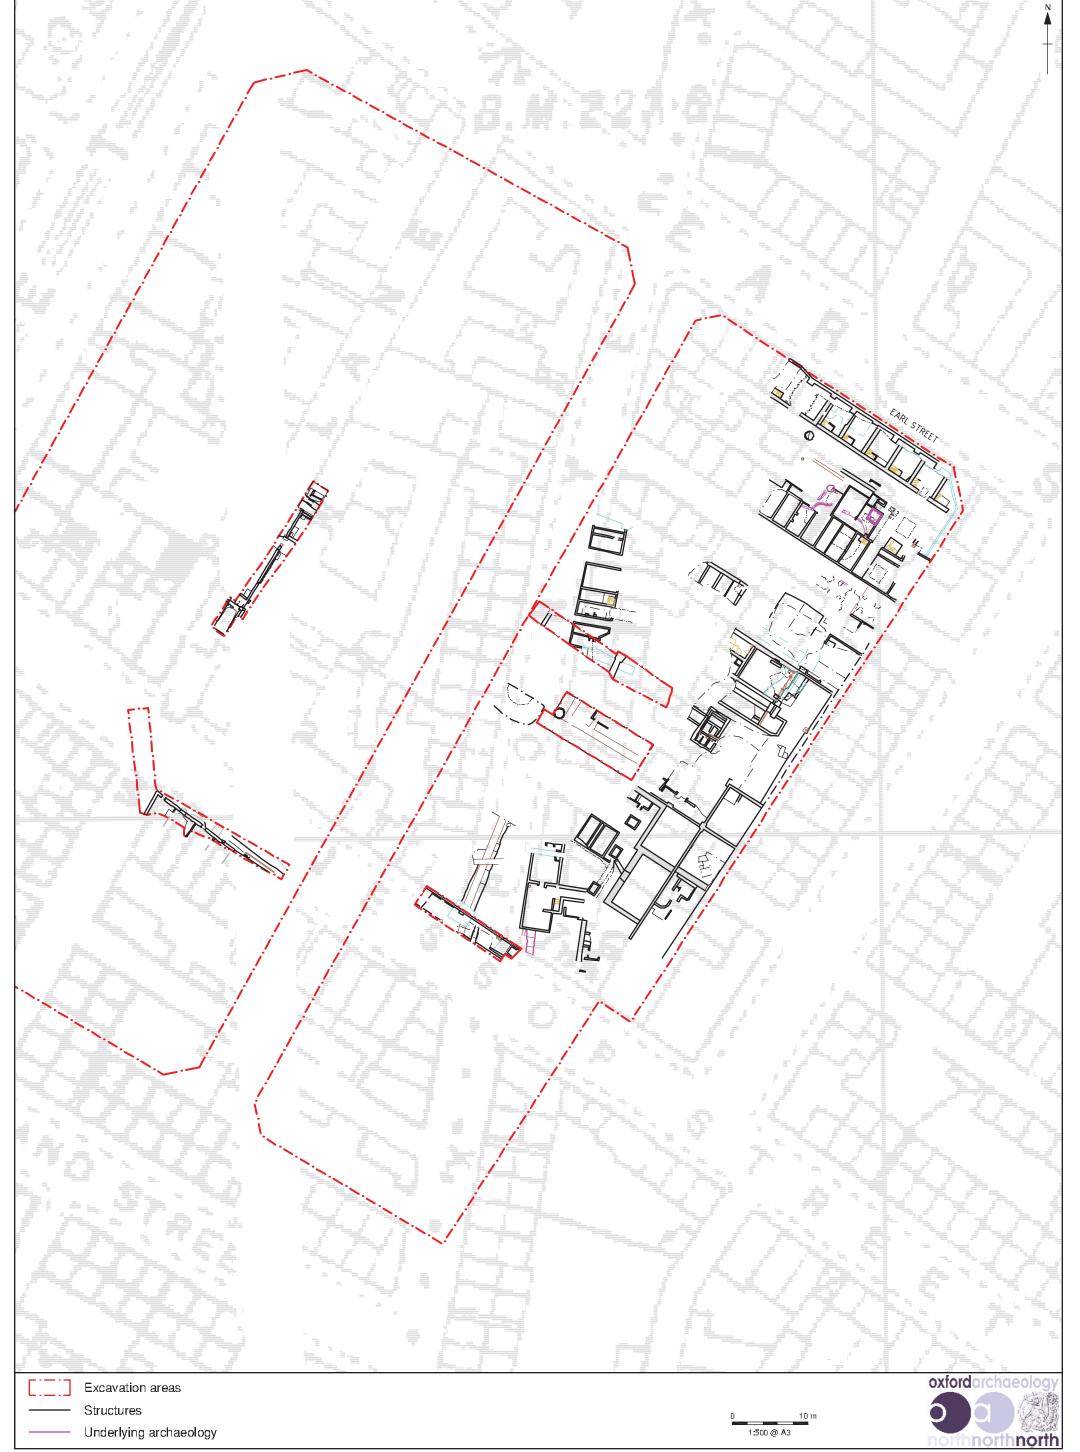
Figure 5: Archaeology superimposed on the 1894 Ordnance Survey 1:2500 map
