# **ST MARY'S CHURCH, PENWORTHAM, LANCASHIRE**

## **Archaeological Watching Brief and Excavation**

**Oxford Archaeology North**

June 2011

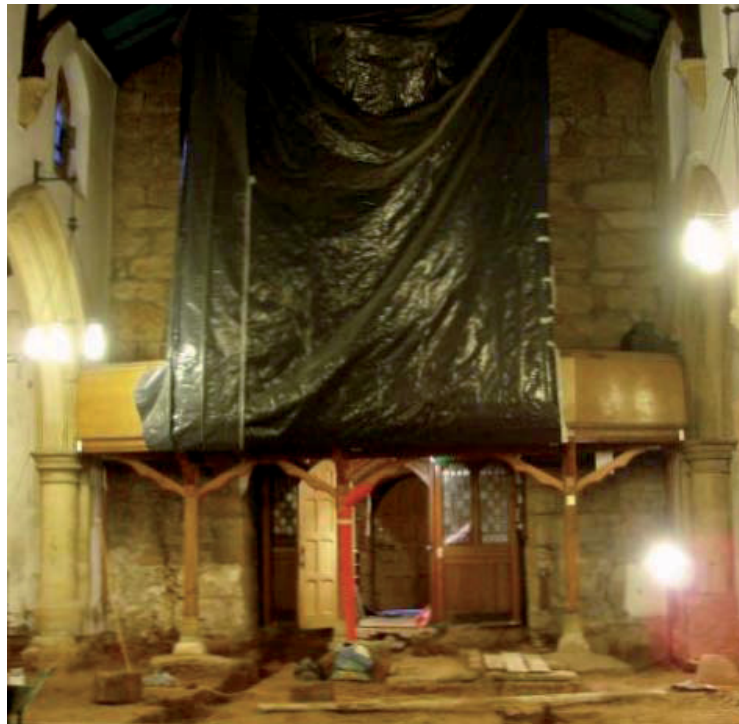
Plate 13: The roof scars visible on the east side of the tower (west end of the nave), either side of the tarpaulin

1.3.19 The most conspicuous modifications to the church occurred in 1855-6, by the renowned Edward Paley of Lancaster; described by Pevsner as one of the "Lancaster dynasty of architects [who] did more work in the county, and for a time more outstanding work, than any other" (Pevsner 2002). This phase of work resulted in the nave being dismantled and rebuilt, the northern and southern aisles being added, the restoration of the chancel, the opening up of the tower arch, the addition of a porch, and other alterations and improvements (Hardwick 1857, 596; Baines 1891, 210; LRO PR3164/4/7; LRO PR3161/2/5). Illustrations of the church following these alterations were published in 1863 (LRO PR3164/14/1; Plate 11), and a photograph was taken of the church in 1865-6 (LRO PR3164/14/41; Plate 12). These images show that, by the second half of the nineteenth century, the church exterior had essentially evolved into the current form of the building (Plate 1). The southern side of the churchyard was also enlarged at this time (Hardwick 1857, 596). Two former roof-lines are visible on the interior side of the church tower, in addition to the current roof (Plate 13). It is likely that the lower of these lines, which is steeply pitched, represents the low roof of the nave dating to the fifteenth century, or earlier, which was depicted on Buck's engraving of 1728 (Plate 4). The higher roof-line, which has a shallower pitch, is likely to represent the level of the roof following the modifications

undertaken in 1812. The current roof is the same height and pitch as that constructed during the alterations of 1855-6. A further phase of work was undertaken in 1884, when the tower was restored (Farrer and Brownbill 1911, 56-61).

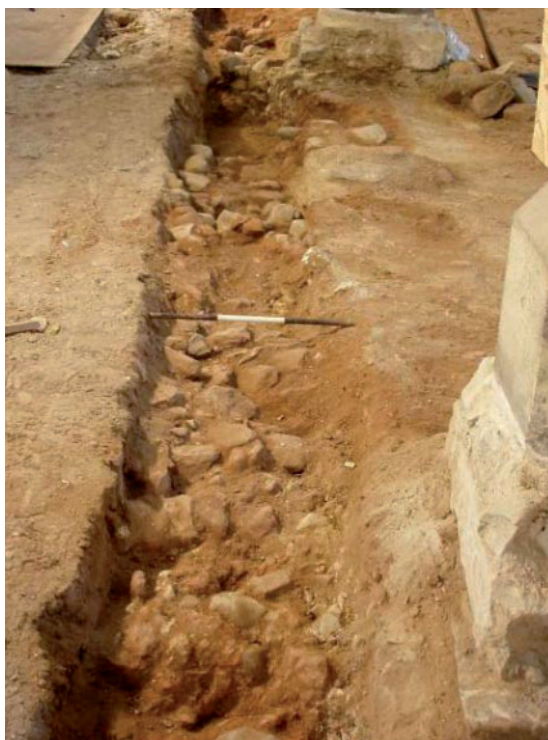
Plate 26: Western part of the medieval wall revealed within Trench 2

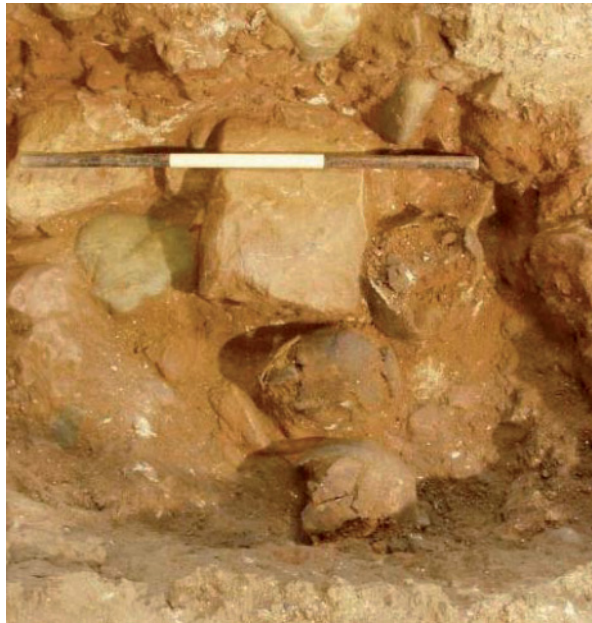
Plate 27: Three skulls deposited within wall 23

random fragments of bone, three intact skulls (SF 1-3; Plate 27), without lower jaws, were discovered within the foundation of the northern wall (23). The skulls had been carefully deposited with the top of the skull uppermost and side by side across part of the width of the wall.

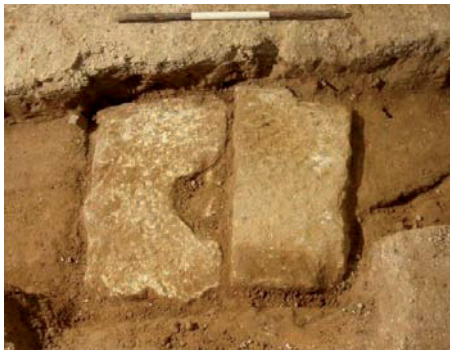
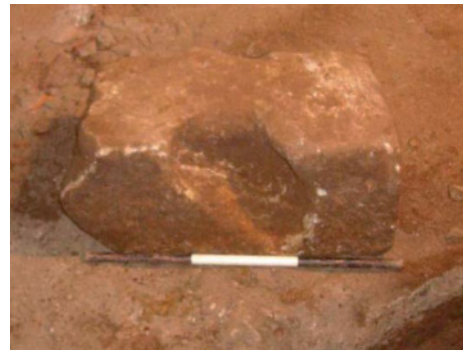
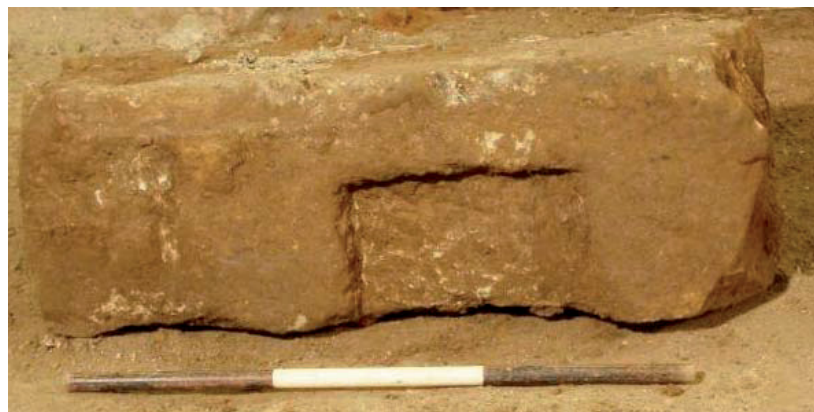
Plate 28: Reused masonry from column bases 158 (top) and 180 (bottom)

4.2.5 In total, seven probable column bases (Fig 7) were revealed within Trench 3 (**81, 158, 180**), Trench 4 (**191, 193**), and the area adjacent to the western nave entrance (**39, 194**). All of these structures comprised slabs and blocks of limestone, which measured up to 0.78m by 0.4m by 0.3m. The presence of cut niches, which had been filled with stone or which were present within sides of the blocks that had been laid face-down, demonstrated that several of the limestone blocks had been reused (Plate 28). Several of the bases had been laid on thin bedding deposits of clayey-silt and fragmented limestone patches, such as layer **185**. Four of the columns (**158, 180, 191, 193**) were exposed at roughly equidistant intervals in east to west alignments along Trenches 3 and 4, but were not consistently placed in opposing pairs. Instead, the bases in each line were staggered, so that the stones within one line would be directly opposite the space between the stones in the opposing line.

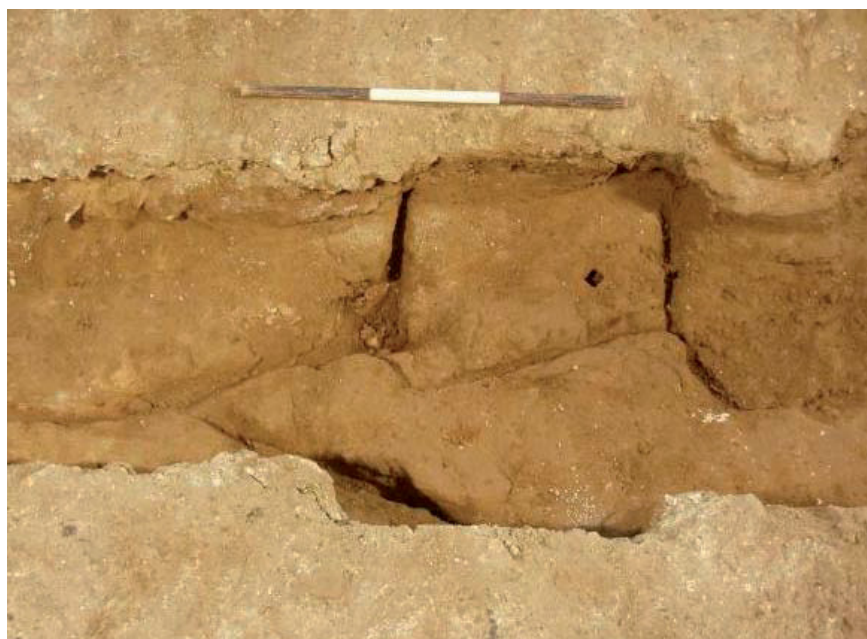
Plate 29: Numerous inter-cutting grave voids revealed within subsoil **156** in Trench 3

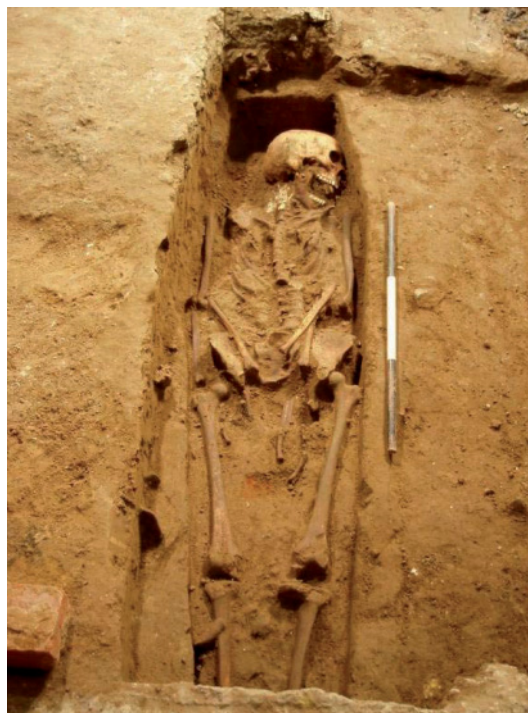
Plate 30: GR **164** with column base **158** at the top of the frame, looking west

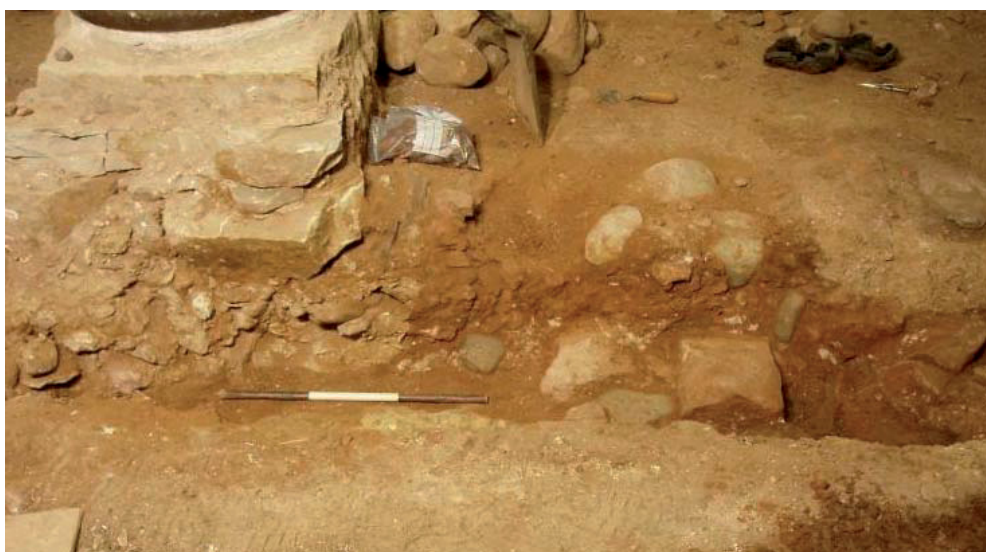
Plate 31: North-facing section showing the foundation (68) for a column base (left) cutting wall 23 (centre), which was overlain by mortar level 17 (right)

- 4.2.15 The next event, stratigraphically, was the erection of the columns that currently form the arches separating the nave from the aisles (Plate 31). This comprised the excavation of pits, such as 154, to hold rubble foundations, such as 55, 65, 66, 67, and 98 (Fig 2), that would support the stone bases of the columns. These bases utilised reused limestone that appeared to be similar in dressing style to the limestone used to form the Phase 2 column bases. Following the construction of the column bases, and possibly the erection of the columns and arches, a large portion of the church was overlain by the laying down of a mortar level (15, 17; Plate 31). This mortar layer directly

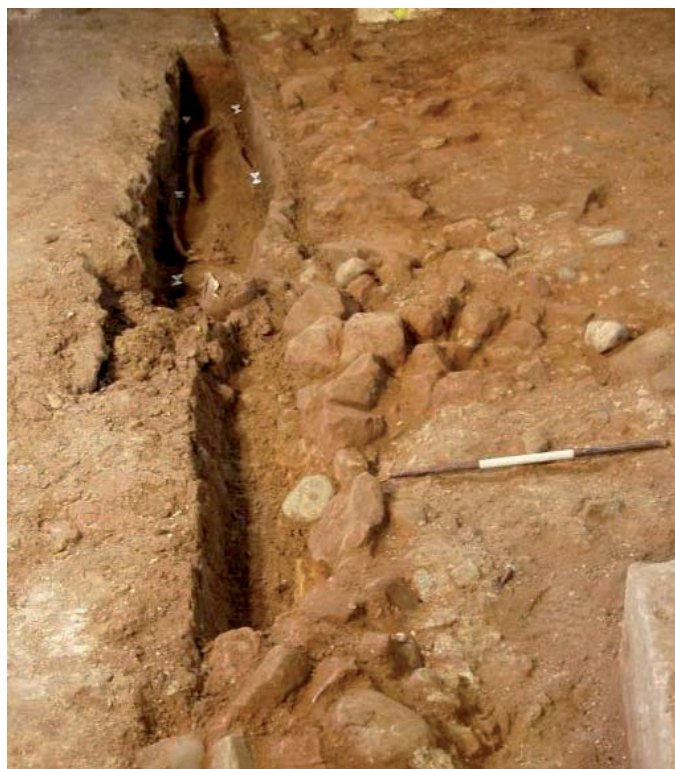
Plate 35: Graves *143* and *144* cutting wall *21*, looking east

This not only demonstrates the congregation's desire to be buried close to the church, but that they were buried prior to the demolition of the earlier walls. There was no indication of any burials disturbing the central part of the walls, which had been levelled in the mid-nineteenth century. All of the burials disturbed only the outer edges of the wall, suggesting that when they were interred when the wall was still standing, and that the sub-surface foundations stepped out slightly from the visible walls. This means that although the grave plot was apparently sited abutting the exterior wall, it would cause disturbance to the projecting lower levels. All of these graves, therefore, pre-dated the church modifications of 1855-6.

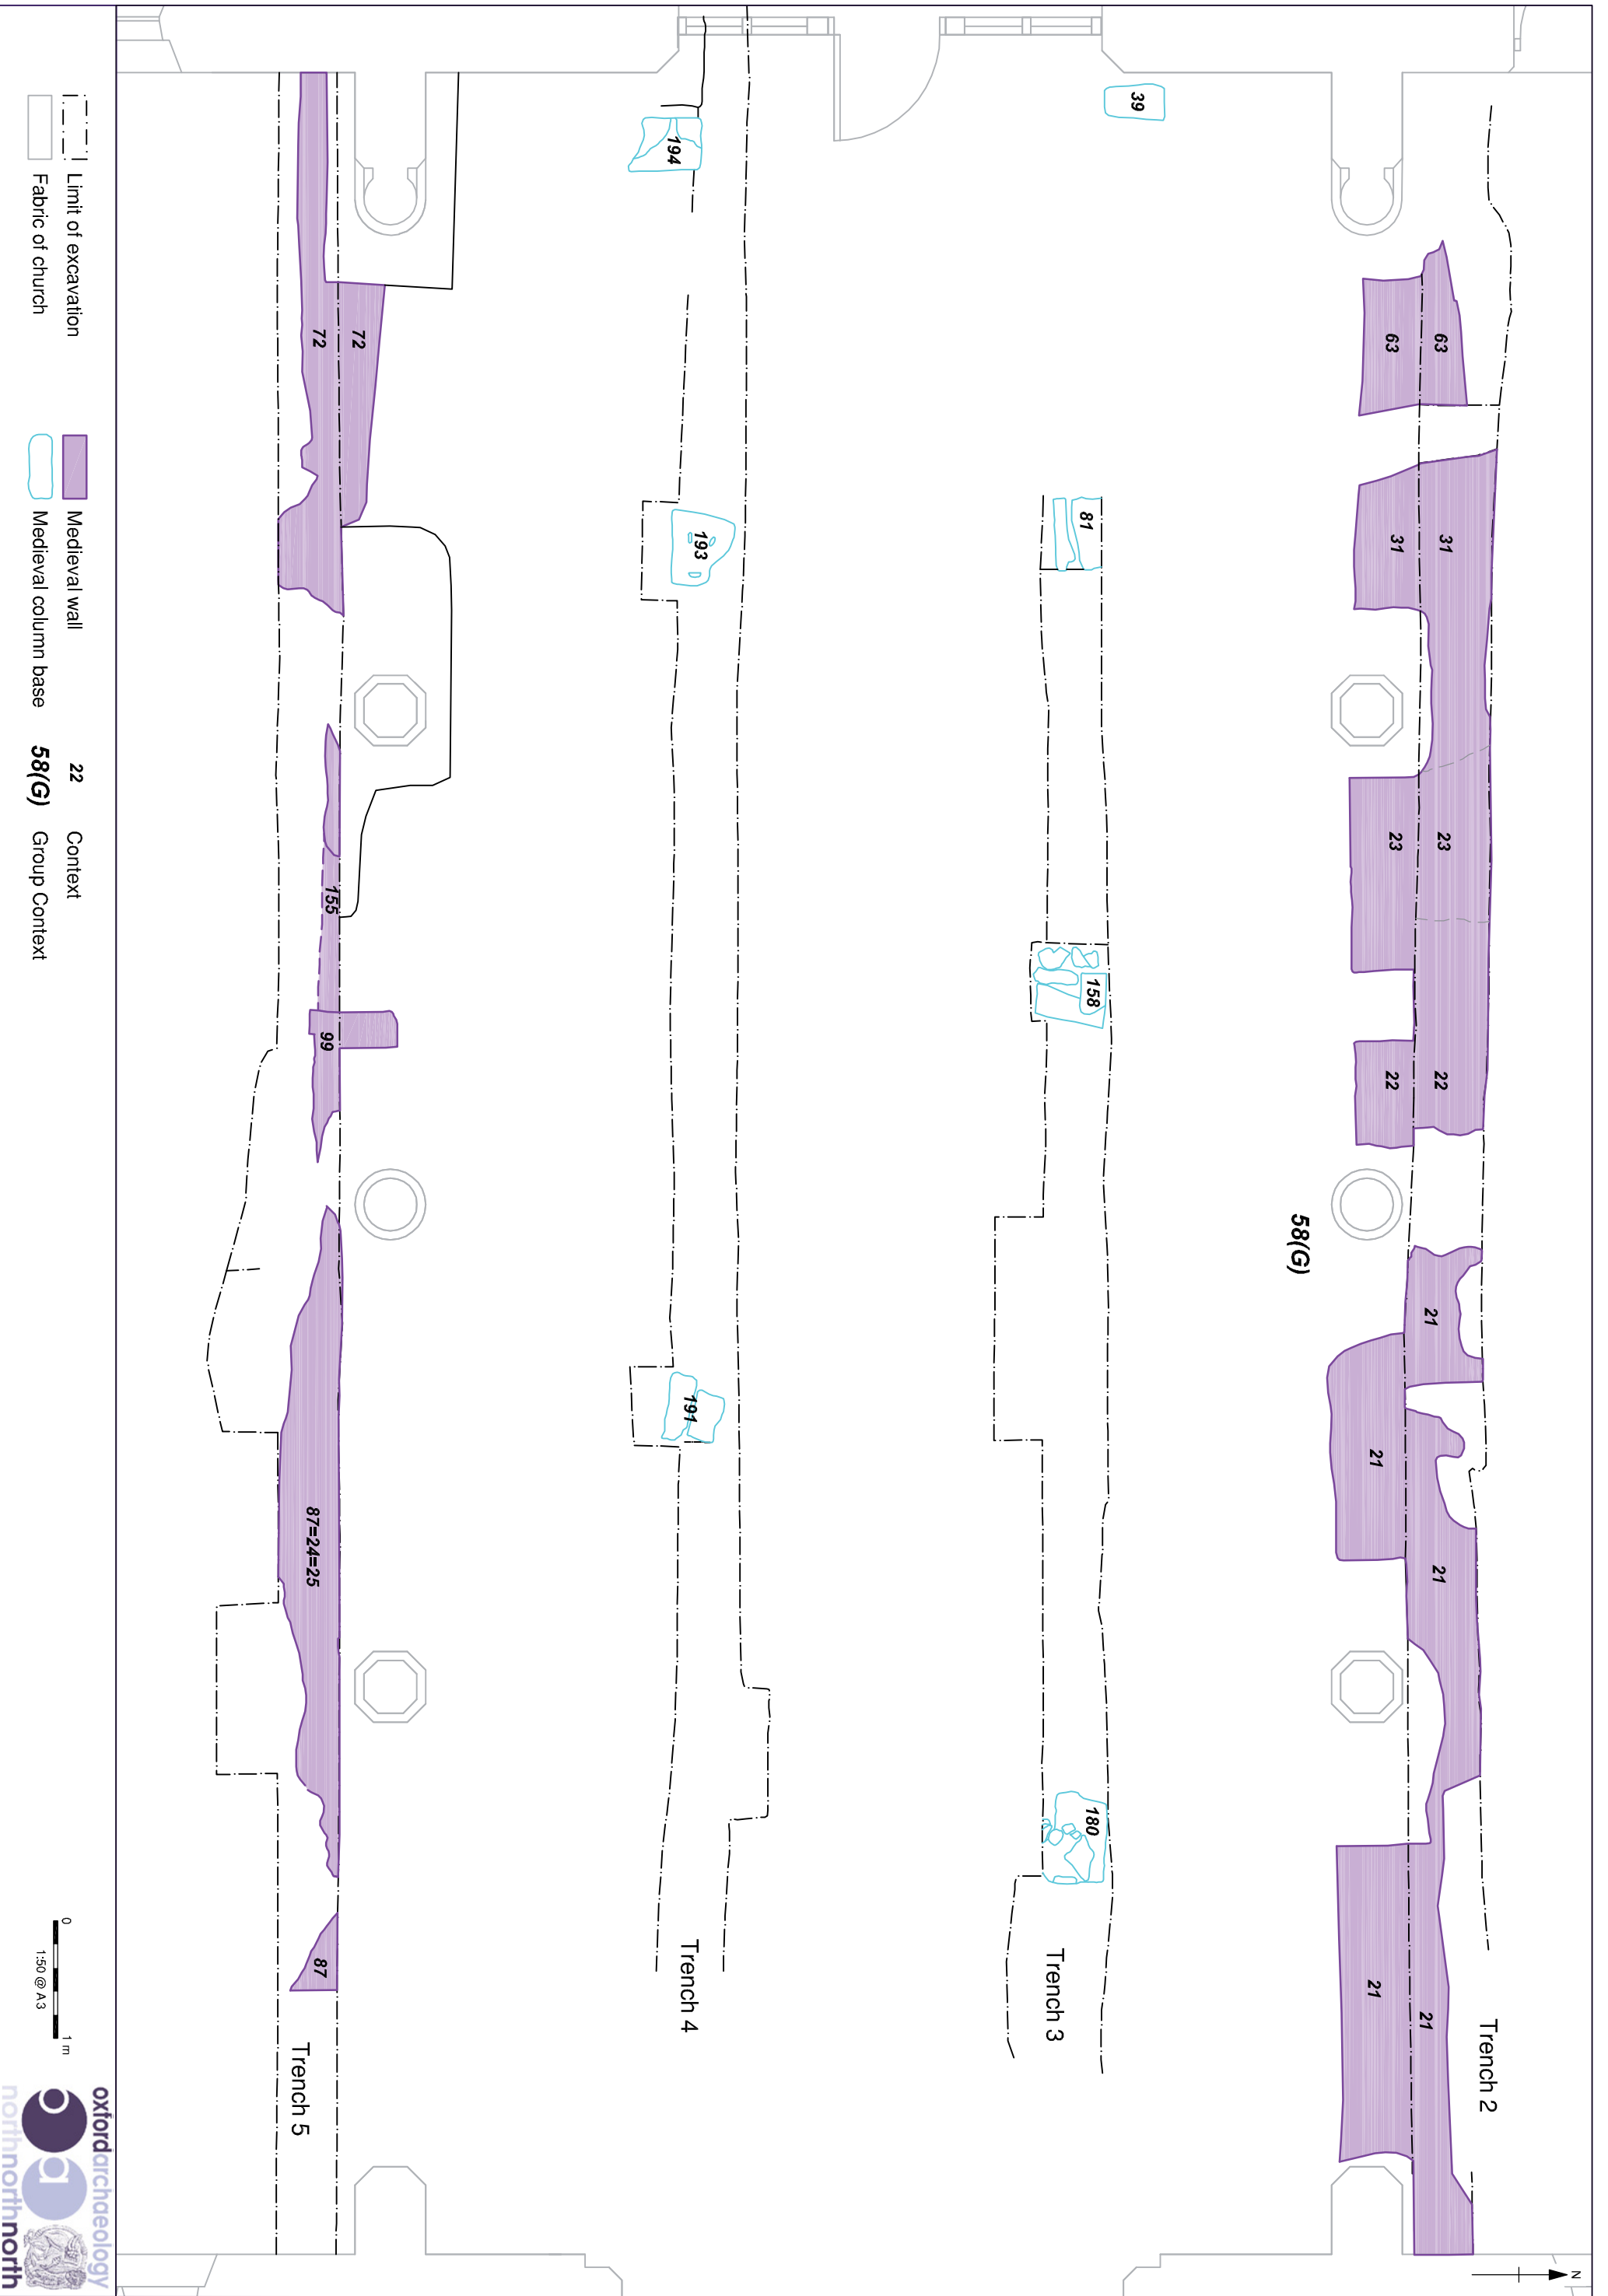
Figure 7: Phase 2 features

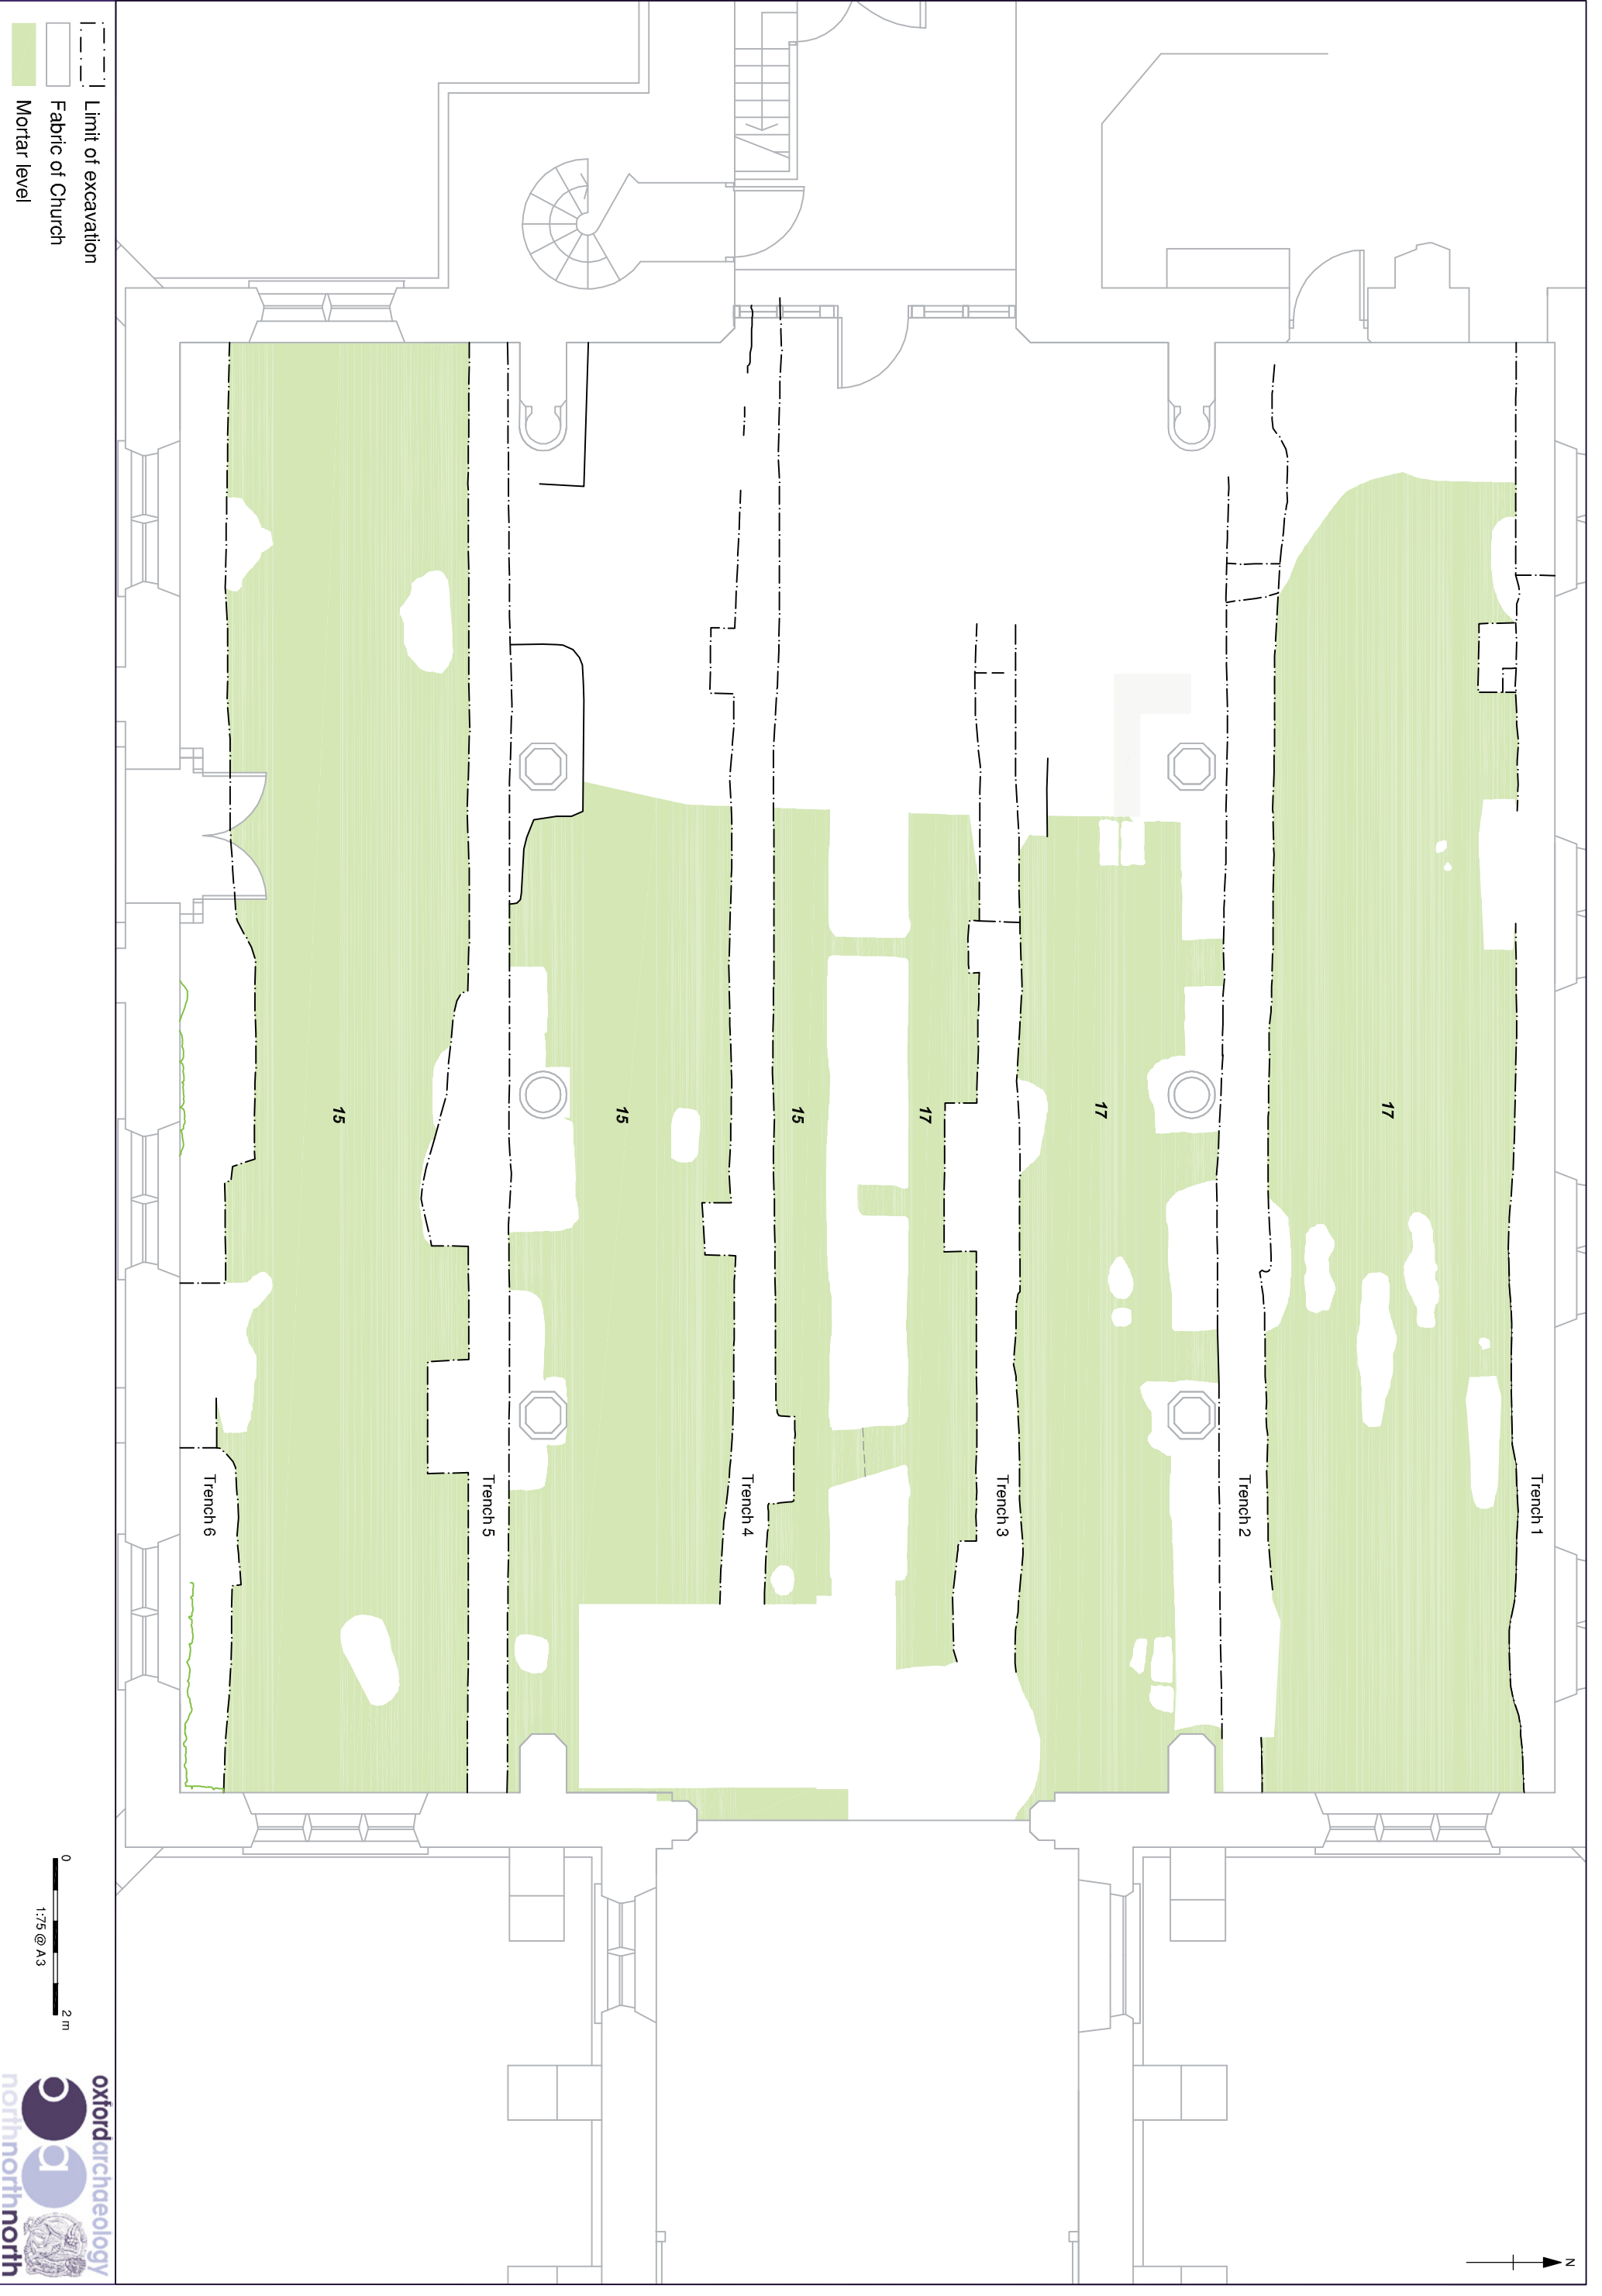
Figure 10: Phase 5 features

- 4.2.14 **Phase 5:** this phase consisted of the extension of the northern and southern aisles (Fig 10). There are several observable stratigraphic events that have been assigned to this phase and, although sequential chronological relationships are evident between several of these events, they are all attributable to the broad overarching phase of activity that relates to the historically documented expansion of the church in 1855-6 (see e.g. Crosby 1988, 26-7). The earliest such event was the demolition of the medieval exterior walls recorded in Trench 2 (21, 22, 23, 31, 58, 63) and Trench 5 (24, 25, 72, 87, 99, 155) (Plate 26). The demolition of the northern wall (Trench 2) was evidenced only by the horizontal truncation of the structure to leave low foundations. In Trench 5, however, the demolition of the southern wall was represented by similar truncation, and also by the presence of a dump of demolition material (26) that overlay part of the wall foundations (99). At this time, possible robber pits (57, 68) might also have been excavated through the northern wall (31).
