HAMELDON HILL WIND CLUSTER, NEW BARN FARM, BURNLEY, LANCASHIRE

Archaeological Watching Brief

Oxford Archaeology North

April 2006

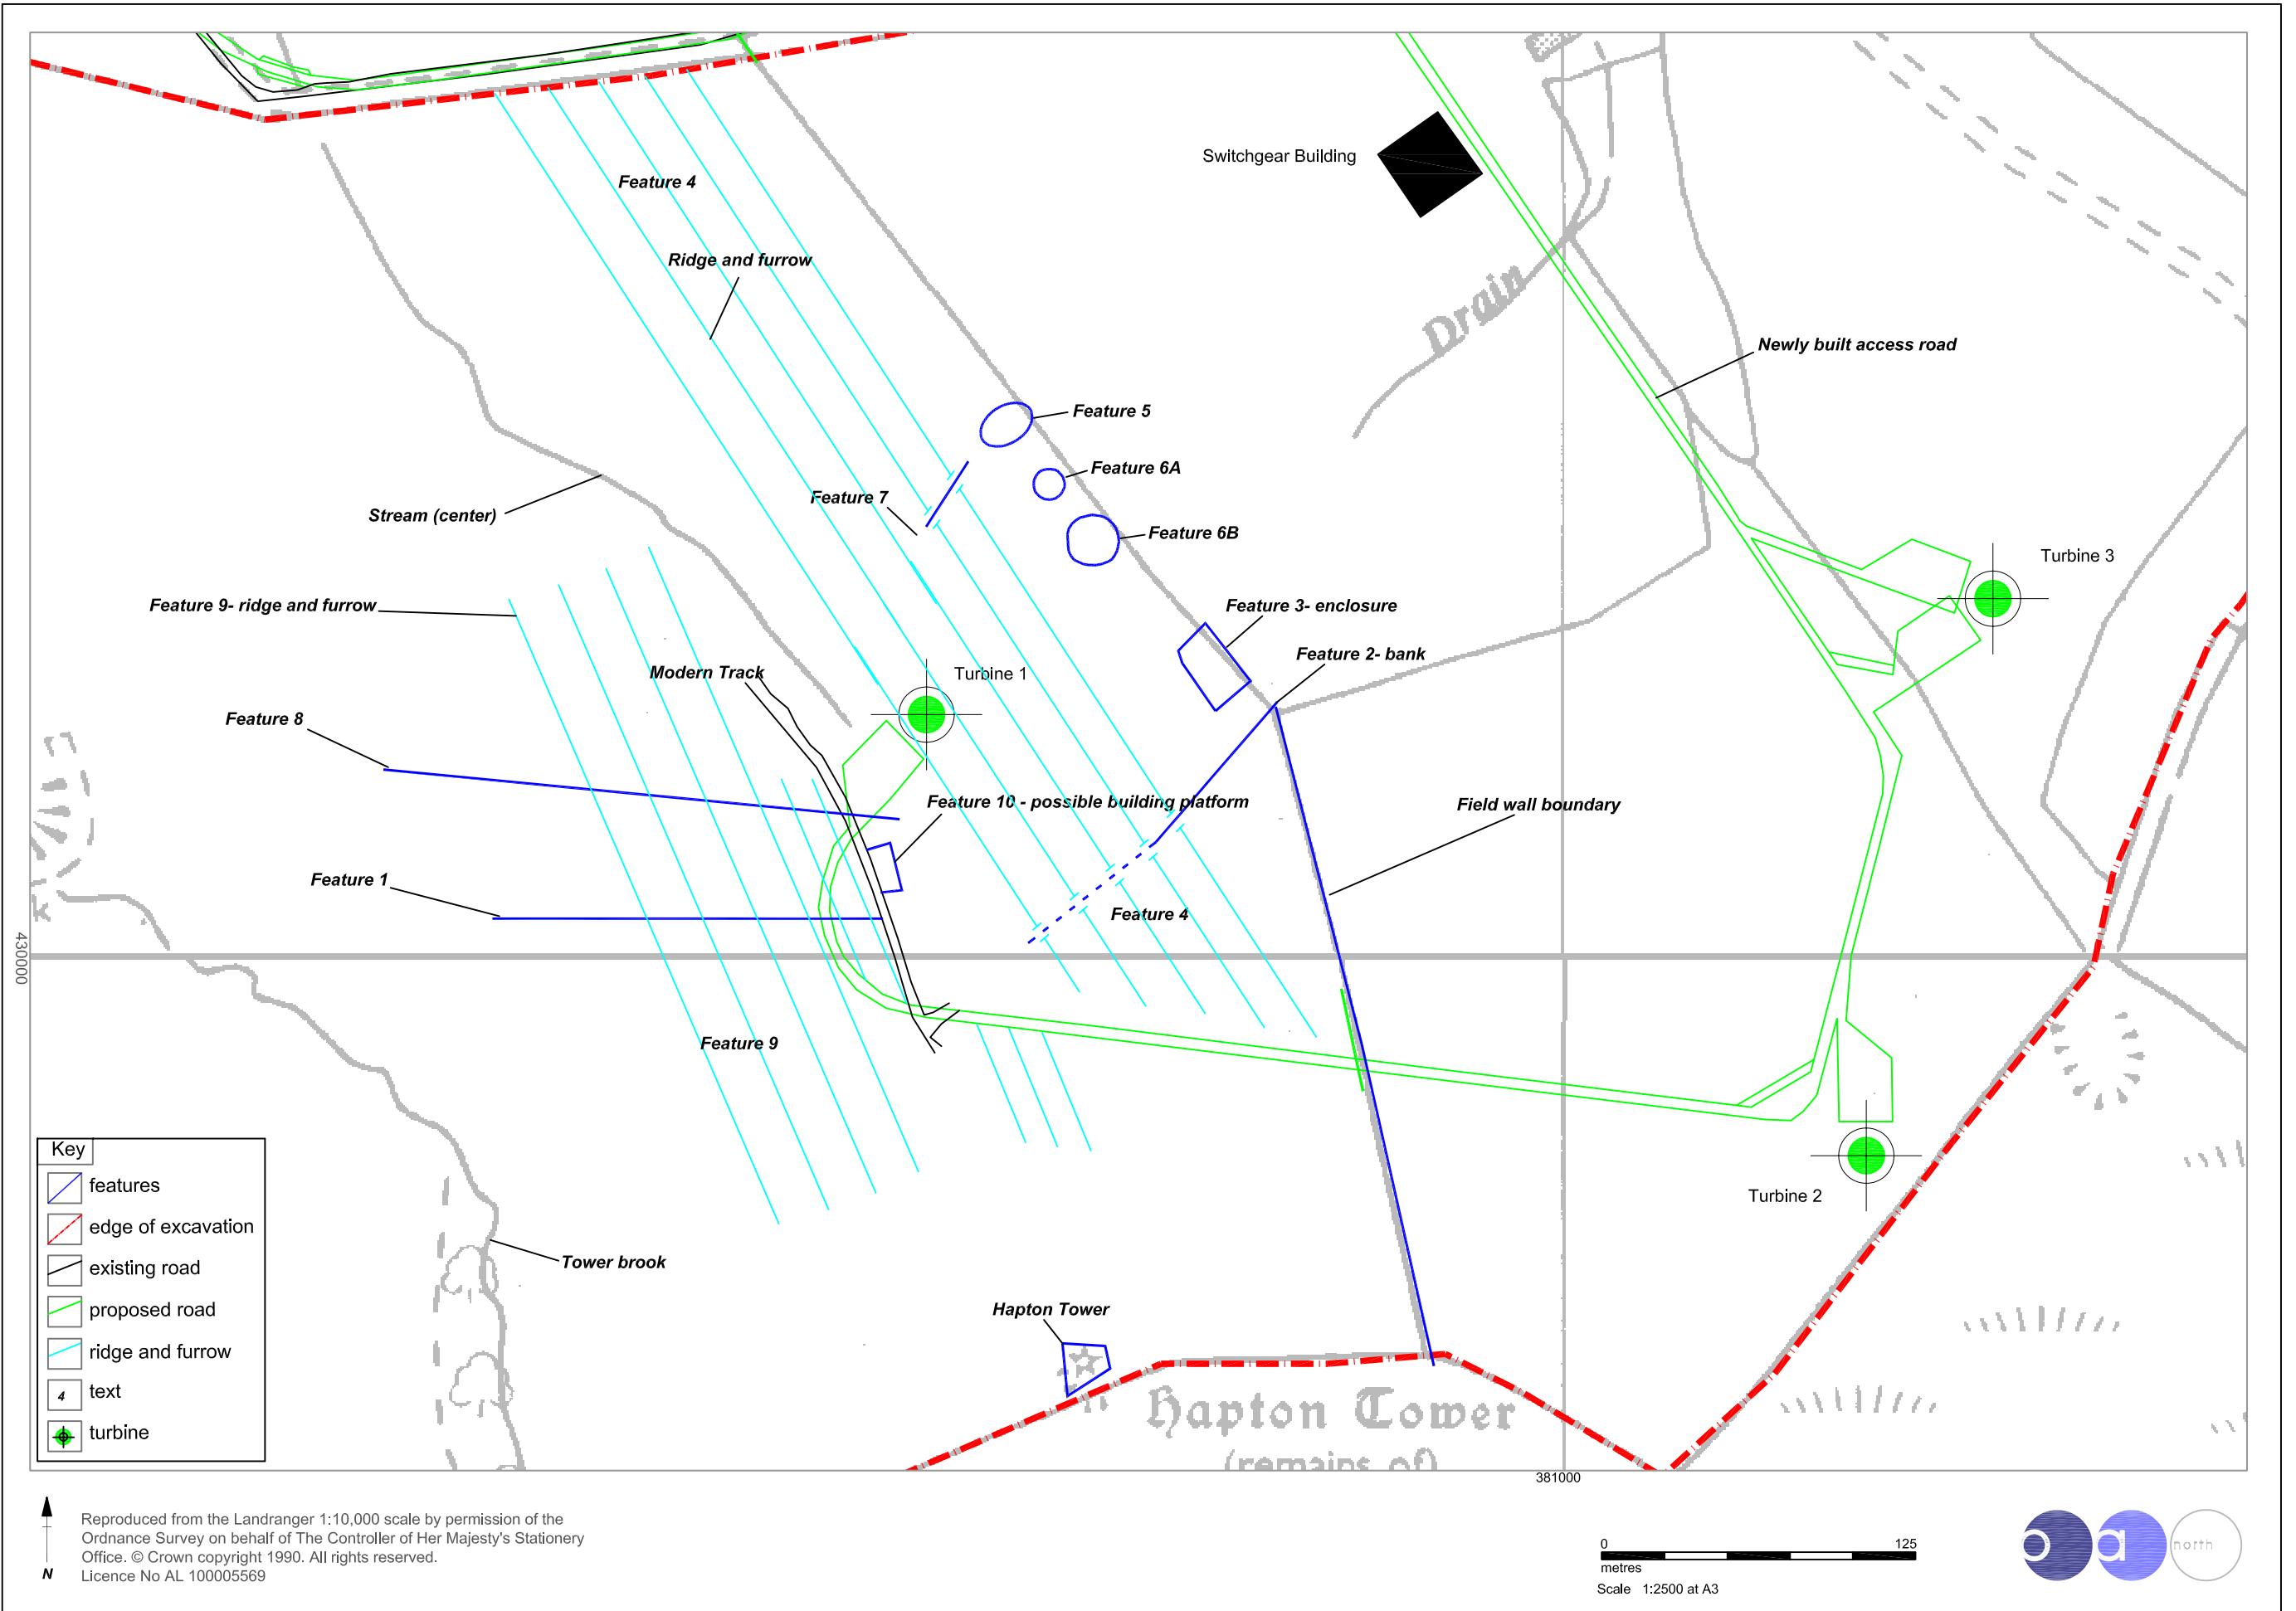
Figure 2: Plan of Watching Brief Features

- 3.1.3 The new access road ran in a loop south-east (c 400m), then south-west (c 140m), north-west (c 360m) and then north-east (c 75m) again (Figs 1 & 2). The access road was approximately 4m wide along its full length. The excavated depth of the access road varied considerably due to the incline of Hameldon Hill and the deposits across it. On the first stretch of the access road, between New Barn Farm and the proposed location of Turbine 3, excavations reached a depth of 0.3m into the subsoil horizon, within which no archaeological features were visible. On the southerly part of the road, across a more level area of the hill between the proposed locations of Turbines 2 and 3, excavations reached a depth of 0.7m, down to natural boulder clay. No archaeology was apparent here either. Heading west from Turbine 2, excavations reached a depth of only c 0.2m before reaching the natural geology and, at the road's terminus, at Turbine 1, excavations were very shallow, with a natural sandstone deposit being encountered at a depth of c 0.1m or less. Only in the case of the approach to Turbine 1 was archaeology visible; here, the access road transected the course of a bank (Feature 01; Section 4), and a ditch flanked by banks to the north and south (Feature 08; Section 4). The access road also transected the ridge and furrow (Feature 09; Section 4) observed within this field, but such features were not visible either in the limited section or of the exposed plan of the access track.

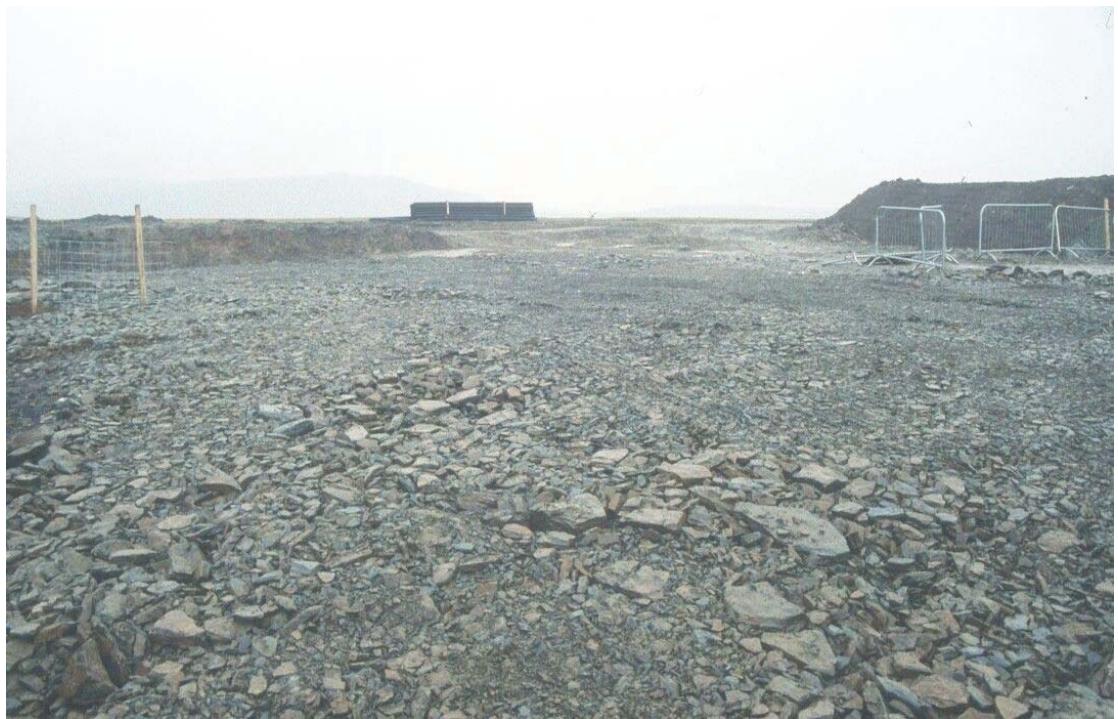
Plate 1: Area beneath Turbine 1

- 3.2.1 *Turbine 1:* is located at the western terminus of the access road, within the same field as the bank and ditched enclosure identified during the desk-based assessment and walkover survey (CWR 2002). Sediment stripping of the

turbine base and the associated area of hard standing revealed a thin veneer of sandstone pebbly subsoil, 70mm thick, beneath a 0.1m thick layer of topsoil. Beneath the subsoil, the scree-like natural was revealed (Plate 1). Across the field in which the turbine lies are clear traces of several banks and of intermittent ridge furrow (Plate 2), along with a possible building platform (Feature 10; Section 4). Many of the features show the marks of fresh tyre tracks across them, but no traces of ridge and furrow or of other archaeological features were present within the stripped area of the turbine platform.

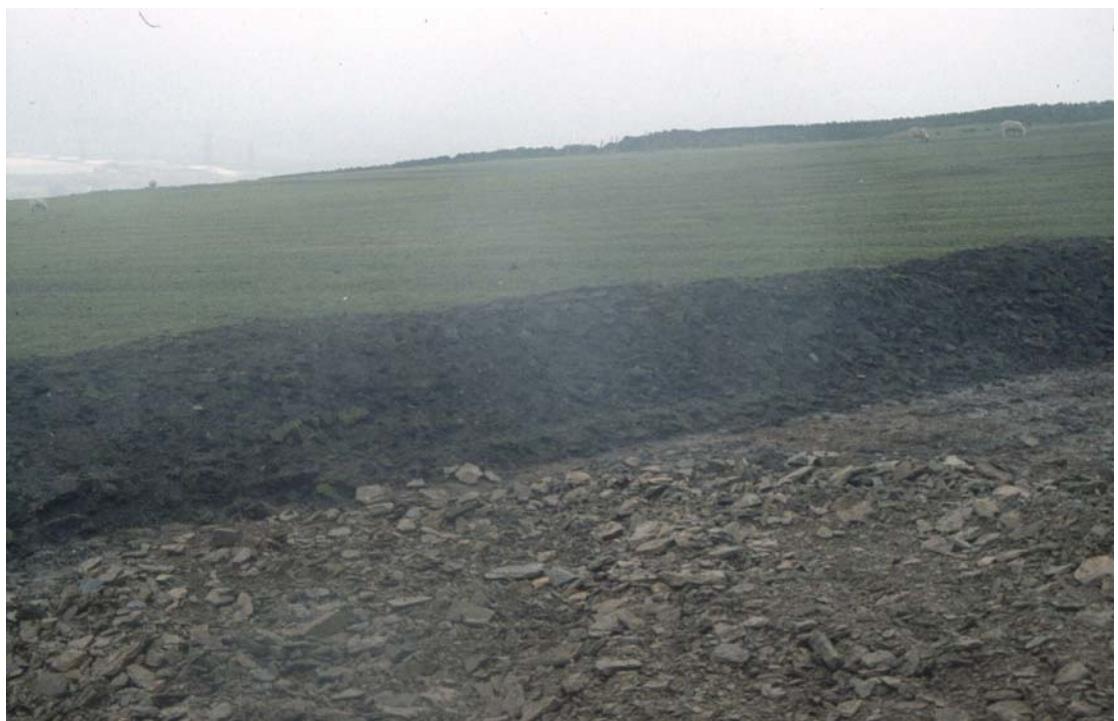
Plate 2: Ridge-and-Furrow

Feature number	04
Site name	Hameldon Hill
NGR	SD 80916 29967 (south-east) SD 80675 30360 (north-east) SD 80791 29988 (south-west) SD 80538 30353 (north-west)
Site type	Ridge and furrow
Period	Medieval/post-medieval
SMR No	-
Statutory	-
Designation	-
Sources	Walkover Survey
Description	Ridge and furrow can be seen across much of the field in which Turbine 1 is located, covering an area roughly 75m by 400m, although much of it has already been disturbed due to the long term presence of agriculture and animal husbandry in this field. The ridge and furrow runs north-west/south-east along the north-east incline of the field but appears to respect many of the other features around it. The location of Turbine 1 is in an area of the field where the ridge and furrow has virtually disappeared already. Each sequence of ridge and furrow is 3m wide.
Assessment	The feature is in the same field as turbine one but is unlikely to be directly affected by it. It has been, and will continue to be, affected by farm vehicles tracking across it however and animals grazing upon it.

Feature number	09
Site name	Hameldon Hill
NGR	SD 80568 29978 (centred)
Site type	Ridge and Furrow
Period	Medieval/post-medieval
SMR No	-
Statutory	-
Designation	-
Sources	Walkover Survey
Description	Ridge and furrow can be seen, in a roughly rectangular area (c 270m by c 80m), to the west of the stream. There is more definition here than there is to the ridge and furrow on the east side of the field (Feature 04). This site runs up to the foot of the hillock on which Hapton Tower once stood. The ridge and furrow may also have been truncated by quarrying to the west.
Assessment	Largely unaffected by the current development project, although some of the current farming practices do impact upon it.

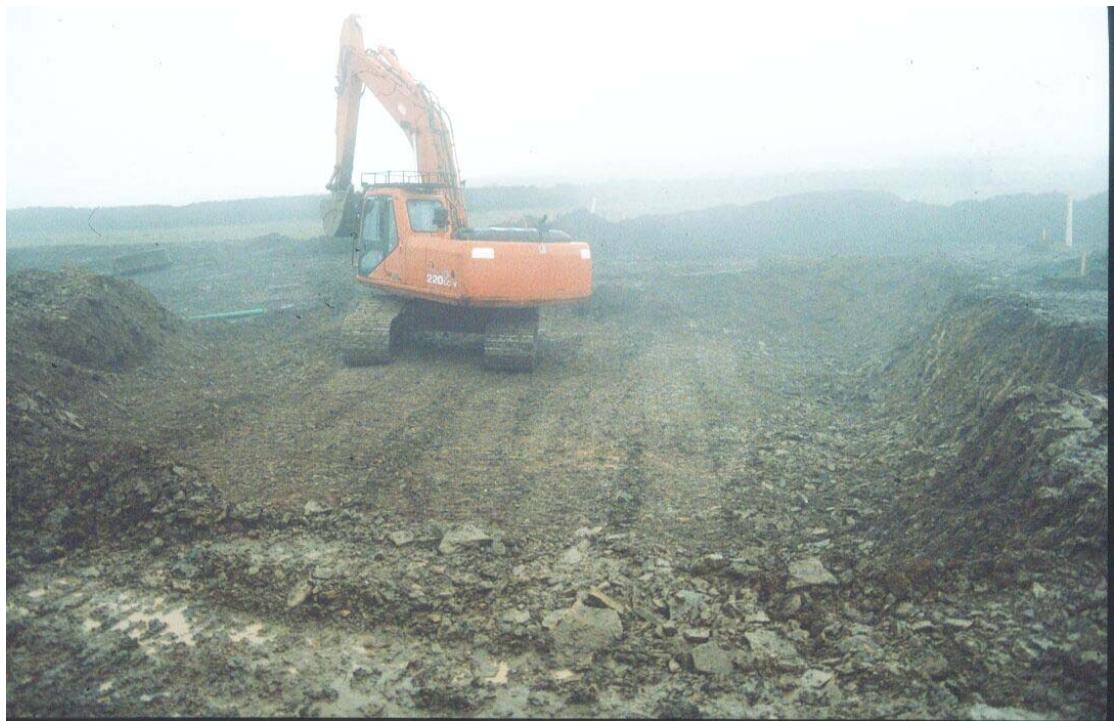
Plate 3: Working Shot showing Shale Geology beneath compound

- 3.1.2 Immediately to the west of New Barn Farm, the access road was extended from the newly widened trackway, past the McNicholas Construction site compound. The stripping of topsoil to a depth of c 0.2m within the c 30m x 50m site compound area took place before the archaeological monitoring was commissioned, but an examination of the revealed scree-like weathered bedrock surface demonstrated the absence of any archaeological features cutting into the natural (Plate 3).
