**WALLER'S MILL,
NEW ISLINGTON,
ANCOATS,
MANCHESTER**
Greater Manchester

Archaeological Evaluation

Oxford Archaeology North

November 2004

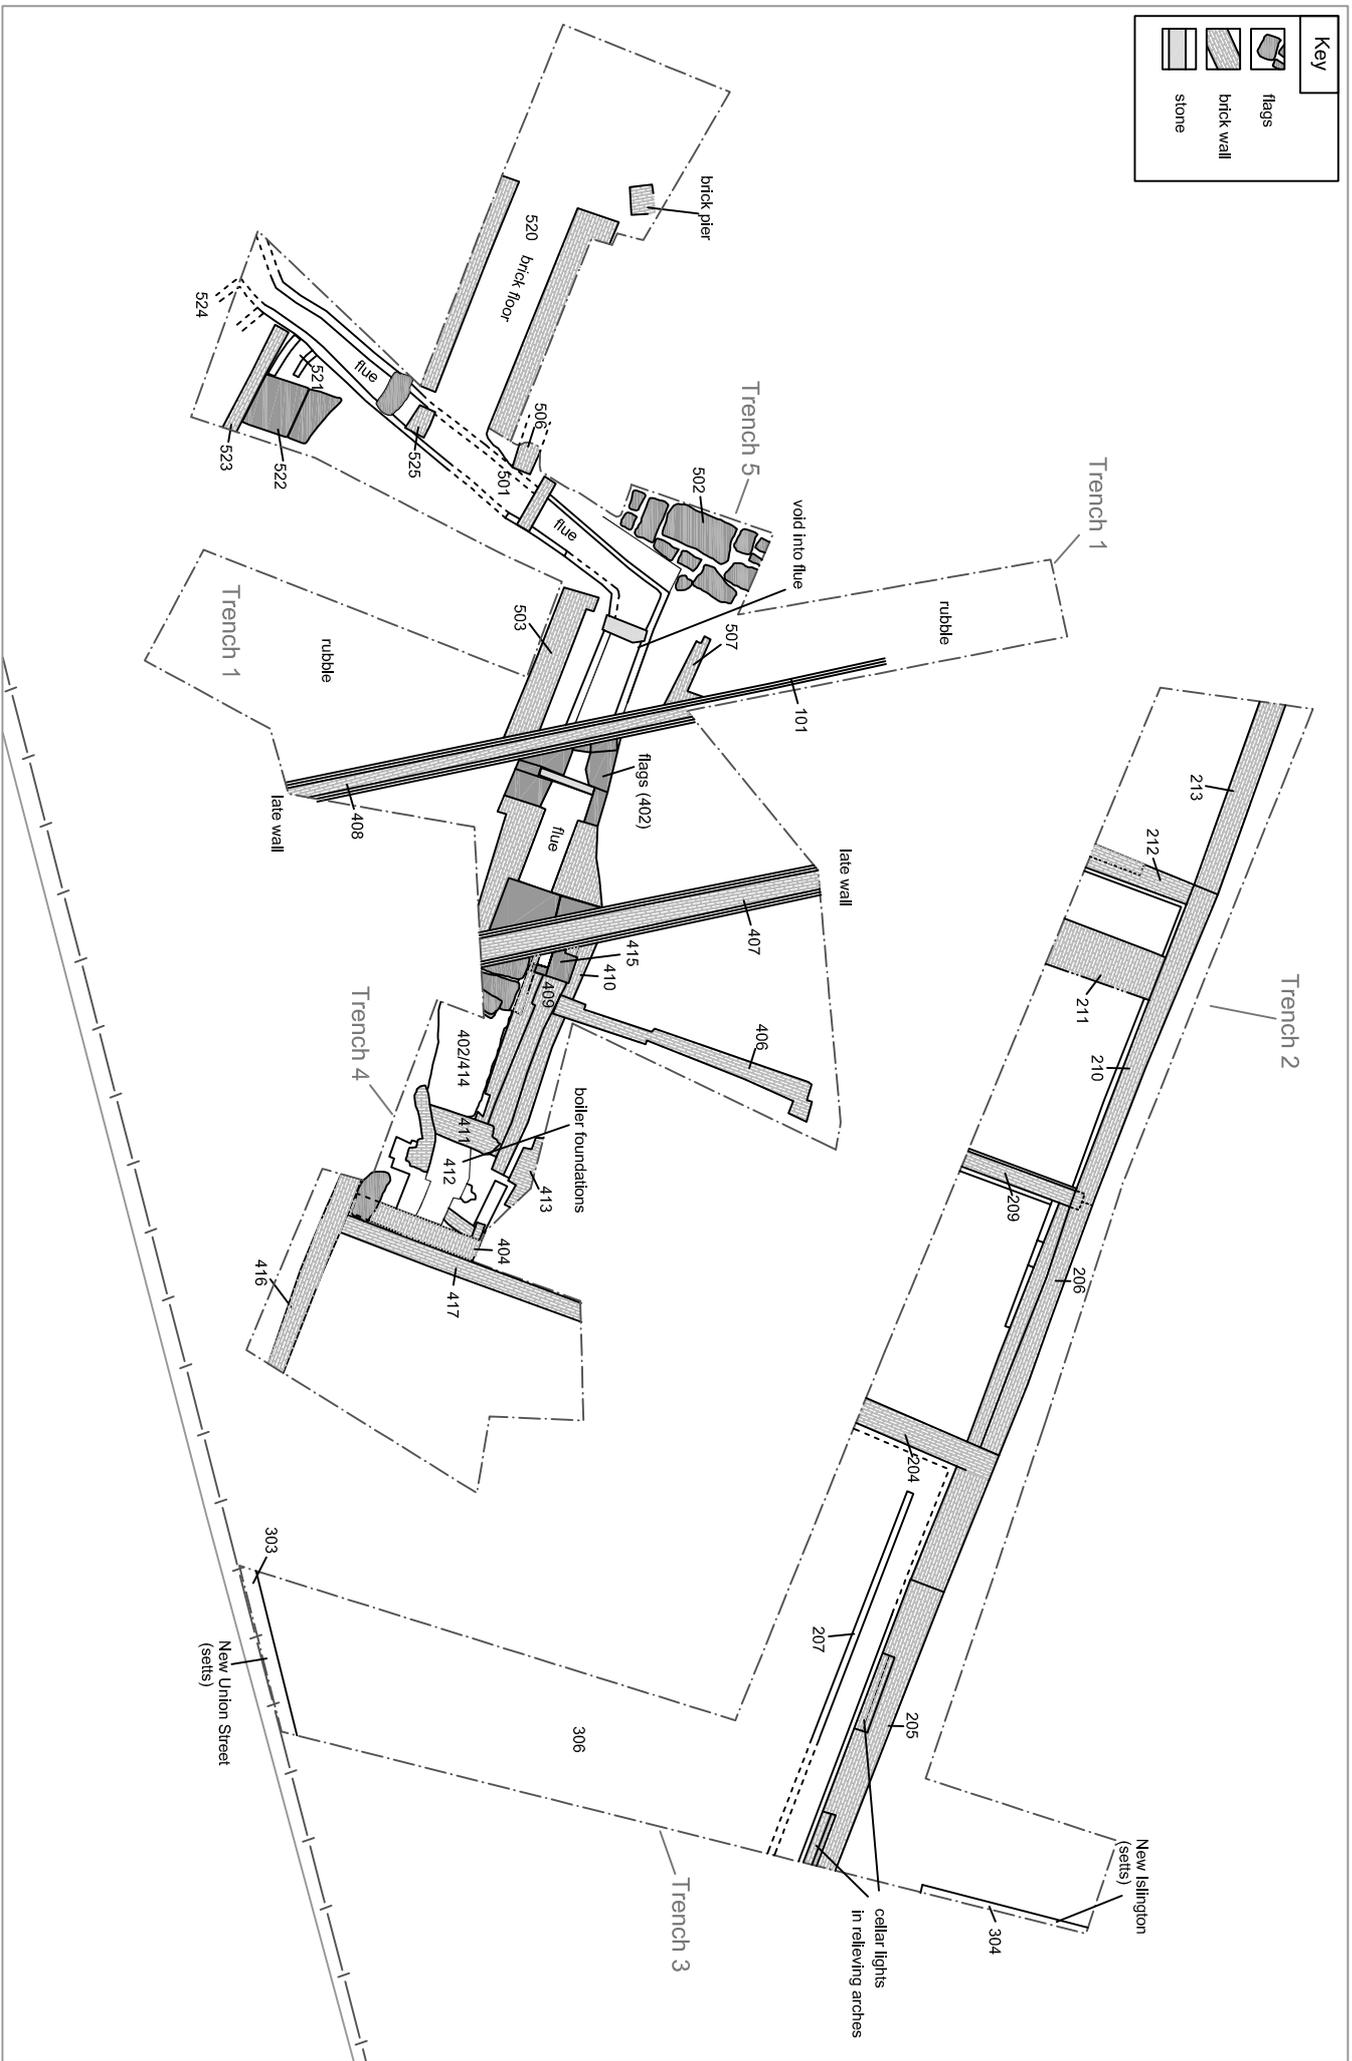
Figure 9: Detail of evaluation trenches

- 3.2.8 The northern wall (**205**) of the mill was encountered along the south-west facing section of the trench, at a depth of 1.10m below the modern ground surface (Fig 9). The wall comprised hand-made bricks, seemingly mould-thrown and bonded with a lime-based mortar. The wall survived to a maximum height of 1.28m, in an English Garden Wall bond, and the upper course of the original part of the wall (see 3.2.9 below) had a maximum width of 0.35m (Plate 2). The two basal courses comprised irregularly-coursed, offset foundations, with no clear evidence surviving for the use of mortar (Plate 3). The foot of the foundations were exposed some 2.38m below the modern ground surface, at a height of 45.75m aOD, indicating that wall **205** had formed the edge of a basement.

- 3.2.14 A second north-east/south-west aligned cross wall (**209**) was exposed at a distance of 4.40m to the north-west of wall **204** (Fig 9). This wall was bonded to wall **206**, and was similarly composed of hand-made bricks set in a lime-based mortar. It measured 0.22m wide across the uppermost exposed course, but widened to 0.33m at its base with the incorporation of a single offset foundation course.

- 3.2.24 A north-west/south-east aligned wall (**416**), exposed at the south-eastern end of the trench, lay parallel to wall **205** (Trench 2), some 7.3m to the south (Fig 9). Wall **416** was 0.25m wide, and comprised hand-made bricks bonded with a lime-based mortar (Plate 9). It seems probable that this wall represented the south-western wall of the original mill building, and whilst health and safety considerations precluded excavation to the foundations, wall **416** had almost certainly formed part of a basement.

- 3.2.28 Immediately adjacent to the north-west of wall **417** was wall **404** (Fig 9). This measured some 0.32m wide, and was composed of hand-made bricks set in a lime-based mortar. It formed the south-eastern end of a flue system (3.2.29 *below*), and may have represented the foundations for a boiler.

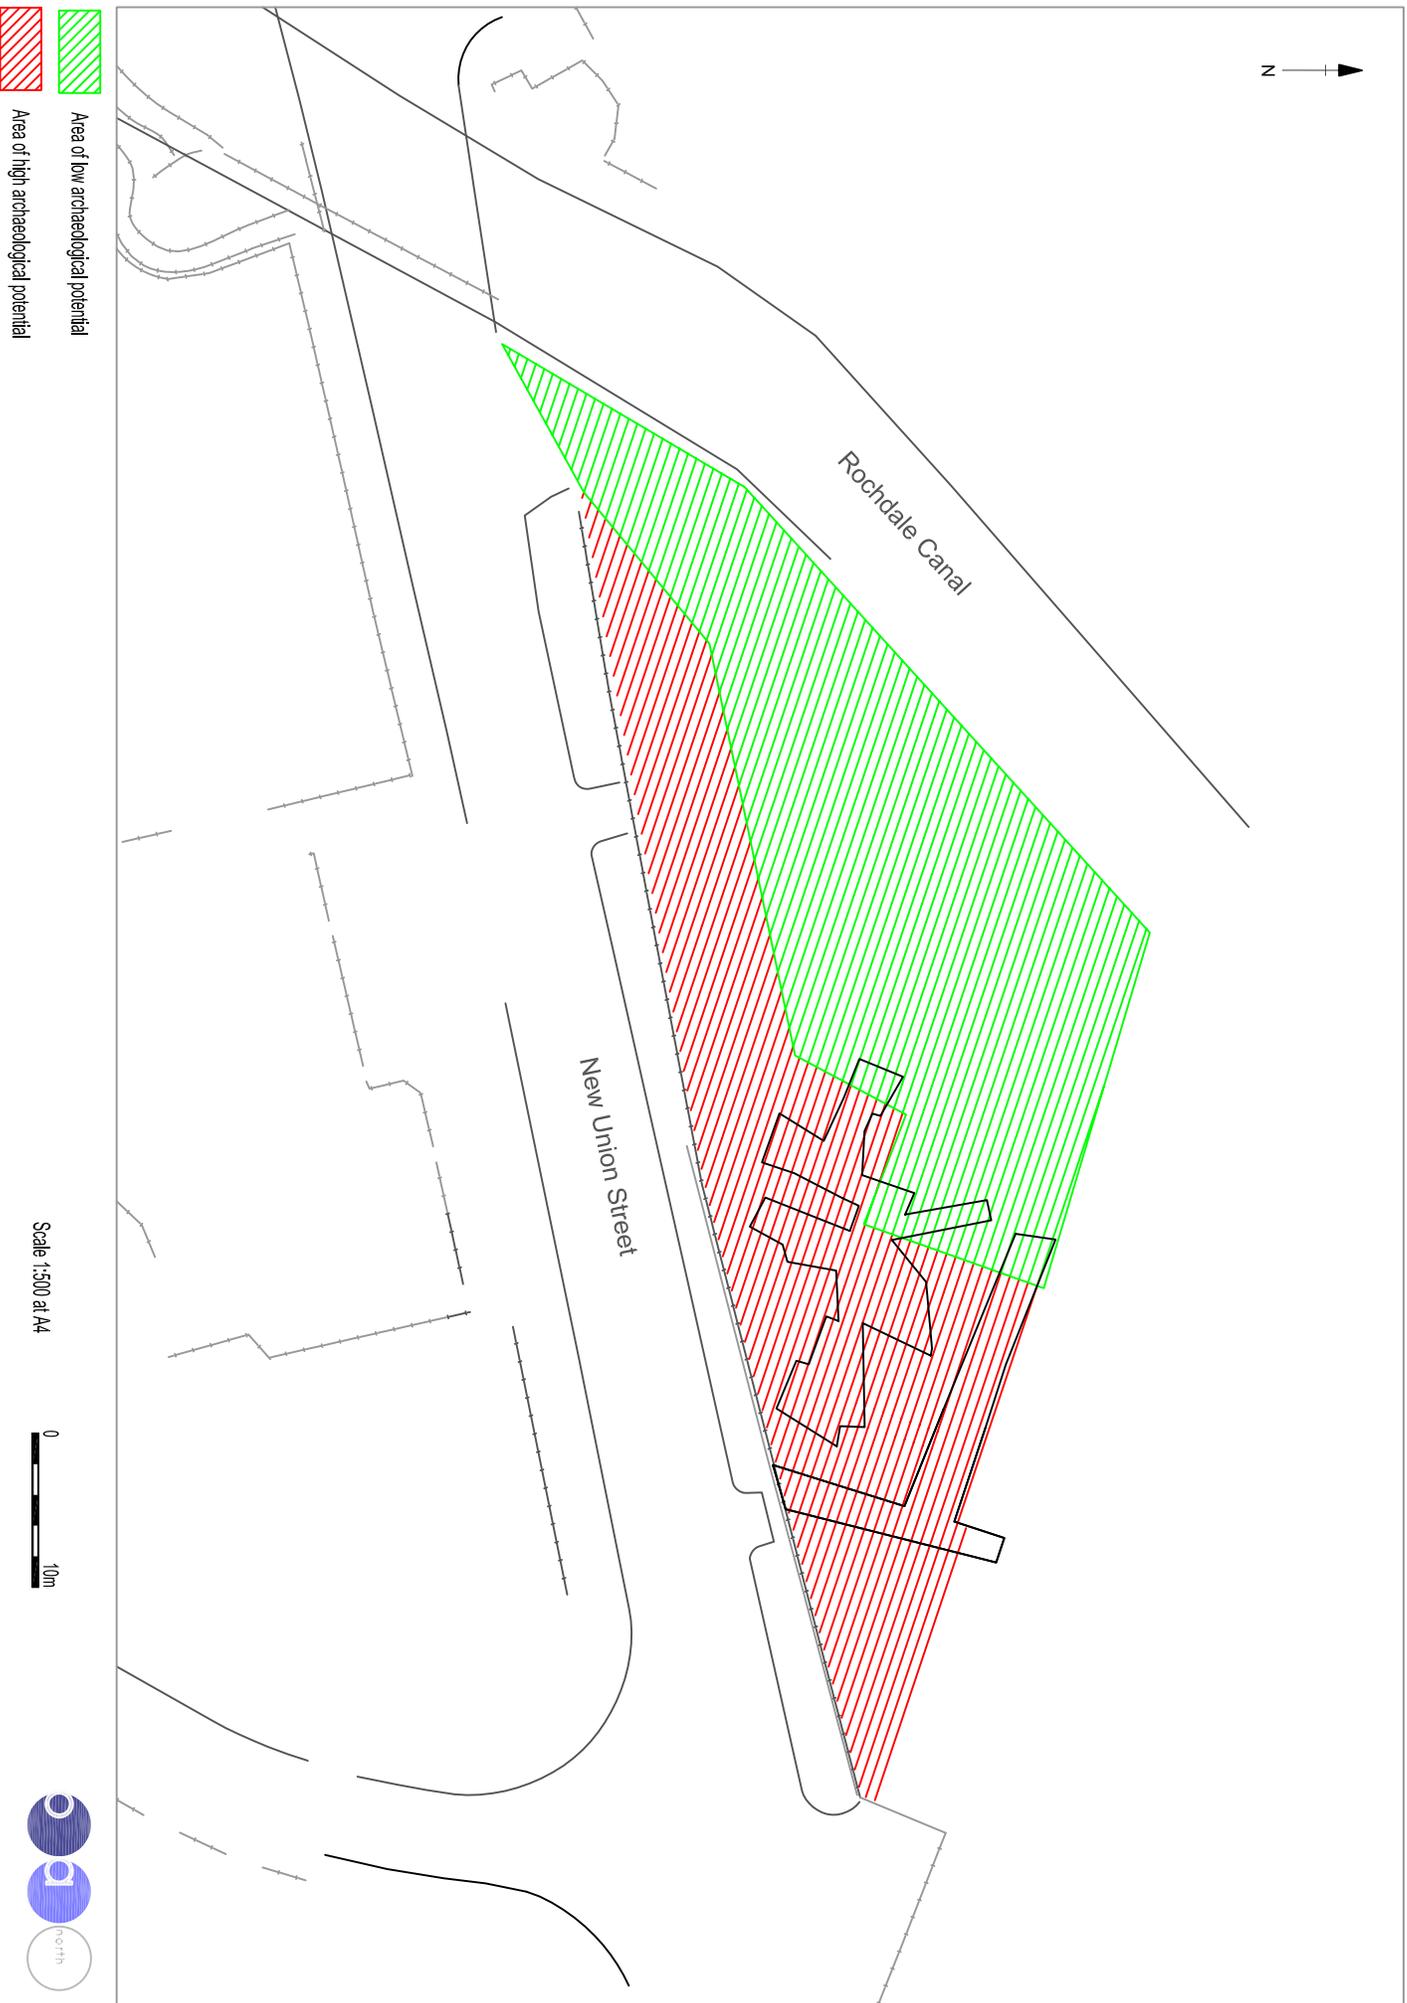
Figure 10: Zoning of archaeological potential within study area

- 5.1.2 The archaeological remains to the south-east are more deeply buried. Moreover, these remains represent the shell of the former mill with little, or no, survival of internal features. Hence, ground-reduction works within the footprint of the mill are unlikely to have a significant negative impact, providing that the external walls of the former building are not damaged in the process.

Area of low archaeological potential

- 5.2.1 It is recommended that a watching brief be undertaken during any earth-moving works within the study area in order to record any structural remains that may survive *in situ*. In particular, a watching brief should be targeted at compiling a record of the western extent of the flue and its associated chimney, any surviving floor surfaces within the two room at the north-eastern end of the mill, and any structural elements of the L-shaped extension adjacent to New Union Street. Confirmation of a water channel between the mill and the canal should also be sought, with clarification of the origin of the black silt identified to the north-west of the mill providing an initial focus.

- 5.2.2 It is further recommended that, where possible, any future design proposal for the redevelopment of the site should allow for the surviving structural elements that represent the shell of the former mill to be retained *in situ*.

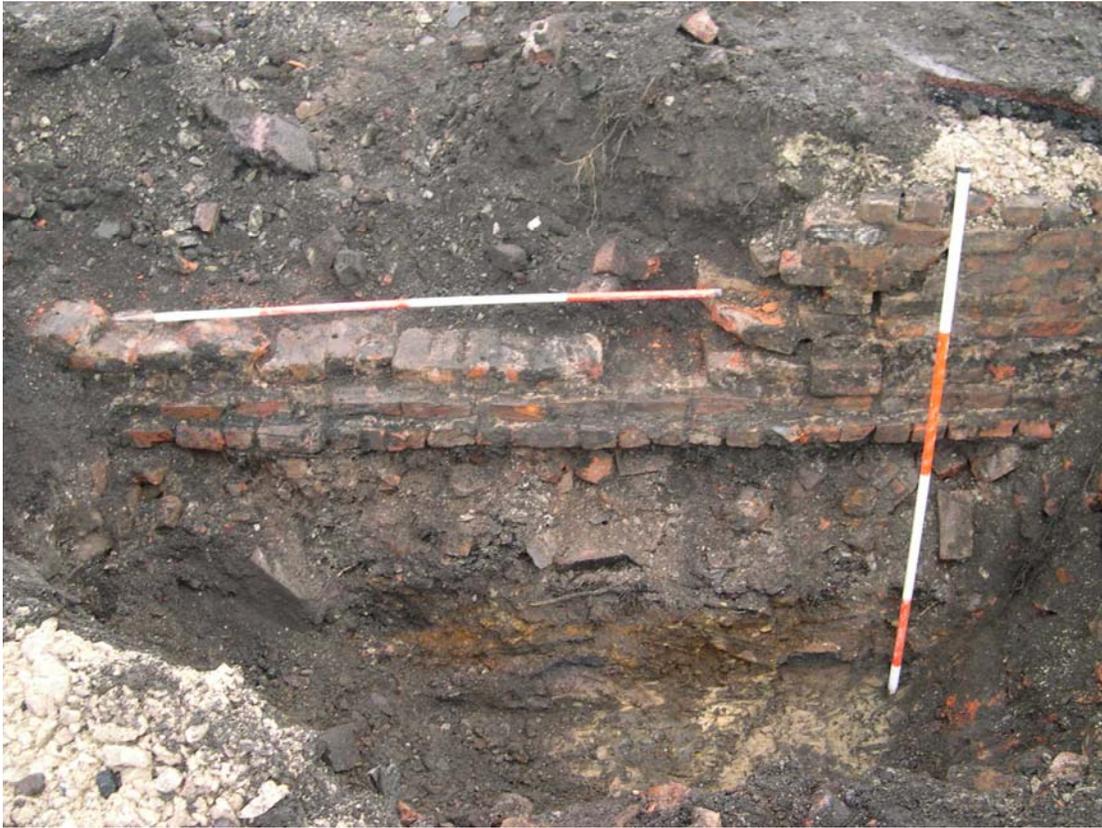
3.2.5 A brick wall (**101**) had been constructed above rubble layer **102** (Plate 1). Wall **101** comprised a mixture of hand-made and machine-pressed bricks, the latter component indicating a date no earlier than the late 19th century; map regression analysis has indicated that wall **101** probably represented the development of the site during the early 20th century. It was aligned broadly north/south, and had a width of 0.24m, with two offset foundation courses (Fig 9). The top of the wall was encountered at a depth of 0.18m below the modern ground surface, and survived to a maximum height of 0.80m.

Plate 1: Wall *101* and underlying deposits *102*, *103* and *104*, in the west-facing section of Trench 1

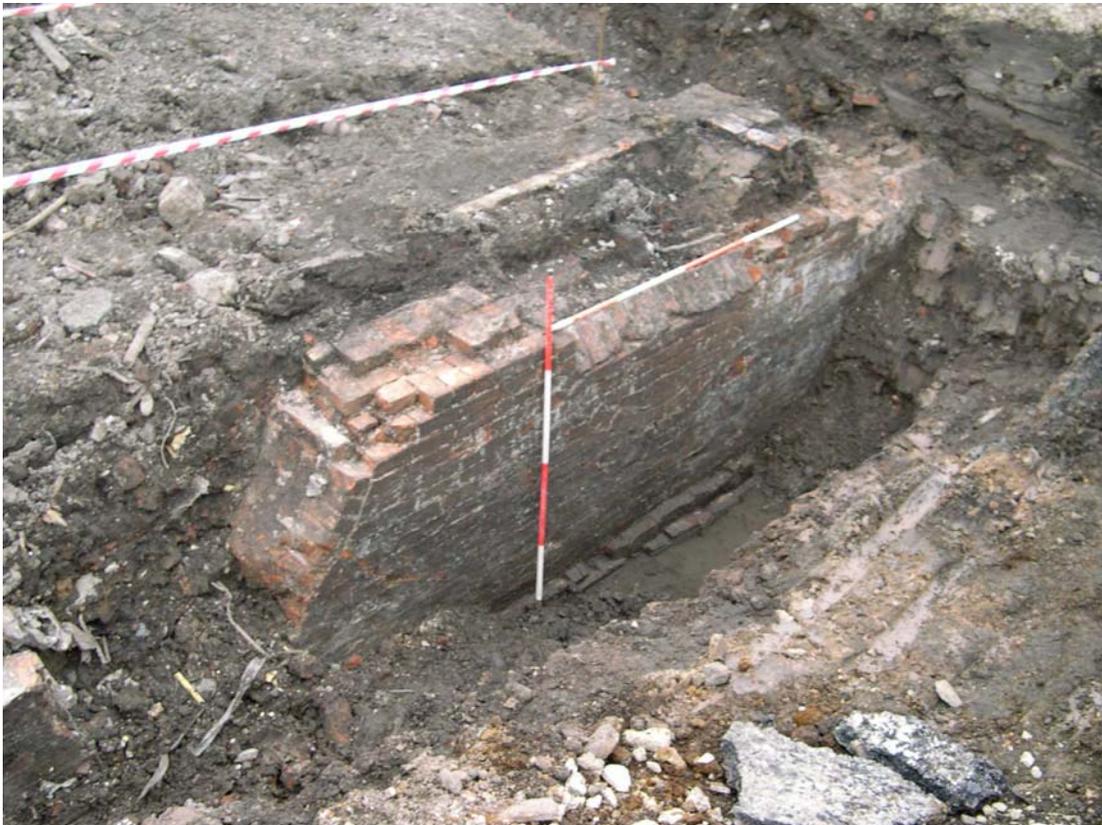
Plate 2: South-eastern end of wall *205* within Trench 2

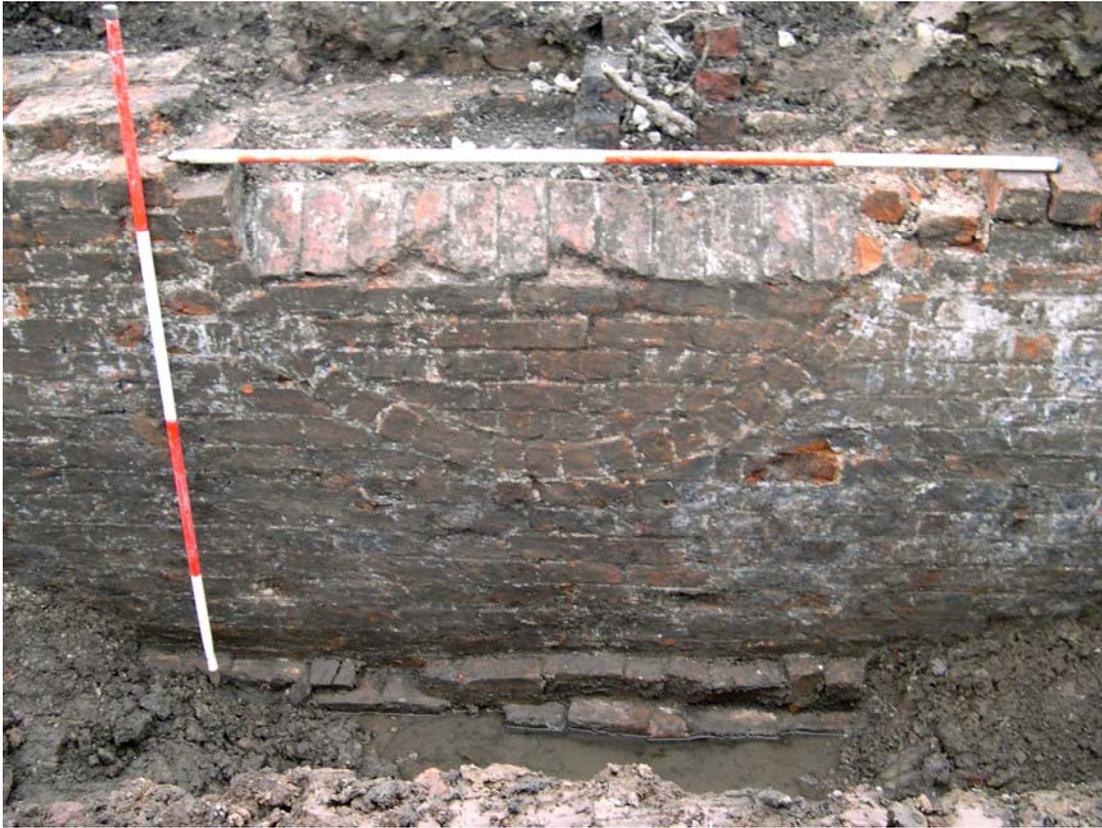
- 3.2.10 Two of the relieving arches had also been modified, perhaps at a later date, with the insertion of a course of sloping bricks, implying that the arches had been converted into cellar lights. The north-western arch did not retain any evidence for its conversion to a cellar light, although it had been damaged by the insertion of a manhole (**208**) as part of a modern drainage system (Plate 4).

Plate 3: The central relieving arch within wall **205**, Trench 2, with sloping bricks denoting use as a cellar light

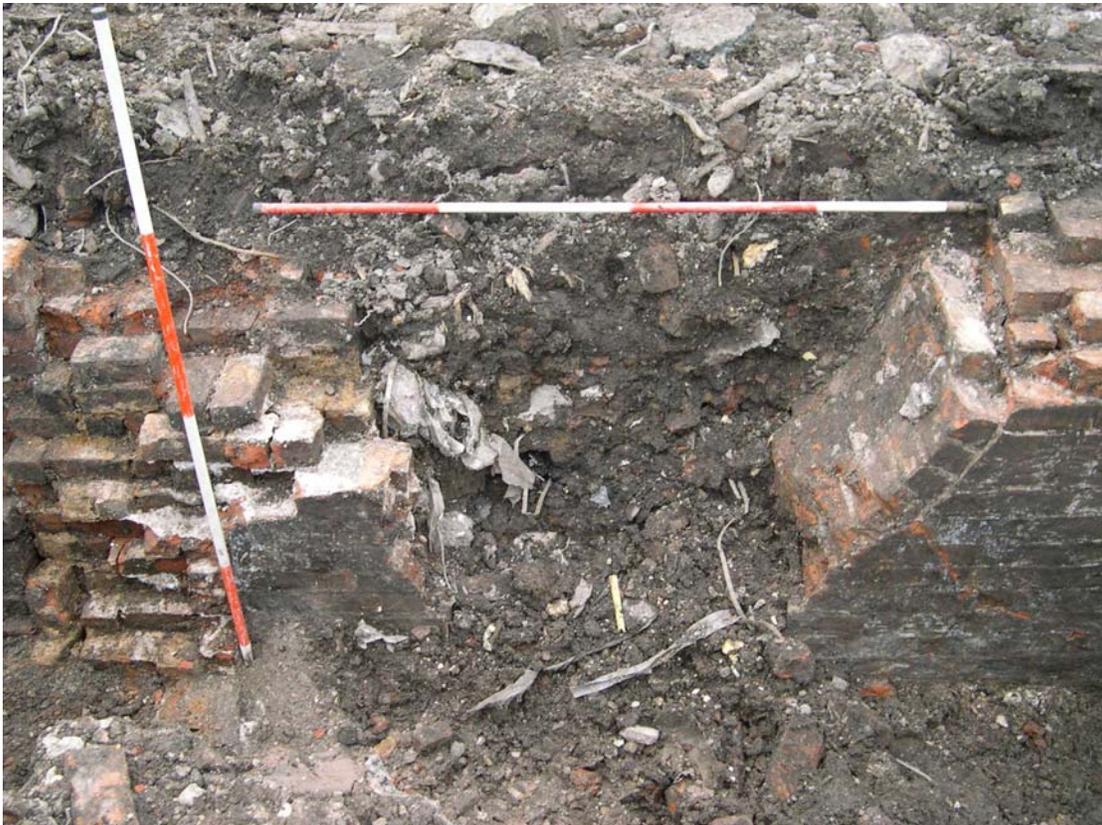
Plate 4: The north-western relieving arch within wall **205**, damaged subsequently by the insertion of manhole **208**

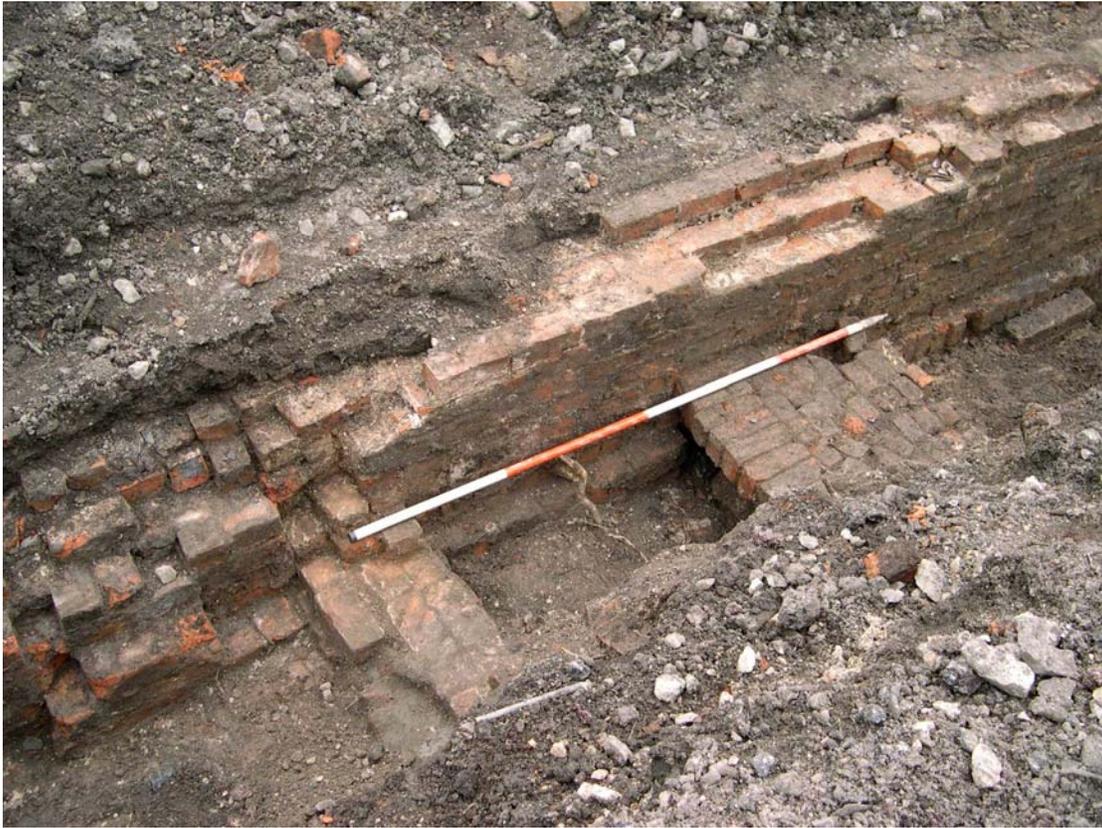
- 3.2.15 The north-eastern extent of wall **209** was butted by wall **210**, which was aligned north-west/south-east, forming an extension to wall **206** (Fig 9). The butt joint implied wall **210** to have been an addition to the original build. Whilst this could not be corroborated by other physical evidence, it is tempting to associate this with the putative extension to the mill apparent upon Thornton's map of 1824 (*1.3.8 above*). The wall was again composed of hand-made bricks, laid in an English Garden Wall bond, with a single offset foundation course. The upper surface of this wall was encountered at a height of 48.33m aOD, and its foundations were exposed at a height of 47.53m. The wall measured 5.63m long, and was butted by wall **212** at its north-western end (Fig 9).

- 3.2.16 Wall **212**, aligned south-west/north-east, formed a return to the building and was again composed of hand-made bricks set in a lime-based mortar. The position of this wall corresponds with the north-western gable, as shown on Bancks and Co's map of 1831 (Fig 8). Situated between walls **209** and **212** was a small surface composed of hand-made bricks (**211**), which was three courses thick and overlaid the offset foundation of wall **210** (Plate 5). The function of surface **211** could not be ascertained with confidence, although it perhaps represented a solid foundation for an item of machinery.

- 3.2.17 The north-western end of wall **210** was butted by wall **213**, which was clearly of a later construction. Wall **213** was similarly on a north-west/south-east alignment, forming a continuation of wall **210** (Fig 9). The wall was composed of hand-made bricks, but had been bonded with a dark grey mortar. The position and alignment of wall **213** corresponded with an apparent boundary wall along the southern edge of New Islington, as shown on Bancks and Co's map of 1831 (Fig 8). The north-western end of the wall had been damaged by the insertion of a cast iron service pipe (**214**).

Plate 5: Walls *210*, *212*, and *213*, and brick surface *211*, Trench 2

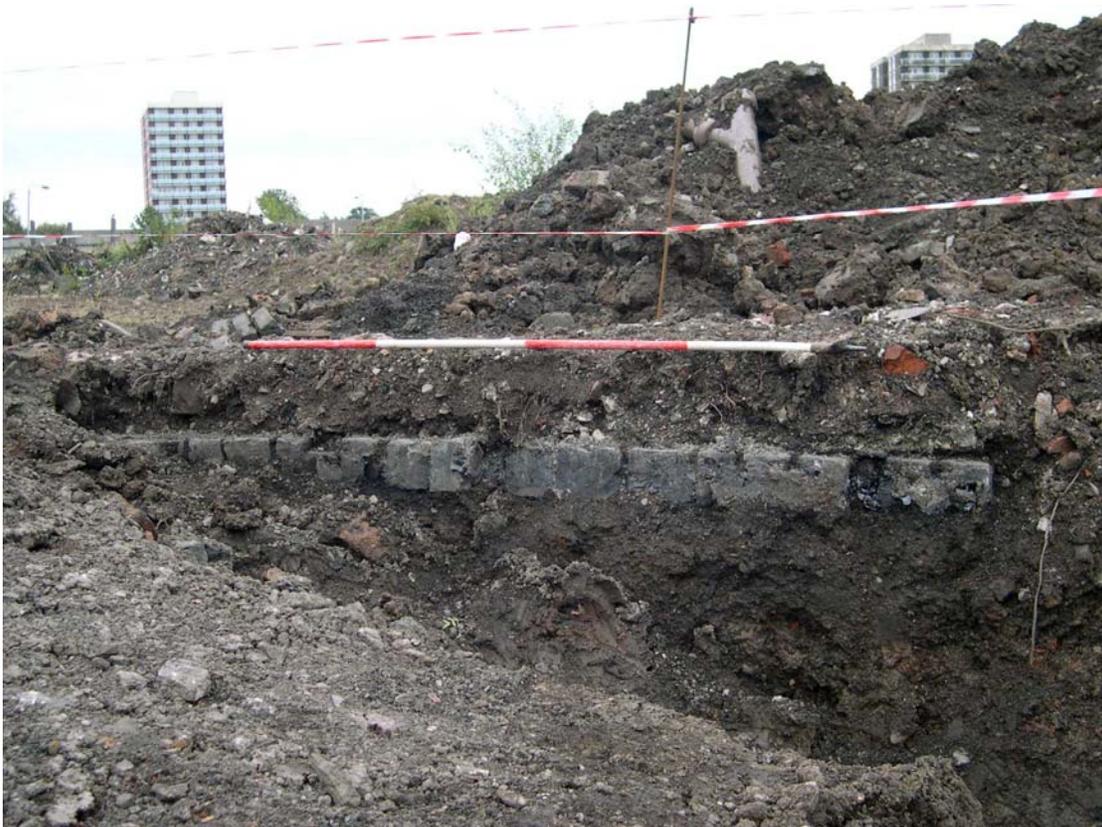
Plate 6: The remains of New Islington road in the north-facing section of Trench 3

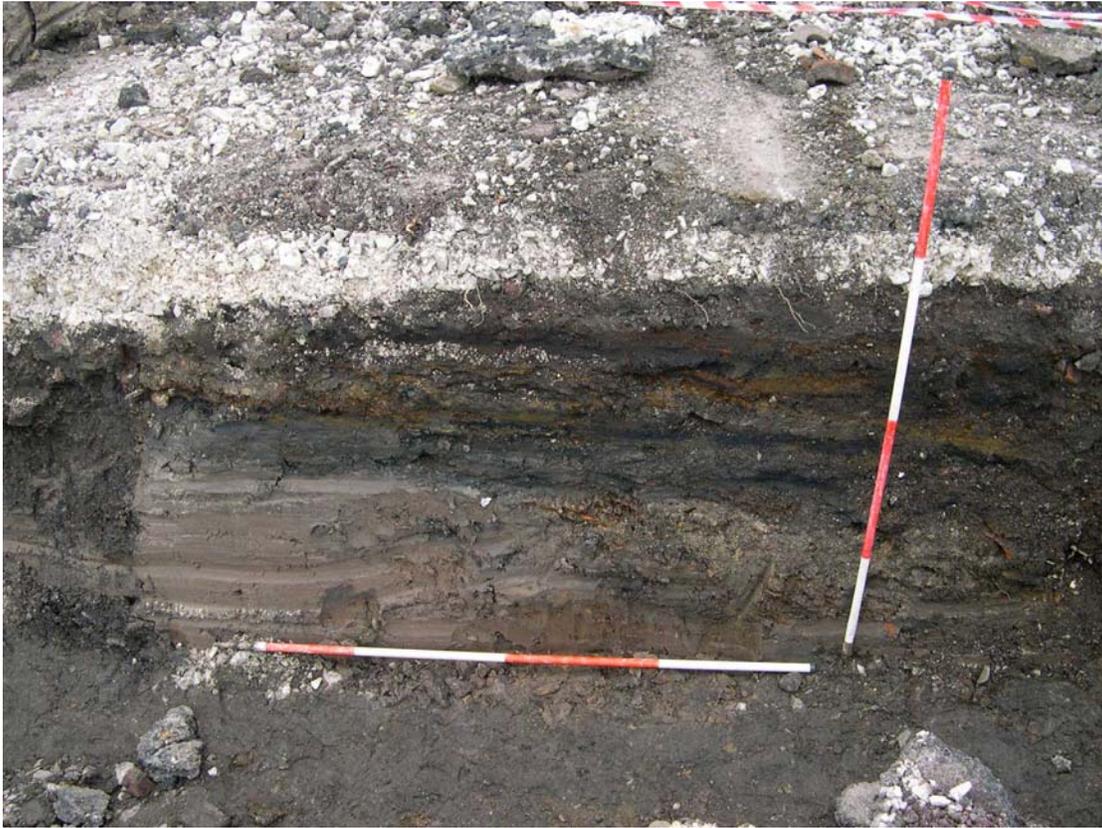
Plate 7: Part of the north-facing section of Trench 3, showing backfilled material

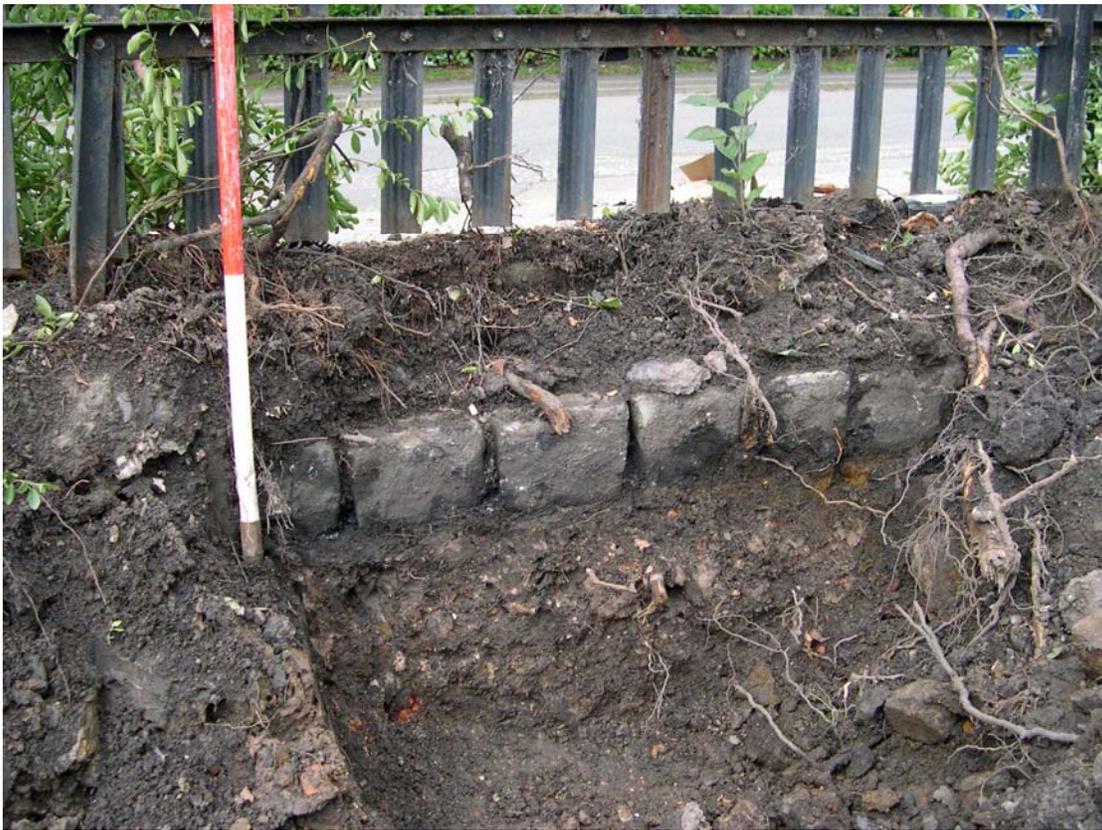
Plate 8: The original surface of New Union Street exposed in the section of Trench 3

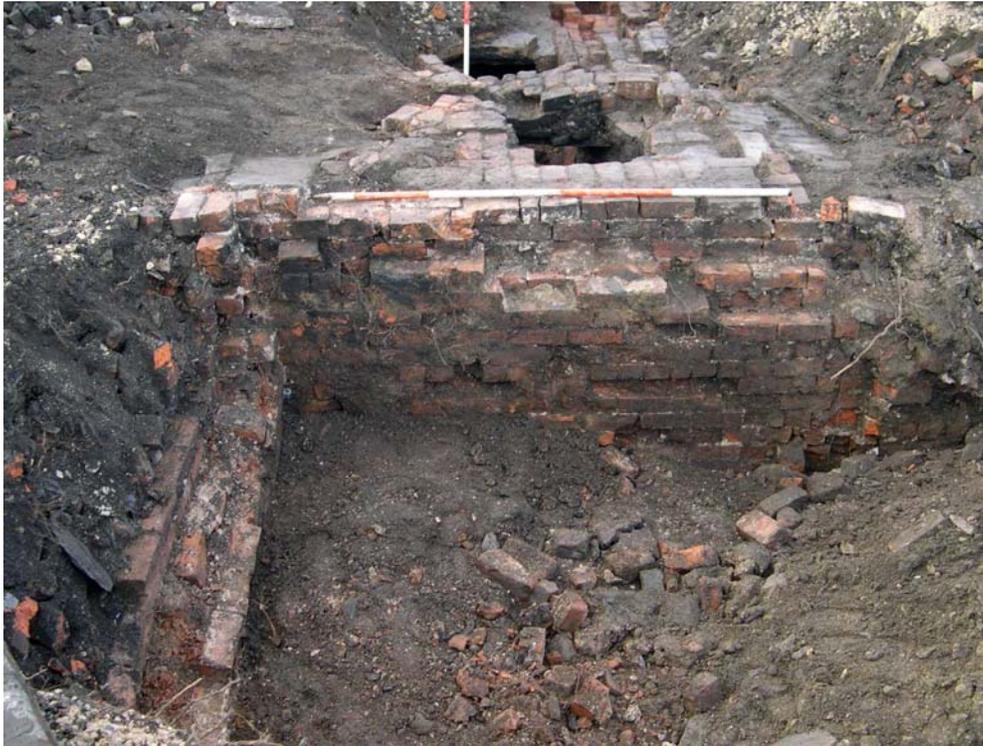
Plate 9: Walls *417* and *416*, Trench 4, with flue system *402* to the rear

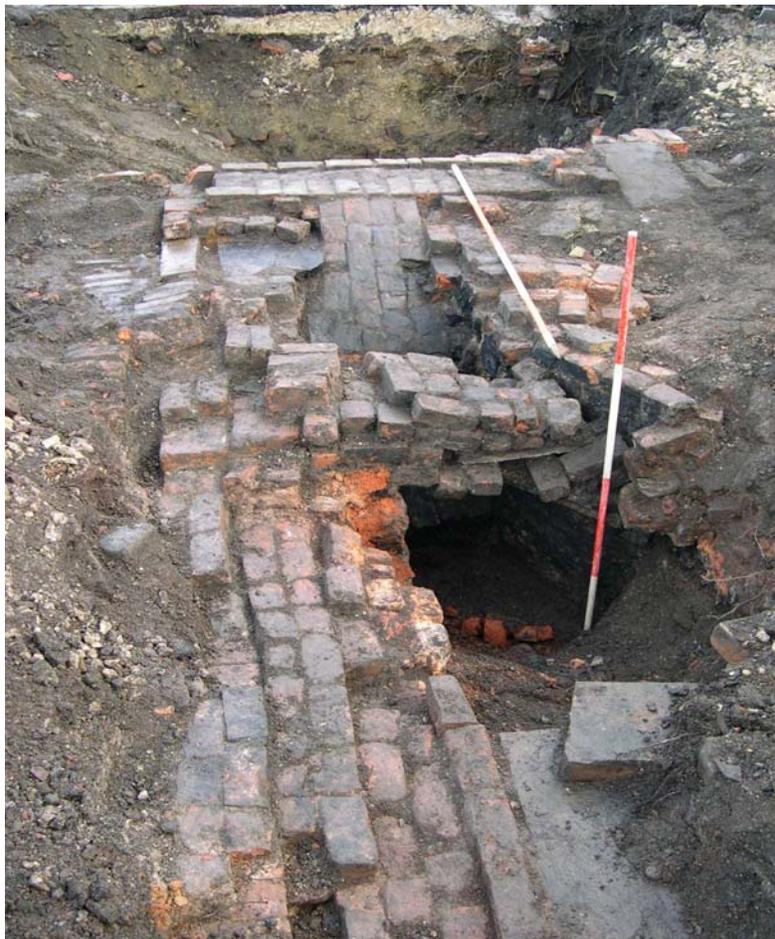
Plate 10: Looking south-east along Trench 4, showing the remains of the flue system. Wall *417* and *412* to the rear, metal lintel *411* in the centre, and wall *409* in the foreground

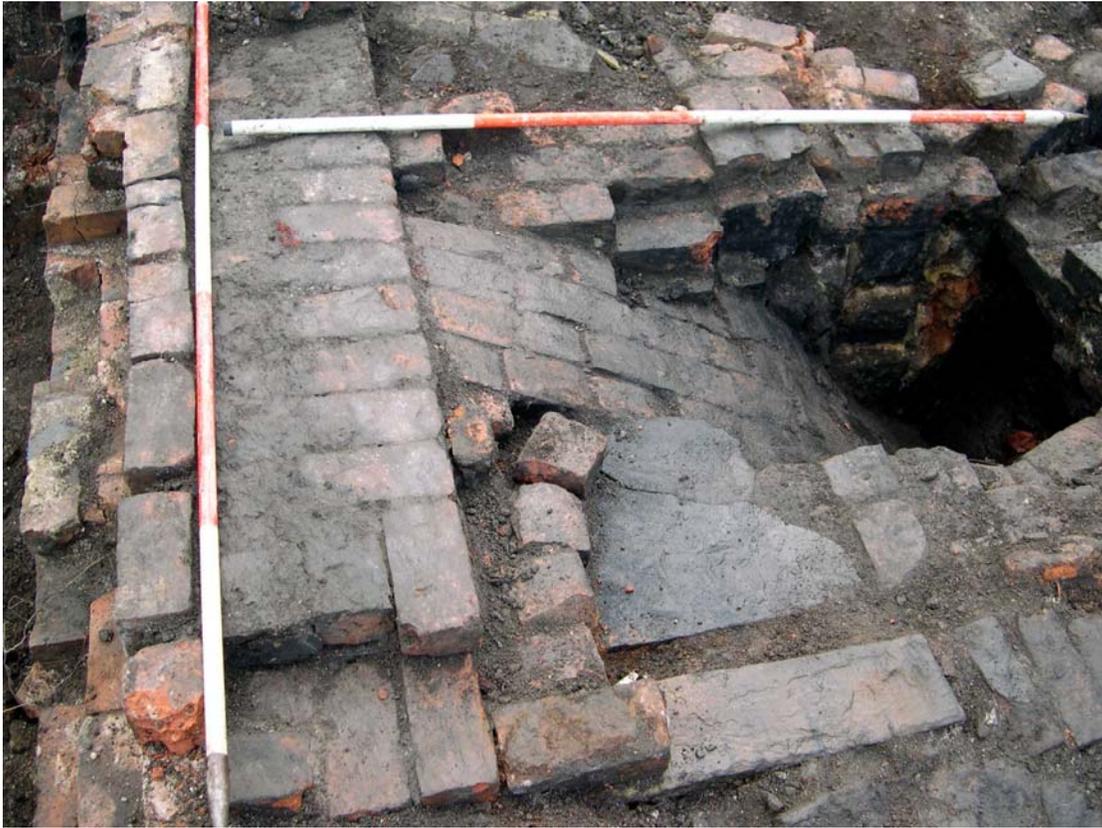
Plate 11: Feature **412**, Trench 4

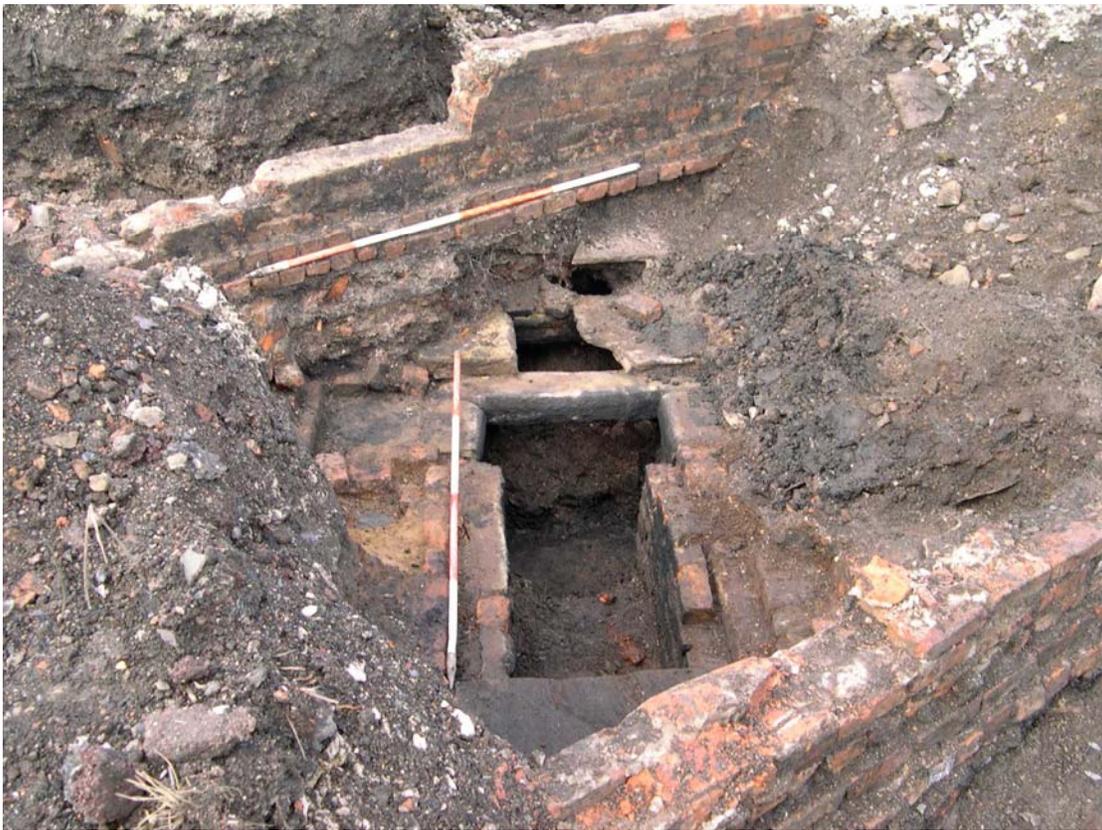
Plate 12: Flue **402** within the north-western end of Trench 4, showing wall **407** and **408**. The putative access point into the flue may be seen in the centre.

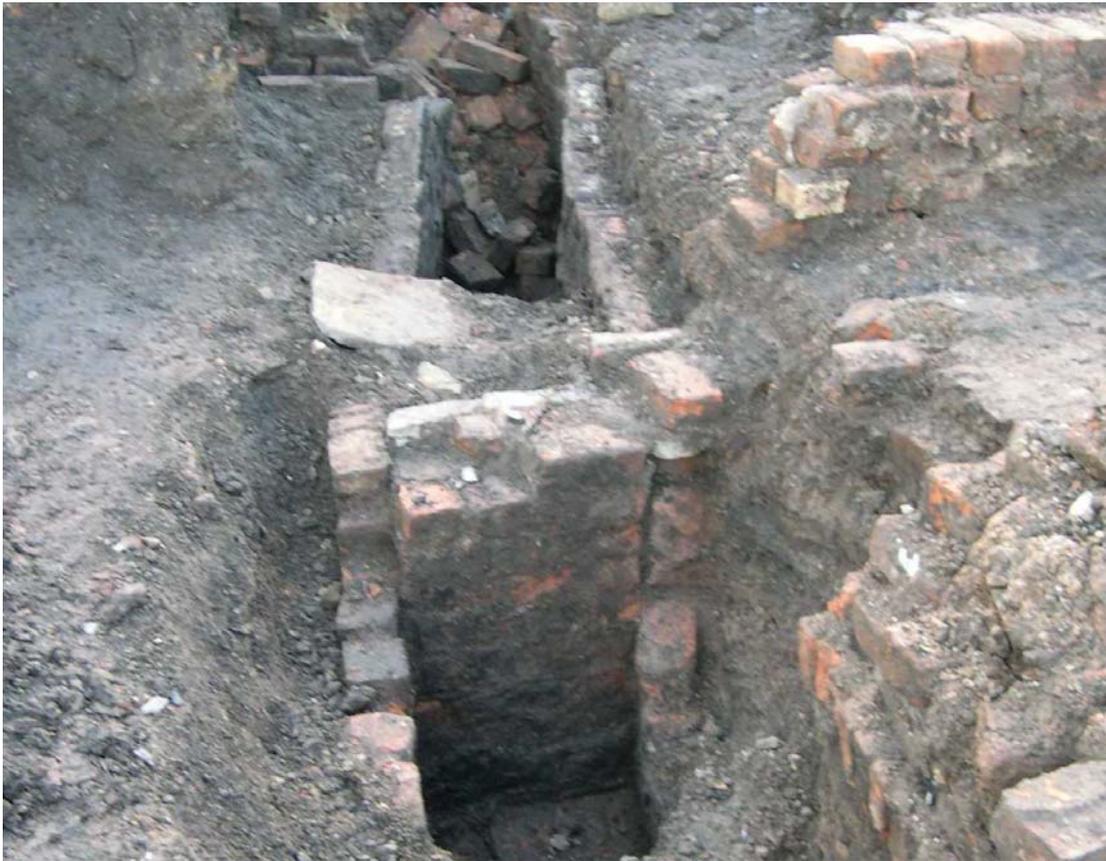
Plate 13: Flue blocking wall 525, Trench 5

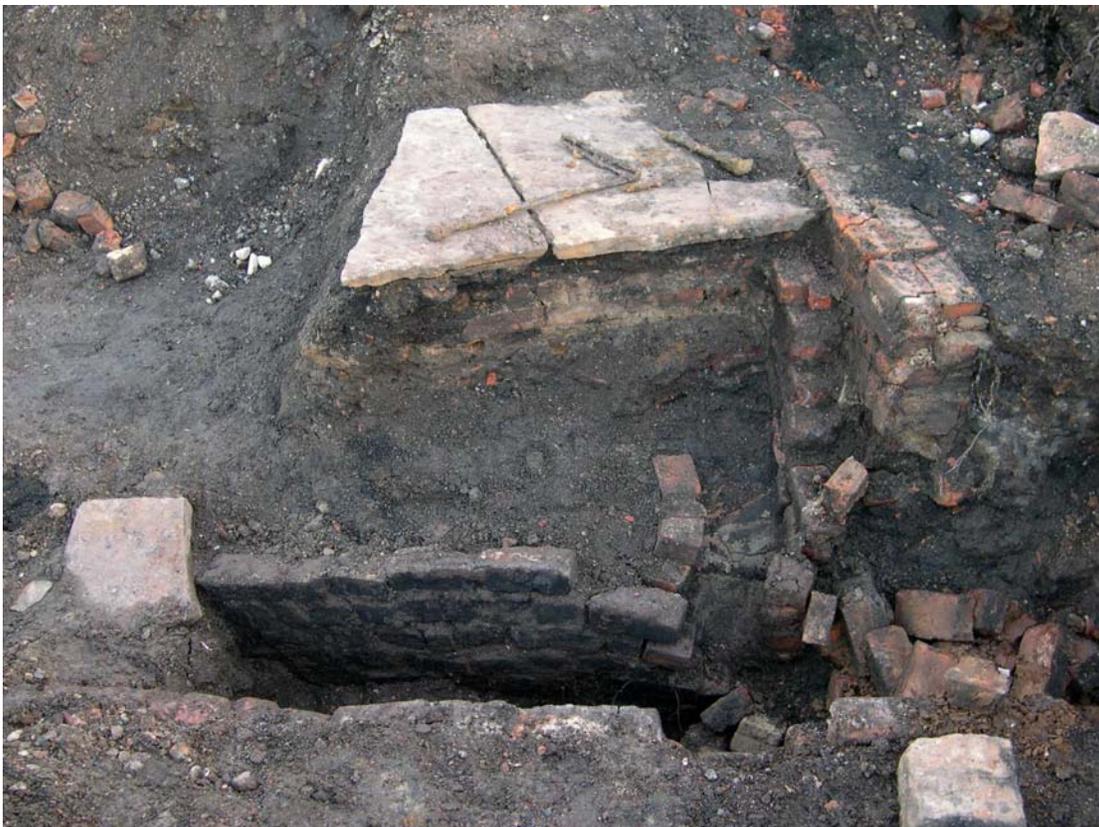
- 3.2.37 A short series of structures were exposed along the south-eastern side of flue **501**, beyond blocking wall **525**. At the south-western end of the trench, an insubstantial, narrow channel (**521**) connected with the flue (Plate 14). The channel was 0.20m wide, comprised heavily-sooted bricks, and sloped up from the flue. A short distance to the south-west degraded traces of an iron housing was noted to cross the channel of flue **501**. This may have represented a mechanism to control flue gases.

Plate 14: Flue 501 and channel 521, with wall 523 and surface 522 to the rear

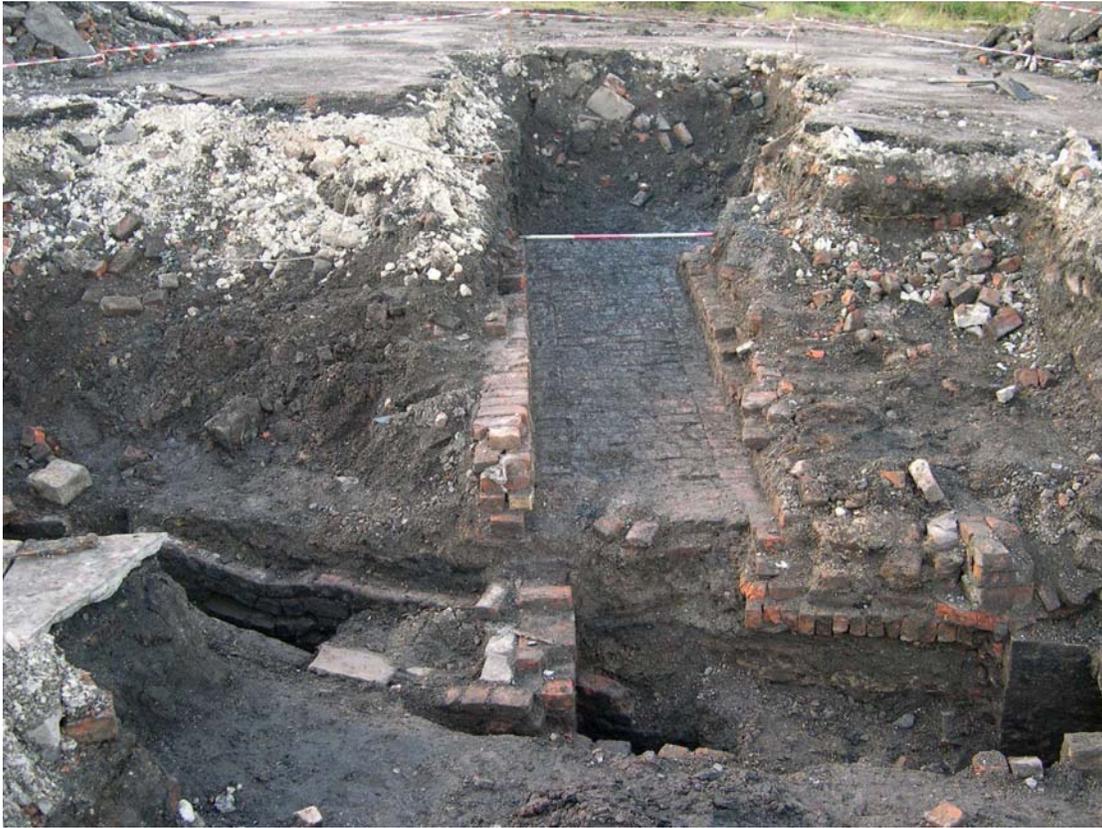
Plate 15: Putative entranceway 520, with flue 501 in the foreground

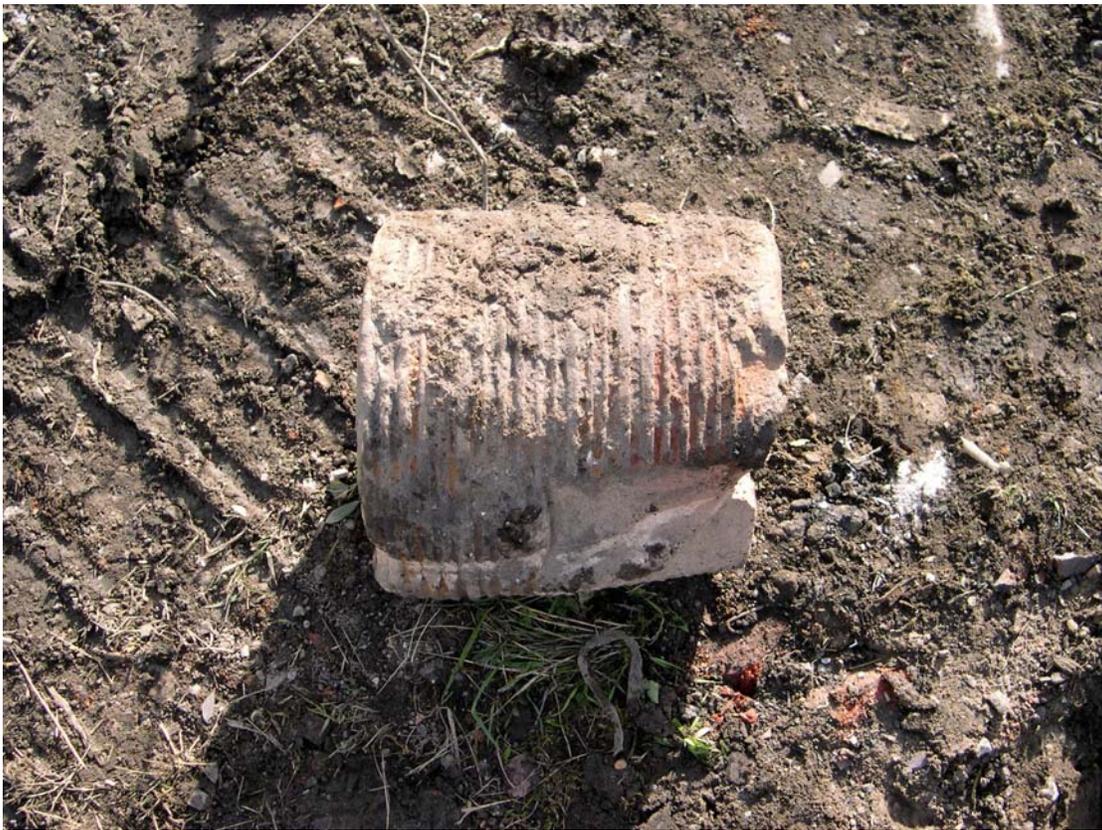
recovered from layer **401**, Trench 4. The smallest object had a diameter of 185mm, a thickness of 70mm, and a central circular hole of 70mm diameter. Two shallow rebates worn into the surface around the periphery suggested that this object may have been used as a pulley connected to a line shaft, used to power an item of machinery.

Plate 16: Large stone object
