**CASTLE COMBE  
WILTSHIRE**

**PROGRAMME OF  
ARCHAEOLOGICAL RECORDING**  
*For*  
**WILTSHIRE COUNTY COUNCIL  
AND ENGLISH HERITAGE**

CA PROJECT: 1928  
CA REPORT: 09034

MARCH 2009

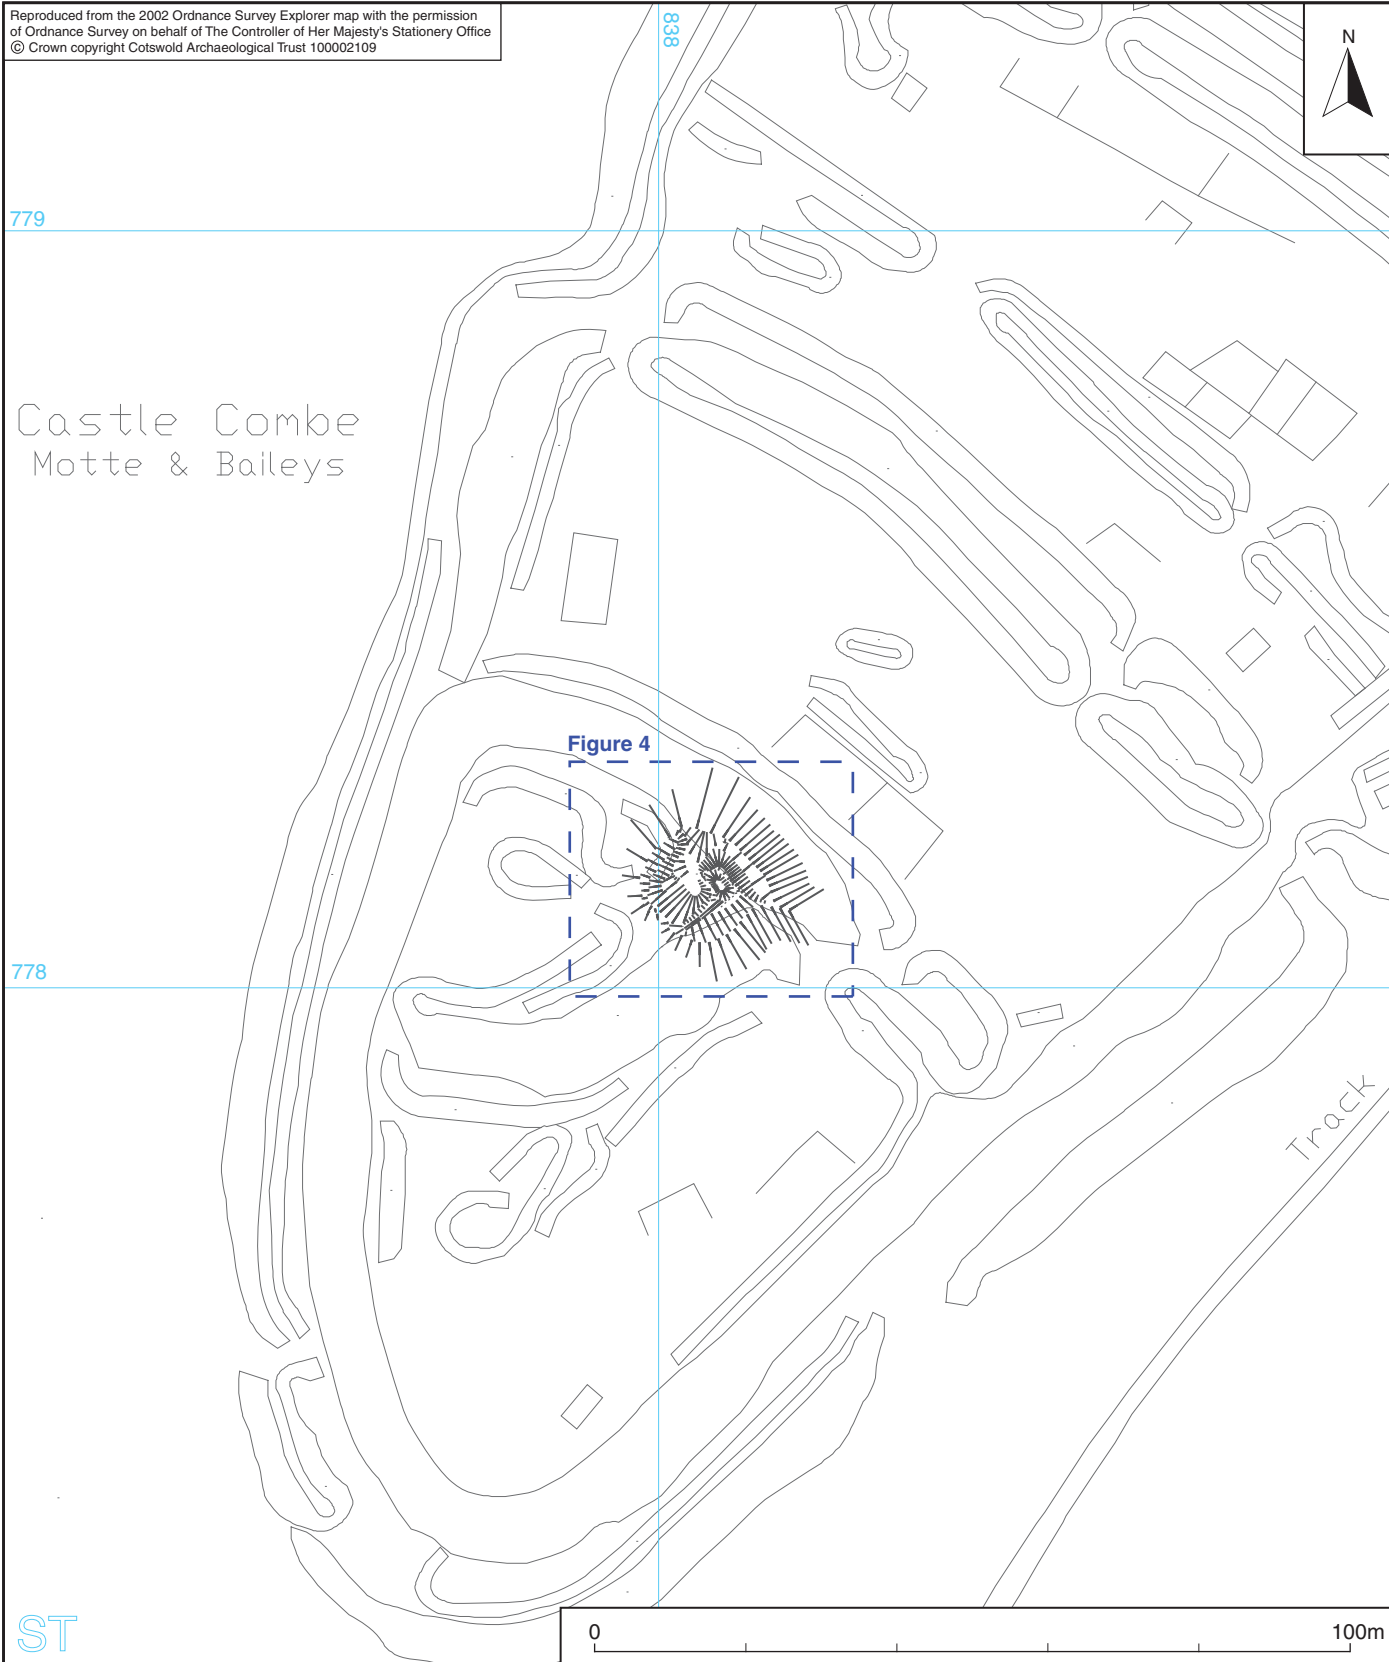
**2**

**Site location plan, showing area of earthwork survey and subsequent archaeological recording**

- 1.6 The castle consists of four baileys, with indications of approximately 17 masonry structures or buildings, and a motte (information from Wilts. CC SMR) possibly occupying the site of an Iron Age promontory fort (Fig. 2). William of Worcester recorded in an entry of 1450-60, in the cartulary of Castle Combe, that 'there was a castle in the middle of the park here, seated upon a hill, which was destroyed by the pagan people coming from the kingdom of the Danes, as invaders and enemies to King Alfred, in the year of Christ eight hundred and (seventy) eight', although there is no currently physical evidence to support the identification of Saxon occupation on the site. The castle remains have statutory protection as a Scheduled Monument (County monument no. 12285). A stone-built rectangular stone tower/keep survives within the eastern part of the upstanding earthwork motte. This tower was cleared of rubbish a few years before 1852, and the two lower storeys of the building revealed were identified as the lower parts of a keep (Scrope 1852).

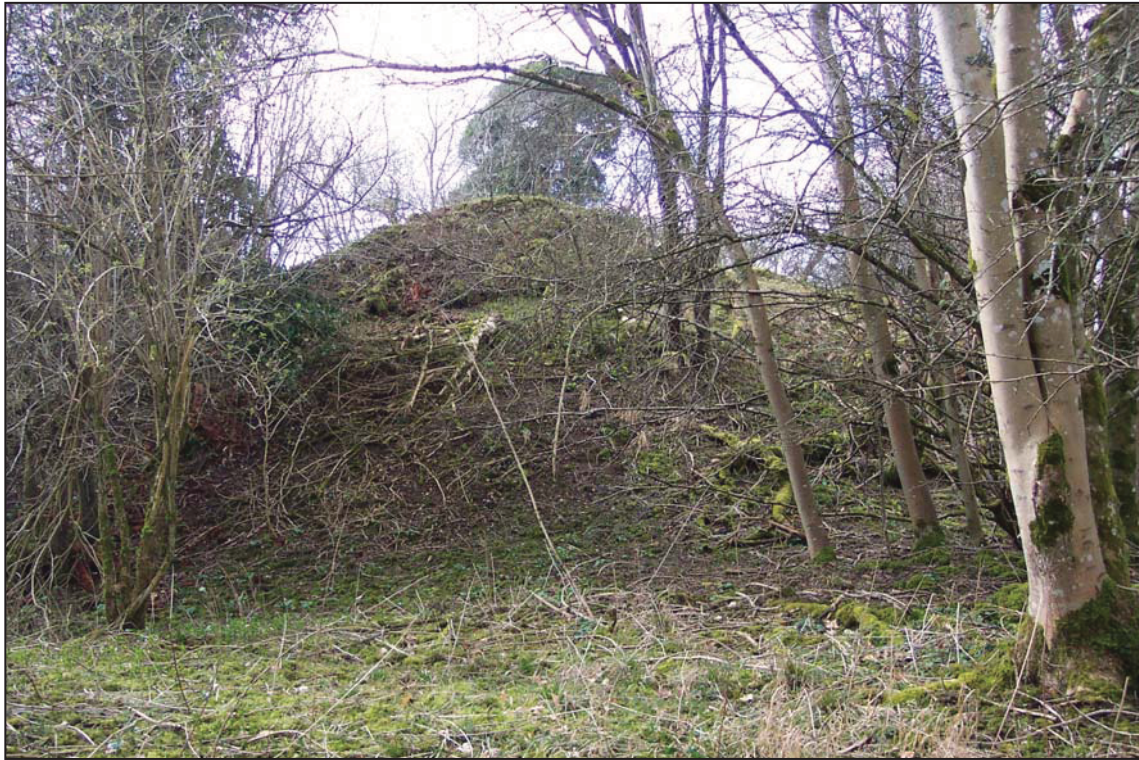
3a View of earthwork mound, looking south-west

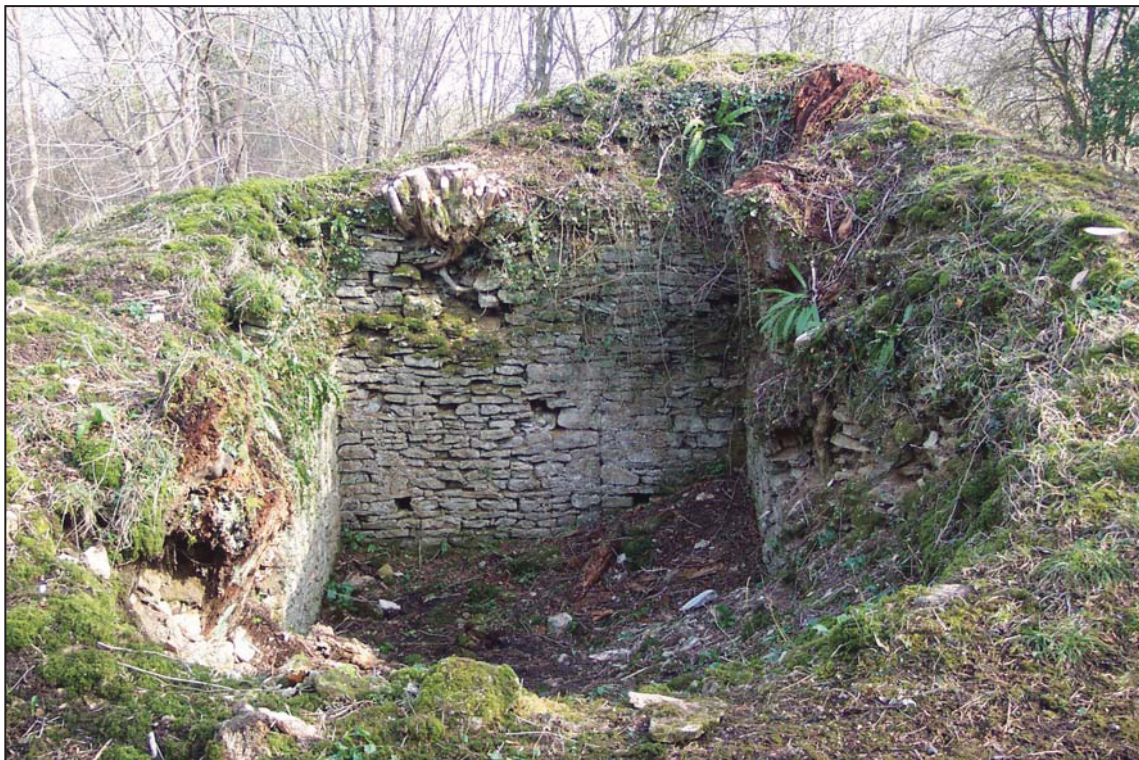
- 1.2 The staged programme of recording was carried out in conjunction with consolidation works to a stone tower/keep within the south-western part of the castle at Castle Combe (Fig.2). This structure, which survives in parts to a height of 3.5m, had been subject to damage from trees growing within the masonry and parts had collapsed in recent years. As part of a proactive programme of monument management, following discussions between English Heritage and Wiltshire County Council, these trees were cut down in February 2005 to remove the sources of damage and to enable emergency consolidation works to be carried out to the surviving structures to prevent further collapse (Fig. 3) and these took place between March and September 2005.

3b View of structural remains, looking north-east

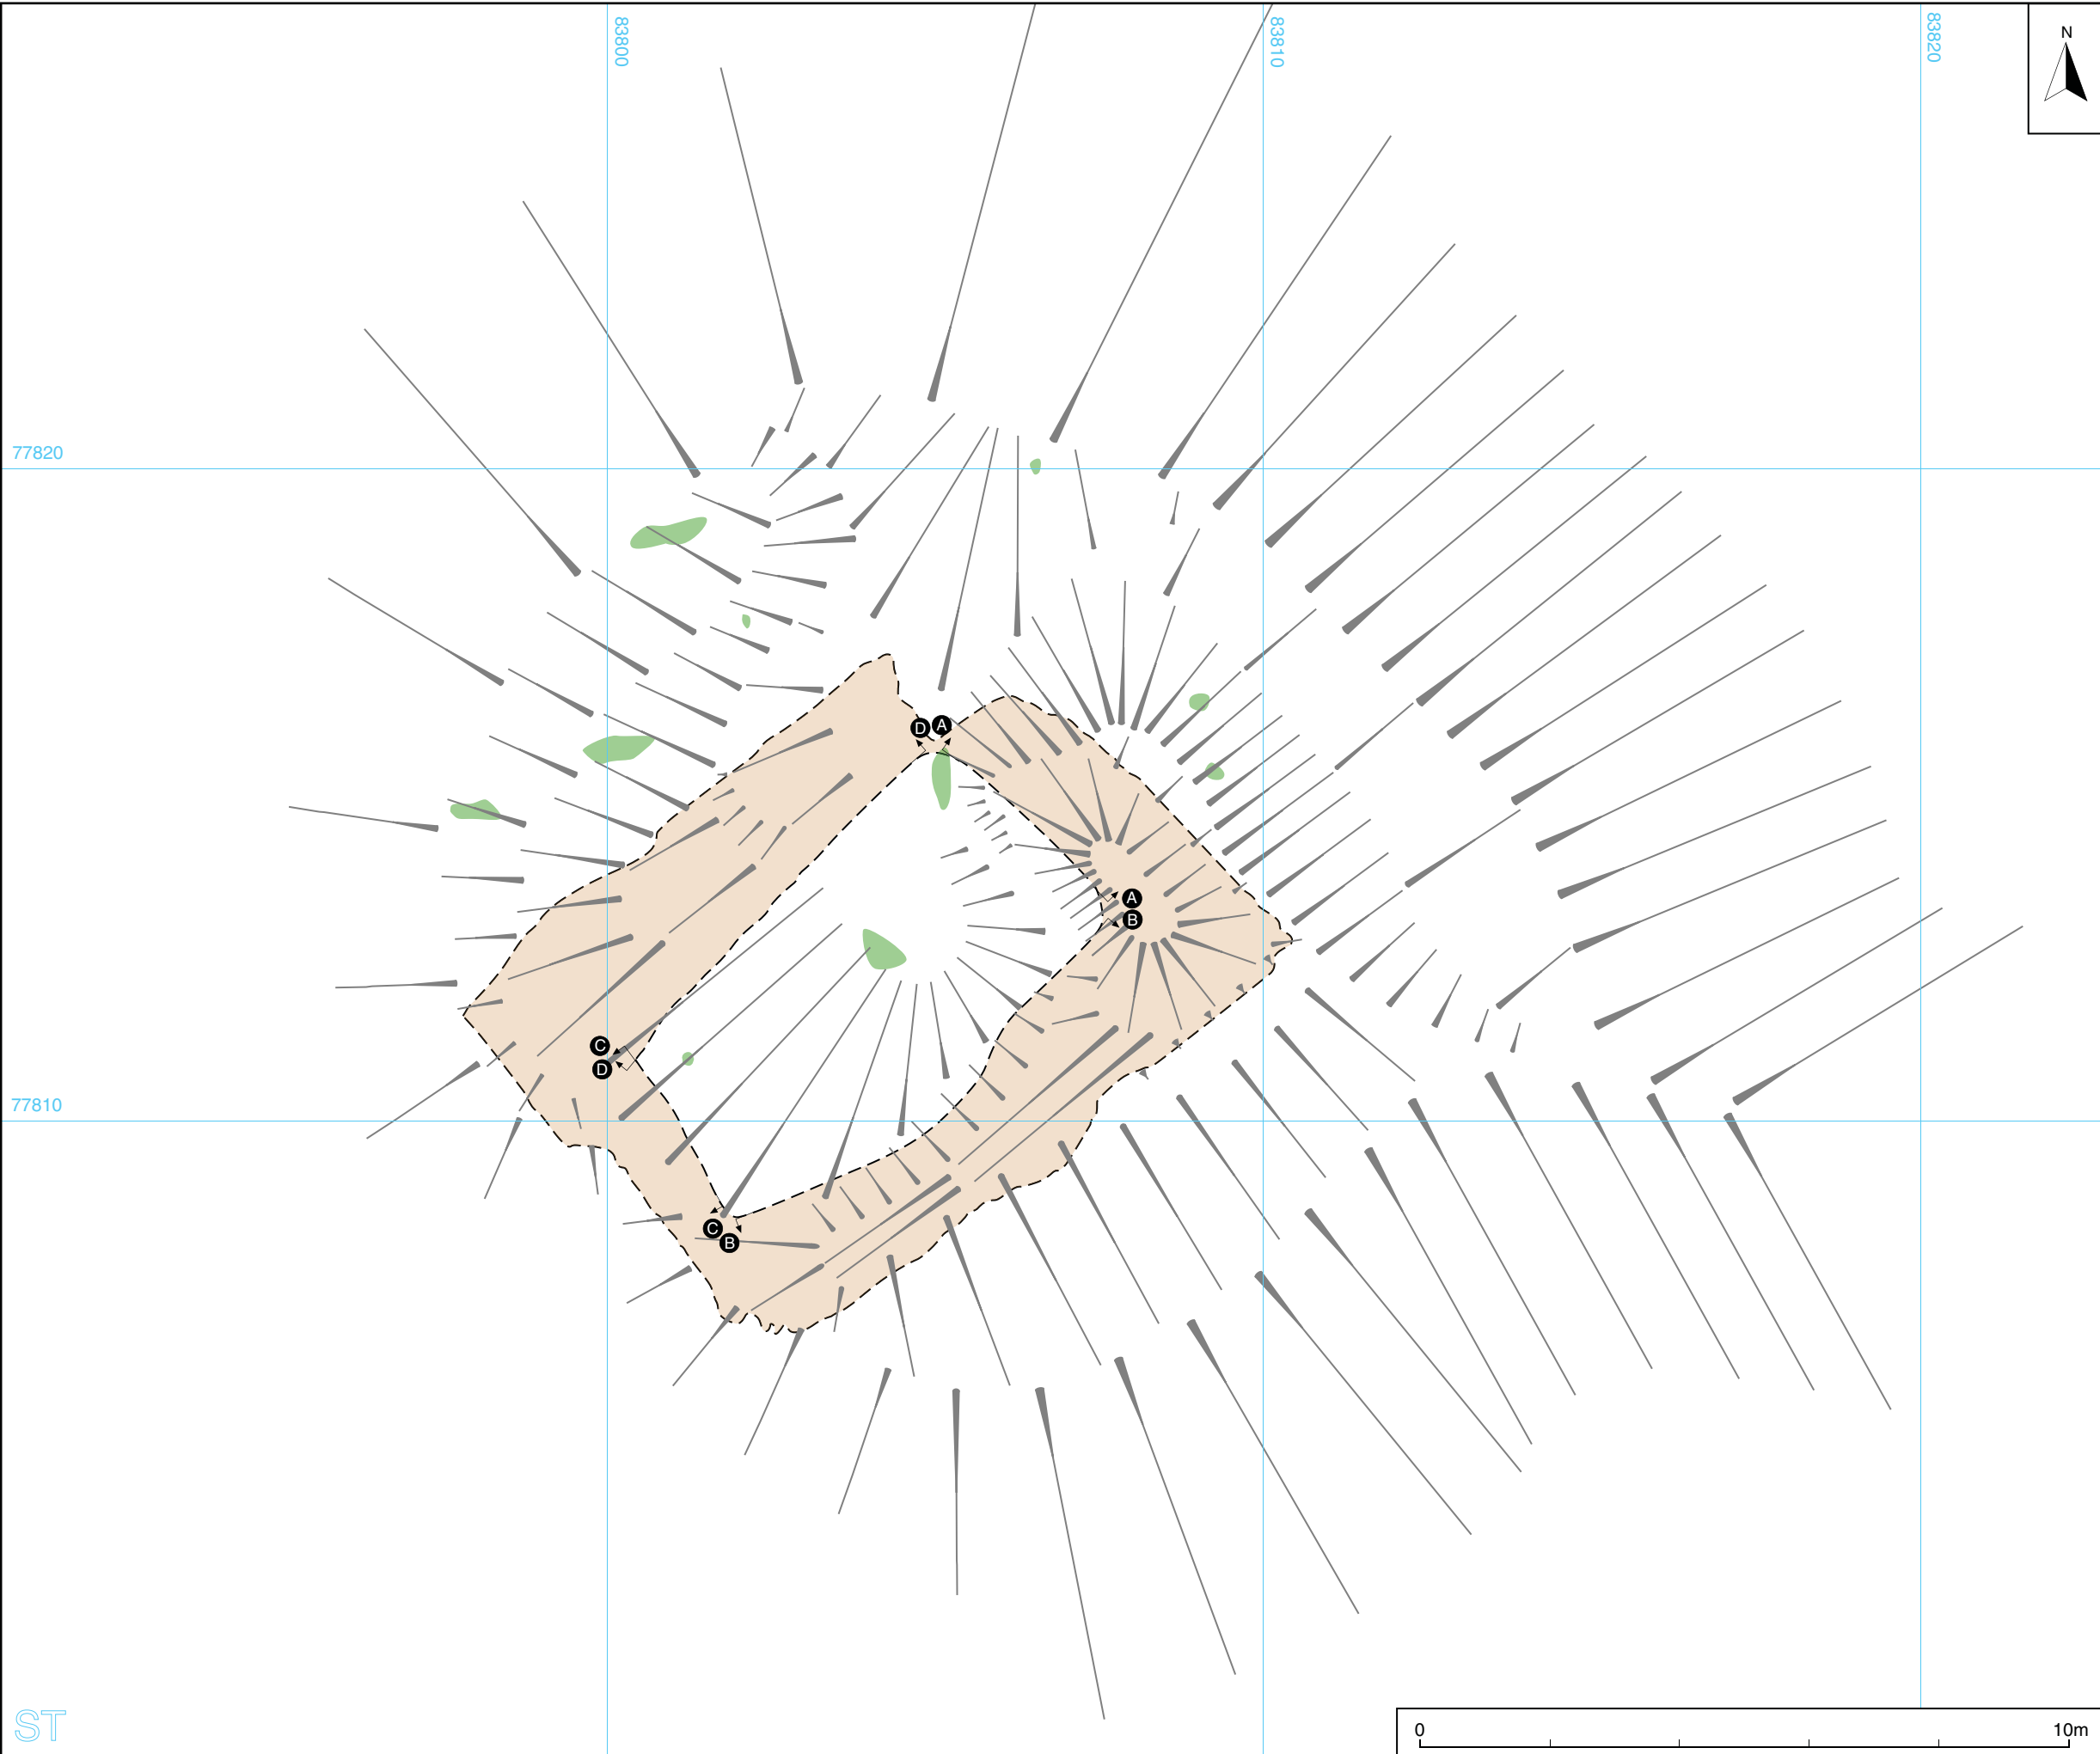
SCALE	PROJECT NO.	FIGURE NO.
1:100@A3	1928	<b>4</b>

FIGURE TITLE  
**Plan showing earthwork survey  
results and position of structural  
remains**

i) A base site survey was first undertaken using electronic Total Station and hand-measurement of exposed masonry structures and the immediate setting within the motte, including an earthwork plan of the outside of the motte, supplemented by photographic survey (black and white, colour slide and digital) and a written description of the remains. This provided an essential 'point in time' picture of the site before the works began and the first detailed site survey for use in the subsequent works (Fig. 4).

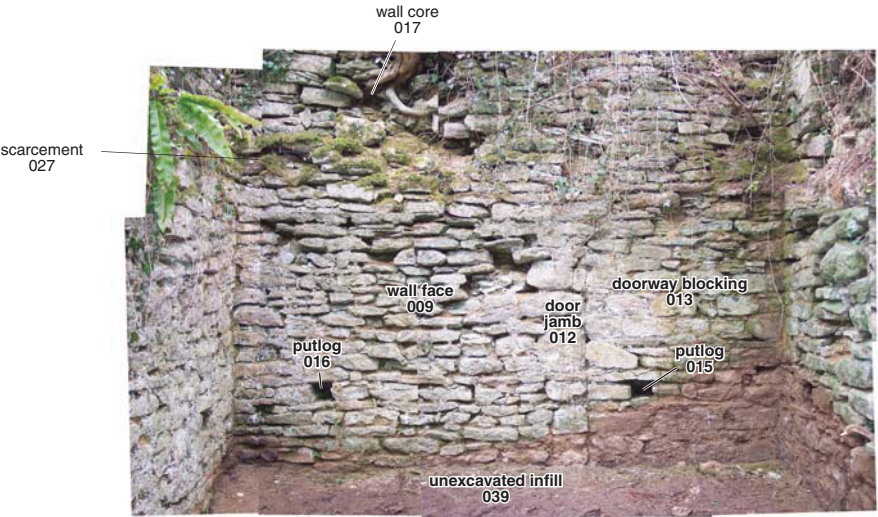
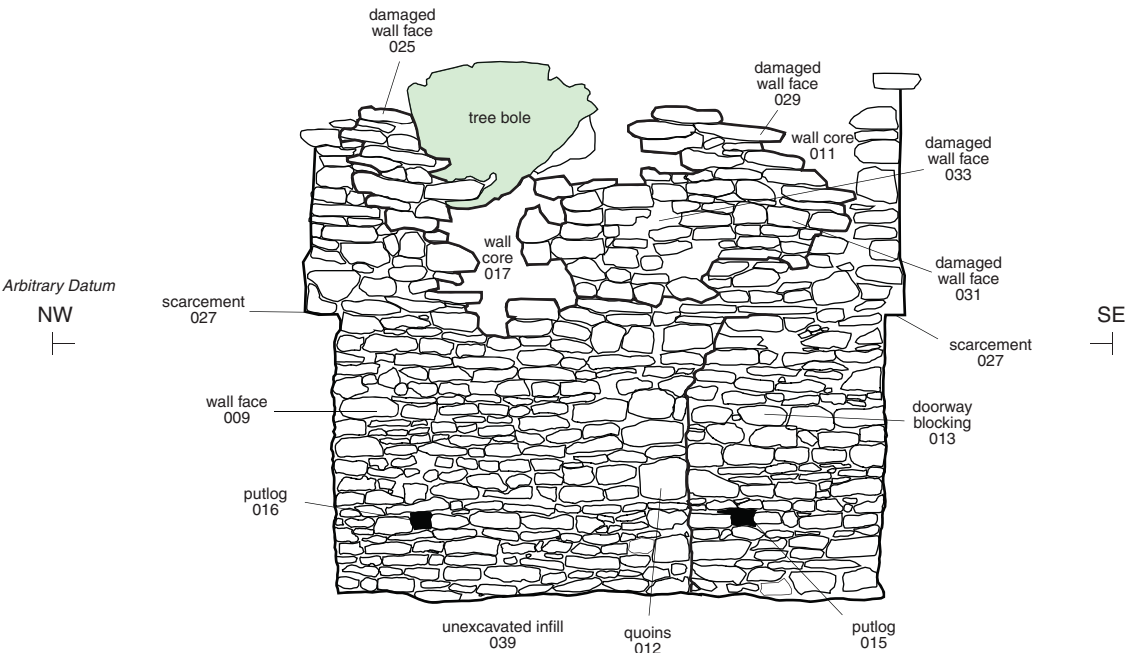
DRAWN BY	SCALE	PROJECT NO.	FIGURE NO.
RK	1:50@A4	1928	5

- 2.3 The north wall 009 was 3.6m in length and approximately 1.6m wide, with up to 20 courses surviving in good condition to a height of 1.85m above the limit of excavation to the level of a clear ledged scarcement 027 and 002, formed by the fabric of the east and west walls. Above this level frost-shattered and root-affected areas of wall face and core 011, 017, 025, 029, 031 and 033 were noted and

recorded prior to repair. The surviving wall fabric continued a further 1.5m above the scarcement and survived to approximately 15 courses, with wall core exposed above this. It was noted during recording that the face of this upper part of the north wall was set back from the face of the wall below from about three courses above the scarcement level, and it is likely that this represents a rebuild of the upper part of the structure.

- 2.4 Within the eastern part of the north wall clear quoins of roughly squared limestone 012 were identified, apparently forming the jamb of a former arched doorway, 1.3m in width and at least 1.85m in height (to scarcement level 027). The east wall apparently formed the other jamb of the door. No sill or associated floor level was encountered in the area of investigation. This doorway had been blocked with mortared limestone rubble 013. Subsequently two putlog holes were inserted in the wall, 015 within the blocking material, and 016 in the original main wall fabric 009.

North Wall photomontage, looking north-east

North wall south-west facing elevation AA

FIGURE TITLE  
**North Wall (internal): photomontage  
and south-west facing elevation**

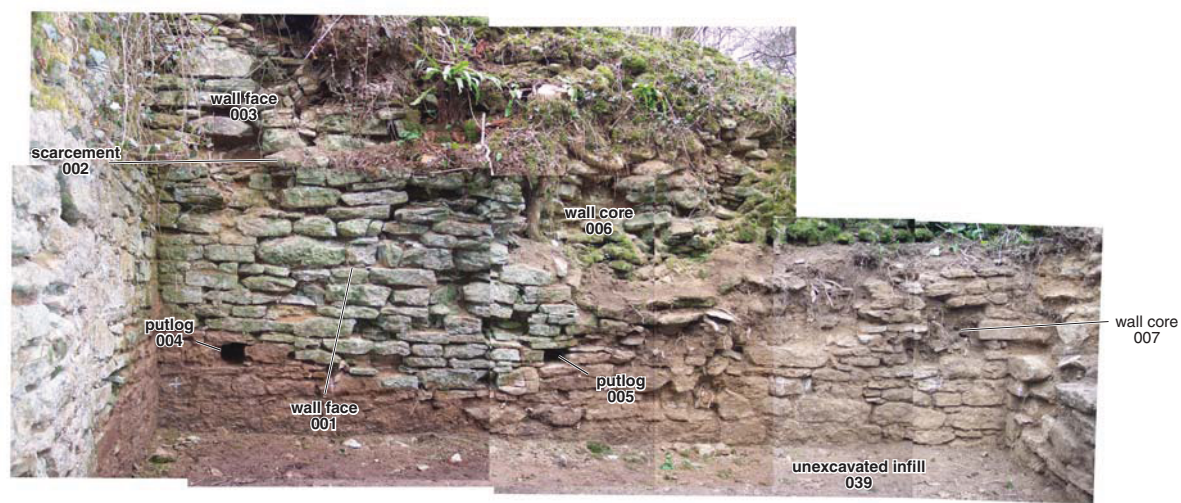
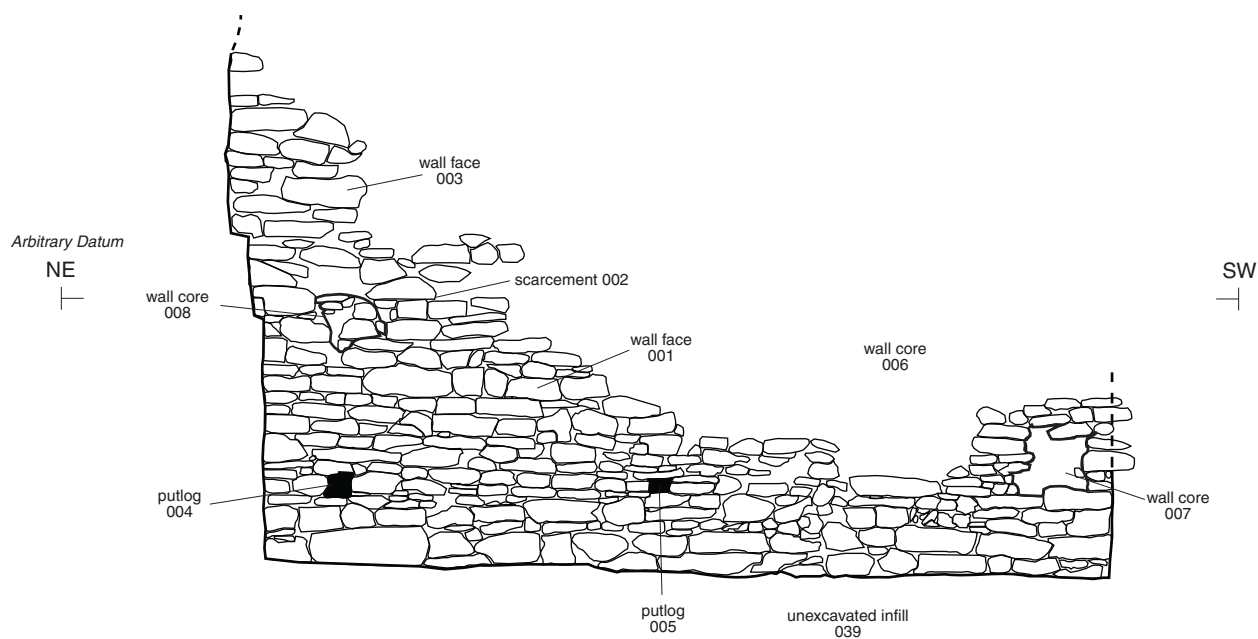
FIGURE NO.  
**6**

- 2.5 The east wall 001 was 5.6m long, approximately 1.9m thick and survived to 1.75m in height from the limit of excavation to scarcement level 002 which was formed as a stepped ledge within the surviving wall fabric. Extensive areas of wall core 006, 007 and 008 were exposed. The wall face 001 itself was generally poorly preserved although twelve courses survived to a height of 0.8m to the scarcement, and a further eleven courses above this at the northern end. It contained a single sherd of medieval pottery in its matrix, and a further three sherds of 11th to 13th-century pottery were recovered from within the wall fabric around scarcement 002, together with one intrusive 19th to 20th-century glass bottle in the loose rubble. Putlogs 004 and 005, approximately 0.10m by 0.12m in size, were noted in the east wall at 0.44m and 0.5m above the limit of excavation.

East Wall photomontage, looking south-east

East Wall north-west facing elevation BB

FIGURE TITLE  
**East Wall (internal): photomontage  
and north-west facing elevation**

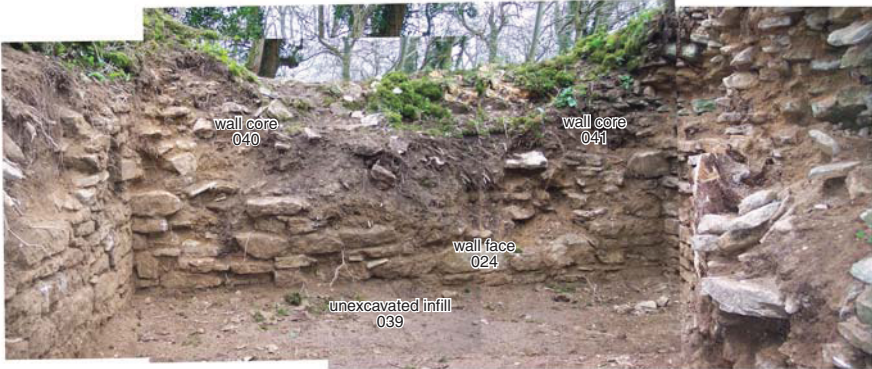
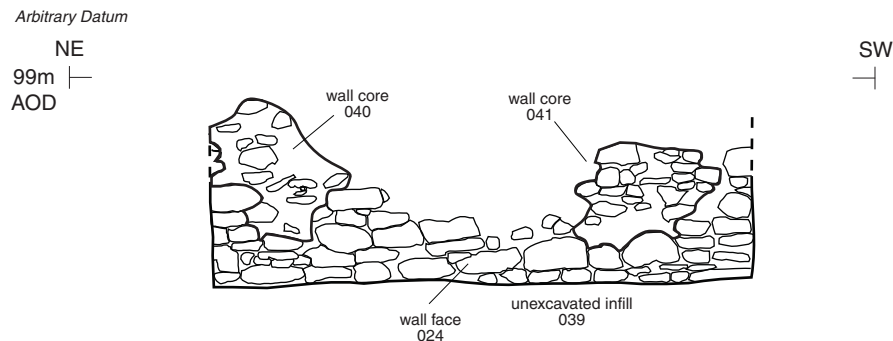
DRAWN BY	SCALE	PROJECT NO.	FIGURE NO.
RK	1:50@A4	1928	<b>7</b>

- 2.6 The south wall 024 was 3.55m in length, approximately 1.75m in width and survived only to 1.26m above the limit of excavation. The wall was far less well-preserved than the north wall, and the surviving fabric consisted mainly of large areas of rubble wall core 040 and 041 exposed as a result of root and frost damage. No features were recorded within the fabric.

South Wall photomontage, looking south-west

South Wall north-east facing elevation CC

FIGURE TITLE  
**South Wall (internal): photomontage  
and north-east facing section**

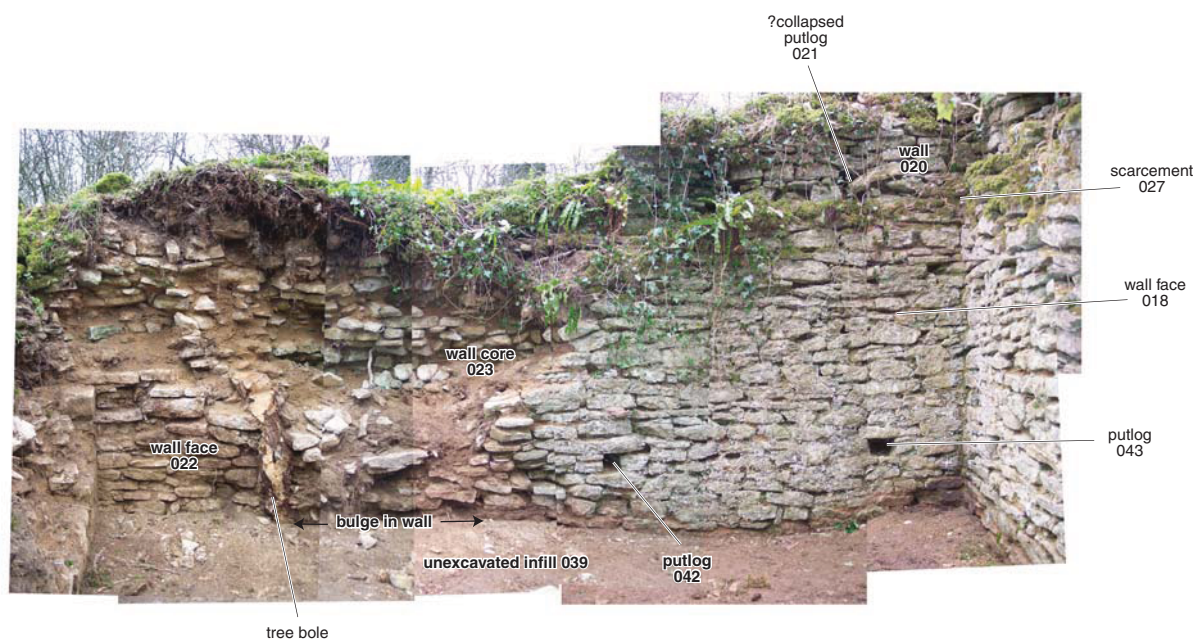
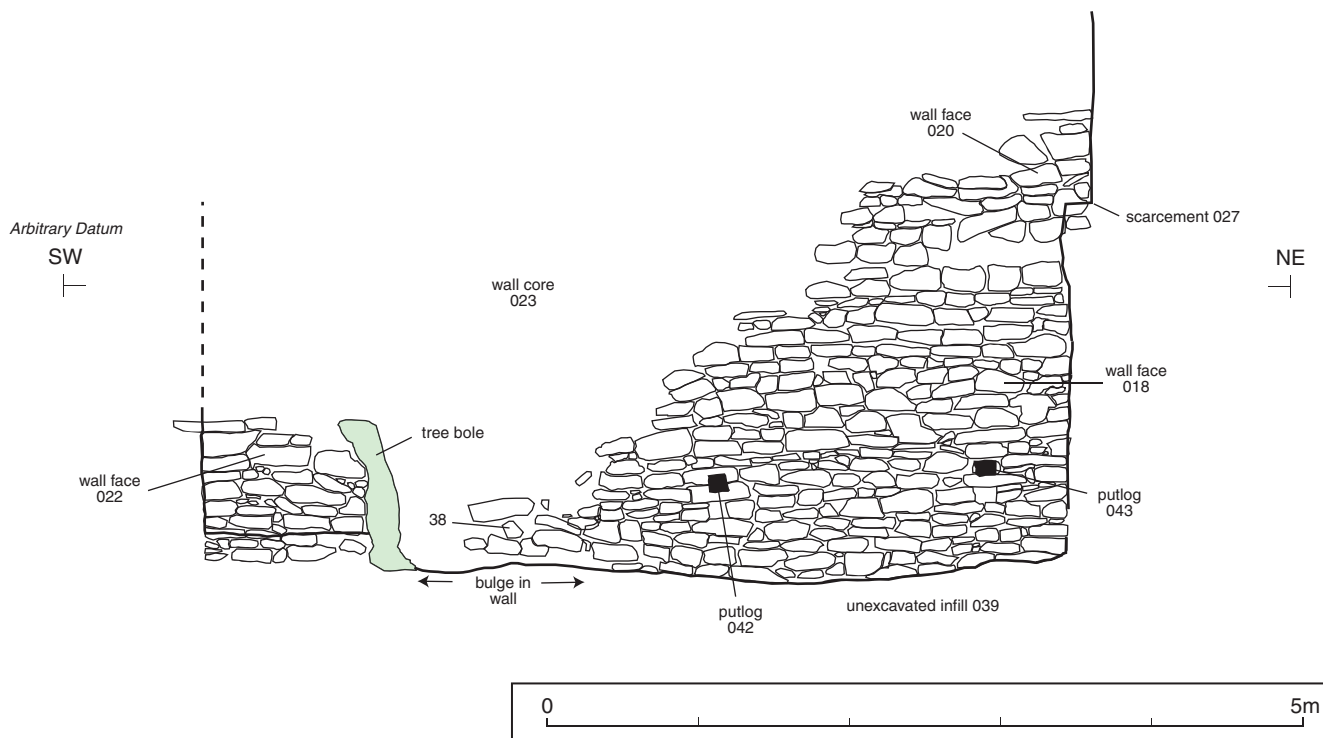
**8**

- 2.7 The west wall 018/022 was 5.7m in length and 1.6-2.4m in thickness, with up to 22 courses to the scarcement 027 surviving at its northern end (1.8m above the limit of excavation). Above this, a further eight courses were recorded. The wall face was extensively damaged along its south half, where a large area of wall core 023 was exposed and a discernible bulge noted. Putlogs 042 and 043 were recorded in the fabric of the wall, at the same level as those recorded in the north wall.

West Wall photomontage, looking north-west

West Wall south-east facing elevation DD

**West Wall (internal): photomontage and south-east facing section**

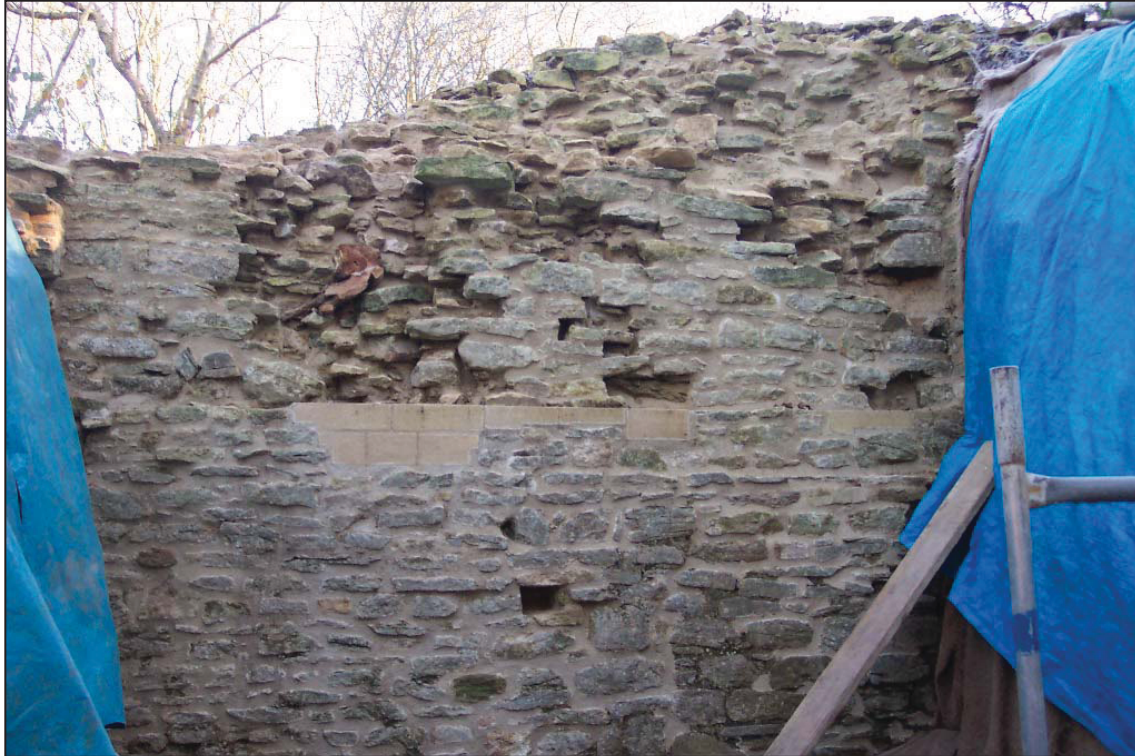
9

**9 View of North Wall with blocked doorway, looking north-east, showing consolidated stonework**

**View of consolidated structural remains (North Wall)**

vii) Consolidation works undertaken by Stonewood Builders of Castle Combe in accordance with a *Schedule of Works* (WCC 2005) were monitored by CA in case of need for further investigation/recording.
