Woodhall House, Colinton, Edinburgh.

November 2011 – March 2013

Carried out on behalf of Lorn MacNeal Architects

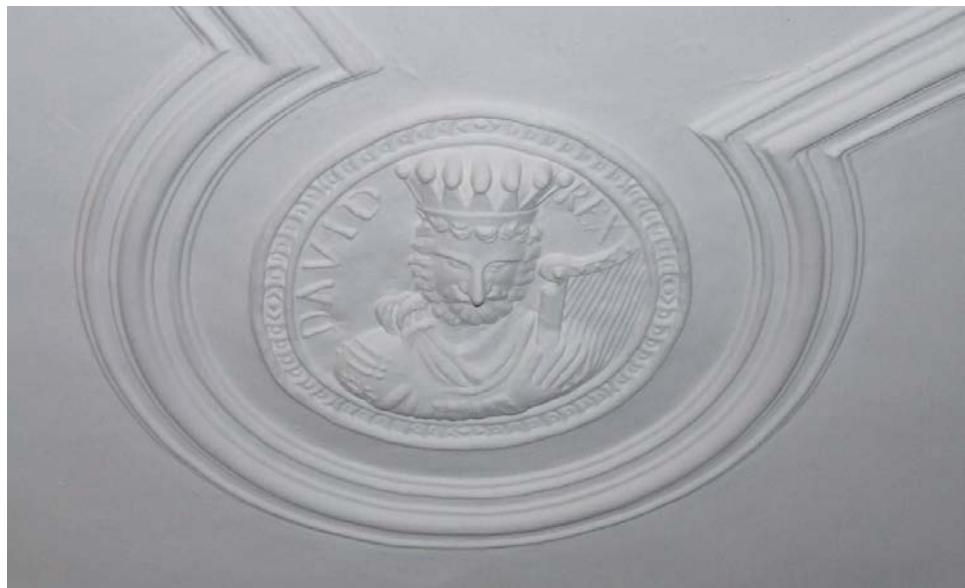
PLATE 1: KING DAVID MEDALLION ON THE 17TH CENTURY PLASTER CEILING

the history of the Estate and it's then owners the Cunninghames. Clan Cunningham fought for King *Alexander III* of Scotland at the Battle of *Largs* in 1263 and David is in fact a double allusion relating also to the King David of the bible, with his harp. (Plates 1) The motto NOBIS HAEC INVICTA MISERUNT 108 PROAVI – *To us 108 ancestors have sent these unconquered things.*

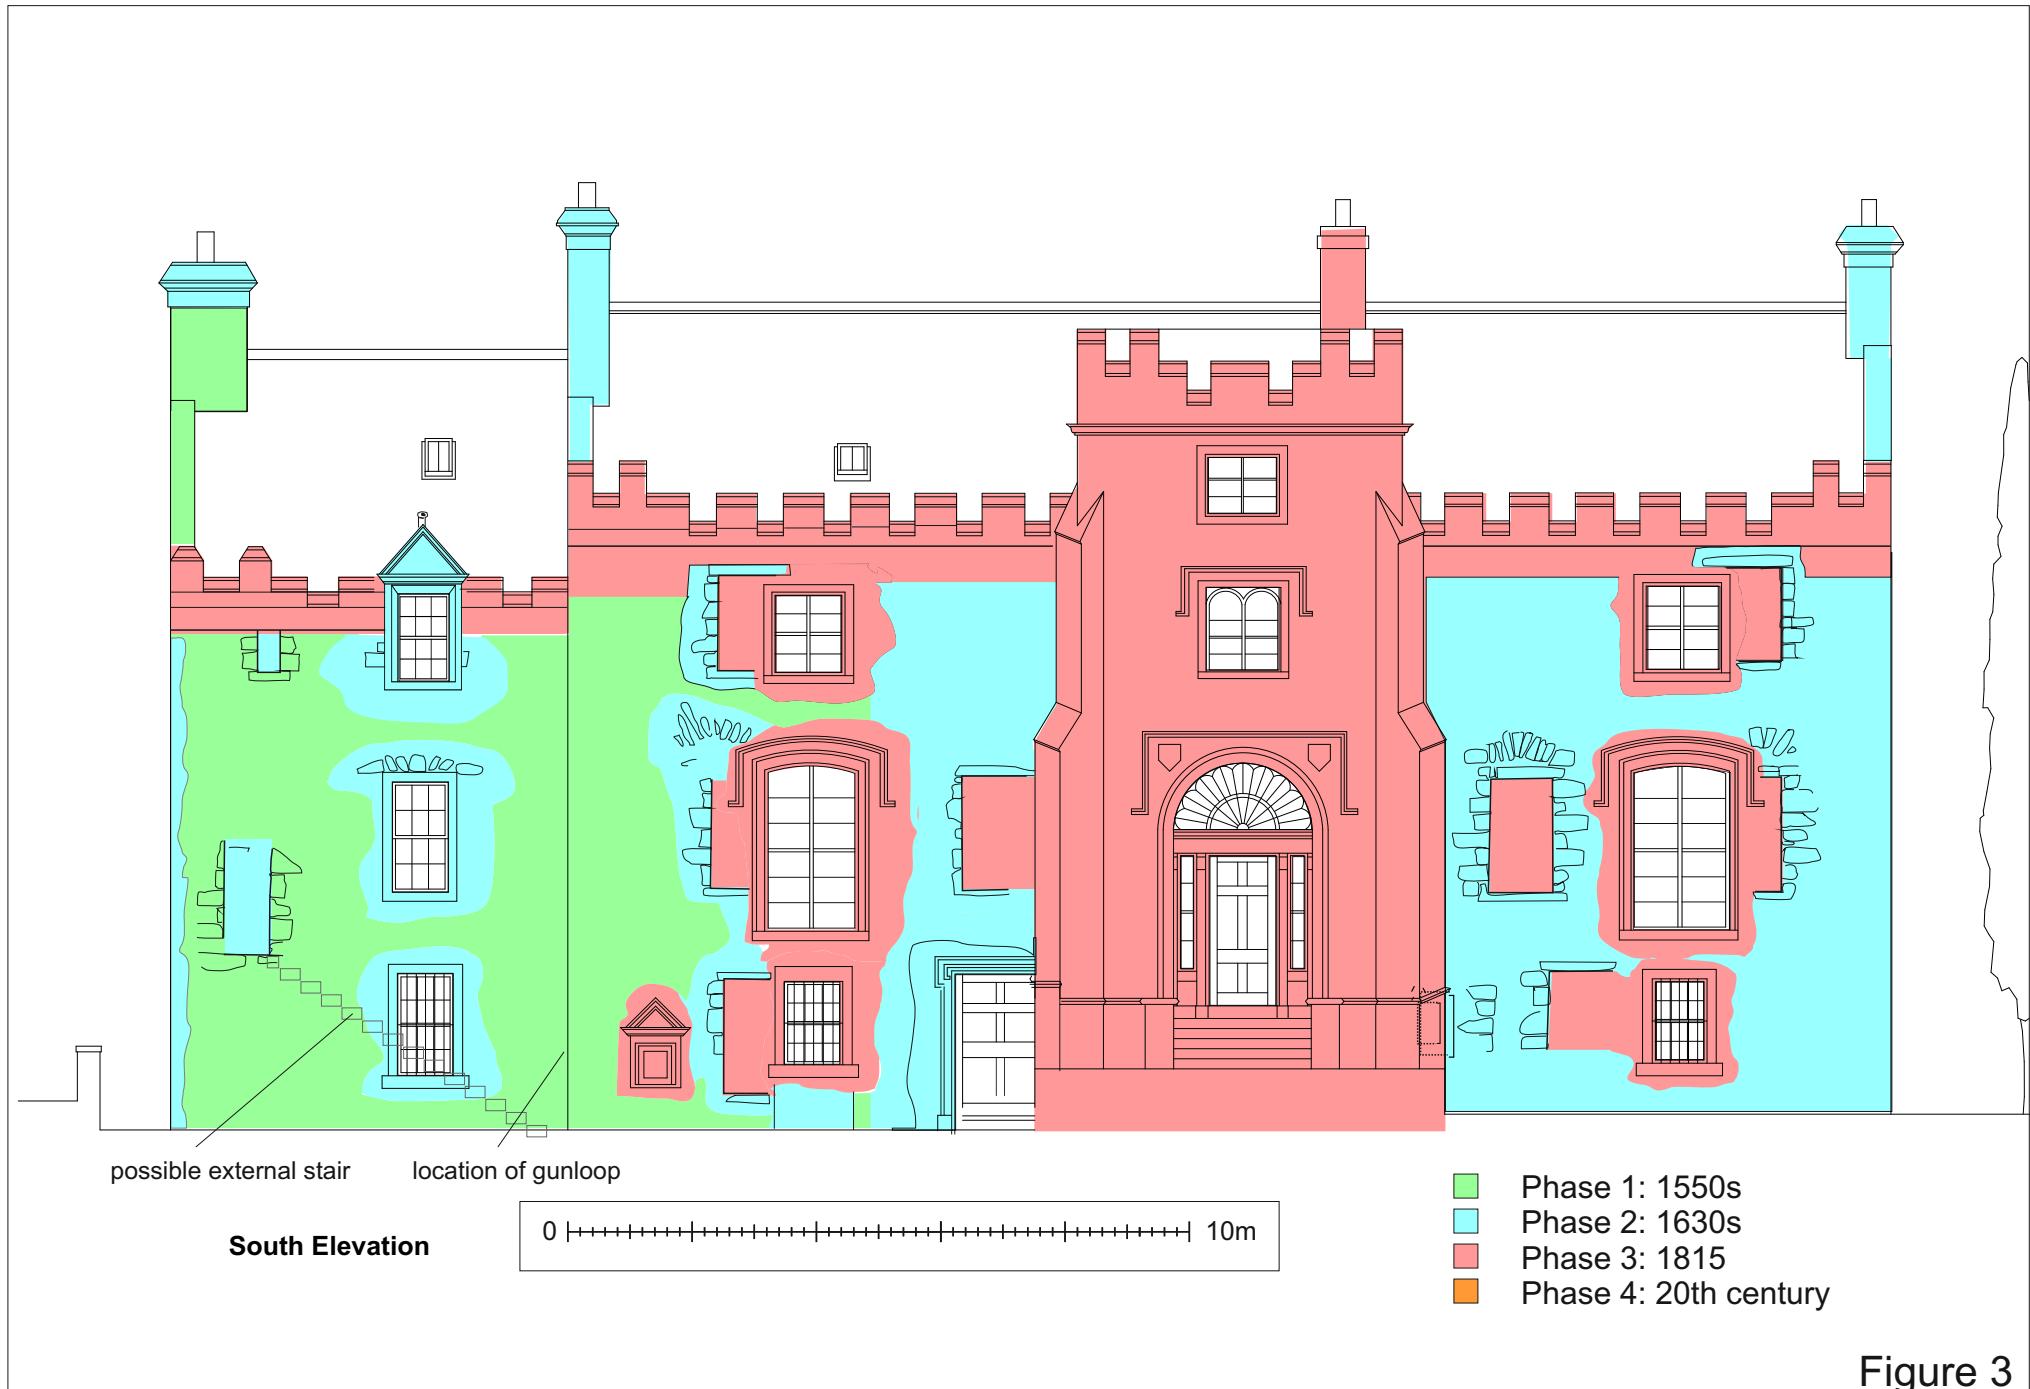
Figure 3

- 5.2.2 The south principal elevation shows 3 main phases of activity (Figure 3) which can be assigned to known events and people within the historical timeline. The earliest belongs to a stout tower house which occupies the western range of the current structure. Apart from a small window (now blocked) on the upper story, no windows from this phase survive, however, an opening was uncovered during the raking out of the cement (Plate 3).

- 5.2.4 The second fenestration phase can be dated to the 1630s, as again attested by the documentary evidence. It is evident that a new more open fenestration was adopted, and the door moved to the lower floor as well as the entire building being extended to the east by at least 4 bays. It is noticeable that the three central bays on the first floor (upper floor) seem to have no window openings.

- 5.2.5 The final phase comes with the major alterations to Georgian style by Sir John Foulis in or around 1815. His additions include the fine central staitower entrance with broad steps and magnificent fanlight and hooded doorway with shield devices. In addition to the stair tower, Foulis adds a castellation to the upper floor wallhead, and in the process, raises the wall and roof, meaning the entire roof structure dates to no earlier than 1815.

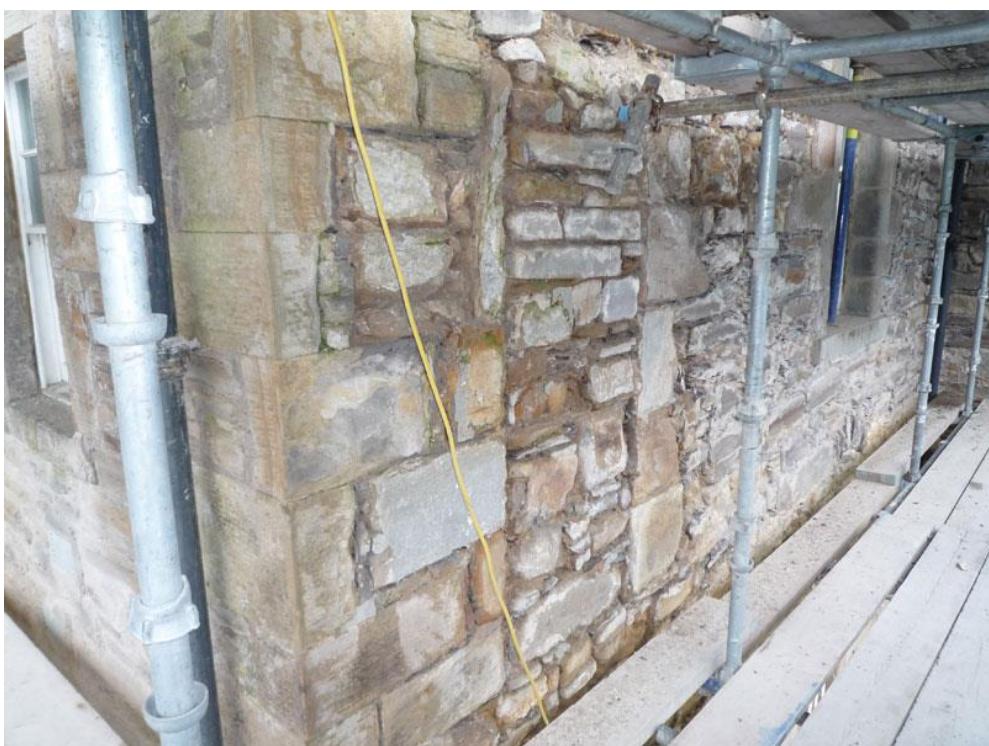
PLATE 3. BLOCKED DOORWAY AT SOUTHWEST CORNER OF SOUTH ELEVATION

- 5.2.3 This opening is clearly not a window, given the base where the sill would be found is at floor level (based on the vaulted chamber below) and so may be a first floor door accessed by a now missing stair. This would make sense of the gun loop in the west range angle, as the loop is of classic 16th century design and covers the ascent to the doorway. Given the times that this building was constructed, the 1st floor door and defended entrance would make sense.

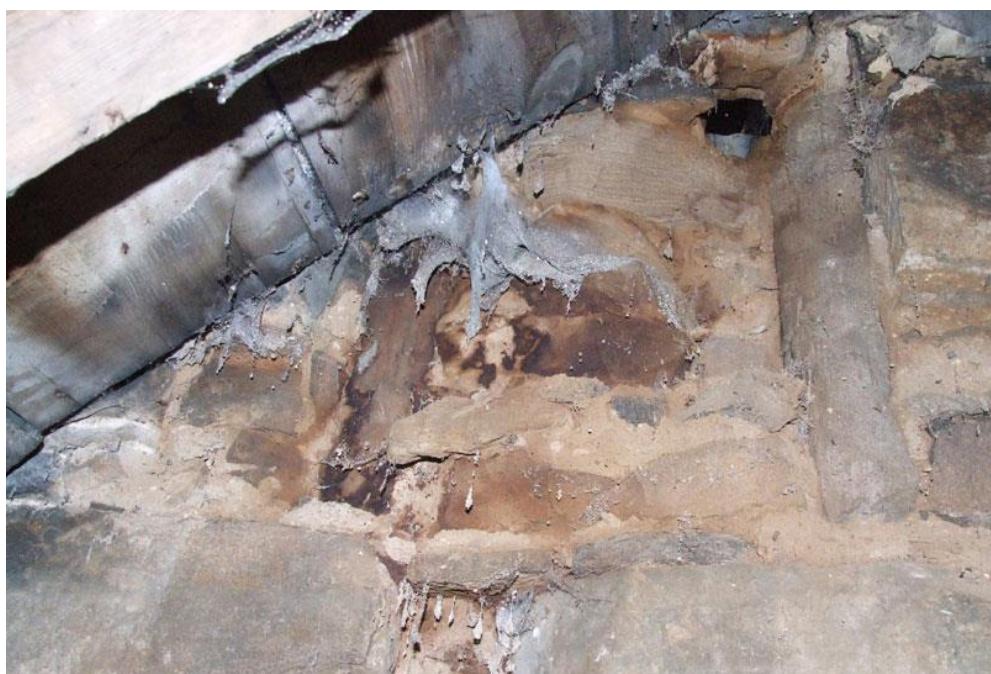
PLATE 4: BLOCKED WINDOW IN WEST GABLE FROM INTERIOR ROOFSPACE, THOUGH NOT VISIBLE ON EXTERIOR.

- 5.2.6 The west elevation is of note given that the quoins are of distinctive early 19th century form – with droved and broached margins. The honey gold sandstone masonry of the wall fabric is also built from long coursed stonework, which is not matched by the rest of the rubble built structure. It is quite possible, though remarkable that the west gable has been completely refaced and the corners rebuilt. This seems to be confirmed by the presence of a window in the gable elevation that is visible on the interior but not the exterior. (Plate 4)

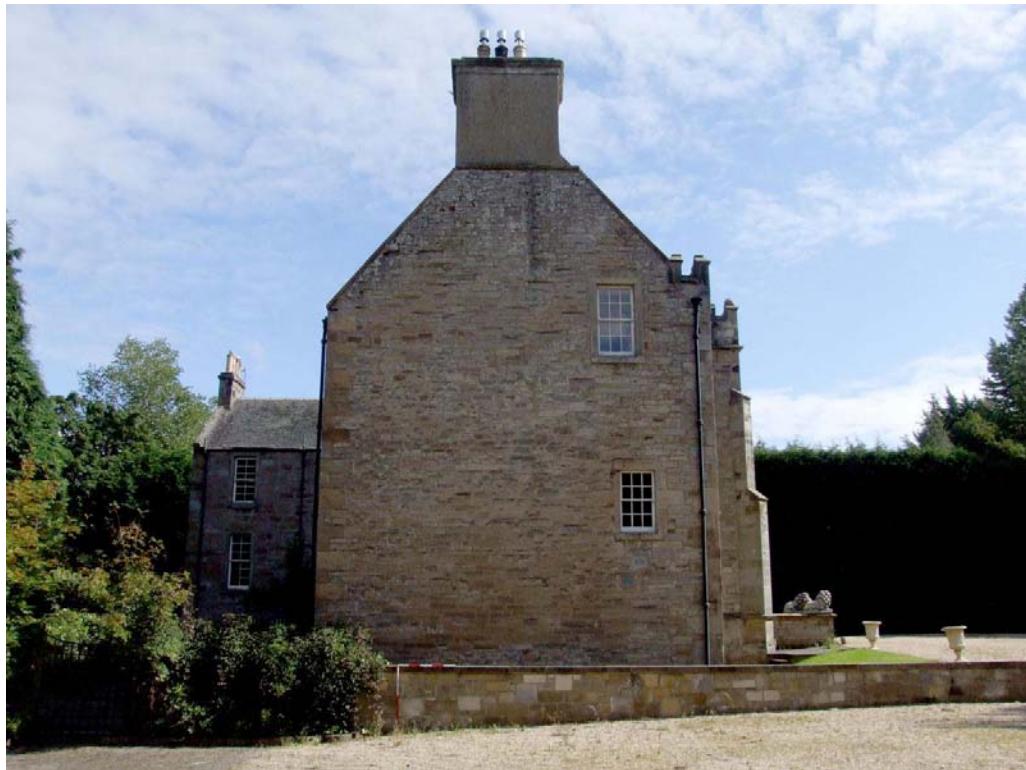
PLATE 5: WEST GABLE – NOTE THE OFF CENTRE CHIMNEY AND COURSED MASONARY. THE ‘MISSING’ WINDOW LIES ABOVE THE CURRENT UPPER WINDOW.

- 5.2.7 This also suggests that the original towerhouse was a further story higher, that would perhaps make sense of the off centre chimney stack. If this as the case (and it is conjecture) then this would have been an impressive tower house in keeping with a noble family.

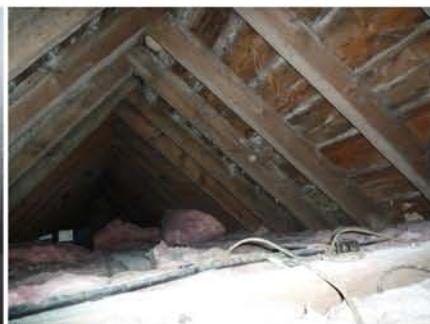
WHH12_03.JPG

Ref.		Direction to:	Description
WHH12_	1		View into roof space in west range.
WHH12_	2	East	View of attic space room. Note 20 th century conversion.
WHH12_	3	East	Roof space in east range. Note wide sarking and machine cut truss timbers (19 th century).
WHH12_	4	North	Principle elevation of Woodhall House centred on entrance tower. Earlier west range to the left.
WHH12_	5	North	East end of principle south elevation. Note how large window has truncated earlier fenestration.
WHH12_	6	Northeast	View of stair tower south elevation and west elevation showing relative locations of the hood moulded window on the ground floor and earlier fenestration. Note also lower 17 th century door with roll mouldings, partially obscured by later entrance tower block.
WHH12_	7	East	View of gun loop in angle of west block. Note this must have originally covered an entrance into the building.
WHH12_	8	North	Later inserted feature consisting of a face masked plaque below a dormer window pediment. Note blocked window to right.

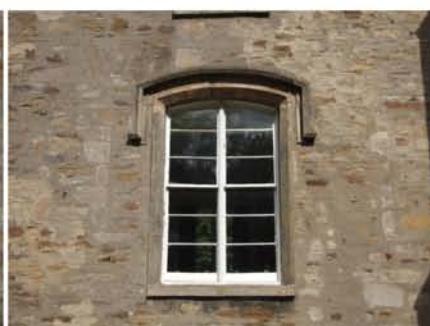
WHH12_09.JPG

WHH12_	9	North	19 th century (1815) hood moulded window in principle south elevation.
WHH12_	10	North	Example of 17 th century inserted window with low margins, sill and relieving arch.
WHH12_	11	North	Surviving dormer window from 17 th century. Note later 18 th century castellation. Pediment of dormer window retains original ornamentation.
WHH12_	12	North	Example of later 19 th century 1 st floor window replacing earlier 17 th century window to left.
WHH12_	13	North	Example of later 19 th century castellation above original fabric with chimney stack beyond.
WHH12_	14	Northeast	West range of Woodhall House showing relationship of earlier block to later fenestration. Note doorway blocked at 1 st floor level.
WHH12_	15	East	Gable end of west range containing 2 windows. Note coursed stonework not in keeping with the original fabric and chimney stack located off centre.
WHH12_	16	South	Part of north rear elevation showing less ornate ground floor window and barred cellar window below.

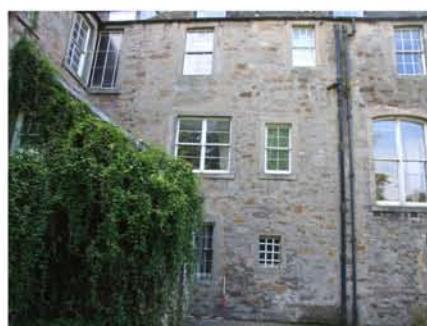
WHH12_17.JPG

WHH12_	17	South	Rear elevation showing various windows from various periods and clearly showing differing stonework between the original 16 th century range to the right and 17 th century range to the left.
WHH12_	18	East	1815 extension to rear of main building. Note equal fenestration and window

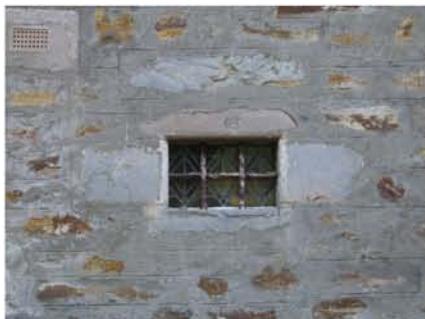
WHH12_19.JPG

panes all of early 19 th century design with landscape panes 6 over 6.
WHH12_	19	South	Detail of lower basement window with rounded surround and original iron bars into kitchen.
WHH12_	20	South	Detail of lower basement window of 17 th century design with original iron bars but much larger than earlier opening which it must have replaced.
WHH12_	21	South	Detail of ground floor rear window in west range but note different stone wall material to right of window as opposed to left.
WHH12_	22	South	Detail of downpipes to left of west range showing harl behind.
WHH12_	23		Detail of harl behind cement render.
WHH12_	24	South	Detail of harl behind cement render on lower ground floor.
WHH12_	25	Southwest	Detail of lower part of east gable elevation at join between main building and 19 th century extension. Note use of various stonework from other locations.
WHH12_	26	West	View of blocked window on ground floor in east gable elevation.

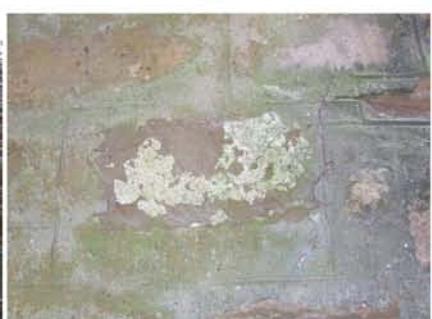
WHH12_27.JPG

WHH12_	27		Detail of harl on east gable elevation.
WHH12_	28	Northwest	Large boulder foundations on east gable.
WHH12_	29	East	Interior of attic space. Note machine cut timber (19 th century).
WHH12_	30	West	Within attic space of west range. Note blocked window in gable not visible on exterior.
WHH12_	31	West	Within attic space of west range. Remains of harl on chimney stack and evidence of the roof being raised in the 19 th century.
WHH12_	32	East	View of trusses in attic space in west range.
WHH12_	33	East	View of stone wall chimney flue.
WHH12_	34	North	View of west range south elevation.
WHH12_	35	North	View of central stair entrance tower of south elevation.
WHH12_	36	North	East end of west range. South elevation.
WHH12_	37	Northwest	View of stair entrance tower elevation and side and part of east range.
WHH12_	38	Northeast	Detail of inserted 1815 hood moulded window surround. Note twist and bulge on wall.

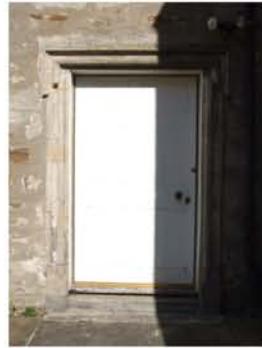
WHH12_39.JPG

WHH12_	39	North	View of roll moulded 17 th century door on lower basement level of west range, south elevation.
WHH12_	40	Northwest	Detail of upper castellated walling after joints raked out.

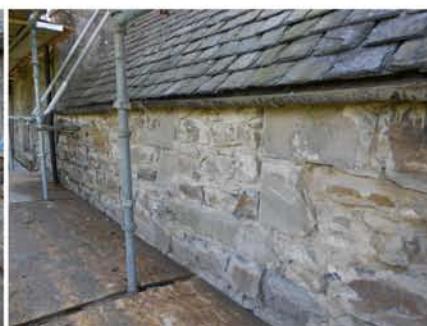
WHH12_41.JPG

WHH12_	41	Southea st	Detail of truncated dormer window of 16 th century date on north elevation west range after joints raked out.
WHH12_	42	Northwe st	General view of chimney breast works from central stair tower.
WHH12_	43	Northea st	View of east gable chimney stack and 1960s college beyond.
WHH12_	44	North	General view of work on central chimney stack from stair tower.
WHH12_	45		Interior of 1 st floor room with floorboards stripped showing machine cut joists.
WHH12_	46	Northea st	Detail of 1 st floor door in west range, south elevation (possible original entrance). Note quoins to west gable end are droved in a typical 19 th century style, suggesting entire gable end has been replaced.
WHH12_	47	South	North rear elevation of west range, blocked windows and lower basement floor opening. Note truncated dormer at top of elevation.
WHH12_	48		Inside drawing room, detail of cornice work 18/19 th century.

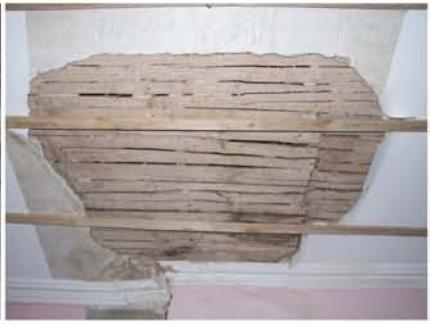
WHH12_60.JPG

WHH12_	60	Vertical	Area of ceiling plaster falling away to reveal typical Georgian lathe work.
WHH12_	61		Georgian door surrounds in ground floor rooms.
WHH12_	62		Georgian door surrounds in ground floor rooms.
WHH12_	63	North	Exposed stone window in ground floor bedroom. Blocked on exterior.
