NEWBYRES HALL, GOREBRIDGE, MIDLOTHIAN

JULY 2015

CARRIED OUT ON BEHALF OF NEWBYRES NURSERY

**archaeology**
Connolly Heritage Consultancy

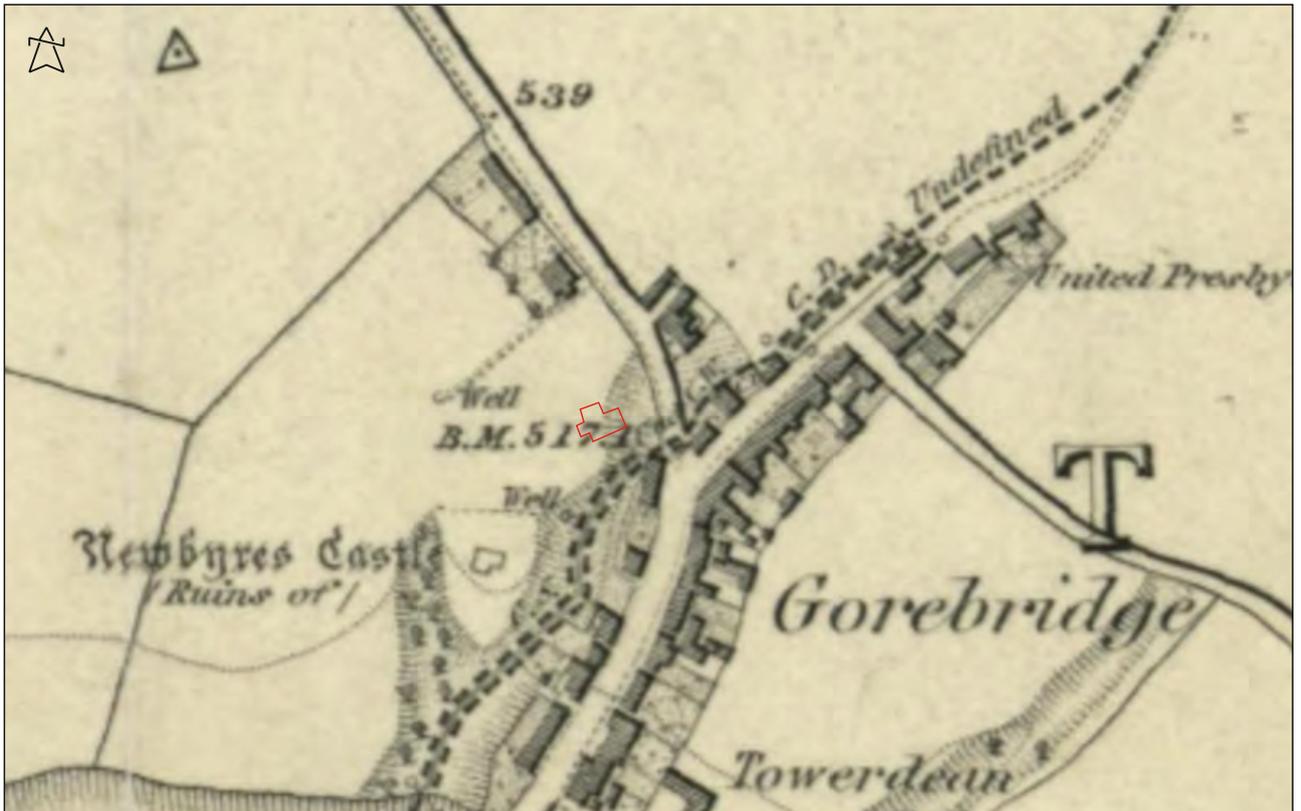
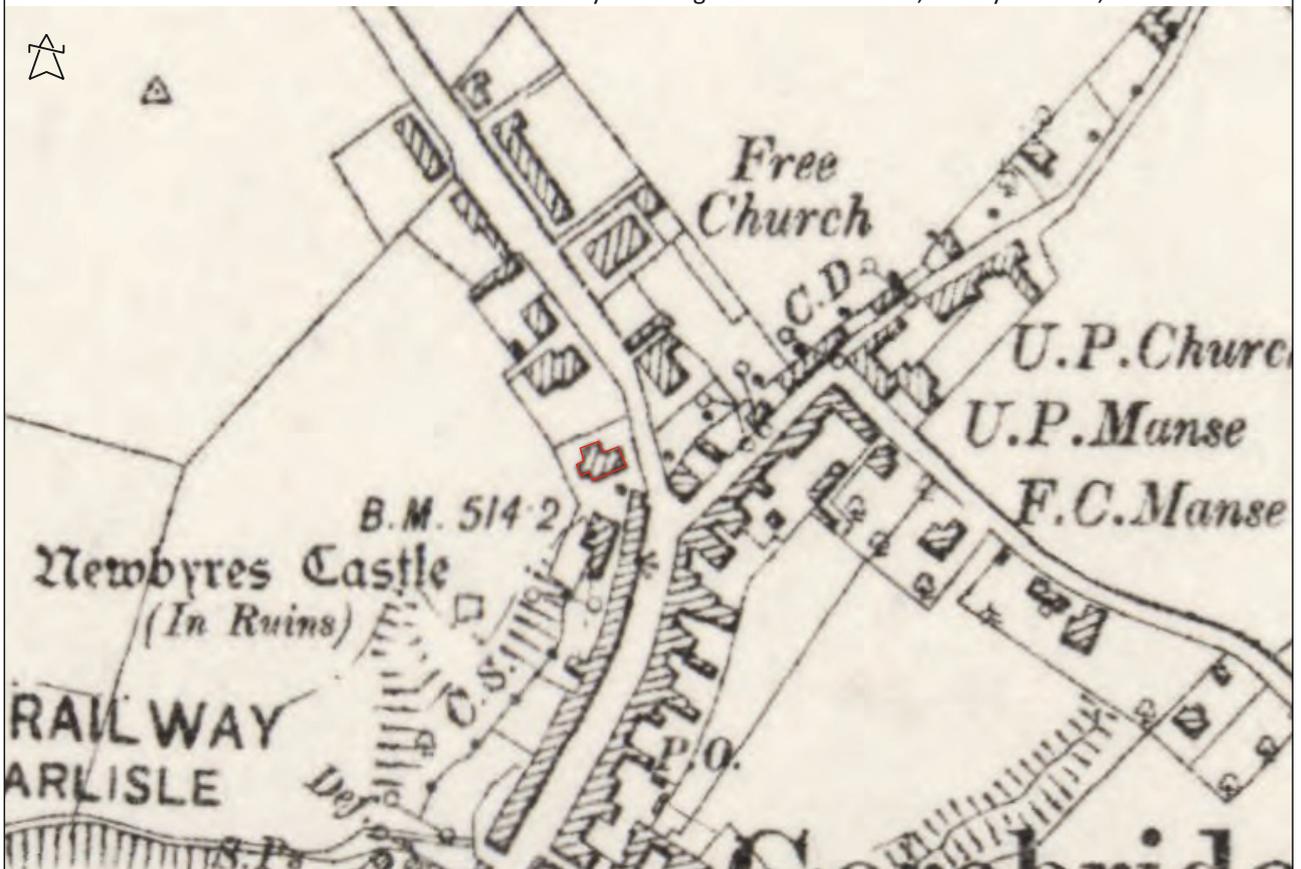
Figure 2: Map regression showing site empty on 1st edition OS mapping and with extension already in place on 2nd Edition

Ordnance Survey Edinburghshire Sheet 13, Surveyed: 1852-53, Published: 1854

Ordnance Survey Edinburghshire Sheet XIV.NE, Surveyed: 1892, Published: 1895

- 2.2.1. Map regression (Figure 2) identifies no structures on the 1st edition six-inch Ordnance Survey map (1854). The building first appears on the 1895 second edition, by which time the original structure has already been extended and developed.

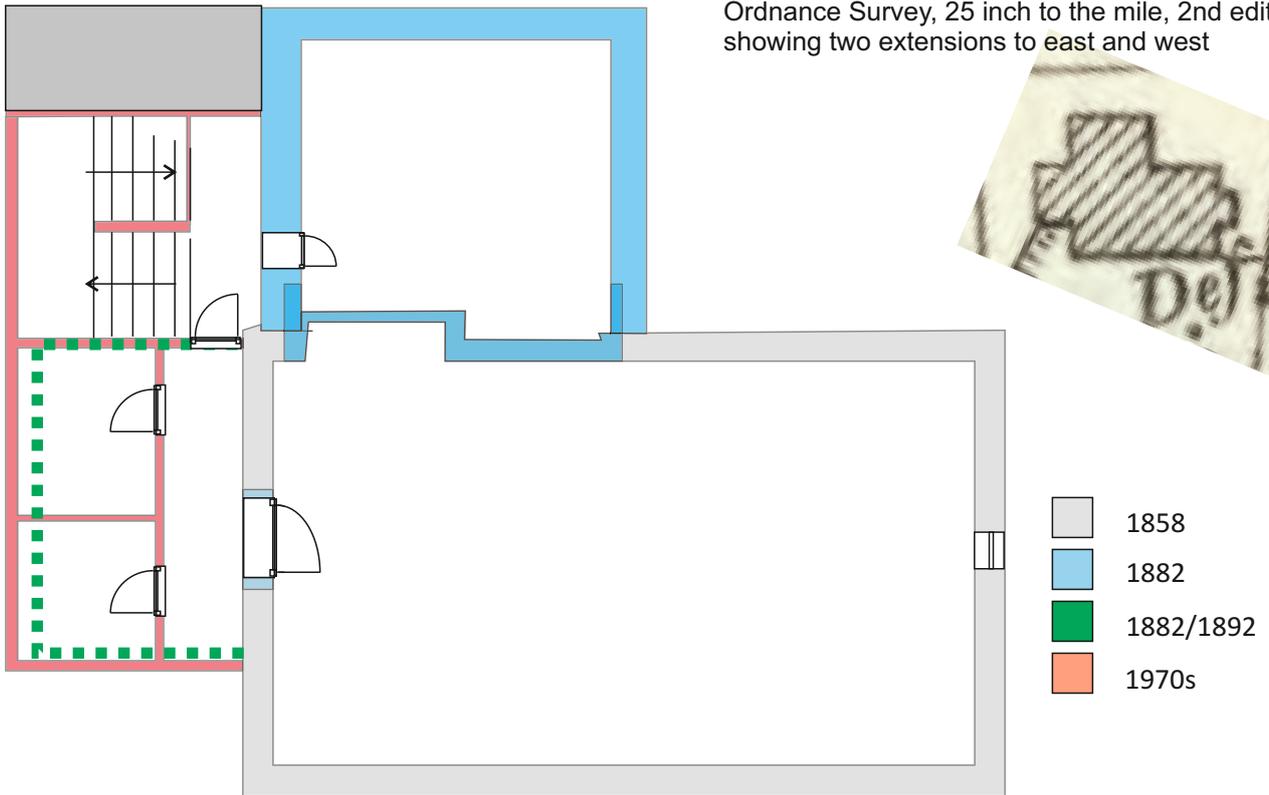
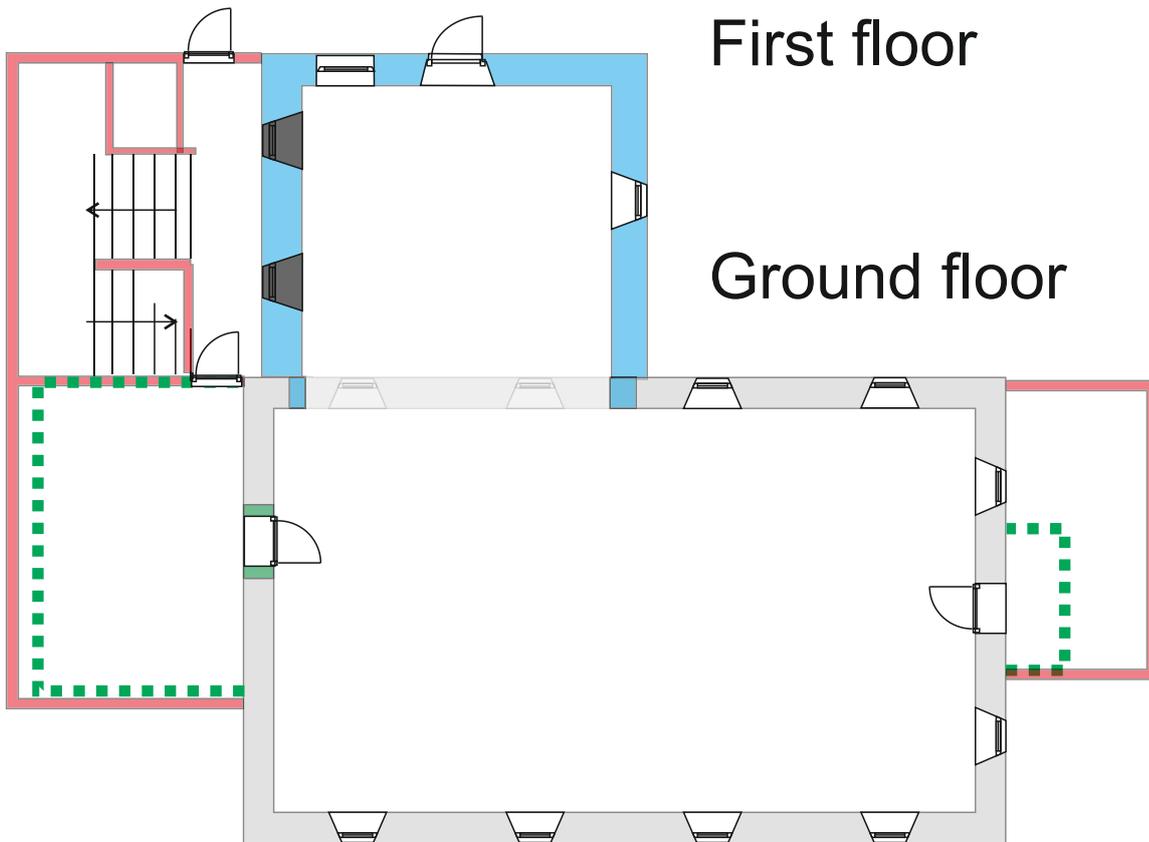
Figure 3: Floor Plans

First floor

Ground floor

5.2. INTERIOR (FIGURE 3)

- 5.2.1 The Simple interior contains few architectural details that are not evidence on the exterior elevations, and much of the interior has been stripped back or altered by later developments. However, there are some elements that are worthy of comment, relating to the buildings history and phasing.
- 5.2.2 It is clear that originally the main church building was to be a single simple rectangular space with window light provided on the north and south by four matched gothic windows with internal splays on each elevation. However, this was soon extended to the north by Robert Dundas' Workers Institute extension in 1882. (with probably the porch at the east end.) The extension would also have been full height, given the lack of upper floor fenestration and the supply of only a single oculus in the gable pitch and no internal staircase within the extension.

- 5.2.3 Between 1882 and 1892 however, the first rear extension is built. Clearly to give access to an upper floor. The first floor allows more use of the space and doubles the usable area, but requires a staircase to access; the simple solution is an external stairwell.

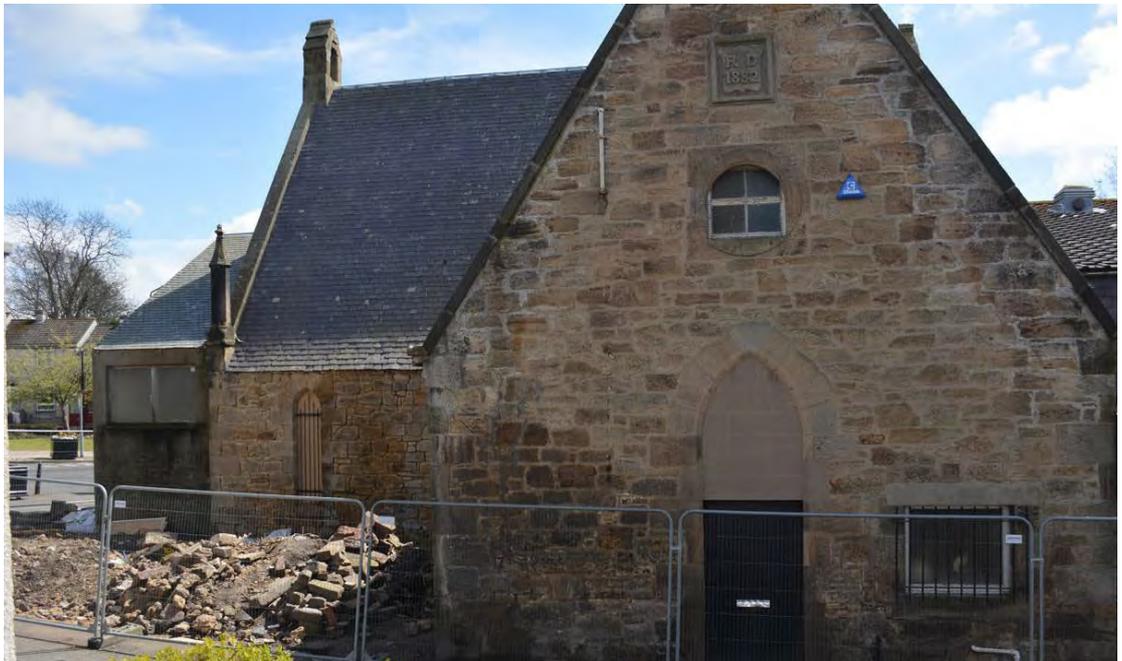
Plate 1: the 1882 extension to the north with datestone

- 5.1.6 THE north elevation shows the gable elevation of the 1882 extension and the north wall of the original church. The extension gable contains a ground floor door with ashlar surround and a square window to the right that has been forced through with concrete lintel and surround. A small oculus (circular) window pierces the gable pitch to provide some light to the roofspace but has had a square windowframe

oddly inserted (perhaps when the roofspace becomes part of the first floor. Above is a square datestone, with the initial RD with 1882 below – The RD standing for Robert Dundas. Again this northern 1882 extension is made from the local yellow sandstone.

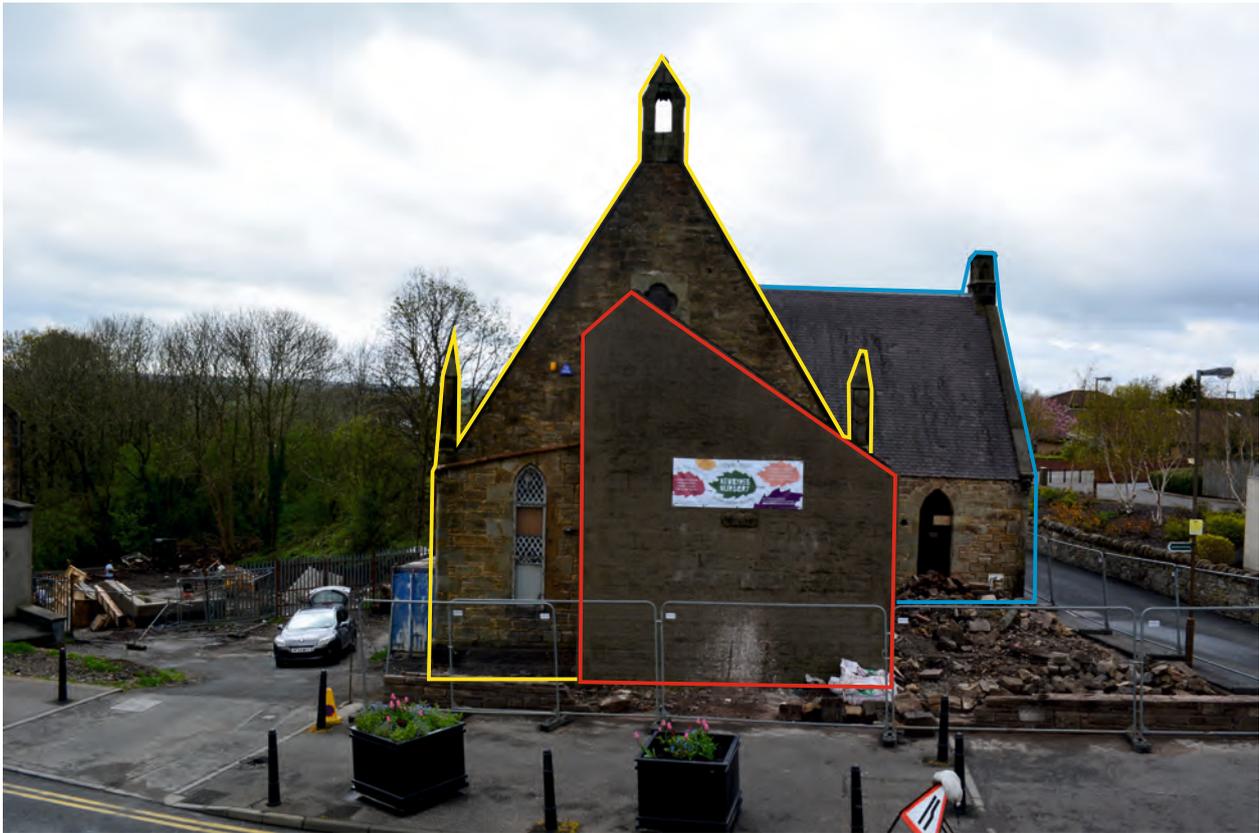
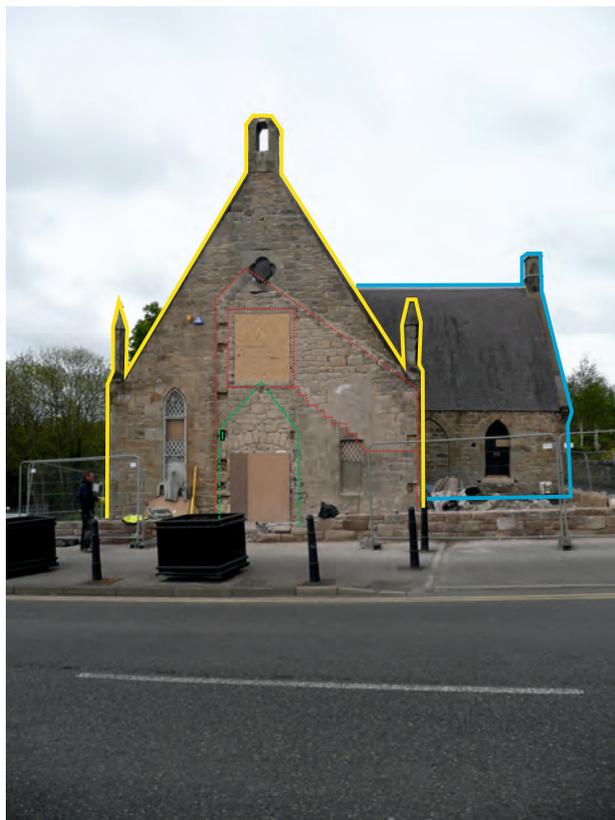
Figure 4: Principal east elevation before and after removal of late 20th century extension

- 1858
- 1882
- 1882/1892
- 1970s

- 5.1.1 The single story church building was built in 1858 from local yellow sandstone ashlar masonry, with gabled east and west elevations. The steeply pitched roof is of slate with the principal elevation gable having two matched pinnacles above the skewputs and a ridge mounted bellcote. A quatrefoil window pieces the east gable and two gothic long windows flank the central doorway. The east frontage has between 1858 and 1894, been provided with a pitch roofed porch, which can be seen in the scarfed joist holes around the central doorway. (Clearly an addition, as the wall was not bonded to the main building fabric and would have formed a risband joint (butted as opposed to tied in). The later 1970s stair extension would have removed this porch and joins the groundfloor to a new opening at first floor level.

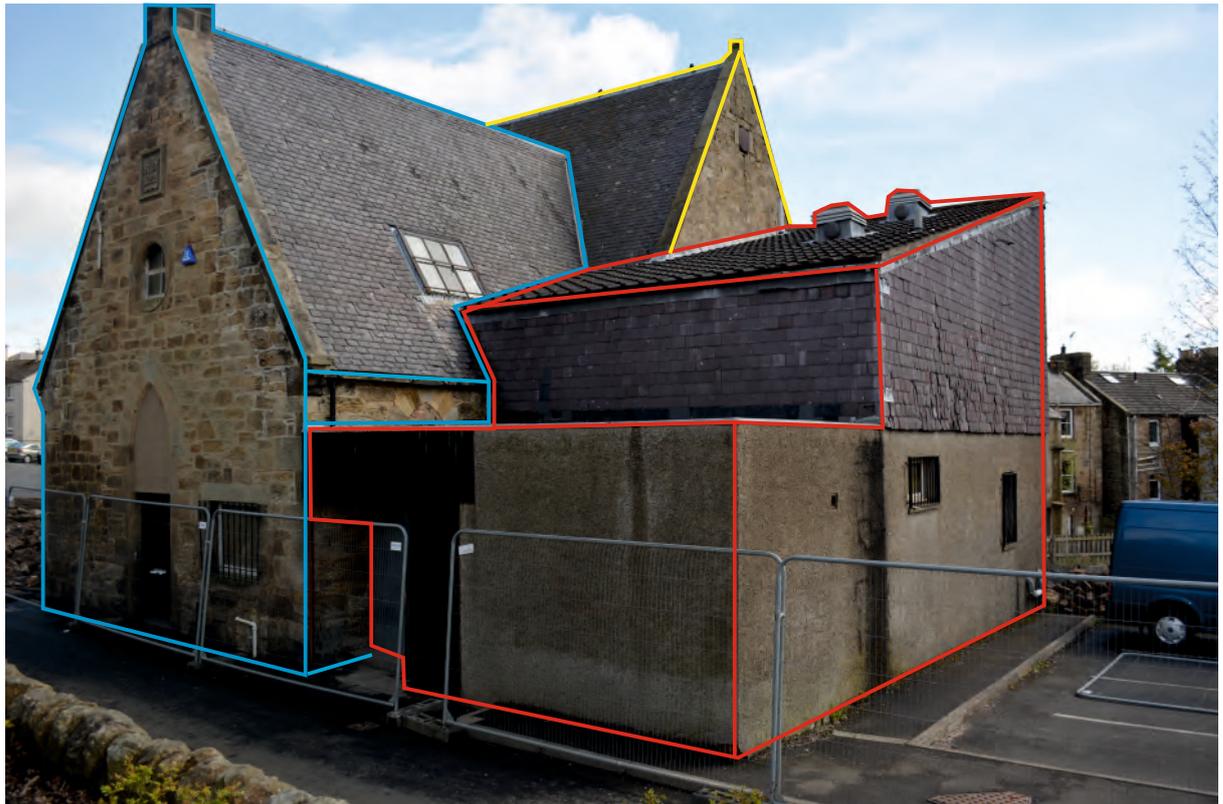
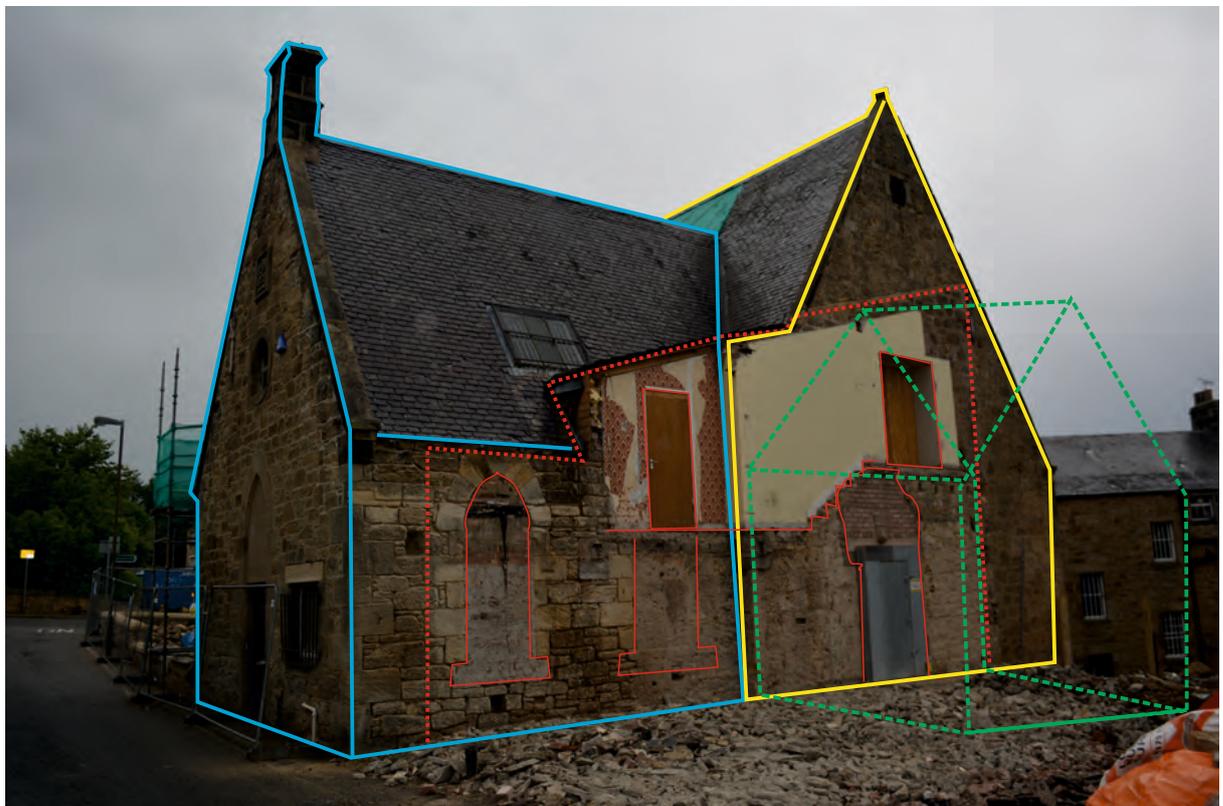
Figure 5: Principal west (rear) elevation before and after removal of late 20th century extension

| | 1858 | | 1882/1892 |
| | 1882 | | 1970s |

- 5.1.3 The west elevation contains a further mix of constructional detail. With the original 1858 church structure, extended to the north by a further steep gabled structure with slate roof. The pitch terminates with a solid stone ashlar chimney breast. Once again there are the traces of a secondary extension to the rear of the church that may have related to the necessity for a access staircase to the upper story (post 1882). The excavation of the rubble to the rear of the property clearly showing that brick constructed boxes holding rubble from the original gable wall, has been used as a stable foundation for this extension. (it clearly appears on the 1892 OS plan of the site (Figure 3).

- 5.1.4 The standing 1882 extension is set back some 20cm from the line of the west elevation and contains two blocked windows of similar gothic style to the rest of the building, however are noticeably wider. A dormer window services the upper roofspace.

- 5.1.5 The later 1970s extension was like the front extension, constructed of brick and girders with cement renders and shallow pitched or flat roofs. The rear extension designed to carry a suite of store rooms, toilets and staircase to the first floor.

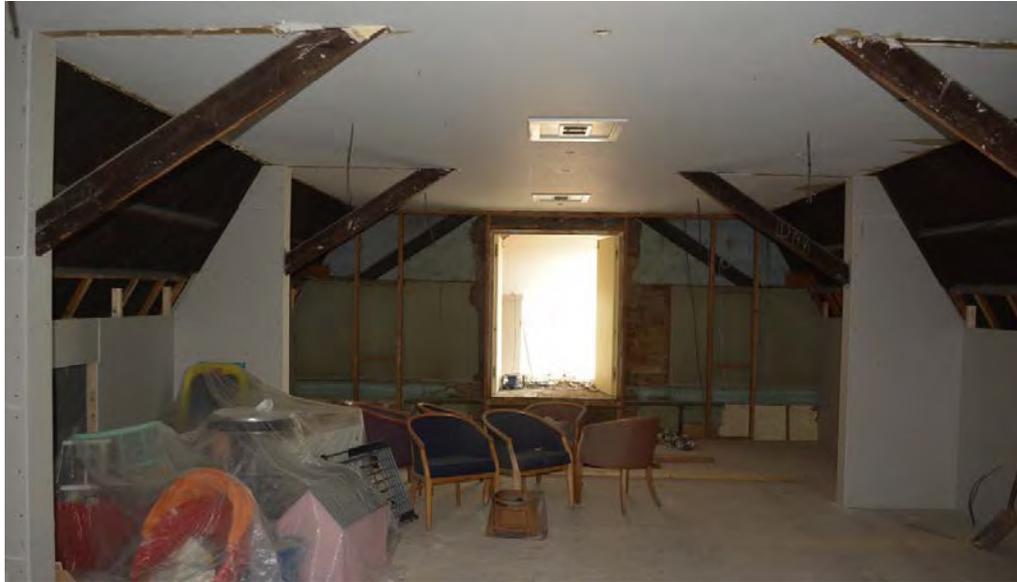
Plate 3: Upper floor utilising the roof space, with 1970s opening in east gable.

- 5.2.4 The 1970s extensions continue this theme, but with the addition of a further set of stairs to the east, it does allow a secondary access and escape route from the buildings upper floor in the event of a fire.
- 5.2.5 Interestingly, there is clear evidence for a fire in the roofspace that has been repaired – however, no documentary evidence was uncovered – consisting of charred and replacement timbers in the extension roofspace. (see plate 4).

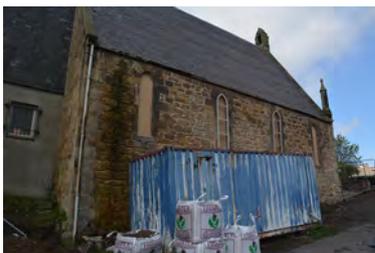
DSC_4867.JPG

ID	File	Description	Direction	Date
25	DSC_4867	General view of exterior	NE	09/05/2015
26	DSC_4874	Sandstone plaque bearing the name Newbyres Hall inserted into the front extension	W	09/05/2015
27	DSC_6049	Brick foundation bay to rear of property, filled with rubble from the west wall. Foundation for 1970s extension	E	02/07/2015
28	DSC_6063	Exterior shot of rear (west elevation) after removal of 1970s extension	SE	02/07/2015
29	DSC_6064	Composite image of interior of front extension, with door into first floor	W	02/07/2015
30	P1020991	Exterior shot of principal (east elevation) after removal of 1970s extension	W	02/07/2015
