## Papple Cottages, East Lothian

**Carried out on behalf of Whittingehame Estate**

connolly • heritage • consultancy

- 1.1 An archaeological buildings appraisal was carried out based on the requirements from East Lothian Council Archaeology Service (ELCAS) to meet the conditions attached to planning application 06/01018/FUL and 10/00786/P. The structure numbers are based on the plans produced by Simpson and Brown Architects in June 2009, Job number 1454. These works were commissioned by Mr M Brander, Whittingehame Estates. The work was undertaken in September 2010 and was restricted to the exteriors of the structures 1-4 & 6 and the exteriors and interiors of structures 5, 7-10.

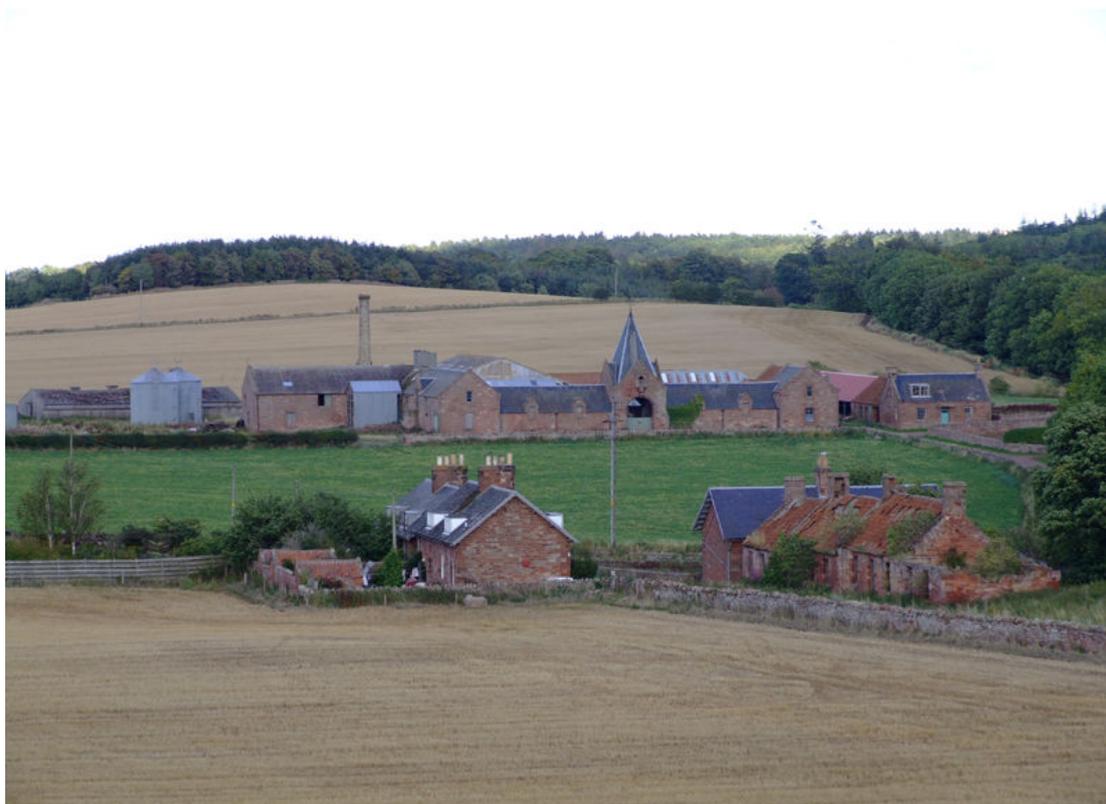
Plate 1: View over the cottage group with Papple Steading in the background to the east.

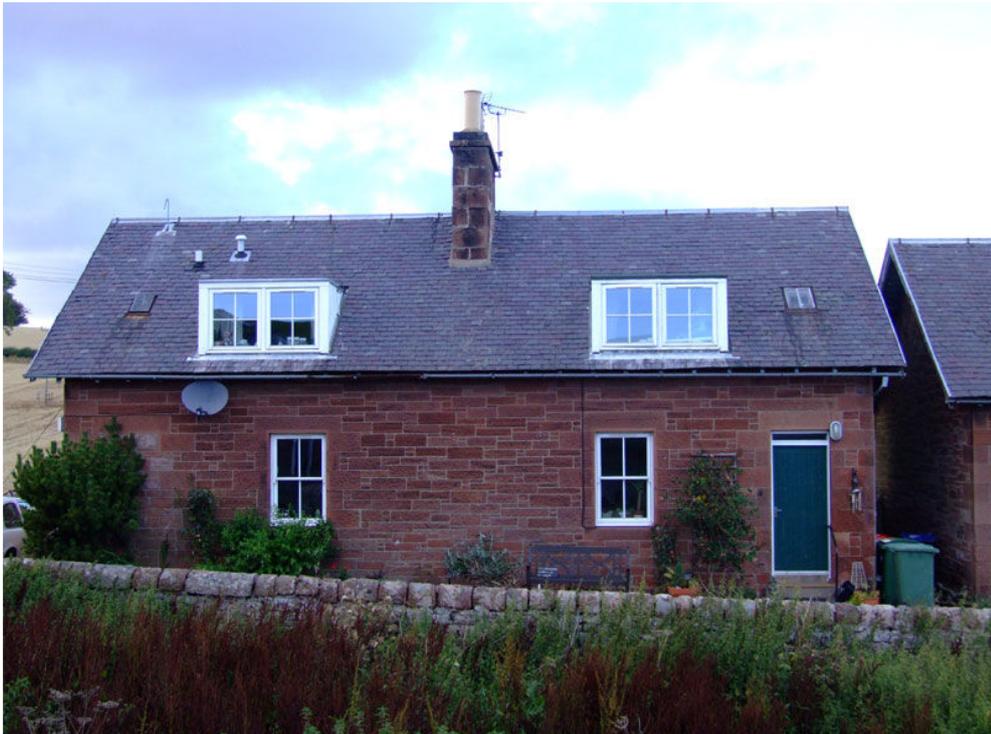
Solid built red sandstone one and a half storey cottages, built from squared and coursed ashlar. Each of the two cottages is divided into two separate living quarters with a central flue leading to a chimney supporting four chimney pots. The principal elevation contains two bays with 6 over 6 sash windows (units 1 & 2) four pane sash and case windows (units 3 & 4) surrounded by well cut, droved sandstone flush to the wall. Doors are located at either end of the cottages principal elevation (to the east and west) with a narrow transom light above the door frame. The exception is structure 4 where the doorway has been blocked and a new porch and entrance has been forced in through the west gable elevation.

**Plate 3:** Principal elevation of Units 3 and 4 (note the blocked door for unit 4 on the left) Units 1 and 2 are similar in all details except for the blocked door.

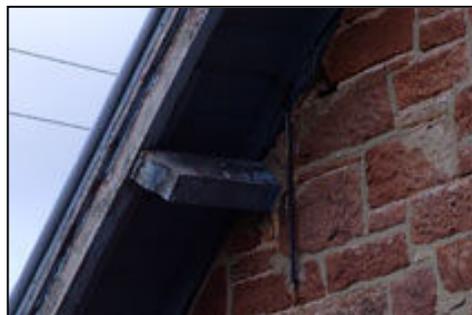
The roof is of a blue grey slate with two matching double width flat dormers with four pane windows on each roof pitch and two double pane skylights above the internal staircase which is located on the gable ends. The overhanging eaves have a distinctive ogee end, which is different from those on structures 5 & 6. The interior layouts are as built in c. 1860s with a small amount of modernisation from the 1930s and mid 60s/70s. (see figures 4 & 5) Currently structures 3 and 4 are inhabited and the interior of 1 and 2 show no sign of alteration from construction, with only superficial decoration being evidenced.

**Plate 4:** Overhanging eaves on structures 1-4

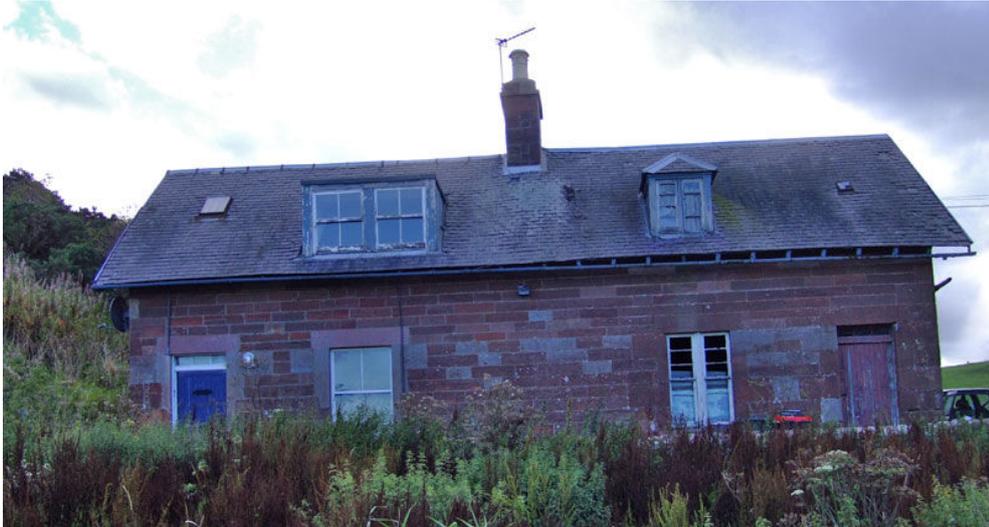
Solid built red sandstone one and a half storey cottages, built from squared and coursed ashlar. The cottage is divided into two separate living quarters with a central flue leading to a chimney supporting four chimney pots. The principal elevation contains two bays with 6 over 6 sash window to the north (unit 5) and 4 pane sash and case to the south (unit 6)

The roof is of a blue grey slate with matching double width flat dormers with four pane windows on each roof pitch in unit 6 and a single hipped dormer on the east elevation of unit 5 with two double pane skylights above the internal staircase which is located on the gable ends.

**Plate 5:** Principal east elevation of structure 5-6

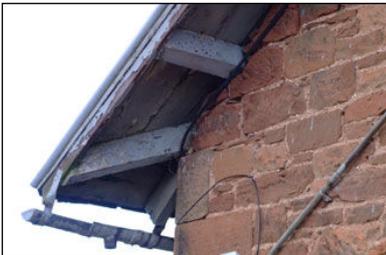
**Plate 6:** Overhanging eaves on structures 1-4

The overhanging eaves on this construction are flat ended, unlike those on structure 1-4 and may represent a small constructional phasing gap between this and the structures 1-4 which date from c. 1860s; the construction method and layout being

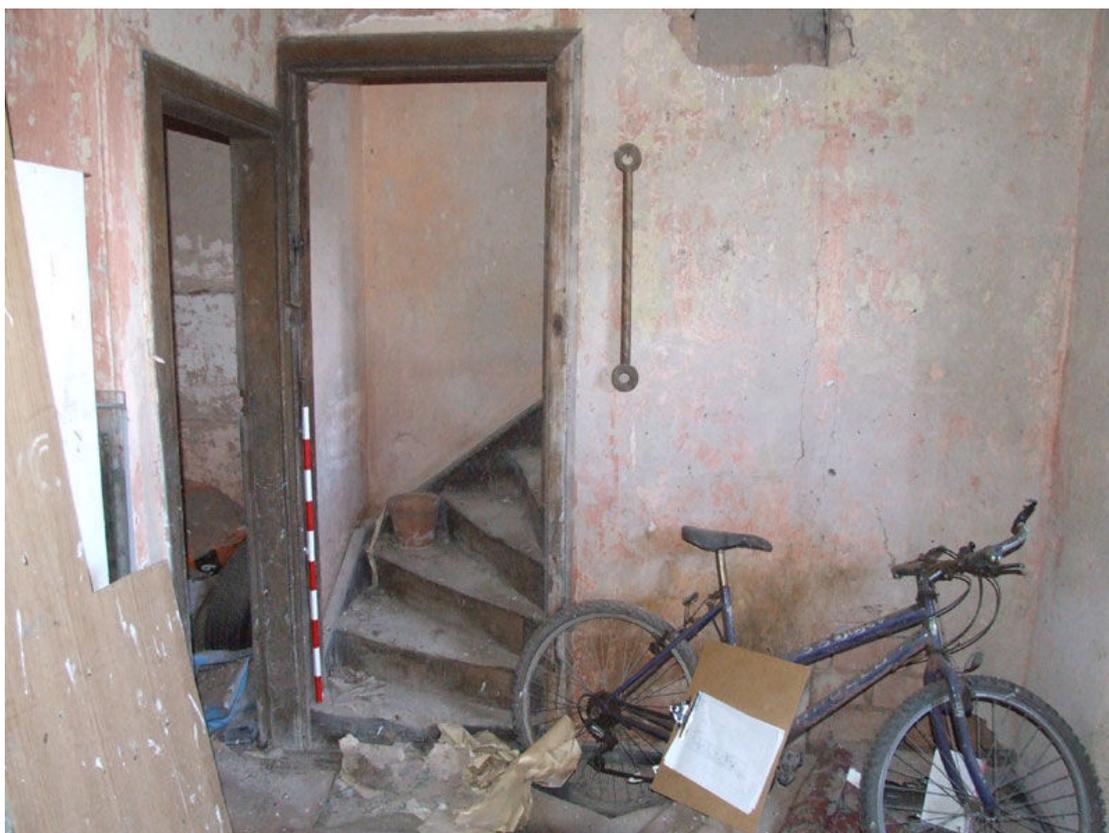
**Plate 7:** Wooden stairs leading up to first floor in structure 5

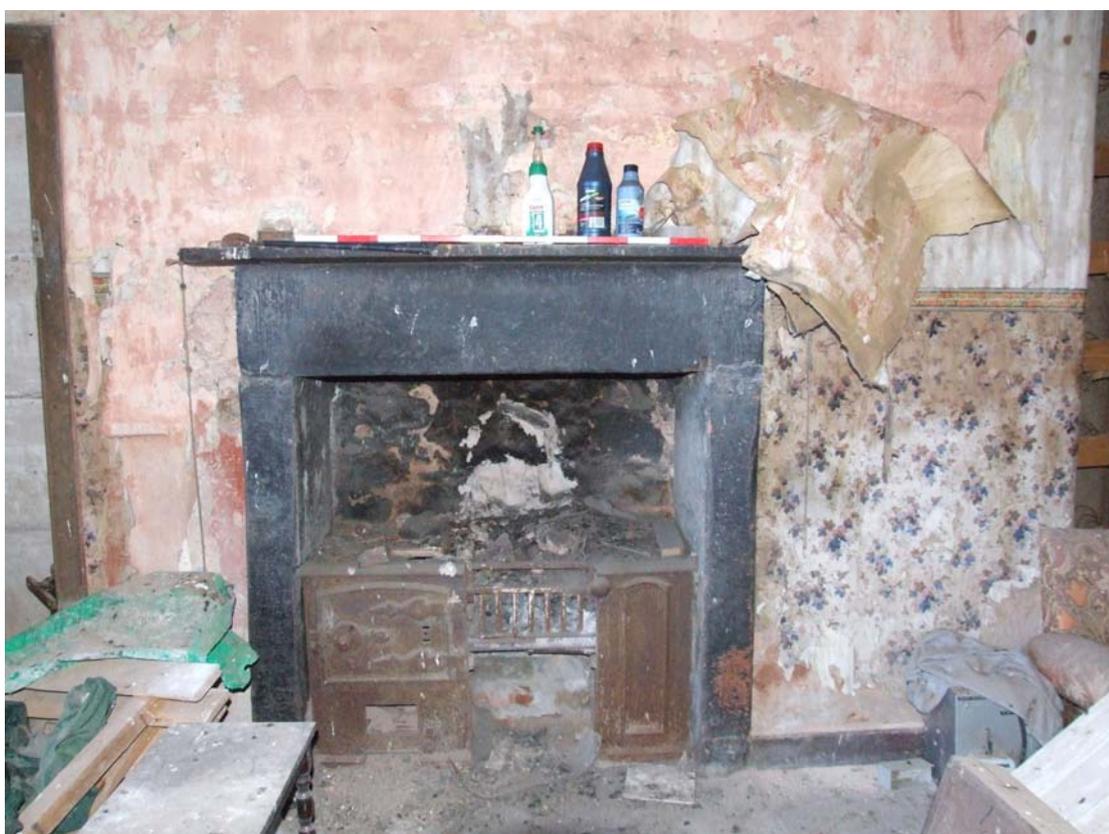
exactly the same. The interior is a simple layout with a large ground floor room sub divided by a partition into two with fireplace in the east room, a small room to the rear and stairs leading up to the 1<sup>st</sup> floor, where there are three rooms; two bedrooms and a smaller box room. It is possible that the hipped dormer precedes the larger box dormer. The interior layouts are as built in 1858 with a small amount of modernisation from the 1930s and mid 60s/70s. (see figures 4 & 5). To the rear of unit 6 is a modern box extension of brick forming a kitchen.

**Plate 8:** The intact fireplace and full kitchen grate within the main ground floor room of structure 5

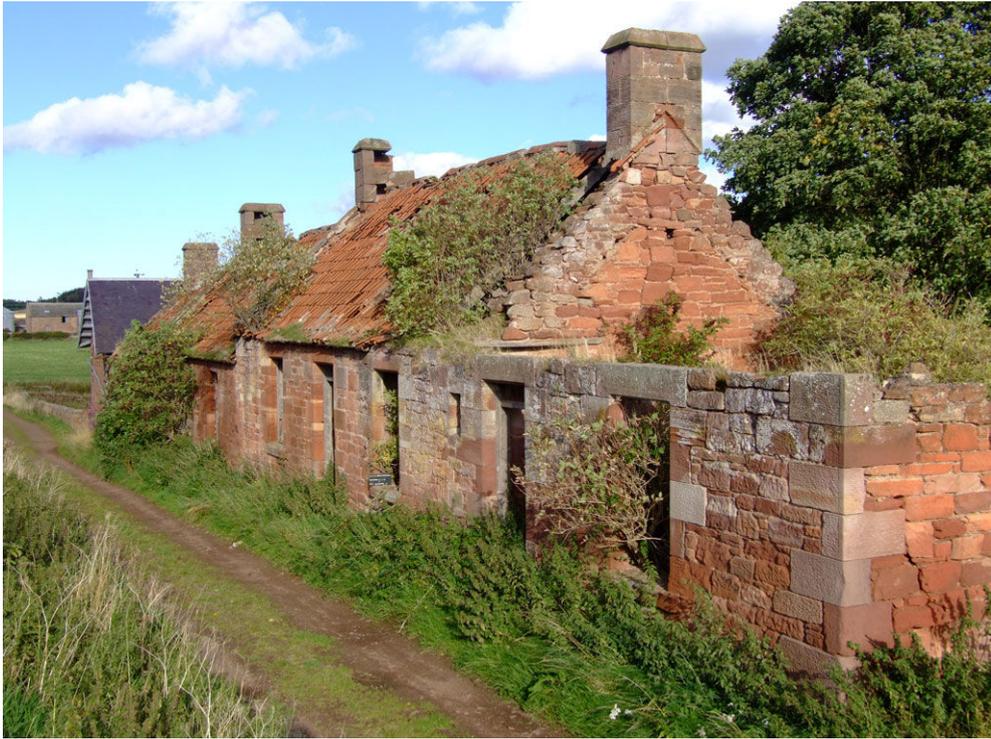
**Plate 9:** View of the north facing principal elevation of structures 7-10 with unit 10 in the right foreground. (note the raised gable)

The cottage row is constructed of roughly coursed and squared red sandstone, with droved and stucked quoins on the west gable elevation. However on the east gable elevation the lower quoins are roughly squared blocks with the later droved and stucked quoins clearly demarking the raising of the wall head and gables. The window and door surrounds which have a broad chamfer are droved and stucked and may be contemporary with the earliest renovations from 1854. The surviving roof is pantile with central chimney breasts leading to flues which serve each component unit. The principal elevation on each unit (excepting unit 10) has a central door flanked by casement windows with 6 over 6 panes. The door has a narrow transom light over. The doors still have the original latch handles. The rear elevation has a window providing light to one room (to the east in units 7 and 8 and 10 and to the west in unit 9, a central window is located in units 7-9 providing light to the narrow bathroom). The windows in unit 7&8 have been blocked with stonework. There are narrow backyards to the rear, set into the quarry cut. The backyards contain a series of small outbuildings servicing each property. Externally, the 1854 modifications are noticeable in the gable ends with clear signs of the raising of the properties (**see figure 5**). Within the east gable elevation there is a blocked window which must relate to the original phase of construction. In the west external elevation of unit 9 there is a clear scar where the flue has been extended to the new chimney stack.

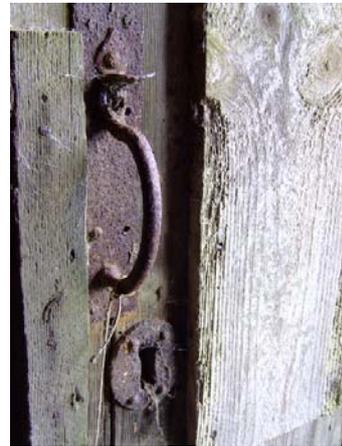
**Plate 10:** Door latch

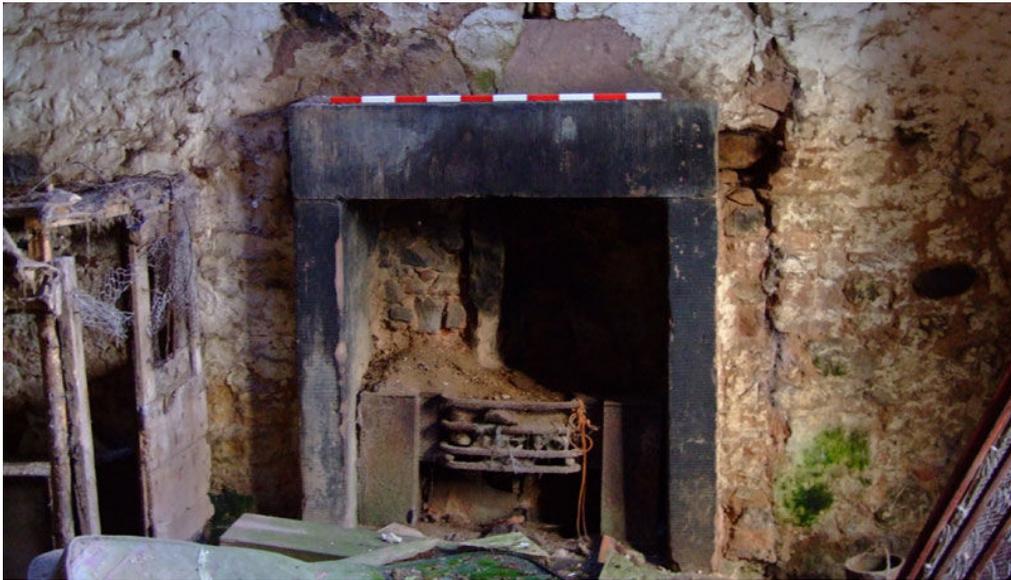
units 8 & 9 evidenced by the bricking up of the fireplace and the remains of stove and stovepipe hole in the brick blocking. Within unit 7 (which has been at some point converted into an animal pen), the original grate is still present in both rooms. The central area has a narrow room to the rear that functioned as a wash room with a sink, though no sign of a toilet is present (suggesting outdoor facilities or other arrangements). The dividing walls within units 8 and 9 are of brick which are plastered on the hard and unit 7 contains wooden laths and plaster. Unit 10 which was added in the 1854 renovations, is a single room, and has been open to the elements for some considerable time, removing most traces of interior fittings. The floors are wooden joists with floorboards rather than the expected flag floor; however, it is clear from the location and height of the fireplaces that this was the original floor level.

**Plate 101:** Original fireplace and grate within structure 7

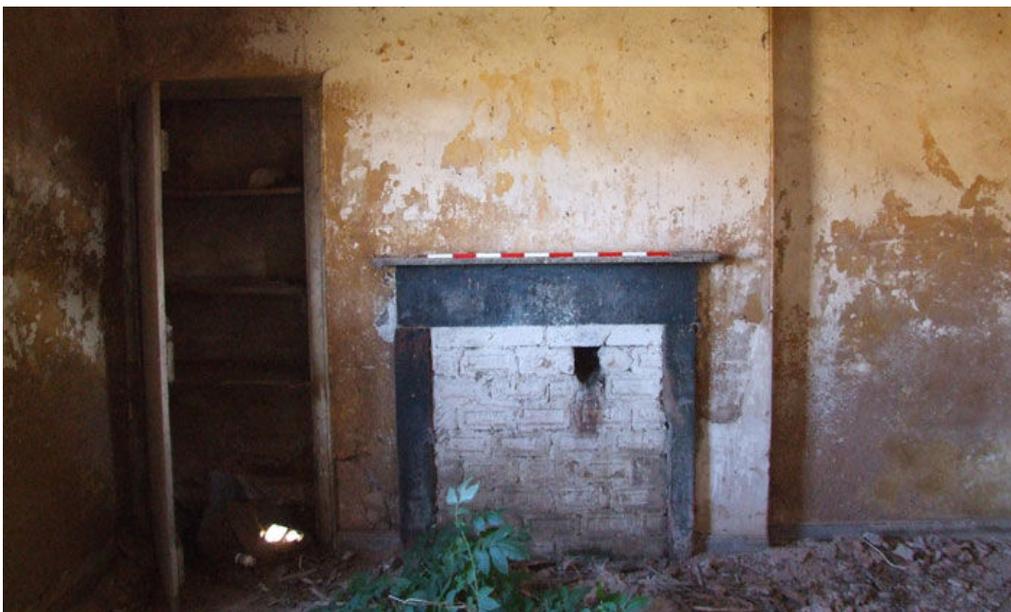
These are simple rooms with little in the way of fittings, having only a single press or cupboard next to each fireplace. There was no sign of electrics within the building.

**Plate 112:** Structure 8 has blocked fireplace with hole for stove pipe and shallow press to the left.

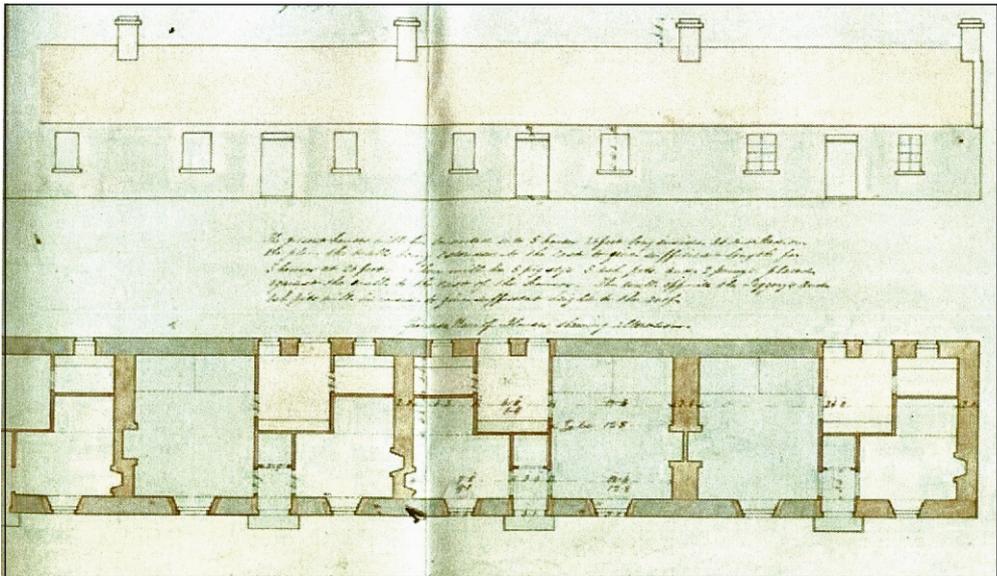
1854 plan showing conversion of existing cottages with extension in to No. 10 and raising the wallhead and new pantile roof

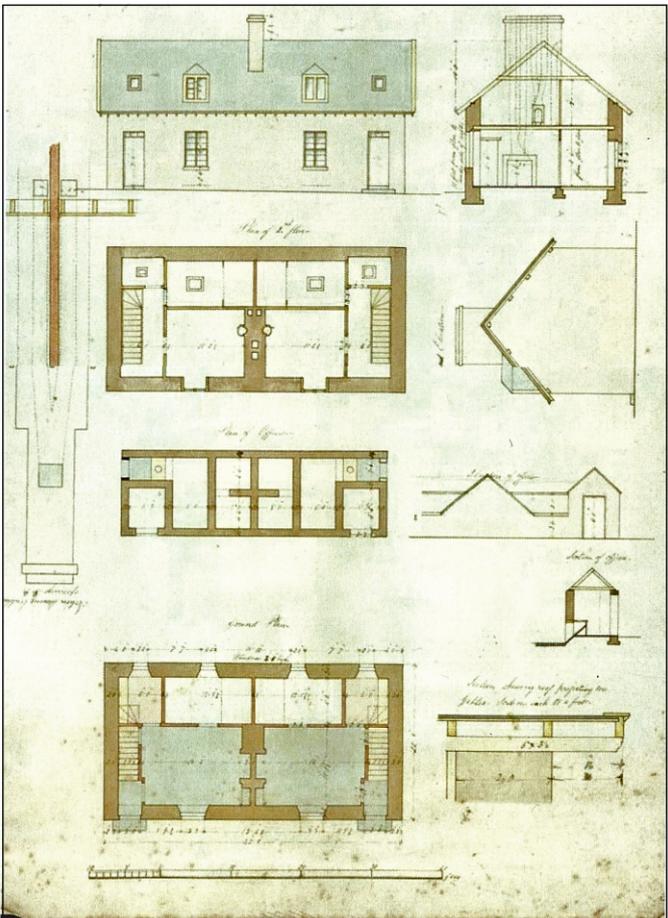
Extract from 1858 construction plans for Units 5 & 6

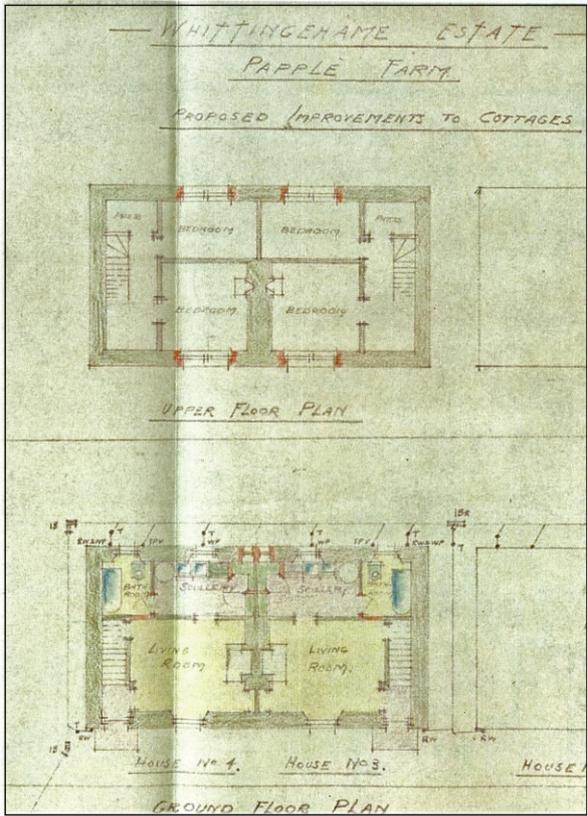
1934 plan showing proposed improvements to Units 1-4

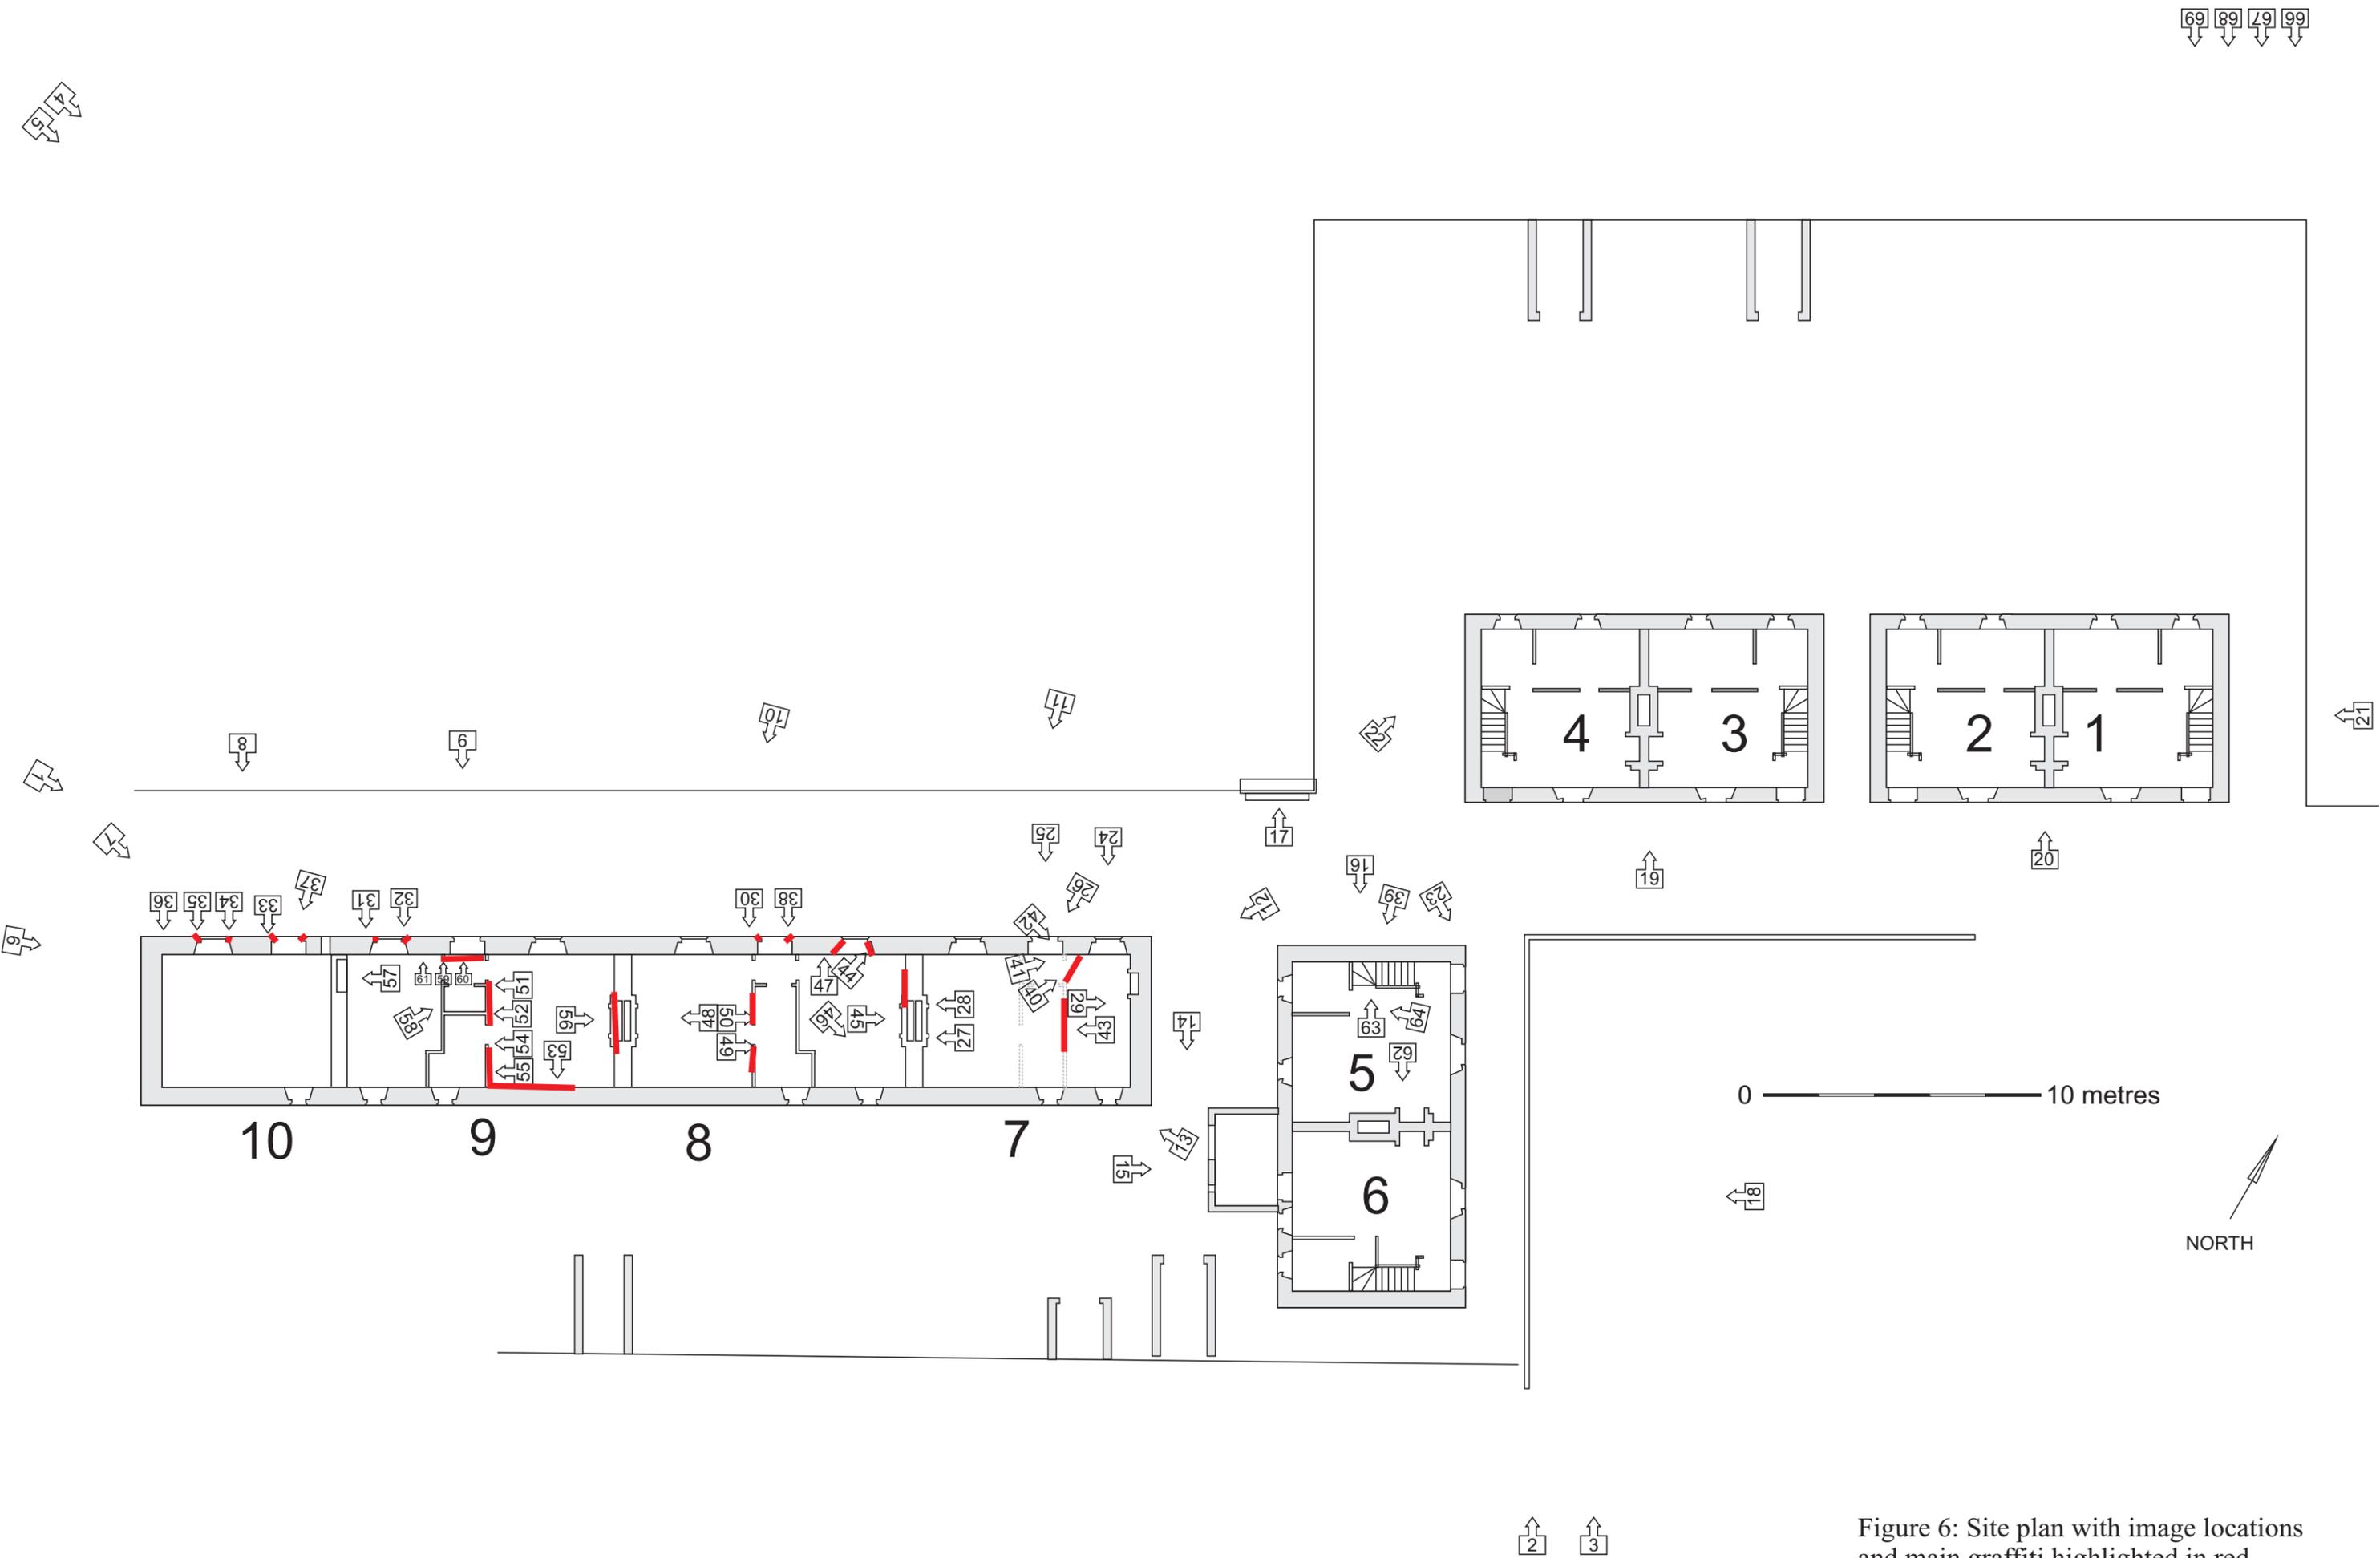
Figure 6: Site plan with image locations and main graffiti highlighted in red.

The interior is a simple arrangement typical to many cottages of this period and earlier. With a small hall leading off to the right and left (**see figure 6**) to small rectangular rooms each containing a fireplace. The earlier grates had been replaced with stoves in

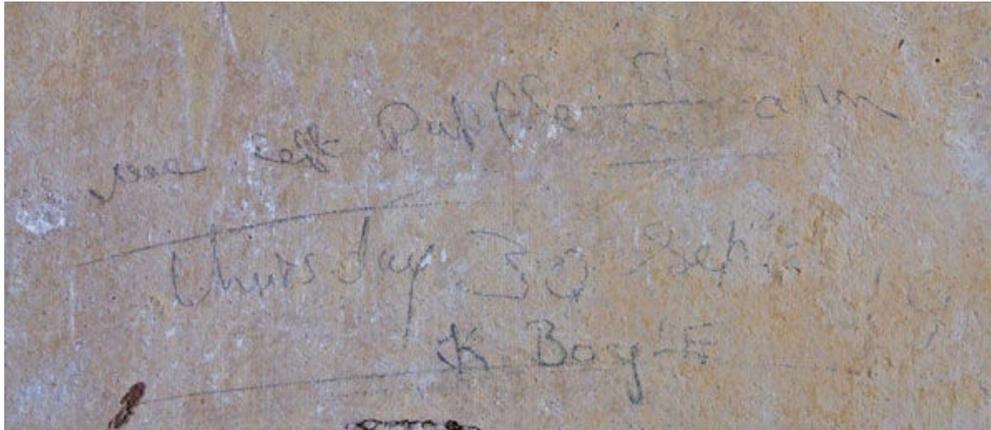
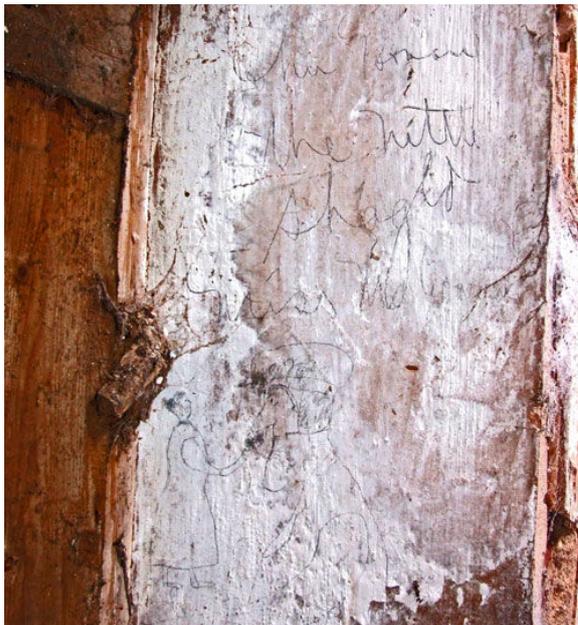
Within the building group structure 7-10 there was a quantity of pencil and carved graffiti recorded that provides an insight into the later occupation of the cottages in the 1940s and 1950s. From the graffiti that is decipherable it is clear this represents a time after the second world war when labour for farms was in short supply, with many Irish people travelling to Scotland to find work in tending the turnip fields and other harvest activities. They lived in these basic cottages in groups until it was time to return home in the late autumn. Below, the message from K Boyle states "we left Papple Farm on Thursday the 30<sup>th</sup> September 1954".

A photographic record of the graffiti was undertaken to record this fleeting glimpse of the past. It is most often written on doors and plasterwork in pencil and is slowly fading. To the left is one of only two pencil drawings.

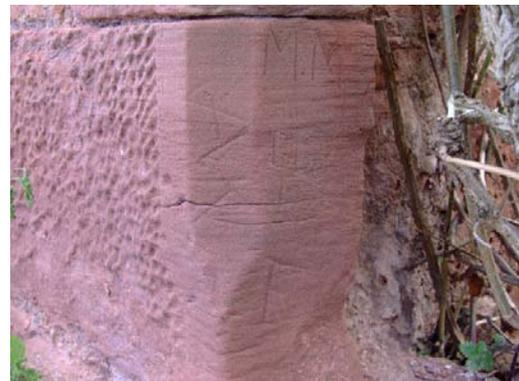
Other graffiti can be seen on the door and window surrounds carved into the sandstone, and consists of initials such as CR MM or DG (right)

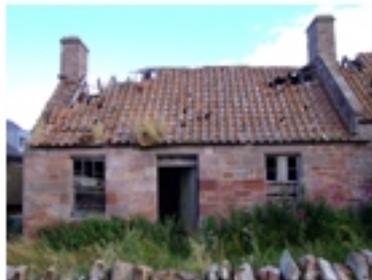
PAP10\_11.JPG

11	PAP10_11	South	North elevation of structure 7.	11/09/2010
12	PAP10_12	West	East elevation, east gable end of structure 7. N.B. two blocked windows and gable scar from earlier cottages.	11/09/2010
13	PAP10_13	Northwest	South elevation of structure 7. N.B. two blocked windows.	11/09/2010
14	PAP10_14	Southeast	North & west elevation of outbuilding to rear of structure 7.	11/09/2010
15	PAP10_15	East	Rear kitchen extension of structures 5&6. N.B. Brick repair to chimney, asbestos tiles and altered windows to right.	11/09/2010
16	PAP10_16	South	North elevation of structure 5.	11/09/2010
17	PAP10_17	North	Tap and basin feature in wall to west of structure 4.	11/09/2010
18	PAP10_18	West	East elevation of structures 5&6. N.B. box dormer to left and dormer to right. Cement repair to 5&6 door and window.	11/09/2010
19	PAP10_19	North	South elevation of structures 3&4	11/09/2010
20	PAP10_20	North	South elevation of structures 1&2	11/09/2010
