Geophysical Survey Report

Church of St Michael, Cropthorne, Worcestershire

J2061

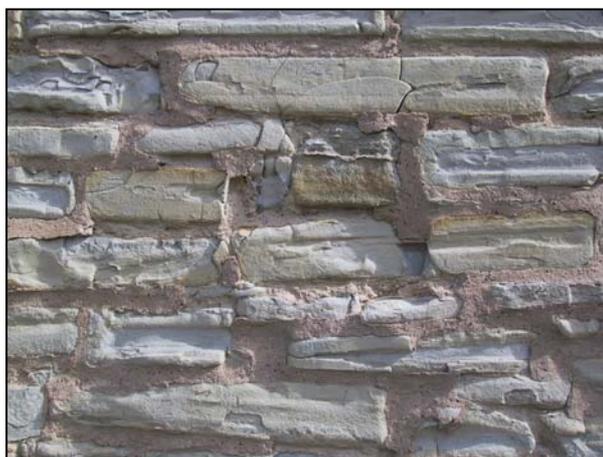
The construction of the tower consists mainly of lias and mortar with oolitic limestone ashlar quoins and mullions. The surface of the tower is rough with areas of surface erosion.

Plate 1: Showing construction material and surface of the church tower

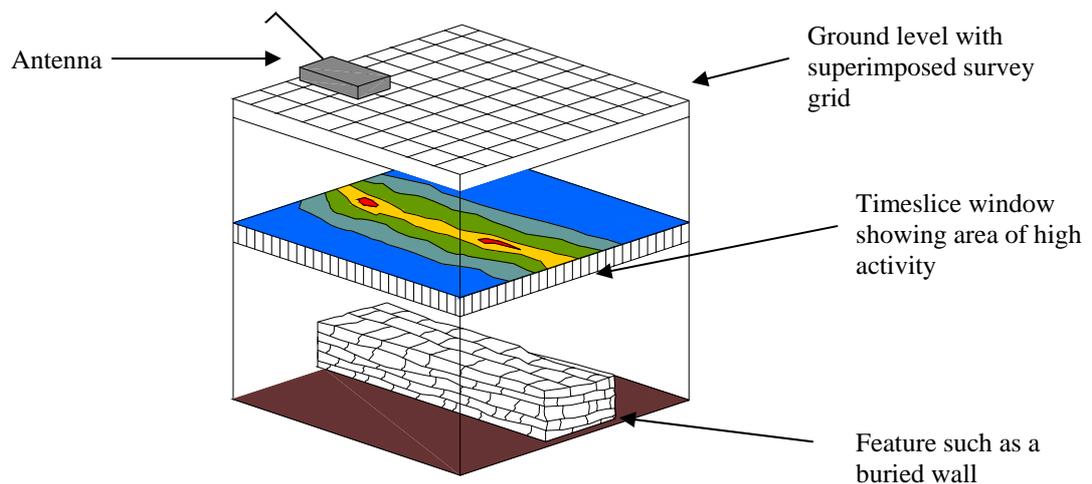
The GPR data is compiled to create a 3D file. This 3D file can be manipulated to view the data from any angle and at any depth within range. The data was then modelled to produce activity plots at various depths. As the radar is actually measuring the time for each of the reflections found, these are called "time slice windows". Plots for various time slices have been included in the report. Based on an average velocity calculations have been made to show the equivalent depth into the ground. The data was sampled between different time intervals effectively producing plans at different depths into the ground.

The weaker reflections in the time slice windows are shown as dark colours namely blues and greens. The stronger reflections are represented by brighter colours such as light green, yellow, orange, red and white (see key provided in Figures 2-5).

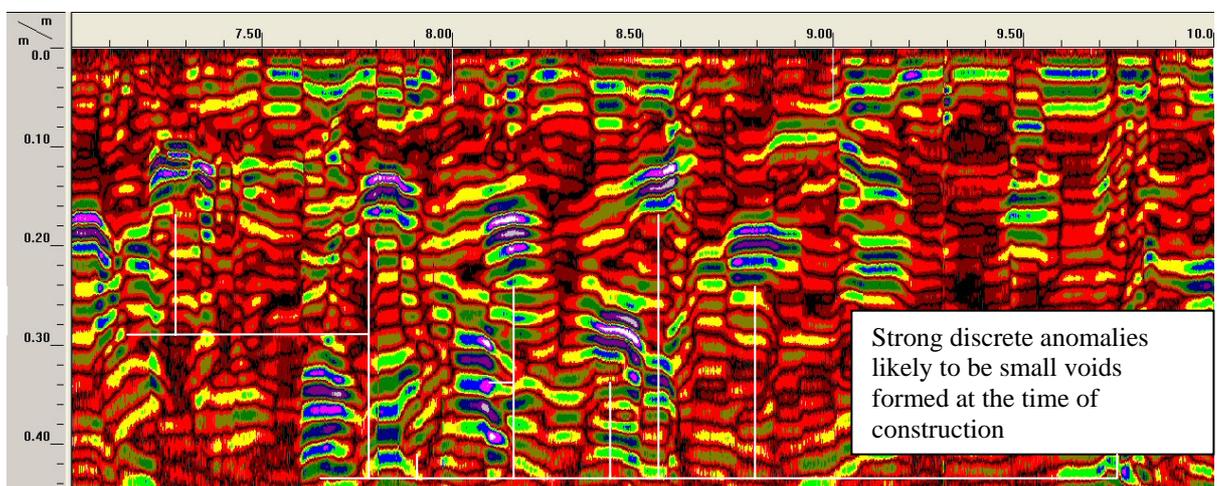
The manual abstraction of the radar has produced a large number of radar anomalies. The data is dominated by a large number of strong discrete responses with an average length of 0.1m ranging in depth from 0.07 to 0.35m. These anomalies appear frequently within the radar data and may represent small voids created during the construction of the tower. The responses mainly appear at a depth of 0.09-0.15m. It is likely that these voids lie to the rear of the outer face of lias blocks (Example Radargram 1). Therefore, any anomalies larger in size, depth or thickness to these possible construction anomalies must be considered as possible voiding or further erosion of the construction voids.

Example Radargram 1: West wall, 5.2E, 7-10. Showing strong discrete responses that may be the caused by the tower construction

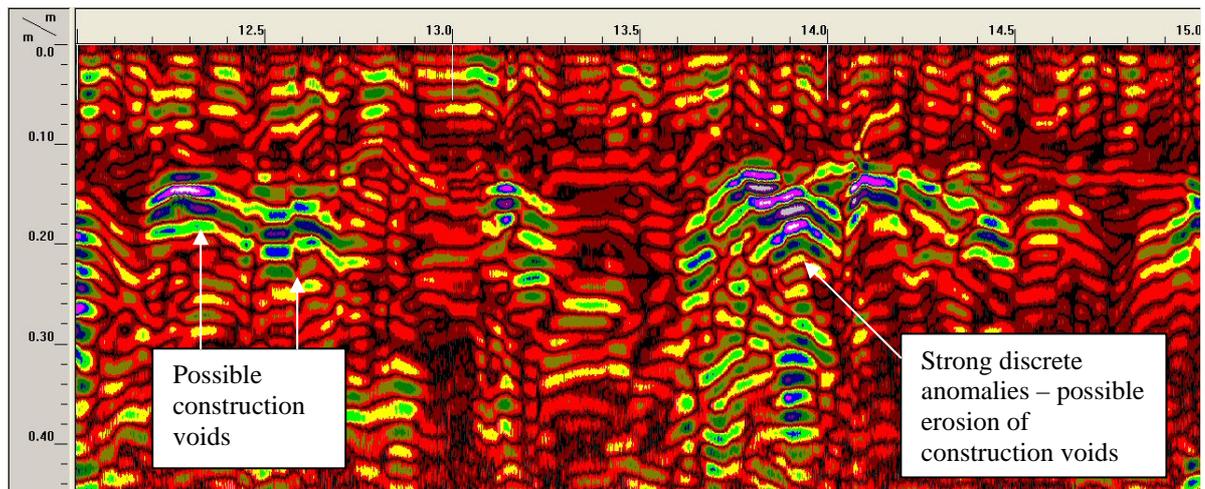
A large number of possible construction voids have been identified within the north wall. Particularly strong discrete responses have been targeted as possible areas of further degradation of original construction voids (Example Radagram 2). No evidence for substantial voiding has been identified within the north wall.

Example Radargram 2: North wall, 4.5E, 12-15. Strong discrete response possibly indicating erosion of construction voids

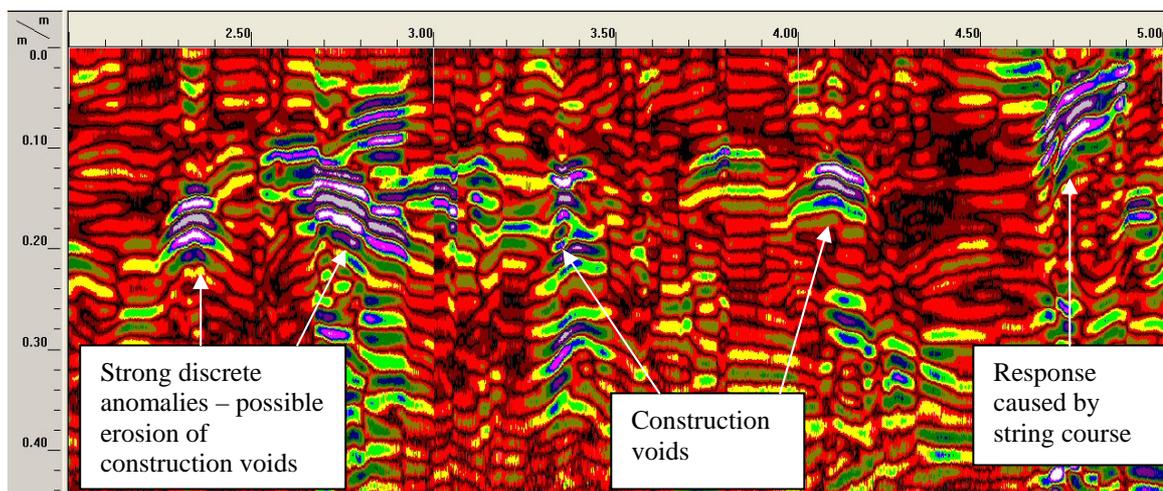
A number of possible construction faults have been identified within the east wall, mainly situated around the central window at depths of 0.07-0.13m (Example Radargram 3). No substantial voiding can be identified within the east wall.

Example Radargram 3: East Wall, 1.5E, 2-5. Strong discrete responses possibly indicating further erosion of construction voids

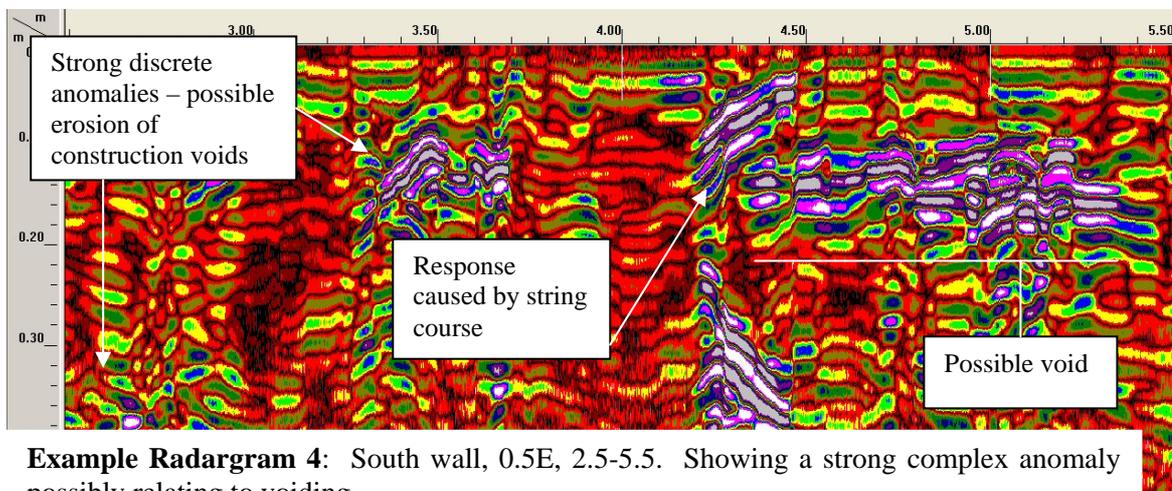
Two large areas of strong complex and discrete responses have been identified to the left of the main window. These two area responses indicate possible voids, with the lower void extending to depth (example Radargram 4 and 5)

Example Radargram 4: South wall, 0.5E, 2.5-5.5. Showing a strong complex anomaly possibly relating to voiding.

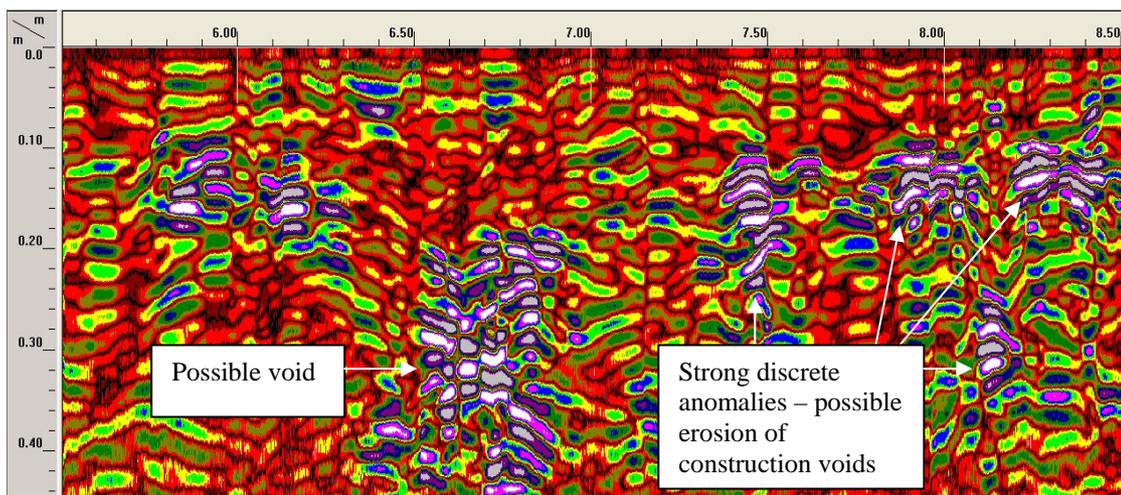
Example Radargram 5: South wall, 0.5E, 5.5-8.5. Strong complex area indicating a possible void extending to depth

Three possible larger voids have been identified with the GPR survey. Two possible voids are situated in the south wall left of the main window, the lower void may extend to depth (see Example Radargram 5). Another possible void has been identified within the centre right of the west wall (see Example Radargram 6). The radar data is dominated by strong discrete anomalies at depths of 0.07-0.15m. These anomalies have been interpreted as small voids created during the construction of the tower. Areas of particularly strong responses may represent further erosion of these construction voids and have been identified across all four faces of the tower. A reduction in the number of anomalies identified towards the bottom of the west and north wall suggest the absence of possible voiding within these areas.

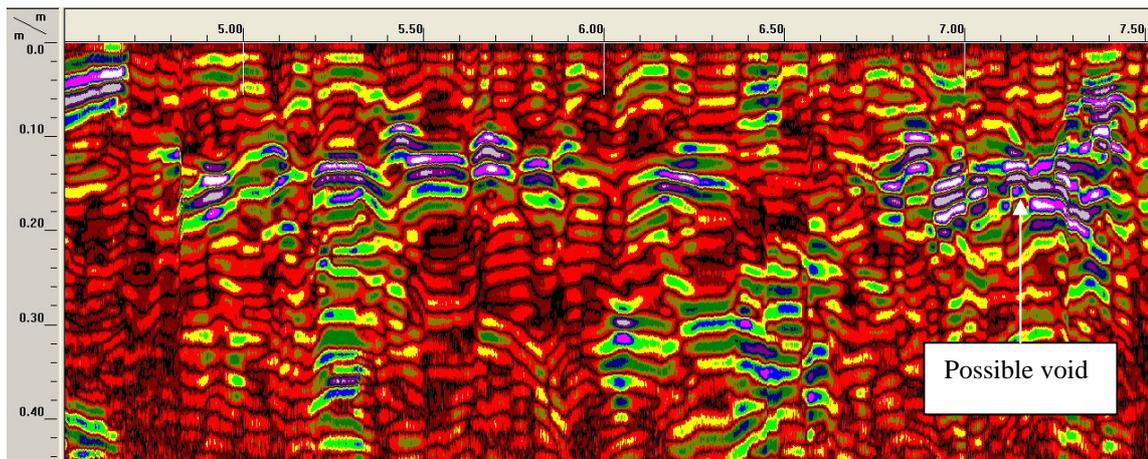
Within the west wall a large number of possible areas of erosion from construction voids can be identified. A small void has been identified within the centre right of the wall (Example Radargram 6). However, there appears to be a reduction in discrete responses towards the bottom left of the tower, suggesting an absence of construction voids.

Example Radargram 6: West Wall, 4.2E, 4.5-7.5. Showing strong complex anomaly possibly indicating a void
