Moor House, Drone Hill, Coldingham Historic Building Appraisal

Data Structure Report No. 1915

Author	Stuart Mitchell MA AIfA
Illustrator	Graeme Carruthers MA MAAIS
Editor	Melanie Johnson MA PhD FSA Scot MIfA
Commissioned by	Natural Power Ltd
Date issued	July 2011
Version	0
OASIS Reference	cfaarcha1-104160
Planning Application No	
Grid Ref	NT 8441 6789

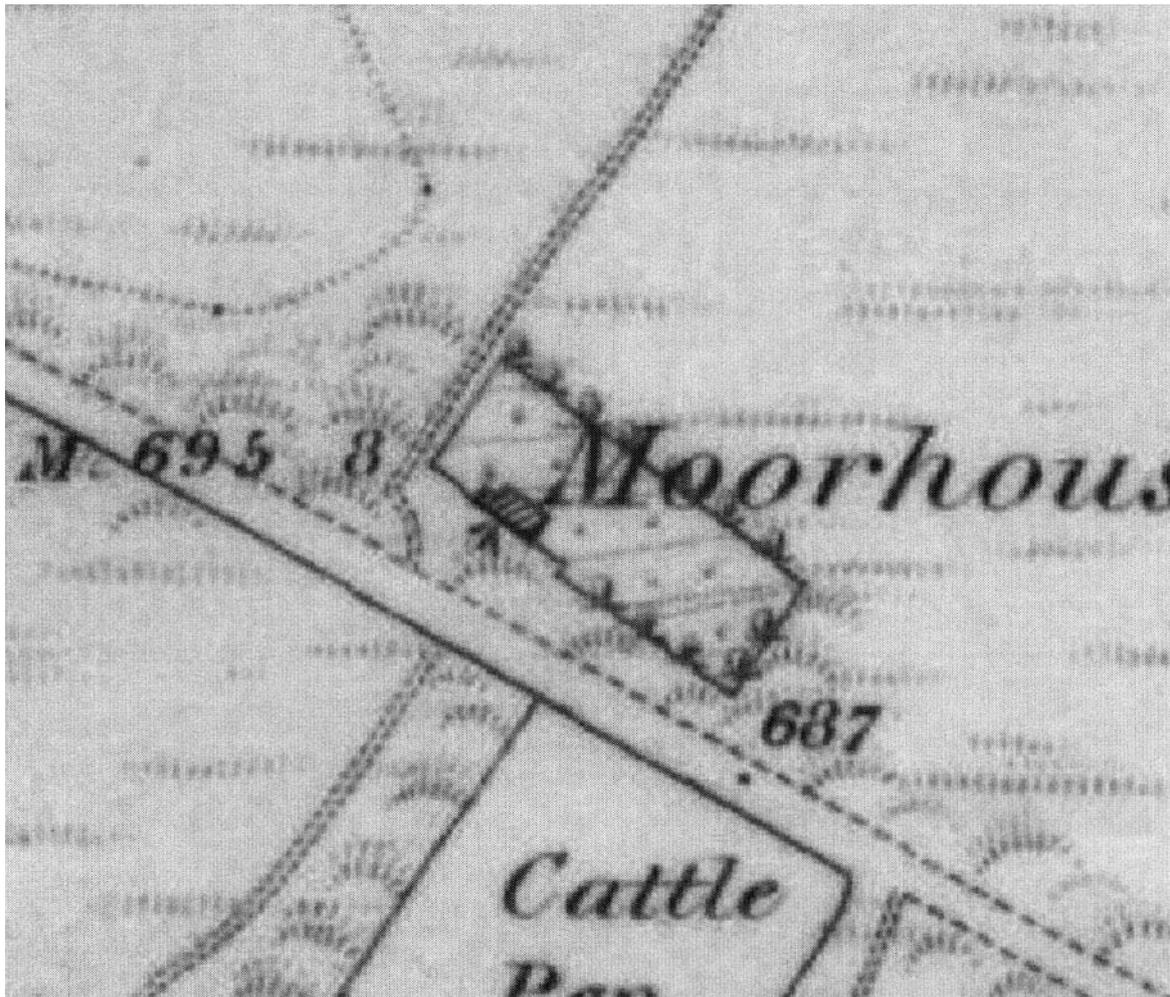
Fig. No: 2 Revision: A Client: Natural Wind Power Ltd

Fig. 1	Location map
Fig. 2	'Moorhouse' as depicted on 1856 edition Ordnance Survey map
Fig. 3	Floor plan
Fig. 4	Exterior view of south-facing elevation
Fig. 5	Exterior view of west-facing elevation
Fig. 6	Exterior view of North and east-facing elevations
Fig. 7	Exterior view of front porch extension and dormers, south-facing elevation
Fig. 8	Interior, room 2
Fig. 9	Interior, room 4
Fig. 10	Interior, room 5
Fig. 11	Interior, room 9
Fig. 12	Original roof within cupboard, room 9
Fig. 13	Exterior, door and tie-plate, south-facing elevation

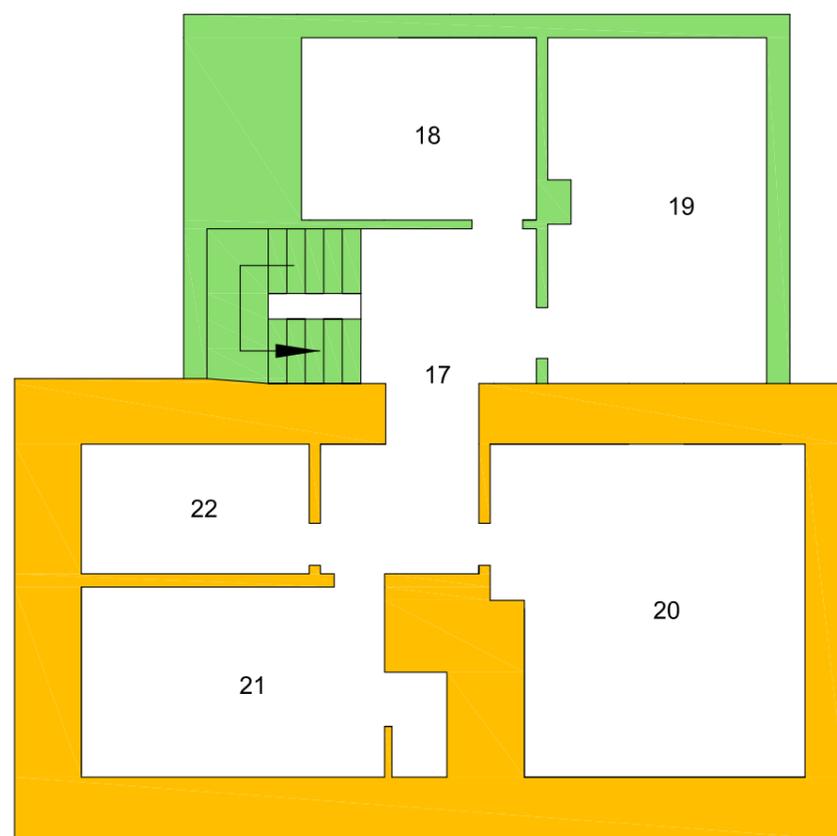
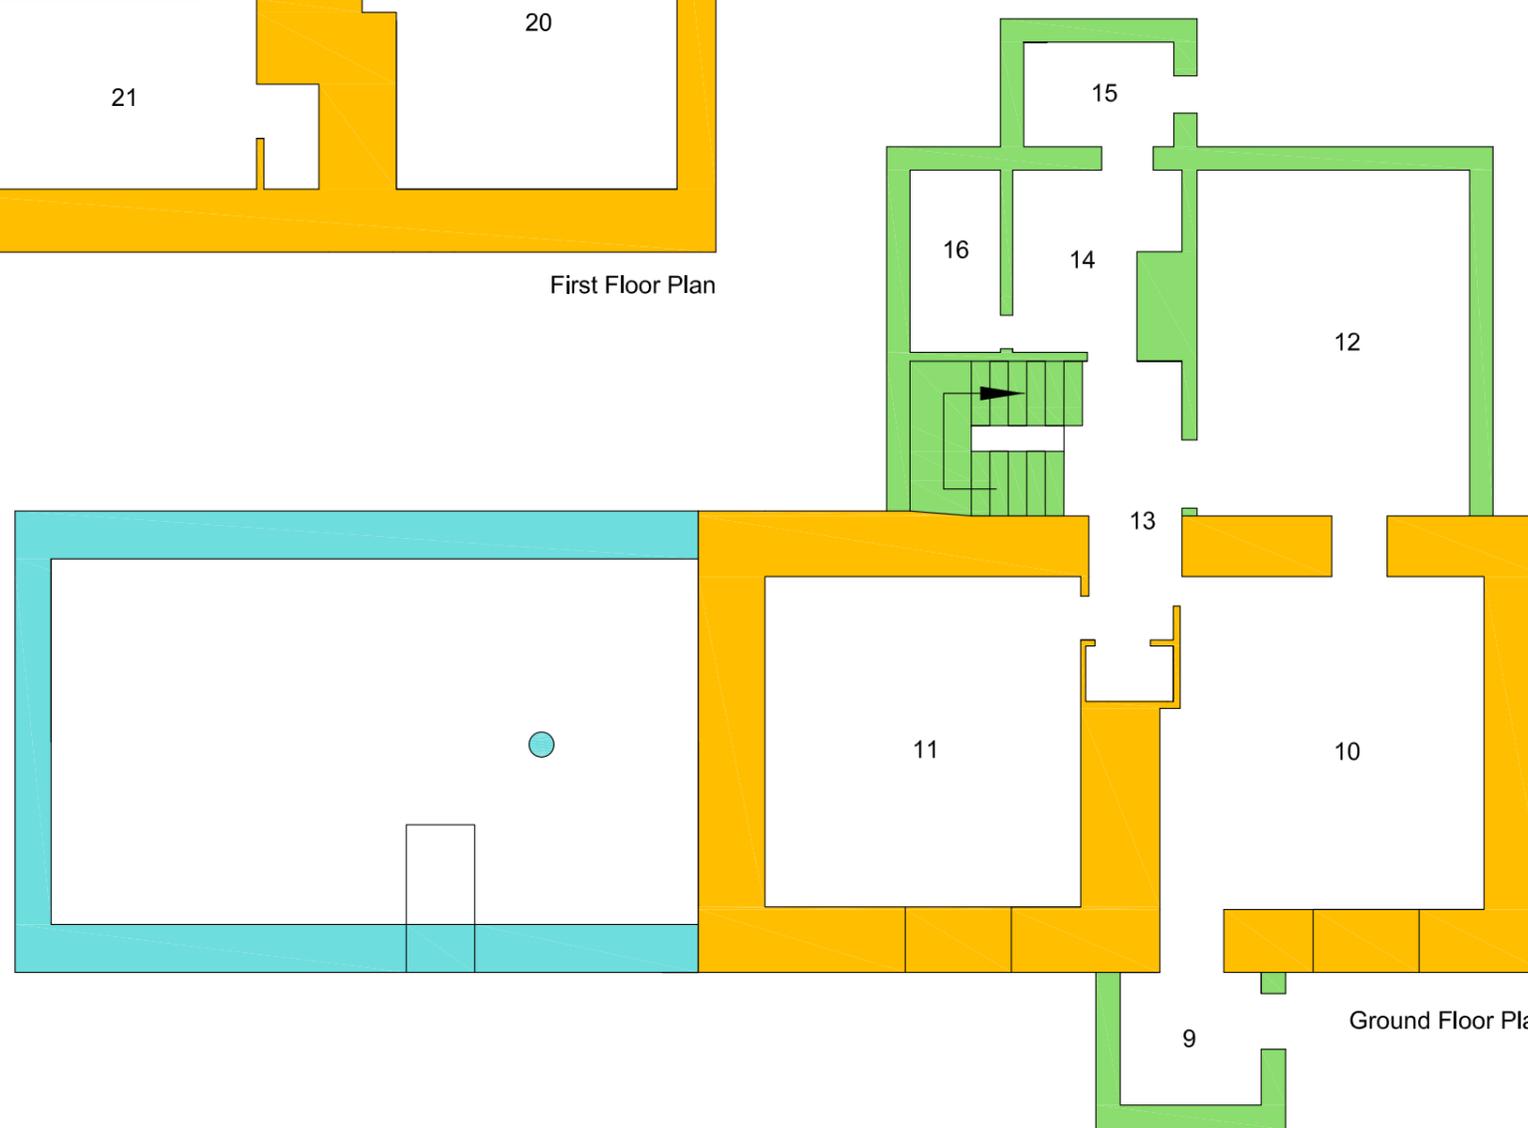
Fig. No: **3** Revision: **A**

Moor House is a linear building comprising a single storey house with modern extensions, a loft conversion and an adjoining barn (Fig. 3). Outbuildings comprise a cattle shed to the west side and a pigeon coop to the rear. Three broad phases of construction and use can be discerned. Interior unit numbers have been ascribed to the ground plan and are listed in the text in parentheses and in Appendix 1.

Title:
Floor Plans

Three broad phases of construction can be identified at Moor House.

The earliest phase is the construction of the house itself, which was most likely used as a farmer's or farmworker's cottage. The remains of this phase can best be seen on the west-facing elevation of the house, inside the barn, where the line of the original pitched roof and a small gable window are visible.

The second phase of construction is the building of the barn abutting the west end of the house. It is likely that this functioned as a barn and was not used as domestic quarters.

The third phase of construction is represented by the conversion of the cottage to a modern dwelling which has involved converting the loft, building the extensions to the front and rear, and harling the exterior.

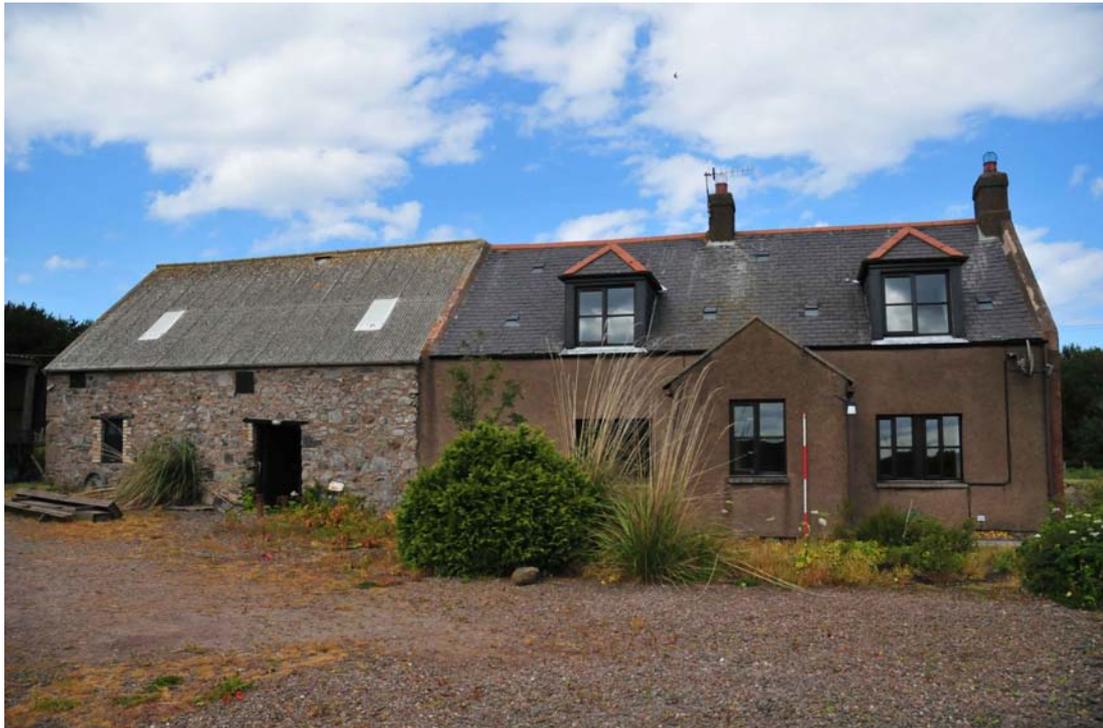
The south-facing elevation (1) forms the front of the house (Fig. 4). It is harled and painted dull reddish-brown and has a centrally placed entrance door, now inside a

later porch extension (6). Two large windows are set either side of the door, with concrete sills and modern timber framed windows. It is likely that these windows are either slapped or enlarged from earlier smaller openings, although it is not possible to ascertain this.

Fig. 4 Exterior view of south-facing elevation

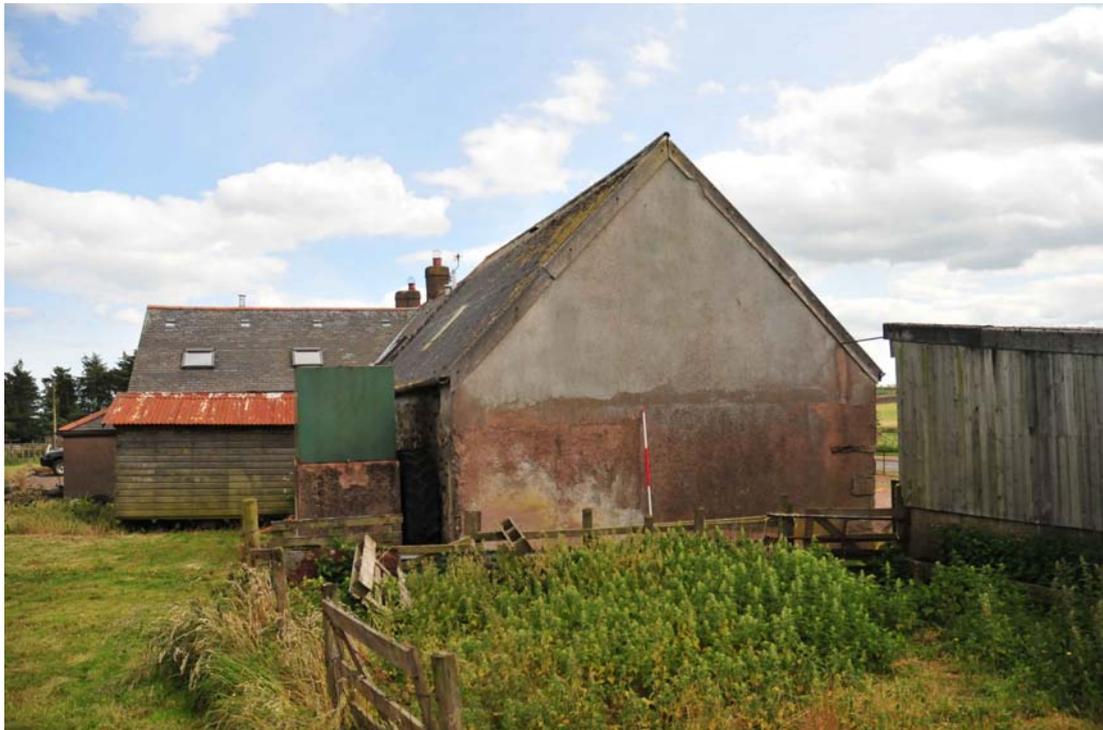
The west-facing elevation (4), the build of which is described above, appears to have been heightened, indicated by faint diagonal joins and horizons which correspond to the original wallhead level of the barn, described below. The west-facing elevation features a small blocked up window, centrally situated. The window has a timber lintel. It is partly obscured by the presence of loft joists within the barn.

Fig. 5 Exterior view of west-facing elevation

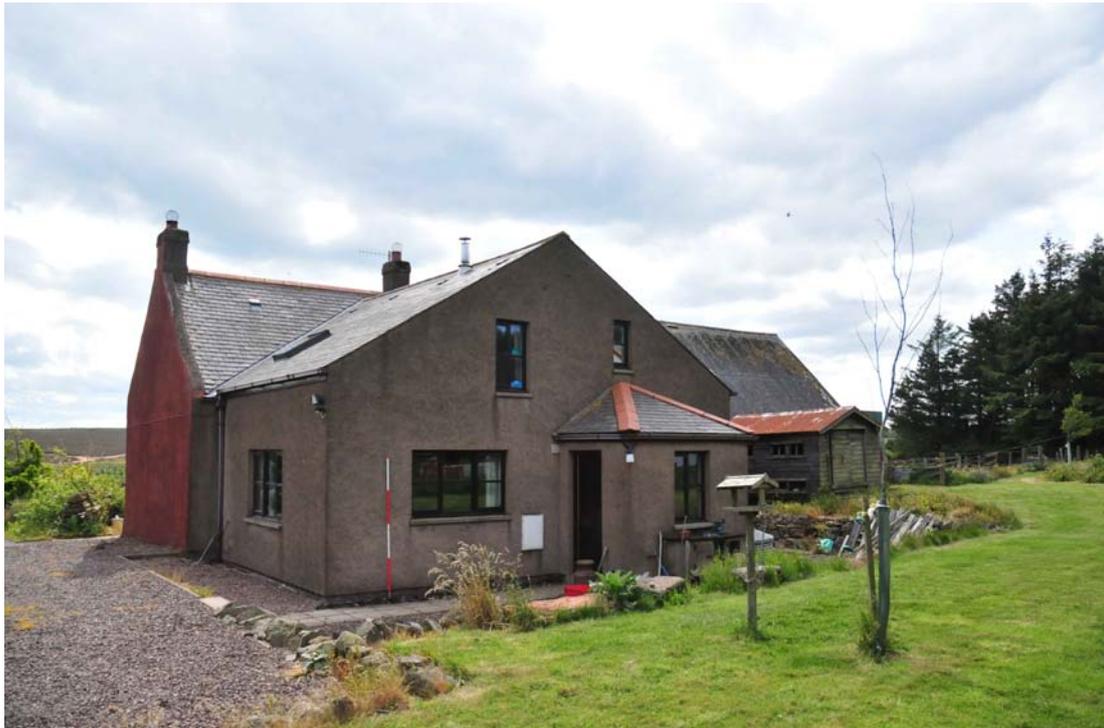
Much of the original north-facing elevation (3) is obscured by a later extension to the rear of the house (Fig. 6). The remaining visible external wall is harled and painted dull reddish brown and has a single window to the west end of the wall; whether this is an original window opening or a later modification is unclear.

Fig. 6 Exterior view of north and east-facing elevation

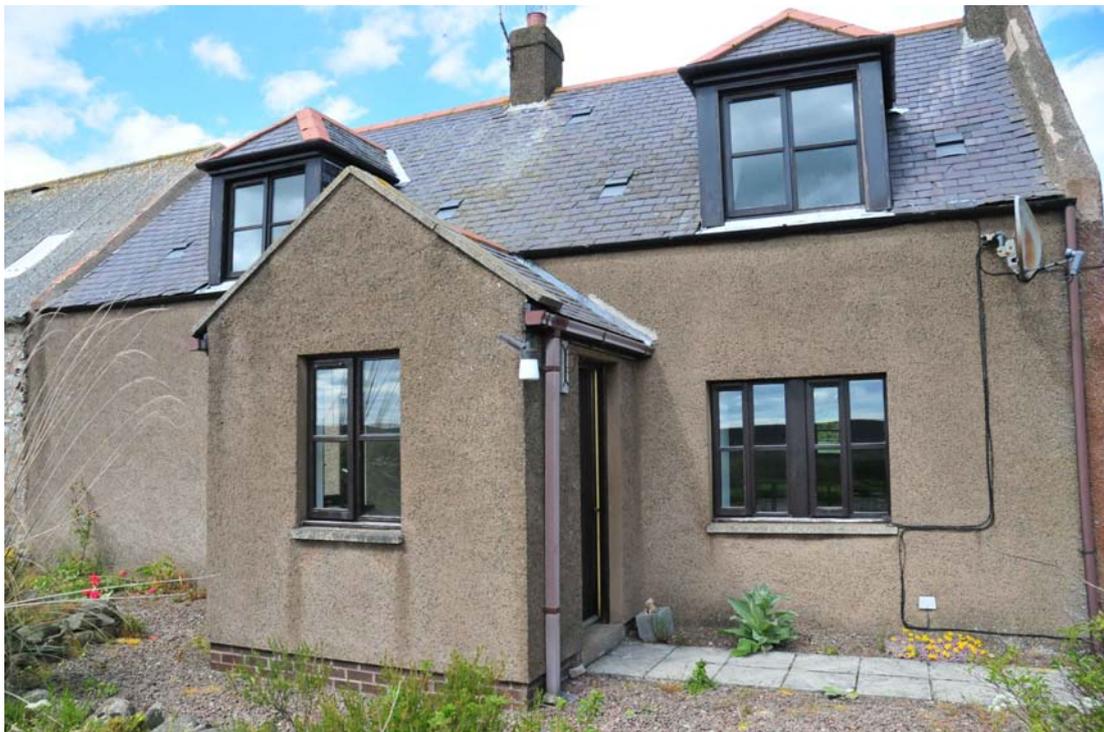
The extension on the south-facing elevation comprises a small porch (6) (Fig. 7). It has a pitched roof and features a small window on its west and south elevations and an entrance door on its east-facing elevation.

Fig. 7 Exterior view of front porch extension and dormers, south-facing elevation

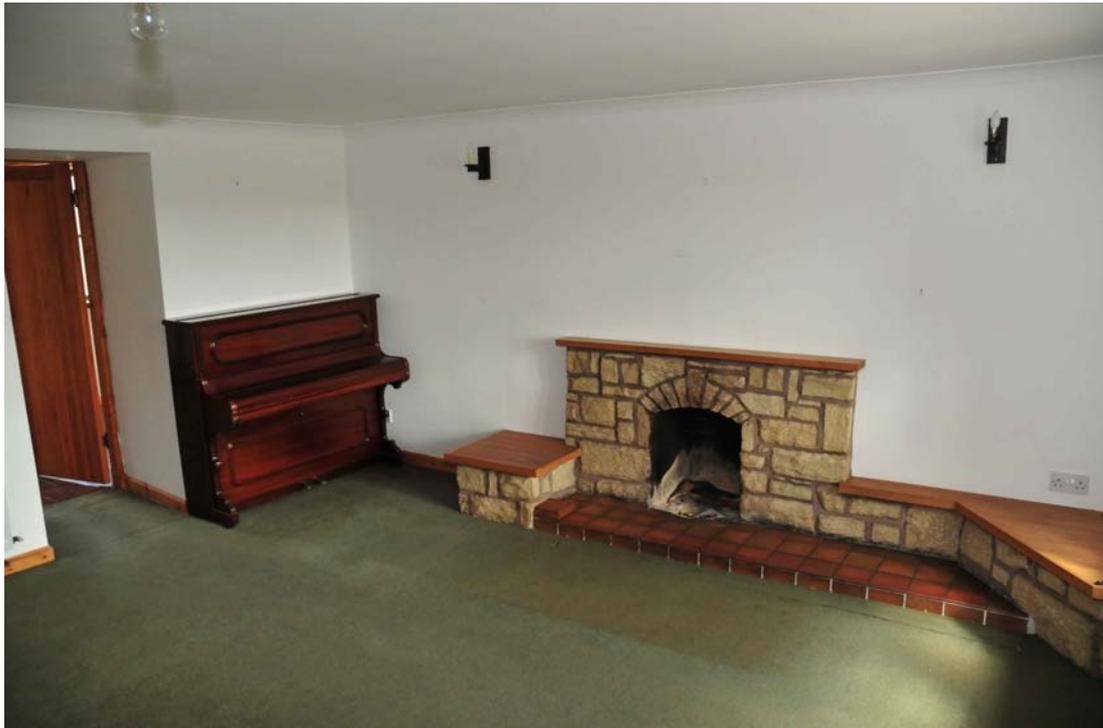
The interior of the house comprises a domestic dwelling. The ground floor contains the entrance vestibule (9) within the porch (5), a dining room (10) (Fig. 8), lounge (11), kitchen (12) (Fig. 9), hall (13) (Fig. 10), utility room (14), back porch (15) and downstairs WC (16). It is fitted and decorated with modern materials throughout including plastered and papered walls and modern moulded pine skirting boards. The lounge, dining room and hall floors are covered with fitted carpets, the WC, utility rooms and kitchen are floored with quarry tiles. The WCs and bathrooms are furnished with modern plastic and ceramic suites and the kitchen is fitted with modern units and an oil-fired 'Stanley' range cooker.

Fig. 8 Interior, Room 2

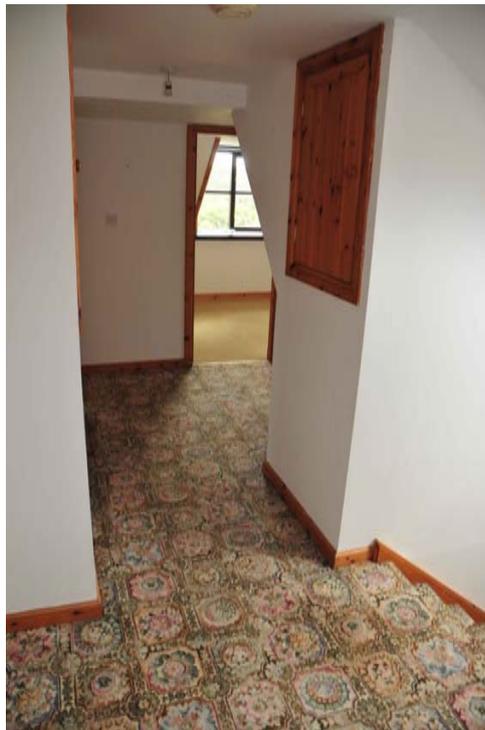
The first floor comprises a converted loft containing a landing (9) (Fig. 11) which leads to four bedrooms (10-13) and a bathroom (14). The upper floor has modern fittings throughout including plastered and papered walls and modern moulded pine skirting boards. The internal dividing walls are stud and plaster and doors are timber framed and panelled. The floors of the landing and bedrooms are carpeted and the bathroom floor covering is fitted linoleum sheet. The landing has two cupboards set into the wall, both of which open to reveal the original roof, still fitted with tiles (Fig. 12).

Fig. 11 Interior, Room 9

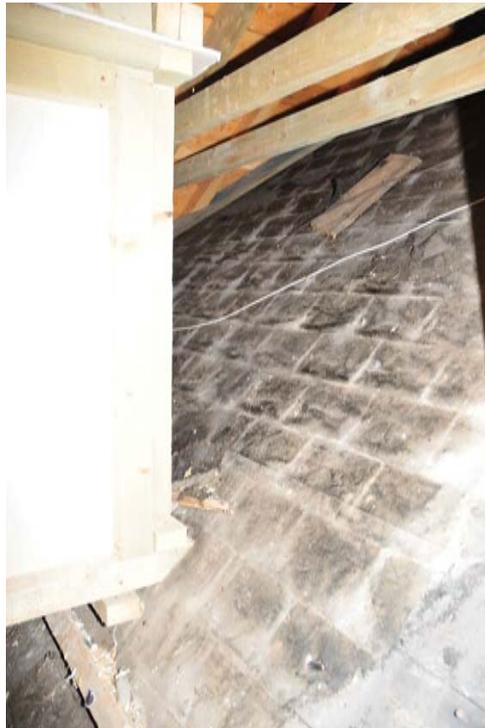
Fig. 12 Original roof within cupboard, Room 9

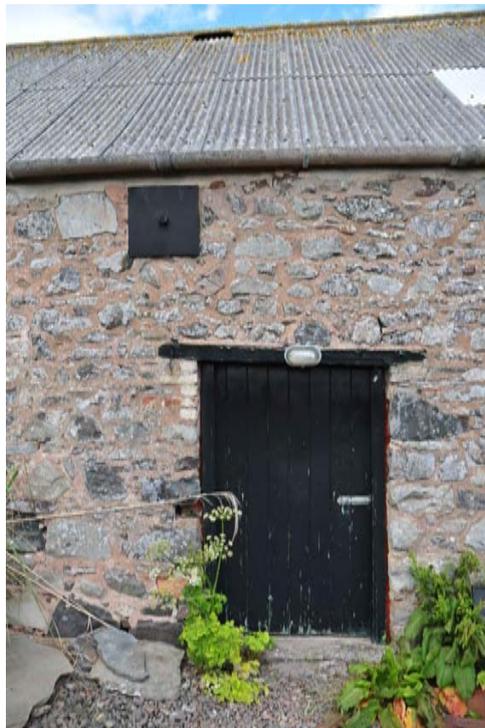
The south-facing elevation (23) features an entrance doorway fitted with a timber door (Fig. 13). The doorway has a timber beam lintel and has been repaired with brick. It is unclear whether the doorway was originally incorporated into the wall build or is a later addition although there is no indication of the doorway being cut through the wall. A small window has been cut through the wall and framed with brickwork. Two square iron tie-plates are present close to the wallhead. A benchmark has been carved into one of the quoins on the south-west corner of the building (Fig. 14).

Fig. 13 Barn exterior door and tie plate, south-facing elevation

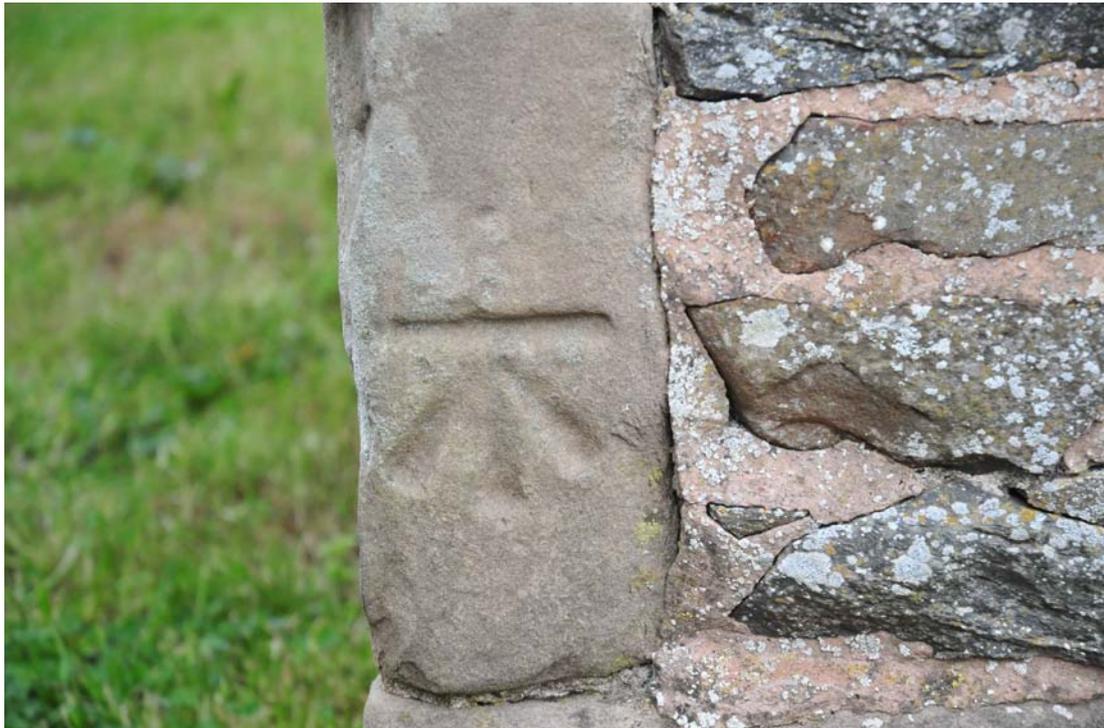
Fig. 14 Exterior, benchmark, south-facing elevation

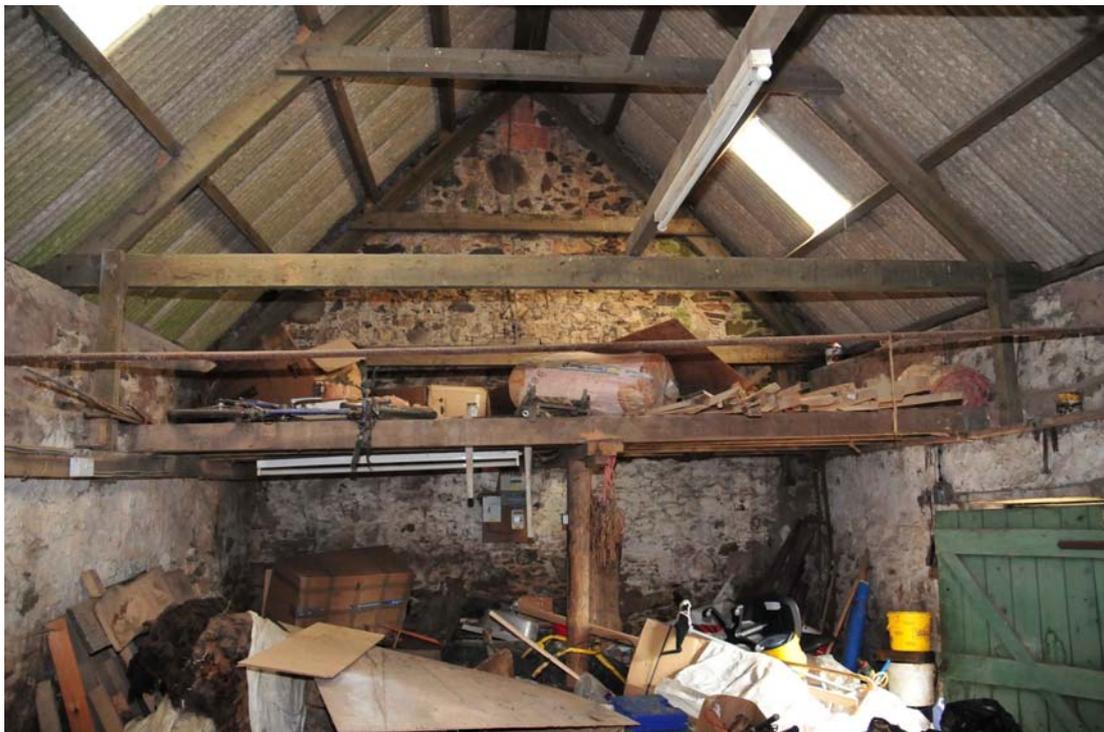
The original wallhead level had been raised (27) using rubble along the sides (Fig. 15) and breeze block at the gable. The pitch on the interior east-facing gable was built of brick (28). A partially surviving loft level (29) was located in the eastern half of the interior, comprising machine cut timber joists set into sockets flush with the original wallhead. The sockets continue along the full length of the barn, indicating the prior existence of joists at this level. The existing loft joists are supported by a timber post which is set slightly off-centre (Fig. 16).

Fig. 15 Interior, east-facing gable of house inside barn, raised wall head and roof truss

It is clear that the barn and the house have been raised in height although it is unclear when. However, the use of rough sandstone rubble to raise the level of the side walls of the barn, the rubble build of the heightened pitch on the west-facing elevation of the house, the large sandstone skewers and substantial build of the chimney stacks do not suggest a recent date. While the breezeblock section raising the wallhead level on the barn's west gable may be anomalous, it could be the result of a repair and a need to create a level surface for building the brick pitch onto.

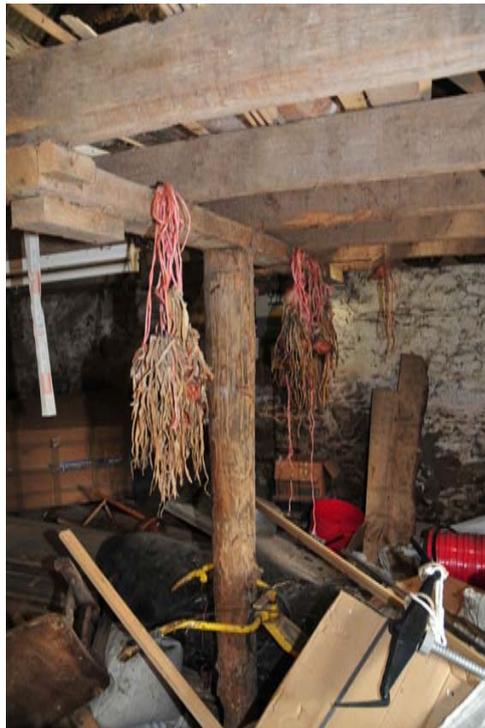
Fig. 16 Interior, post supporting joists at original level

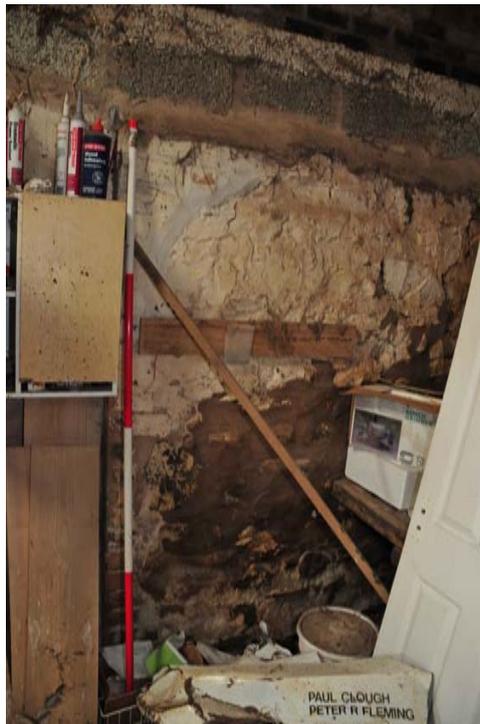
The blocked opening on the internal east-facing elevation, visible on the external west-facing elevation, is built from brick and sandstone rubble and stands slightly proud of the main internal wall line (Fig. 17). It is likely this represents a former doorway, although the possibility exists that it may be a heavily repaired former fireplace.

Fig. 17 Interior, west-facing elevation, blocked doorway
