**Abbey Walk, St Andrews  
Fife**

**Archaeological Watching Brief**

**Report No. 2148**

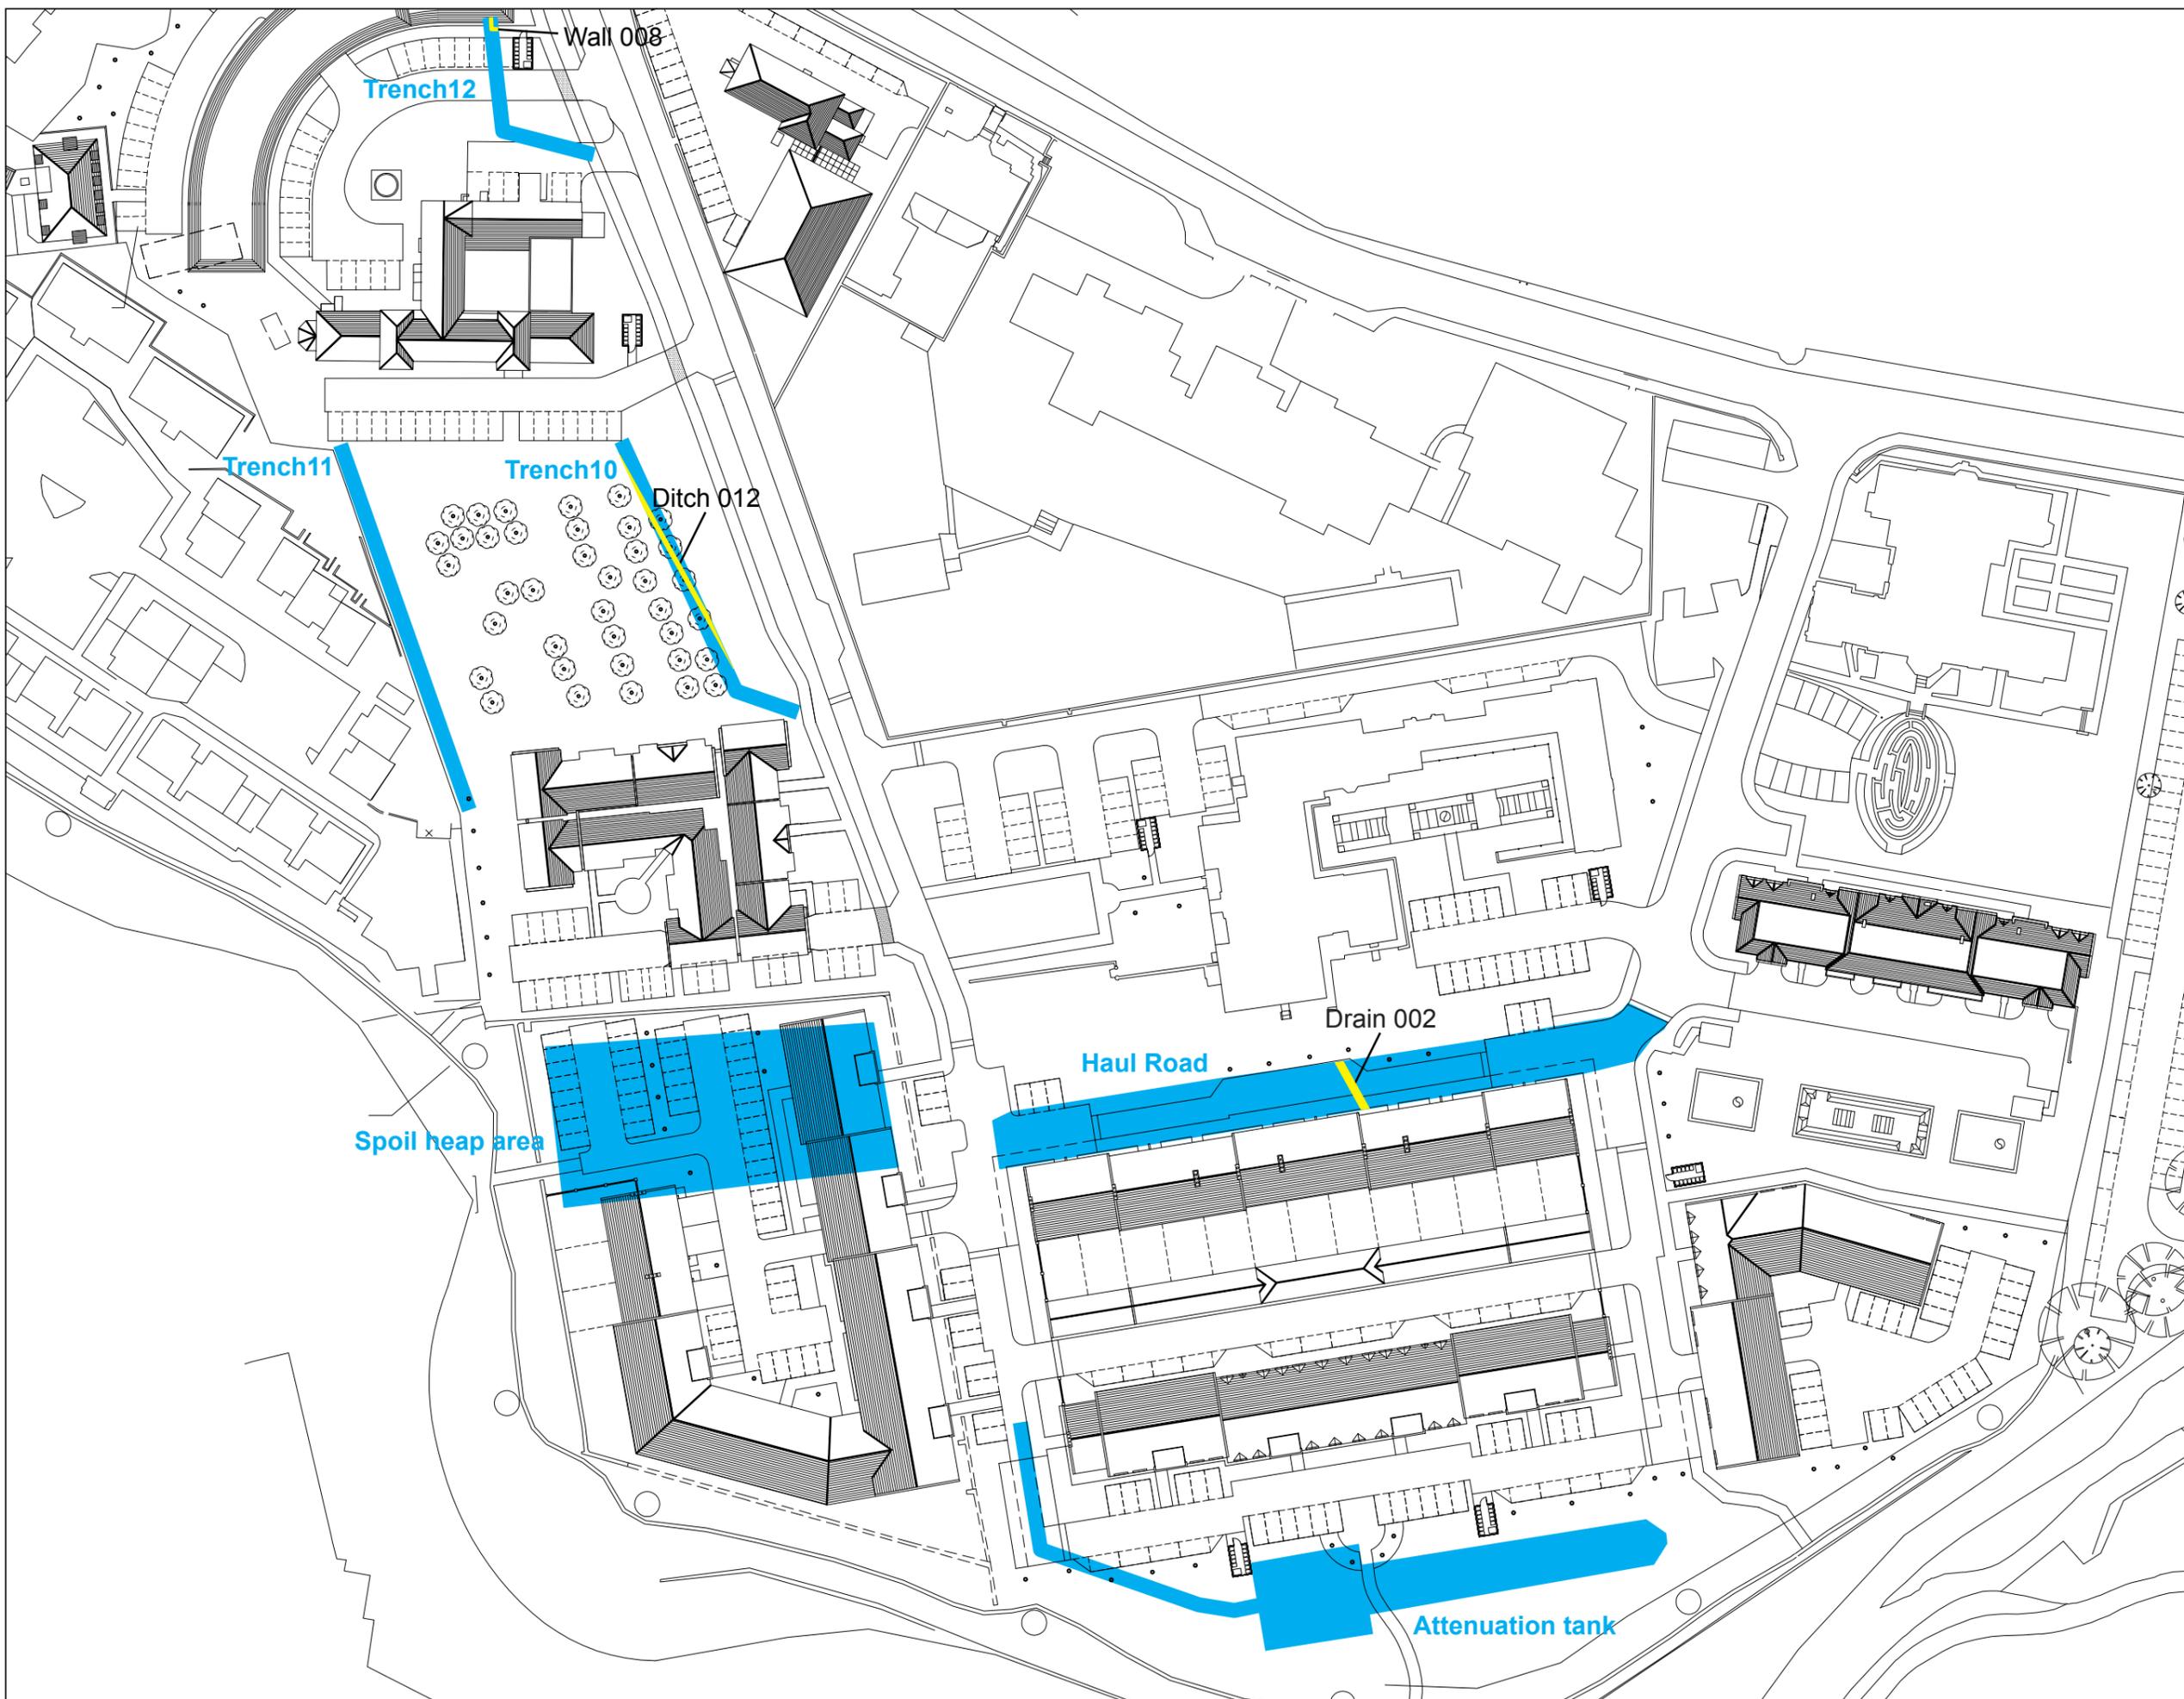
Fig. No: 2 Revision: A

The watching brief observed the excavation of the spoil heap area, haul road, attenuation tank and service trenches (Fig. 2). Numbers in bold and parentheses refer to contexts (Appendix 1).

Title:  
 Site plan showing new development, areas of Watching Brief and location of features

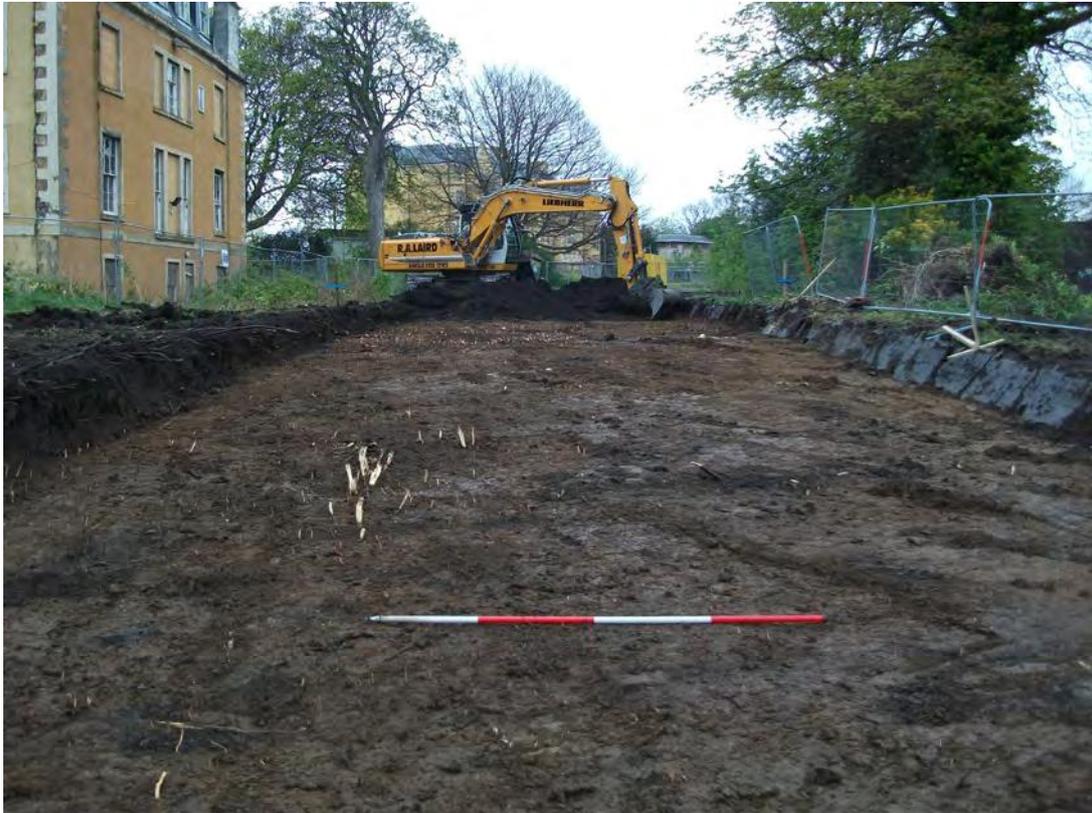
The haul road was aligned east-west and measured approximately 120m long and 8m wide. The stratigraphy consisted of 0.5m of topsoil (**000**) overlying the natural geology (**001**).

Fig.3 : Haul road after topsoil removal

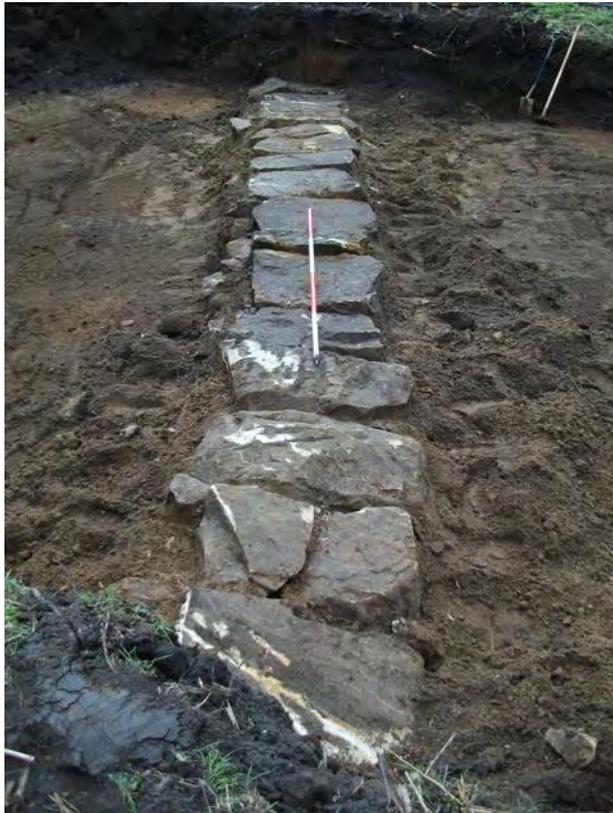
A single stone-lined drain (**002**, Fig.4), cut into the natural subsoil (**001**), was recorded. The drain was aligned north-west/south-east, measured 10m long and extended beyond the edges of the haul road. The top (**003**) was built of a number of roughly rectangular sandstone capstones, which each measured about 0.9m long by 0.4-0.6m wide and 0.2m thick. The sides (**005**) and base were constructed of rectangular sandstone blocks. The void of the drain measured 0.9m deep and 0.5m wide. The bottom 0.25m was filled with drain refuse (**006**) which consisted of dark brown sandy clay with loose sandstone chip (from the drain) inclusions. The drain was backfilled with a mixture of topsoil and natural (**004**).

Fig.4 : Drain 002 showing capstones

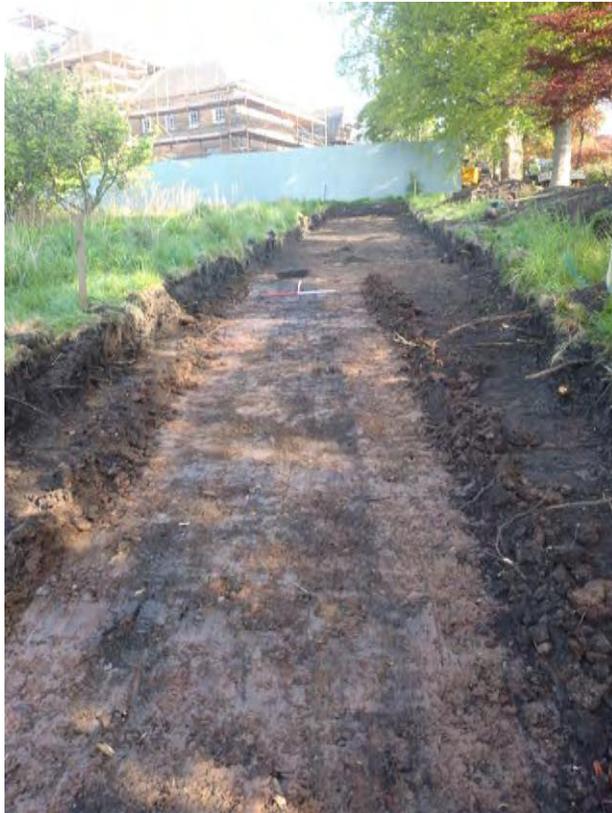
Trench 10 was aligned NW-SE and measured 40m long, 2.5m wide and 0.5m deep. In the base of the pipe trench was a small linear ditch, aligned NNW-SSE (**012**, Figs. 5 & 6). It measured 28.5m long, 0.3m wide and 0.13m deep. The stratigraphy comprised of dark grey clay (**014**) with animal bone, mussel shell and 19<sup>th</sup> century pottery inclusions. Below **014** was brown sandy loam (**013**), no inclusions.

Fig.5 : Post strip, Trench 11 showing Ditch 012

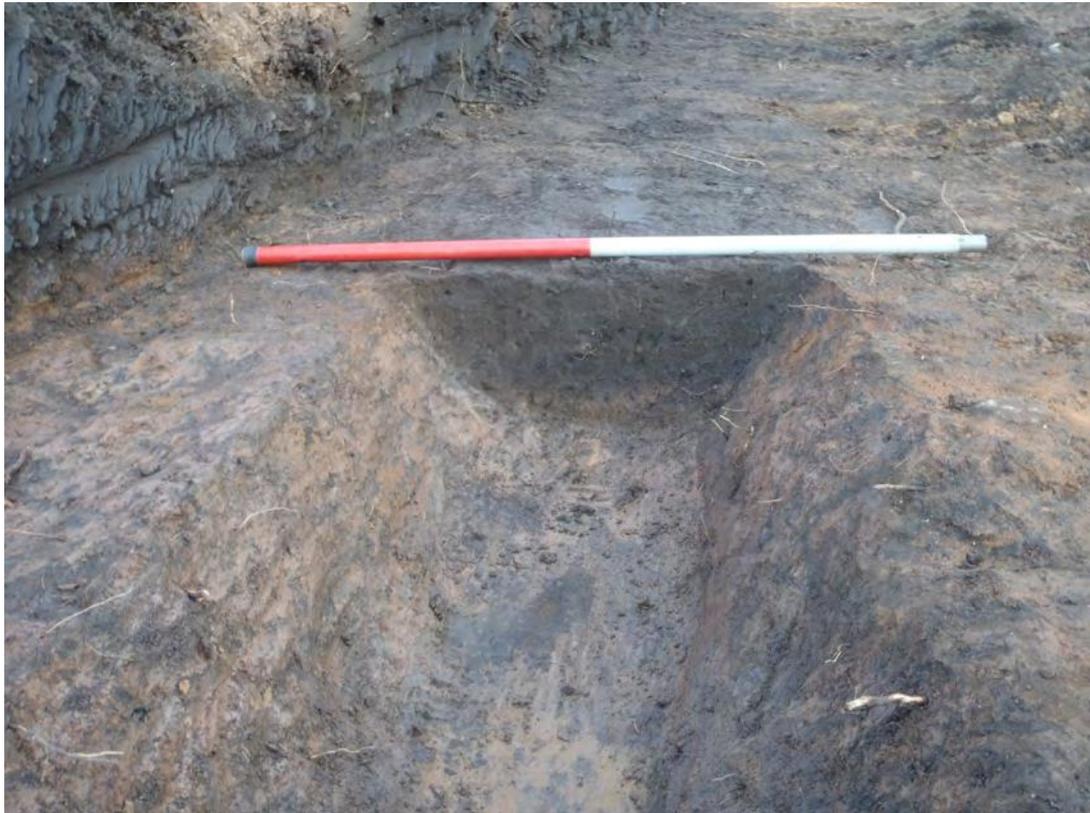
Fig.6 : South-east-facing section of Ditch 012

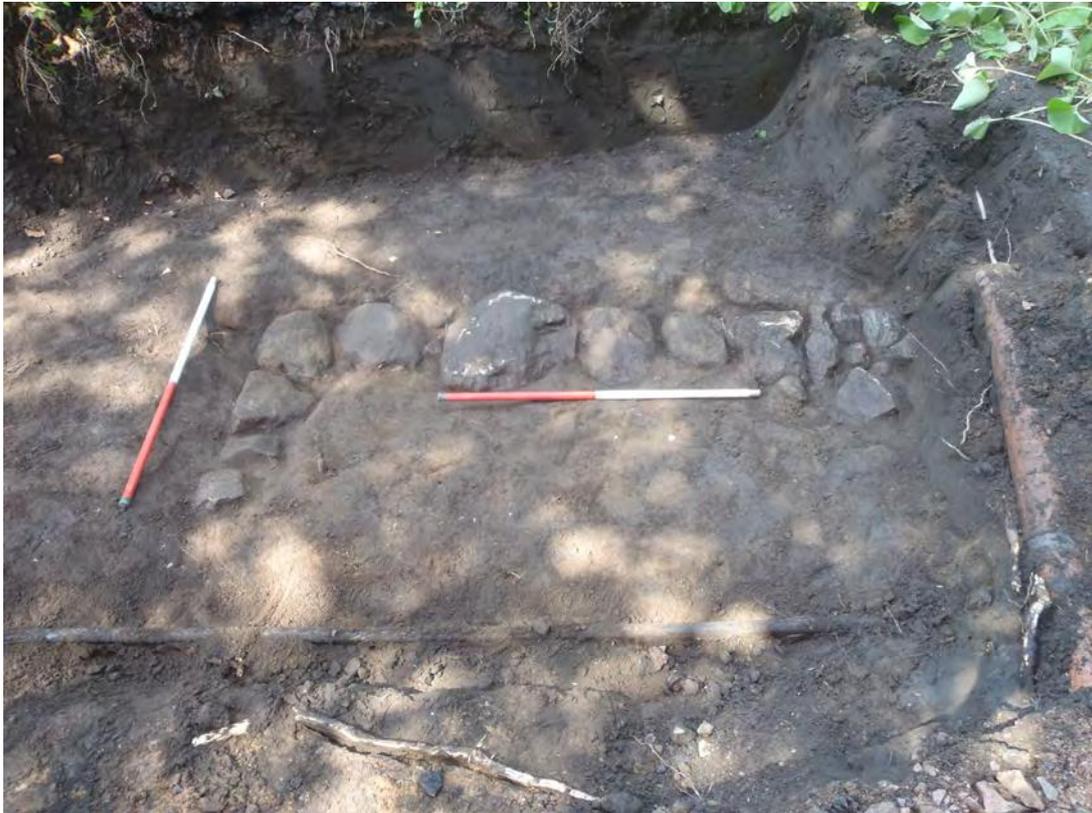
Trench 12 was located in the northern part of the site and aligned initially NW-SE before turning N and measured 3m wide and 0.9m deep. At the northern end of the trench an L-shaped wall (**008** & **009**, Figs. 7 & 8) was found. The wall was aligned N-

S and then turned E and measured 3.3m long, 0.4m wide and 0.4m high. It was constructed of rough hewn masonry blocks and positioned within a foundation cut (007), which was then backfilled (010 & 011). It extended beyond the northern limit of excavation and was truncated by a modern pipe at its eastern end.

Fig.7 : Wall 008

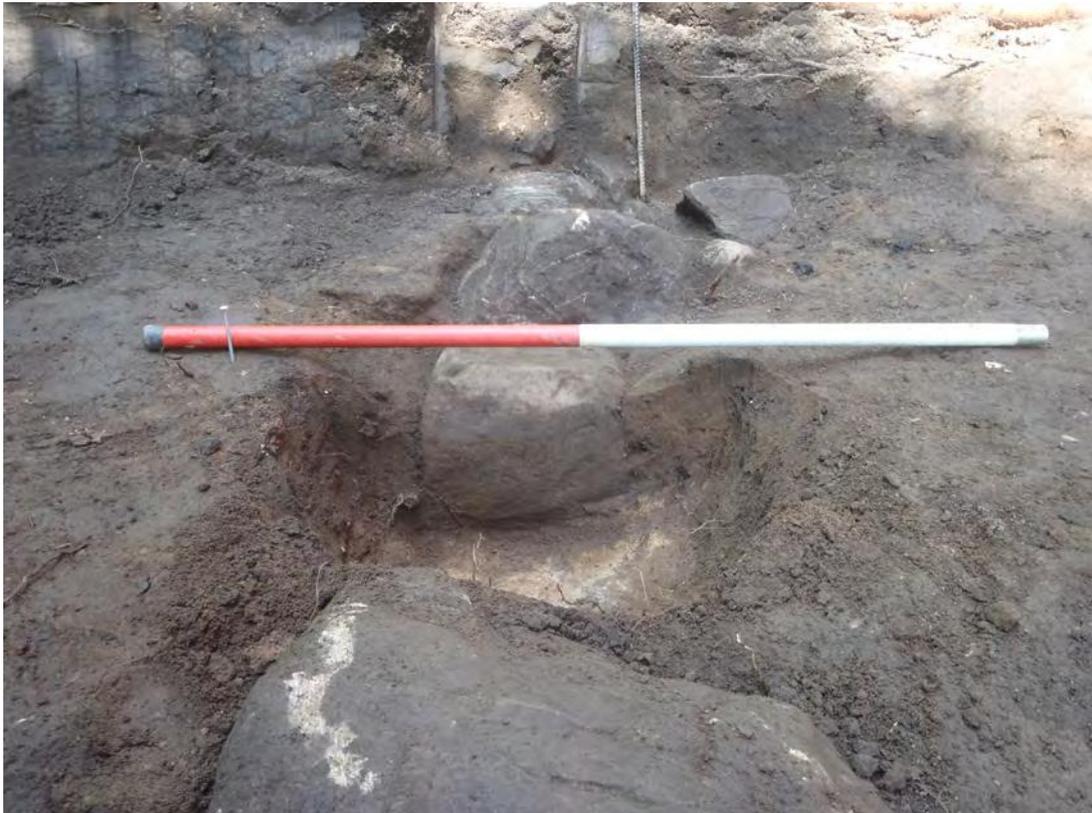
Fig.8 : Wall 008, south-facing section
