**4 Jeanfield Road, Perth,
Perth & Kinross**

**Archaeological Evaluation
& Standing Building Survey**

Report No. 2175

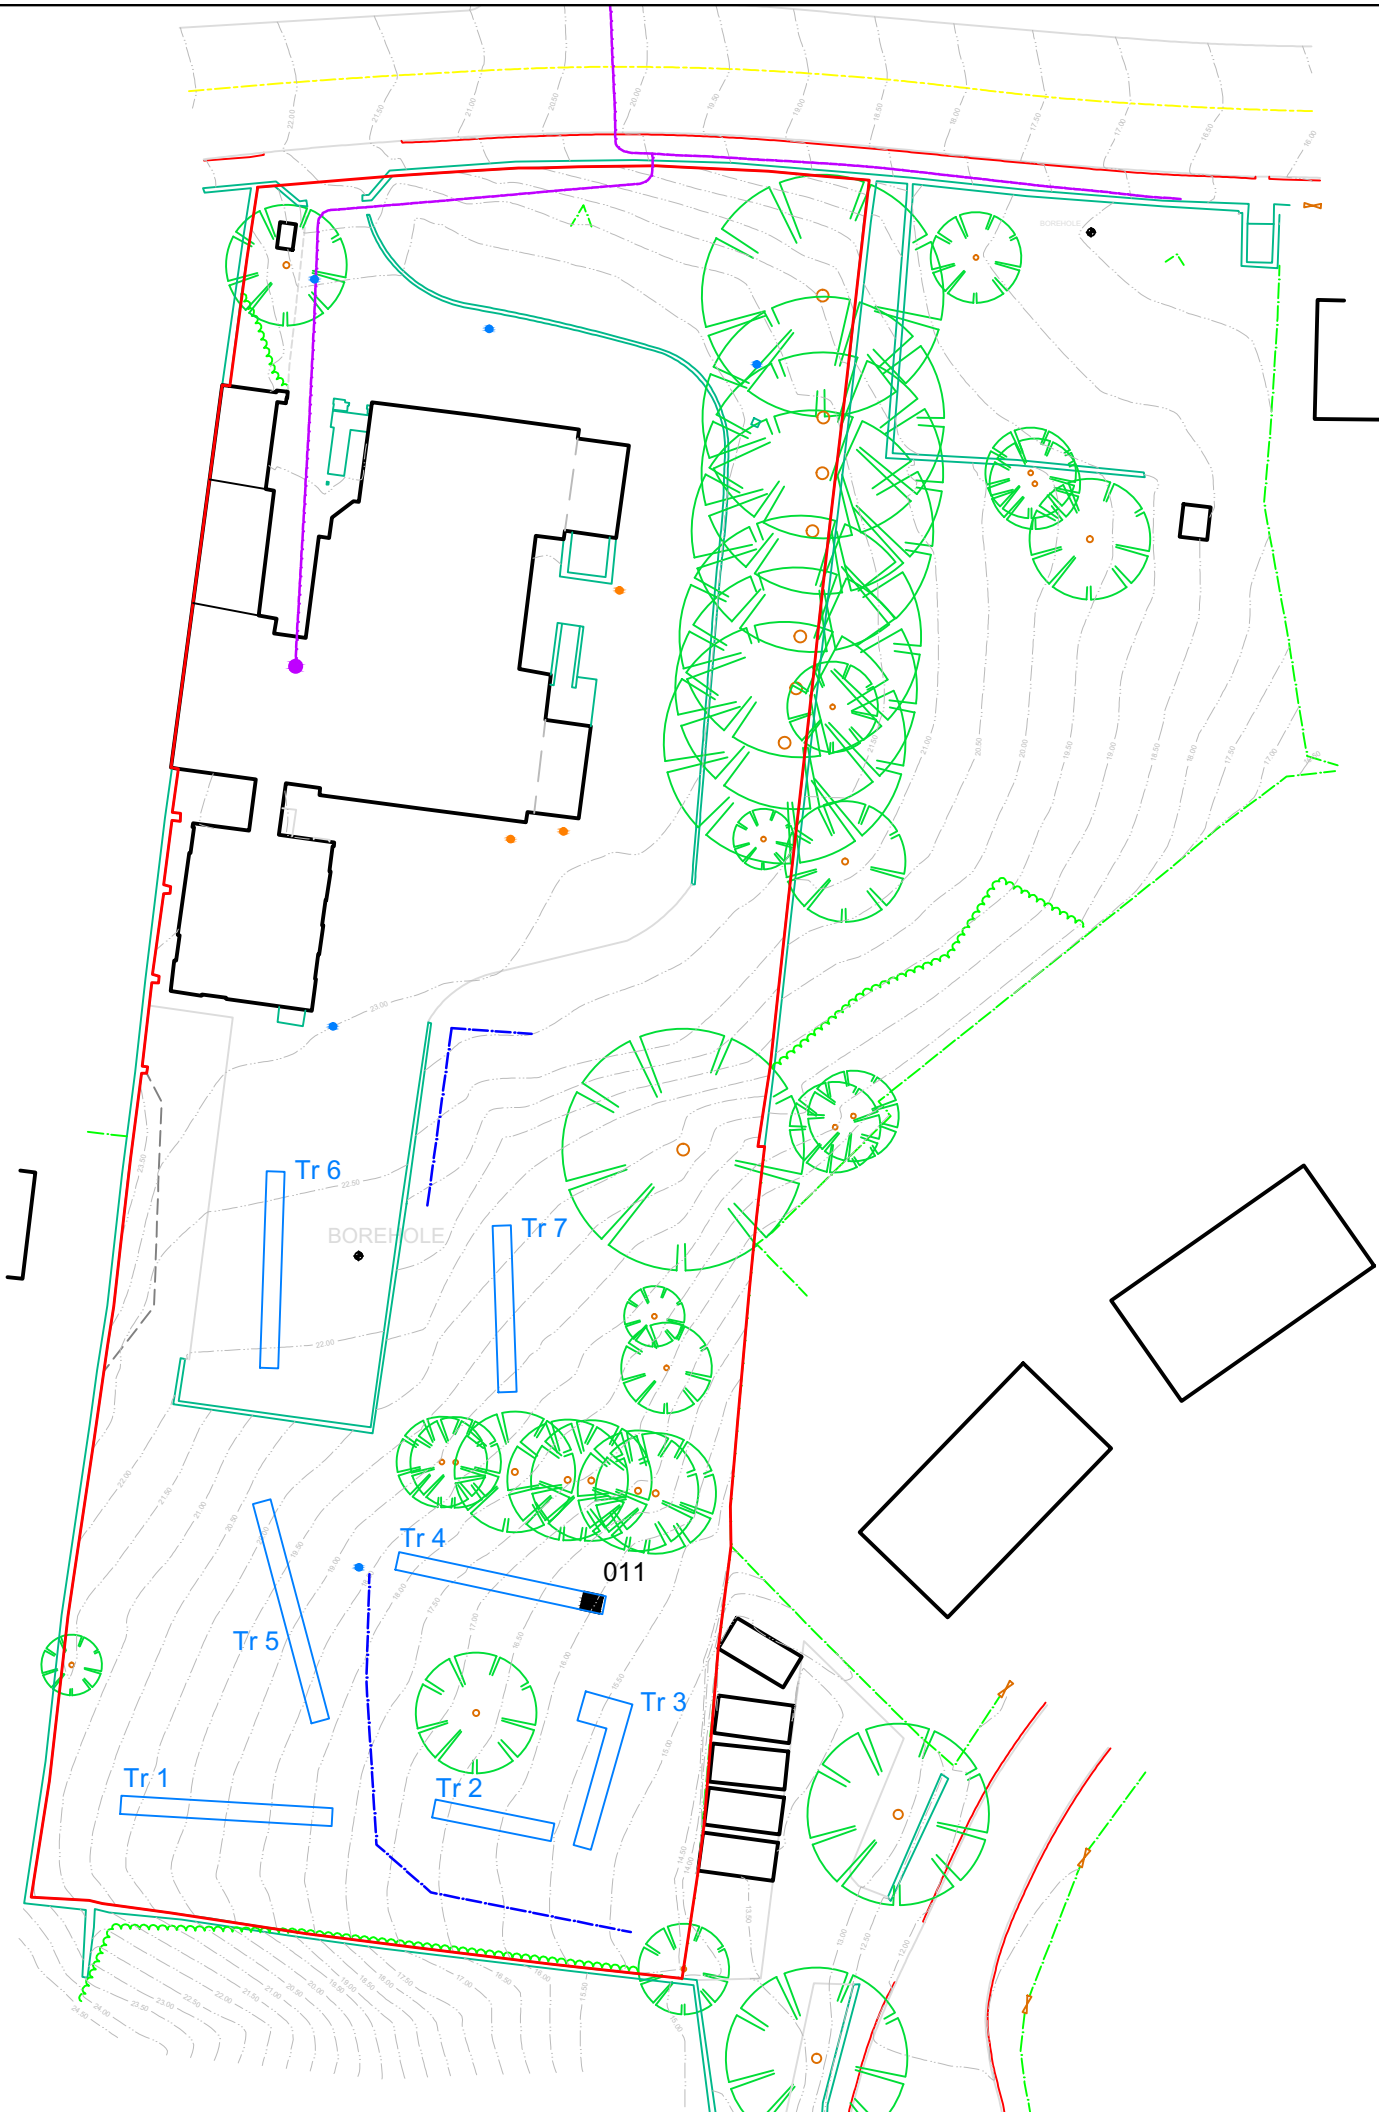
Fig. 1 Site location map, trench plan and on-site restrictions

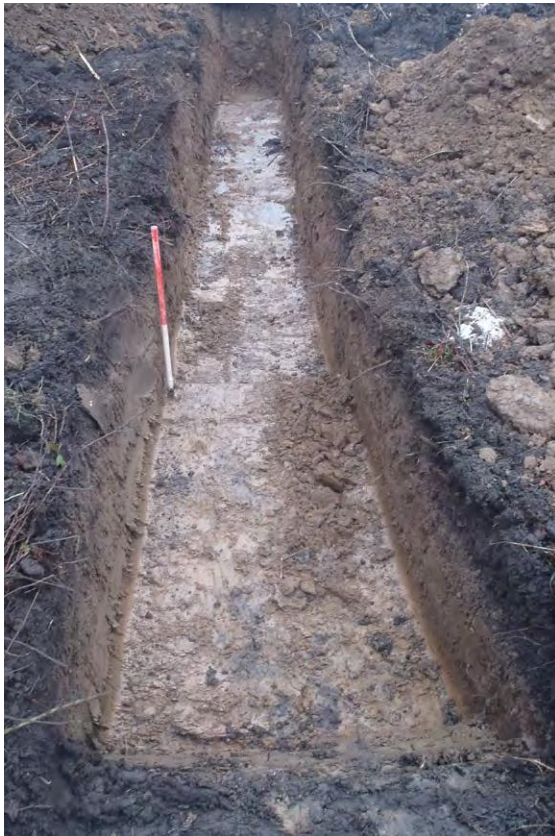
Topsoil (**001**) measured 0.25m-0.3m thick and overlay a mid grey-brown silt (**009**) with coal inclusions, measuring 0.2m-0.27m thick. This overlay a subsoil layer (**010**) of light to mid grey-brown homogeneous silt clay measuring 0.4m-0.47m thick, which overlay natural (**002**). At the eastern end of the trench, a modern cut (**011**, Fig. 4) with near-vertical sides, measuring 1.45m wide by at least 1.1m deep, directly underlay the topsoil and cut through both **009** and **010**. It was filled with a mixed deposit of mid brownish-orange re-deposited natural (**021**). The cut became waterlogged during excavation and so base of the feature was not reached.

Fig 3 - Trench 4, post-excavation shot, from west

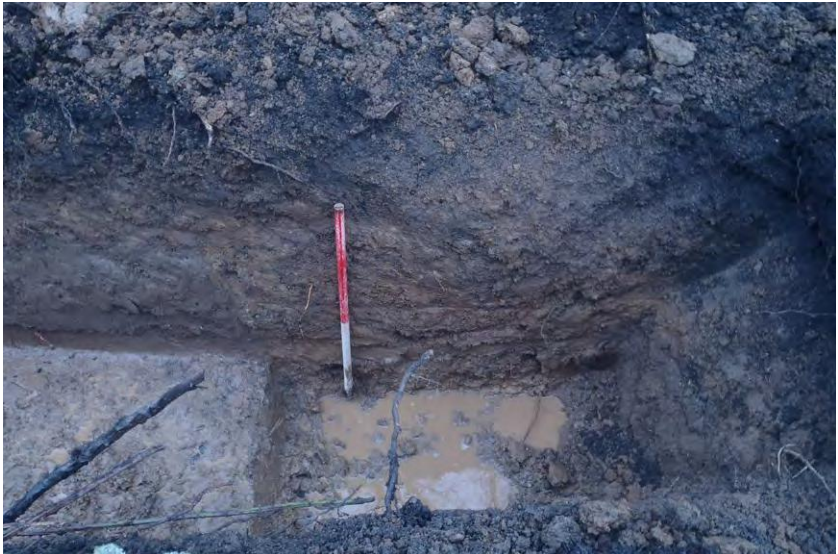
Fig 4 - Trench 4, south-facing section showing modern cut (011), from south

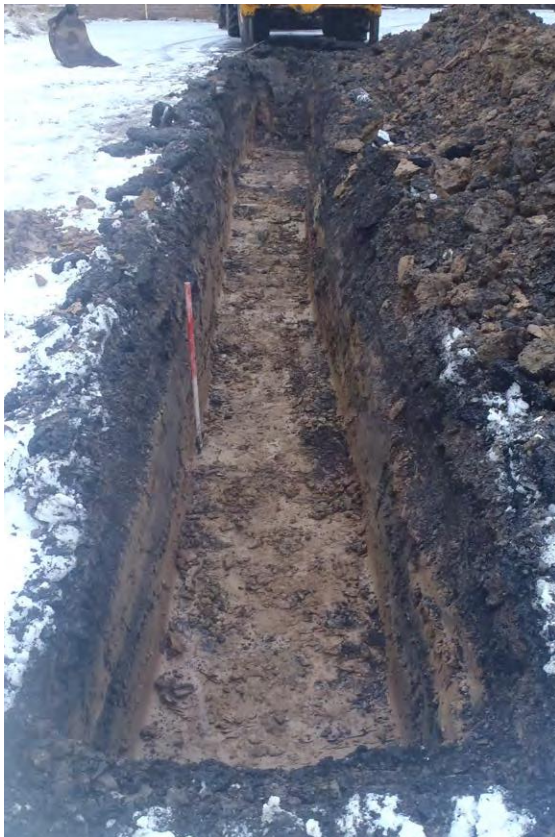
A layer of tarmac (**013**) and Type 1 hardcore with sand lenses (**014**), measuring 0.34m-0.5m thick, overlay a deposit of made ground (**015**) comprising mid brownish-orange silt clay measuring 0.22m-0.38m thick. At the south end of the trench, **015** overlay a second deposit of made ground (**016**) comprising mid grey silt clay with coal, ash and occasional rubble, measuring 0.15m thick, which overlay a further subsoil layer (**017**) comprising 0.2m of mid grey-brown silt with coal inclusions, which overlay natural (**002**). From 2.75m from the south end of the trench, **015** directly overlay natural. A circular clay pipe drain was identified at 3.5m from the north end of the trench, cut through **002** and infilled with **016**.

Fig 5 - Trench 6, post-excavation shot, from south

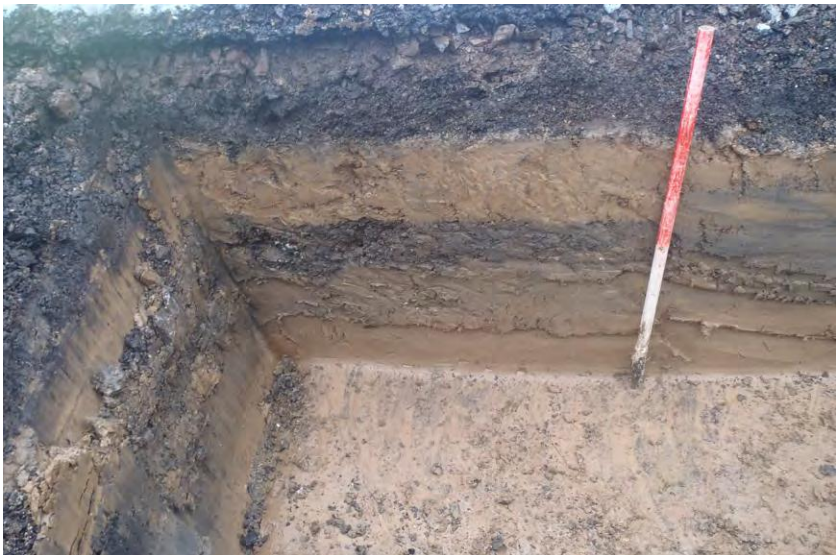
Fig 6 - Trench 6, east-facing section at south end of trench showing modern made ground, from east

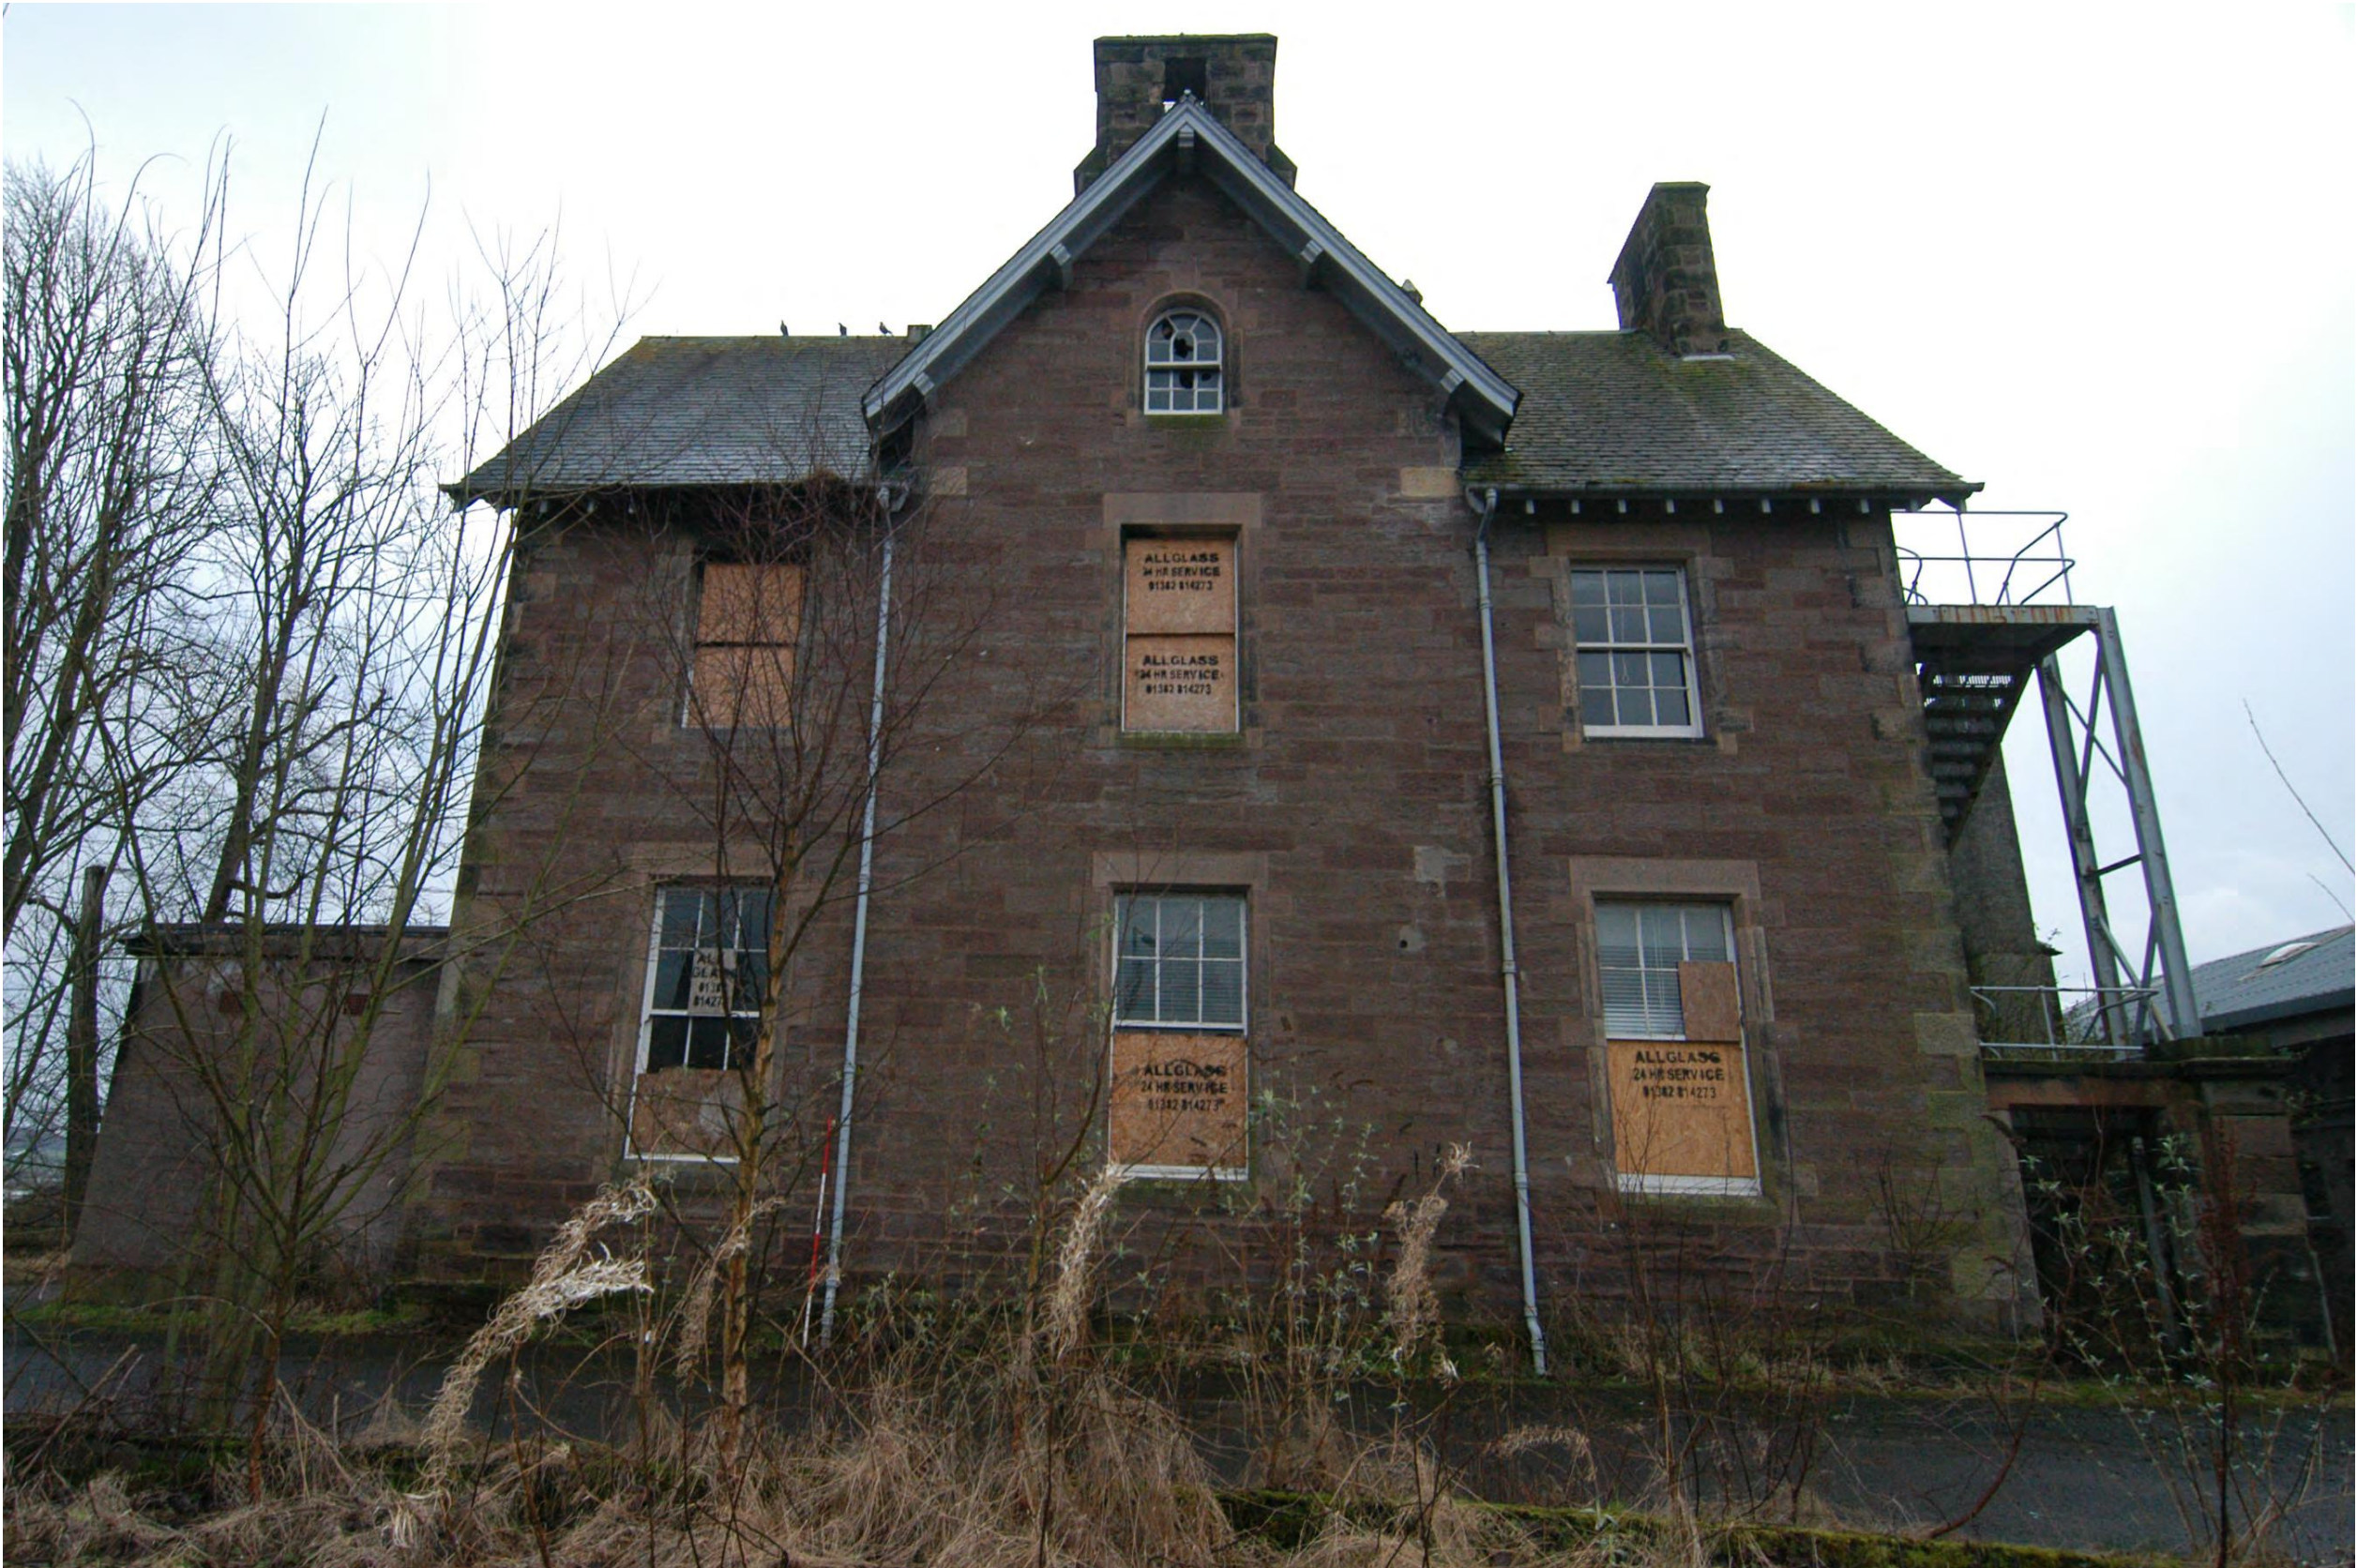
Fig. No:	8	Revision	A
Title	Jeanfield House, north-facing elevation		
Project	4, Jeanfield Road, Perth		
Scale at A3	N/A		
Client	Ryven Ltd		
Drawn by:	SW	Checked by:	MC
		Report No:	2175

The north-facing (front) elevation measured 17m long. Attached to the east end of the main elevation was a c.1950s annex building which was featureless. The main elevation had three bays and was constructed of red snecked ashlar sandstone with lighter cream-coloured stugged quoins. The ground and first floor windows were all 6-over-6 sash and case set within square-headed surrounds with chamfer mouldings. The first floor windows were slightly smaller than the ground floor windows (2.2m high and 1.2m wide). The central bay had a pitched slate roof, below which was a small round-headed attic window (6-over-6).

The roof was slate and had projecting eaves. A chimneystack at the centre of the elevation had a shouldered base merging into a double flue. Another stack on the west end of the elevation was plain.

At the west end of the elevation was a steel-framed fire escape supported on a gate pier. The ashlar pier was roughly 2.5m high. A former doorway was present between the end of the elevation and the gate pier. The door jambs and stone lintel were all contemporary with the main block. Approximately 2.5m from the aforementioned gate pier was a second gate pier masked by vegetation.

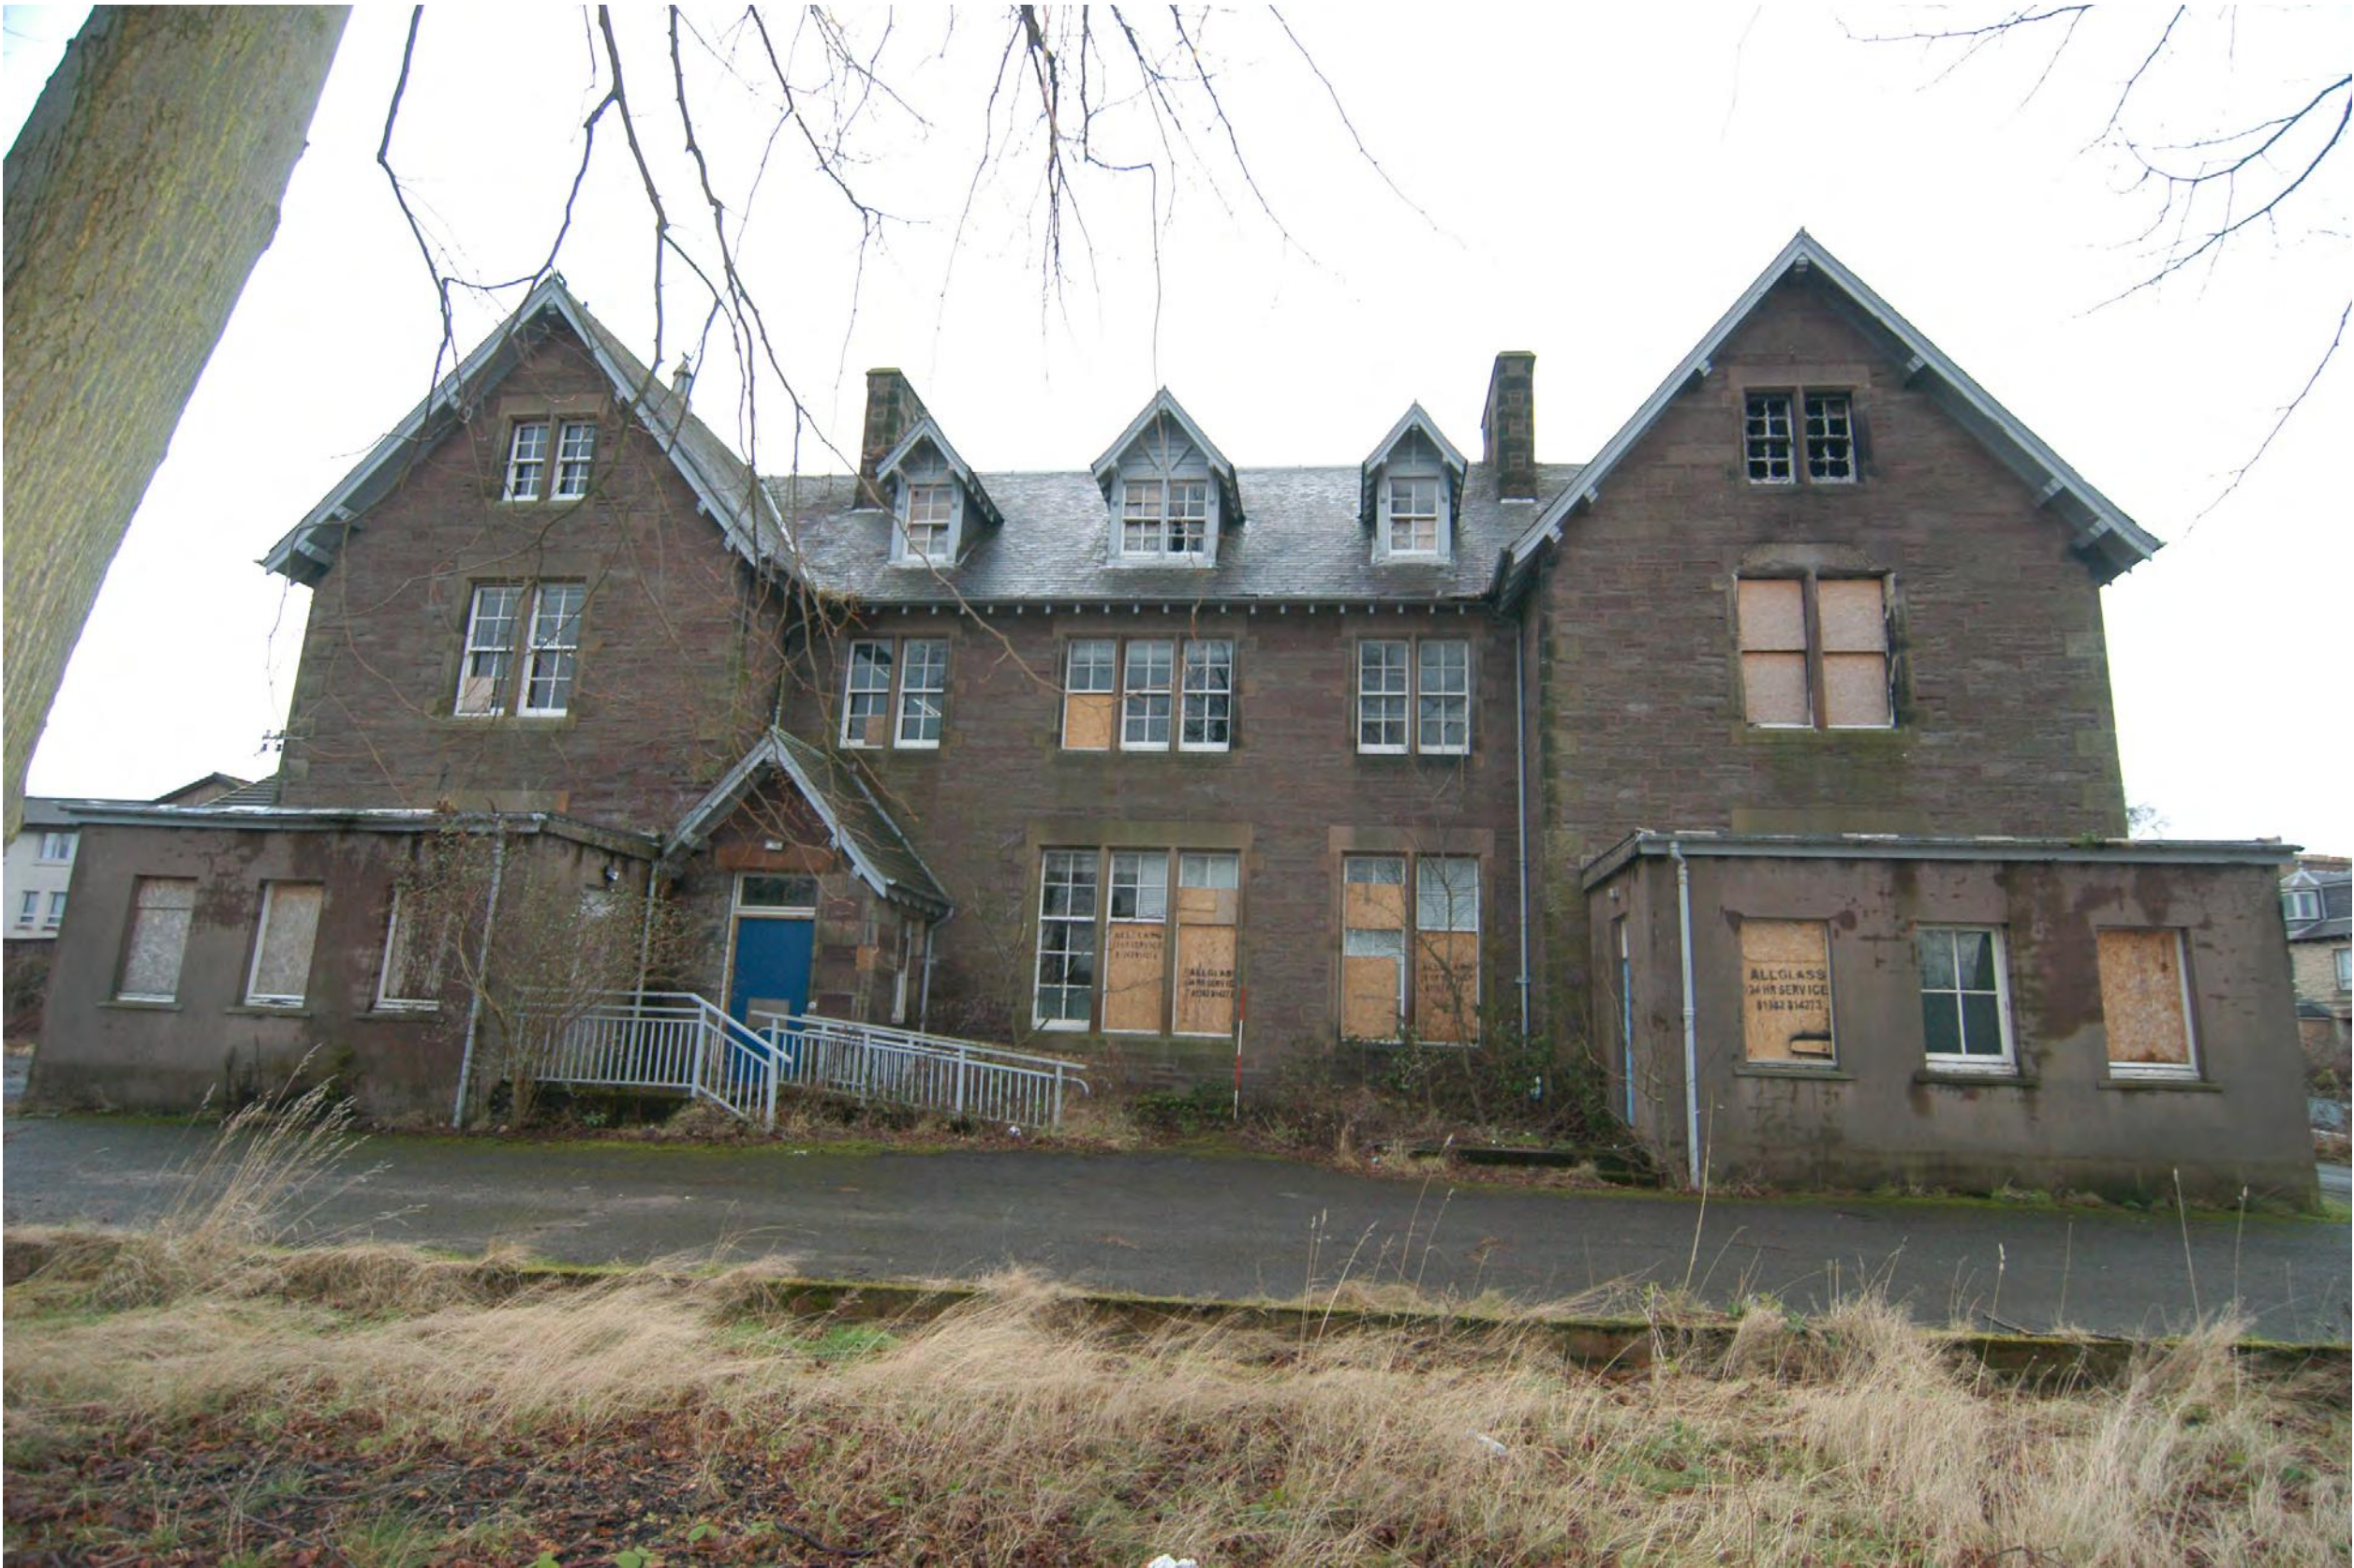
Fig. No:	9	Revision	A
Title	Jeanfield House, east-facing elevation		
Project	4, Jeanfield Road, Perth		
Scale at A3	N/A		
Client	Ryven Ltd		
Drawn by:	SW	Checked by:	MC
		Report No:	2175

The east-facing elevation was constructed of coursed sandstone with lighter cream-coloured quoins. The elevation measured 26m long and had five bays. Projecting off the main elevation were the north and south wings. The wings both had bipartite stone mullioned windows placed centrally on the first and second storeys, all containing 4-over-4 sash and case windows. At the ground floor of both wings were brick-built c.1960s annex buildings, which originally had four paned windows (five were boarded).

A porch was present in the corner formed by the south wing and the central part of the elevation; the porch had a pitched slate roof and plain panelled door, and was lit by a window on its north side.

A tripartite mullioned window (4-over-6 sash and case) occupied the ground floor of the middle bay, with a bipartite mullioned window on its north side. At first floor level, the middle bay had a smaller tripartite mullioned window with 4-over-4 sash and case; the bays on either side contained bipartite mullioned windows (4-over-4 sash and case).

Within the roof space were three gabled dormer windows with projecting eaves and wooden barge boards. The central dormer was wider than the dormers on either side.

The east-facing elevation is symmetrical, with the gables of the north and south wings framing the east-facing elevation of the main block. The large tripartite window and the smaller flanking windows on the ground floor would probably have lit class rooms. The main living accommodation would have been on the first and attic floors. The porch contained the formal school entrance, which continued in use as the main entrance until the building was vacated.

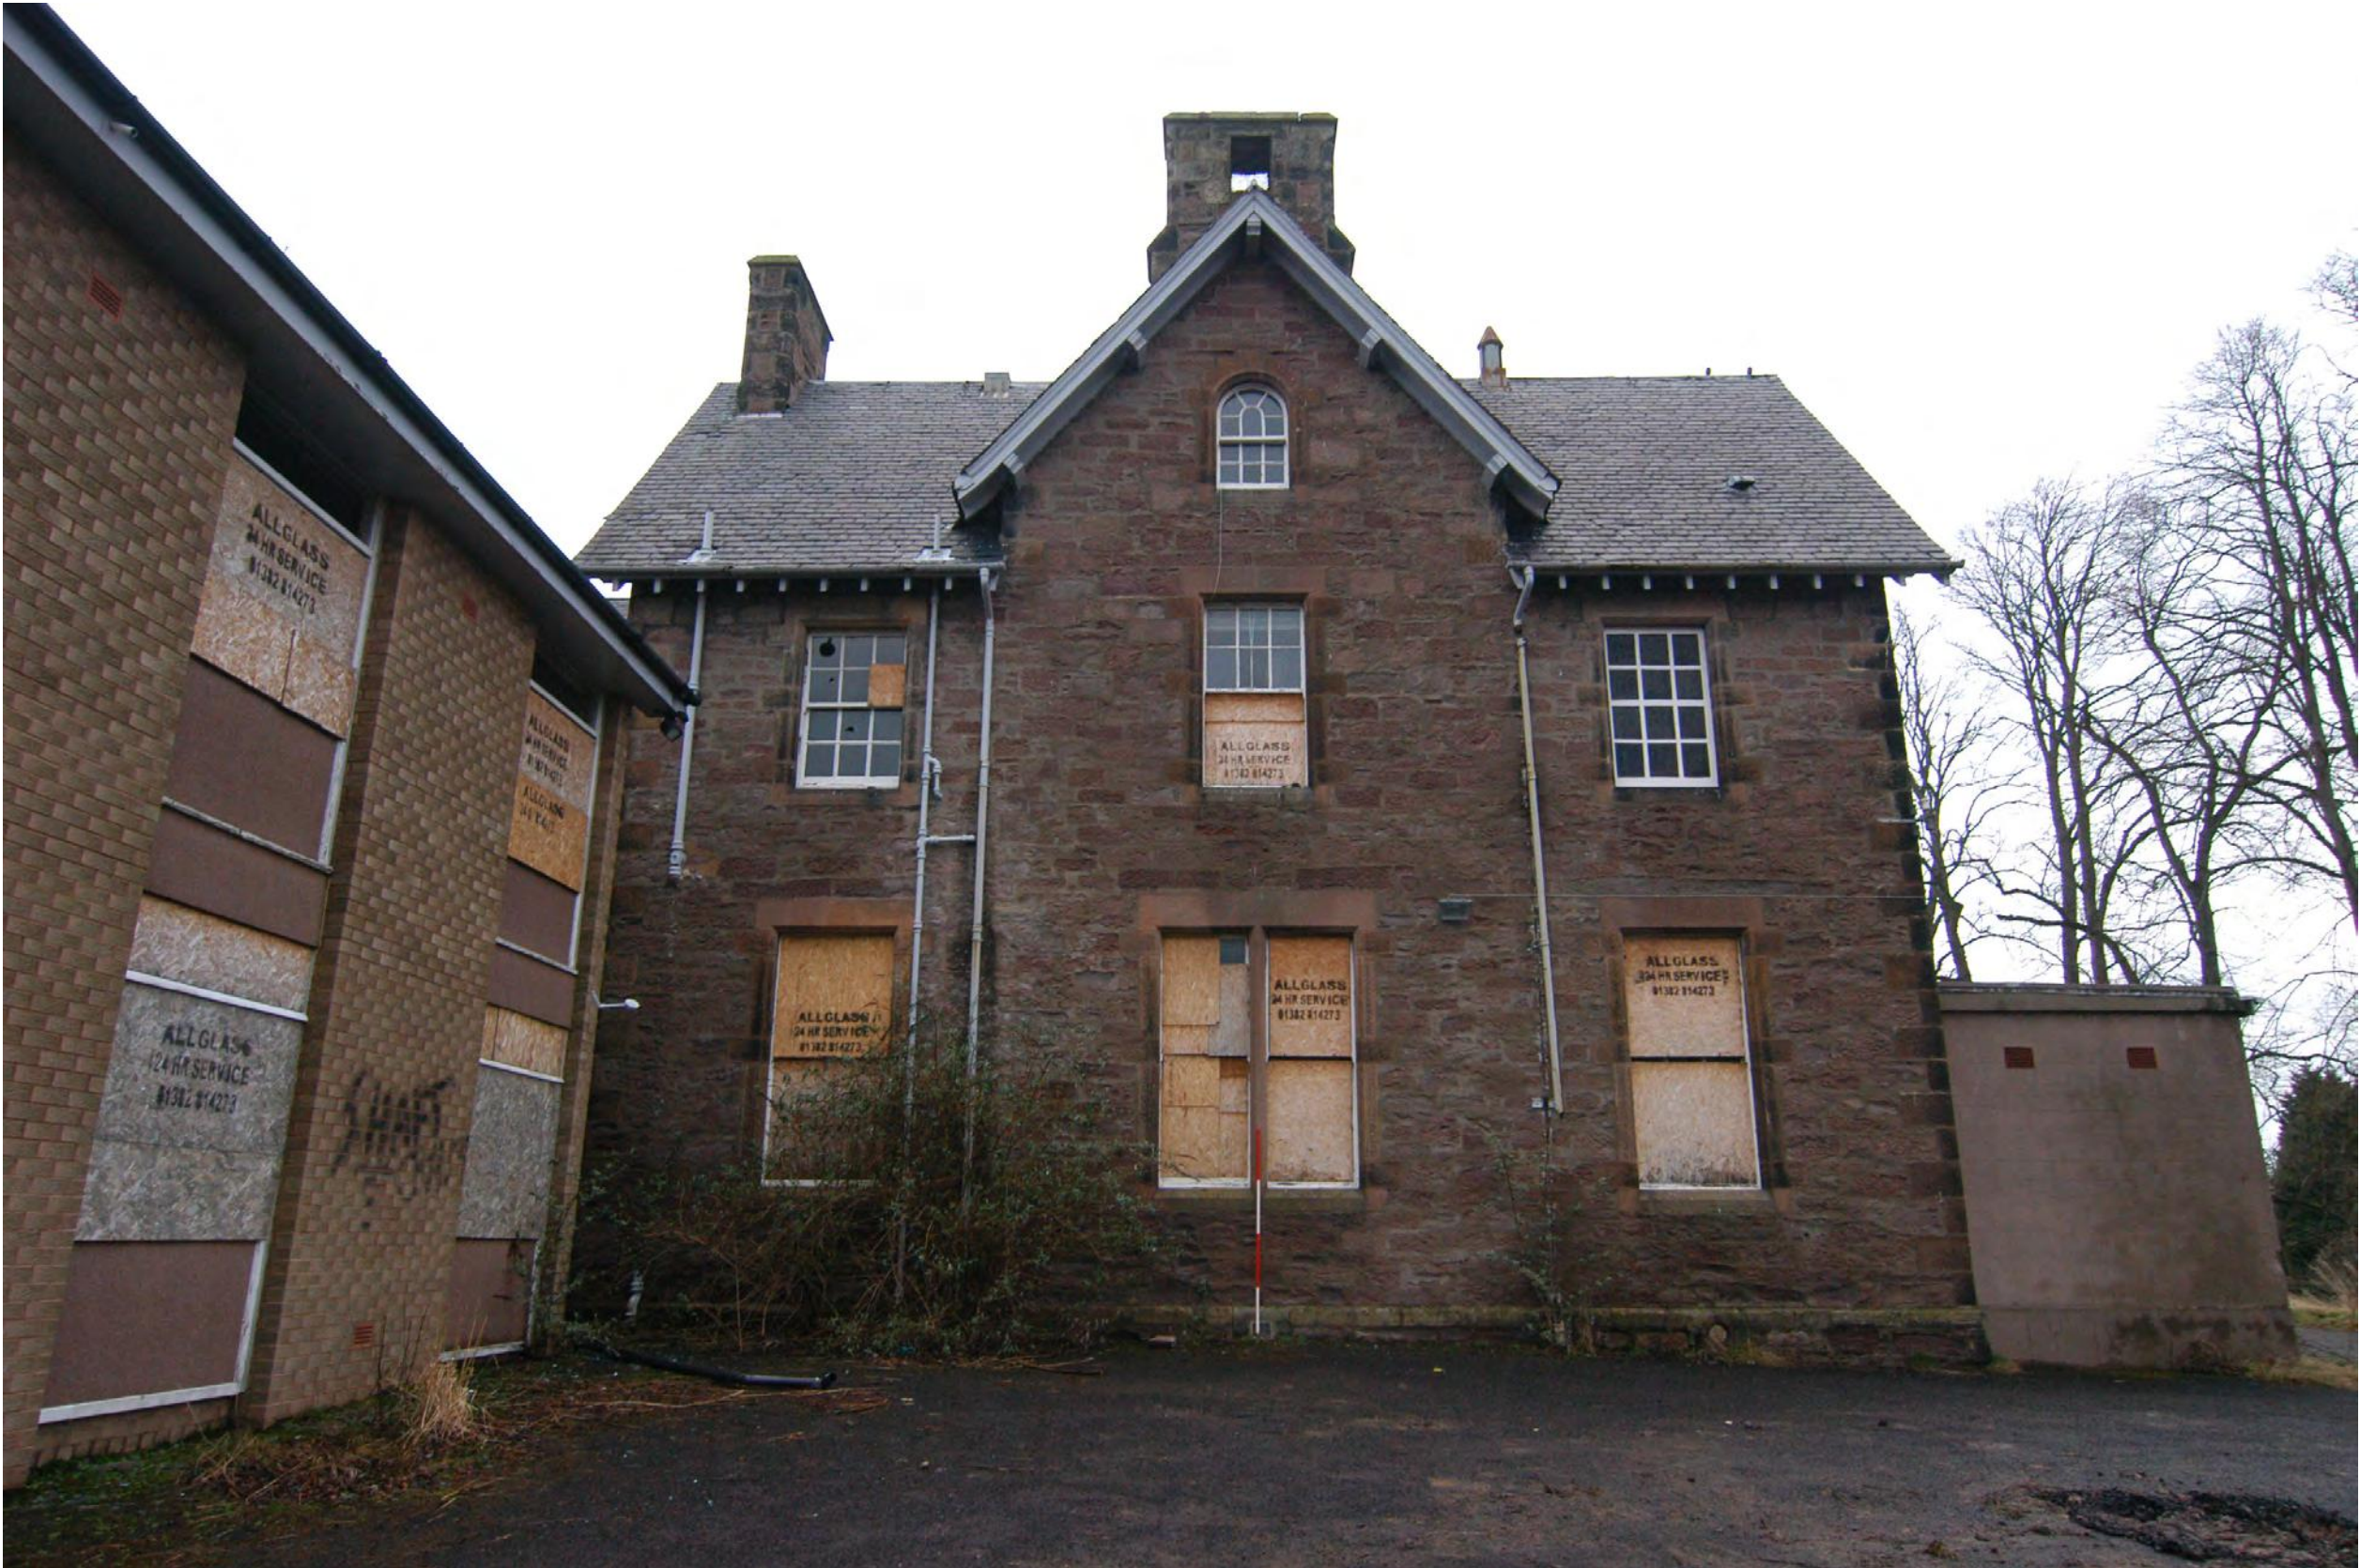
Fig. No:	10	Revision	A
Title	Jeanfield House, south-facing elevation		
Project	4, Jeanfield Road, Perth		
Scale at A3	N/A		
Client	Ryven Ltd		
Drawn by:	SW	Checked by:	MC
		Report No:	2175

The south-facing elevation measured 8.5m long and had three bays. The middle bay had a bipartite mullioned window on the ground floor, surmounted by a square-

headed window at first floor level. Above this window on the second floor was a round-headed attic window. The flanking bays had plain square-headed windows (6-over-6 sash and case). The east bay had a blocked window on the first floor with black and white painted windows. The roof configuration mirrors that on the north-facing elevation.

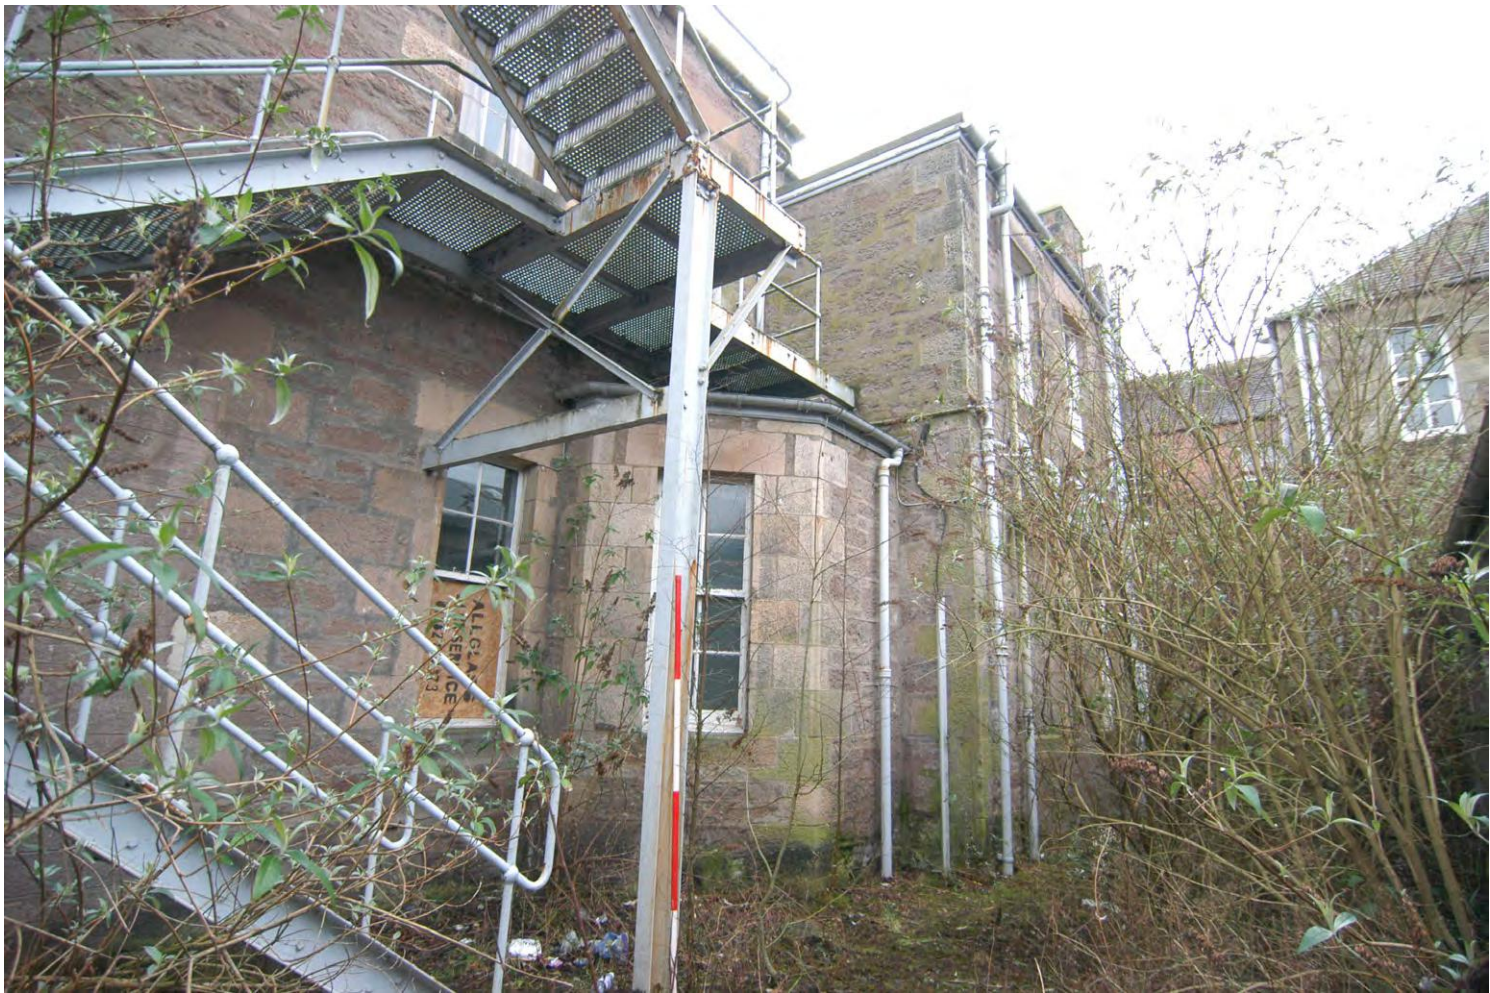
The west-facing elevation measured 16m long and included the two pitched gables of the north and south wings. Both had advance eaves and barge boards. In between these two gables was a two-bayed flat roof block.

A steel-framed fire escape was located on the north end of the elevation. Underneath the fire escape at ground floor level an ashlar-built bay had been added which had a single window (4-over-4 sash and case) facing north-west. On the north side of the bay, still at ground floor level, was another window and a blocked doorway. The doorway had been blocked with ashlar. The fire escape led to a fire exit at first floor and attic levels.

Projecting off the south wing was an L-shaped building with a brick-built north-facing elevation of late 19th century date, constructed in English Bond (5:1). Two windows were situated within the elevation and each had a sandstone lintel but no sill. Below the windows a cat-slide slate roof covered a later brick-built building with central doorway. The north end of the L-shaped building was stone built with a hipped slate roof. Two windows and a chimney stack for the adjoining boiler house occupied this elevation. The gable behind the hipped roof was accessed from an adjoining property and was featureless.

The west-facing elevation has had a steel fire escape added, probably in the 1960s to meet the needs of fire regulations. This feature was partly supported on an original 19th century gate pier. The west-facing elevation is dominated by the two storey block that has had a canted bay window added to the ground floor. The only blocked feature on this elevation was a door below the fire escape. Its position close to the former gated entrance suggest it was the main service access to the school. The boiler house, chimney and fuel store probably date to the first half of the 20th century.

Fig 11a - Jeanfield House, west-facing elevation at ground floor level

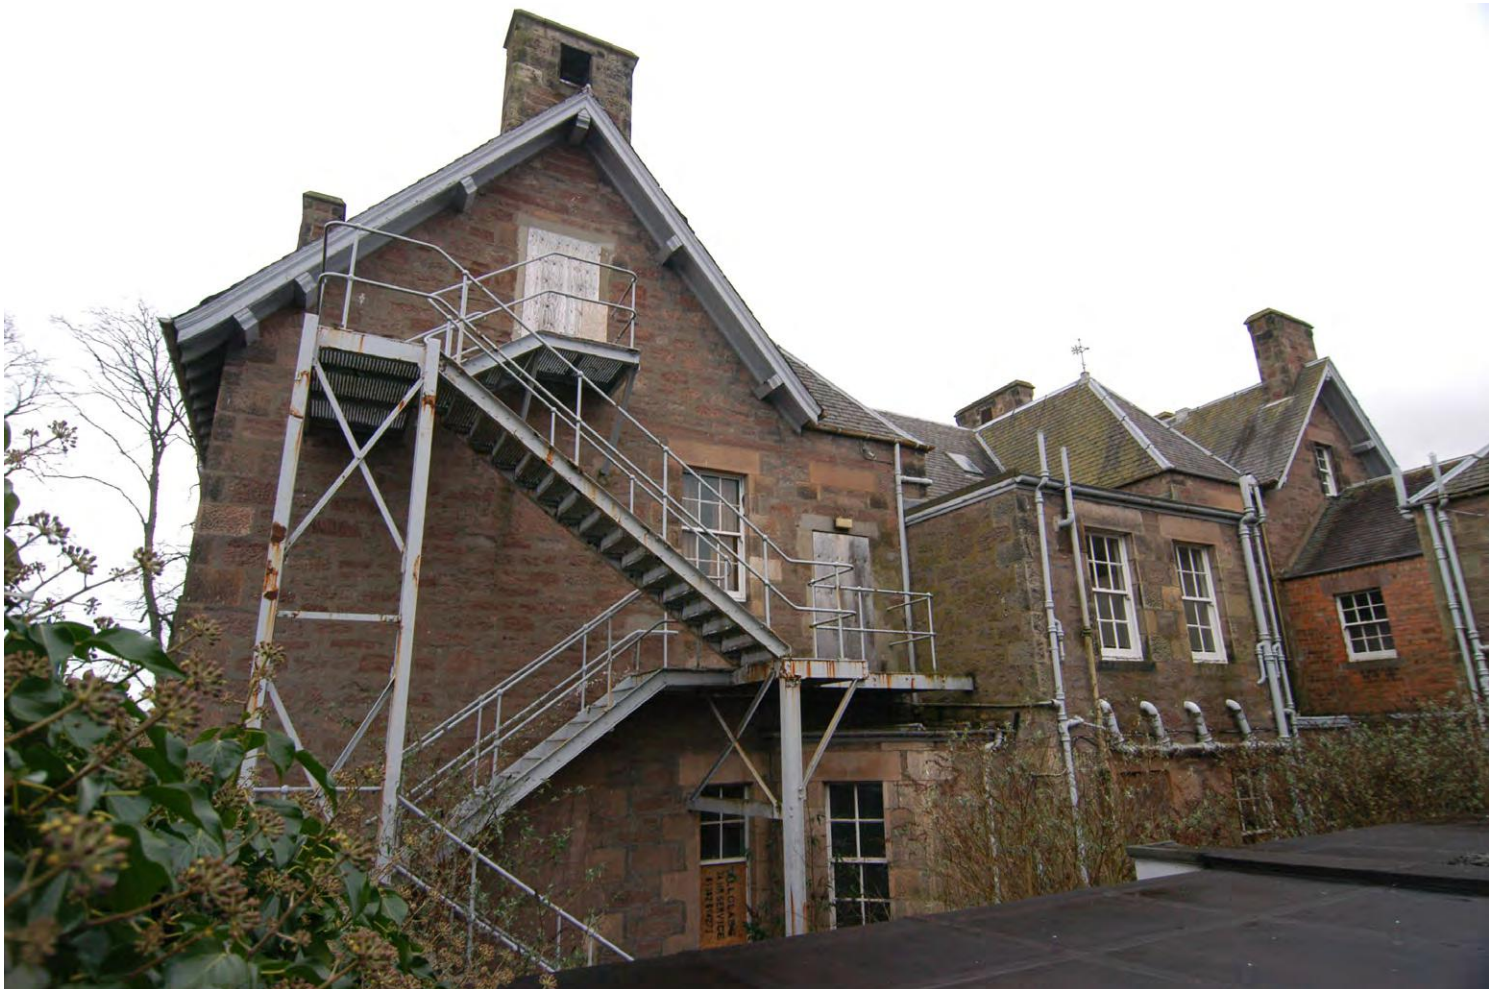
Fig 11b - Jeanfield House second floor and attic level

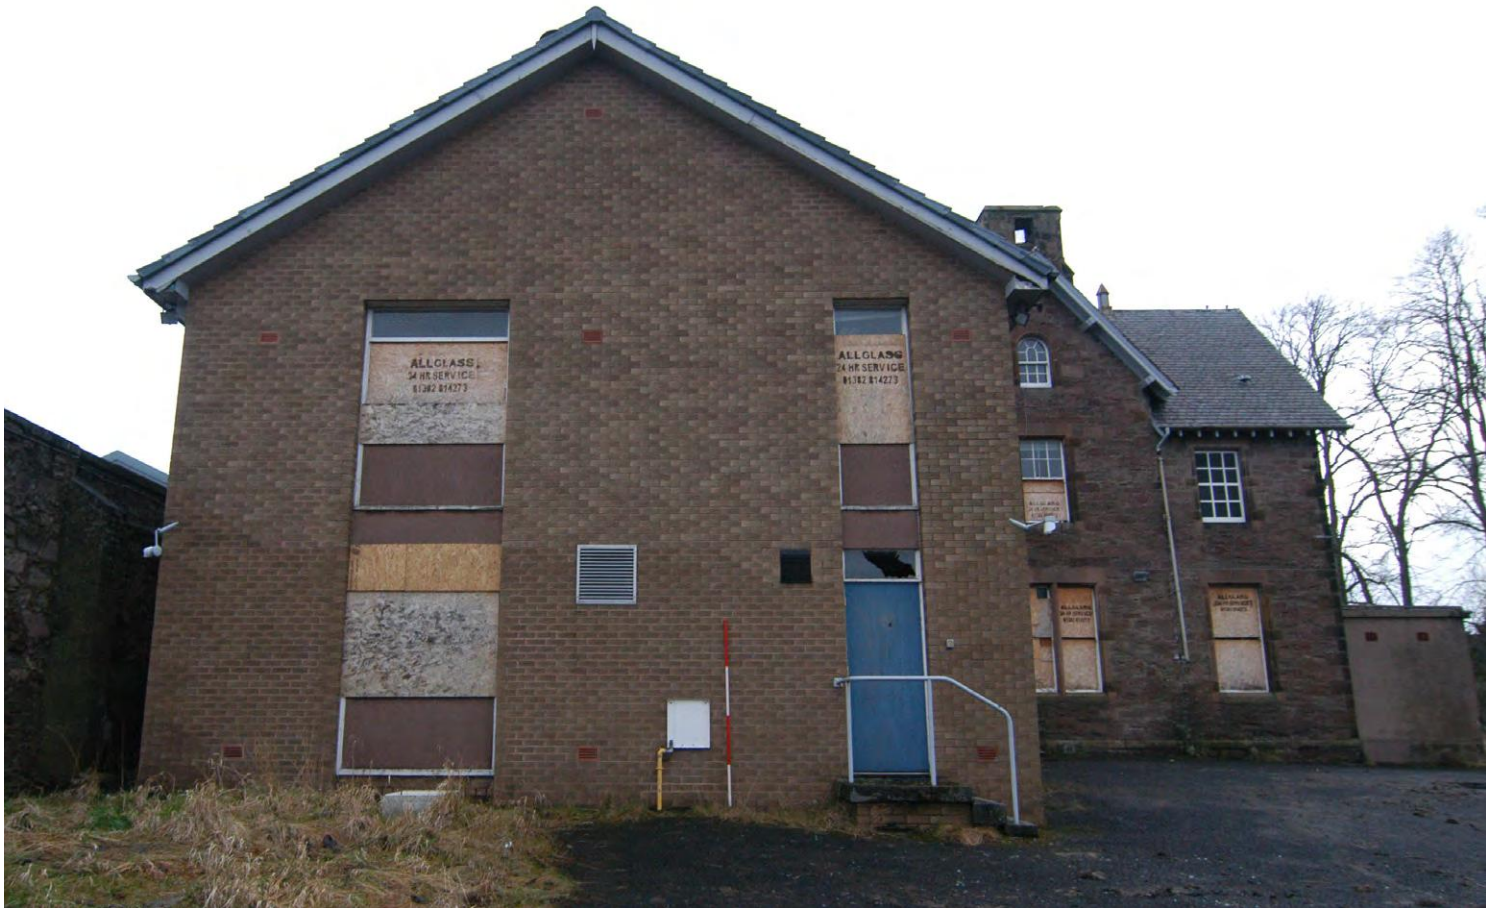
A modern office block, measuring 11.5m by 9.5m, was situated on the south side of Jeanfield House and was connected to it by a timber-framed and panelled two storey corridor.

The south-facing pitched gable was 8.7m high (from ground level to ridge) and had two bays with three casement windows and a blue-painted panel door on the east side of the elevation. The east-facing elevation had three bays with casement windows set

Fig 12a - Office Block, south-facing elevation
