**4 Jeanfield Road, Perth,
Perth & Kinross**

**Archaeological Evaluation
& Standing Building Survey**

Report No. 2175

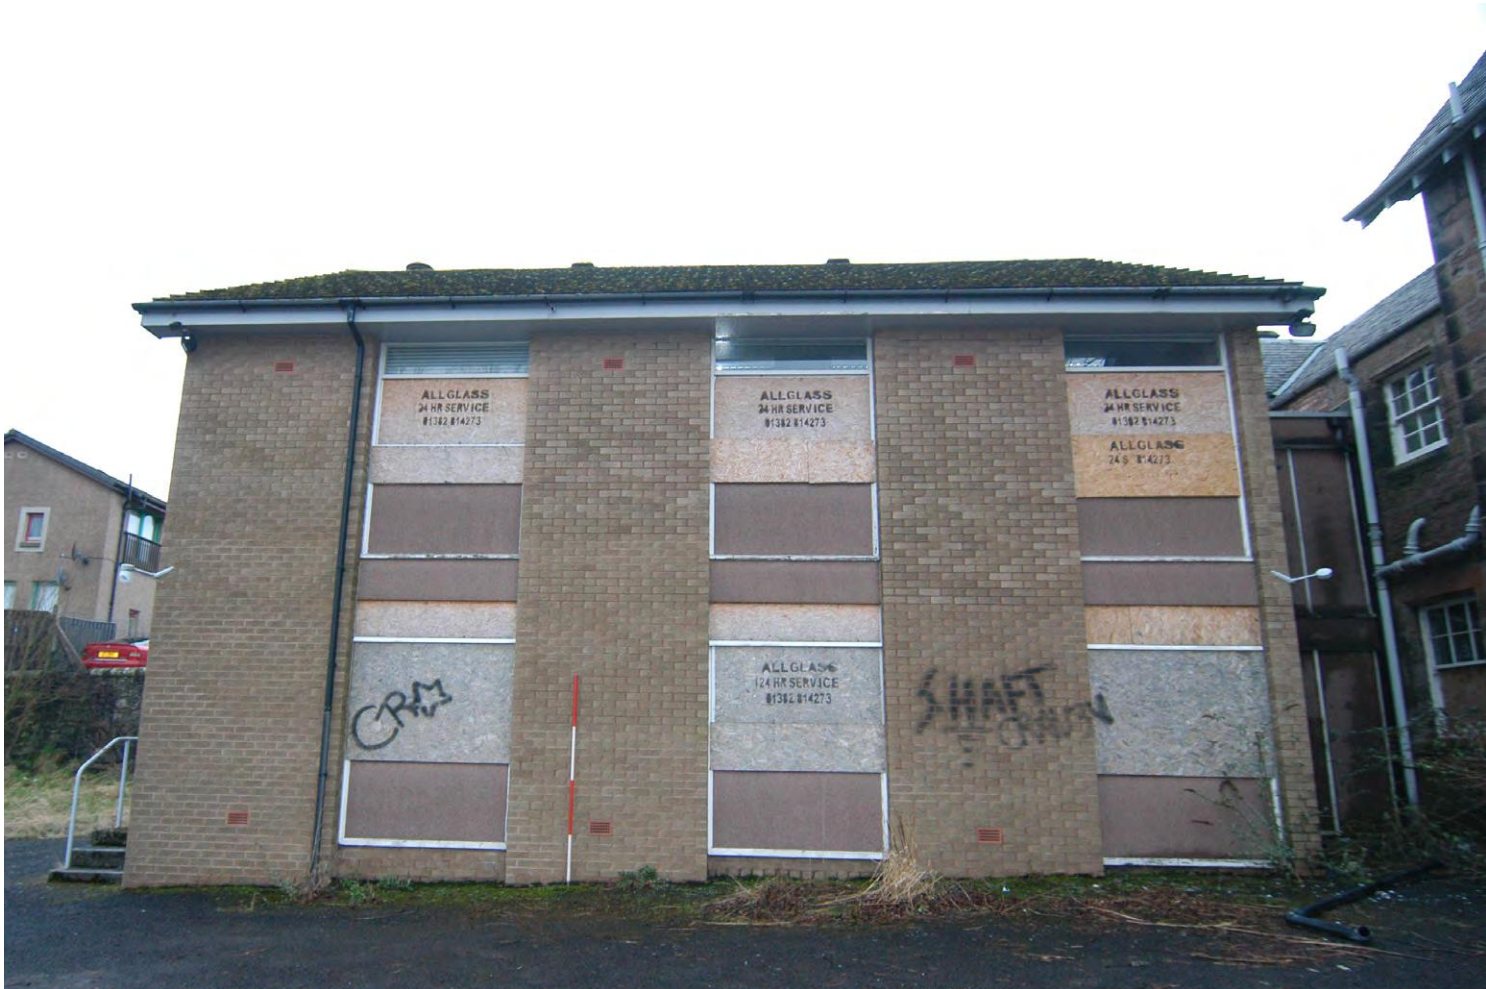
The south-facing pitched gable was 8.7m high (from ground level to ridge) and had two bays with three casement windows and a blue-painted panel door on the east side of the elevation. The east-facing elevation had three bays with casement windows set

above pebble-dashed panels. At the north end of the elevation the corridor had a double-leaved five panelled door surmounted by a large casement window.

Fig 12b - Office Block, east-facing elevation
