**Land between Canongate,  
Holyrood Road & St John Street,  
City of Edinburgh**

**Archaeological Evaluation (Phase 1)**

**Report No. 3010**

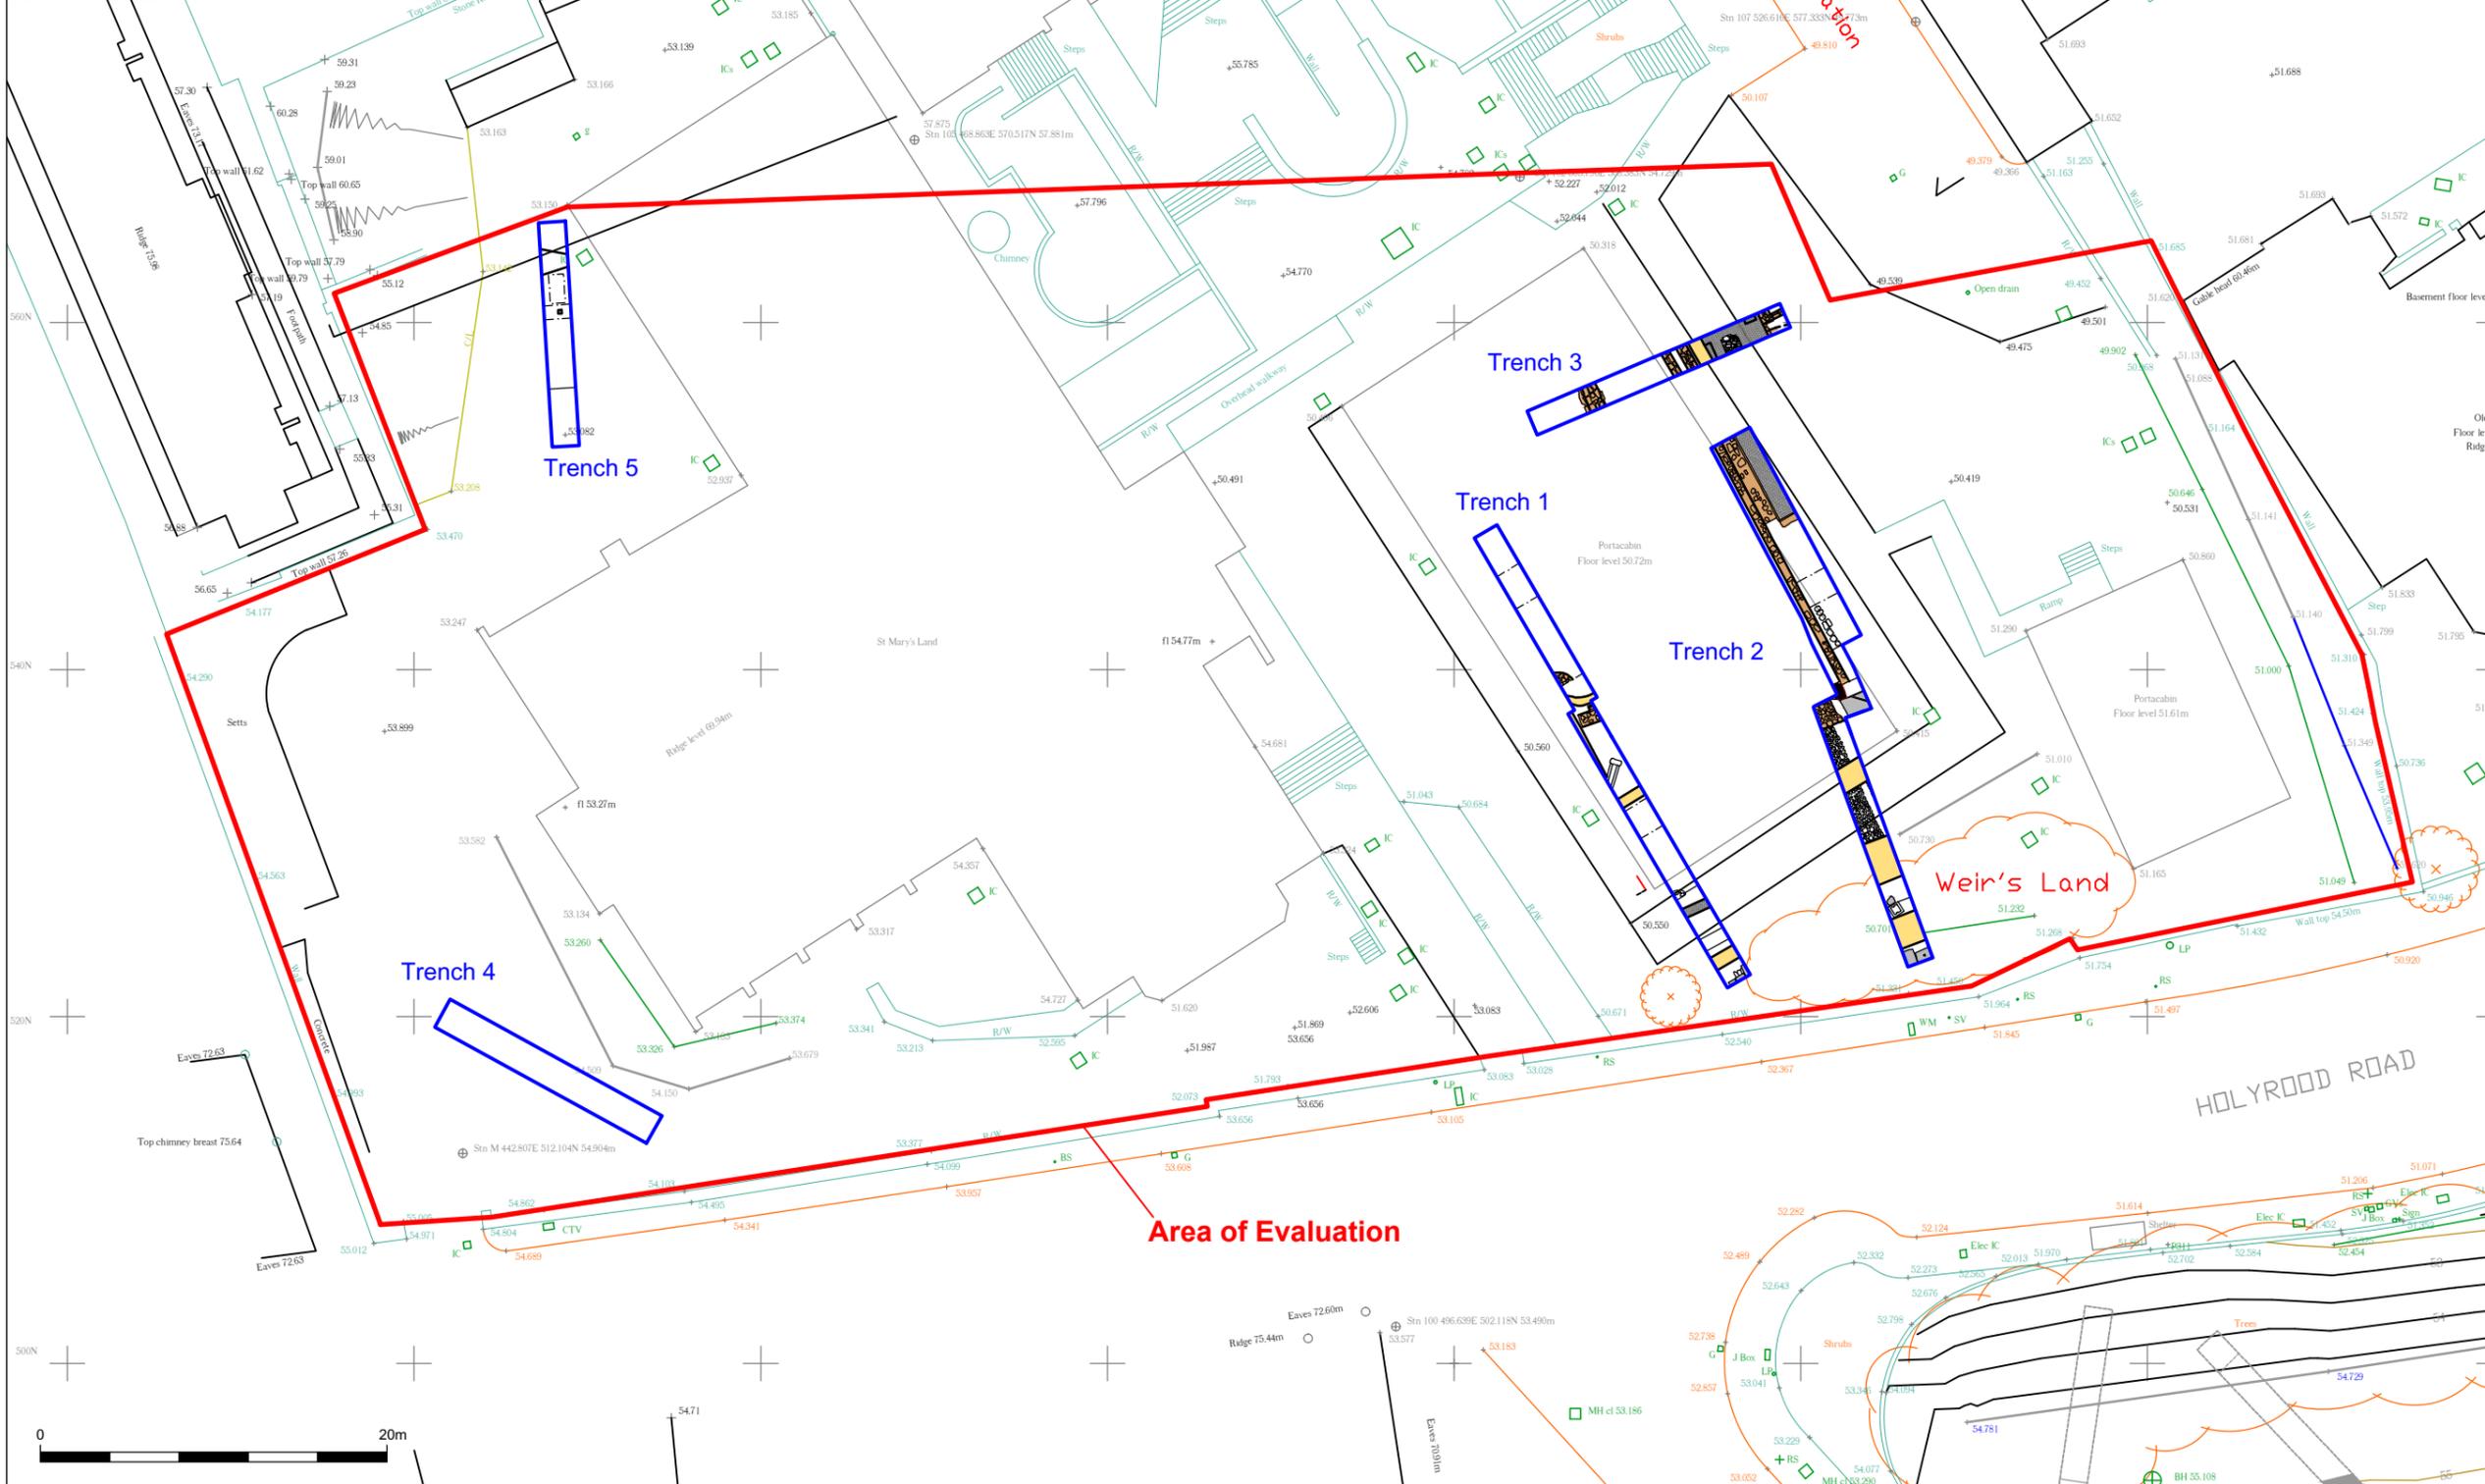
Fig. No: 1 Revision: A

Title:  
**Location map and site plan showing trenches**

Five trenches were excavated (Figs. 1 & 3). A total of 133m<sup>2</sup> was examined (Trenches 1-3) (Fig. 4) to the east of St Mary's Land and a total of 42m<sup>2</sup> to the west (Trenches 4-5) (Fig. 4).

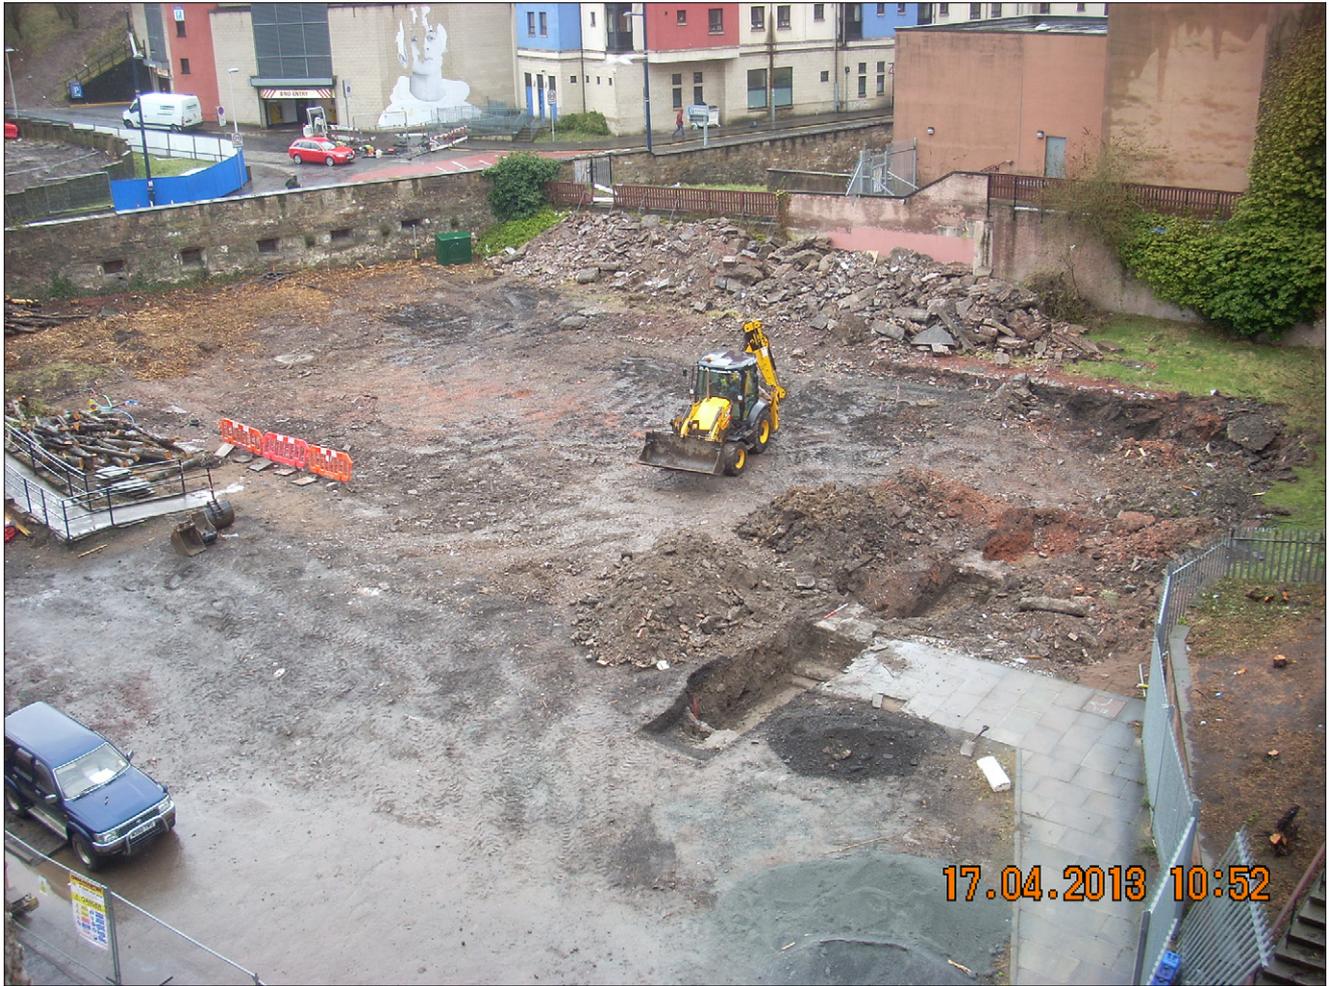
Fig. No: <b>2</b>		Revision: <b>A</b>	Project: Land between Canongate, Holyrood Road and St John Street, Edinburgh

Fig. 2 - General view of the eastern area

Two areas were currently available for evaluation. The eastern area lies to the south of Chessel's Land and immediately to the east of St Mary's Land (Fig. 2). The western area lies immediately to the west of St Mary's Land.

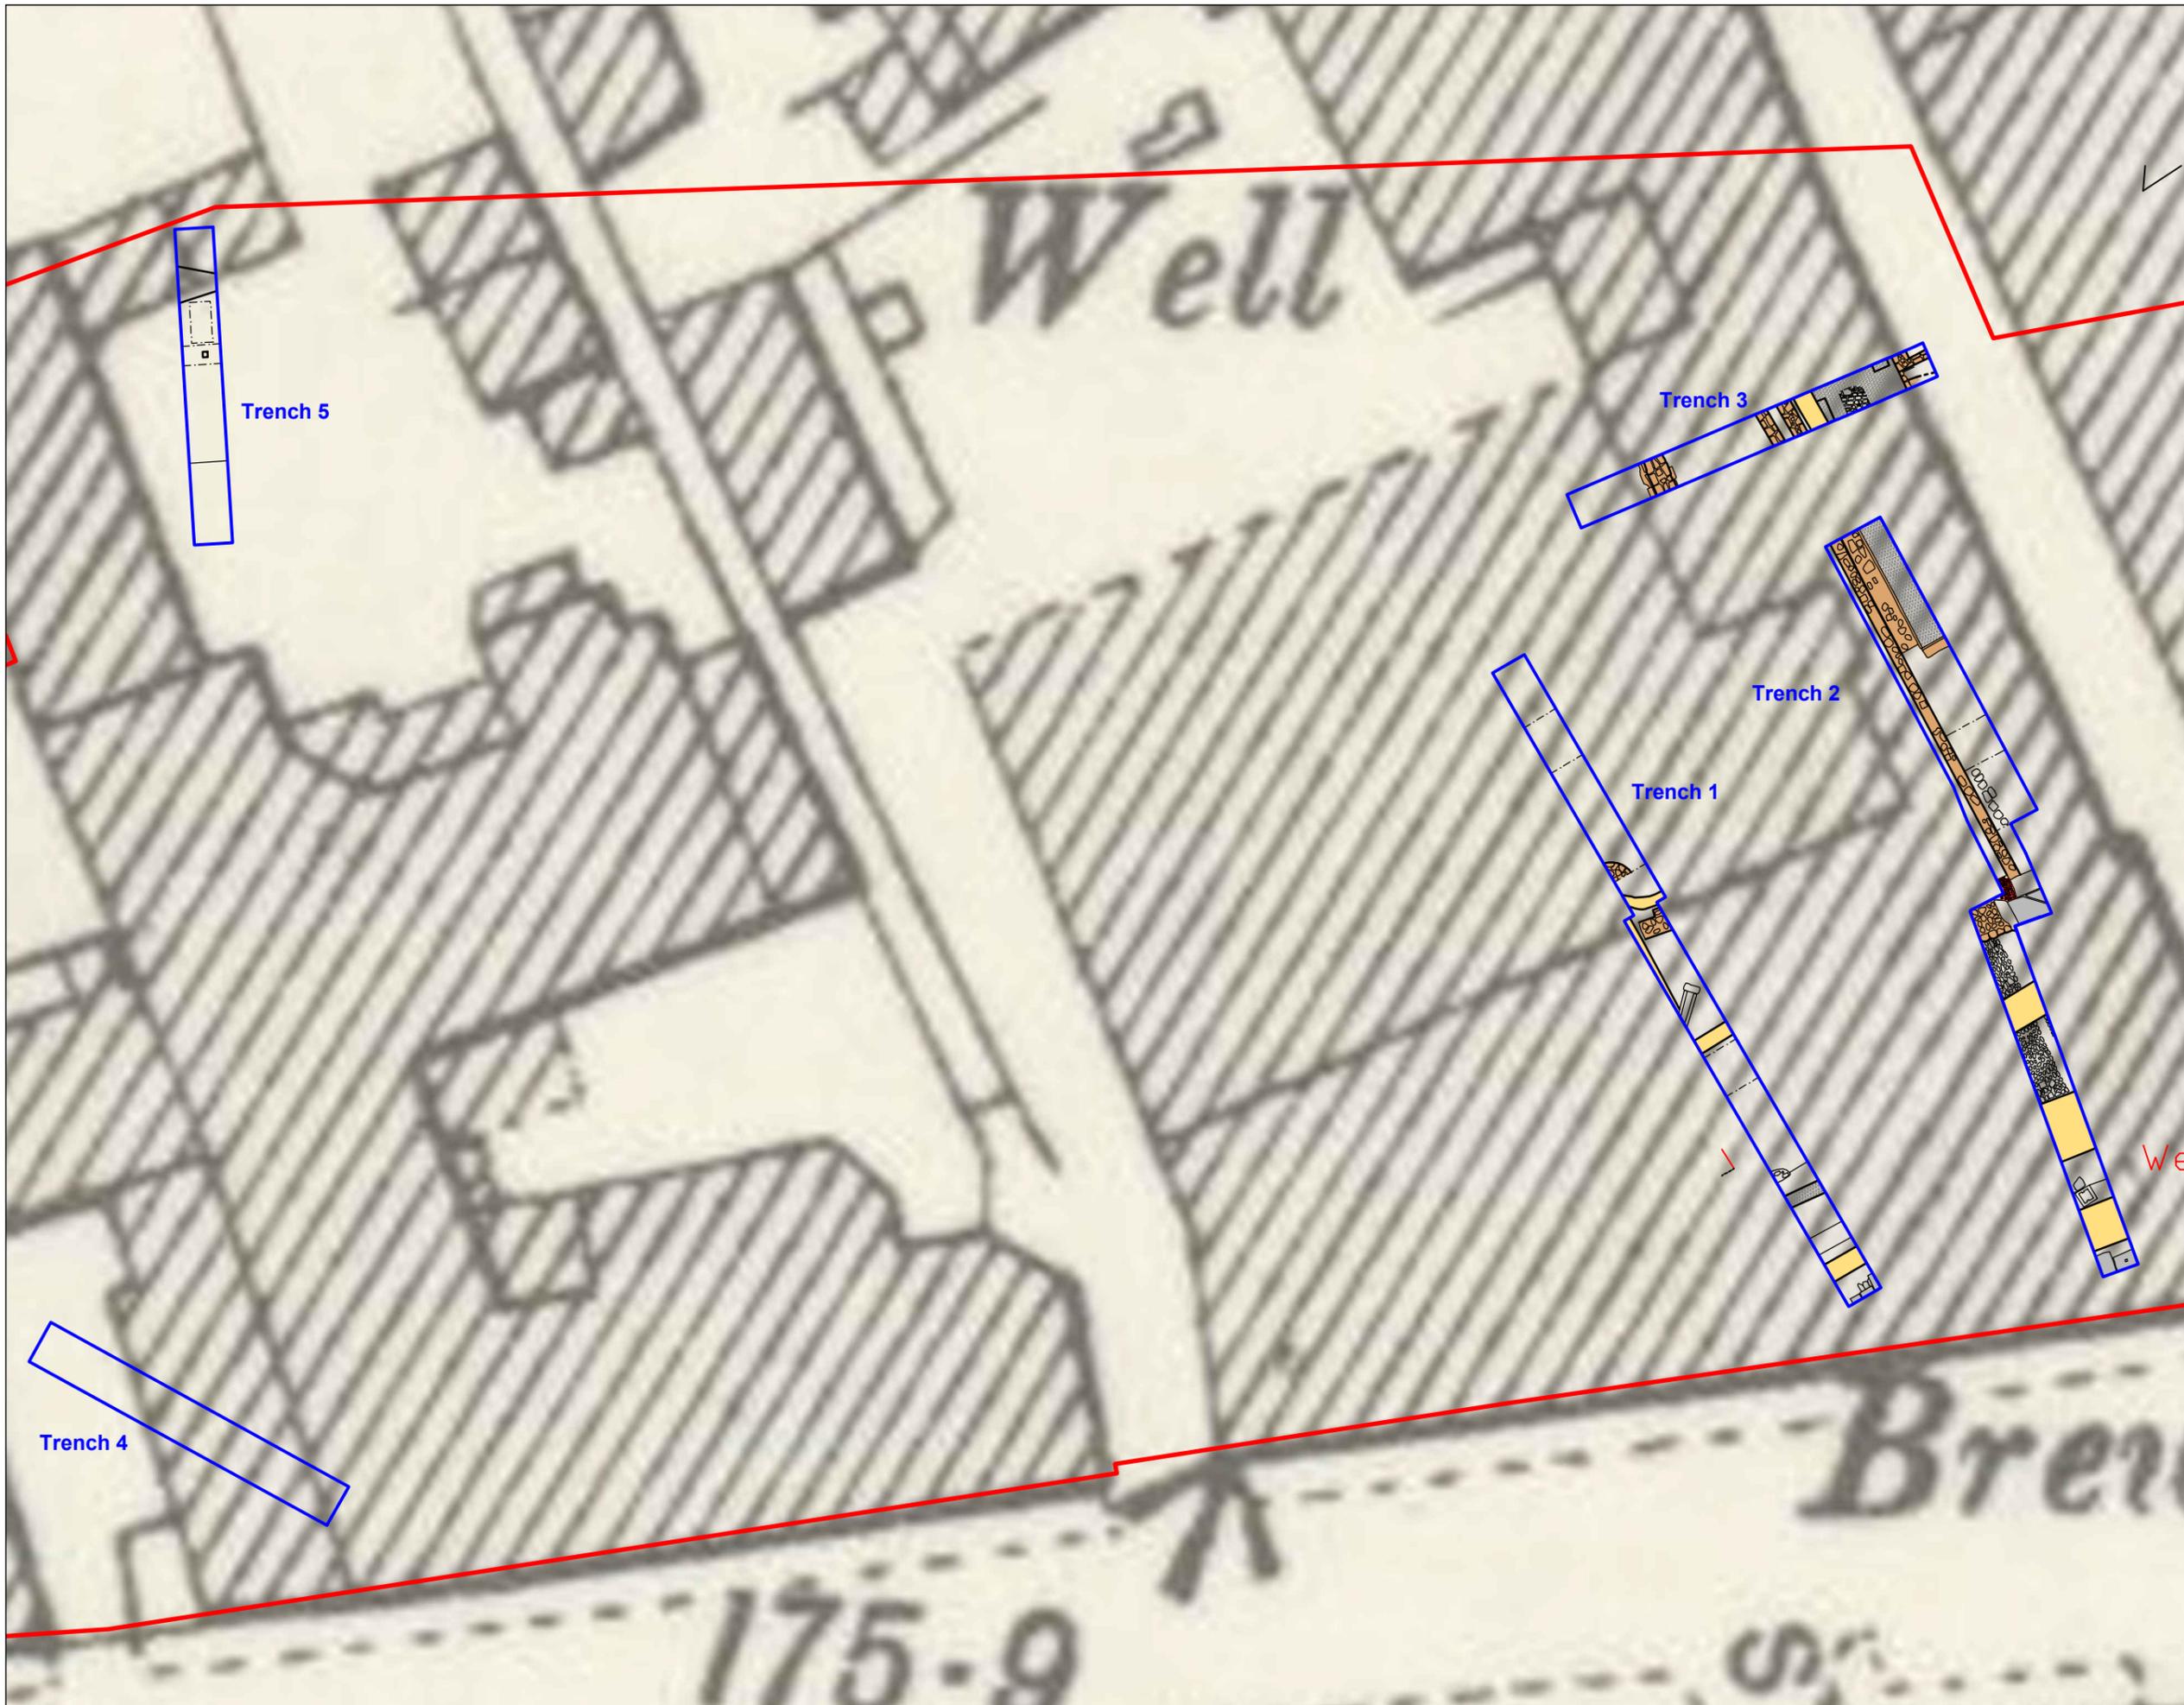
Fig. No: 3      Revision: A

Title:  
**Trench Plans overlain on the OS Second Edition Map published 1896**

The Ordnance Survey Town Plan of Edinburgh dated 1894 shows the eastern area to contain part the Edinburgh and Leith Brewery (Fig. 3). The same map shows the western part of the site to lie within the St Mary's Brewery.

The walls and surfaces identified in Trenches 1, 2 & 3 are interpreted as the remains of the 19th century brewery buildings. The brewery buildings are best represented on the OS 1896 map (Fig 3). Walls 106, 302 and 306/307 are all potentially main structural walls for the mapped brewery buildings (Fig.3) whilst the other walls and surfaces could be internal features. No definitely earlier features were identified.

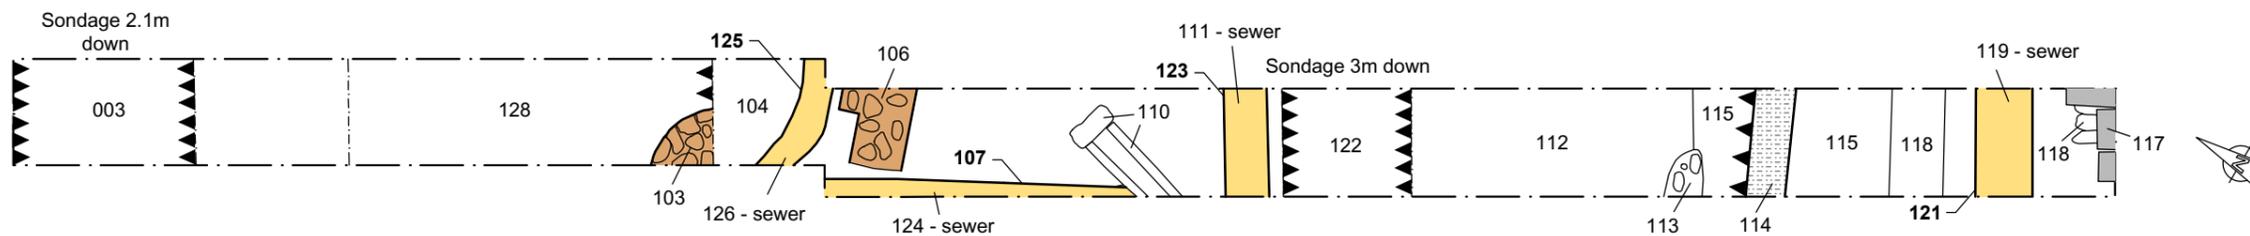
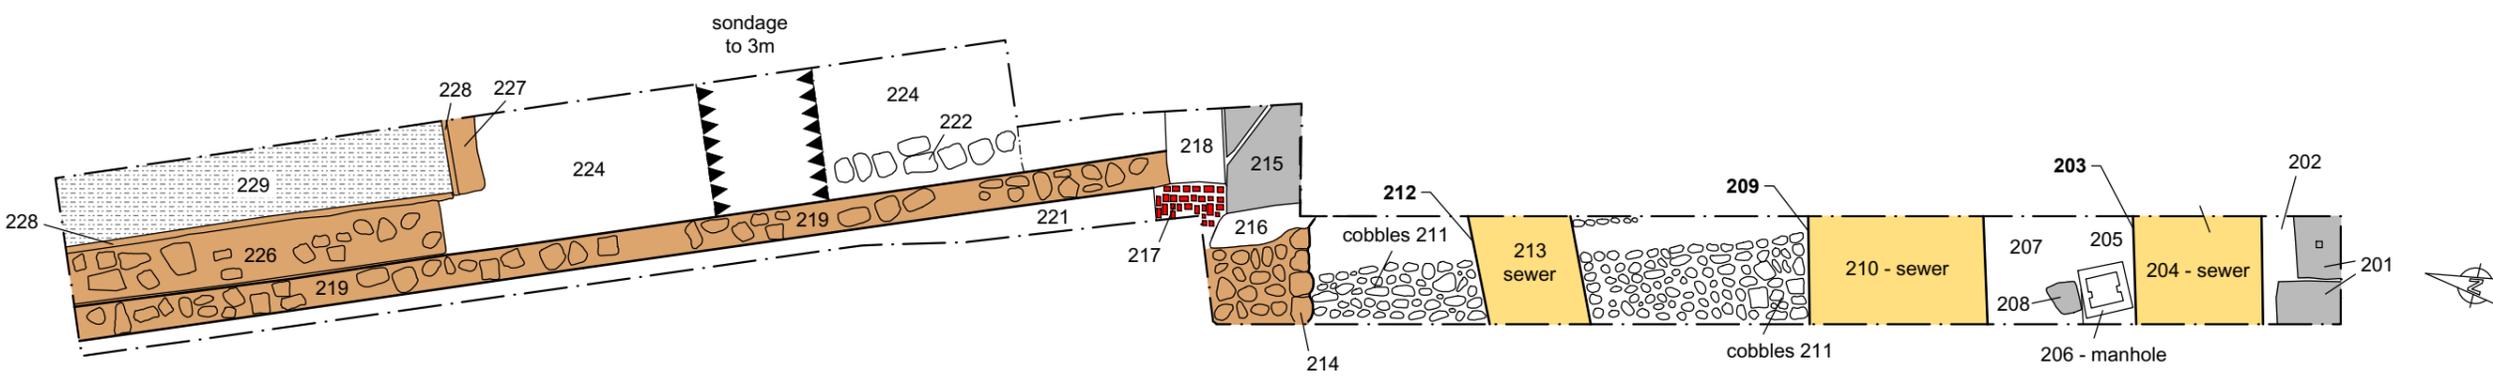
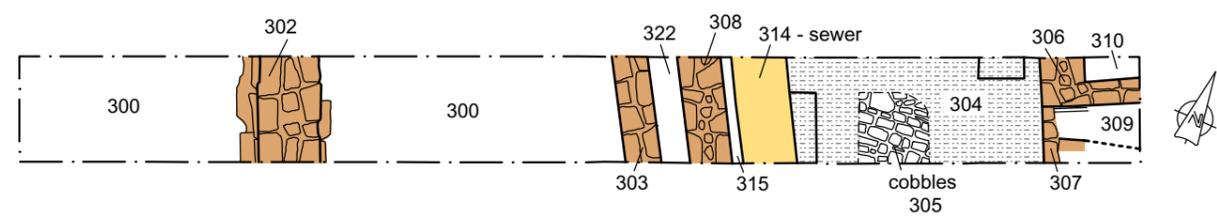
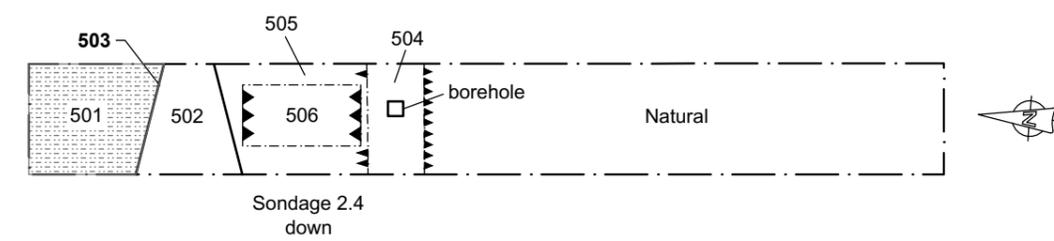
Fig. No:	4	Revision:	A
----------	---	-----------	---

Title:  
**Trench Plans**

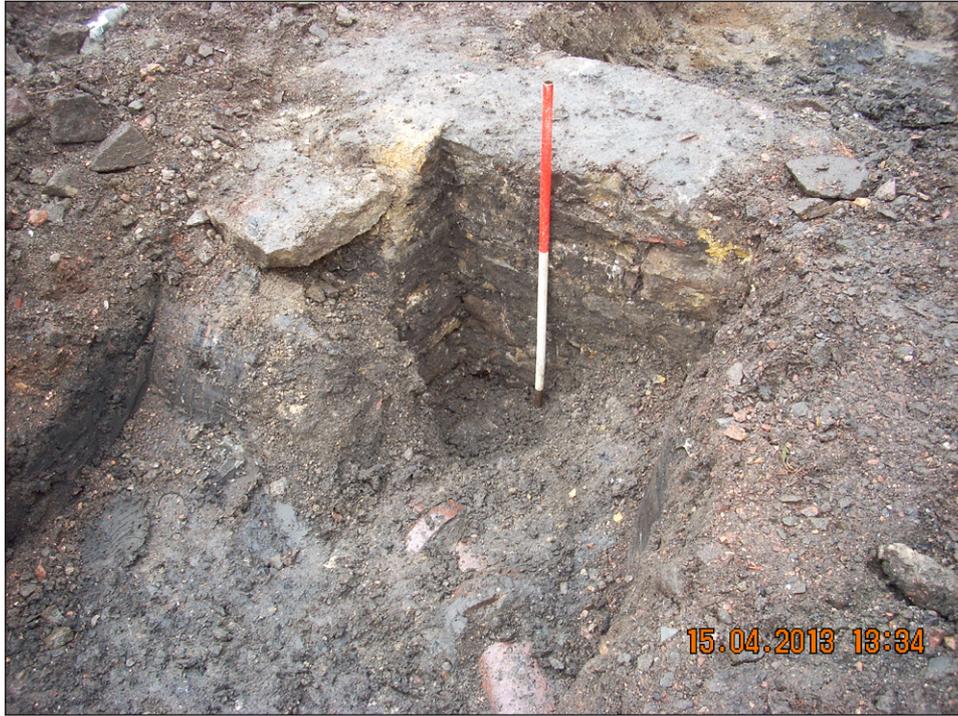
A substantial wall (**106**) (Fig. 5) was present just below the modern ground surface as were the remnants of a flagstone surface (**117**) which had an underlying bedding layer of angular cobbles and mortar (**118**) (Fig. 6). A stone built box drain (**110**) was also identified below the upper made ground deposit.

Fig. 5 - Trench 1. Wall 106

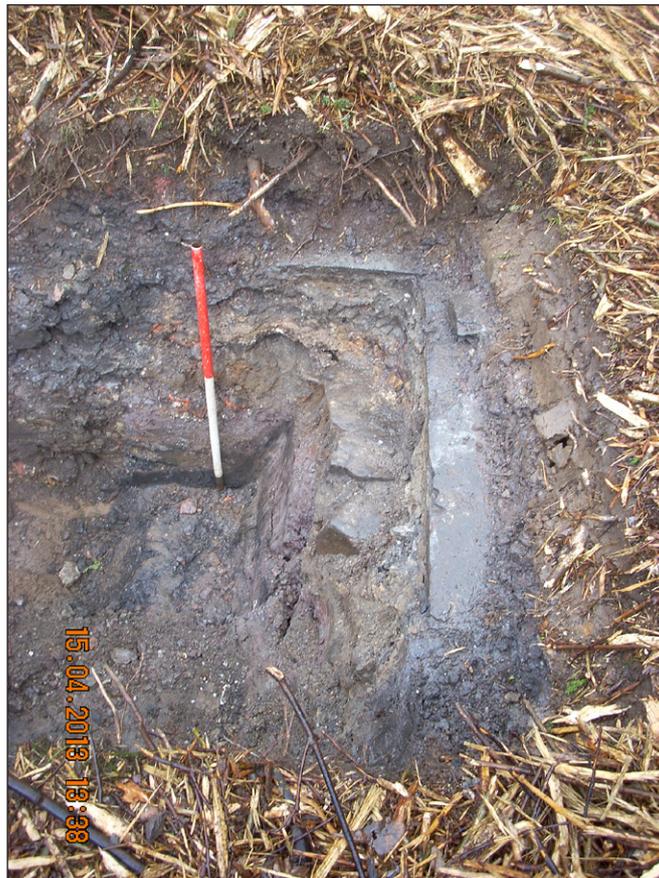
Fig. 6 - Trench 1. Flagstones 117.

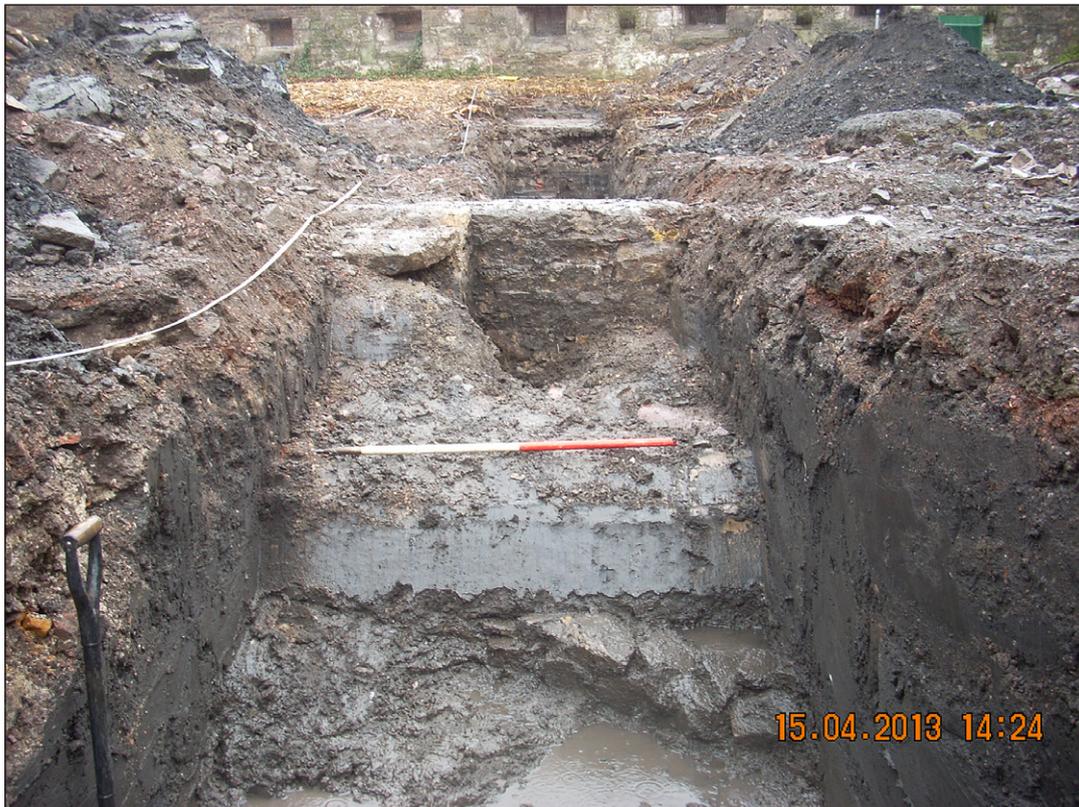
Fig. 7 - Trench 1. Wall 103.

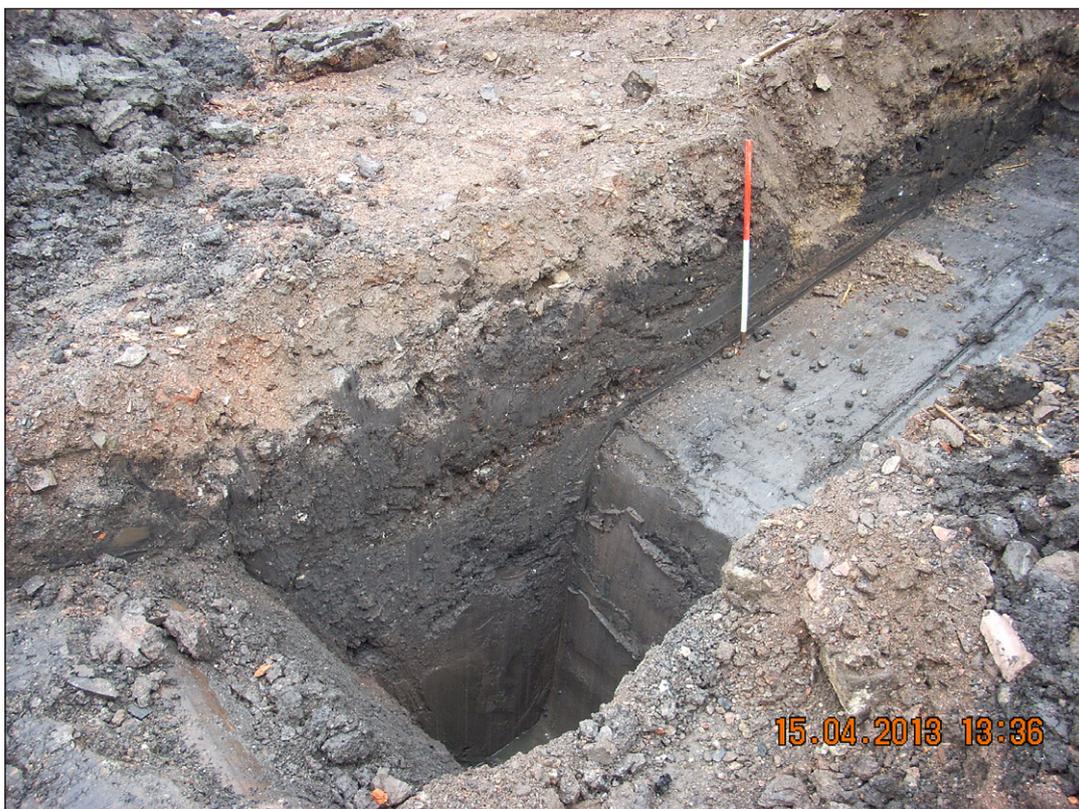
Where sondages were excavated grey silty clay soil deposits (**122, 128**) were identified below **104** and **112**. The sondage in the NW end of the trench revealed that natural (**003**) was present at a depth of 2.2m below the surface. A second sondage (Fig. 8) was excavated to a depth of 3m in the centre of the trench and natural was not revealed. This provided a depth of 0.8m for deposit **122** where it was bottomed and deposit **128** was greater than 1m deep and was not bottomed.

Fig. 8 - Sondage to 3m through the deep soils 112, 122 in the centre of the trench.

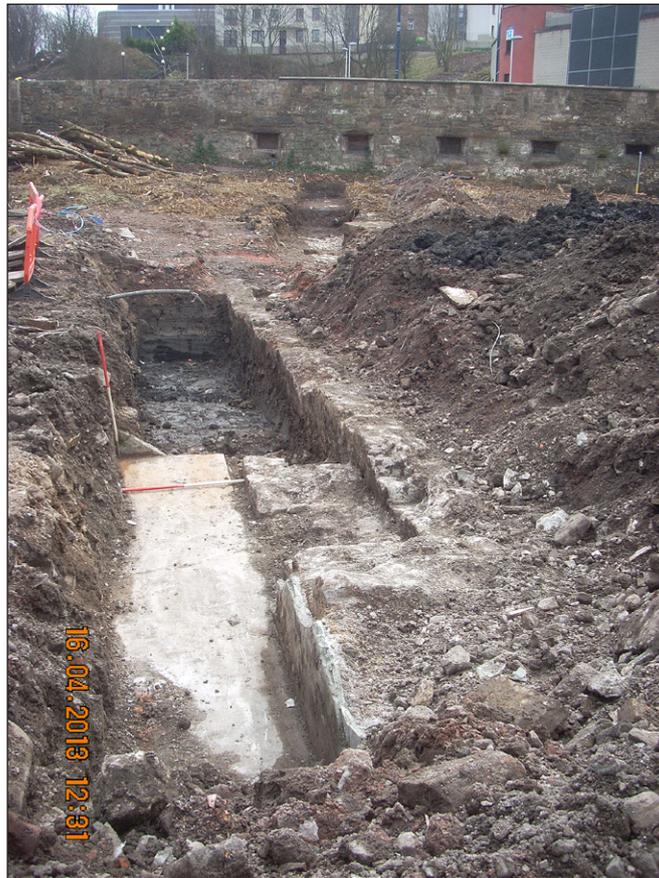
The made ground deposits overlay walls (**214 & 219**); a possible concrete and stone lined tank constructed from walls **226 & 227** which were faced with upright slabs (**228**) and a concrete base (**229**) (Fig. 9); discontinuous flagstone surfaces (**201, 208, 215**); a drain (**206**) and a cobbled surface (**211**) (Fig. 10). Walls (**219, 226**) continued North into Trench 3 as **303** and **308**.

Fig. 9 - Trench 2. General trench view with walls 226, 219, concrete base 229 and slab lining 228 in the foreground

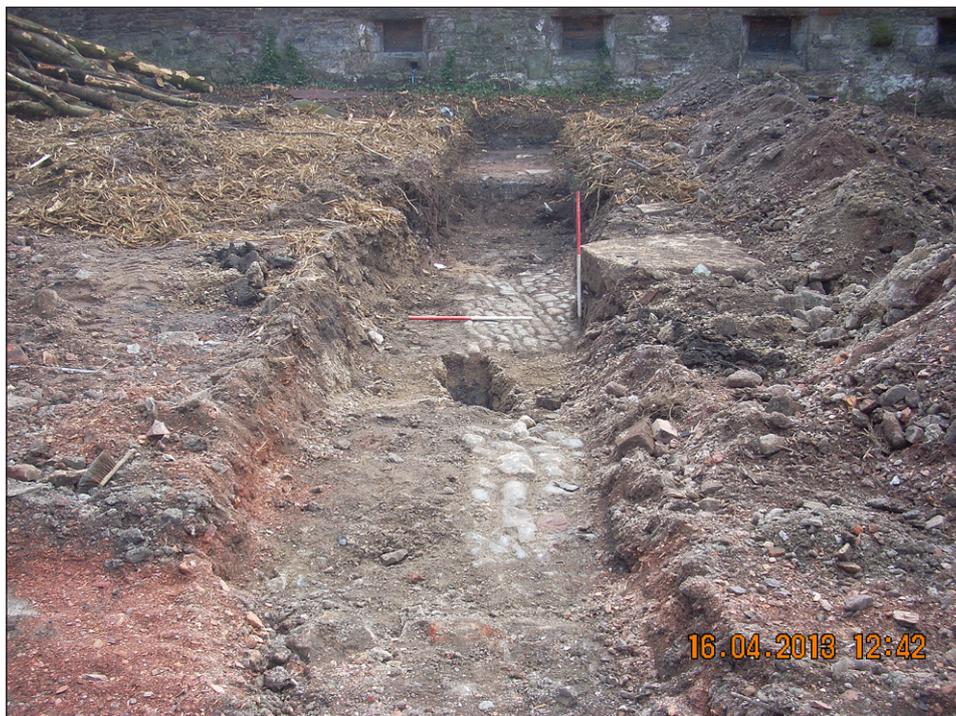
Fig. 10 - Trench 2. Cobbled surface 221.

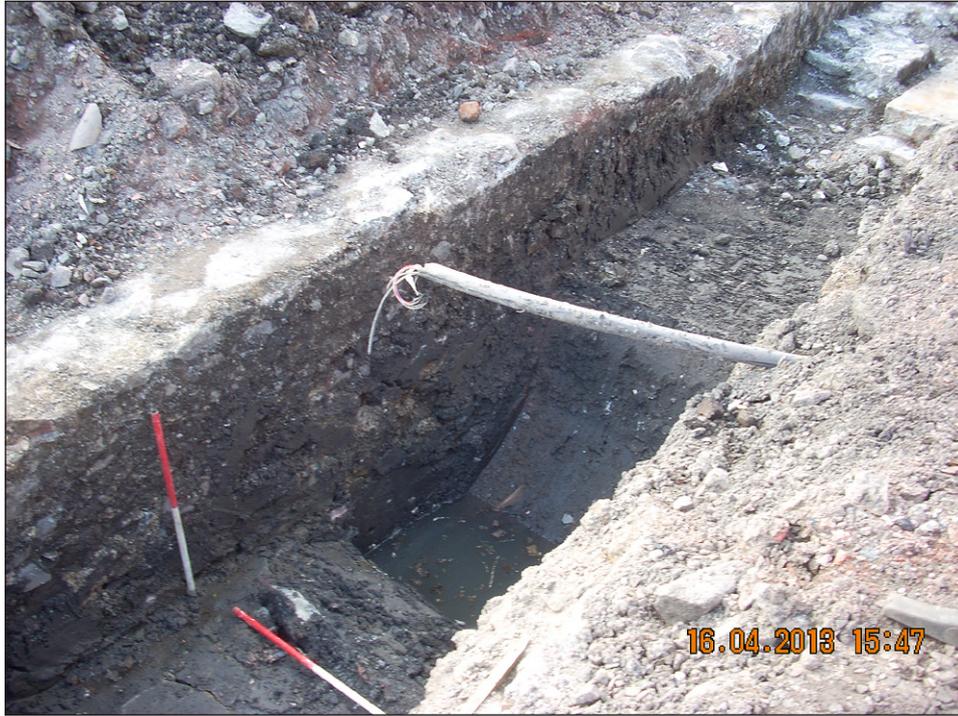
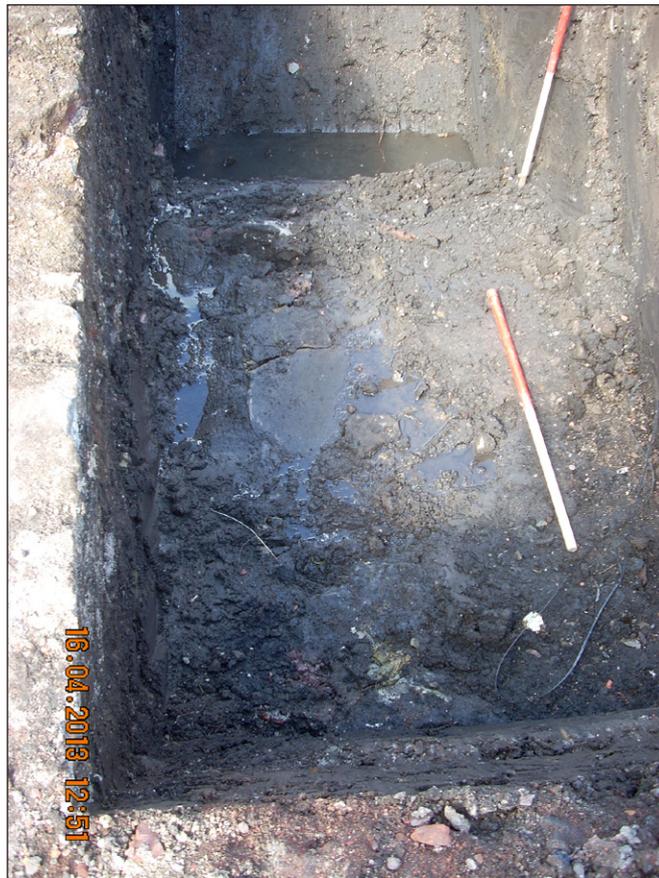
Wall (**219**) was further overlain with a deposit of grey-black silty clay soil (**223**). This was c 1m deep to the foundation level for the wall which was cut into further deposit of grey-black silty clay soil (**224**). At this depth a number of flat stone slabs (**222**) were uncovered also lying directly on **224** (Figs. 11 & 12). It is probable that these are a part of a floor associated with wall **219**.

Fig. 11 - Trench 2. Wall 219 and possible surface 222.

Fig. 12 - Trench 2. Wall 219 and possible surface 222.

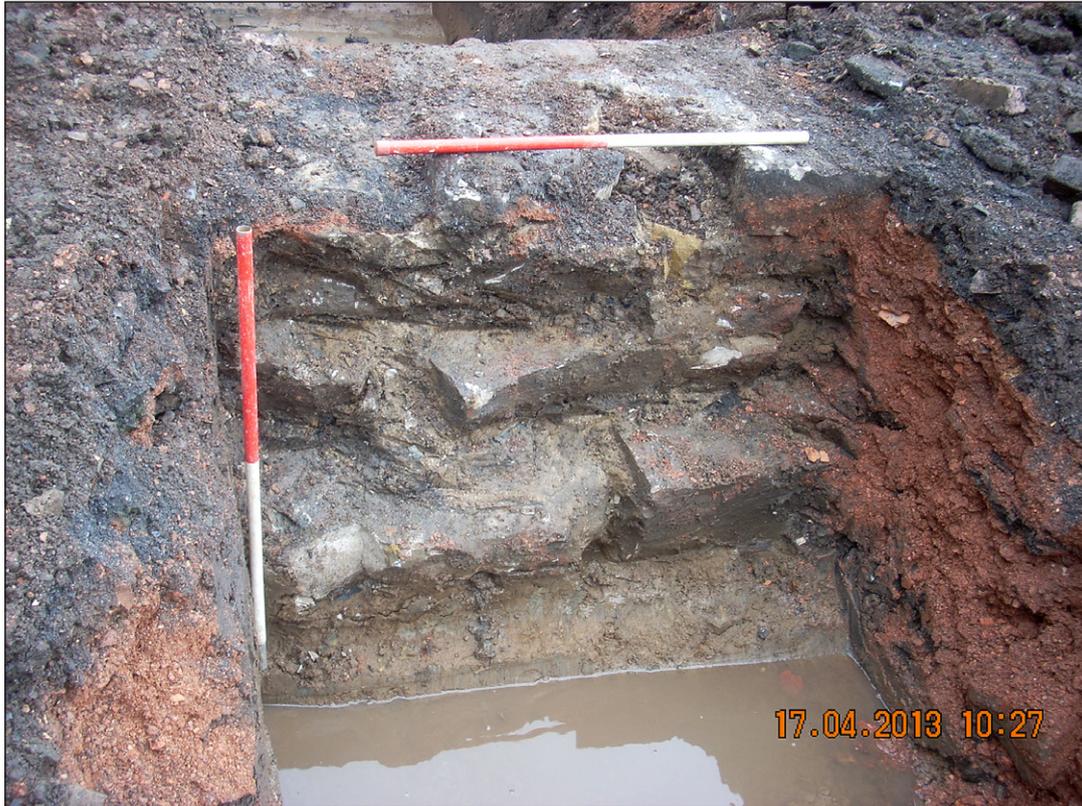
These modern deposits overlay walls (**302 303, 306/307 & 308**) (Fig. 13). In places the upper surfaces of these walls were 0.2m or less below the modern ground surface. Between walls (**306/307** and **308**) (Fig. 14) was a concrete surface (**304**) (Fig. 15). A test-pit revealed that the thin concrete (**304**) overlay a cobbled surface (**305**) (Fig. 15). In the centre of the trench, parallel walls (**303, 308**) continued the alignment of walls **219** and **226** in Trench 2.

All of the walls were appeared to be built directly on to greenish silty clay and bedrock (**300**) (Fig. 13) which was identified between 0.9m and 1.1m below the current site surface.

Fig. 13 - Trench 3. Wall 302 and natural subsoil.

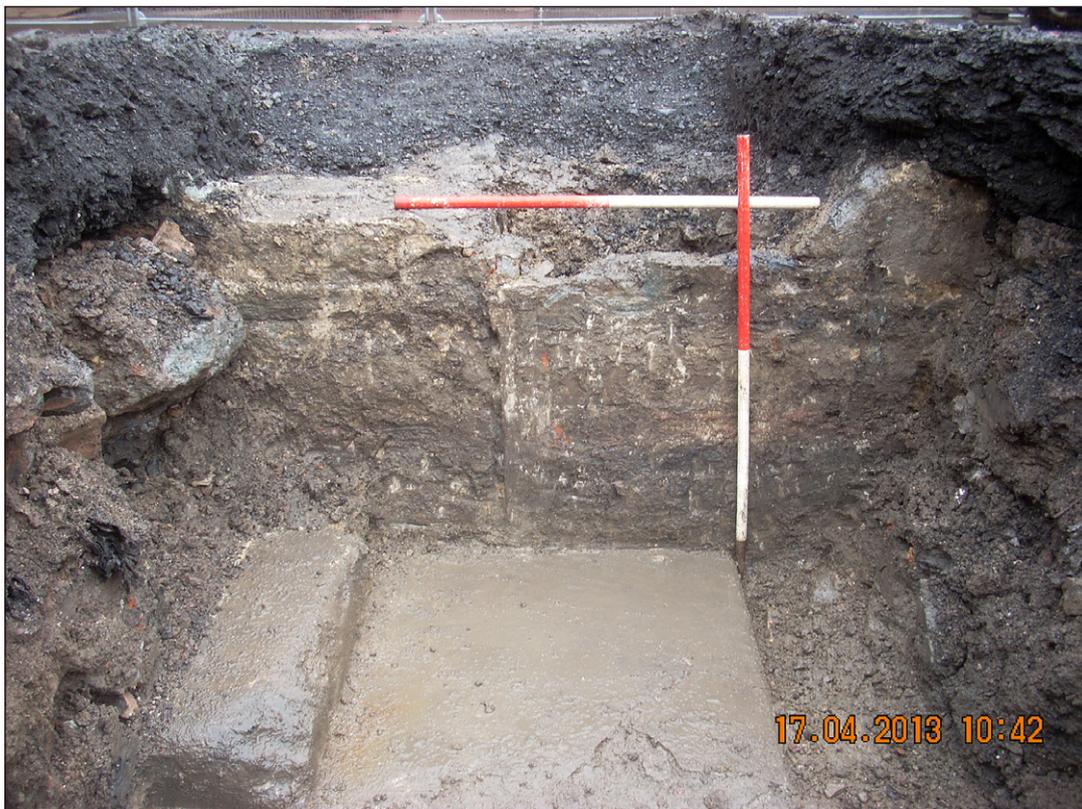
Fig. 14 - Trench 3. Walls 306 and 307 from the SW.

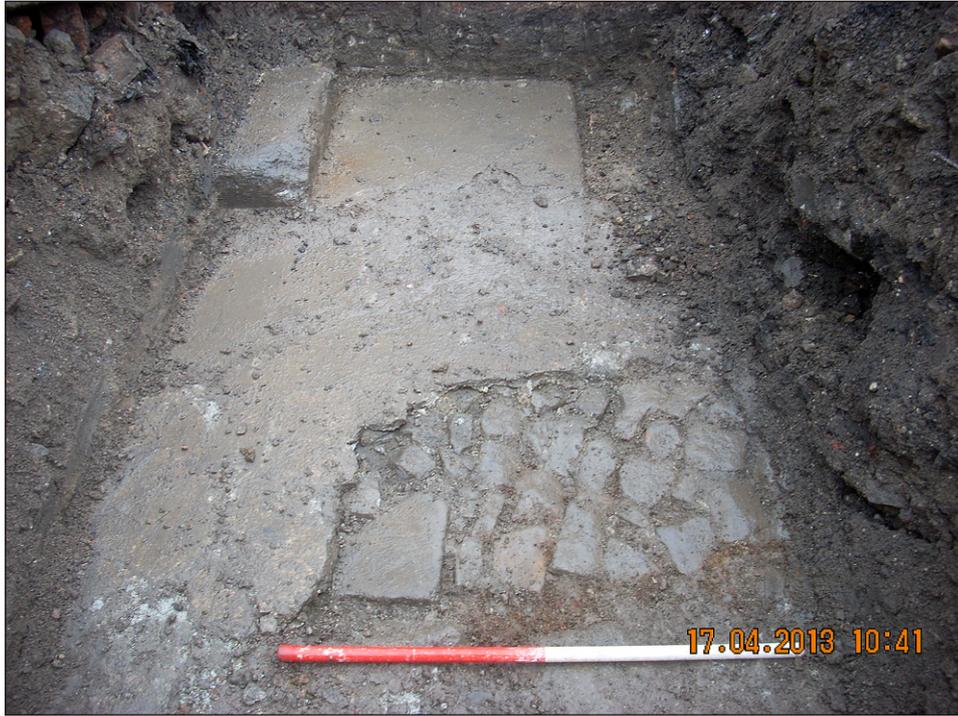
Fig. 15 - Trench 3. Cobbled surface 305 under concrete 304

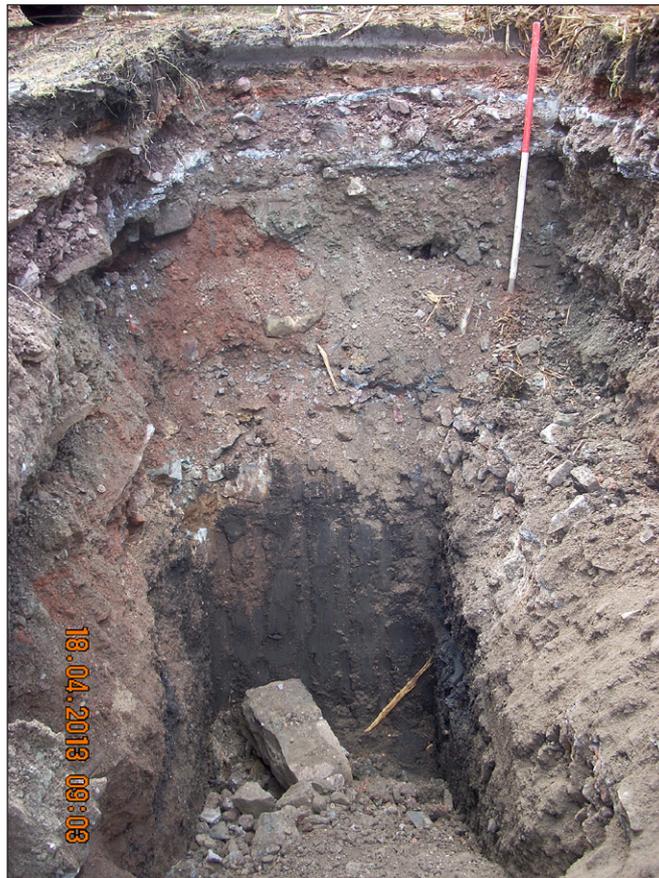
In the SE end of the trench, (401) overlay a deposit of grey-black clayey-silt soil (403) (Fig. 16). Natural was not reached in a 3m deep sondage.

Fig. 16 - Trench 4. Deep soils 403 under demolition debris

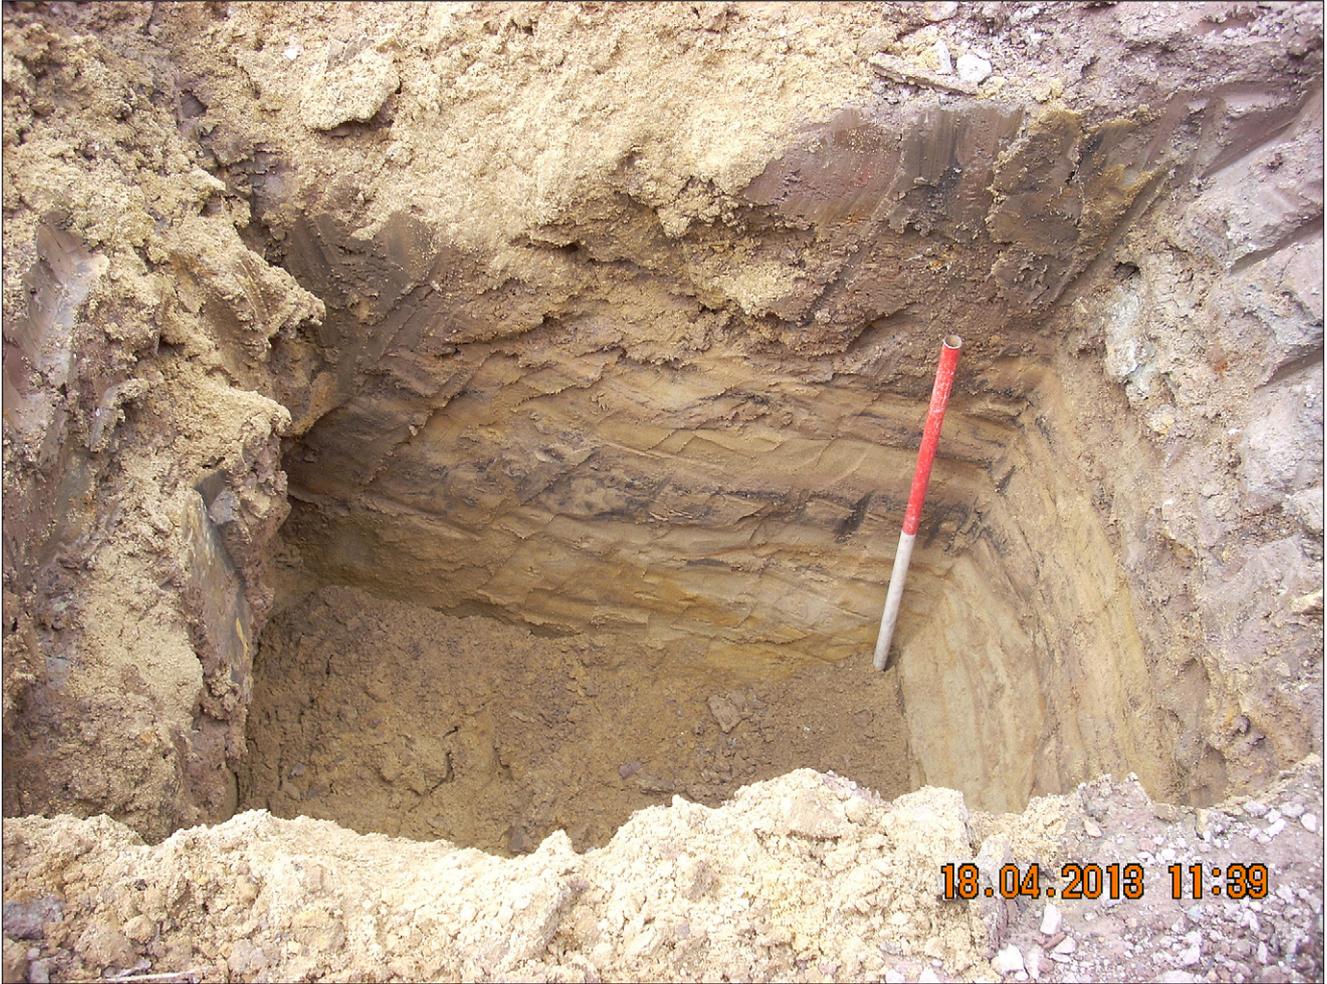
In the centre of the trench, a borehole was present so the ground surface was not reduced in this area and it was left as a raised island. Between it and drain (503), a deposit of clean grey-pink clay (505) lay below 504 and merged into deep deposits of laminated and iron stained sand with thin lenses of grey-pink clay (506) (Fig. 17). A sondage showed this clay and sand to extend to at least 2.4m below the surface. Whilst the sands appeared to be natural, bedrock and other natural deposits (507) identified at the southern end of the trench proved to be igneous / metamorphic. So the presence of sand in such close proximity as a natural deposit is not possible. Unfortunately the boundary between the natural and the sand could not be explored because of the presence of the bore hole. However, it is thought that the clay (505) and the laminated sand and clay (506) may be the sterile backfill of a deep modern service.

Fig. 17 - Trench 5. Test pit section showing laminated sand and silt 506
