**9 West Harbour Road, Granton, Edinburgh
Historic Building Survey**

**Data Structure Report
No. 2167**

Author	Mike Cressey HND BA MSc PhD FSA Scot MifA
Illustrator	Graeme Carruthers MA MifA
Editor	Bruce Glendinning BSc PgDip MifA
Commissioned by	Cruden Homes Ltd
Date issued	July 2013
Version	1
Planning Application No	11/01277/FUL
Grid Ref	NT 23628 77094

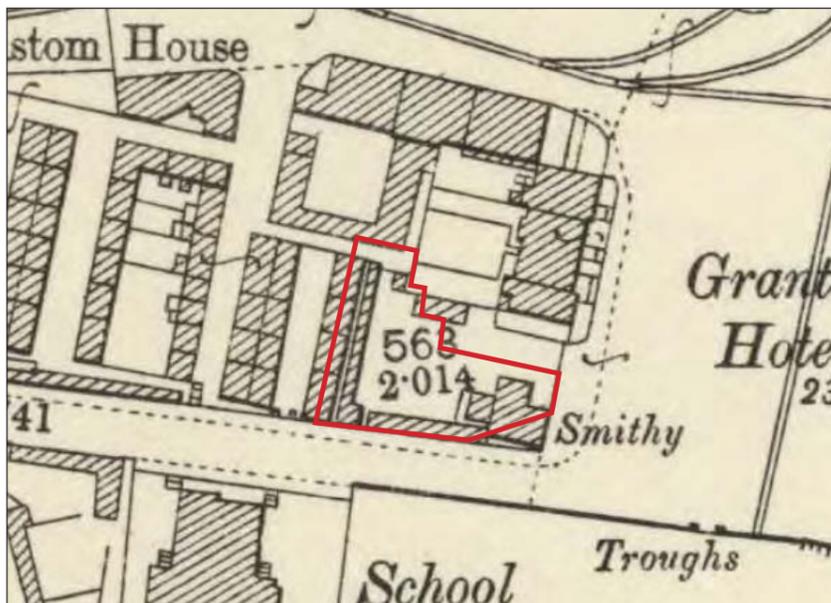
Figure 2a - 2nd Edition Ordnance Survey map 1896

The 1896 Ordnance Survey map (Fig 2a) shows that the surveyed building had yet to be built. This map also shows a narrow rectilinear building aligned roughly north-south with an L-shaped arrangement at its south-end. Immediately to the west a row of probable tenement houses is depicted and these may be present along the westernmost boundary of the site. At the north-east corner of the property boundary there is a *Smithy*. The 1908 Ordnance Survey map (Fig 2b) shows the building to be surveyed for the first time. It is built against the aforementioned rectilinear building. The 1914 Ordnance Survey map (Fig 3c) shows the building with a small outshot structure on its south gable. The 1933 Ordnance Survey map (Fig 3d) shows that the building has been enlarged at its northern end. The small outshot building is still present on its south gable. By 1939 according to the 1939-40 Post Office map (Fig 3e) the narrow rectangular building had been demolished. By 1959 this had been demolished and a much larger building was constructed against the present building (Fig 3f).

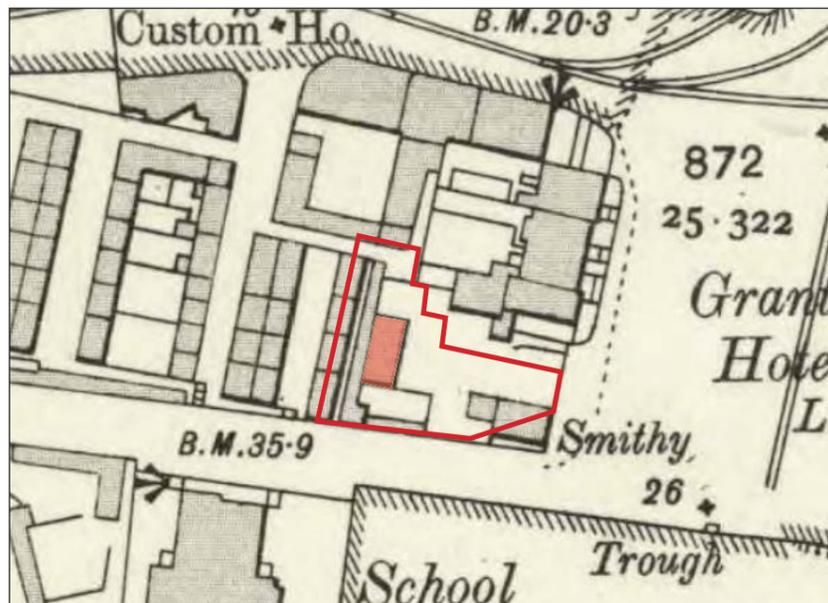
Figure 2b - 3rd Edition Ordnance Survey map 1908

During the survey, stamped brick with a makers name 'MacDonald Braidwood' was found on the west-facing elevation (see below). Cross-referencing of the name with the RCAHMS inventory (Douglass and Oglethorpe 1993) on brick and tile works confirmed that the Lanarkshire Braidwood Brick and Tile Works were in operation between c.1858 and 1907. The end date of 1907 for brick manufacture is broadly in accord with the cartographic evidence (1908) which shows the building for the first time.

The main structure was built sometime before 1908. On the north gable the lean-to building was constructed by 1933 according to the Ordnance Survey map of that year. The felt roof raggle situated on the west-facing elevation relates to a much later roof line associated with a second lean-to that was built sometime after 1959.

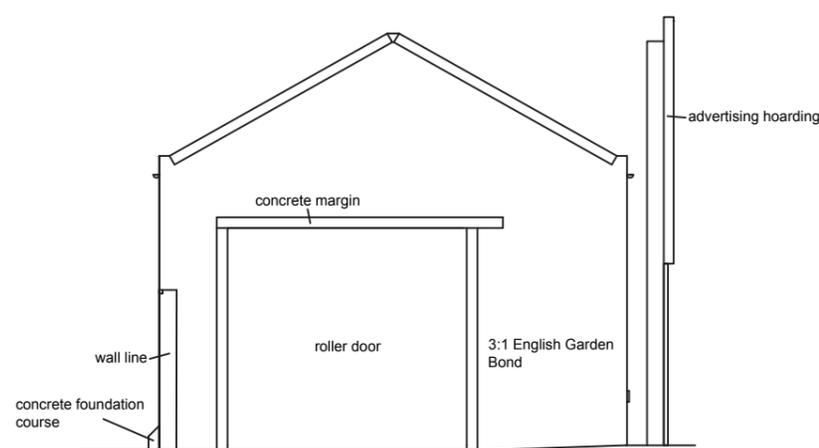
Fig. 3a South facing elevation

The south-facing gable measured 6.4m wide and had an off-centre large bay opening with a steel roller door. The doorway was off-centre and measured 3.4m wide by 3.1m high. The gable was pitched with brick-built ridge copings.

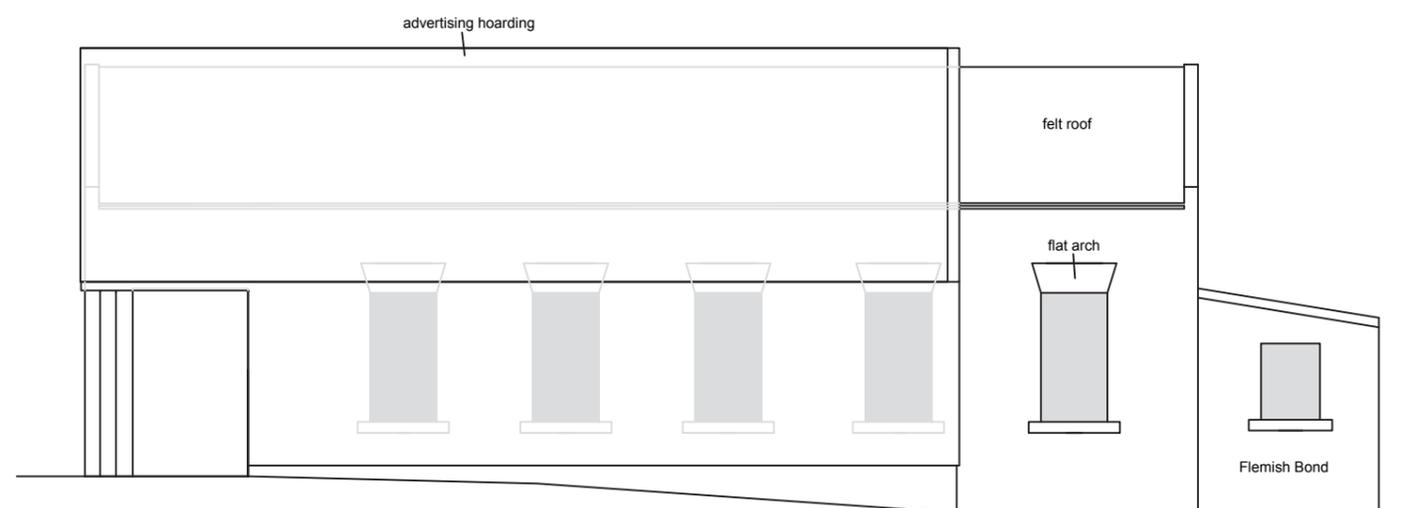
Fig. 3b East facing elevation

The east-facing elevation measured 17.7m long and during the first phase of survey it was almost completely hidden behind the advertisement hoarding. At the north end of the elevation was the lean-to with a corrugated iron roof housing Units 3-5. This had been constructed of a lighter coloured brick than that used on the main block. The lean-to had been keyed onto the gable of the main block showing it was a later structure.

The main block was constructed in English Garden Bond (3:1) brickwork and had five blocked windows. All the windows had segmented flat arch lintels and no sills. The ridge copings were also brick-built. A plank-built timber sliding door was situated at the south end of the elevation.

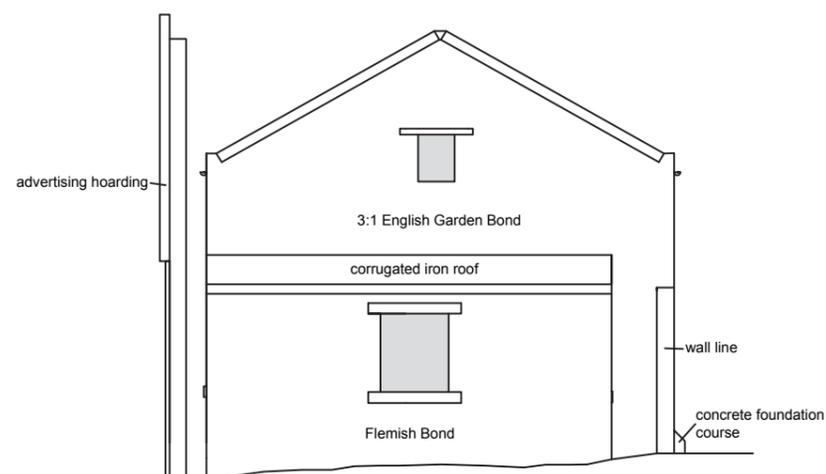
Fig. 3c North facing elevation

The north-facing gable measured 6.4m wide and incorporated the lean-to building. The gable of the main block was constructed of EGB 3:1 and had a

small square window with a timber lintel. The lean-to had a central blocked window.

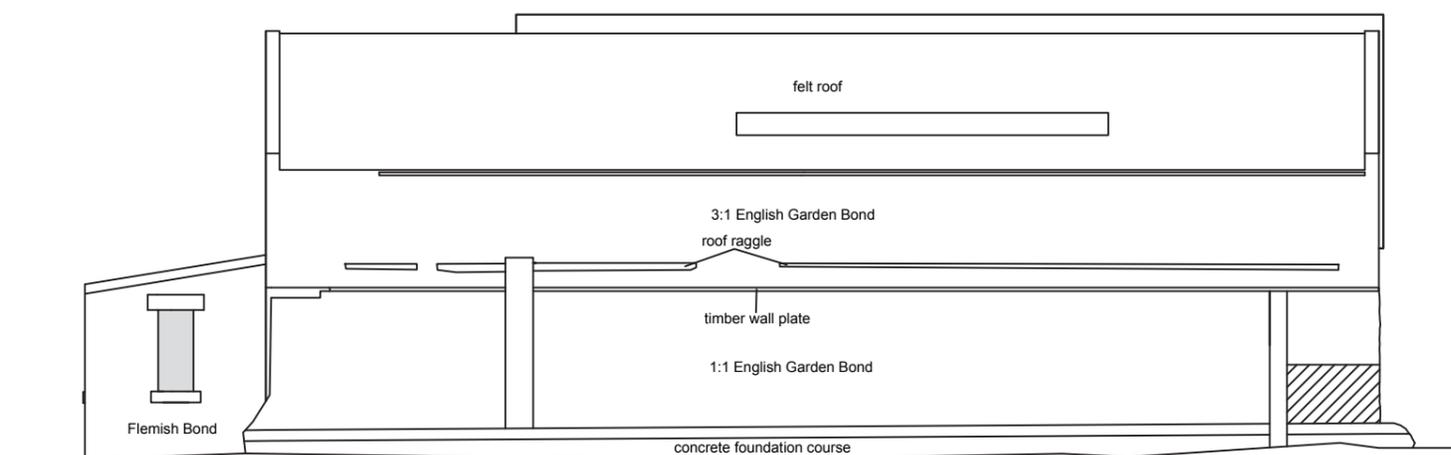
Fig. 3d West facing elevation

The west-facing elevation measured 17.8m long and was brick-built (EGB 3:1) and rested on a low concrete foundation wall measuring 0.36m high. Two metres above the foundation wall was a timber wall plate that ran the entire length of the elevation. Immediately above the wall plate were the remains of a roof raddle that comprised short sections of roofing felt. The brickwork below the wall plate was shale brick (EGB 1:1) and lighter than the brickwork above. Situated 1.3m from the corner of the south gable was the position of a wall line about two courses thick. This feature represented a partition wall that projected off the main elevation. The roof was covered with felt roofing tiles. Towards the south end was a blocked-in roof light. The lean-to building projected 2.6m off the main block's north gable.

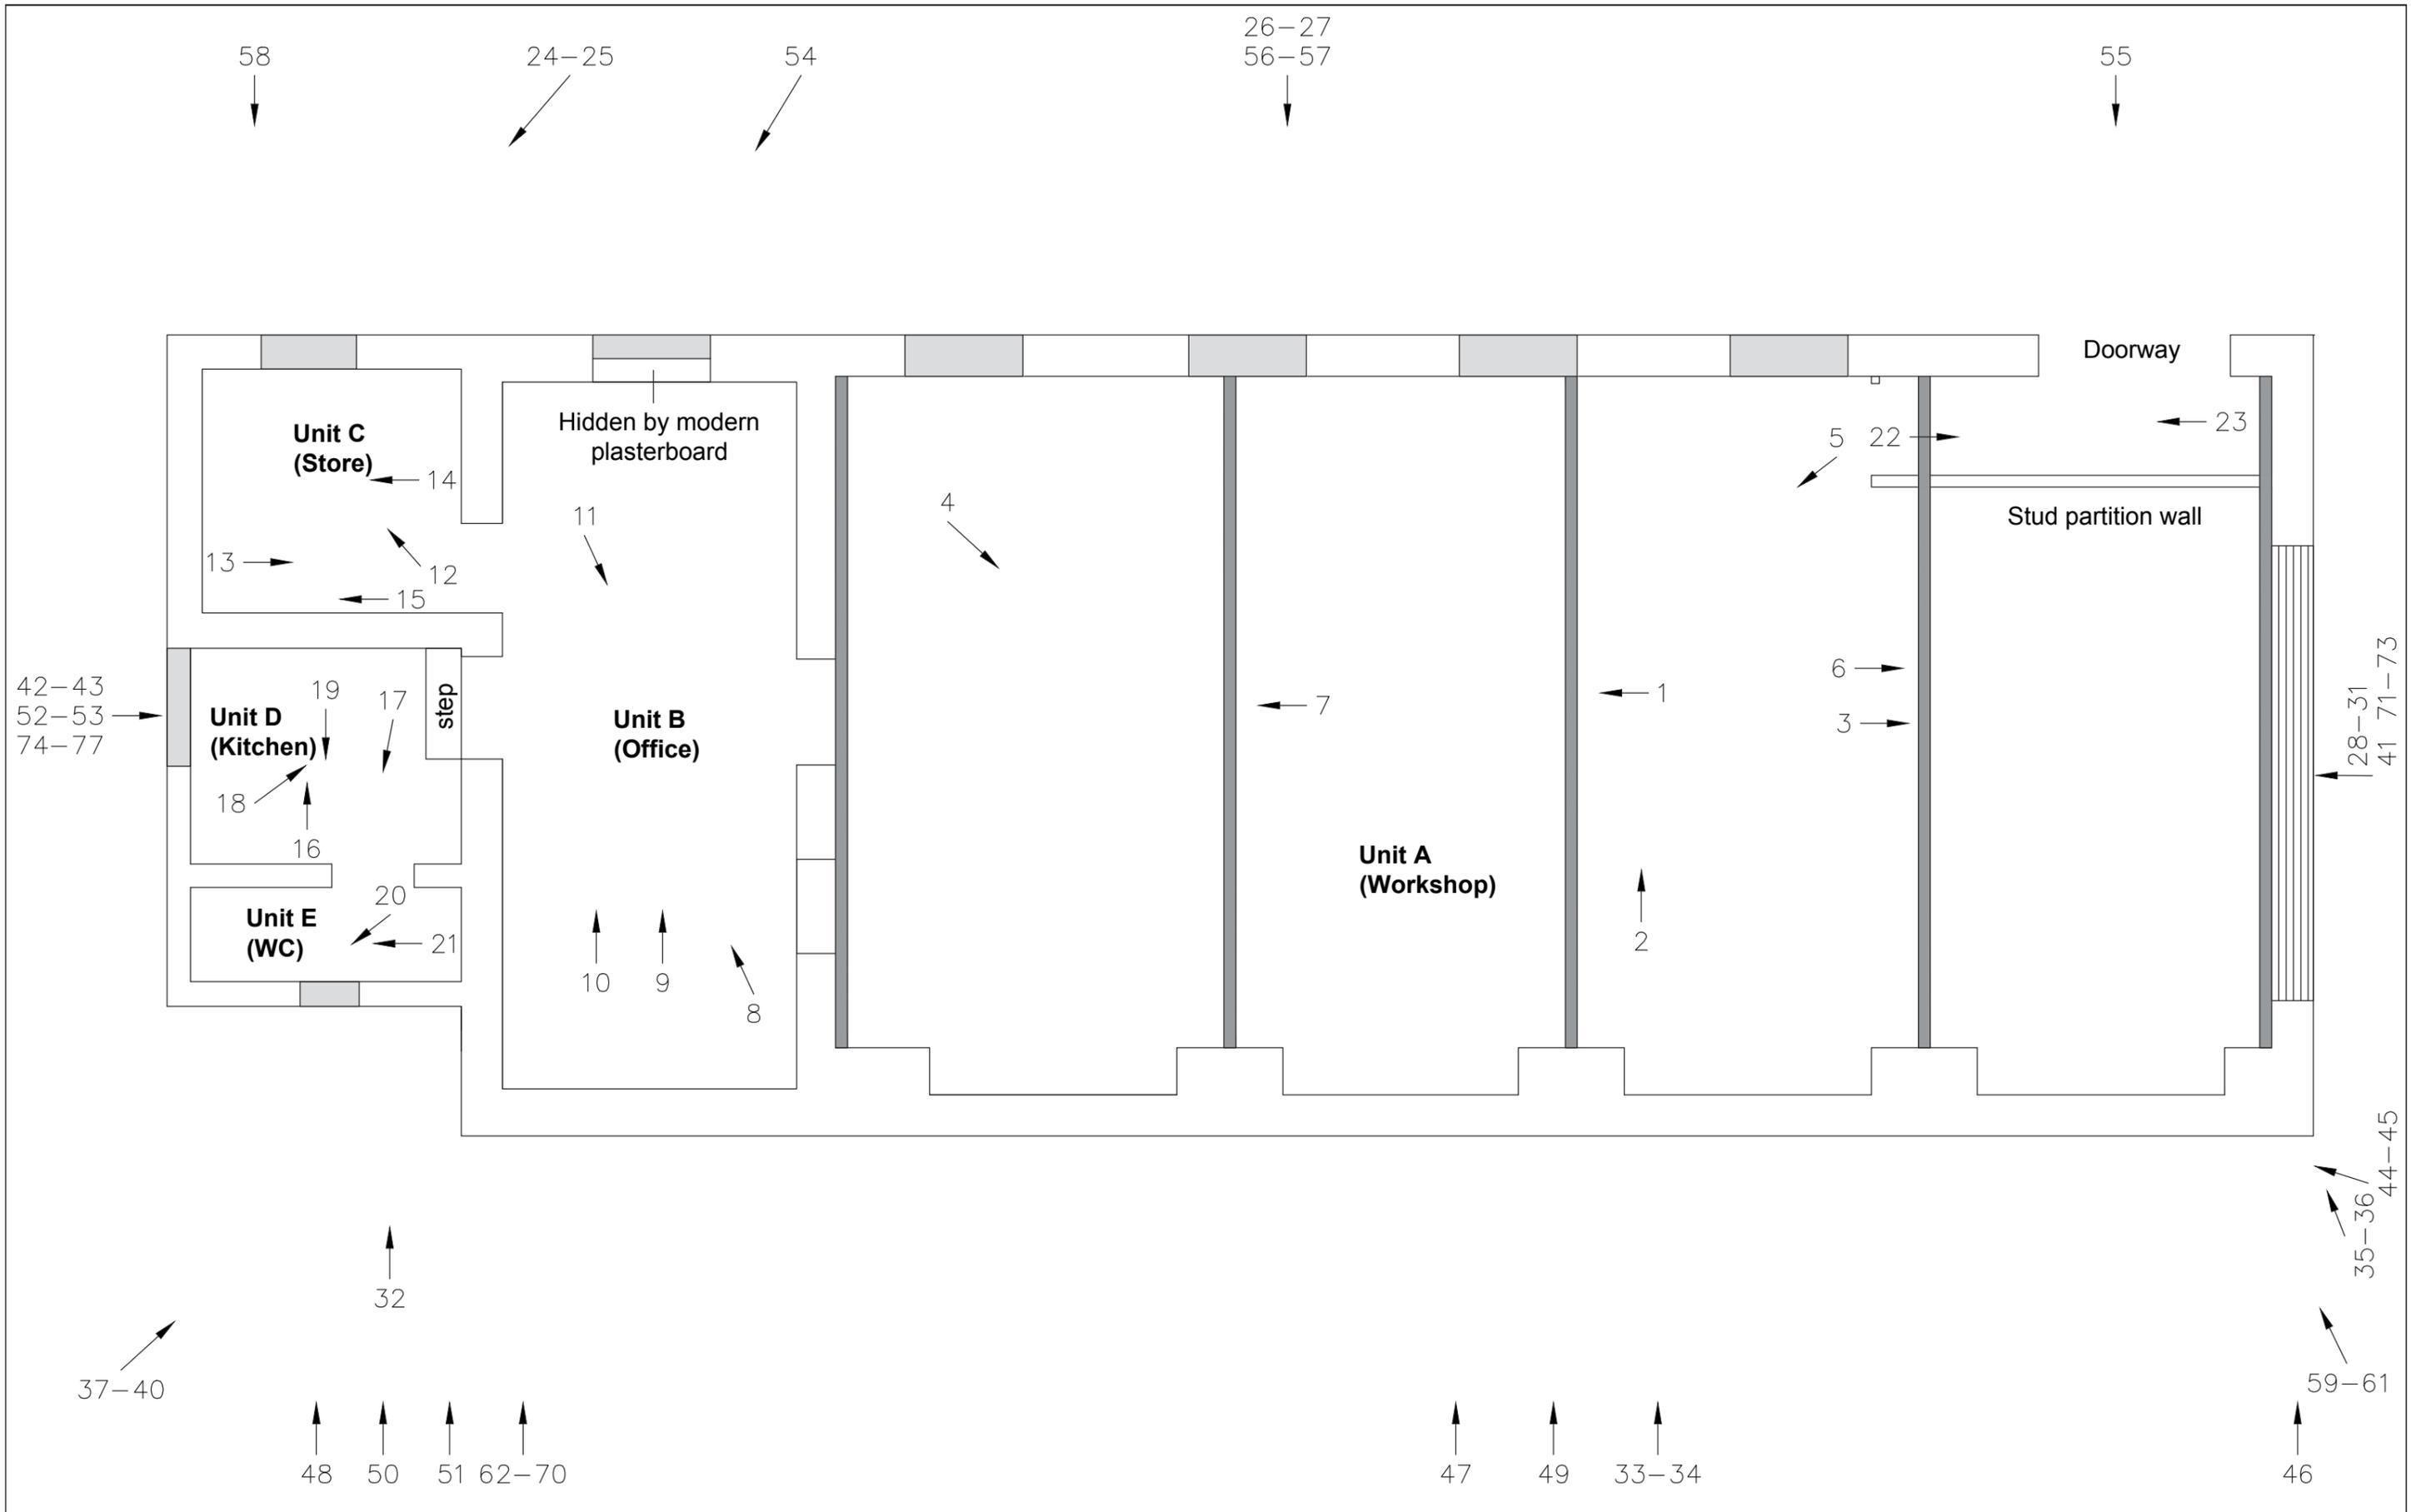
Fig. No: 4	Revision: A	Checked: KH	Report No: 2167 V1	Drawn by: SW	Scale at A3: 1:50
Title: Combined floor and photographic location plan		Project: 9 West Harbour Road, Granton, Edinburgh Historic Building Survey		Client: Cruden Homes Ltd

An internal floor plan was produced to show the positions of the doors, windows and roof trusses and other blocked openings according to CFA conventions. The floor plan is based on a measured plan using a Leica hand-held distometer and worked up to 1:50 scale.

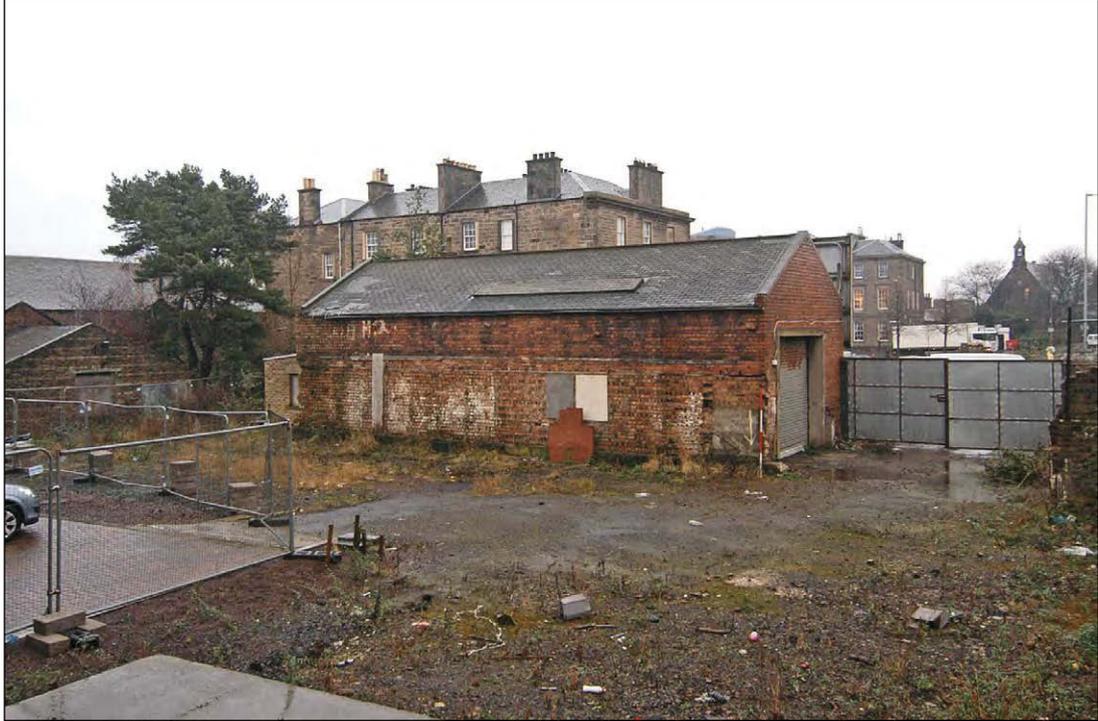
The survey was carried out on a single storey brick-built building with a pitched slate roof located in an area of vacant land (Plate 1). The building was accessed on its gable by a steel roller door. On the opposite gable a small brick-built lean-to had been added. On the west-facing elevation, the remains of a roof raggle was present and contrasting brickwork suggests that another later lean-to building was formerly attached to it. It was suggested by CECAS that the building may have been used by the Royal Navy Volunteer Reserves (RNVR) during the post WW2 period.

Plate 1 - General panoramic view of the building looking eastwards

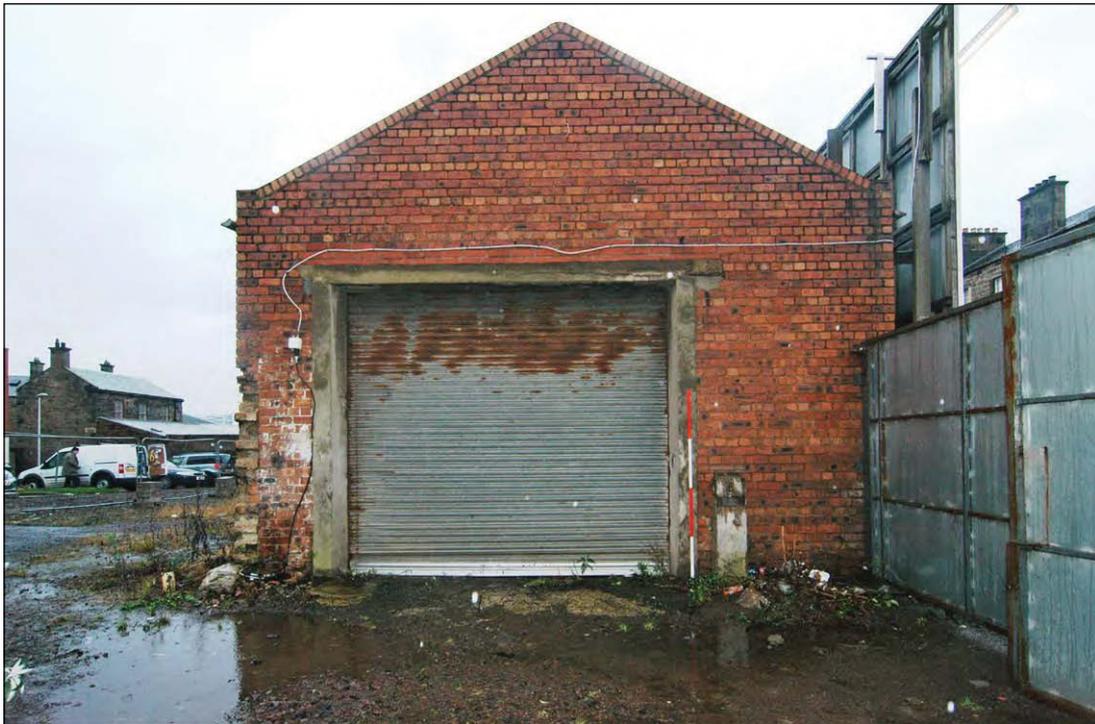
Plate 2 - South-facing gable with roller shutter door

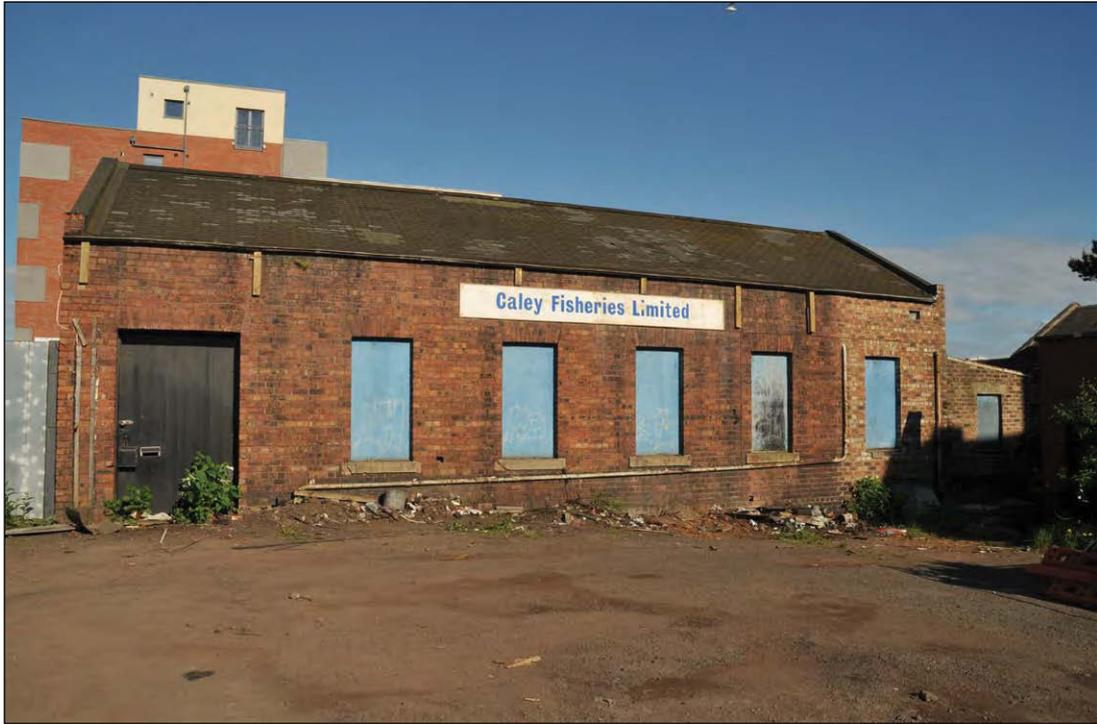
Plate 3 - East-facing elevation

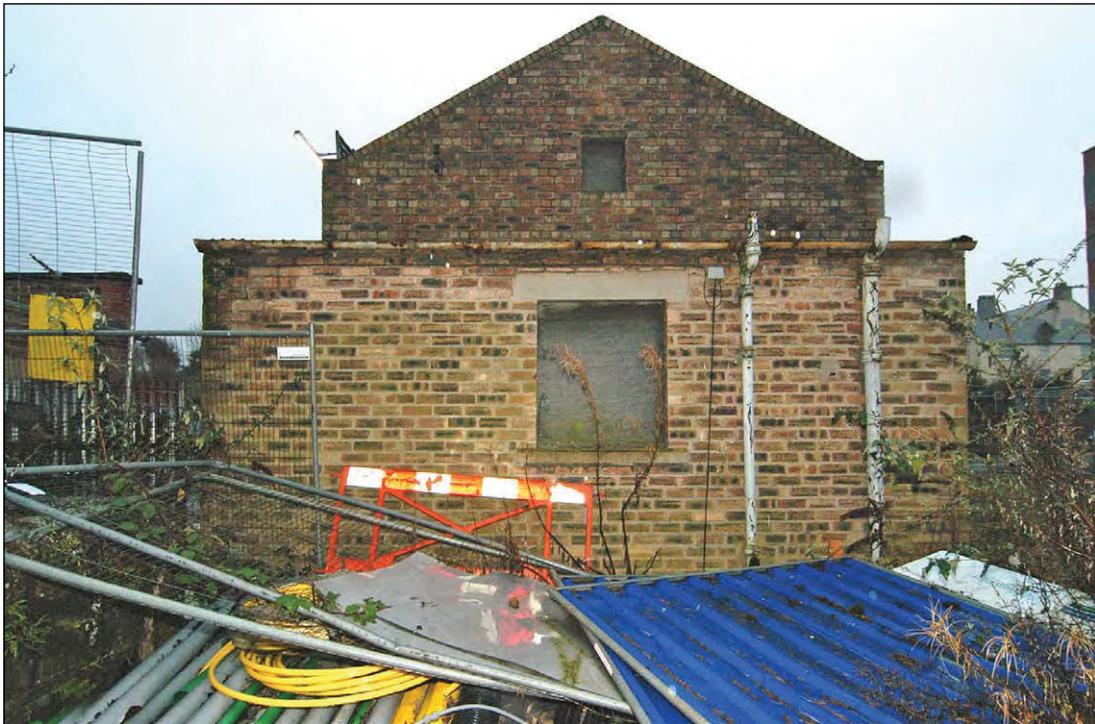
Plate 4 - North-facing gable showing an attached lean-to building

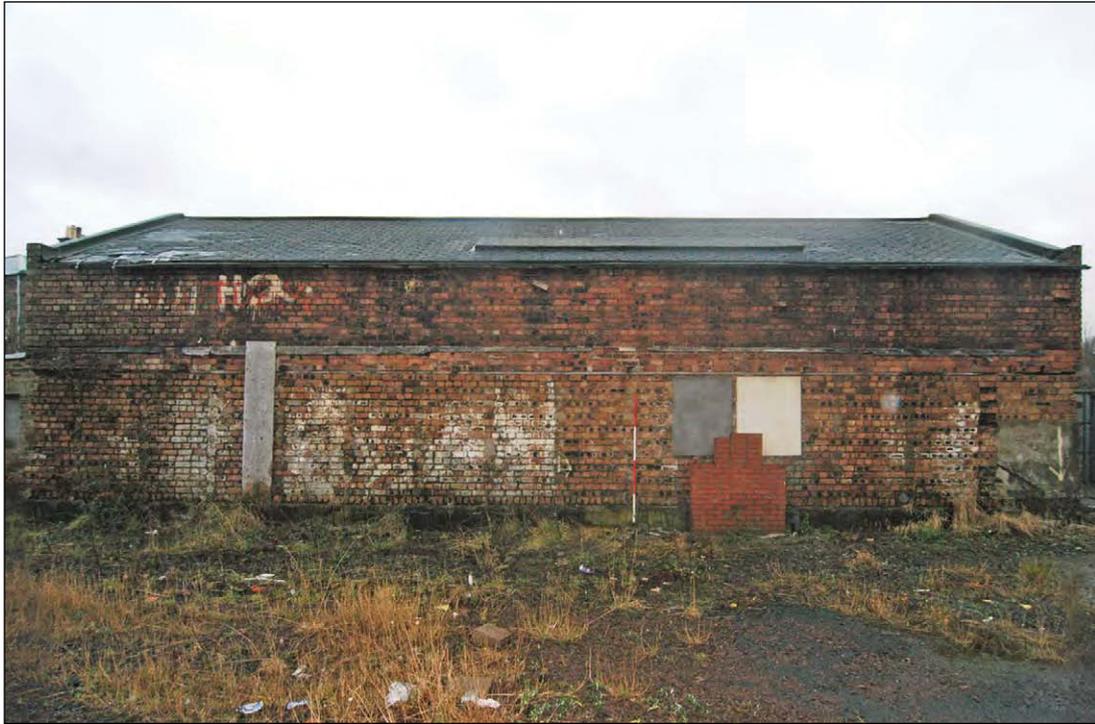
Plate 5 - West-facing elevation, fabric detail

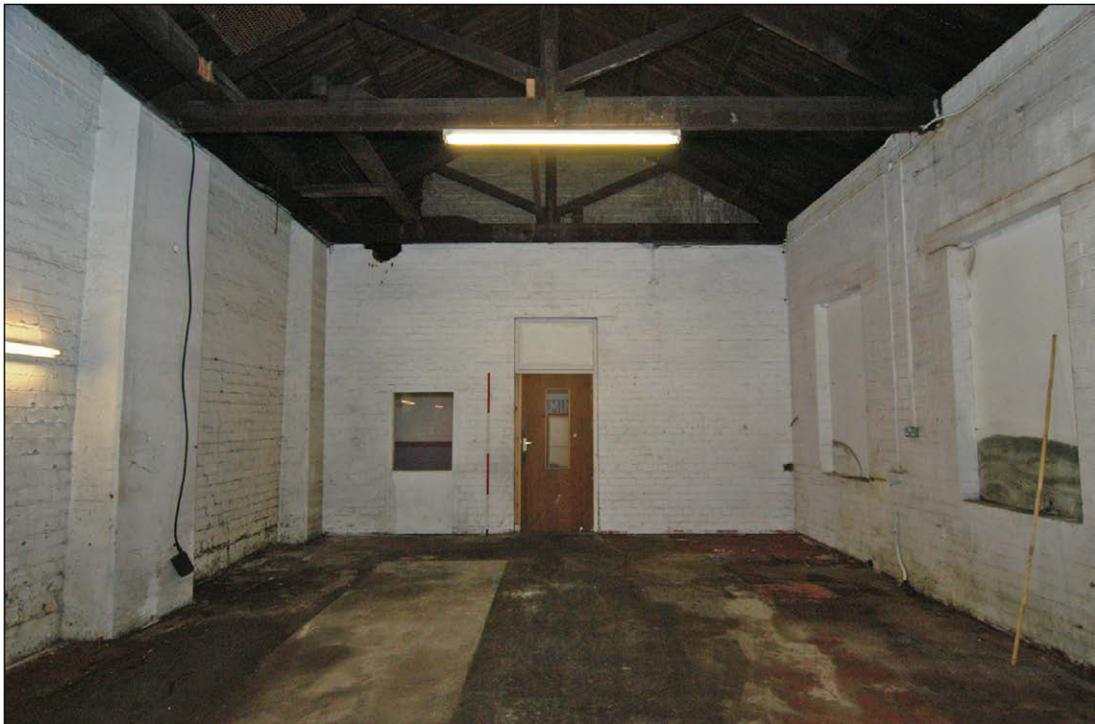
Unit 1 was a large open plan workshop with painted concrete floor. The west-facing elevation (east wall) was constructed of brick laid in English Garden bond (3:1). The elevation had four blocked windows each measuring 1.9m high and 1m wide. The lintels were timber. At the south end of the elevation there was a large plank-built sliding door. A small vestibule constructed of stud and plaster board had been built in front of the doorway. A doorway from the vestibule opened into the workshop. At the south end of the workshop a large steel roller shutter door was present. A roof truss was visible above the door (described below).

Plate 6 - Unit 1, workshop, north end showing flanking walls and a door to Unit 2

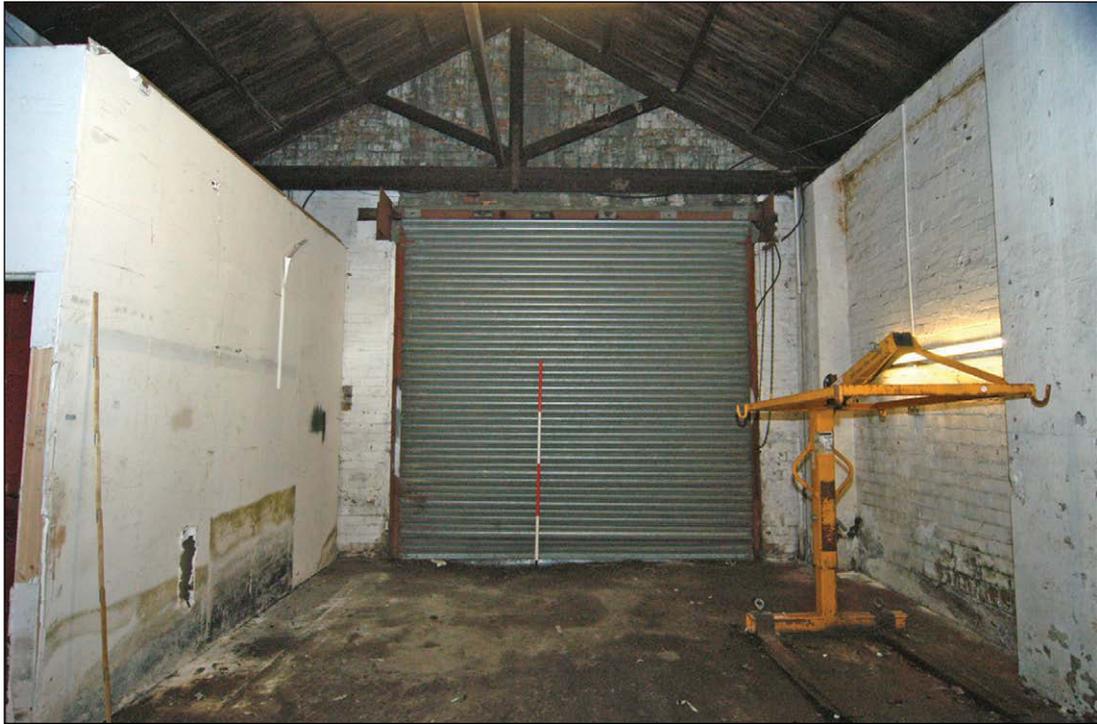
On the east-facing elevation (west wall) a series of five cast-concrete buttresses had been built against the plain brick wall. The buttresses each measured 0.9m by 0.4m and each supported a roof truss. At the north end of the workshop, a brick partition wall incorporated a near central doorway into Unit 2, the office. On the west side of the doorway, a small square window had been inserted into what was a door opening. The rest of the wall was featureless.

Plate 7 - Unit 1, workshop, south end, showing flanking walls and roller door

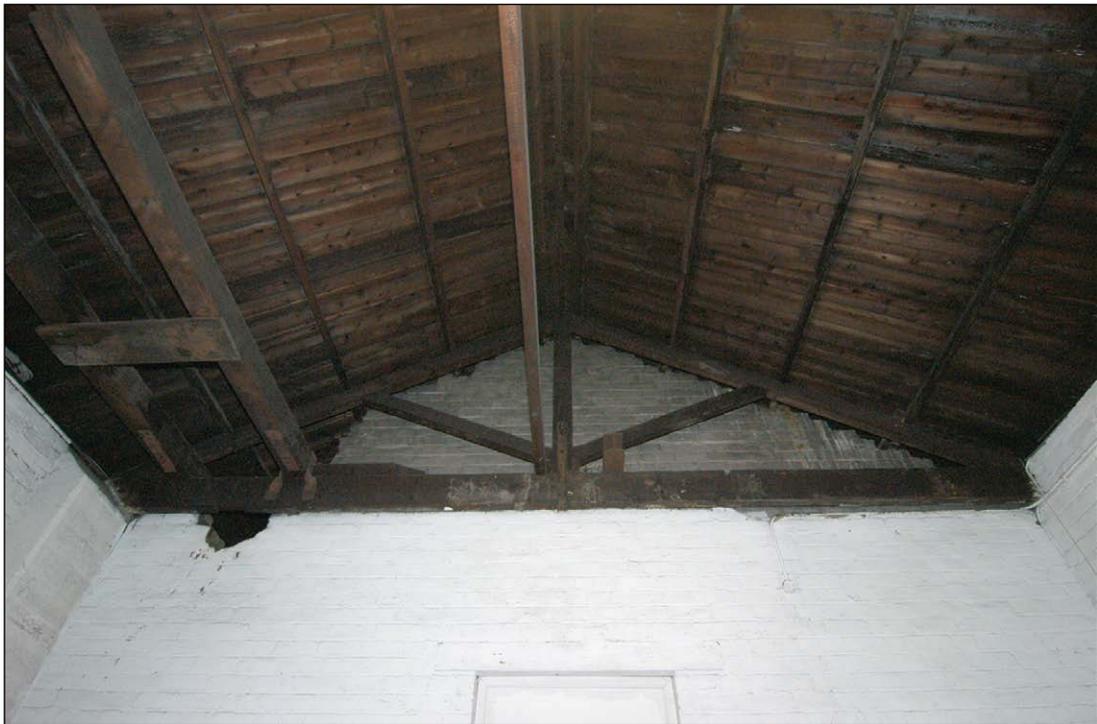
Five King-post trusses were exposed in Unit 1. Each truss rested on the wall head and was supported on the aforementioned concrete buttresses that had been built against the interior east-facing elevation. The principal rafters were approximately 0.3m thick and 0.10m wide and were probably pine. The king-post was held in place using an iron strap. The braces were held in mortise slots at the base of the king-post. The ridge plate sat in a slot cut into the top of the king-post which was flared. The purlins had been bolted onto the rafters. The sarking boards were tongue and grooved pine and ran parallel with the rafters.

Plate 8 - Unit 1, workshop, close up on the south gable king-post roof truss

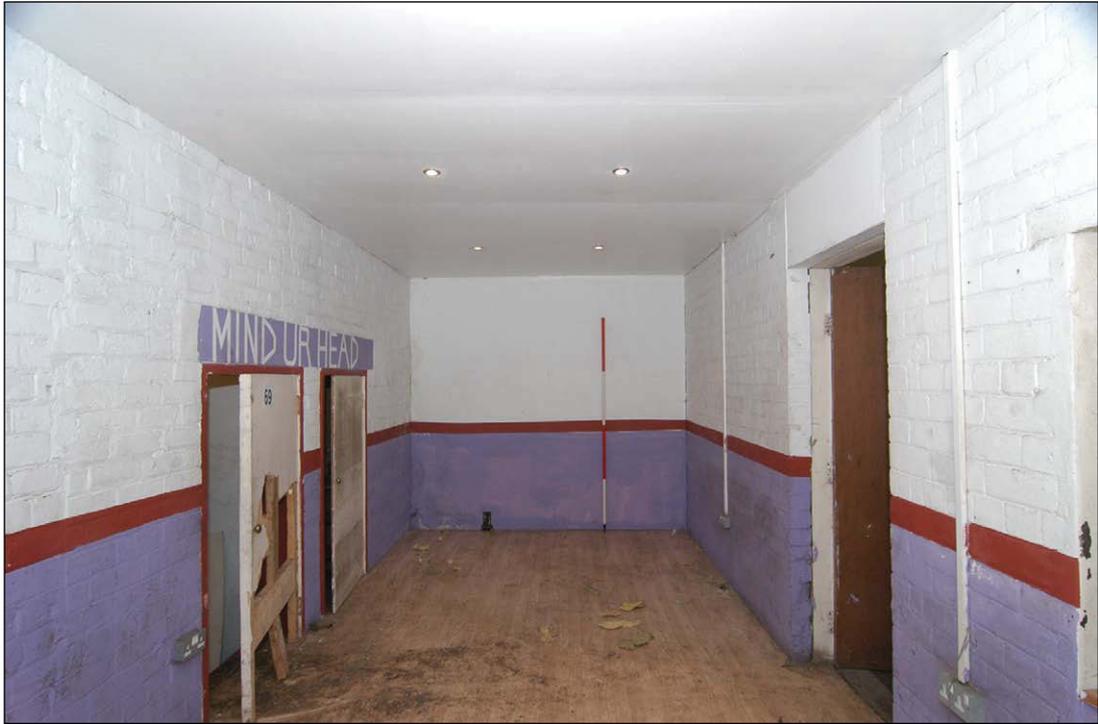
Unit 2 was a former office and had two doors on its north wall that led into a storeroom (Unit 3), the kitchen and toilet (Unit 4 and 5). The floor was covered with wood laminate. The walls at each end of this unit were stud-panelled and the ceiling was a relatively recent introduction that incorporated four halogen lights. The aforementioned square window looked out into the workshop.

Plate 9 - Unit 2, office, general interior view

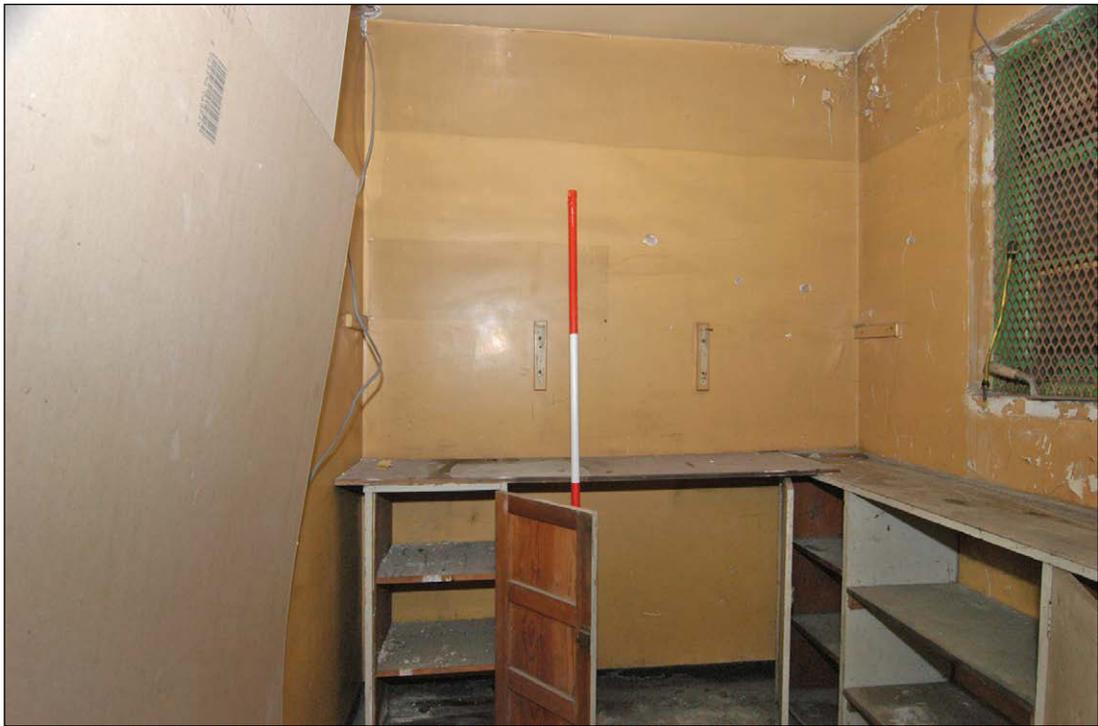
Unit 3 was a former storeroom with a blocked window on its west-facing elevation (east wall). The walls were brown-painted plaster and featureless. A set of pine cupboards had been built against the east and north wall.

Plate 10 - Unit 3, stores, general interior view

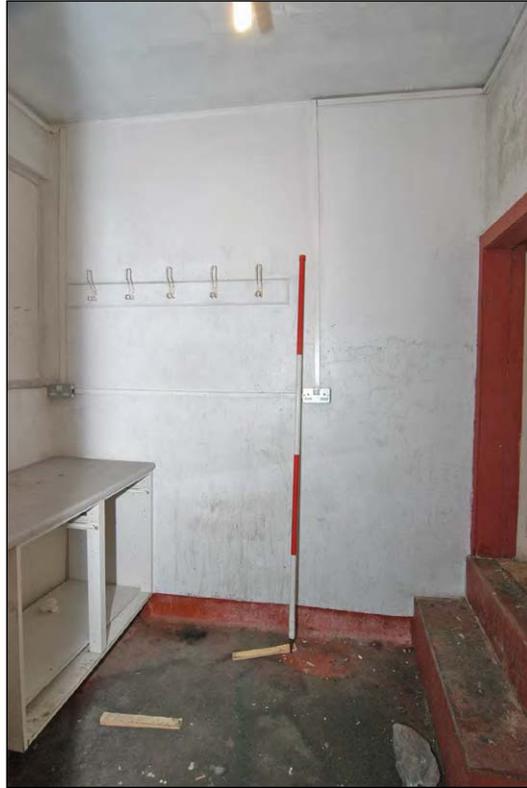
Unit 4 was a small kitchen with plain plaster walls and fitted with a modern kitchen unit on the south-facing elevation (north wall). A blocked window measuring 1m high by 1.1m wide was present on the same wall. On the east-facing elevation (west wall) a 1960s period four panelled door led into Unit 5.

Plate 11 - Unit 4, kitchen, general interior view

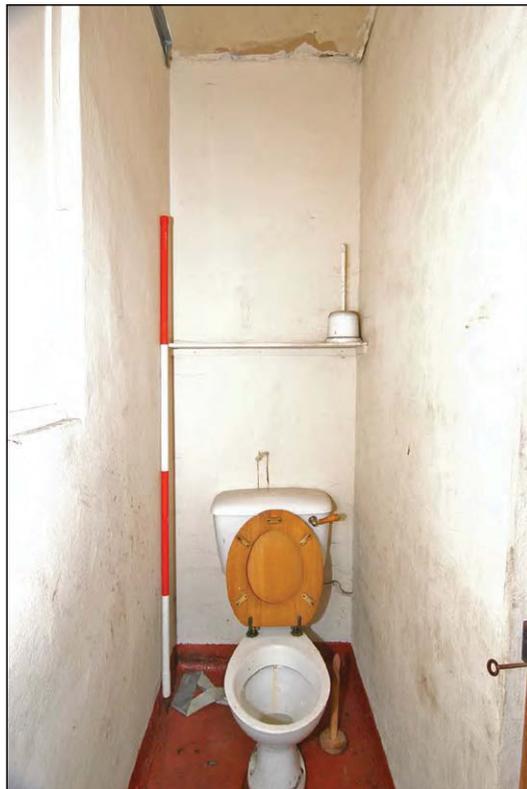
Unit 5 was a small toilet cubical with modern toilet bowl and cistern on the south facing elevation (north wall). A narrow blind window measuring 1.1m high and 0.5m wide was present on the east-facing elevation (west wall). The rest of the walls were featureless.

Plate 12 - Unit 5, toilet, general interior view
