New Road, Ballater Water Treatment Works, Bridge of Gairn, Aberdeenshire

Walkover Survey

**Data Structure Report
No. 3112**

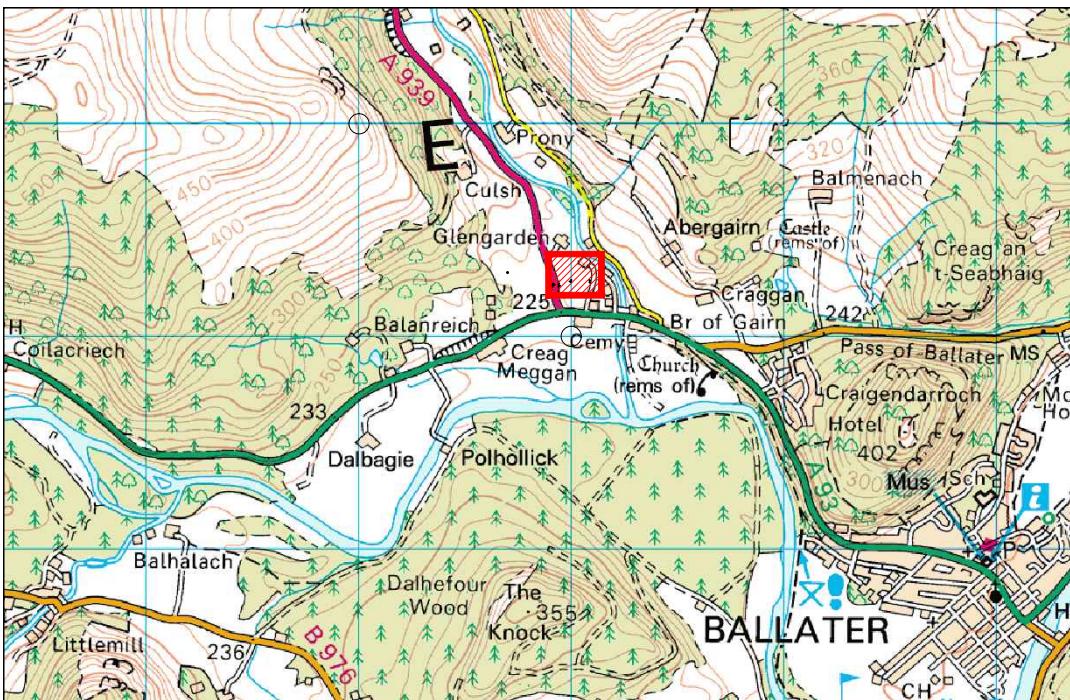
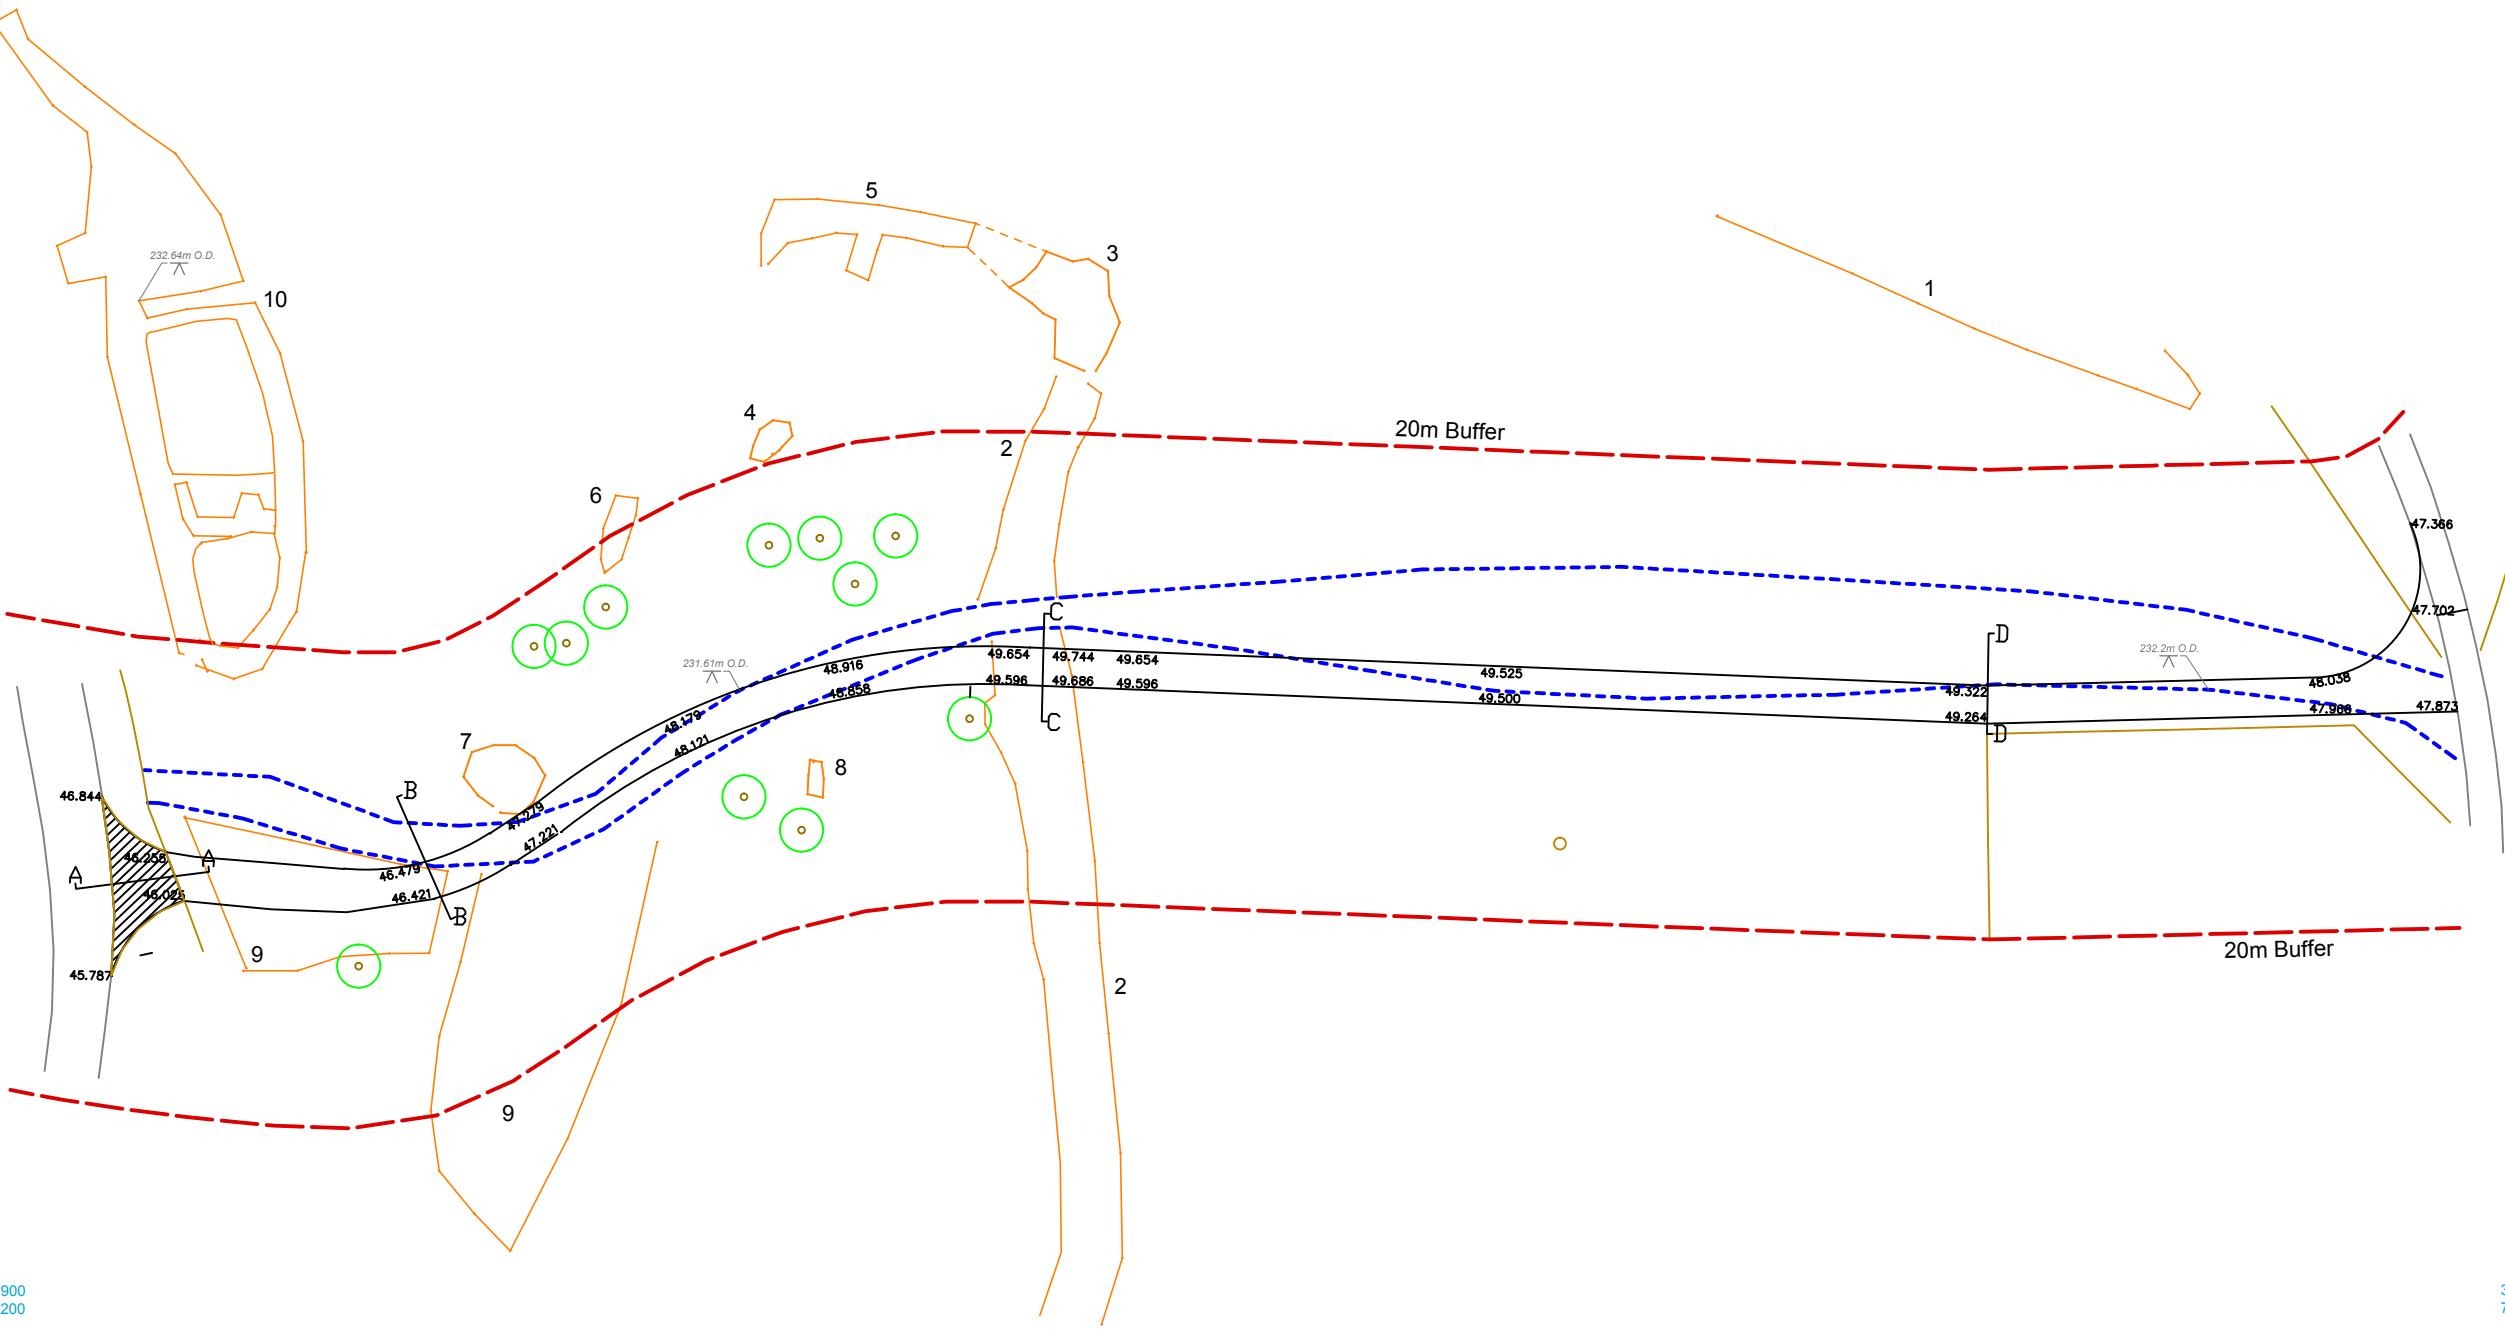
Fig. No: 1 Revision: A
Title: Archaeological sites identified by field survey

An informal track used by farm vehicles was present within the surveyed area, forming an area of disturbance, and this track is marked on Figure 1 (and the disturbance shown on Fig. 12).

Figure 1 depicts the cultural heritage sites identified during the survey of the proposed route of the new road. Illustrative images of the sites identified are presented in Figs. 2-11.

One feature, Site 2, will be crossed by the proposed new road, adjacent to an area where it has been disturbed by vehicle tracks. A further feature, Site 7, is located on the edge of the proposed new road. Site 8 lies within 10m of the edge of the proposed new road.

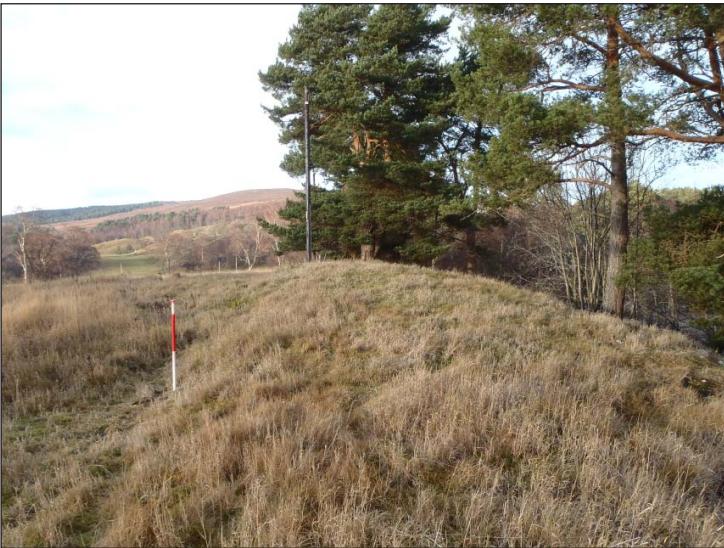
Fig. 2: Site 1 - Field bank

Site No.	Site Name Type	Description
1	Field bank	<p>Field survey identified a field bank at the edge of a field on the edge of an escarpment where the ground drops steeply to a burn below to the north. The bank is orientated east to west and corresponds with a field boundary located on the modern Ordnance Survey map. The bank may have been truncated at the eastern end by an access to a waterworks.</p> <p>The bank has a maximum width of 5m and is upstanding to a height of 0.8m .</p>
2	Field bank	<p>Field survey identified a field bank with a width of between 2-4m and a maximum height of 0.3m was visible as a low spread of stones following an irregular course. The bank has been cut by a farmers track. A section exposed through the bank shows it to be constructed of large stones up to 0.5m long. South of the track, the bank is approximately 7m long and 0.6m high forming a more regular alignment down to the edge of a modern field.</p>

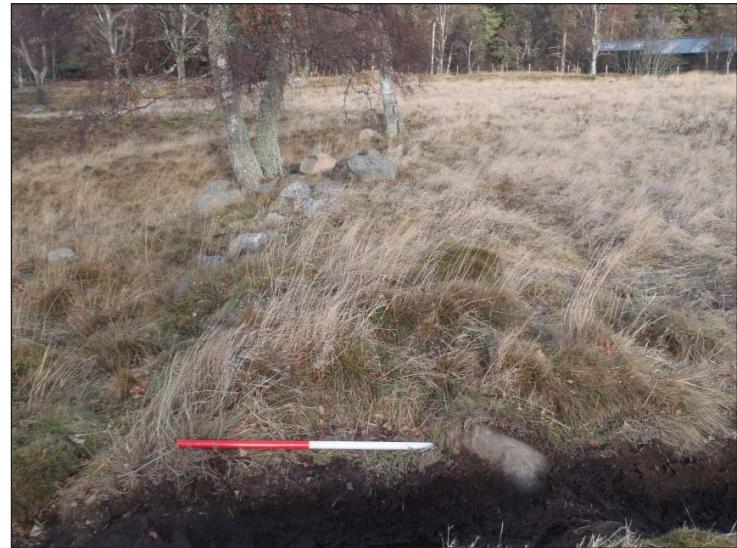
Fig. 3: Site 2 - Field bank

The field survey identified ten sites of potential archaeological importance, as described in Table 1 below. Further features were visible to the north (but outwith the survey area) including field banks and a large clearance cairn. Field bank (2) extends further to the south, beyond the surveyed buffer zone. No attempt was made to record those features which lie outwith the survey area.

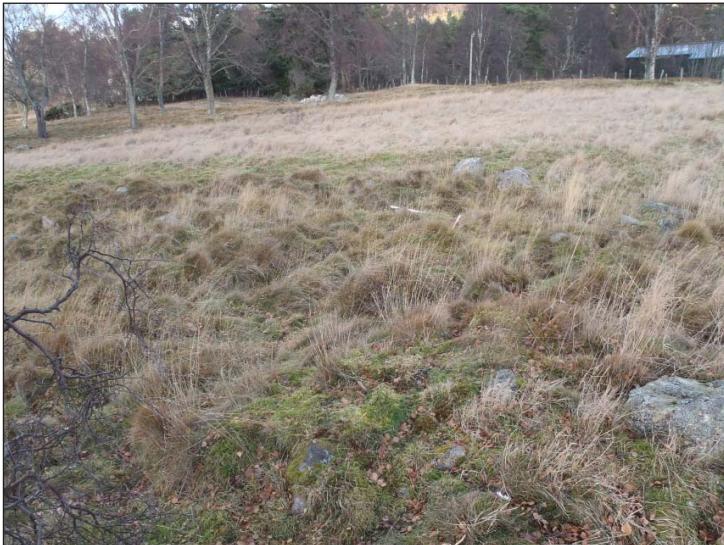
Fig. 4: Site 3 - Enclosure (remains of)

3	Enclosure (remains of)	<p>Field survey identified the remains of a wall 9m in length and aligned north-south and 6m in width aligned east-west. The wall was 1.5m thick and formed a rectangle and was attached to Field bank (2) at the southern end. More stones at the west end may either relate to another enclosure or may be tumble.</p>
4	Cairn (clearance?)	<p>Eight stones were visible on the ground surface forming a possible cairn feature aligned north-east to south-west. The feature measured c. 4m in length by 2m wide and 0.8m high and was situated on the side of an elevated area of ground on top of which were a number of banks</p>
5	Field bank	<p>Field survey identified field t-shaped bank measuring 3.5m wide and up to 0.7m high. At the eastern end of the feature there is the possible remains of a structure but owing to the very overgrown nature of the terrain it is difficult to be certain.</p>

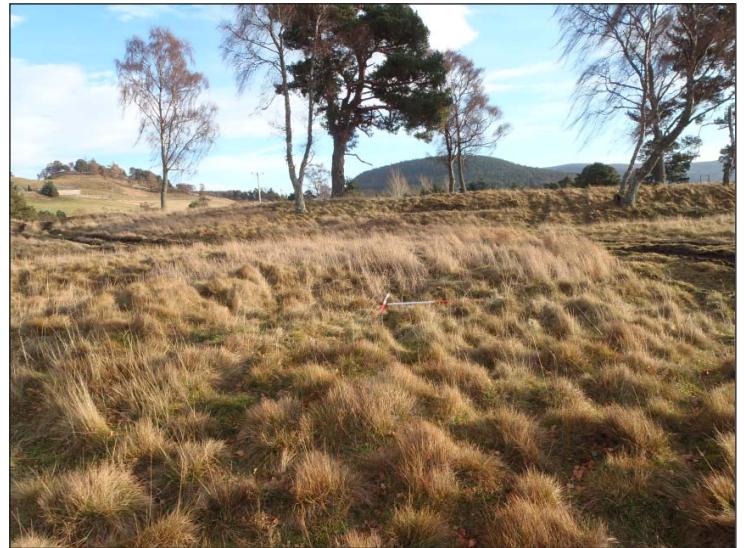
Fig. 7: Site 7 - Structure / Hut Circle (possible)

Site No.	Site Name Type	Description
7	Structure (possible)	Feature 7 may be the remains of a possible hut circle sub-circular in shape with an entrance on its south side. Its banks ate 1m wide and 0.3m high with an internal diameter of approximately 5m. The site is overgrown.
8	Clearance Cairn? (remains of)	Field survey identified the possible remains of a clearance cairn. Six stones were visible on the ground surface. The feature is roughly rectangular measuring 3m north-south and 1.5m east-west. The feature appears to be no more than a single course measuring 0.3m in height.
9	Artificially Flattened area	Field survey identified an area of ground that appeared to have been intentionally flattened below another area of lower ground of a former valley. The flat area drops of to between 1-4m at the south end. At the east end the ground rises to about 1m. No features were present on top of the higher 'platform' area.

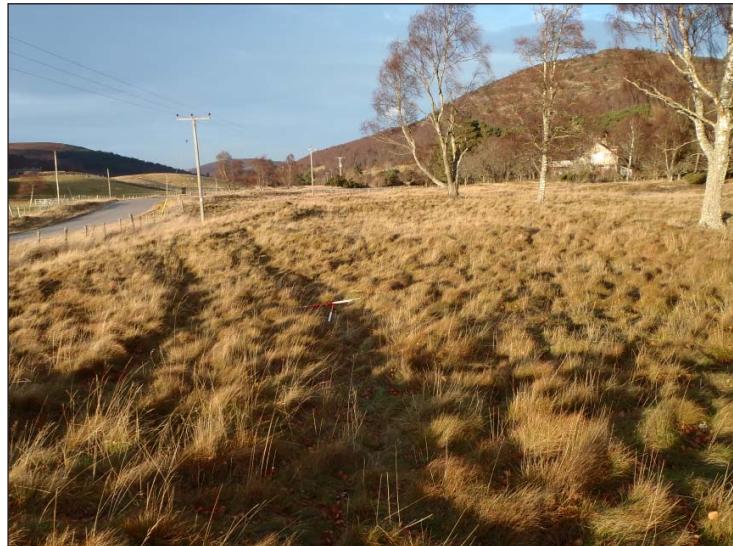
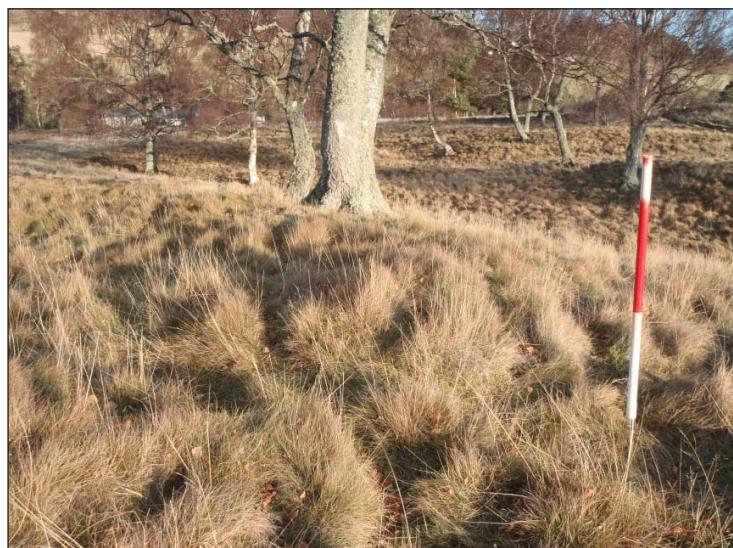
Fig. 10: Site 10 - Enclosure features

10	Field banks (remains of)	Field survey identified a series of low banks measuring 2m wide and 0.4m high enclosing three roughly square features, the most northerly of which was difficult to trace owing to vehicular disturbance. The banks are stone-built and covered with turf. The site occupies a higher area of ground overlooking a possible burn channel situated to the east.
