CFA ARCHAEOLOGY LTD

August 2008

Commissioned by Community Windpower

Aikengall Community Windfarm
Archaeological Watching Brief and Evaluation
Report No. 1521

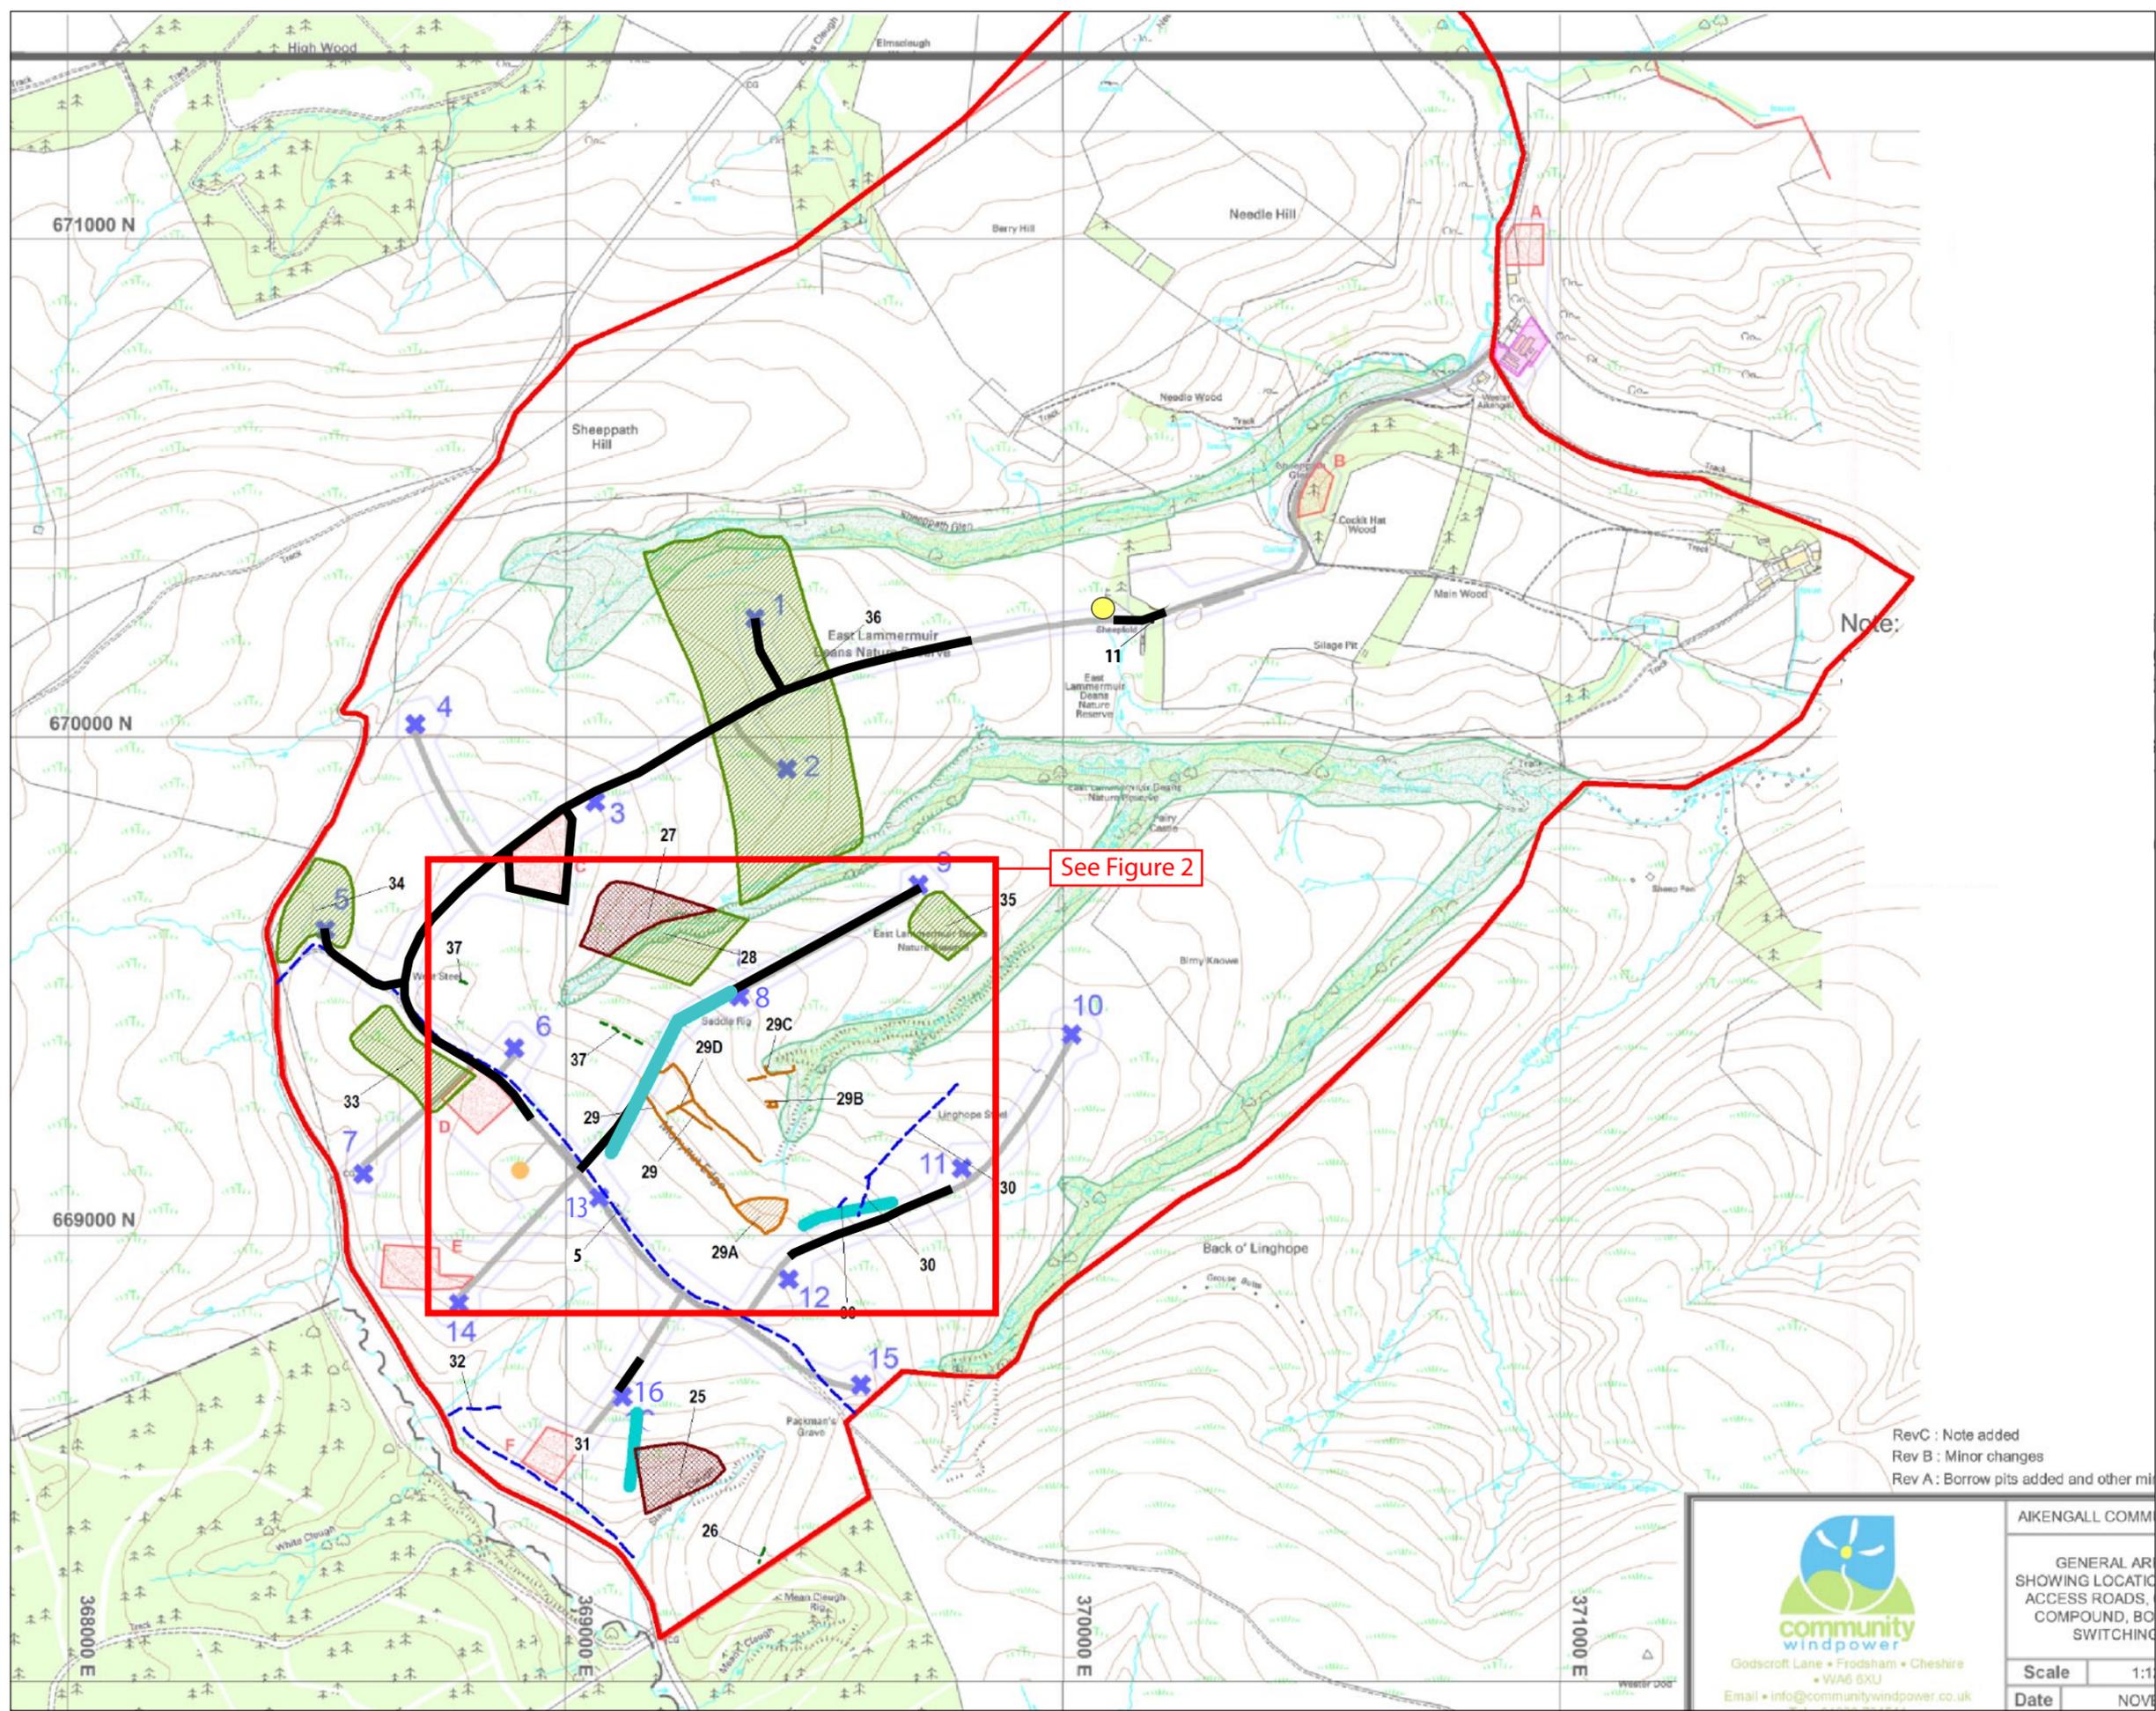
Fig. No: **1** Revision: **B**

Title:
 Map of windfarm showing relevant cultural heritage sites, and areas monitored during watching brief

2.4.3 A permanent presence watching brief was maintained in the vicinity of Sites 11, 25, 29 and 30, as shown in Figure 1.

3.4.1 No sub-surface finds, features or deposits of archaeological significance were encountered during the course of the general watching brief (Fig. 11, 12, 13). Figure 1 shows the areas that were monitored by CFA.

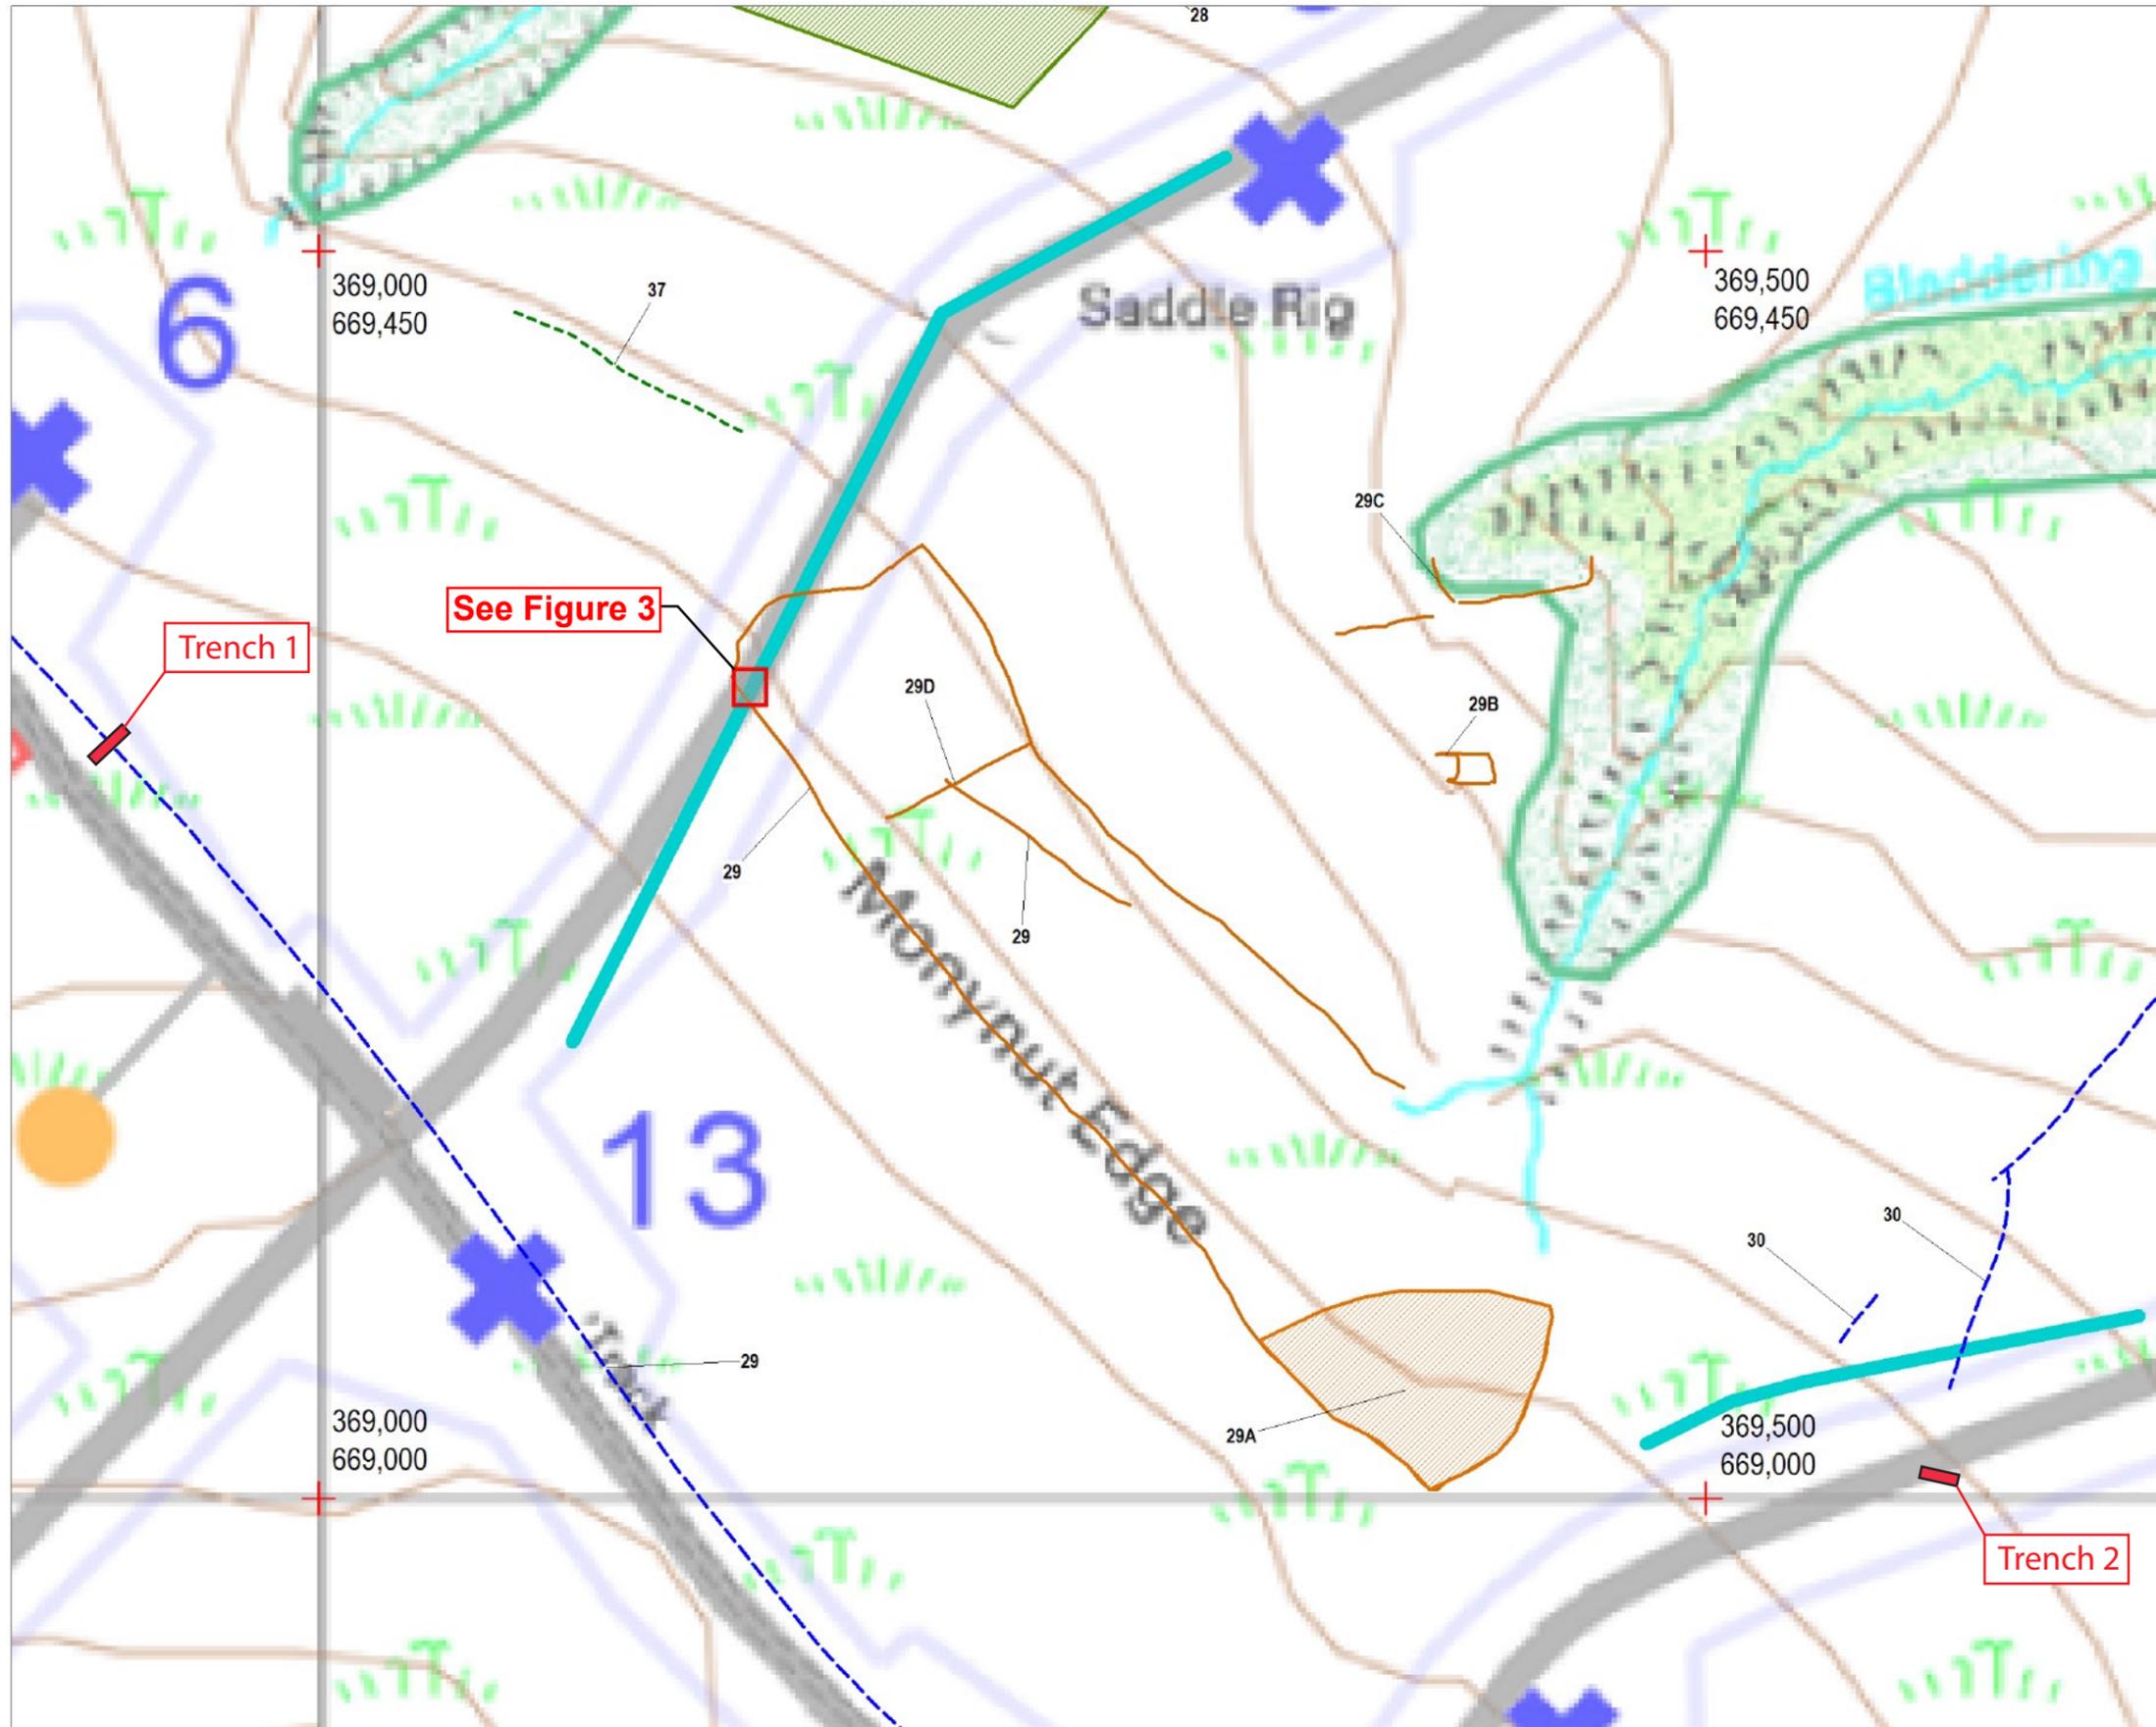
Fig. No: 2 Revision: A

Title:
 Map of windfarm showing relevant cultural heritage sites and trench locations

2.2.1 Two tracks (Sites 5 and 30) were to be crossed by wind farm access roads. Sections were excavated across each of the two tracks and their construction recorded (Fig. 2).

3.1.2 Trench 1 was excavated perpendicularly across track Site 5, measuring 18.7m by 1.9m and aligned SW to NE (Fig. 2, 4, 8). The track appeared as a sunken linear feature running NW to SE. The track was most visible in the SE of the development area, where it was c.0.6m deep. The base of the track measured approximately 1.6m wide. Topsoil (**100**) was removed and measured 0.48m deep. This overlay the natural subsoil (**101**). In the centre of the track was a thin (0.08m deep) layer of mid to light brown loamy sand with approximately 50% inclusions of small pebbles (**102**). This deposit was fairly loosely compacted, but would have been enough to form a rudimentary surface for walking over. The pebbles did not appear to have been deliberately or carefully placed, rather they were probably exposed by repeated usage of the track and erosion.

3.1.3 Trench 2 was excavated perpendicularly across the projected line of track Site 30 where the new access road would cut it (Fig. 2, 5). This trench measured 6m by 1.8m and was aligned east to west. The track was not discernible here as the obvious remains lay further to the north; the new position of the access road avoided the known remains, so the line had to be projected. The remains that were to be affected appeared on the surface as a linear cut with steeply sloping sides which was approximately 0.4m wide by 0.4m deep. No identifiable remains were encountered within the excavation trench that could be associated with the feature being a track, such as a metallised surface. The linear cut identified on the surface was probably a drainage feature. No datable artefacts were recovered from the excavation of the feature.

3.3.2 A watching brief was undertaken on the access road between Turbines 8 and 13 as it crossed the NW corner of Site 29, a field system (Fig. 2). A ditch (200) was identified aligned NW to SE, cutting the natural subsoil (101). It was 1.1m wide, 0.28m deep with steeply sloping sides and an irregular base (Fig. 3, 6). It was filled with damp peat (201), similar to the topsoil material in this area. This ditch corresponds with the ditched enclosure remains identified from aerial photographs and walkover survey. A second ditch, (202), lay 3m to the NE of the first ditch. It was aligned N to S and measured 1.08m wide and 0.19m deep with shallow sloping sides and a curved base (Fig. 7). It was filled with a moderately compacted grey clay (203) with more than 50% inclusions of small angular pebbles. The function of this ditch was not ascertained, but it probably represents the remains of a feature associated with the rest of enclosure Site 29. No datable artefacts were recovered from either of the ditches.

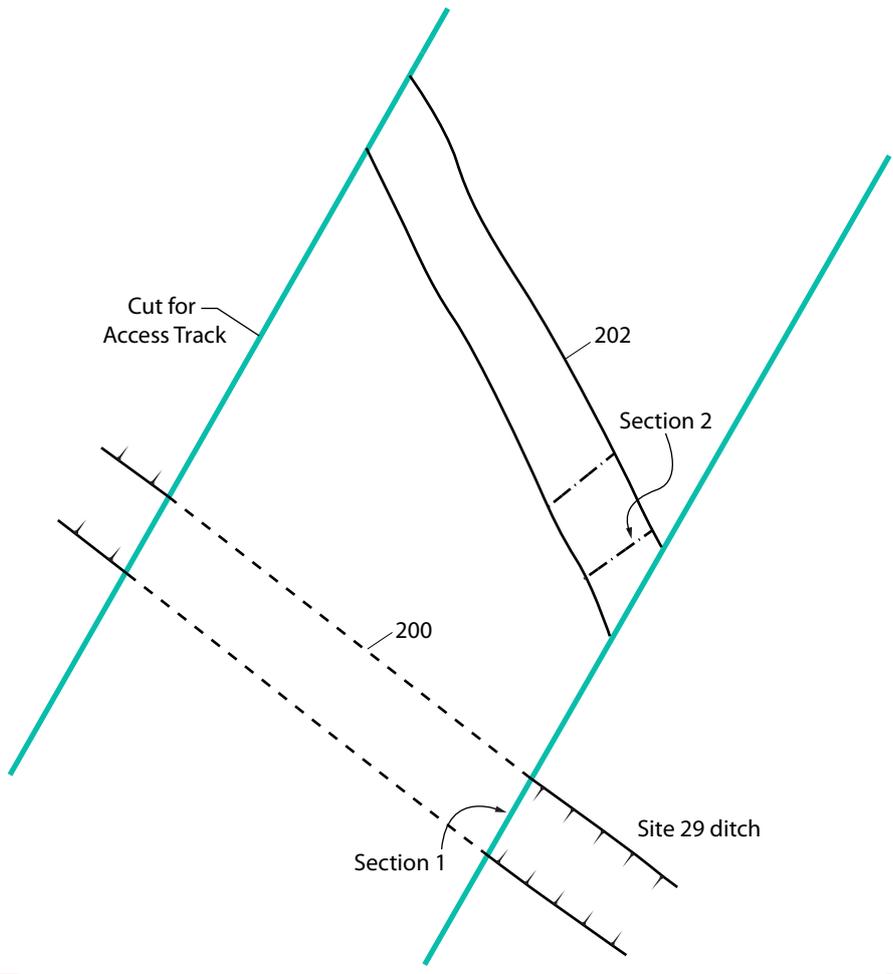
Fig. No: **3** Revision: **A** Client: **Community Windpower**

Title:
Plan of features at Site 29

- 4.5 At Site 29 there was assumed to be two sides of a ditched enclosure within the new access track corridor, forming the northern end of a field system identified from aerial photographs and walkover survey. The discovery of two small ditches at Site 29, one of which corresponded to one of the alignments recorded during the desk-based work, confirmed the presence of the feature, but did not aid in its functional interpretation or provide any dating material. The return arm of the feature was not identified.

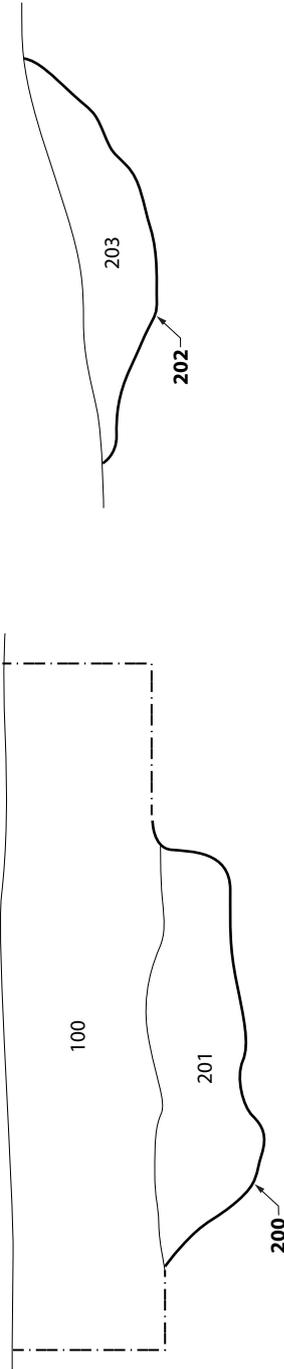
Fig. No:	4-7	Revision:	A	Client:	Community Windpower
Title:	Sections				
Project:	Aikengall Community Windfarm, near Innerwick, East Lothian

Fig 3 - North-east facing section of Trench 1

Fig 4 - North facing section of Trench 2

Fig 5 - North-west facing section of feature 200

Fig 6 - North facing section of feature 202

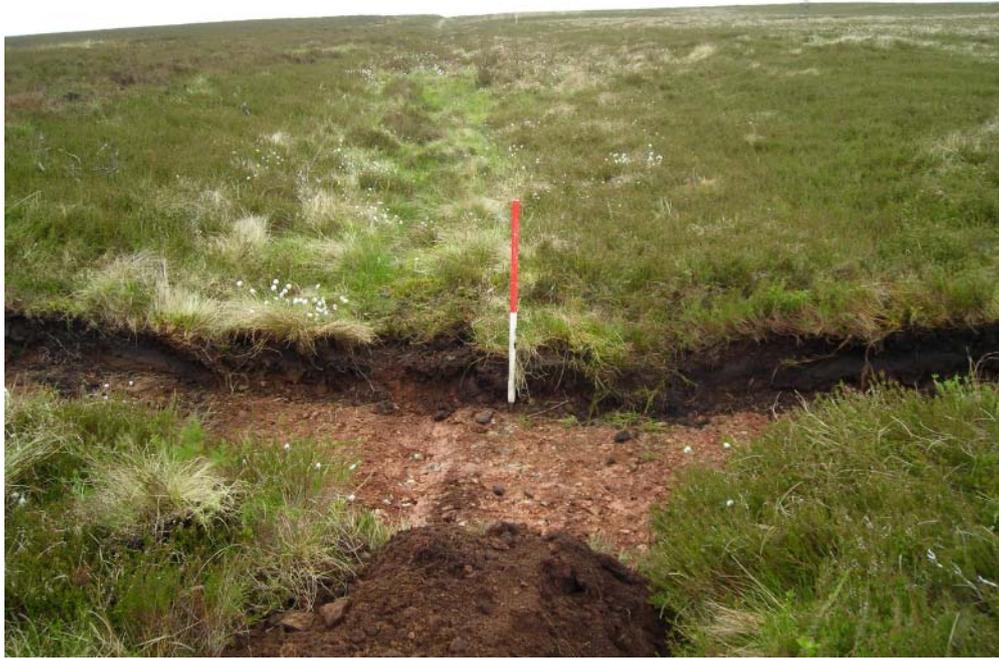
Fig 8 - General shot of Trench 1, NW facing section

- 4.4 The informal nature of track Site 5 is typical of what is found of many such upland trackways upon excavation; i.e. that there is no formal construction and the opportunity for dating such features is limited. Such trackways appear to develop through repeated use of the same route over time rather than as a planned and constructed roadway.

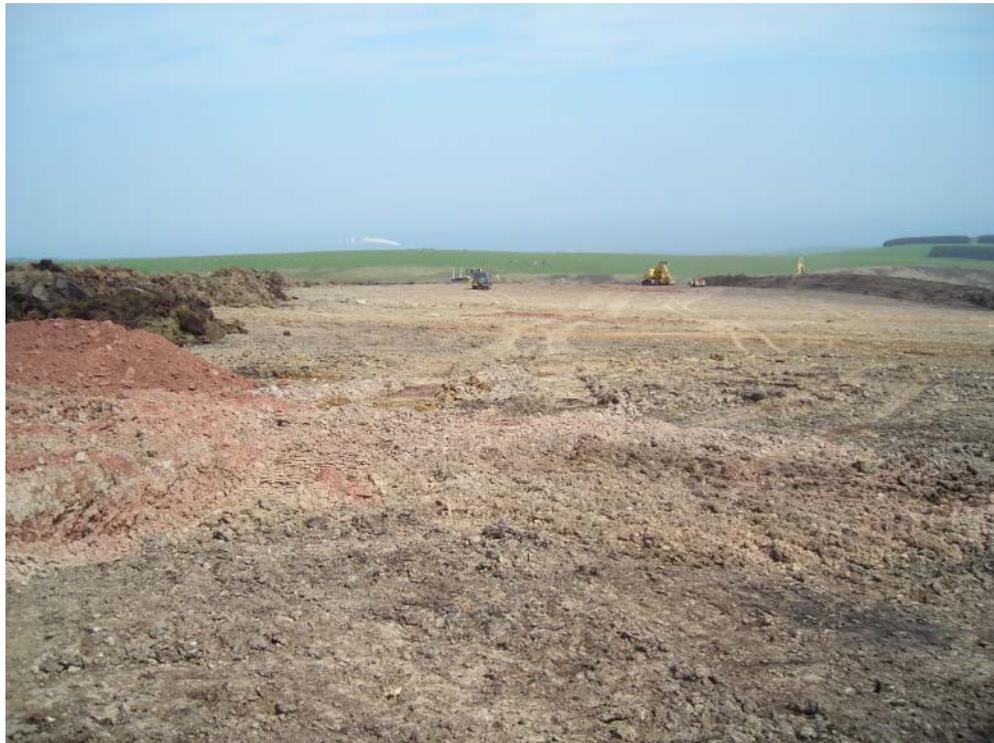
Fig 9 - Topsoil stripping at Borrow Pit C

2.4.2 A total of approximately 7670m of linear access road was constructed. CFA were required, as part of the agreed WSI, to monitor 20% of this, approximately 1 day in every 5 during ground breaking works. In the end, CFA monitored c.3530m of linear excavation – 45% of the total length (Fig. 1). The turbine bases were also monitored. CFA also monitored the stripping of one of the four borrow pits (Borrow Pit C; Fig. 9).

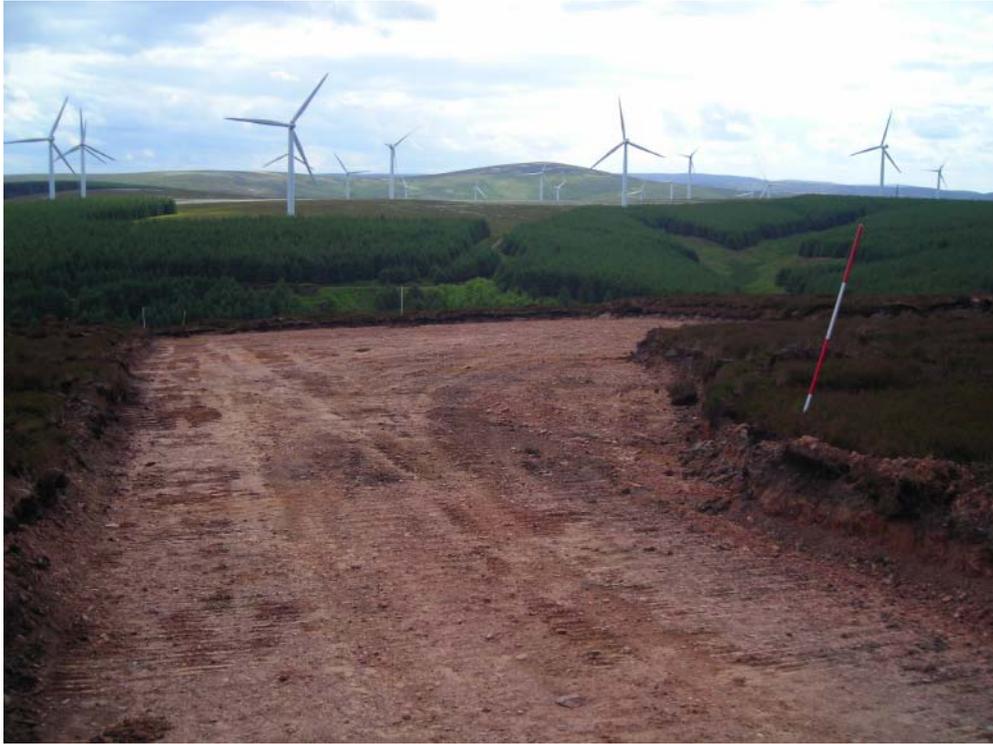
Fig 10 - Stripped area at Turbine 16

3.3.4 The watching brief that was to be conducted to the SW of Turbine 16 did not take place as changes to the construction plans meant that the access road was halted at Turbine 16, and no roads approached Site 25. Monitoring of the topsoil stripping around the base of Turbine 16 revealed no traces of archaeological remains (Fig. 10).

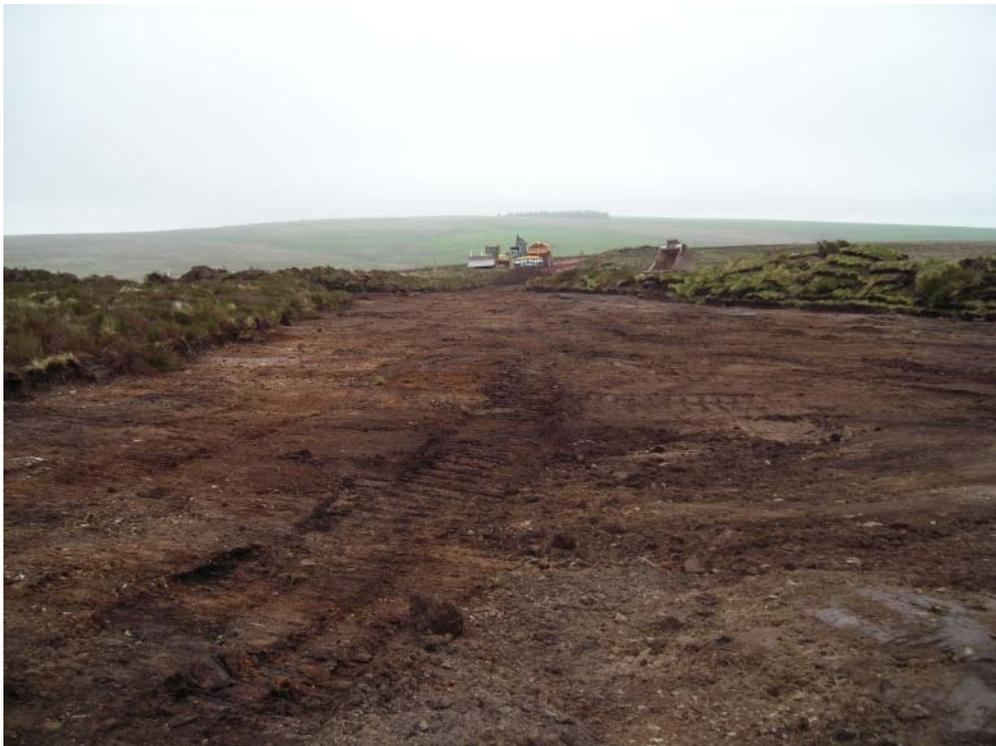
Fig 11 - General shot of work in progress, looking towards the access road from the junction at Turbines 6 & 7

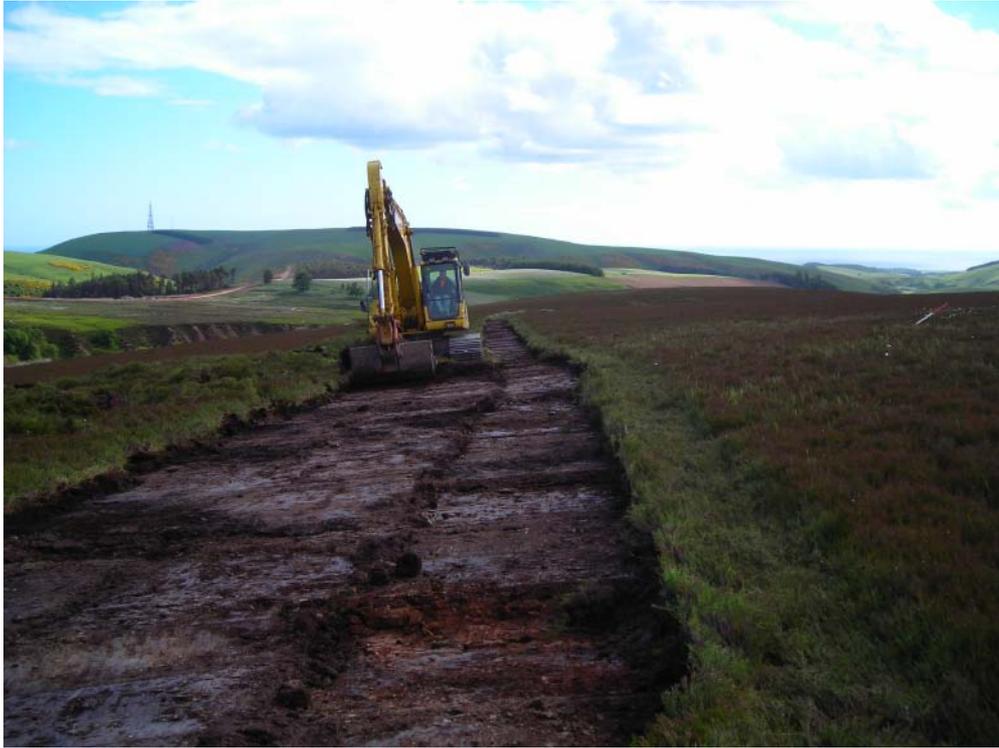
Fig 12 - General shot of work progressing towards Turbine 9

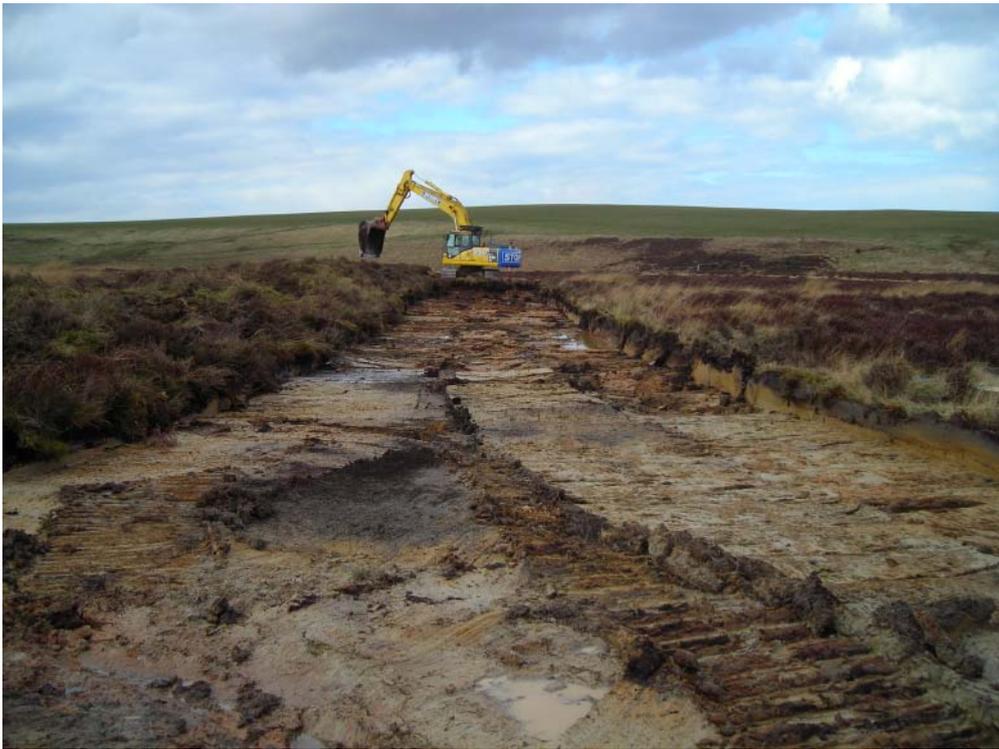
Fig 13 - General shot of access track towards Turbine 1

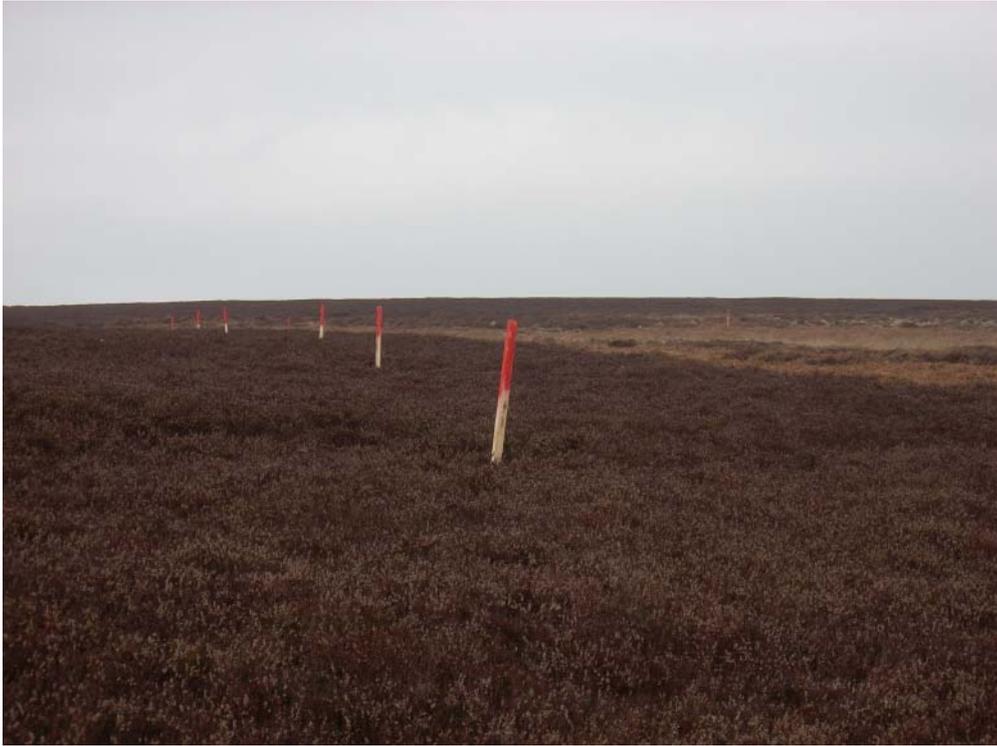
Fig 14 - General shot of marking off at site 25

3.2.1 Site 11 had already been fenced off by the landowner using a wire and post fence. Sites 25 and 29 were demarcated using wooden posts placed at 20m intervals and painted red (Fig. 14, 15). A buffer zone of 10m was given around the extent of the cultural heritage sites.

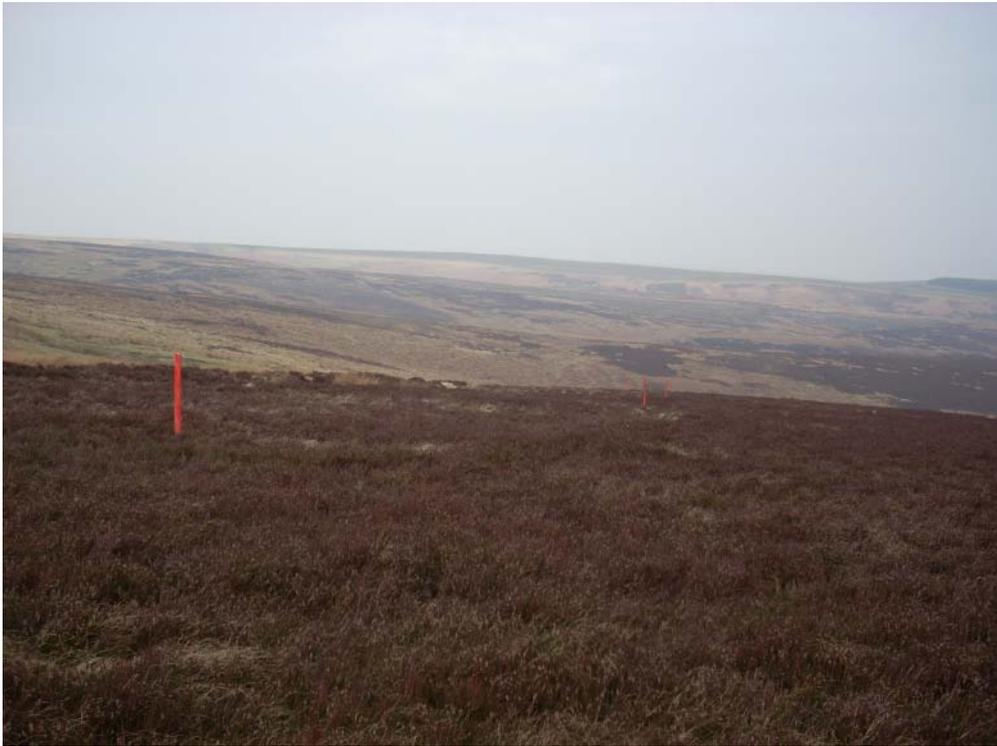
Fig 15 - General shot of marking off at south-eastern end of site 29
