Commissioned by Historic Scotland on behalf of Transport Scotland

**Standing Building Survey:
A96 Fochabers - Mosstodloch Bypass**

Report No. 1566

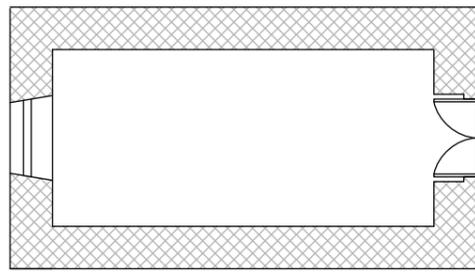
Fig 2 - Ground Plan of Tank Shed (Unit A)

3.2 The Tank Shed (Unit A) (Fig. 2)

3.2.1 The tank shed is situated approximately 12m south of the existing fence line to the south of the A96, and approximately 6m to the south of the disused railway line. The railway line and surrounding area are now heavily overgrown with trees and shrubbery. The structure was rectangular in shape and orientated north-west to south-east. It was 3.7m by 6.6m and 3.5m high, and had a sloping roof (Fig. 5).

- 3.2.7 The northern elevation of the tank shed was lower than the southern elevation allowing for a sloping, corrugated iron roof that was supported by five wooden truss beams. The wooden truss beams were supported by dressed sandstone blocks.

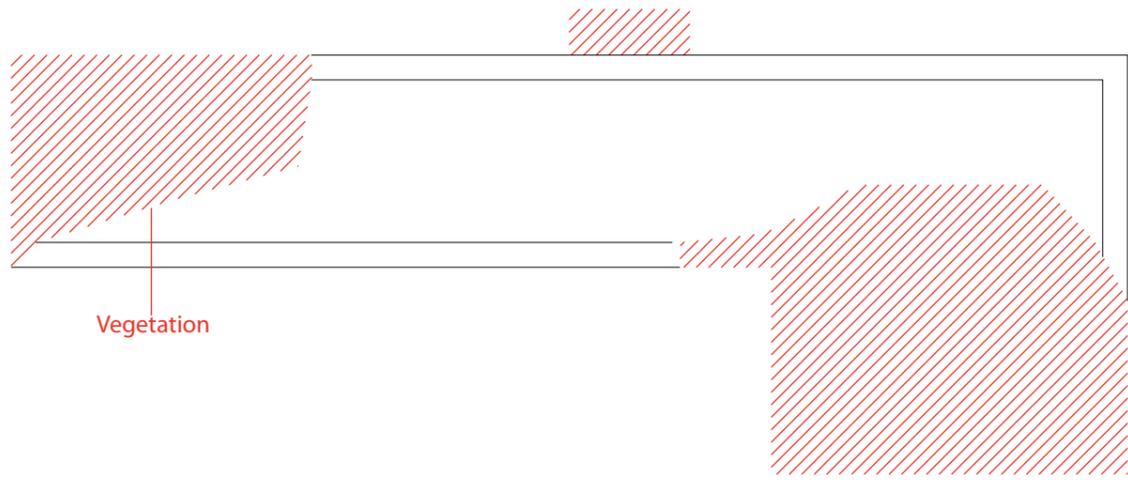
Fig 3 - Ground Plan of Engine Shed (Unit B)

3.3 The Engine Shed (Unit B) (Fig. 3)

- 3.3.1 The visible remains of what may be the engine shed lie approximately 13m to the south of the existing fence line to the south of the A96. The remains of the structure were heavily overgrown with trees and shrubbery allowing limited access and visibility of the structure. The general size and shape of the structure recorded here matches that of the engine shed shown on the Ordnance Survey maps but the remains are so poorly preserved and so heavily obscured by vegetation that it proved impossible to clarify any architectural details. In places, particularly on the south and south-east, the route of the wall footing is conjectural based upon the portions that are visible.

- 3.3.4 The concrete footings that remain were possibly once the base for a wooden superstructure that no longer remains.

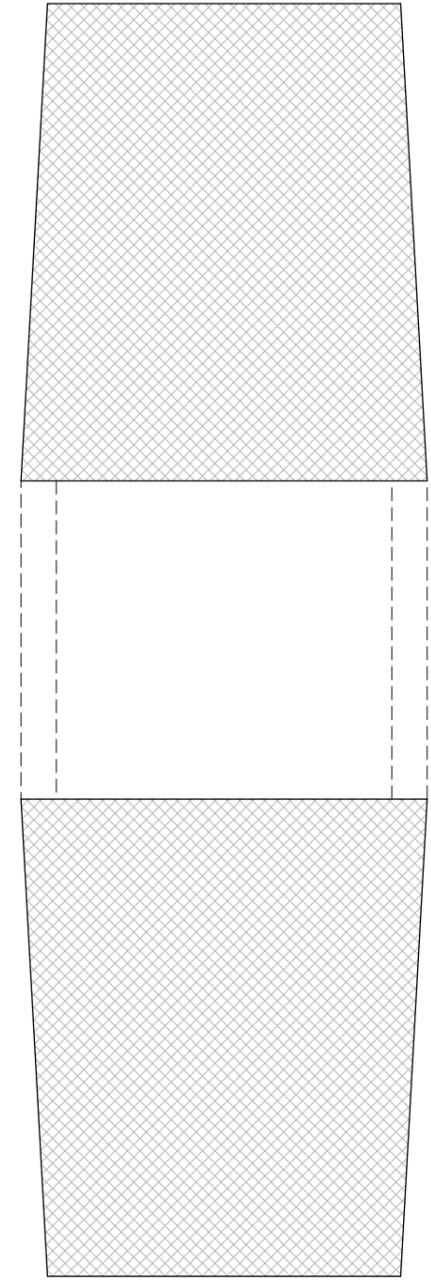
Fig 4 - Ground Plan of Footbridge (Unit C)

3.4 The Footbridge (Unit C) (Fig. 4)

- 3.4.2 The northern and southern abutments of the bridge are 5m to 5.75m wide and 6.75m in length and were set into the built embankments on either side of the disused railway (Fig. 14). The bridge was 5.75m wide at the base and 4.7m wide at the top. The bridge ran for a length of 18m with the arch being 4.5m wide.

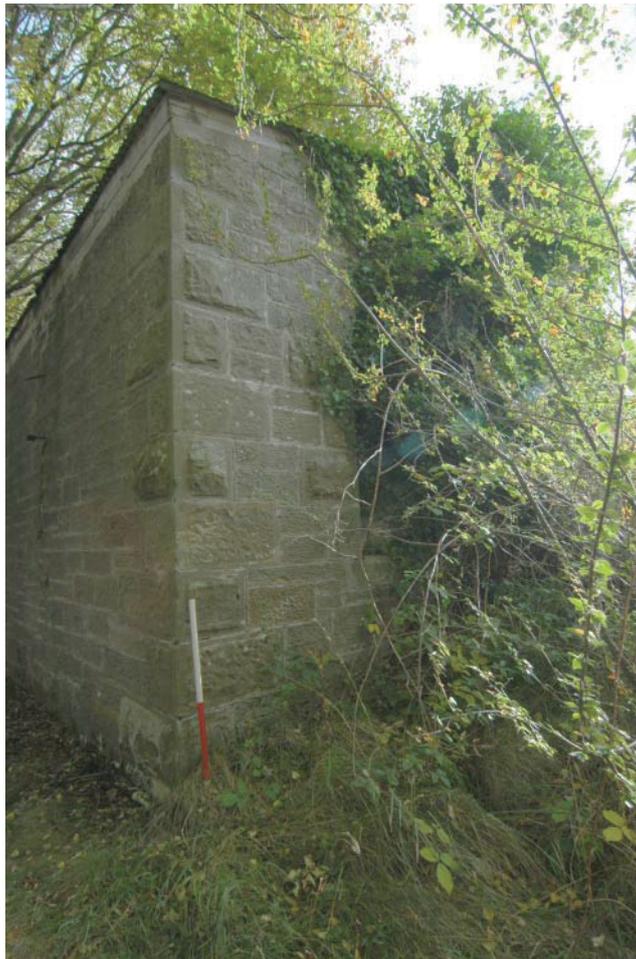
Fig 6 -Unit A Exterior, north-west facing elevation

3.2.4 The exterior north-west-facing elevation of the tank shed comprised large dressed sandstone blocks with bevelled relief, dressed quoins (Fig. 6). The wall was two courses and 0.6m thick and 3.7m wide. An arched window was located at the centre of the wall and was 1.1m wide on the exterior and 1.2m wide on the interior. The window was 2m in height. The original window appears to have been wooden framed but is now blocked up by 0.7m of breeze blocks from the base of the window. The elevation was heavily covered by vegetation (see Fig. 6).

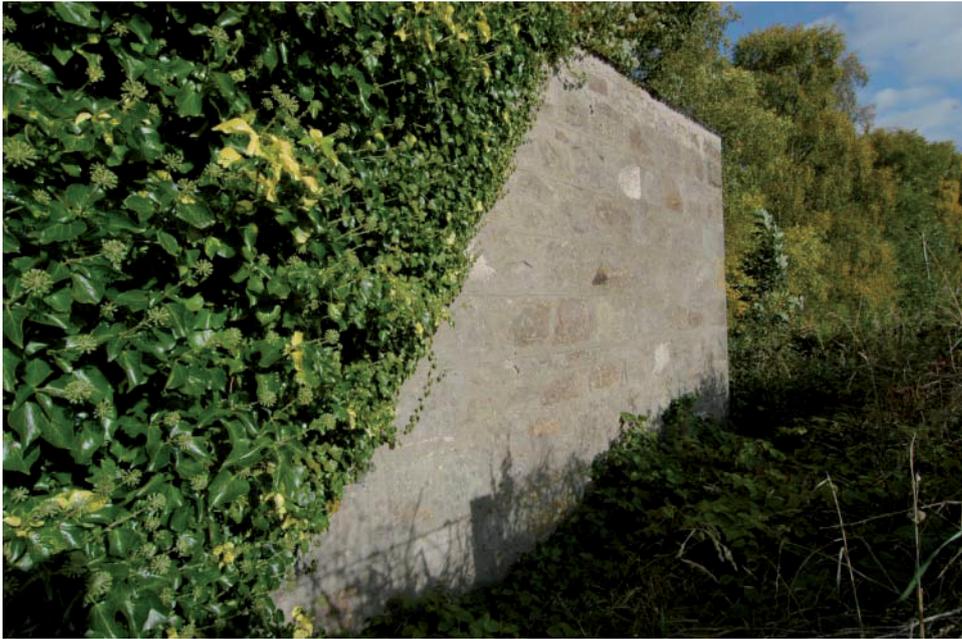
Fig 7 -Unit A Exterior, south-west facing elevation

3.2.5 The exterior south-west-facing elevation of the tank shed comprised large dressed sandstone blocks with bevelled relief, dressed quoins. The wall was two courses and 0.6m thick and 6.6m long. Close examination of the wall was

not possible due to it being obscured by heavily overgrown vegetation (see Fig. 7).

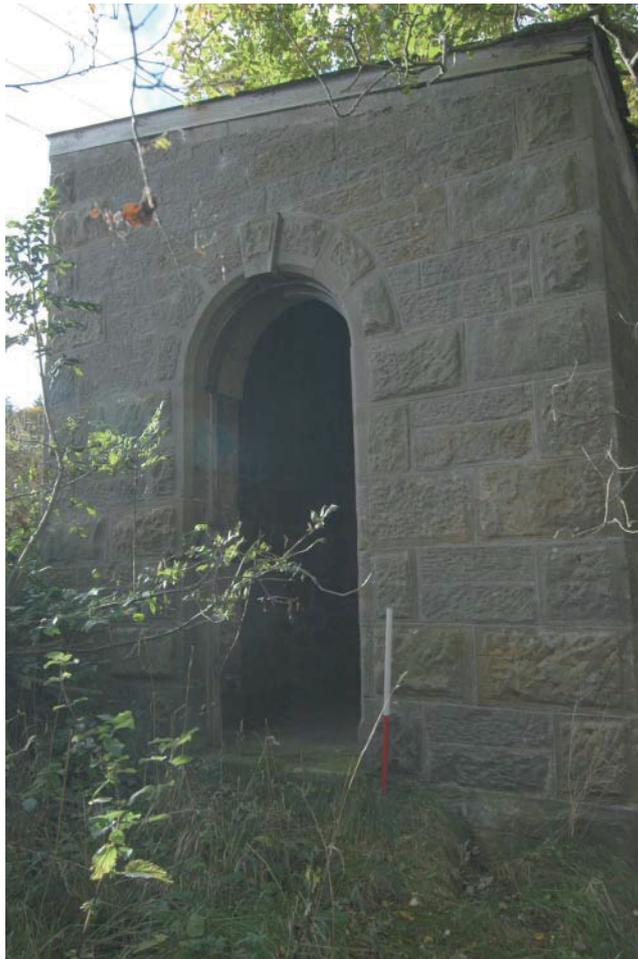
Fig 8 -Unit A Exterior, south-east facing elevation

3.2.2 The exterior south-east-facing elevation of the tank shed comprised large dressed sandstone blocks with bevelled relief, dressed quoins. The wall was two courses and 0.6m thick and 3.7m wide, and twelve courses and 3.5m high. An arched doorway served as the only entrance to the building (Fig. 8). This was located centrally in the exterior south-east-facing elevation and was 1.1m wide by 2.9m high. The arched doorway was surrounded by bevelled relief, dressed quoins, with the keystone standing proud of the rest of the archway. The door was no longer in place, but the remains of a wooden doorframe suggest that the door would have been wooden. An iron link and chain, likely to be the original locking mechanism for the door, was situated to the south side of the archway and penetrates through the exterior course of sandstone and around the wooden door frame.

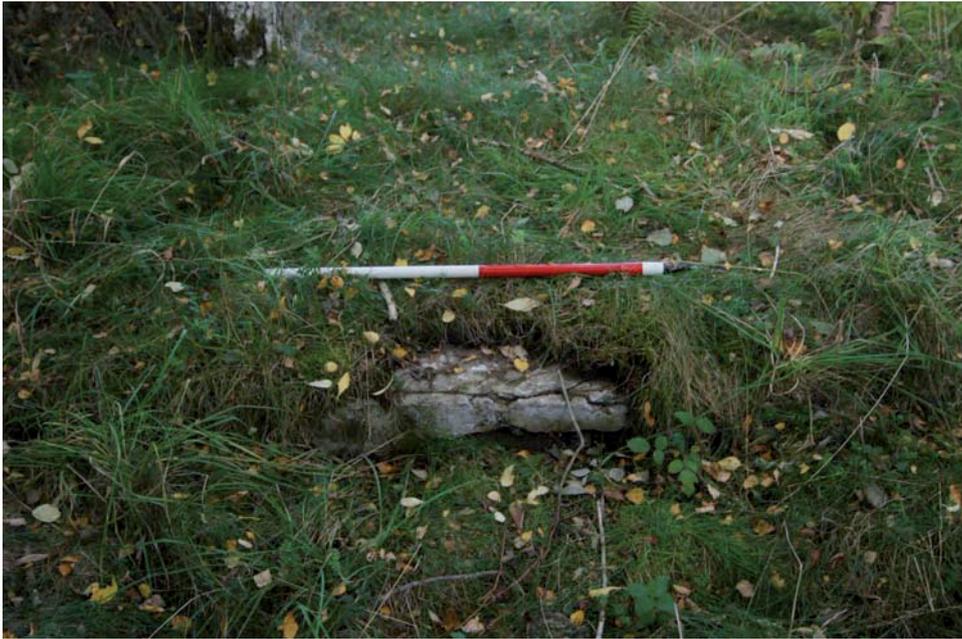
Fig 11 -Unit B, Visible remains of Northern footings

- 3.3.2 The majority of the northern footing is slightly visible amongst the vegetation, as is the south-east corner of the structure. It comprised a concrete wall footing 0.35m wide and 15.8m long and stands to a height of 0.2m (see Fig. 11). It is not apparent where the entrance to the structure might have been.

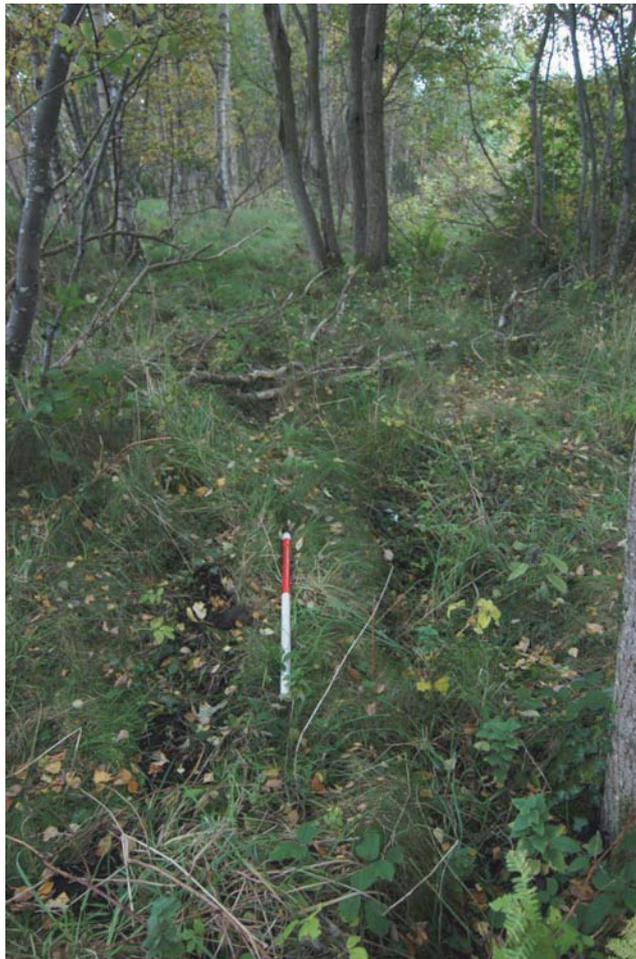
Fig 12 -Unit B, Visible remains of Southern footings

- 3.3.3 Only the north-western half of the southern footing was visible, and as with the northern elevation this comprised a concrete wall footing 0.35m wide and 0.2m high. The remainder of the structure was inaccessible and not visible due to the heavily overgrown vegetation (see Fig. 12).

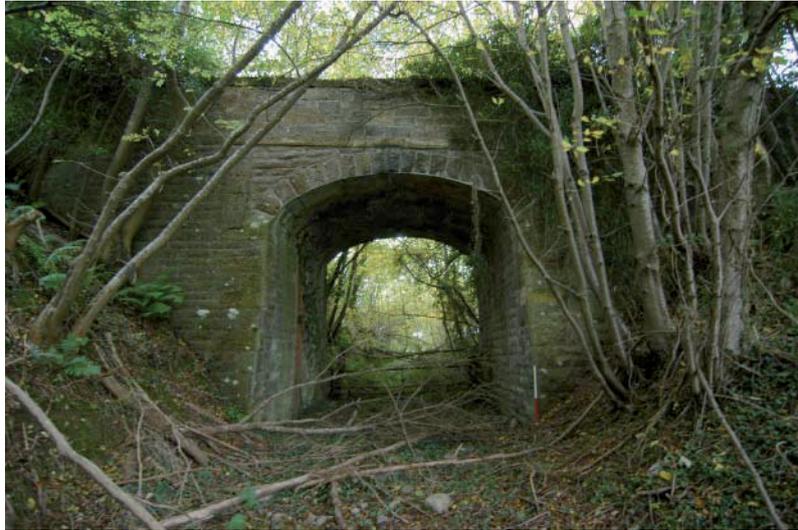
Fig 13 -Unit C, south-east facing elevation

- 3.4.1 The stone-built arched footbridge crosses the disused Fochabers Branch line. The remains of the railway were no longer present beneath the bridge, and was heavily overgrown. It comprised large, dressed sandstone blocks with four basic elements (Fig. 13).

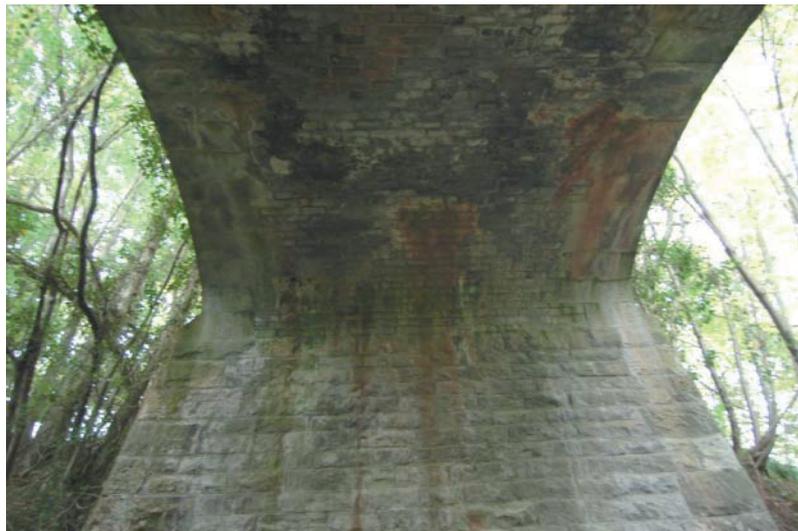
Fig 15 -Unit C, arch detail showing blockwork

- 3.4.3 The arch barrel comprised roughly dressed sandstone blocks. The underside of the arch barrel comprised smaller sandstone blocks, with the archway being approximately 3-4m high (Fig. 15).
