# CFA Archaeology Ltd

## **Crystal Rig II Wind Farm, Lammermuir Hills, East Lothian and Scottish Borders**

**Report No. 1579.2**

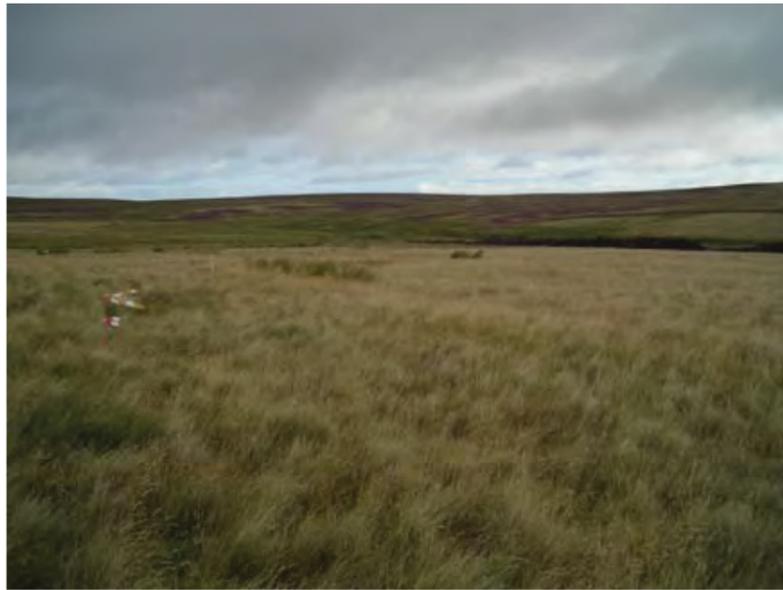
Fig. 2 - CFA Site 7

- 3.2.2 Aerial photography identified the remains of a circular feature (CFA Site **7**, NGR: NT 648 694) with a diameter of about 100m, on the NW-facing slope of Cracking Shaw above Mossy Burn. The feature is not recorded in the NMRS nor is it depicted on any maps. The feature is visible as a vegetation mark when viewed at a distance from the NE but is less evident on the ground at close quarters. It is defined by a discontinuous ring of rushy sedge vegetation. The site was marked on the ground by the attending archaeologist, allowing for a buffer zone of 10m around the entire diameter. Coloured fence posts at 10m intervals delimited the entire area (Fig. 2).

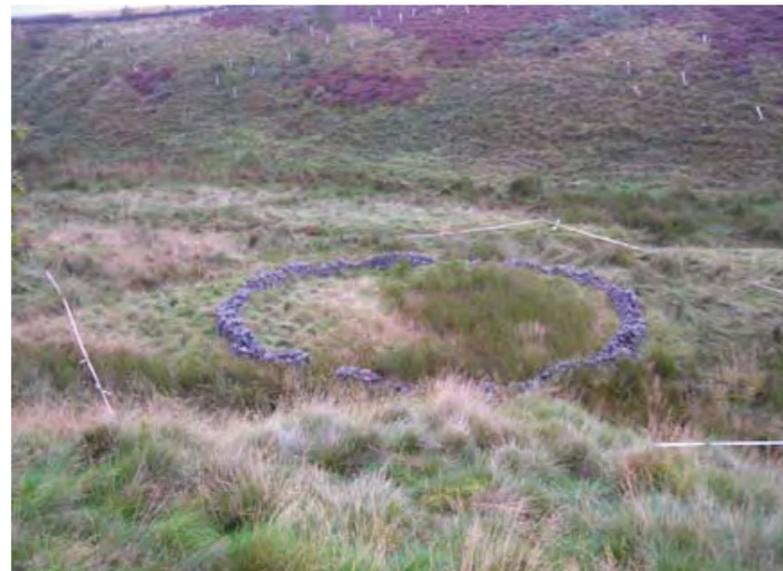
Fig. 4 - CFA Site 14

- 3.2.4 The remains of an upstanding drystone built sheepfold (CFA Site **14**) (NGR: NT 6489 6839) were located at the bottom of a ravine *c.* 100m east of **T42**. Monitoring of this area confirmed construction activity did not impinge on the preservation of the monument. The topography and ground conditions at this time prohibit heavy plant from entering this area, and the site is located beyond the safe working distance of machinery. Site traffic or further groundbreaking is not envisaged; however, the site was cordoned off with a minimal 5m buffer zone (Fig. 4).

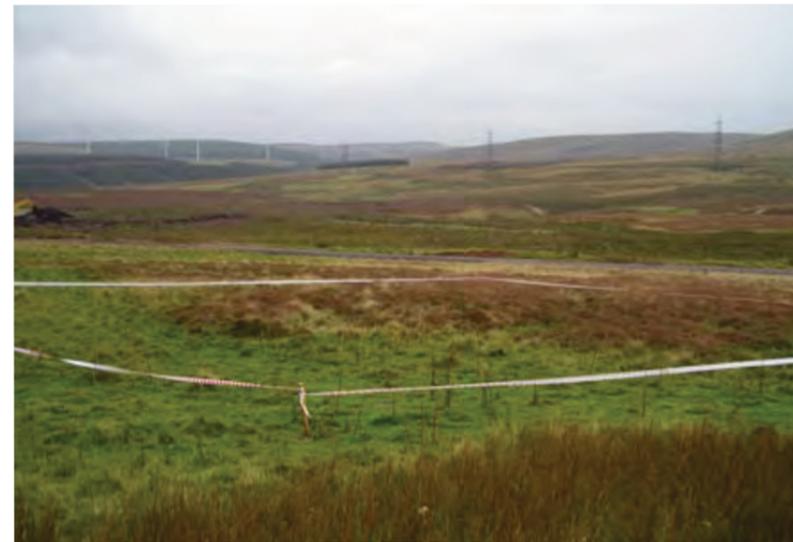
Fig. 5 - CFA Site 41

- 3.2.5 A small 9m diameter earthwork sheepfold (CFA Site **41**) is situated in close proximity to area **T58**. The area was located, pegged at four corner points and cordoned with hazard tape (Fig. 5). There was no construction work to the east of this site, with only the western circumference coming into close contact with groundbreaking and soil spoiling activity. As a consequence, a 10m

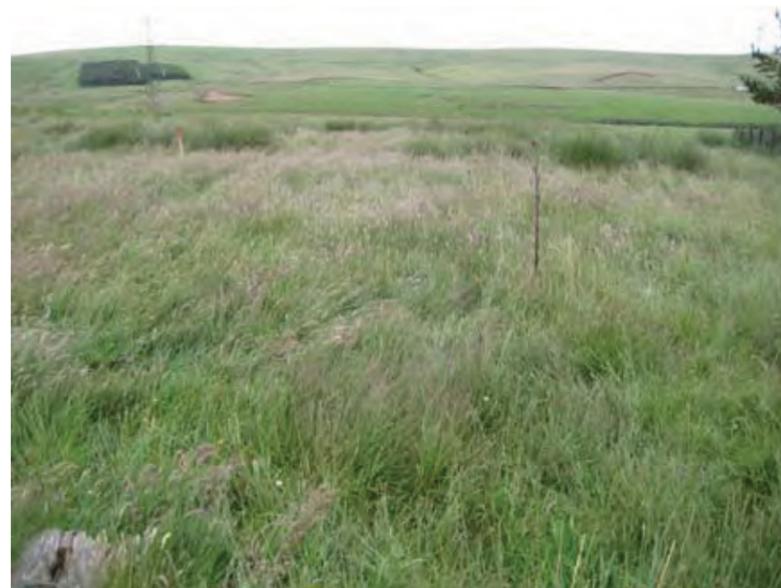
Fig. 6 - CFA Site 58

- 3.2.7 Field survey identified the possible remains of an 8m by 7m enclosure (Site **58**) (Fig. 6). Before soil removal commenced the attending archaeologist located the site, which was situated approximately 20m to the north of **T8**. Construction activity was separated from the site by an existing 1m high stock-fence. This fence, in good repair, effectively created a permanent 15m buffer zone between the site and any soil removal. As a consequence, further fencing was not required and the current provision was deemed more than adequate.

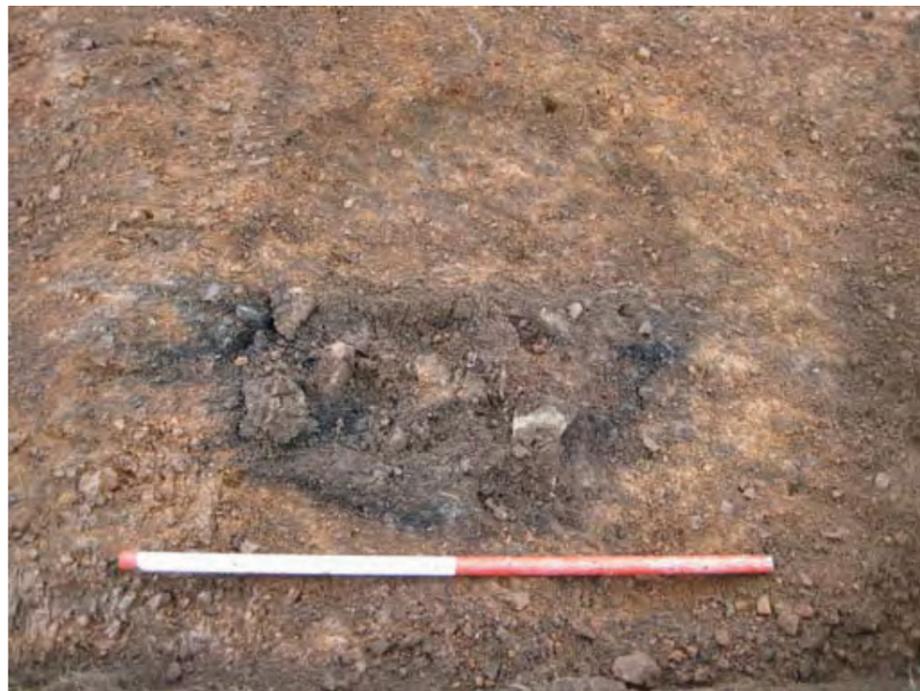
- 3.4.8 During this evaluation, the remains of a shallow-sided, flat bottomed circular pit (**017**) were uncovered at NGR: NT 66335 68236 (Fig. 20 & 21). The pit measured 0.7m in diameter and contained a single mixed fill of loose mid grey silt and abundant angular to sub-angular stone fragments to a depth of 0.1m. The exact purpose and precise date remain unknown, although the physical properties suggest a later, and probably post-medieval, date which is reinforced due to the close proximity of a disused track (CFA Site **35**) leading to Friardykes farmstead (CFA Site **15**).

Fig 20. Pit 017 in section

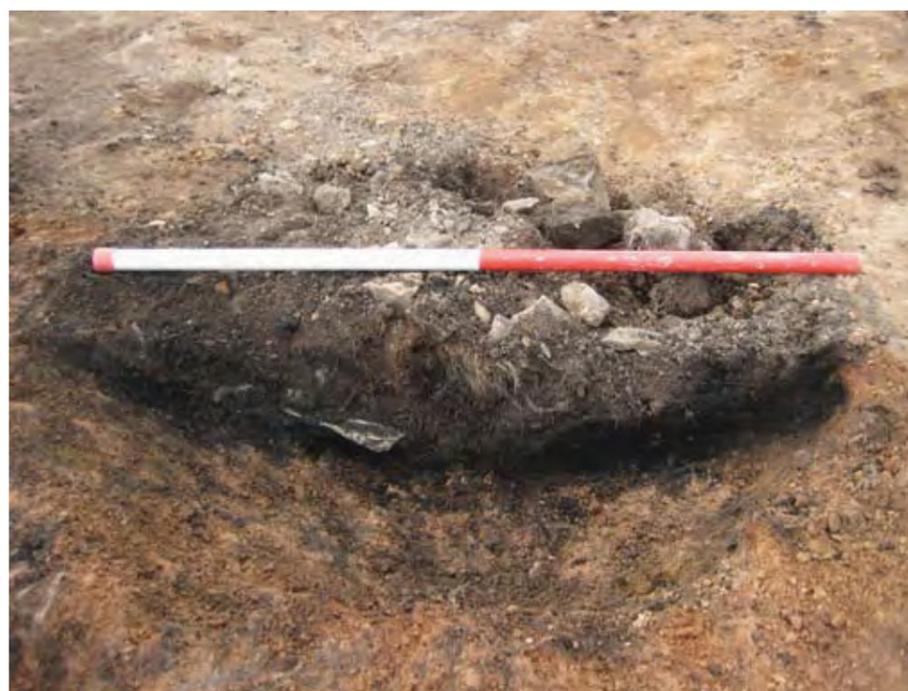
- 3.4.10 At NGR: NT 66354 68268 a circular pit (**080**) of 1m diameter by 0.26m deep was excavated (Fig. 22 & 23). The steep-sided, concave feature contained a charcoal-rich fill (**082**), surrounding a clast of heat-affected stones. A thin primary deposit of brown silt (**081**), suggests the pit may have been open for an archaeologically insignificant amount of time before burnt material **082** was added. The purpose and date remain unknown, although the loose compaction of the upper fill probably indicated the feature did not belong to antiquity.

Fig 22. Pit 080 in section

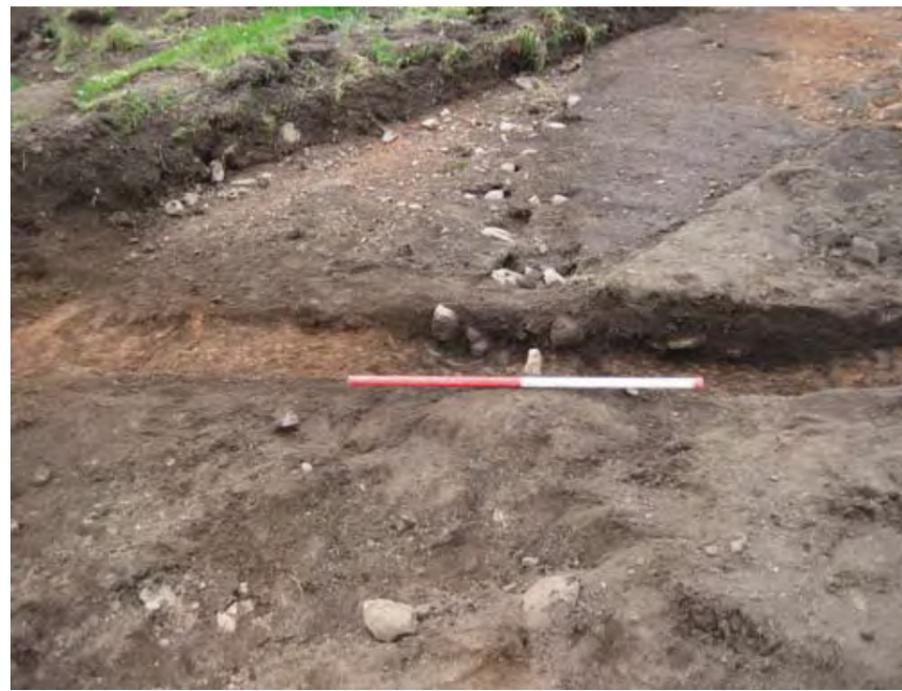
- 3.4.9 The preferred interpretation is that **019** represents the truncated remains of a track which had been truncated by an improvement along the existing route by **021**. Both track ruts show signs of repair, seen in the stony infill of these depressions, probably to stop further erosion. The track was in effect terraced on a slight slope, and erosion or subsidence was clearly a consideration evident in the more substantial repair work of **022** which would have bolstered the running surface and facilitated drainage. This right of way passes Friardykes Farm to the south where field observations noted crudely coursed stonework shoring the track and forming a rudimentary embankment. The trackway is presumed to date from the post-medieval period, although agriculturalism at Friardykes is known to date from the medieval period, which possibly suggests the route may be much older in origin.

Fig 25. General shot of merging trackways 019/021, NE-facing section

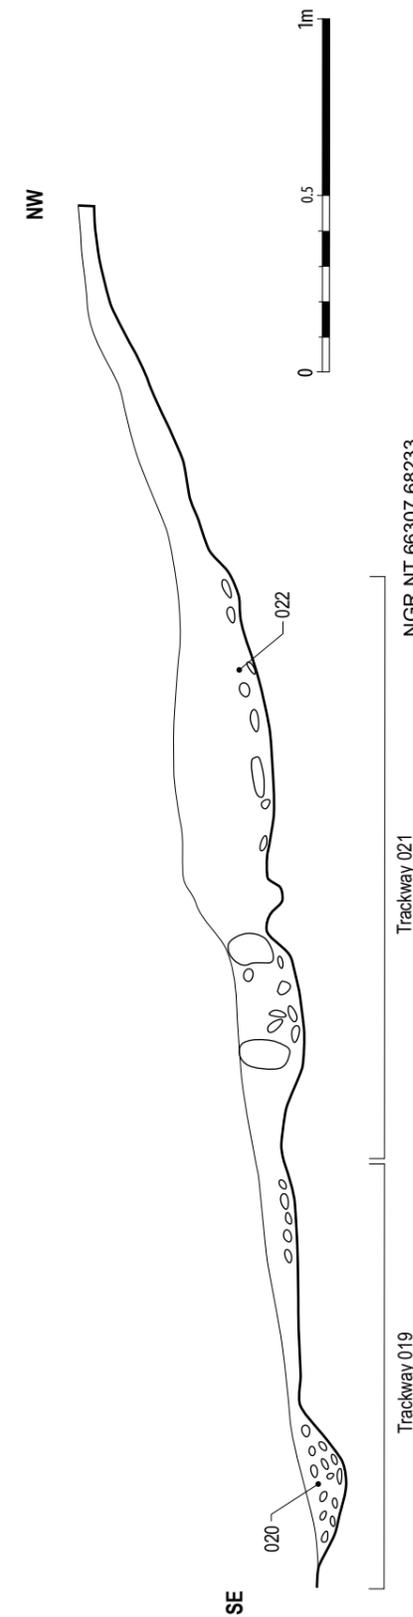
Fig 26. NE-facing-section of merging trackways (019,021) CFA Site 35 near Friardykes

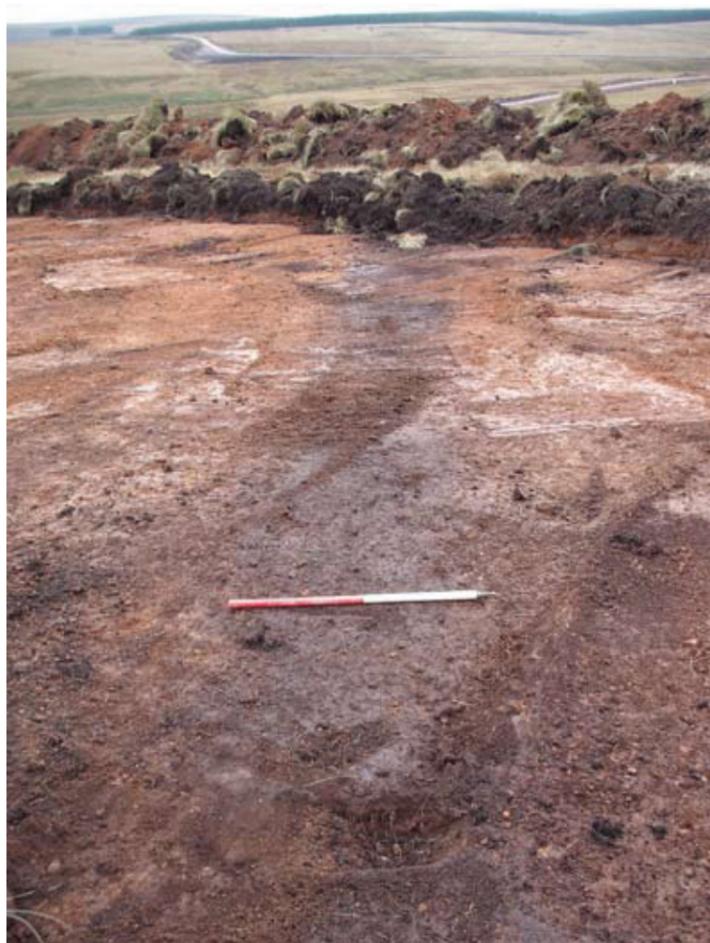
- 3.4.15 Three linear features were identified during soil removal at **T9**, (**092**, **095** & **097**) (Fig. 1). Ditch **092** (Fig 35, 36 & 37) had a concave profile with moderately steep sides. The base and sides were rough due to cobbles protruding from the natural, cut material. The ditch measured 0.9m in width, with a maximum depth of 0.23 and continued in a northeast-southwest orientation for a minimum of 14m. Excavation removed a sterile primary fill (**093**) of re-deposited orangey sandy silt with degrading sandstone fragments to a depth of 0.11m. This was covered by **094**, a light to mid-grey compact deposit of silty sand with mixed gravel inclusions.

Fig 35. General shot of ditch 092 in plan

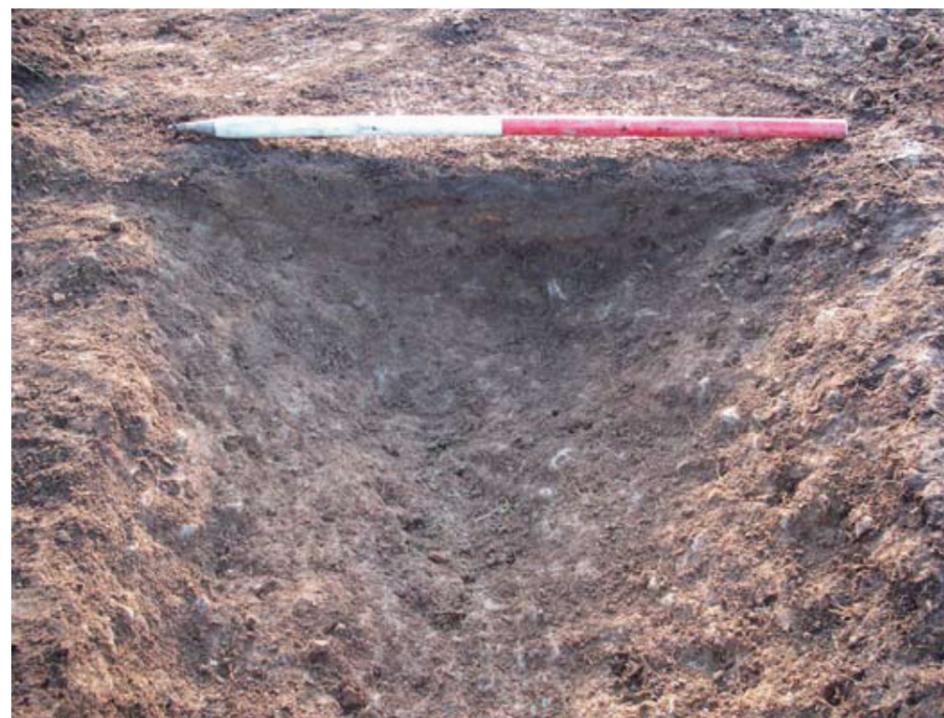
Fig 36. South-facing section of ditch 092

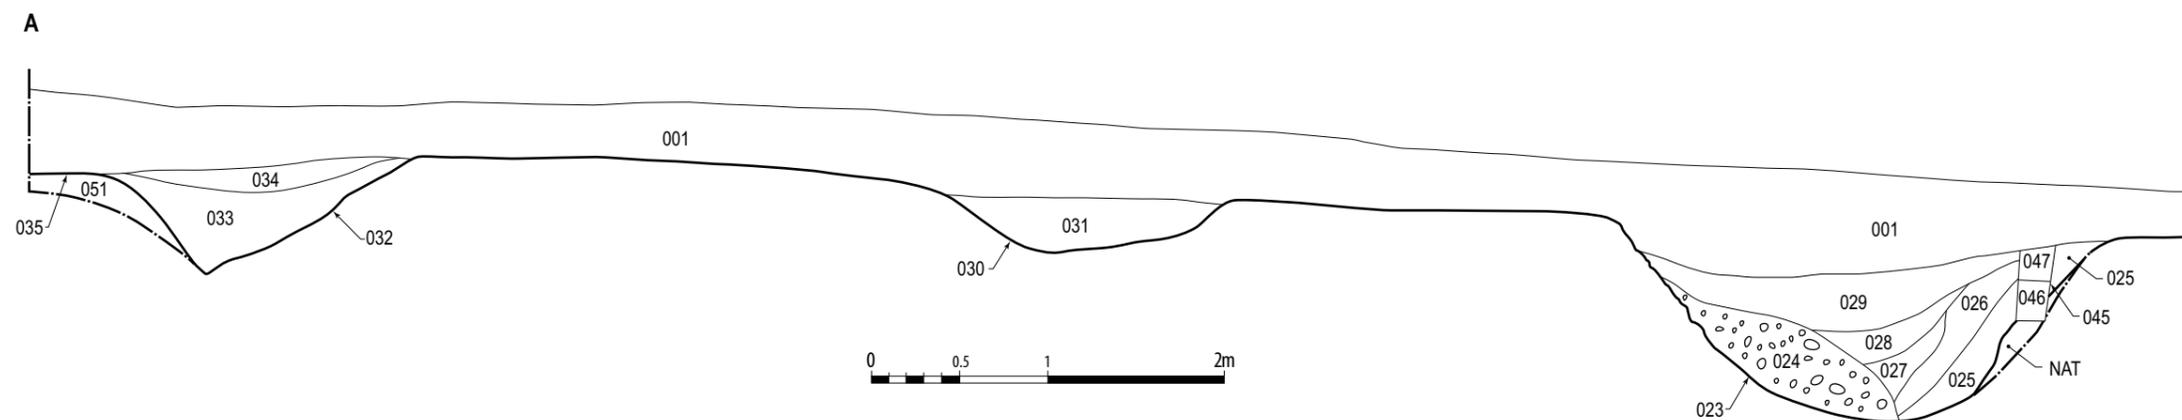
- 4.4 The largest feature recorded was ditch **023/064**. This ditch was cut through natural, tabular rock, which would have required a substantial amount of labour, time and possible resources to complete. Although a small proportion of the feature was uncovered, field observations noted its continuance, by way of a shallow depression, for some distance to the north. The fills of **023** and **064** indicate that an earthwork may have accompanied this ditch on the

- 4.6 Ditch **035** is possibly the earliest feature encountered. Its orientation, which in effect runs at a tangent to the parallel ditches **023**, **030** and **032**, in a northwest-southeast direction, and the presence of a compacted stony fill, free of the loam typically found on site, suggests this feature may belong to a separate phase of activity. This is also inferred from its truncation by **032**, one of three presumed contemporary ditches.

Fig. 43 - Continuous south-east-facing section of ditches 023, 030, 032, 035 and 045

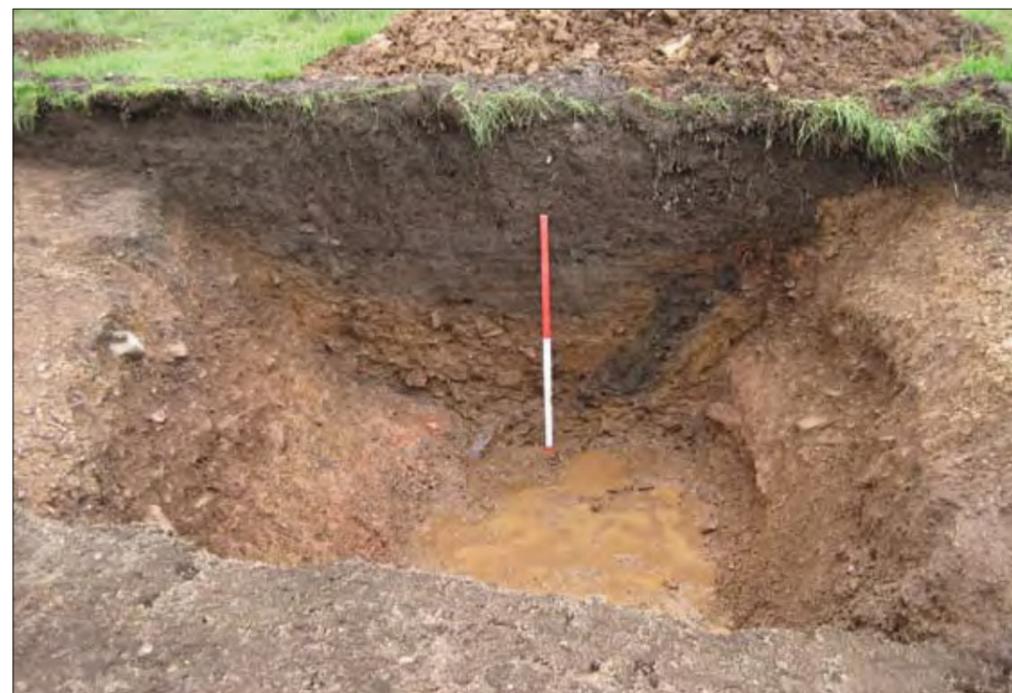
Fig. 46. - South-facing section of ditch 023

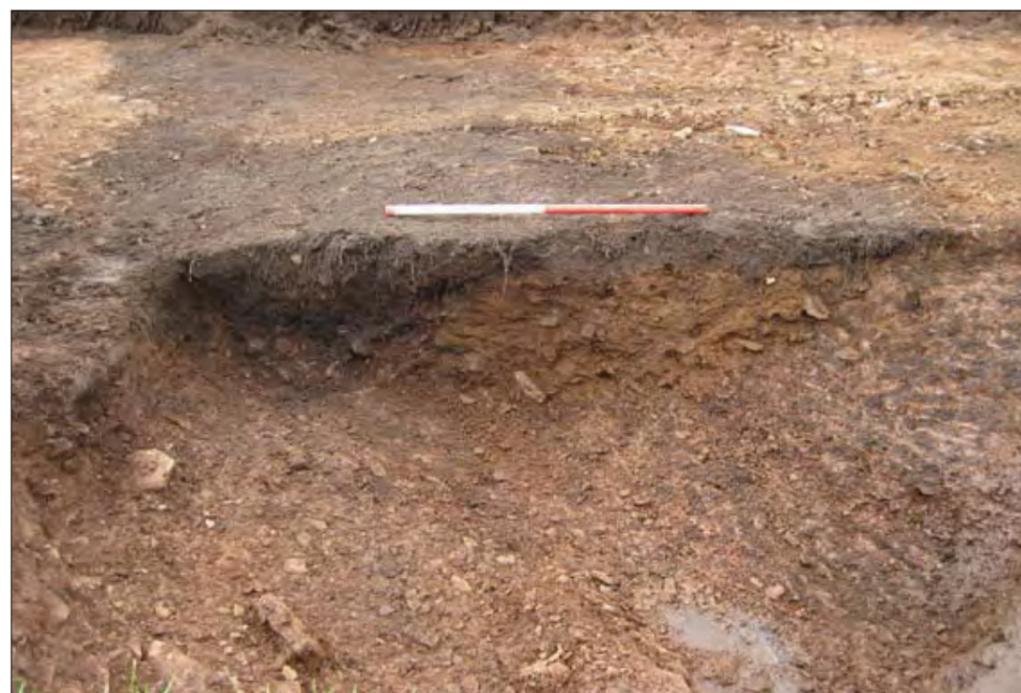
Fig. 47. North-facing section of Intersecting Ditches 032 and 035

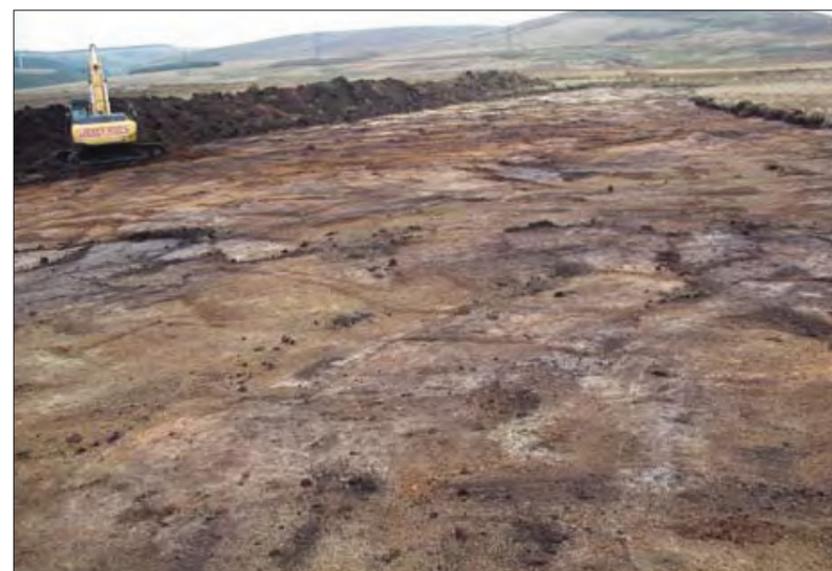
- 3.1.5 Very rarely, natural rocky outcrops were encountered; all of which were assessed as geological in formation. These outcrops, such as the examples noted at **T58** and **T4**, consisted of predominantly angular and sub-angular

Fig. 51. Topsoil Removal at T58 Crane Pad

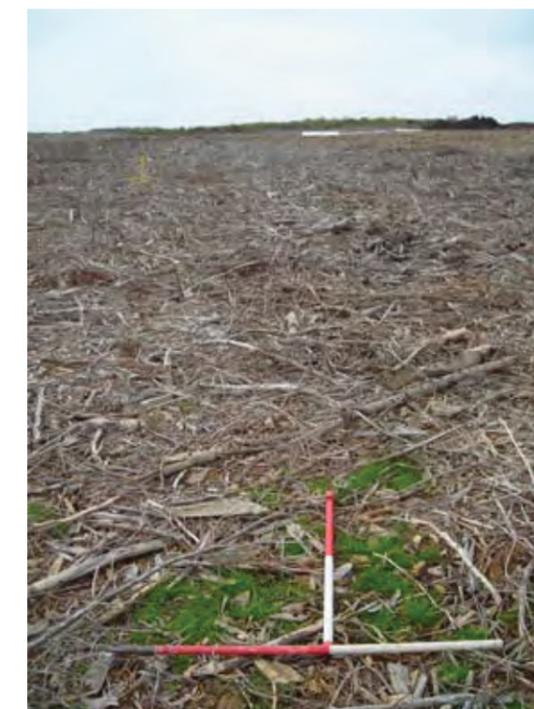
- 3.1.4 The development site contained a large area of coniferous plantation, which was deforested before construction work began. As a consequence of this procedure a large amount of overlying brash was encountered which required removal before groundbreaking could commence. It was noted that root action and cultivation, as expected, had severely disturbed deposits in these areas.

Fig. 52. General View of Ground Conditions Following Felling at Cracking Shaw
