**MANSE STABLES, 244 CHURCH STREET,  
TRANENT, EAST LOTHIAN**

**STANDING BUILDING SURVEY**

**Report No. 1670**

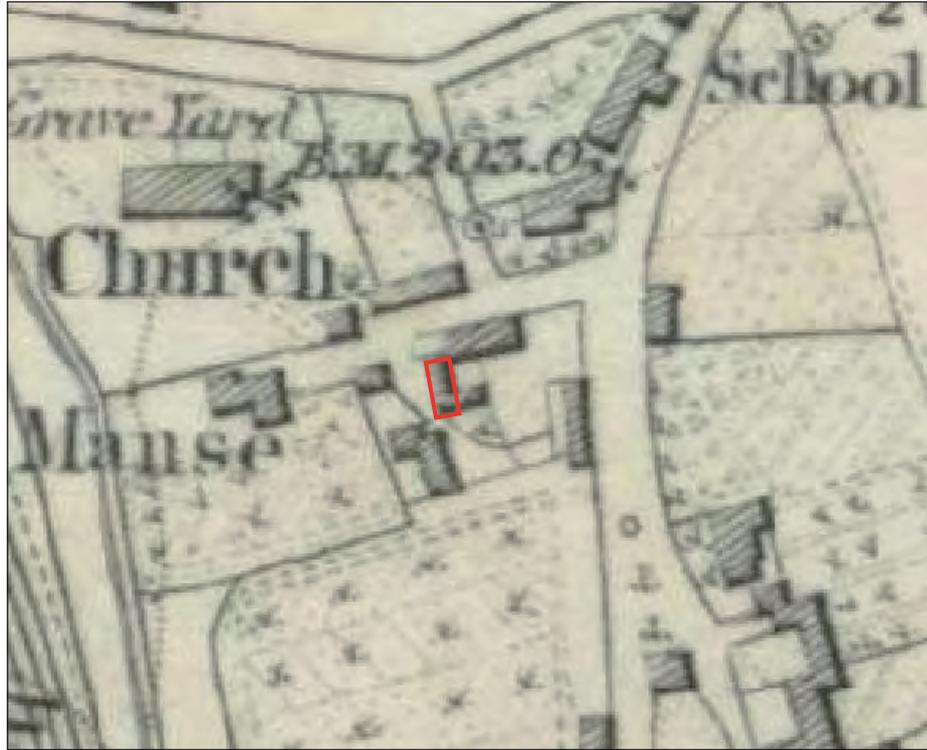
Fig. 2a - Enlarged extract from the 1856 OS map

- 3.1.1 A plan drawn by Brydone in 1831 held in the East Lothian Council Library Service's Local History Section shows the routes of Tranent's water supply. The plan suggests the presence of an L-shaped arrangement of cottages on the present site of the stable. Unfortunately the plan is not reproducible owing to its poor quality.
- 3.1.2 The 1856 First Edition map depicts a rectangular building trending east-west with an outshot L-shaped structure on its west end (Fig 2a). These buildings were cleared to make way for the stable that was built by 1858. The building is depicted on the 1894 Second Edition (Fig 2b) and all subsequent editions and conforms to the present layout.
- 3.1.3 There are no maps pertinent to the stable held within the National Archive of Scotland.

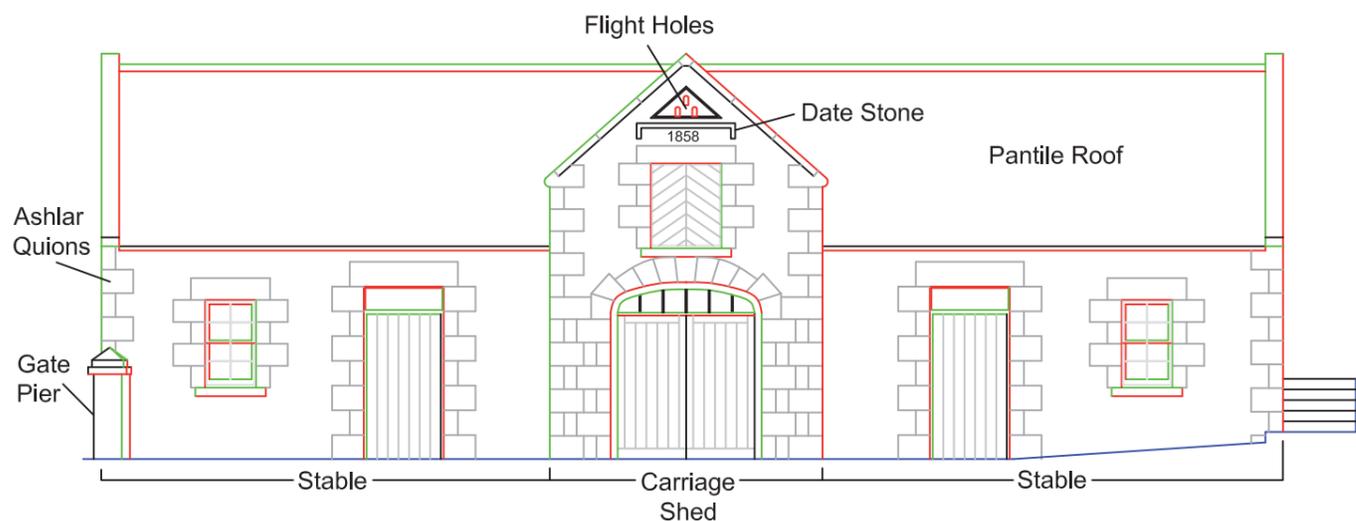
Fig. 3a - West-facing elevation

4.2.1 The west-facing elevation represents the principal elevation and it measures 16.8m long and 3.05m high, with a wall thickness of 0.6m. The roof is pantile and the gables have sandstone copings. The elevation has five bays and comprises squared and snecked rubble sandstone with contrasting droved quoins and window dressings. At the centre of the elevation there is a gabled bay which is advanced with breaking eaves containing a hay loft. The door is surmounted by a dated lintel (1858) (Plate 2). Within the apex of the gable there is a set of three flight holes for doves.

4.2.2 A central double-leafed door leads into what was the carriage shed. Either side of the advanced central gable are two doors and a window that provided access into Units 2 and 3 the stables. The windows are sash-and-case (4 over 4) and measure 1.26m high and 0.62m wide. The rain goods are cast-iron. The timber softwood plank doors have fanlights. At the south end of the elevation there is a decorative iron ornamental lamp bracket.

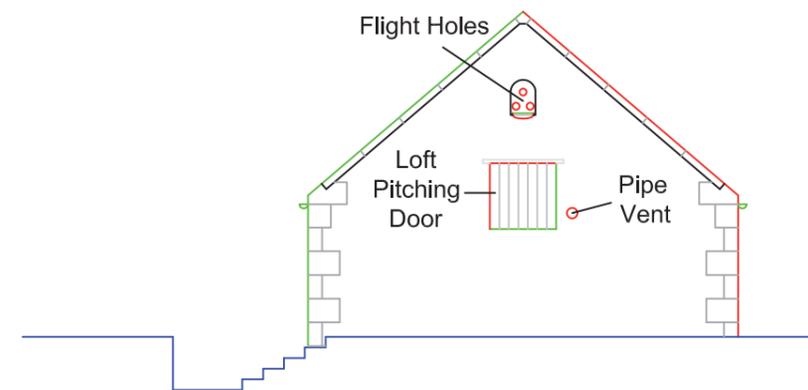
Fig. 3b - South-facing elevation

4.2.3 The south-facing elevation comprises the south gable which measures 6m wide. At the centre is a plank-built loft hatch in a wooden door frame. At about the level of the stone skews, the random rubble stonework is cream sandstone set in lime mortar. Below this level the build is cruder with yellow sandstone of random rubble. Above the loft hatch is a small stone round-headed panel with three flight holes.

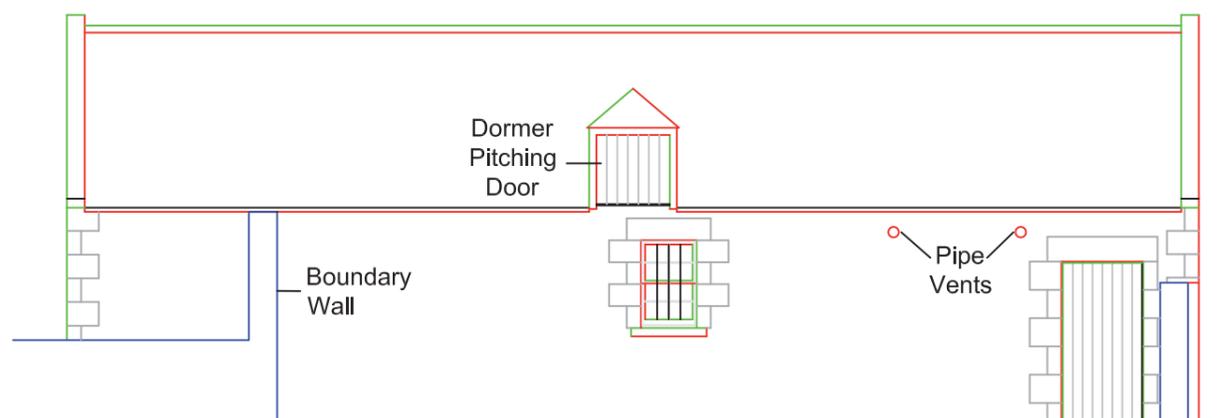
Fig. 3c - East-facing elevation

4.2.4 The east-facing elevation measures 16m long and has three bays with a central window with dressed ashlar surrounds flanked by a single window lighting Unit 1. The windows are all sash-and-case (4 over 4), the central window has square wrought-iron window bars. At eaves level is a pitching door within a dormer with pantiled roof. At the north end of the gable is a plank-built door providing access between the stable (Unit 1) and the rear garden. The doorway surrounds are broached. Towards the south end of the elevation an east-west trending partition wall has been tacked onto the elevation.

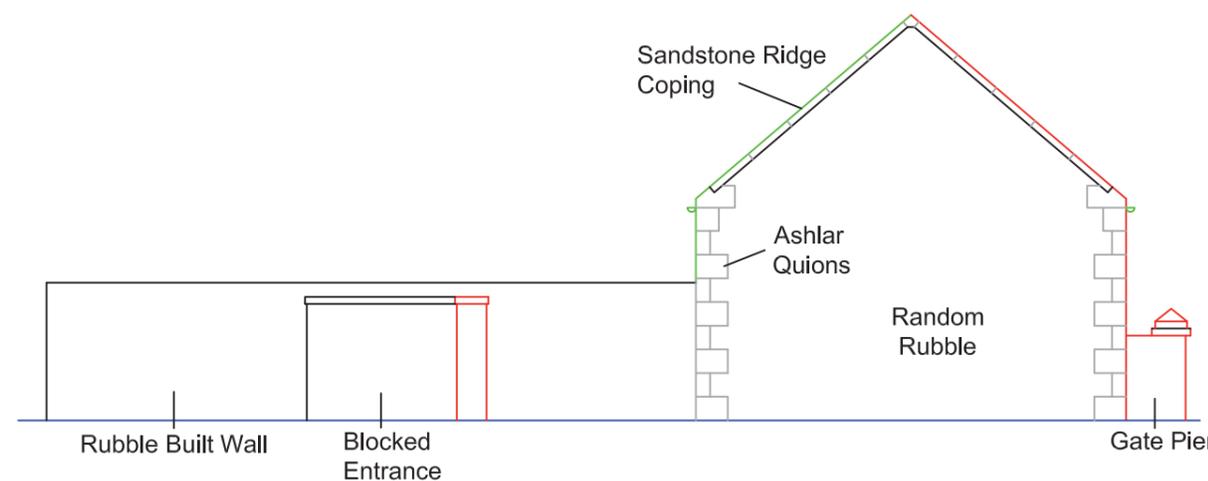
Fig. 3d - North-facing elevation

- 4.2.5 The north-facing gable measures 6m wide and is constructed on coursed rubble and has droved ashlar quoins. The coping stones are sandstone. The elevation is otherwise featureless. A boundary wall running to the east has been attached onto the east side of the gable.

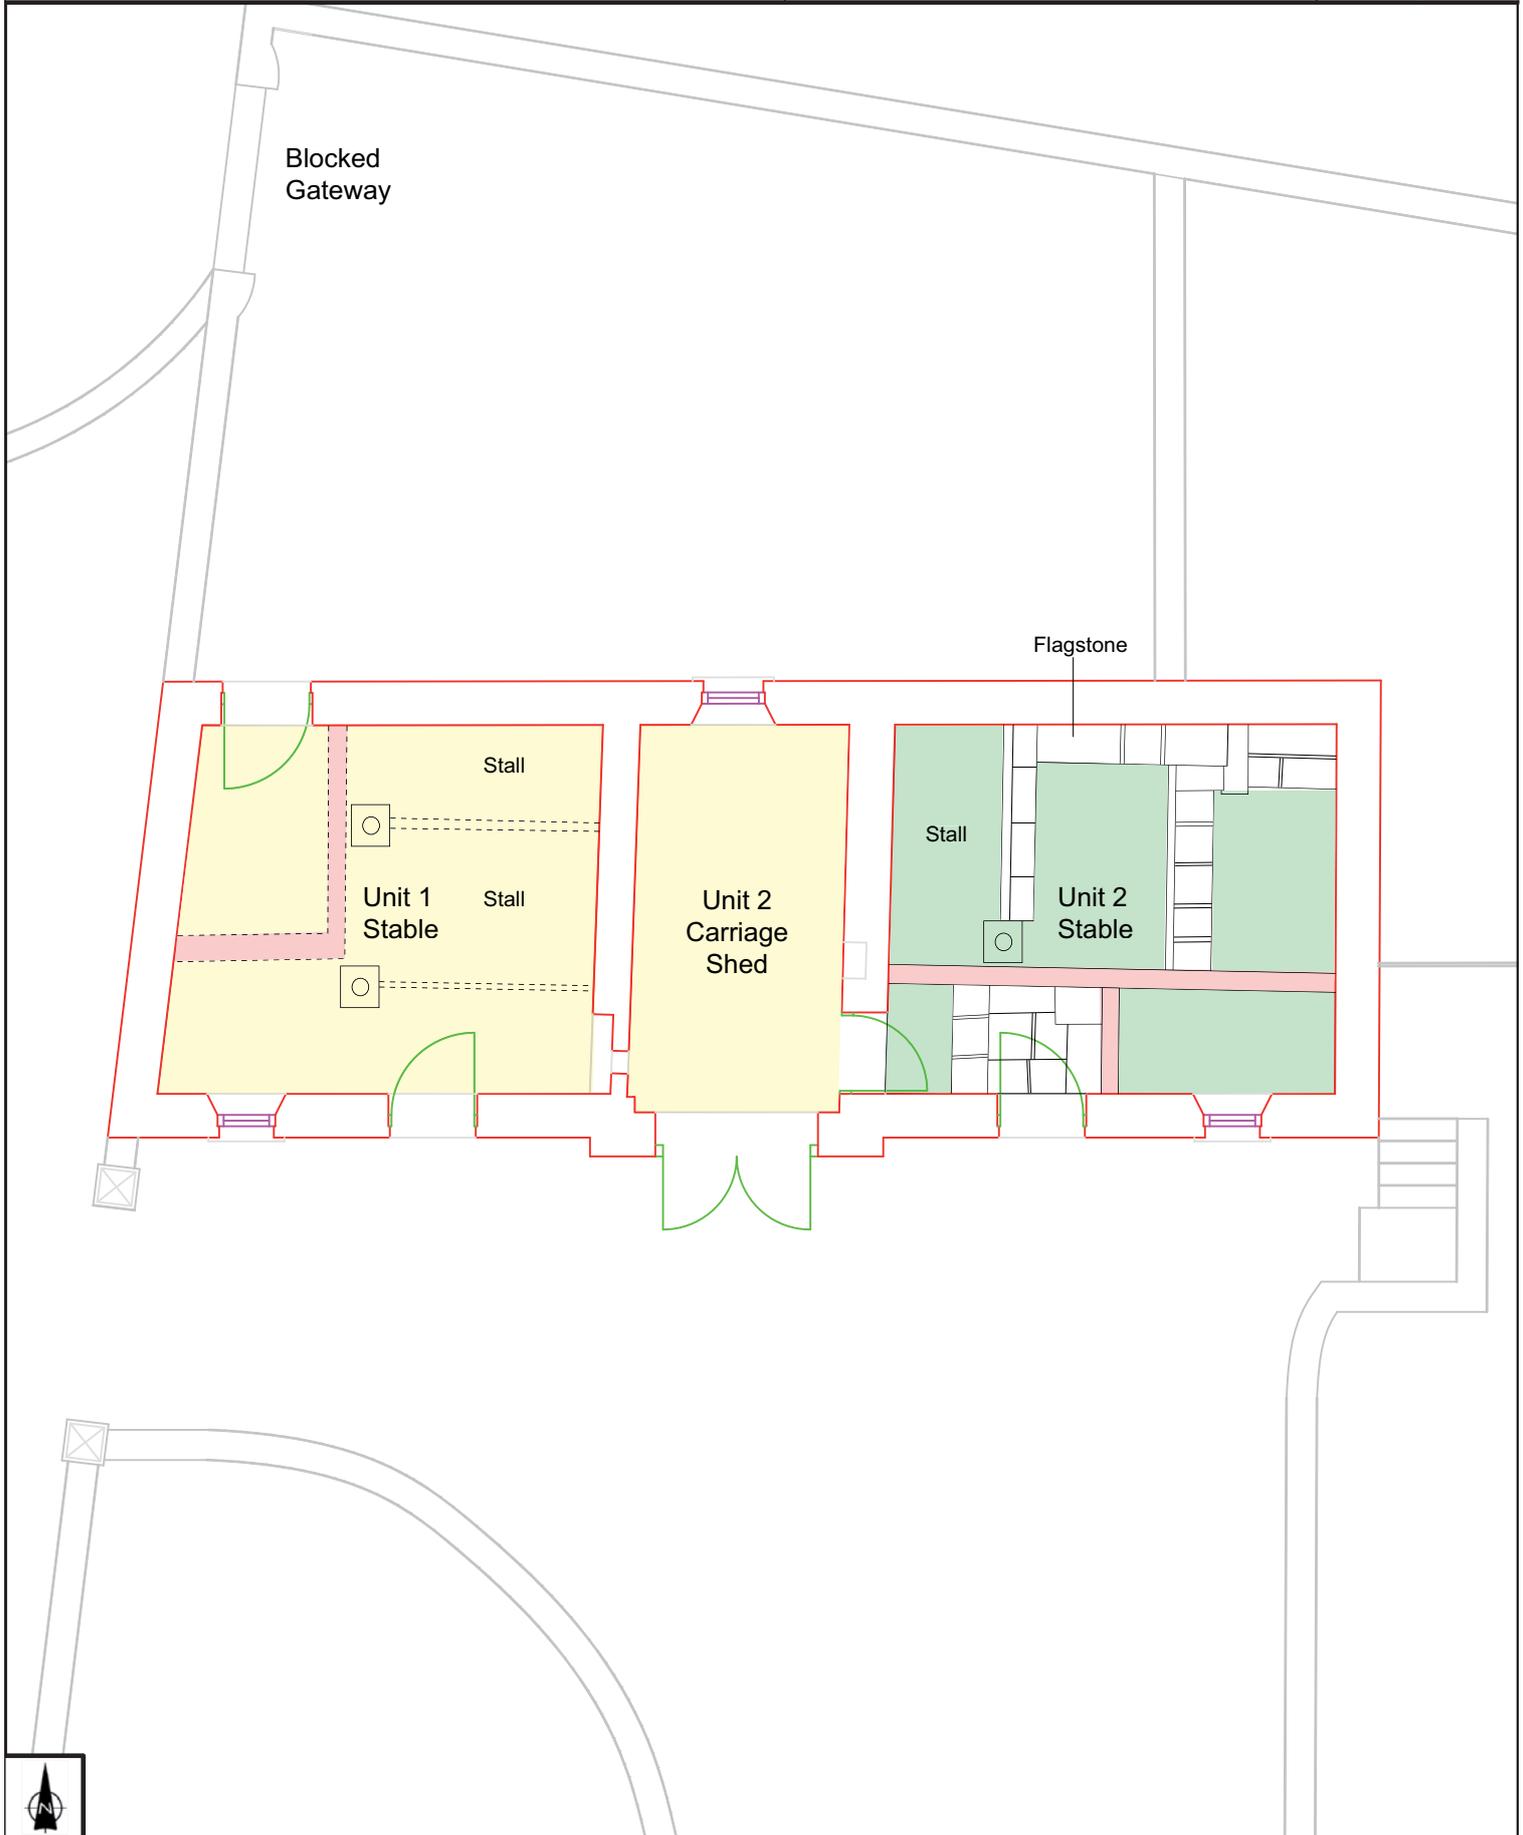
Key:	Fig No: 4	Revision: A	Client: Alasdair Rait

- 4.3.1 The stable measures 5.4m by 4.9m and is 2.7m from the floor to ceiling. The east-facing internal elevation contains the plank-built door in an opening measuring 2.07m high and 1.07m wide. The door is flanked on its north side by the sash and case window. The window has splayed ingos.

- 4.3.2 The south-facing elevation is plain and constructed of random rubble and has white-washed. The west-facing elevation has two ceramic pipe-vents inserted at the wall head. The north-facing wall has a blocked doorway at its west end. Within the centre of the wall is the scars from the removal of the wooden trevisses that formed the sides of the stalls. Within the centre of the room are two cast-iron hind-posts standing to a height of 1.55m. Each has a ball finial.

- 4.3.3 The floor is laid with cobble setts throughout but on line with the position of the stalling is a sandstone drain set within the cobbles which is aligned east-west. The drain has been constructed from sandstone blocks.

- 4.3.4 The Carriage room measures 5.7m long and 2.8m wide. A doorway on the north elevation leads into Unit 3, another stable. To the left of the door is a small aumbry measuring 0.46m by 0.47m and providing a space in which to place a lantern. The room is lit by a central window with splayed ingos on the west-facing elevation. On the south-facing elevation close to the main double-leafed door entrance is a blocked doorway that once allowed access into Unit 1. The blocking work is coursed rubble and has been whitewashed. Both the north and south-facing elevations are not load bearing and have been crudely keyed to the main core block walls.

- 4.3.5 This unit measures 5.9m by 4.9m and is accessed via a door from Unit 2 on the south-facing and east-facing elevations. On the west-facing wall there is a single treviss surviving from a stall. To the right of the stall treviss is a short upright wall. Its function is not clear but it may have formed the upright for housing an iron water boiler that was coal fired in a grate below. The boiler may have been vented by a cast-iron pipe that is present on the south-facing gable. The floor of this unit is a mixture of large flagstone and brickwork with a stone drain leading through a hole in the wall. A lead-pipe protruding from

the east-facing elevation shows that a water-supply was present. The same wall contains the central doorway and flanking windows.

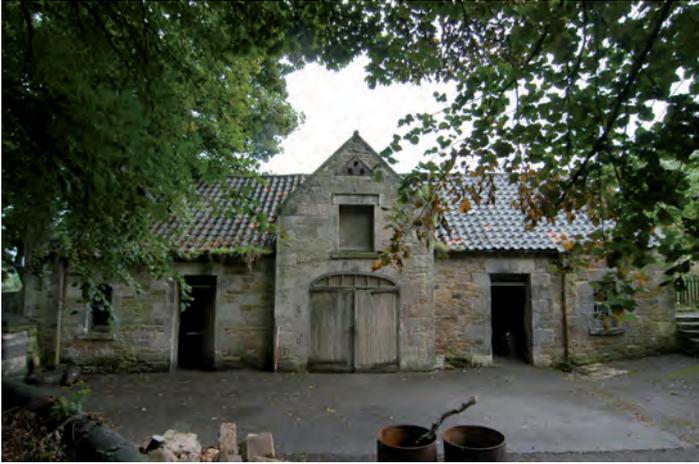
Plate 1 - West-facing elevation of the stable

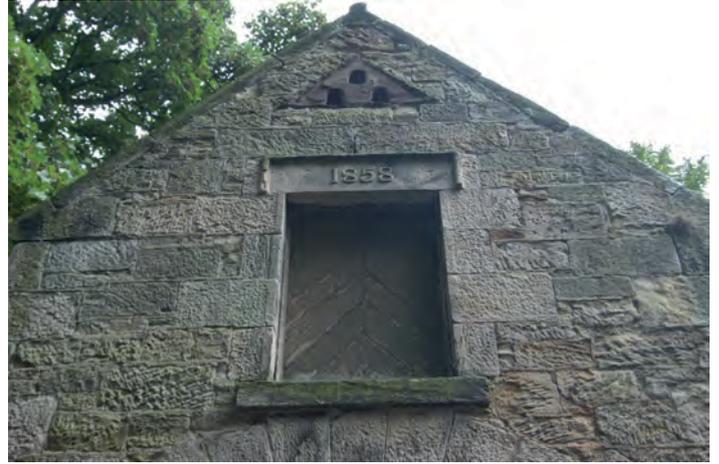
Plate 2 - West-facing loft door with date stone and flight holes

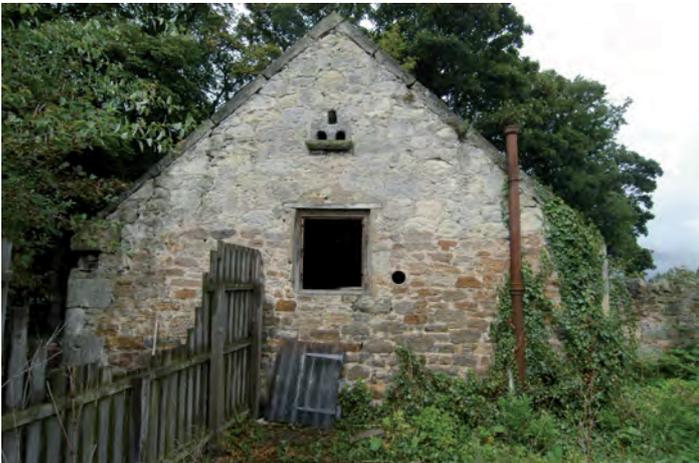
Plate 3 - South-facing gable with loft door and flight holes above

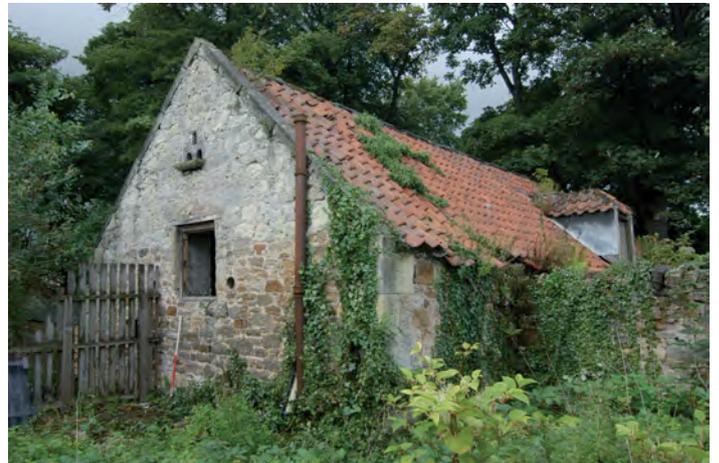
Plate 4 - South-east corner of stable showing pantile roof

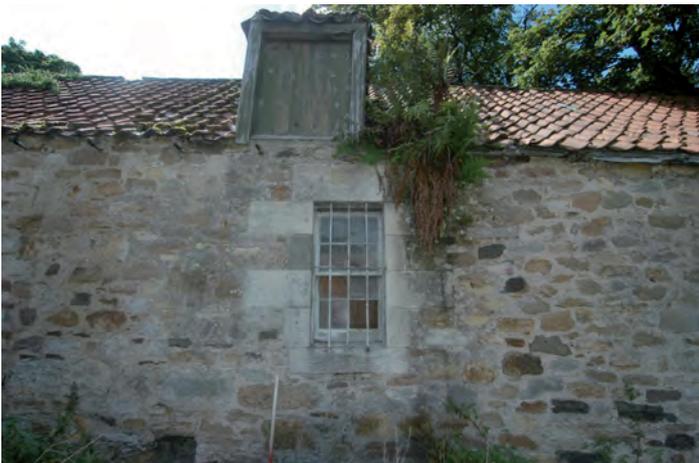
Plate 5 - East-facing elevation showing barred window and dormered pitching door.

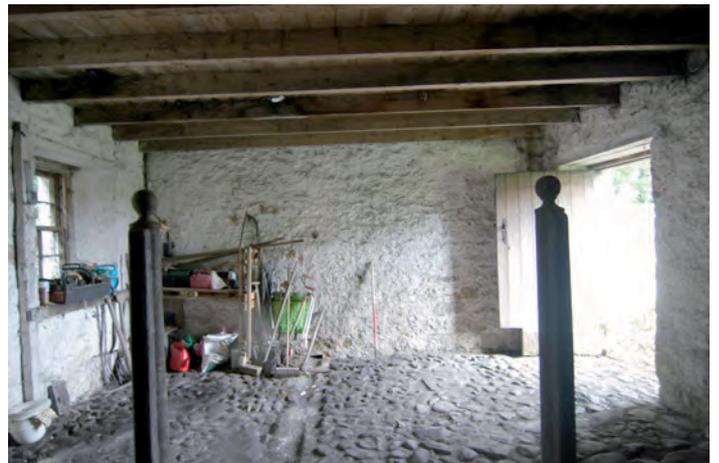
Plate 6 - Interior of Unit 1 with two treviss posts in the foreground

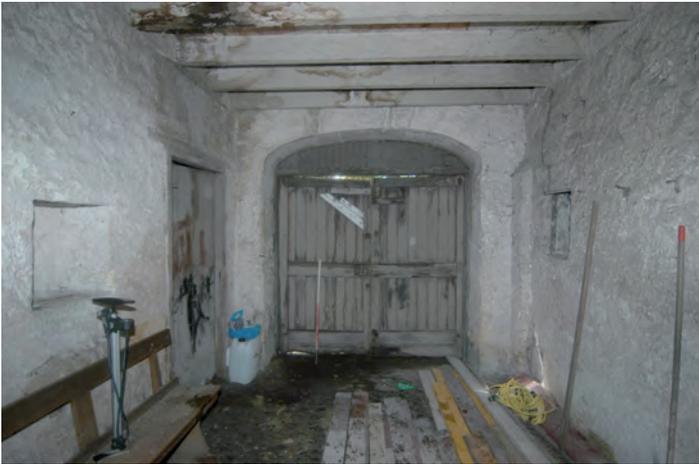
Plate 7 - Interior of Unit 2 showing the arched doorway. A lamp aumbry is present on the left-hand wall

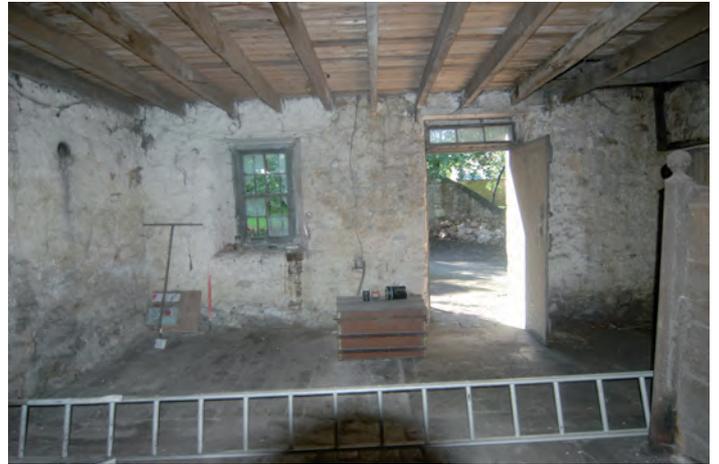
Plate 8 - Interior of Unit 3, showing the loft floor joists and fenestration

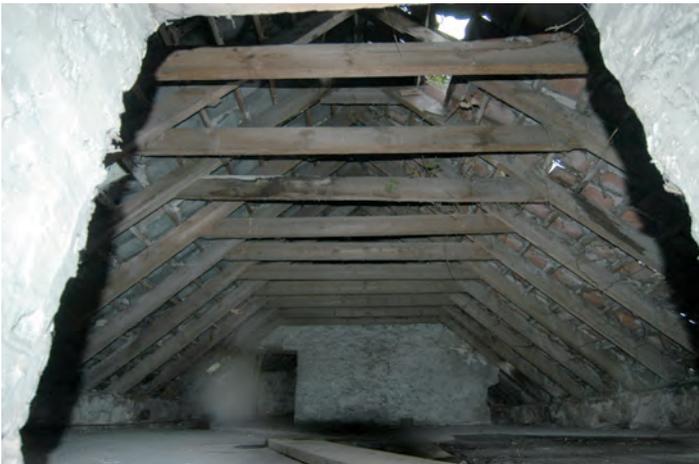
- 4.3.6 The roof timbers were viewed from the hatch on the south elevation and comprise softwood (pine) A-frame joists with nailed scarfe joints. It is likely that these represent the original roof timbers judging by the wrought-iron nails used in the joints. The loft floor is planked throughout but is unsafe to walk on, so no inspection of the loft space above Units 1 and 2 was possible.

Plate 9 - Interior of the loft showing A-frame roof joists

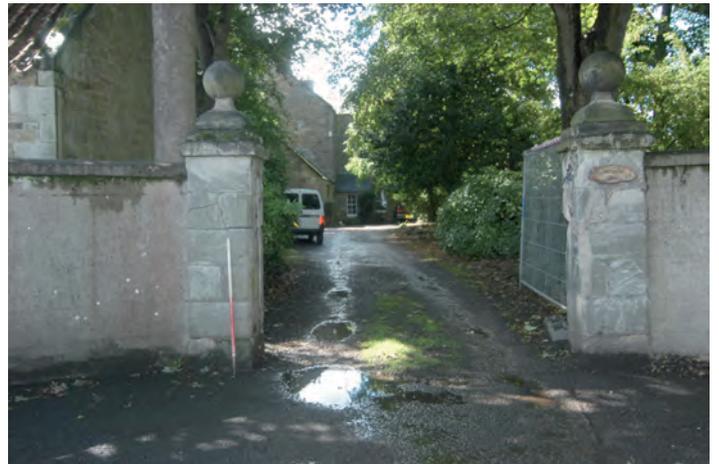
- 4.3.7 The Statutory List includes a retaining wall and gate piers as part of the Grade B Listing. The gate-piers at the entrance to the manse driveway are stugged grey sandstone with ball finials. These are flanked by rendered and lined ashlar-coped walls. At the entrance to the courtyard in front of the stable are squat pyramidically coped piers. A curved sandstone rubble wall with semi-circular copings to the west sweeps south to form a diminutive courtyard which shields the garden of the Manse. The wall adjacent to the main drive entrance has evidence of blocking work and clearly this formed a small gateway into the rear garden behind the stable.

Plate 10 - Ashlar B-Listed gate piers with ball finials at the entrance to the manse driveway
