**52-54 High Street, Haddington
John Gray Centre
Phase 2 Building Survey**

Report No. 1742

Report No. 1742
52-54 High Street, Haddington
John Gray Centre
Phase 2 Building Survey

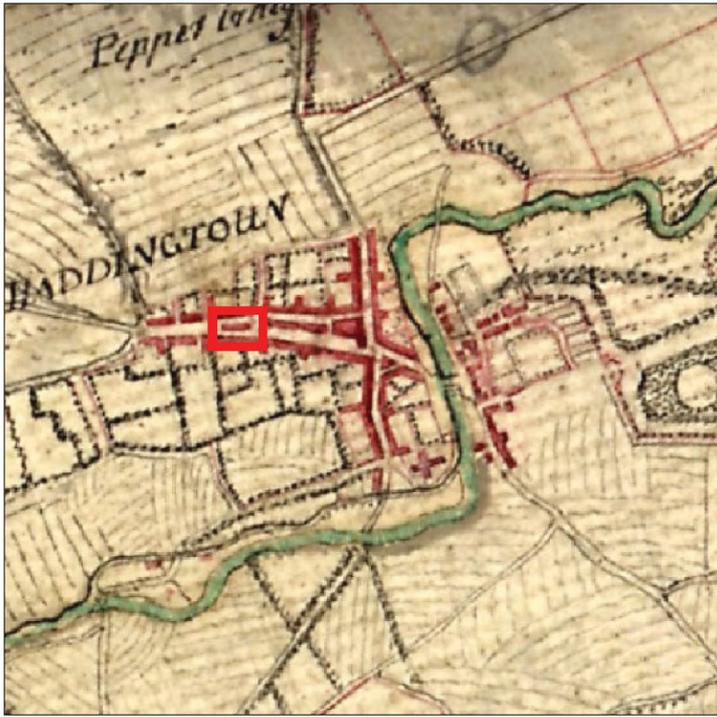
Fig 2a - Roy's Military map of 1747-55

3.2.1 General Roy's Map of 1774-55 (Fig 2a) shows a linear building plot tentatively within the study area. Armstrong's map of 1773 shows a much more ordered block layout with the Town Hall and West Port depicted on the north and west side. Also depicted is a more irregular alignment of the south elevation. Forrest's map of 1799 provides less detail and shows only a simple block layout. John Wood's map of 1819 (Fig 2b) shows the study area to comprise at least six individual units. The arched pend at the west end of the Grain Store had yet to be built. Interestingly, the block was then called Midrow. The south elevation has outshot buildings attached. The buildings to the east of the Grain Store block appear to be narrower and set back from the present day frontage. In all probability these represent a set of earlier buildings that were possibly cleared to make way for those described in the statutory list.

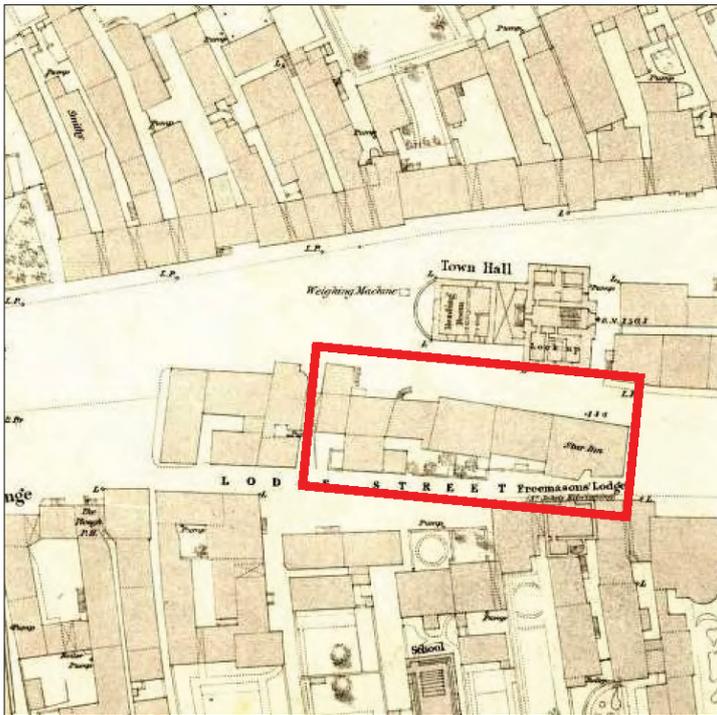
Fig 2c - Large scale Ordnance Survey 1853

3.2.2 The 1853 First Town Map of Haddington (Fig 2c) shows a similar layout as that shown on Woods map. Six individual units make up the core block. The three easternmost units have outshot buildings on the north and south side. Two garden plots are depicted on the south side of 54 High Street. What was to become the City Bank (No 52 High Street) was then the Star Inn.

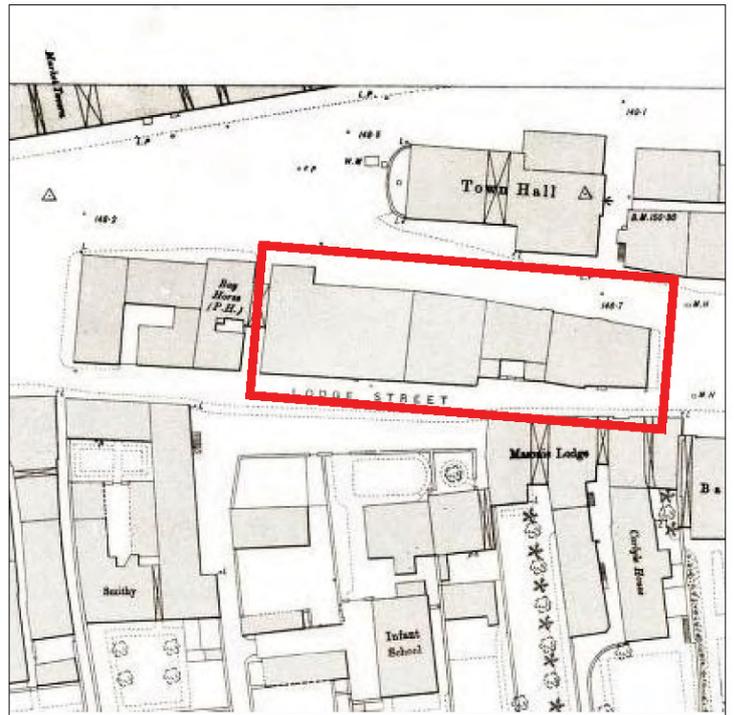
Fig 2d - Large scale Ordnance Survey 1893

3.2.3 The 1893 Ordnance Survey map (Fig 2d) shows the footprint of the core block to be the same as it is today and this was clearly enlarged on the south side to form a fairly straight building alignment. The third edition 1907 Ordnance Survey map shows the same detail as the second edition map.

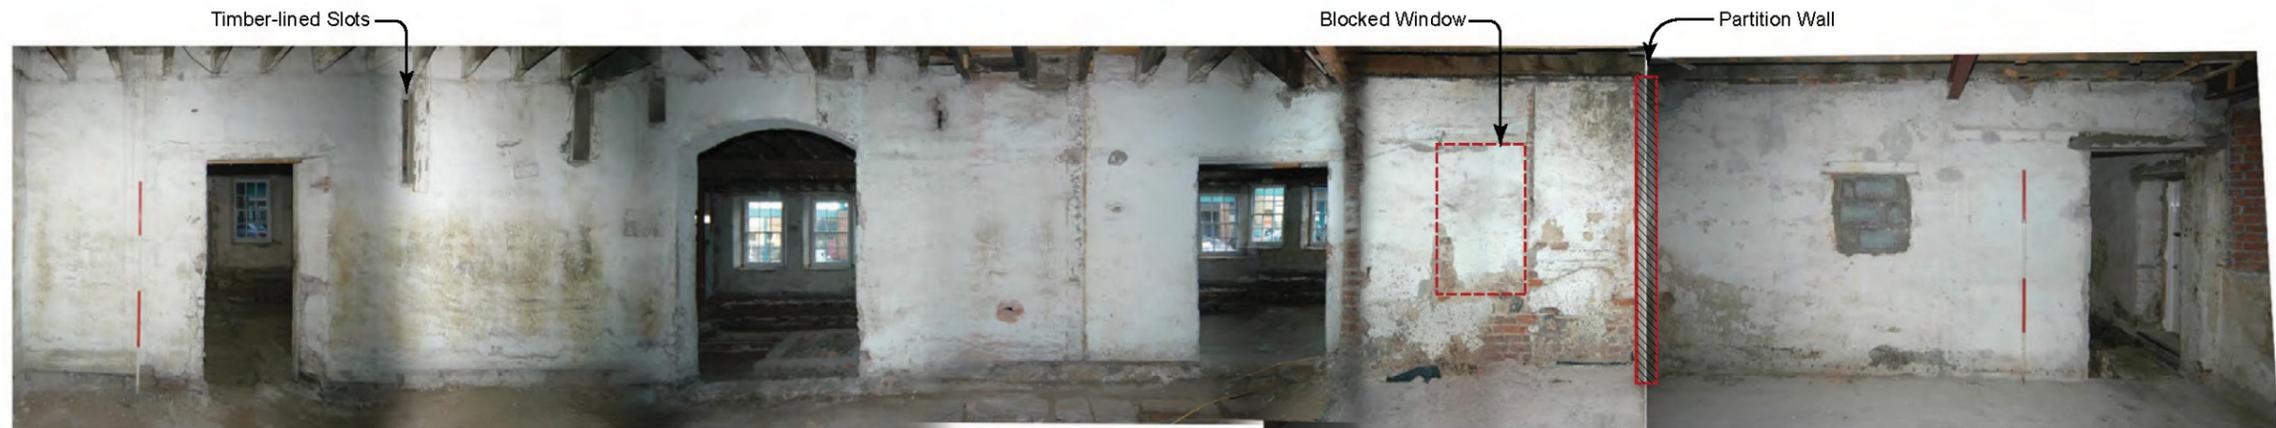
Fig 5a : Spine wall ground floor, north-facing elevation (Units 1, 7 & 8. Refer to Fig 3)

functioned as slots to allow pulley ropes to transmit through the wall. The pulley system was operated by belt-driven apparatus located on the first floor in Unit 16. The floor of this room has been repaired to such an extent that any corresponding hatches that were once in line with this apparatus have now been removed.

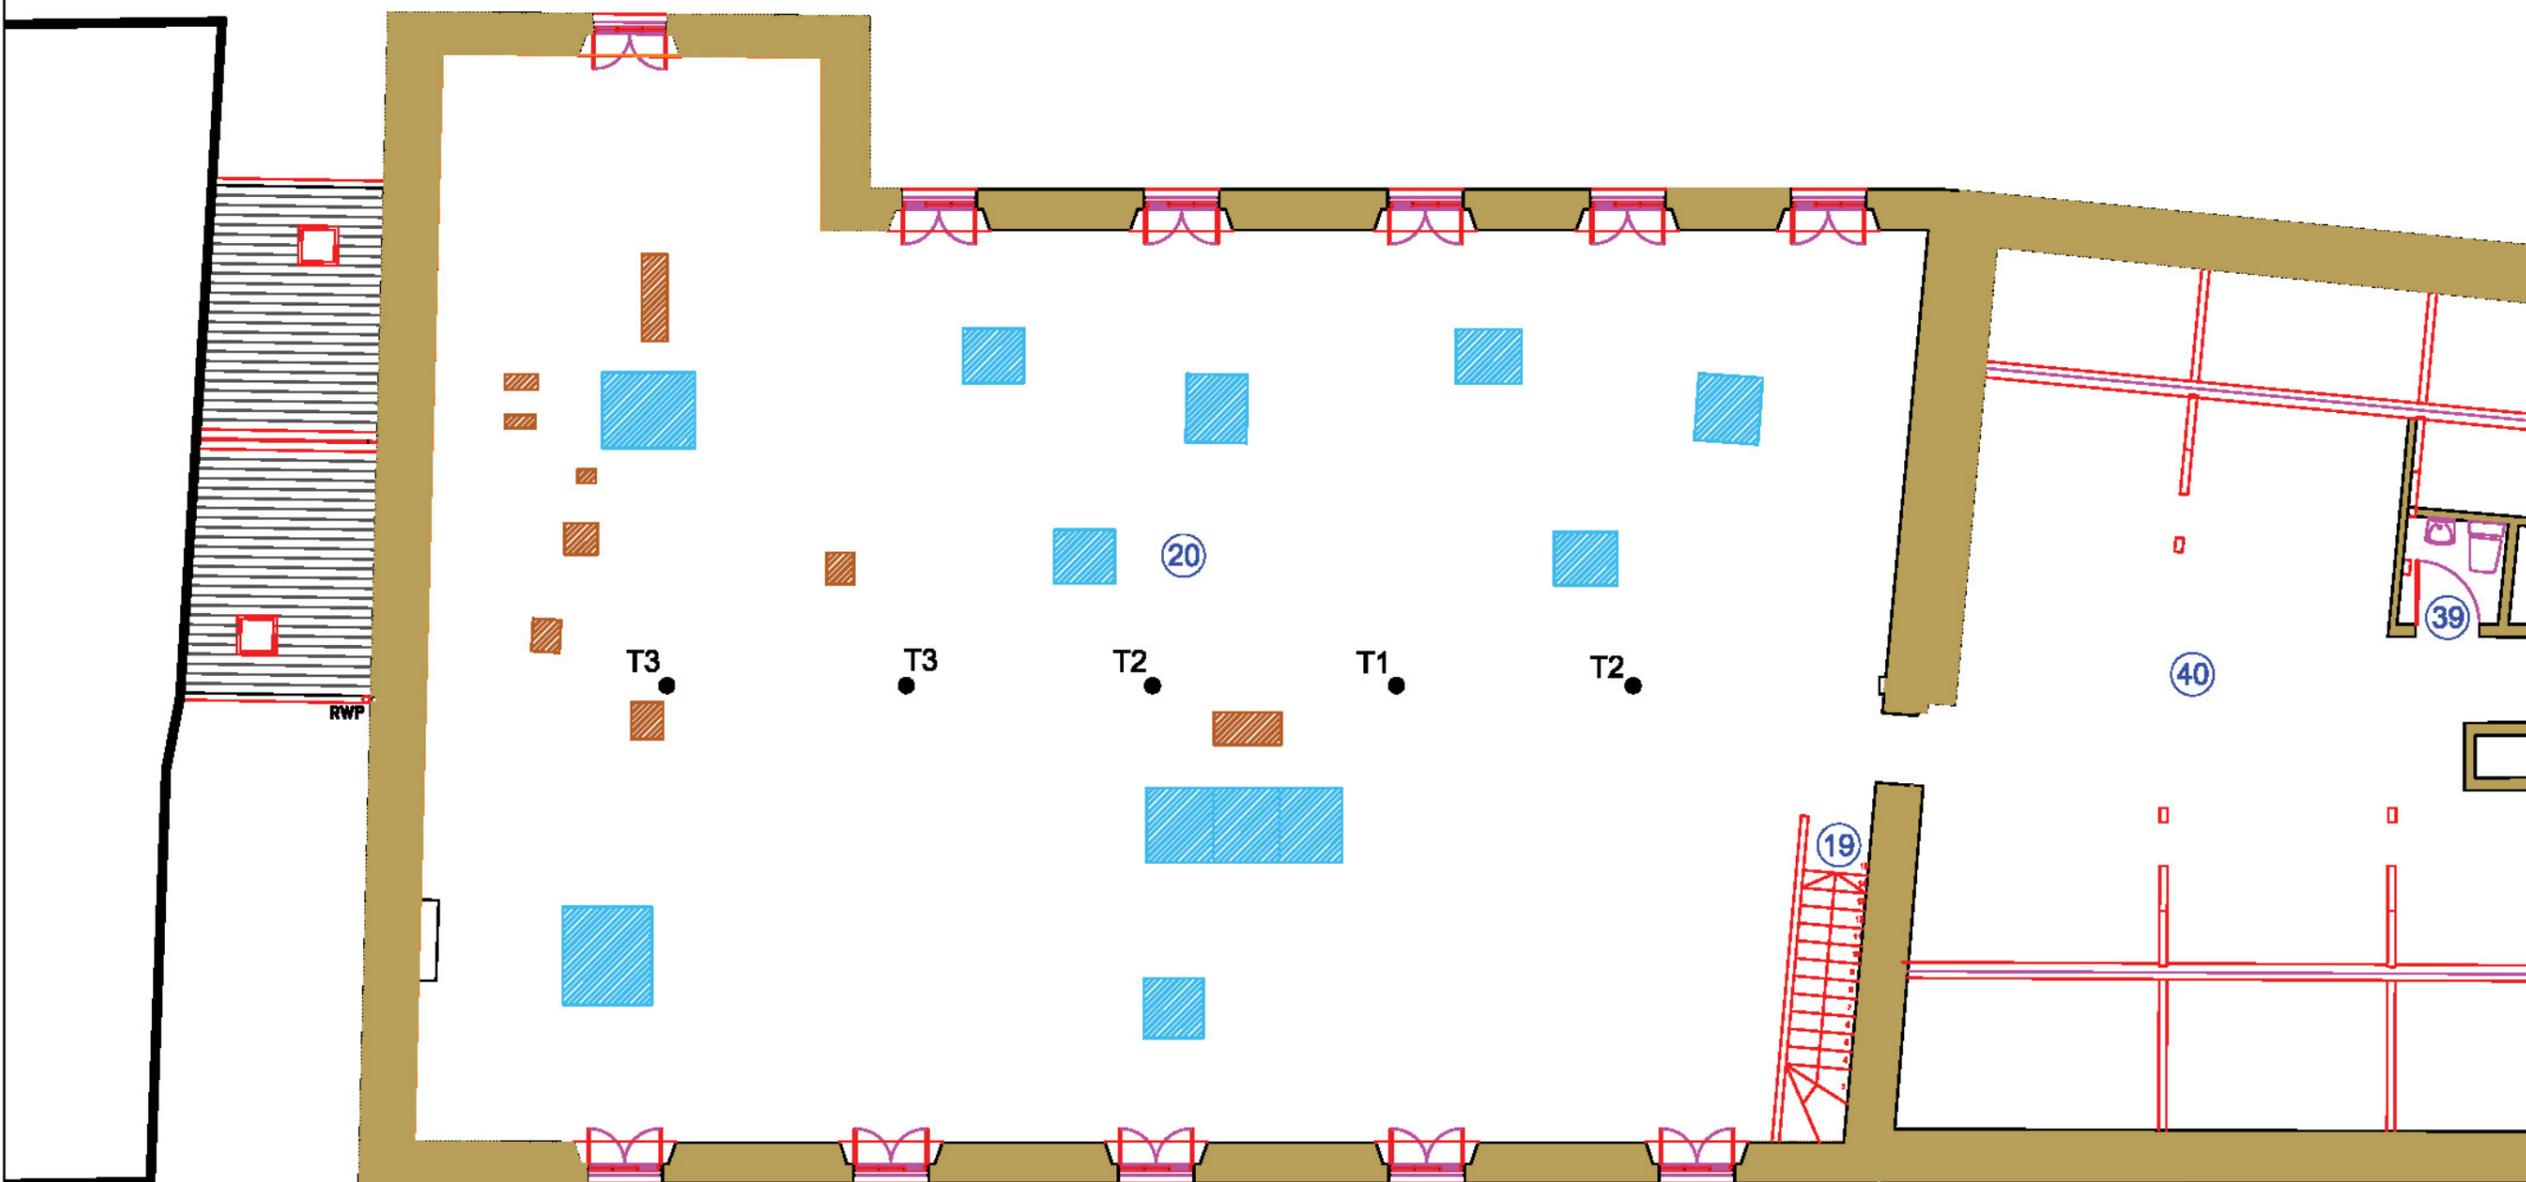
Title:
**Unit 20, third floor plan
showing the positions of
hatches and repairs**

- 5.1.12 The floor of Unit 20 is laid with timber tongue-and-grooved planking. Several square and rectangular hatches measuring between 2.5m x 1m and 0.8m x 0.8m are present in the floor and fitted with brass ring handles and hinges. Several other square patches are flush with the floor and most likely relate to floor repairs.

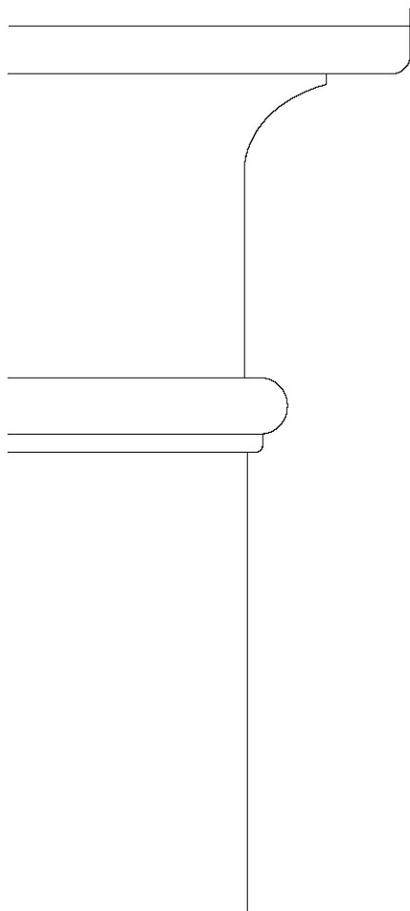
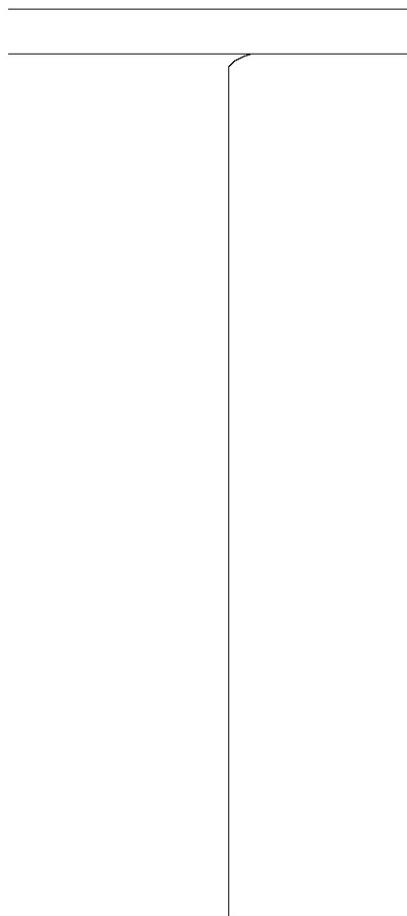
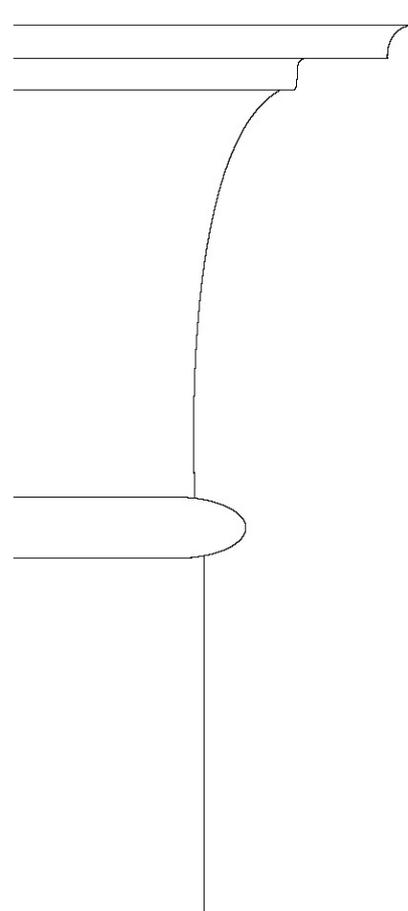
Type 1 : Squat Capital

Type 2: Pipe Column

Type 3: Fluted Capital

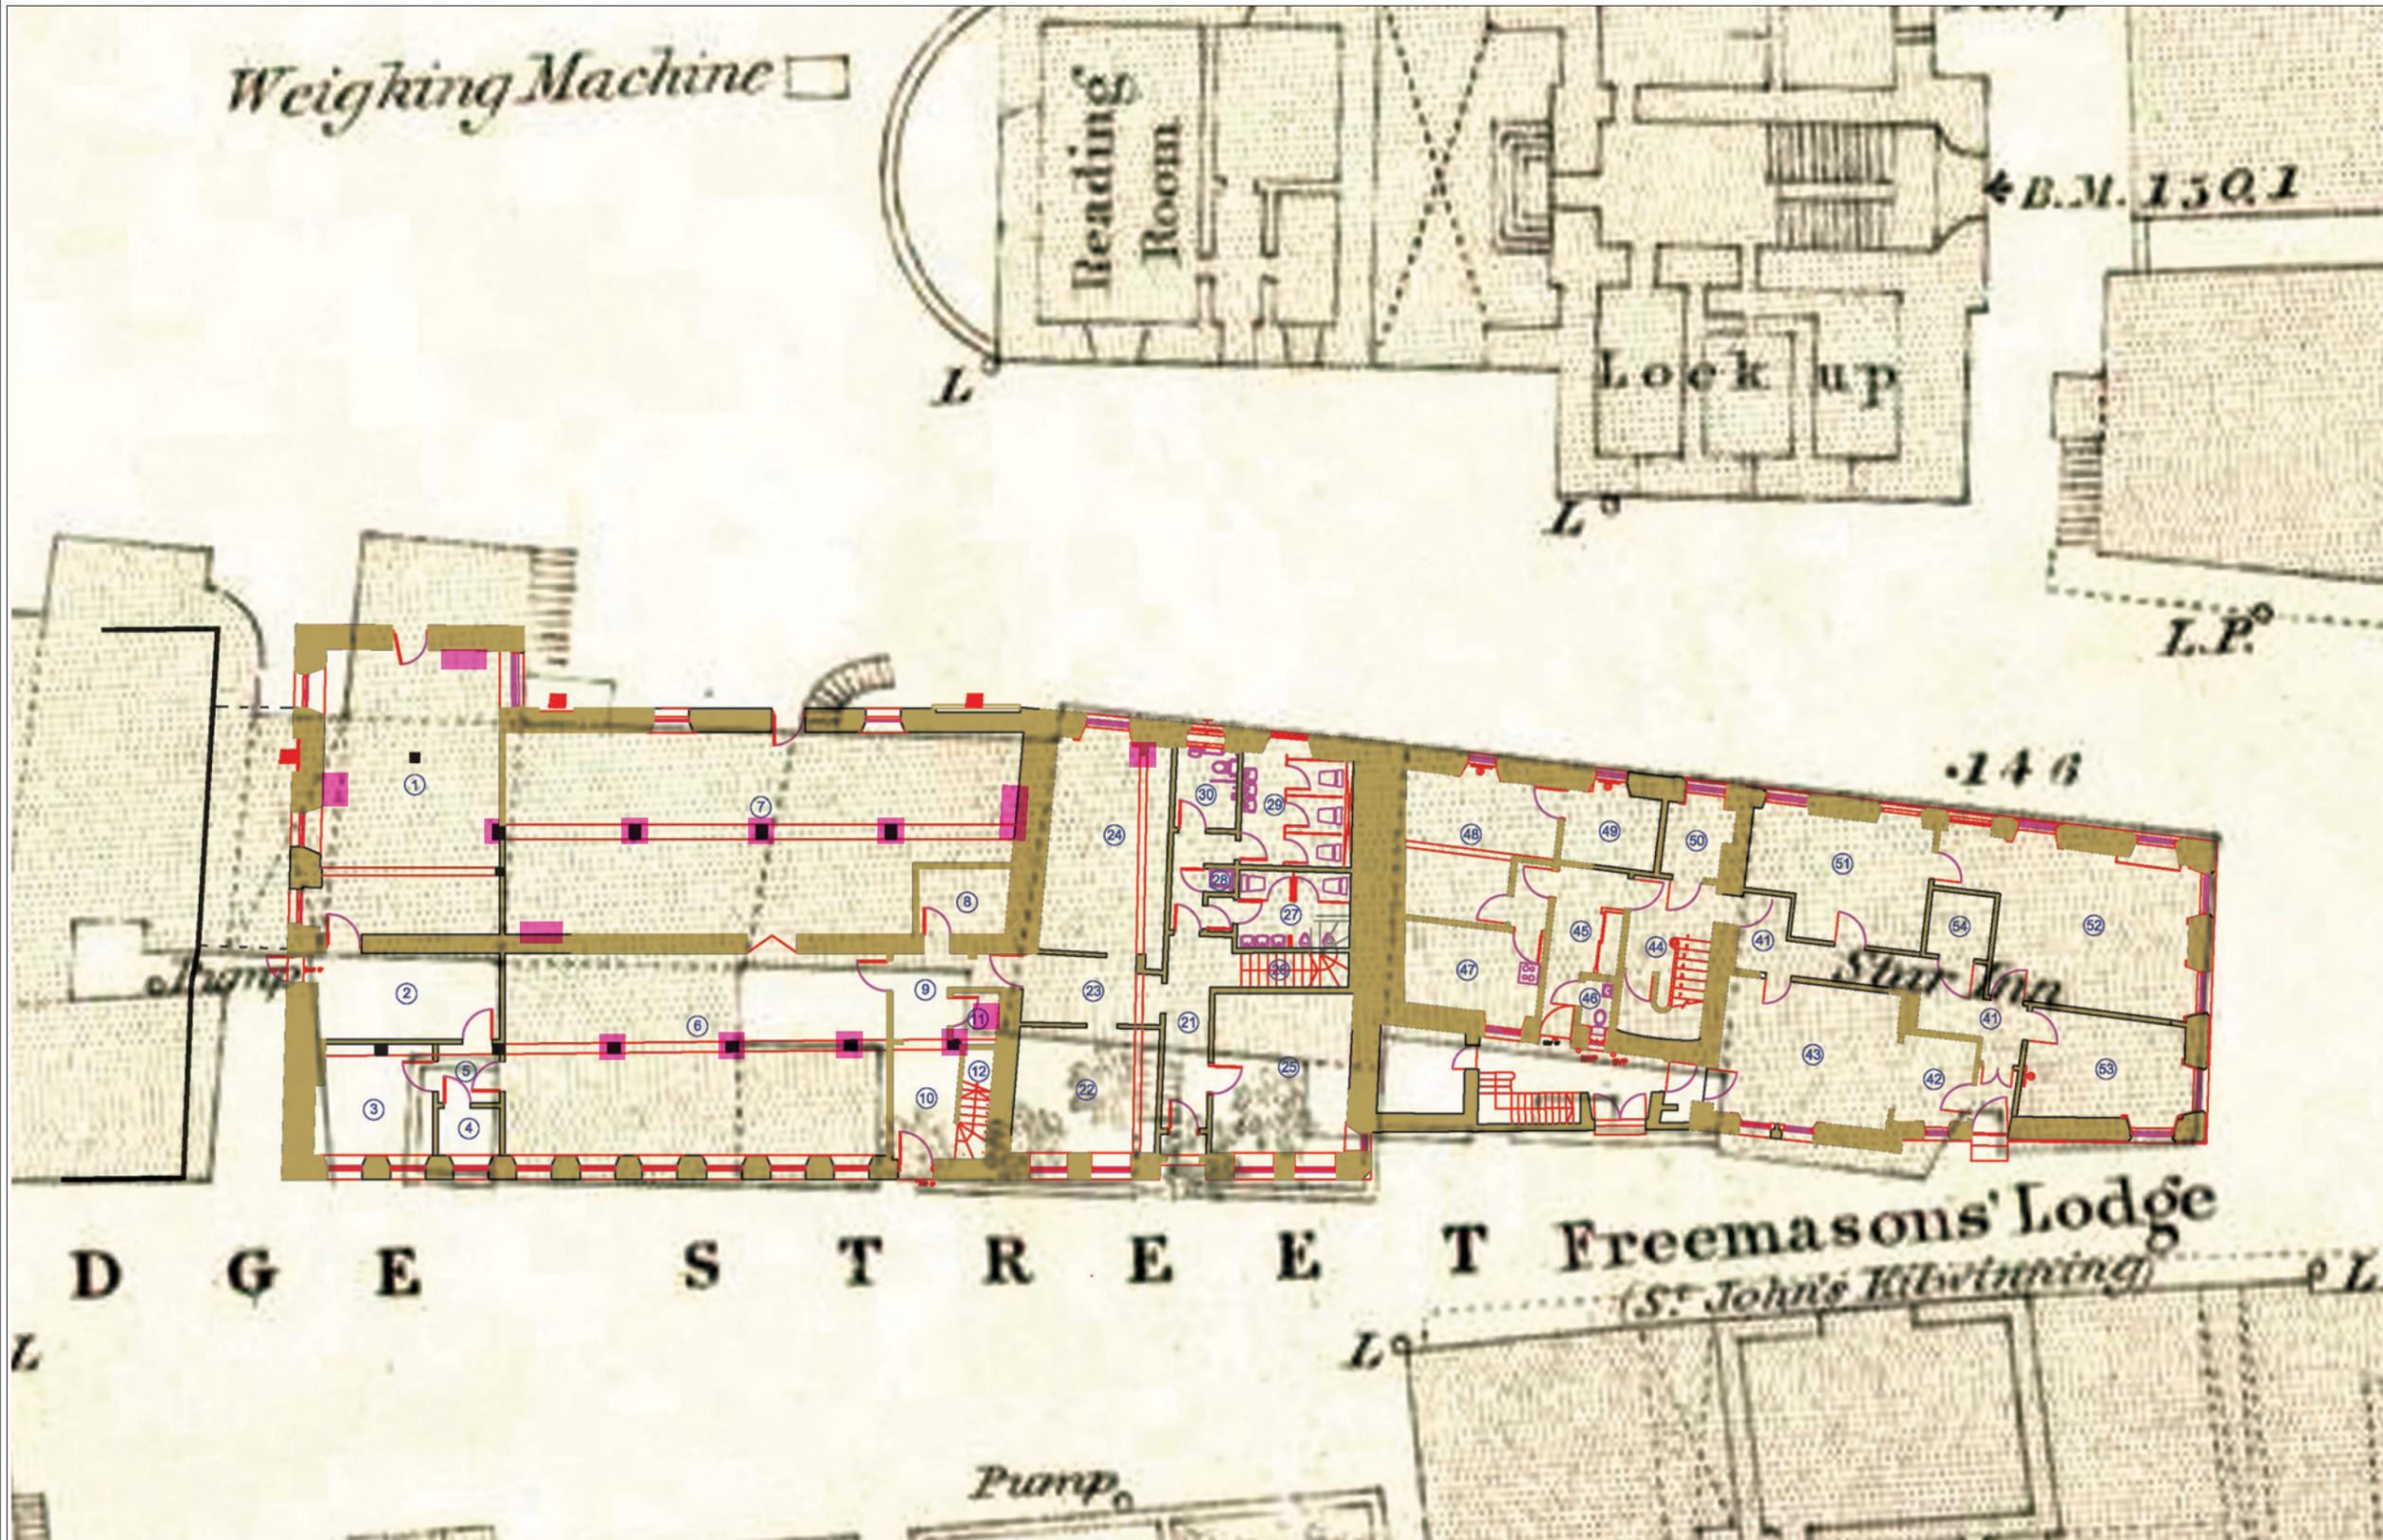
Fig. No: 11 Revision: A

- 6.1.1 The enlargement of the core-block of the grain store to its present footprint (Fig 11) required the installation of cast-iron columns to accommodate the new layout and the double span M-shaped roof. The use of cast-iron columns in industrial buildings stems from after the 1790s with the development and dissemination of the cast-iron building frame which became widely established in ‘fire-proof’ mill design. These early columns were often cruciform in shape and later were replaced by a basic cylindrical shape. The cylinder columns with roll-moulded capitals became the commonest type used in textile mills during the 19th and early 20-centuries (Giles and Goodhall 1992). In the case of the former grain store, it seems likely that the owners may have obtained the columns from a textile mill or some other industrial building.

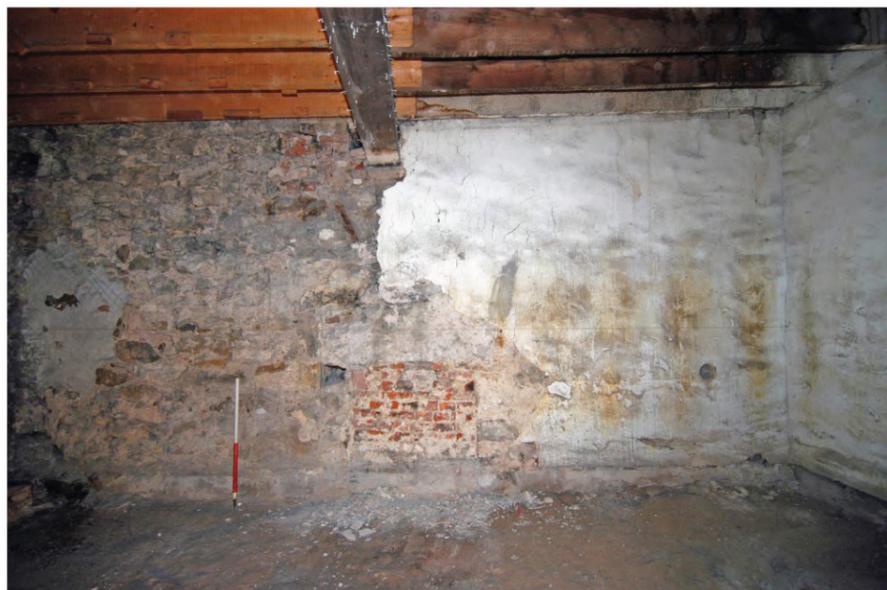
Plate 1: Unit 7, west facing wall fireplace

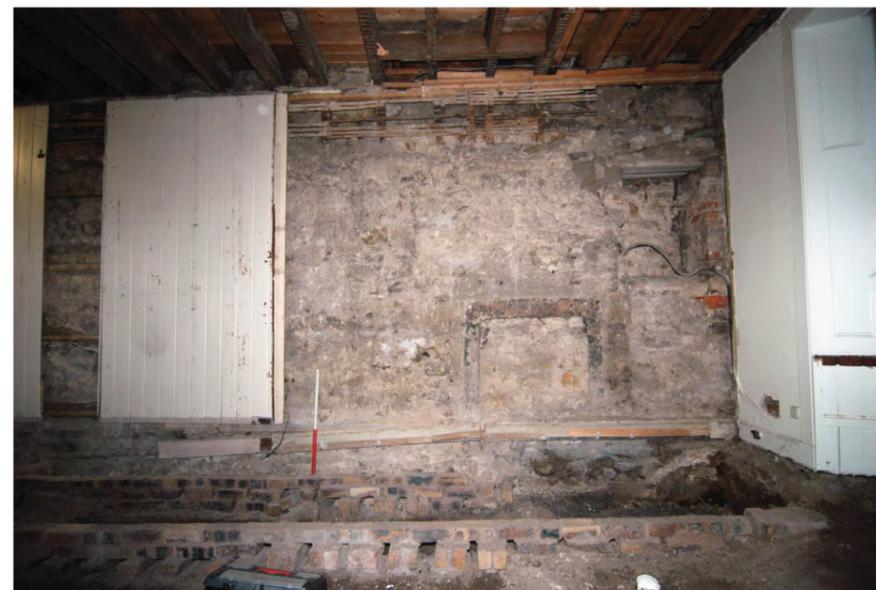
- 5.1.7 A fireplace is visible at the right at the north end of the wall. It is blocked up by mortar bonded rubble. The surround is dressed sandstone and has four holes in the lintel. A press measuring 0.8m wide and 2.2m high is situated to the right of the fireplace and its lower section is blocked and plastered over. It has a modern concrete lintel, and modern block-work is present on the wall above, suggesting a significant repair of recent age.

- 5.1.8 The stonework above the fireplace is random rubble in a lime mortar bond. At floor level there is a timber skirting board. Below this, the foundations of the wall comprise larger sub-rounded boulders bonded with lime mortar.

Plate 2: Unit 24, east facing wall fireplace

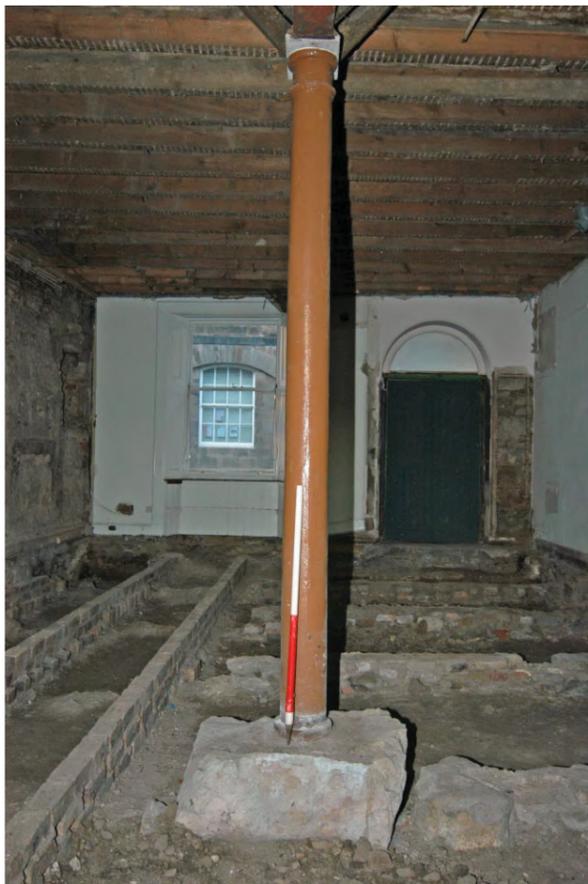
Plate 5: Ground floor, Unit 23 Cylindrical Column

| Location | Dimensions (height) | Summary description |
|---|---|---|
| Unit 23 | 2.7m | A brown-painted column at the centre of the room (Plate 5). The base-plate is 0.32m x 0.32m cemented onto a sandstone block measuring 0.8m x 0.8m and 0.32m thick. The capital is squat with roll-moulded collars and a flat plate to support a modern RSJ. |

Ground floor, Units 23 & 24 columns (Plate 5 & 6)

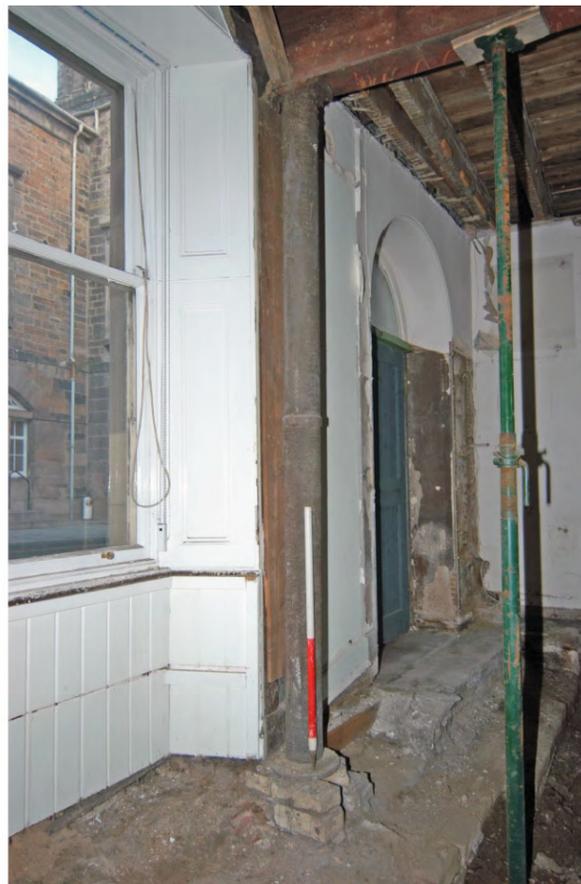
Plate 6: Ground floor, Unit 24 Pipe Column

| Location | Dimensions (height) | Summary description |
|---|---|---|
| Unit 24 | 2.6m | An unpainted steel column 0.28m in circumference resting on a circular base-plate (Plate 6). Mid-way up the column there is a cast-iron collar. The capital is plain. |

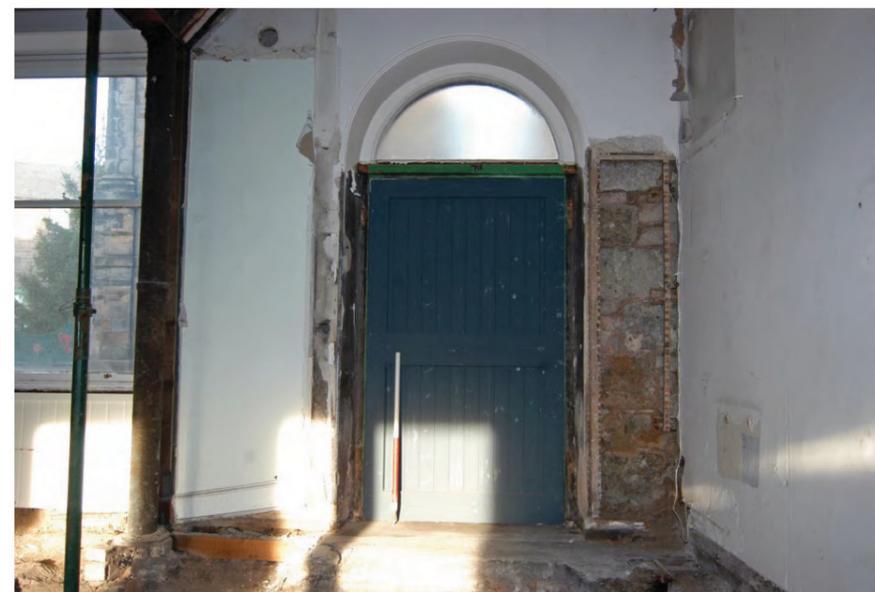
Plate 12: Revealed doorway exposed during soft strip

- 5.2.6 During the appraisal survey a disabled toilet (Unit 30) was lit on its north wall by a semi-circular fan-light of a blocked door (Plate 12). Following the soft-strip the full extent of the door was revealed. The fanlight and door-frame are original late 19-century features but the door is modern.
- 5.2.7 Two horse-shoe shaped fireplaces located in Units 25 and 36 were to be included in the Phase 2 surveys to establish if there was any evidence for the presence of earlier fireplaces. The walls surrounding the fireplaces were not stripped of modern linings and therefore no assessment could be made. The horse-shoe fireplaces were photographed during the Phase 1 survey.

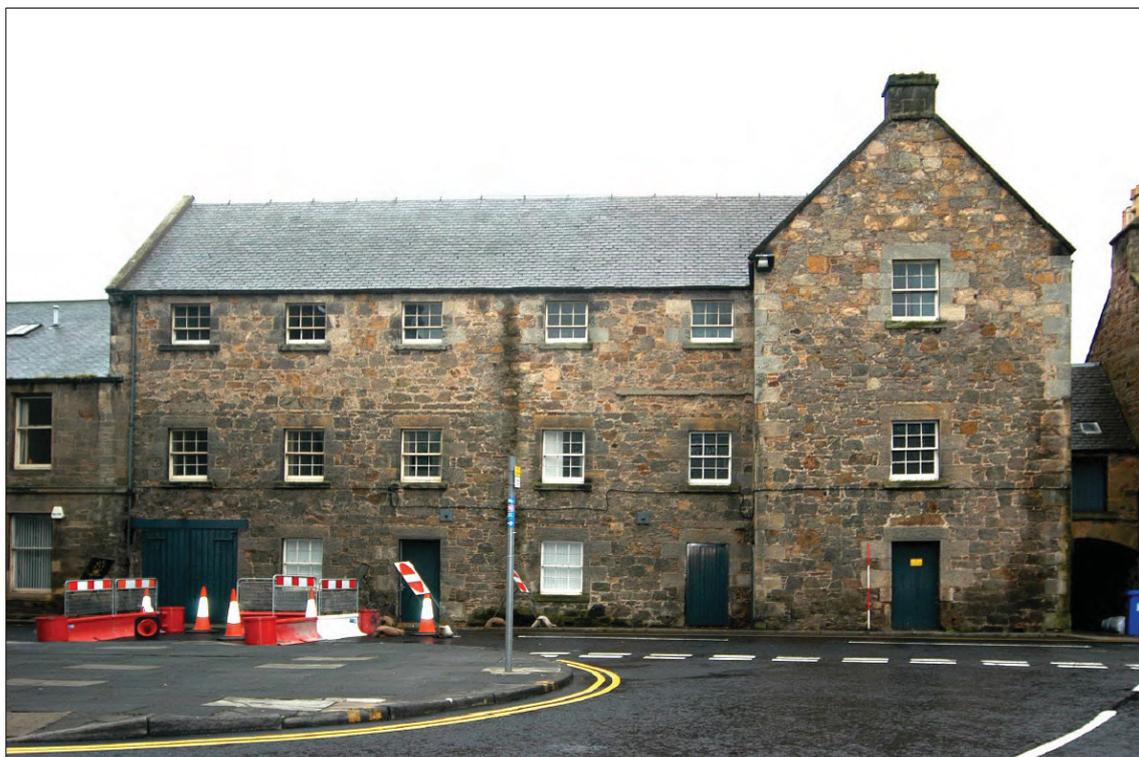
3.1.3 The NMRS holds a record for the former Grain Store (NT57SW 137). There is no formal description within the record. There are two digital images within the record, originally taken by John Hume in the 1960s. The first (SC 613034) shows the north elevation and advanced gable. An earlier roof line can be seen on the advanced north-facing gable and north elevation of the core block. The second photograph shows the west-gable and the south-facing elevation. The different contrasting stonework of the area that was heightened is very clear.

Plate 13 - North-facing elevation of the grain store with contrasting stonework on the second floor.
