**91-93 High Street, Haddington
East Lothian**

Archaeological Watching Brief

Report No. 1725

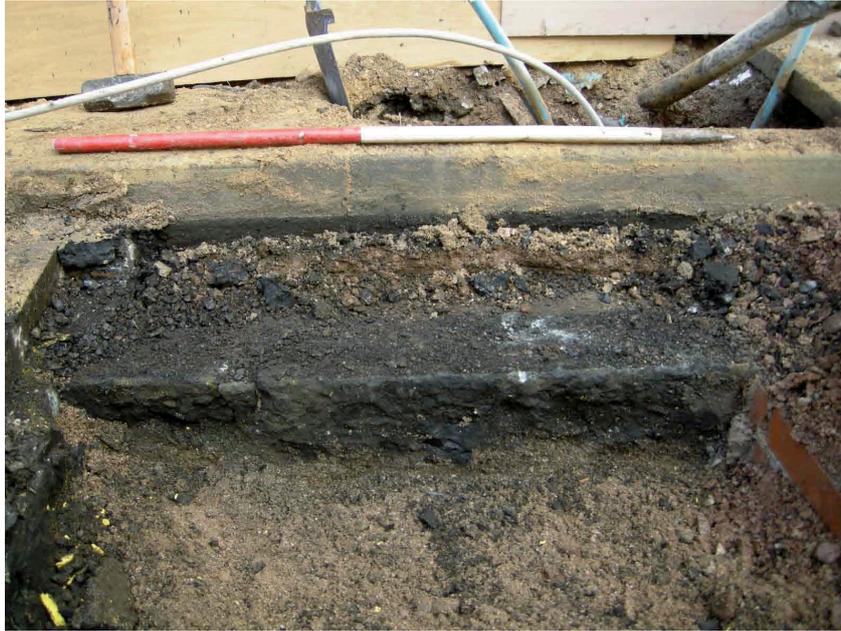
- 3.1.6 The remains of two earlier kerb stones (**007**) were located under the bedding layer for the modern kerb. The stones were aligned E-W, parallel to the High Street, and were left in situ.

Fig. 2 - Photograph showing kerbing stones

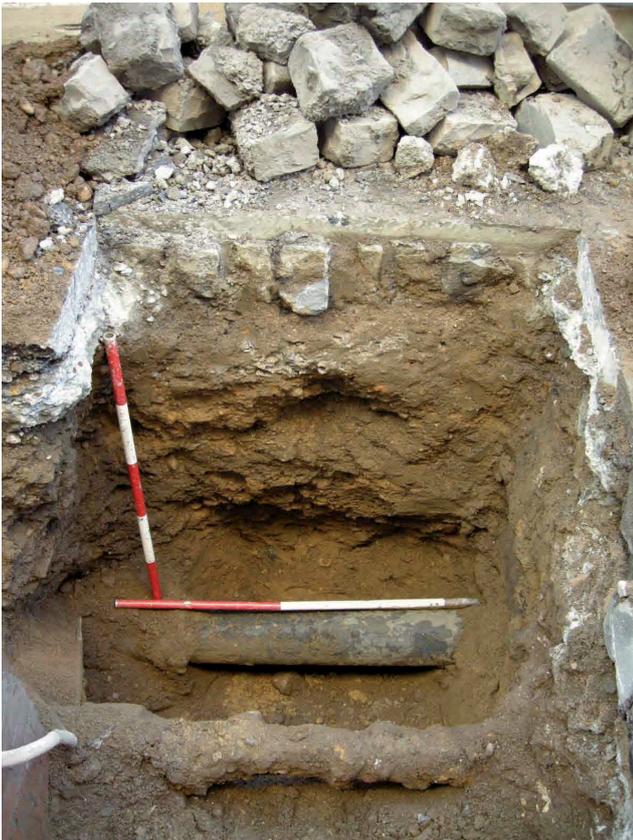
- 3.1.3 Underneath the tarmac road, a deposit of stone setts (**003**) laid upon a bedding layer of light-greyish coarse-grained sand (**004**) was excavated. The setts continued southward underneath **001**. The deposit did not continue to the east and west due to modern truncation during the incorporation of the manhole (**002**) and activity associated with road building or maintenance in the High Street itself.

- 3.1.5 The deposits underlying **005** consisted of mixed orangey-sand and gravel backfill (**006**) for utility service trenches. In total, four extant services were noted running through the trench, indicating the area had been heavily disturbed.

Fig. 3 - Photograph showing buried services & cobbled surface

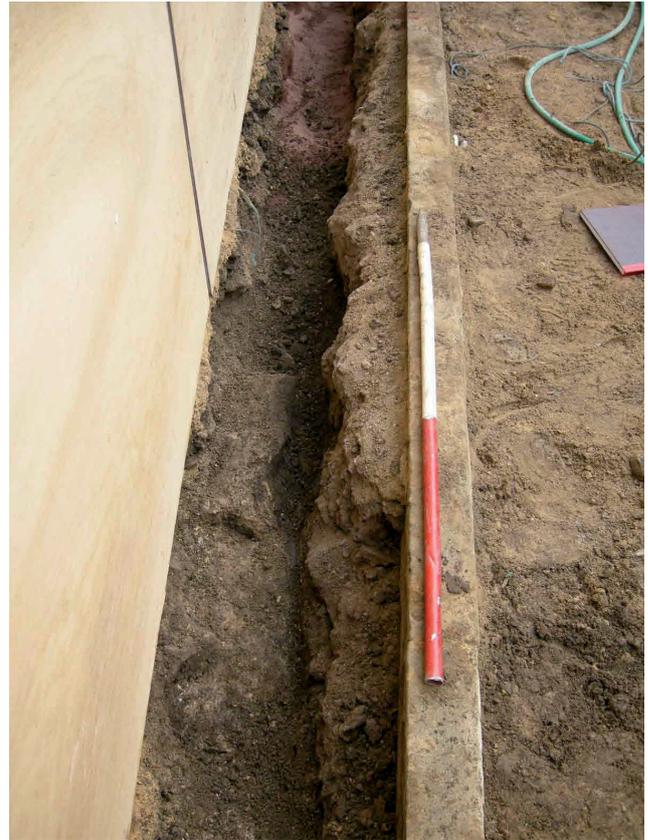
- 3.1.7 Beneath the pavement running parallel to the building's elevation was a linear deposit of masonry which comprised large, roughly hewn stone blocks (**008**). The blocks underlay the modern make-up for the paved surface and continued

under the building. The preferred interpretation is that the stones form the foundation footing for the building.

Fig. 4 - Photograph showing foundation stones
