21 Melville Street, Edinburgh **Historic Building Survey**

> **Data Structure Report** No. 1771

Author	Stuart Mitchell MA AIfA
Illustrator	Graeme Carruthers MA MAAIS
Editor	Melanie Johnson MA PhD FSA Scot MIfA
Commissioned by	Axis Mason
Date issued	May 2010
Version	0
OASIS Reference	cfaarcha1-77760
Planning Application No	09/00972/FUL
Grid Ref	NT 243 737

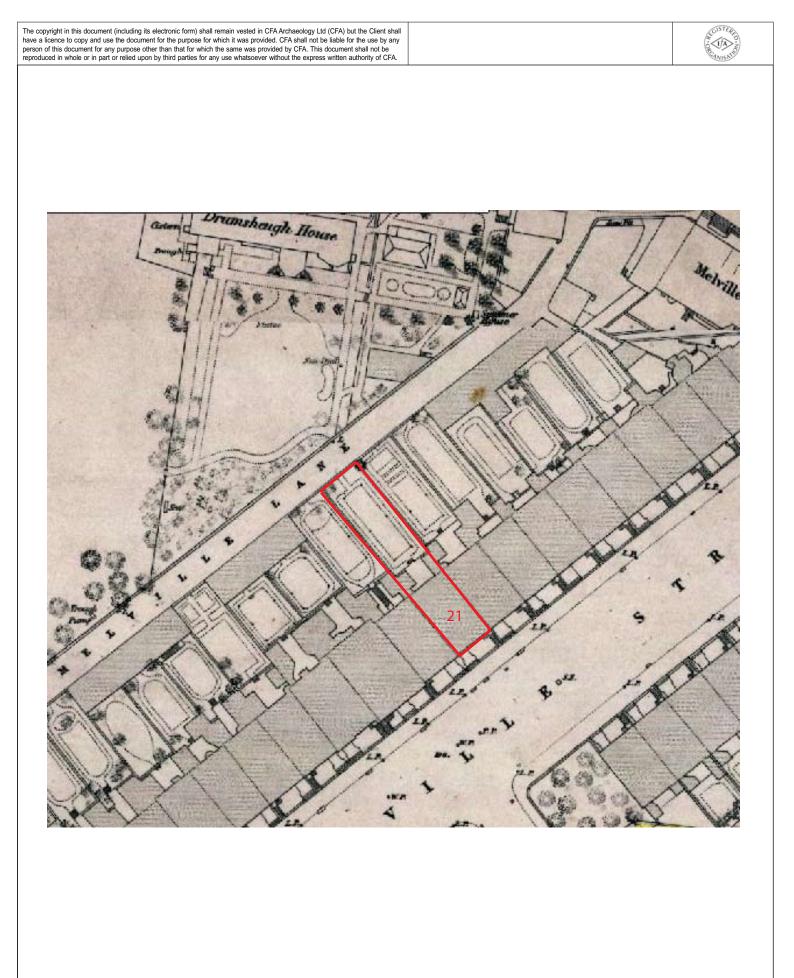
3.1.4 Melville Street is depicted on the 1832 Great Reform Act Plans and Reports map. The 1870-92 Ordnance Survey Town Plans (Fig. 2) and the First Edition Ordnance Survey Map show the same layout of 21 Melville Street as today, including the recessed shed separating the lean-to from the back of the main building, described below.

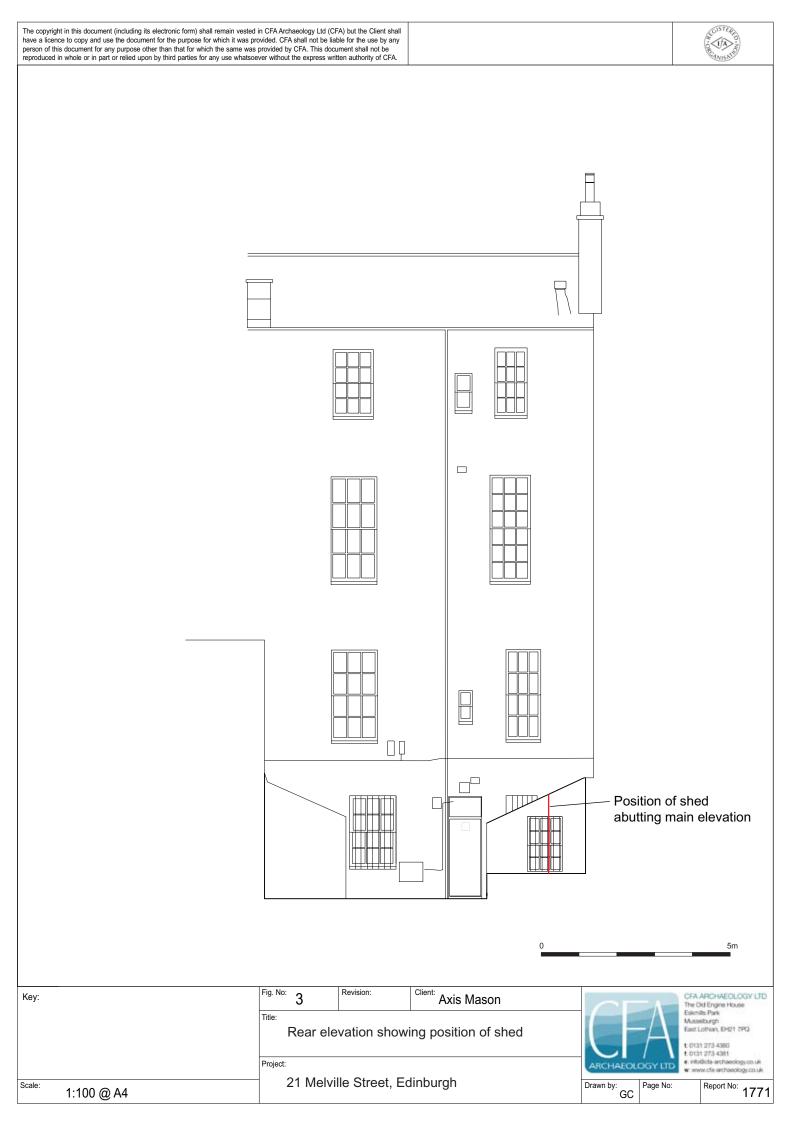
- 2.3.1 A Level 1 Building Survey (English Heritage 2006) was carried out on the lean-to building. All elevations of this feature were photographed. A narrative on the building's character, form and any visible construction phases visible in the fabric were recorded.
- 2.3.2 The position of the lean-to building in relation to the main rear elevation was recorded and annotated on the architect's drawing (Fig. 3).
- 2.3.3 CFA uses a Nikon D100 Professional Digital SLR for historic building recording.

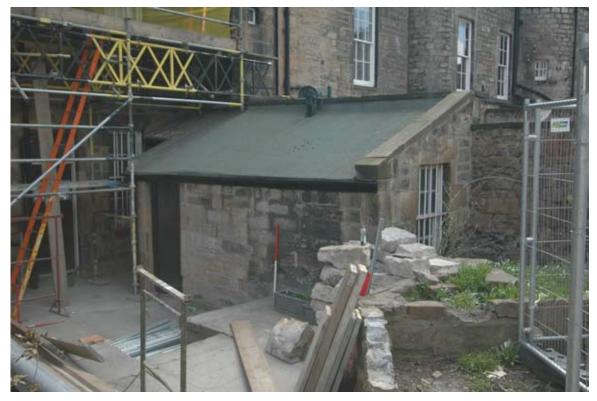
Fig 4. General shot of lean-to

- 3.2.2 The structure forms an exterior shed or outhouse (Fig. 4). It is ashlar built throughout with a shallow single pitched roof covered with bitumous felt, and features a door on the east elevation and a window on the north elevation.

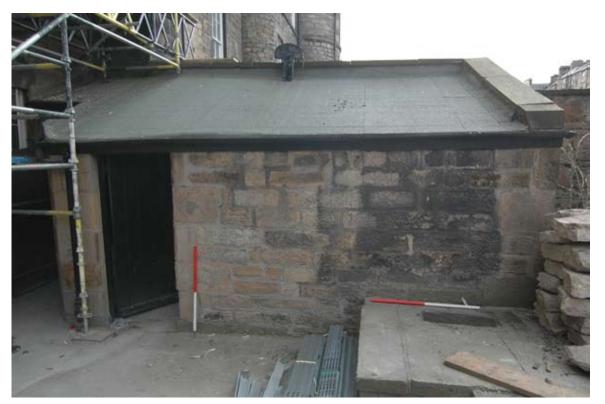
Fig 5. East elevation of lean-to

- 3.2.3 The east elevation (Fig. 5) measures 5140mm wide by 2015mm and forms the front of the structure. It has quoins at the corners of the building and the doorframe, although their use most likely stems from decorative rather than structural demands as the ashlar coursing used for the main wall structure is very regular and thus stable. Some of the stones used have a variety of stugging and droving patterns, although together they do not form any pattern. The door is timber and set in a timber frame, and measures 2000mm high and 910mm wide. The top of the elevation is finished with a black painted timber barge board and plastic roan gutter.

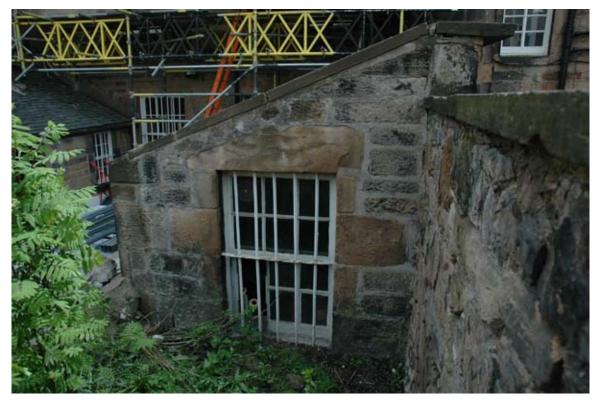
Fig 6. North elevation of lean-to

- 3.2.4 The north elevation (Fig. 6) faces forms the gable end and measures 2480mm wide. It has a centrally placed window containing a sash and case window.

The sandstone used in the build is a mix of pale and reddish stone, again with random stugging and droving on some stones. It abuts the west boundary wall.

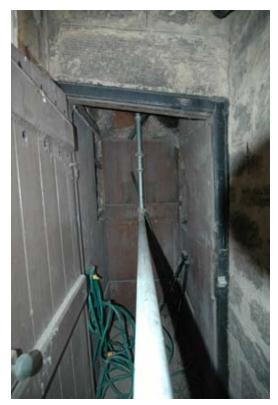
Fig 7 East elevation of shed

- 3.2.6 The lean-to is joined to the rear of the main building by a small shed built against the west wall and recessed between the lean-to and the main building (Fig. 2, 7). It comprises an asymmetric ashlar lintel which abuts the main building to the south and is keyed into the south elevation of the lean-to (Fig. 8). An asymmetric timber doorframe and door forms the front of the shed. The interior of the shed is timber lined to the height of the door.

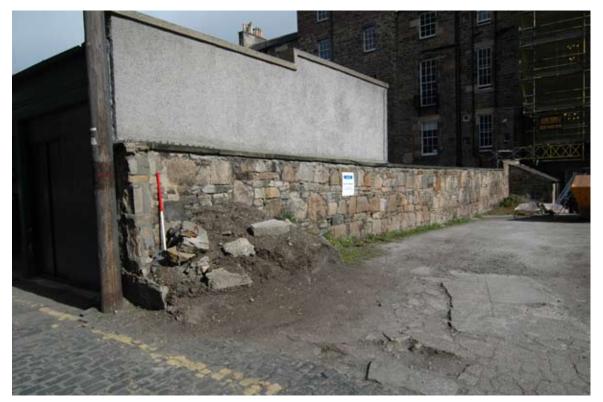
Fig 9. Bounding wall on east side of plot

- 3.2.9 The east wall is 1800mm high and is random rubble coursed, using large rough hewn sandstone blocks with discontinuous string courses (Fig. 9). It is mortar bonded with some concrete repointing. The remains of a return are visible at the north end where the wall abuts the lane, built of rough sandstone quoins. The wall is capped by 65mm thick sandstone slabs.

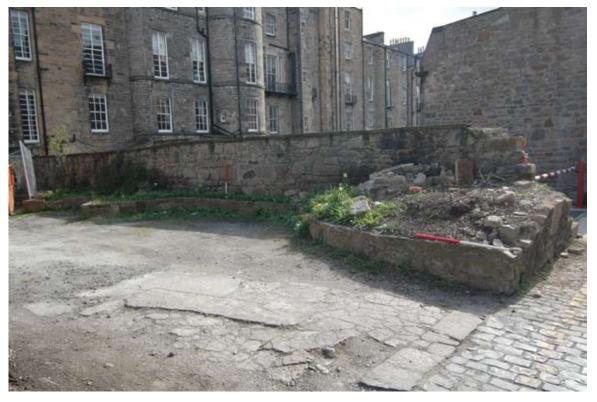
Fig 10. Bounding wall and flower beds on west side of plot

- 3.2.10 The west wall is 1900mm high and is built from random rubble courses set between regular rough hewn sandstone courses and capped with identical slabs to the east wall. The north end is mostly demolished. A wall forming a partial northern boundary adjoins the remains of the west wall (Fig. 10). It is built of random rubble coursed sandstone and has been incorporated into later raised flower beds and car parking bays which run down the side of the west wall.

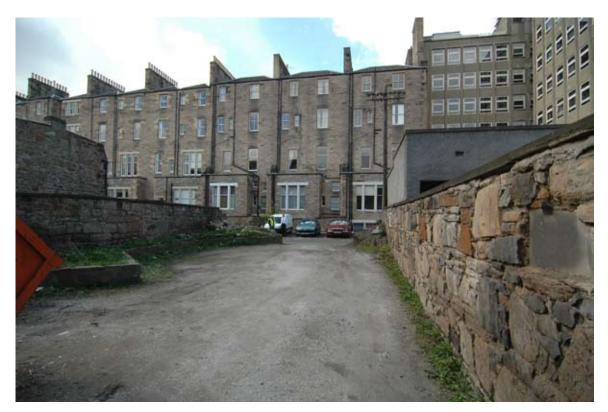
Fig 11. View of plot from rear of building

3.2.1 The lean-to structure lies to the back of 21 Melville Street and is aligned 90° to the terrace. It forms a lean-to against the west boundary wall and is linked to the main building by a small recessed shed. The back of 21 Melville Street forms a linear plot extending to the north and is bounded on either side by sandstone walls (Fig. 11).

- 3.2.8 The car park walls bound the garden plot to the rear and extend for 27.5m north from the main building to Melville Street Lane (Fig. 11). The two walls differ in build, and both have damage to their north end.
