**Airdrie to Bathgate Railway and  
Linked Improvements.  
Armadaale Station Access Road,  
West Lothian**

**Archaeological Evaluation  
Report No. 1820**

Author	Helena Gray MA
Illustrator	Graeme Carruthers MA MAAIS
Editor	Bruce Glendinning BSc PgDip MifA
Commissioned by	Carillion Construction Ltd
Date issued	September 2010
Version	0
OASIS Reference	cfaarcha1 - 82093
Planning Application No	-
Grid Ref	NS 93976 67347

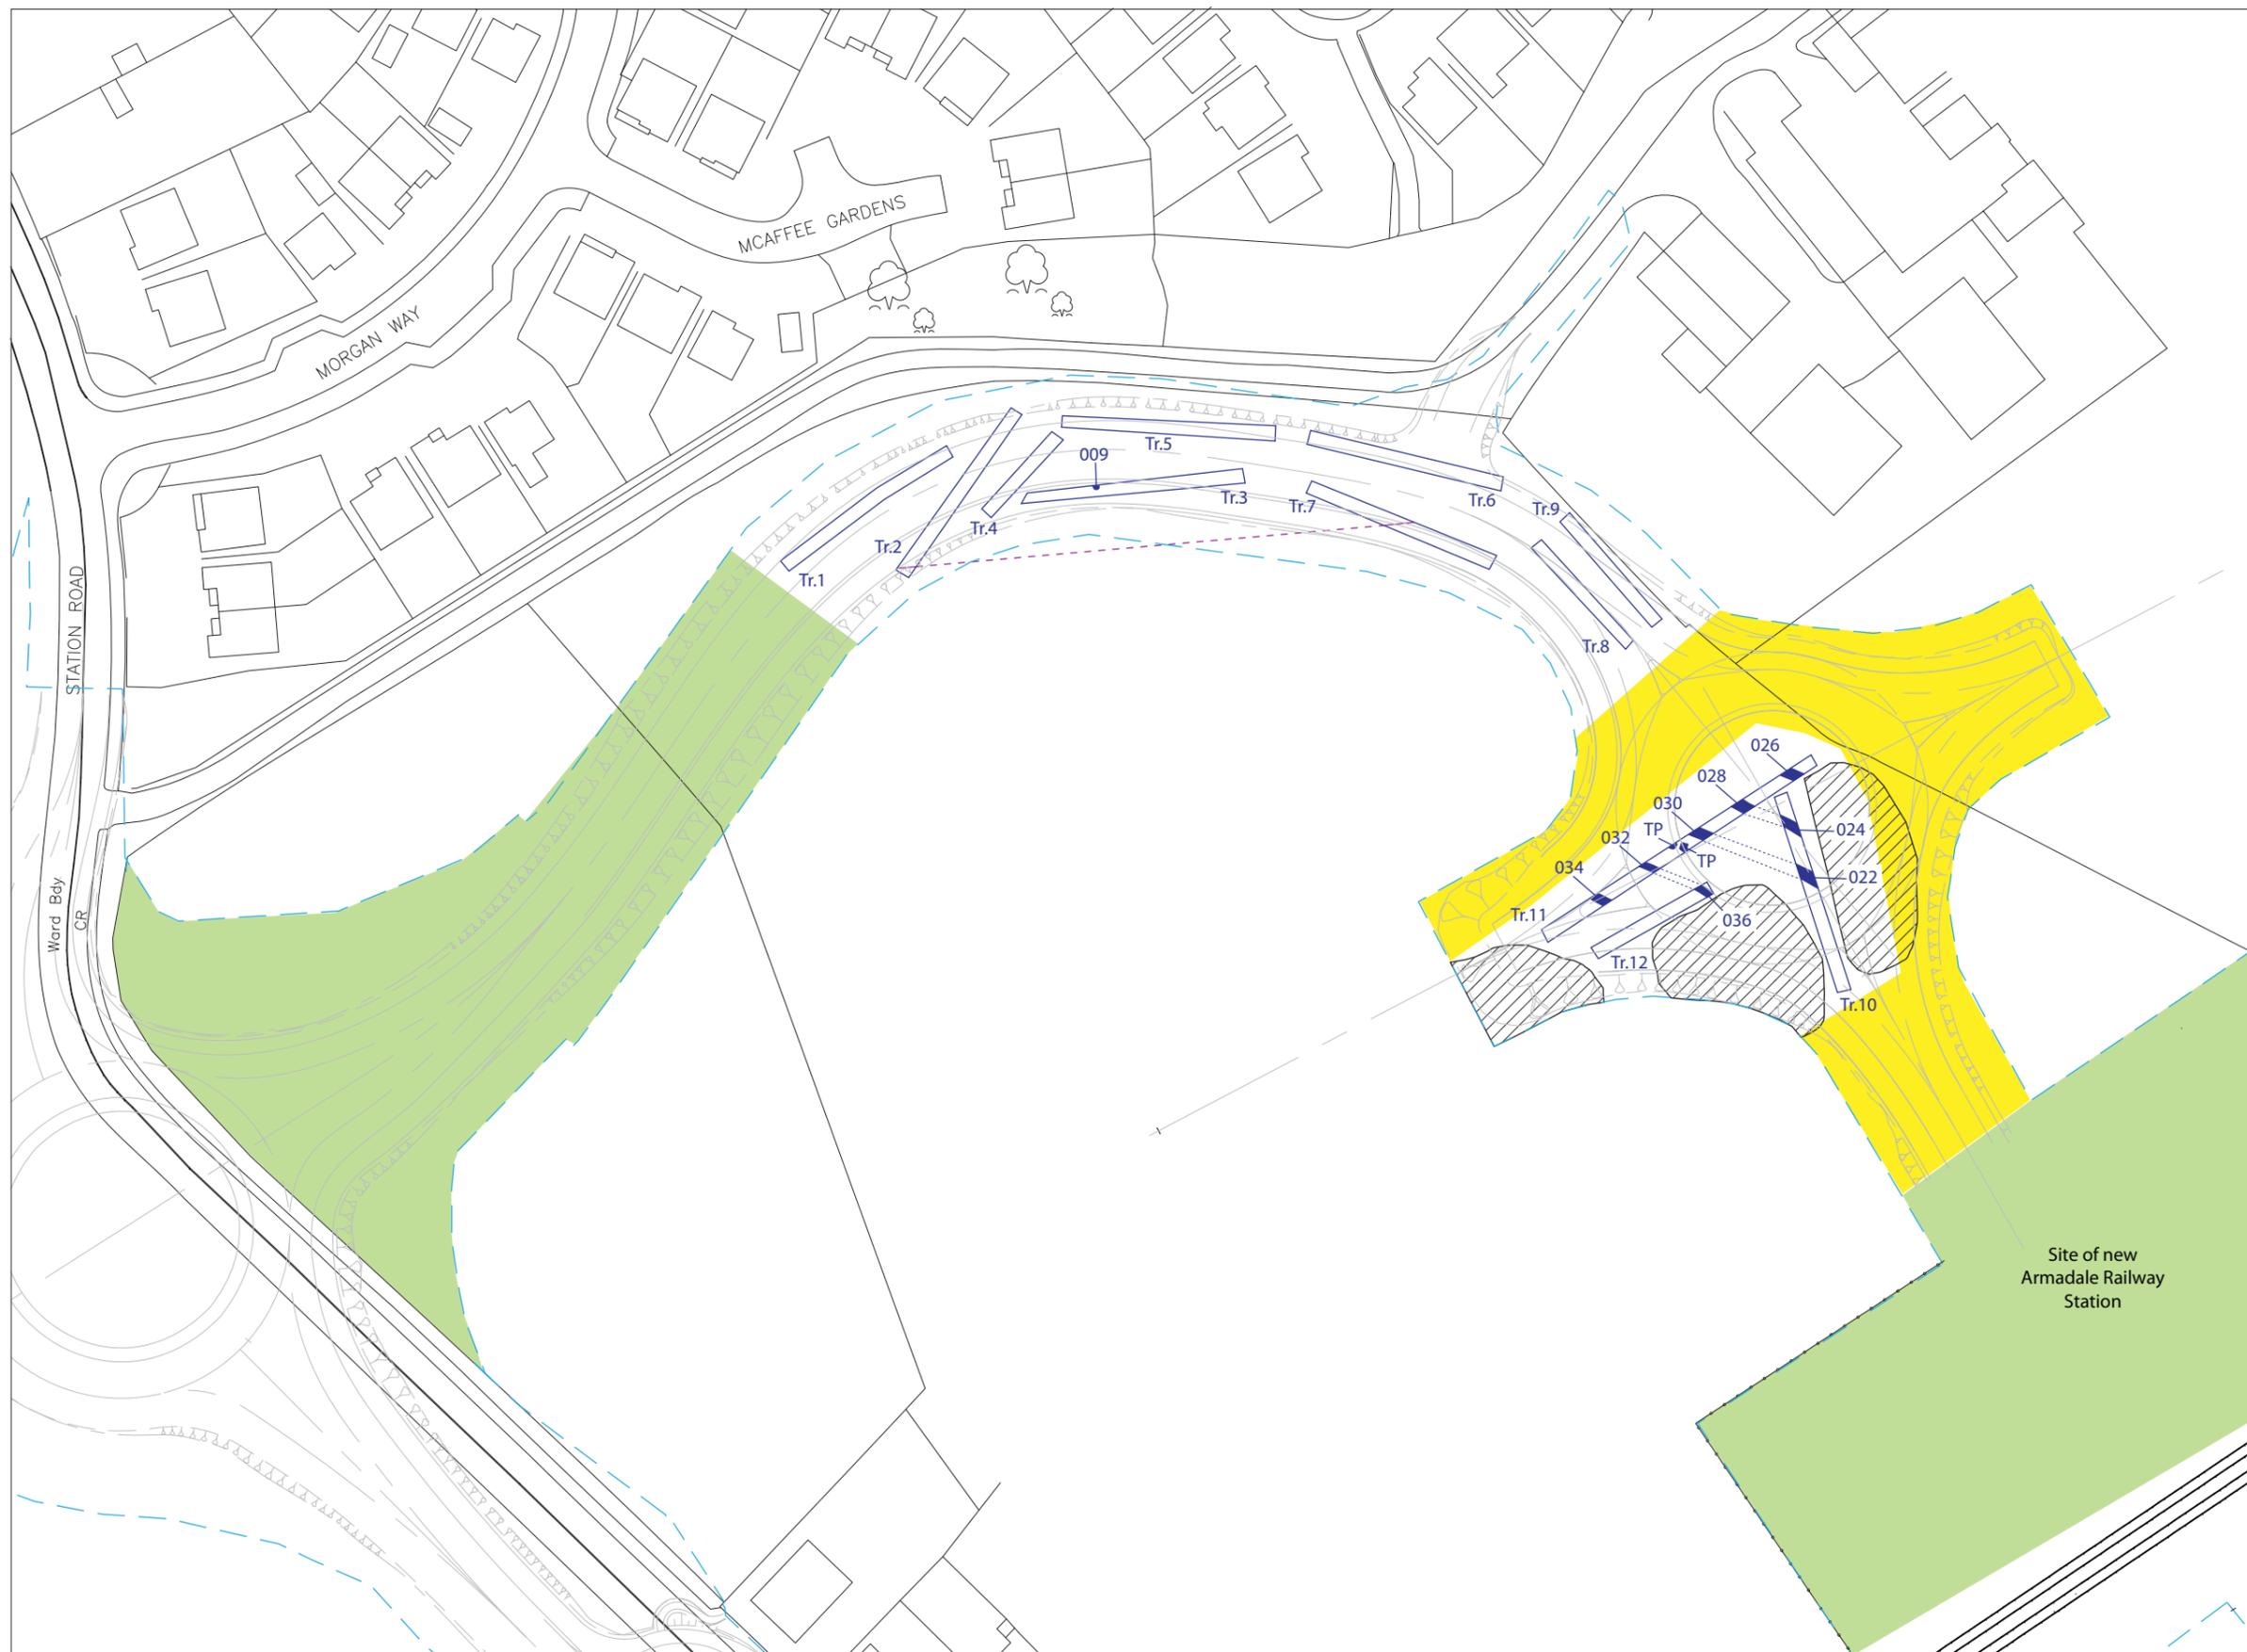
Fig. No: **1**      Revision: **A**

- 3.1.3 No significant archaeological features were identified, nor were any remains of the brick and tile works located. The remains of Rig and Furrow cultivation were revealed in the southern part of the site in the area for a new roundabout (Fig. 1). Natural was reached in all trenches.

- 3.2.2 Two furrows (**022, 024**, Fig 1) were identified cut into the natural subsoil. These were aligned ESE-WNW and were spaced c. 5-6m apart and were c. 1.9m wide. A section was excavated through **022** showing it to have steep sloping sides with a slightly concave base of depth 0.18m. They were filled with a light grey brown silt clay containing flecks of re-deposited natural subsoil (**023, 025**).

- 3.2.4 One furrow was identified in this trench (**036**, Fig. 1). It was on the same alignment as those found in Tr. 11 and was 1.5m in width. It was filled with **037**, a mid bluish brown silty clay.

Title:  
**Site location and location of evaluation trenches**

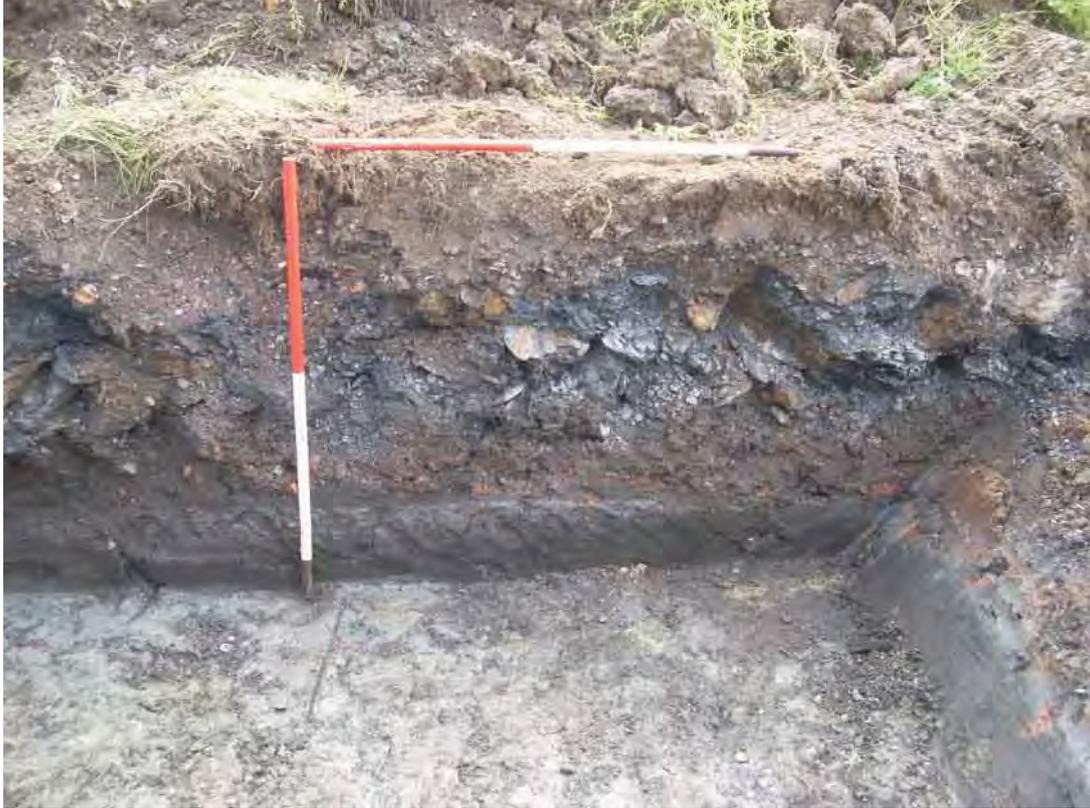
- 3.1.4 In trenches 1-9 deposits of made ground (Figs 2 & 3) were present over natural. These deposits were not present in the remaining trenches

Fig. 2 NW facing section of Tr.1, SW end of trench

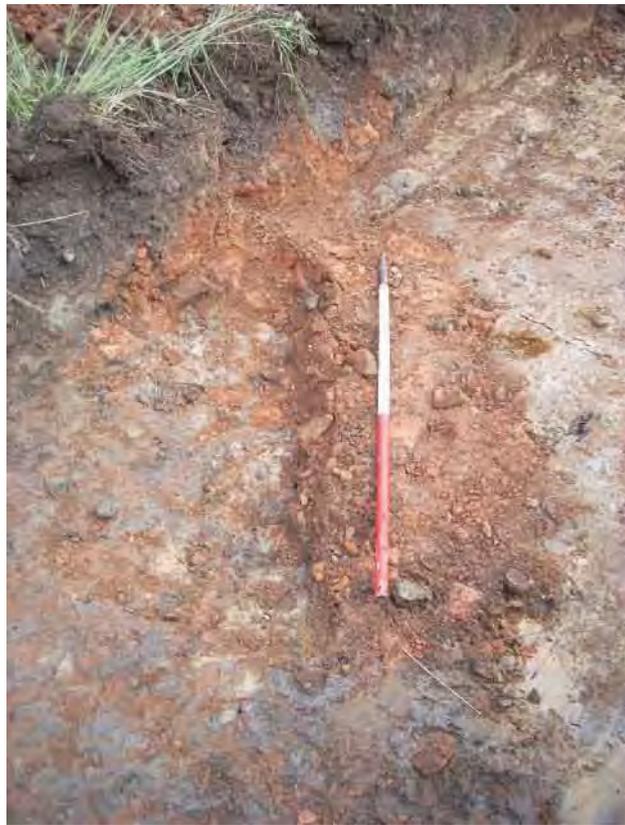
Fig. 3 Shot of brick dump 009 in Tr. 3 from SW

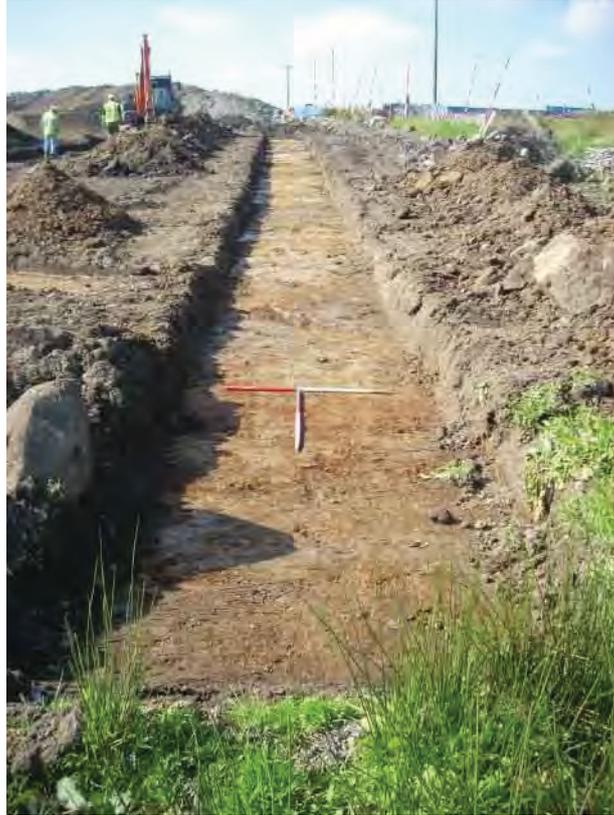
- 3.2.3 Five furrows were identified in this trench (**026, 028, 030, 032, 034**, Figs. 1 & 4), two of which were the continuation of those found in Tr. 10. They followed the same alignment as those in Tr. 10 and were spaced at a similar distance apart, ranging from 1.3 to 1.9m in width. A section was excavated across **026** showing it to have gradually sloping sides and a slightly concave base of depth 0.12m (Fig. 5). The furrows were filled with the same material as in Tr. 10 (**027, 029, 031, 033, 035**), although **033** consisted of a bluish brown silt clay.

Fig. 4 post ex shot of Tr. 11 from NE

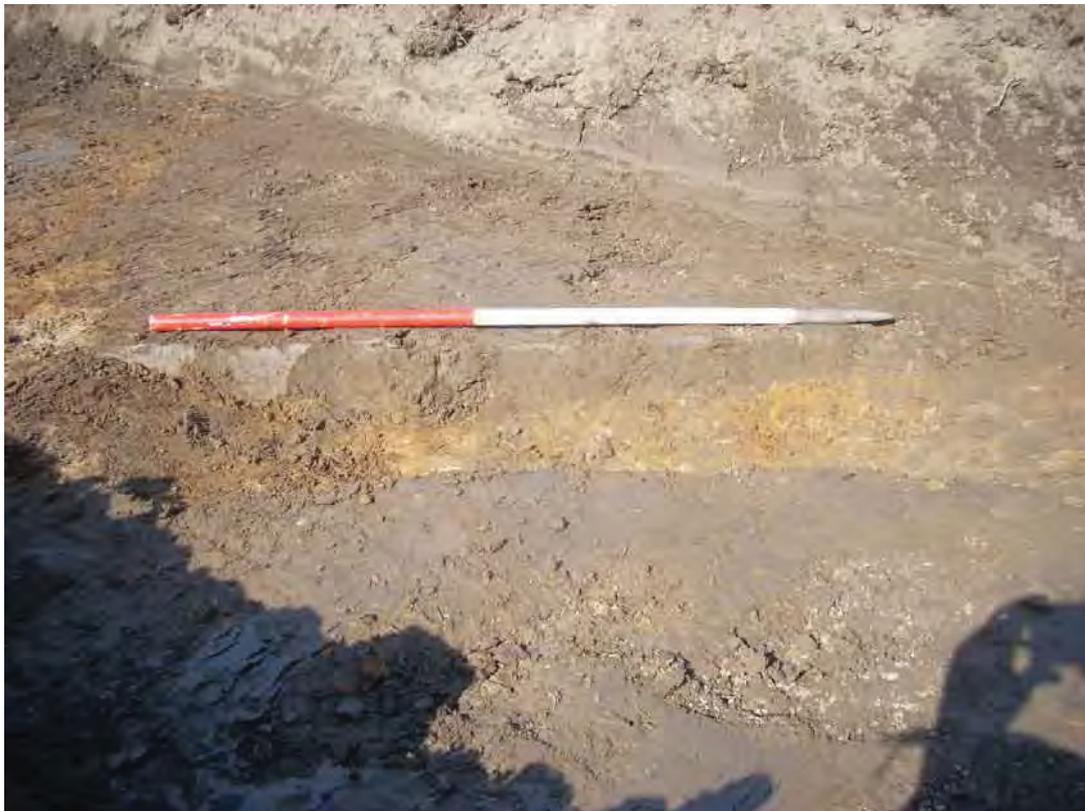
Fig. 5 ESE facing section of Furrow 026 from ESE
