**124 North High Street, Musselburgh  
Historic Building Survey and Watching Brief**

**Data Structure Report  
No. 1855**

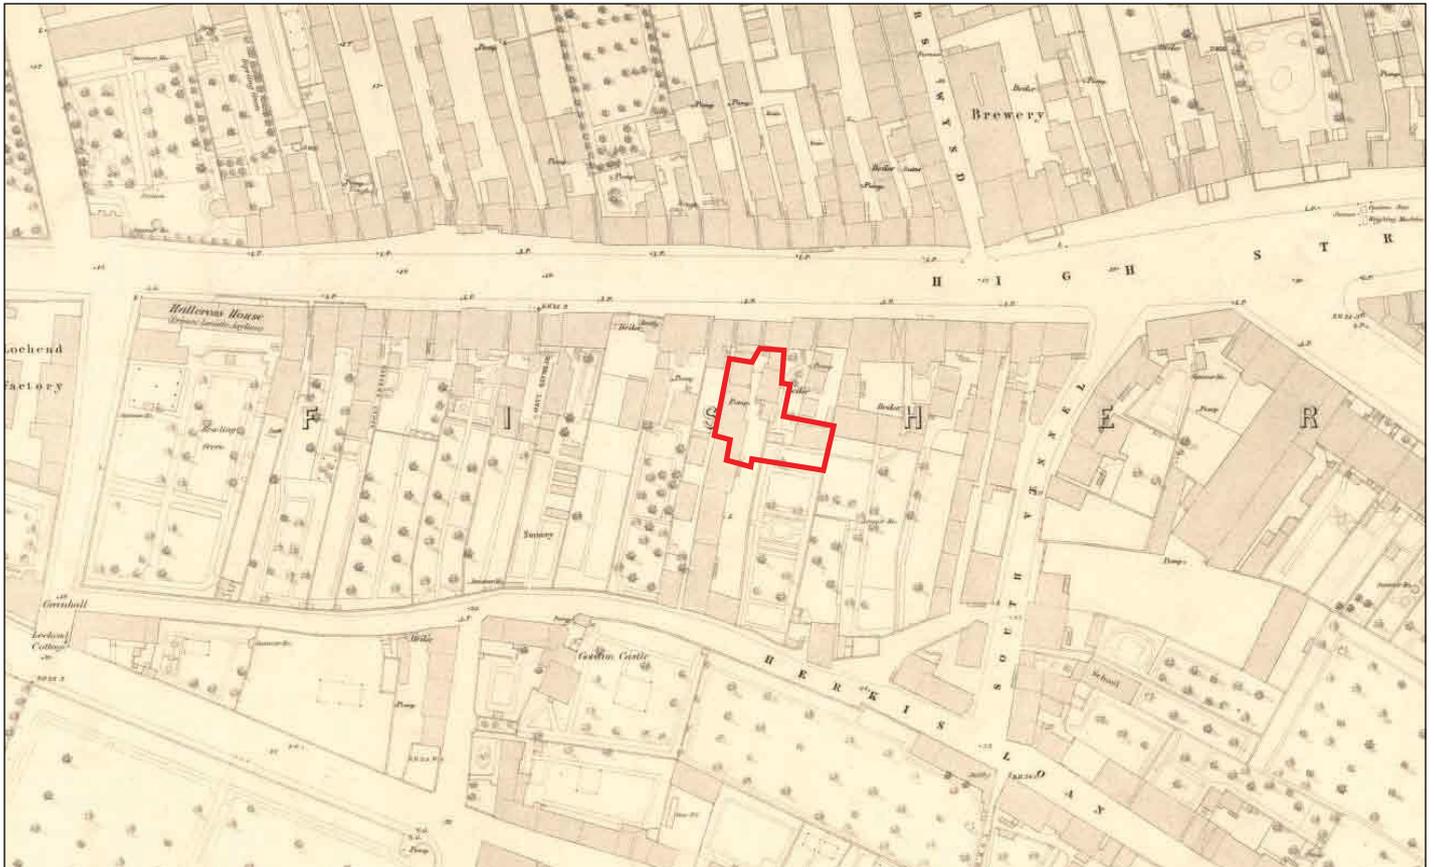
Fig. No: 2      Revision: A      Client: George Herkas  
 Title: Excerpt from Ordnance Survey 1853  
 Large Scale Town plan

The 1853 and 1893 editions of the Ordnance Survey Large Scale Town Plans (Fig. 2) depict a rectangular roofed building which corresponds with the location of the building footprint occupying the south and west corner of the site. Both plans depict an external stair and landing which indicates that the building had a second storey. A smaller rectangular roofed building is also depicted on both editions, occupying the space between the building footprint and the pend. The plans differ, however, in that the pend is not depicted on the 1853 edition, suggesting that significant layout alterations were made to the North High Street buildings in the intervening years.

On the 1853 plan (Fig. 2) the area to the east of the building is depicted as being occupied by a formal garden, which belongs to a separate adjacent plot and has a continuous boundary running from the backs of the North High Street shops to South Street.

By the 1893 edition, the plot is laid out as current. The area previously occupied by the formal garden has been annexed by the yard and the existing boundary walls are clearly depicted. Roofed buildings and an open topped enclosed yard are depicted around the perimeter, which are reflected by gaps in the whitewash on the south and east boundary walls.

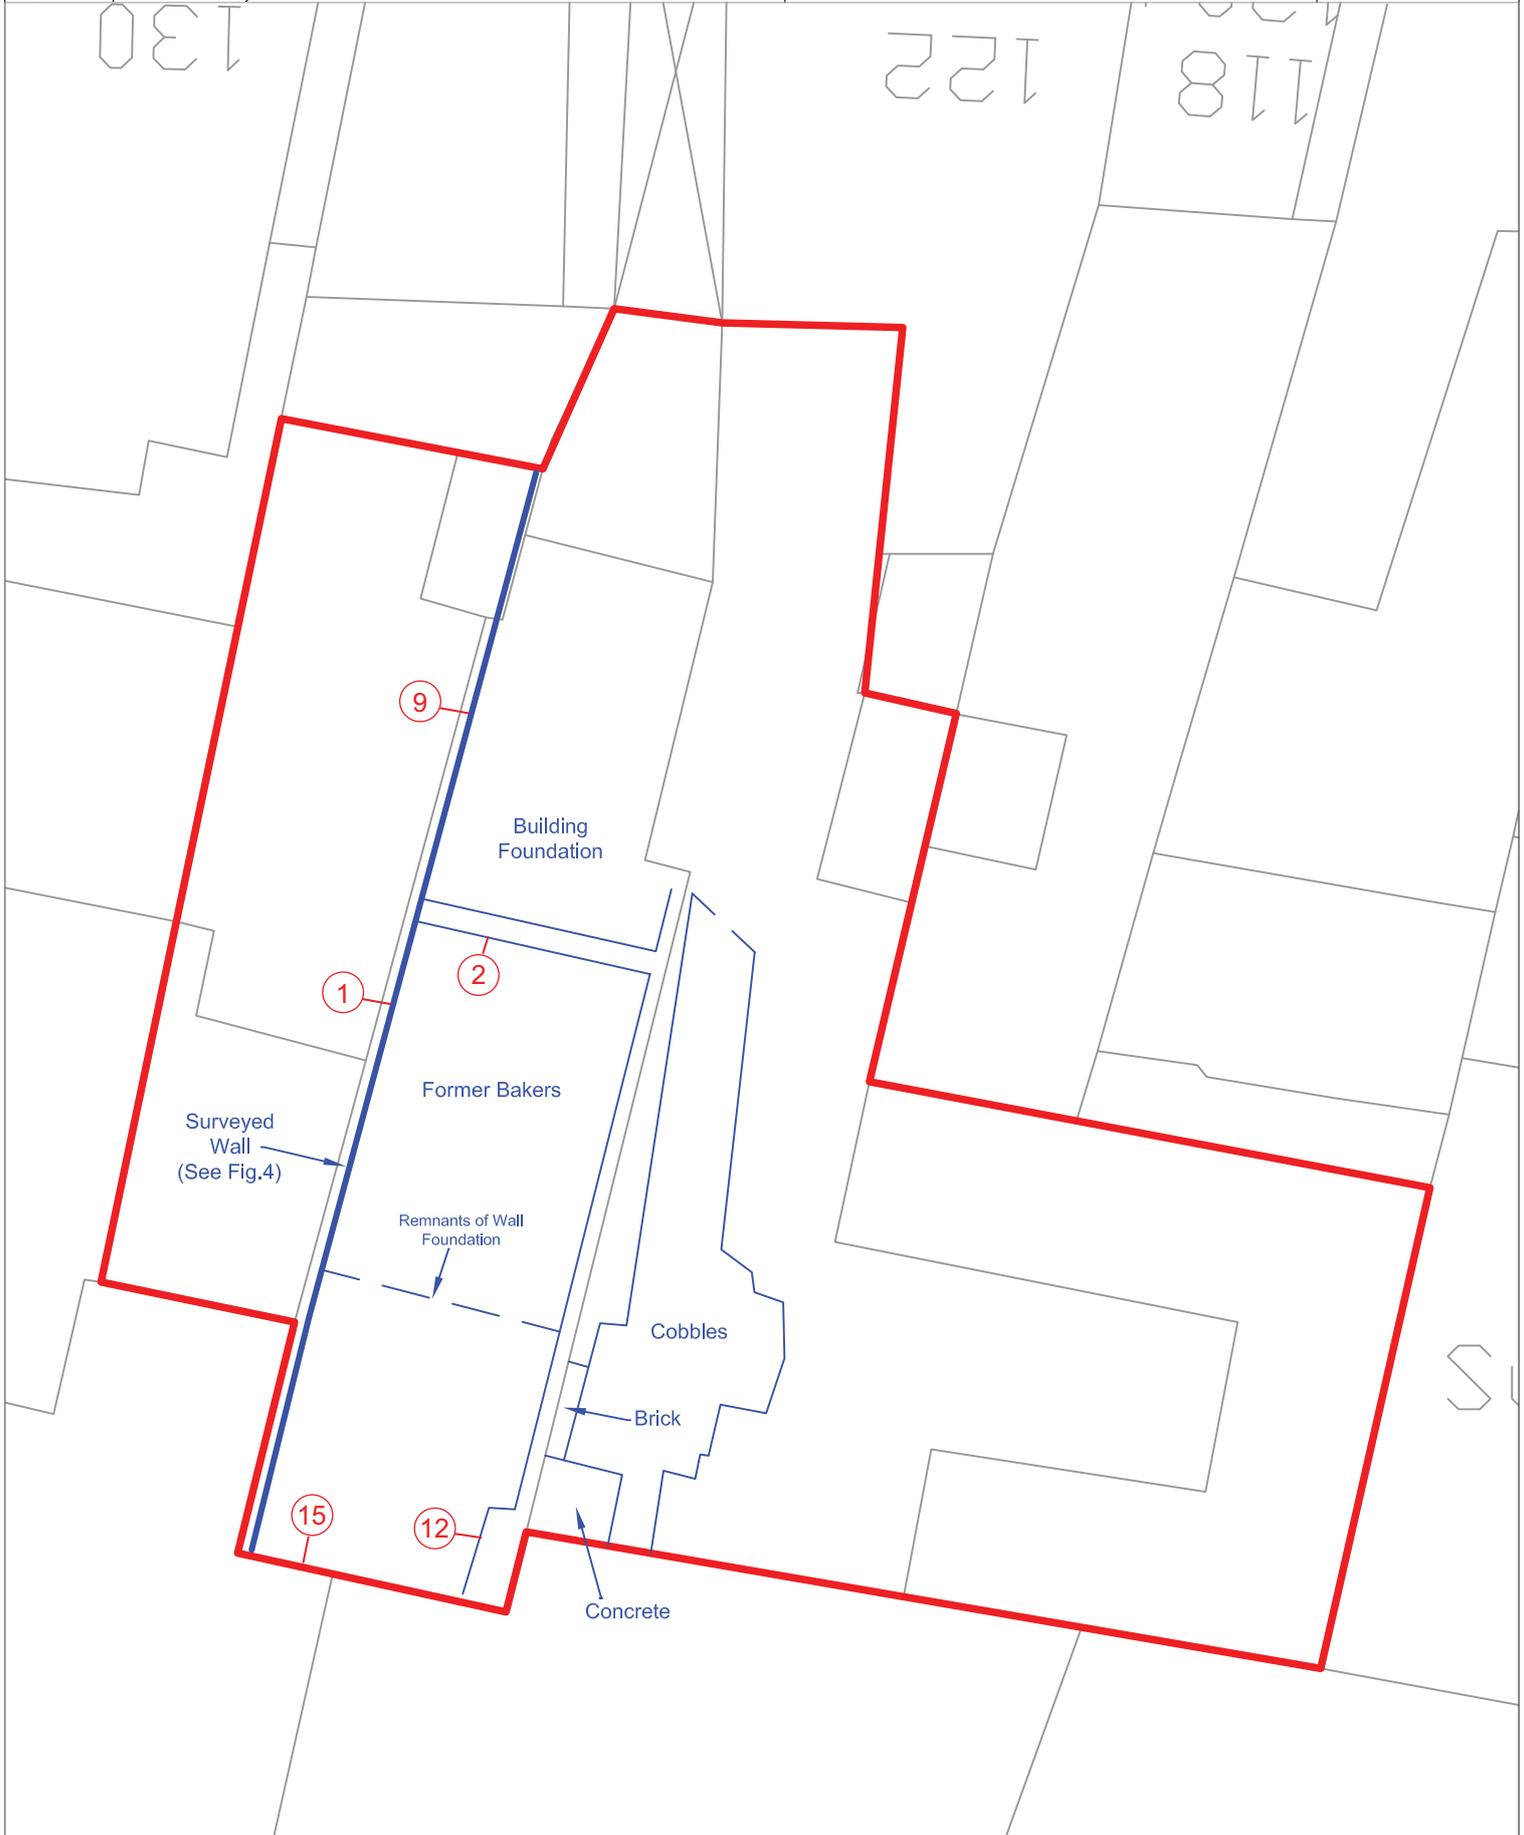
Fig No: <b>3</b>	Revision: <b>A</b>	Client: <b>George Herkas</b>
Title: <b>Plan of site showing footprint of former bakers and extent of cobbles</b>		
Project: <b>124 North High Street, Musselburgh</b>

Full descriptions of the standing and structural remains are outlined in Table 1 and the text below. Numbers in bold and parentheses refer to architectural units, a full list of which can be found in Appendix 1. The site plan is shown in Fig. 3.

Much of the site surface comprised rubble and earth. The remains of a cobble track (23) survived, running from the pend entrance to the east side of the former bakery building. Two parallel sections were slightly raised and were wheel width apart (Fig. 8-9). The track had a slightly recessed drainage channel running down its east side and an iron manhole cover set within it.

The cobbles continued into the yard to the east and formed a surface which had been largely disturbed or removed by earlier demolition works.

The gap between the cobble surface and the east side of the former bakery building was filled with laid bricks (24) forming an exterior footpath along the side of the former building.

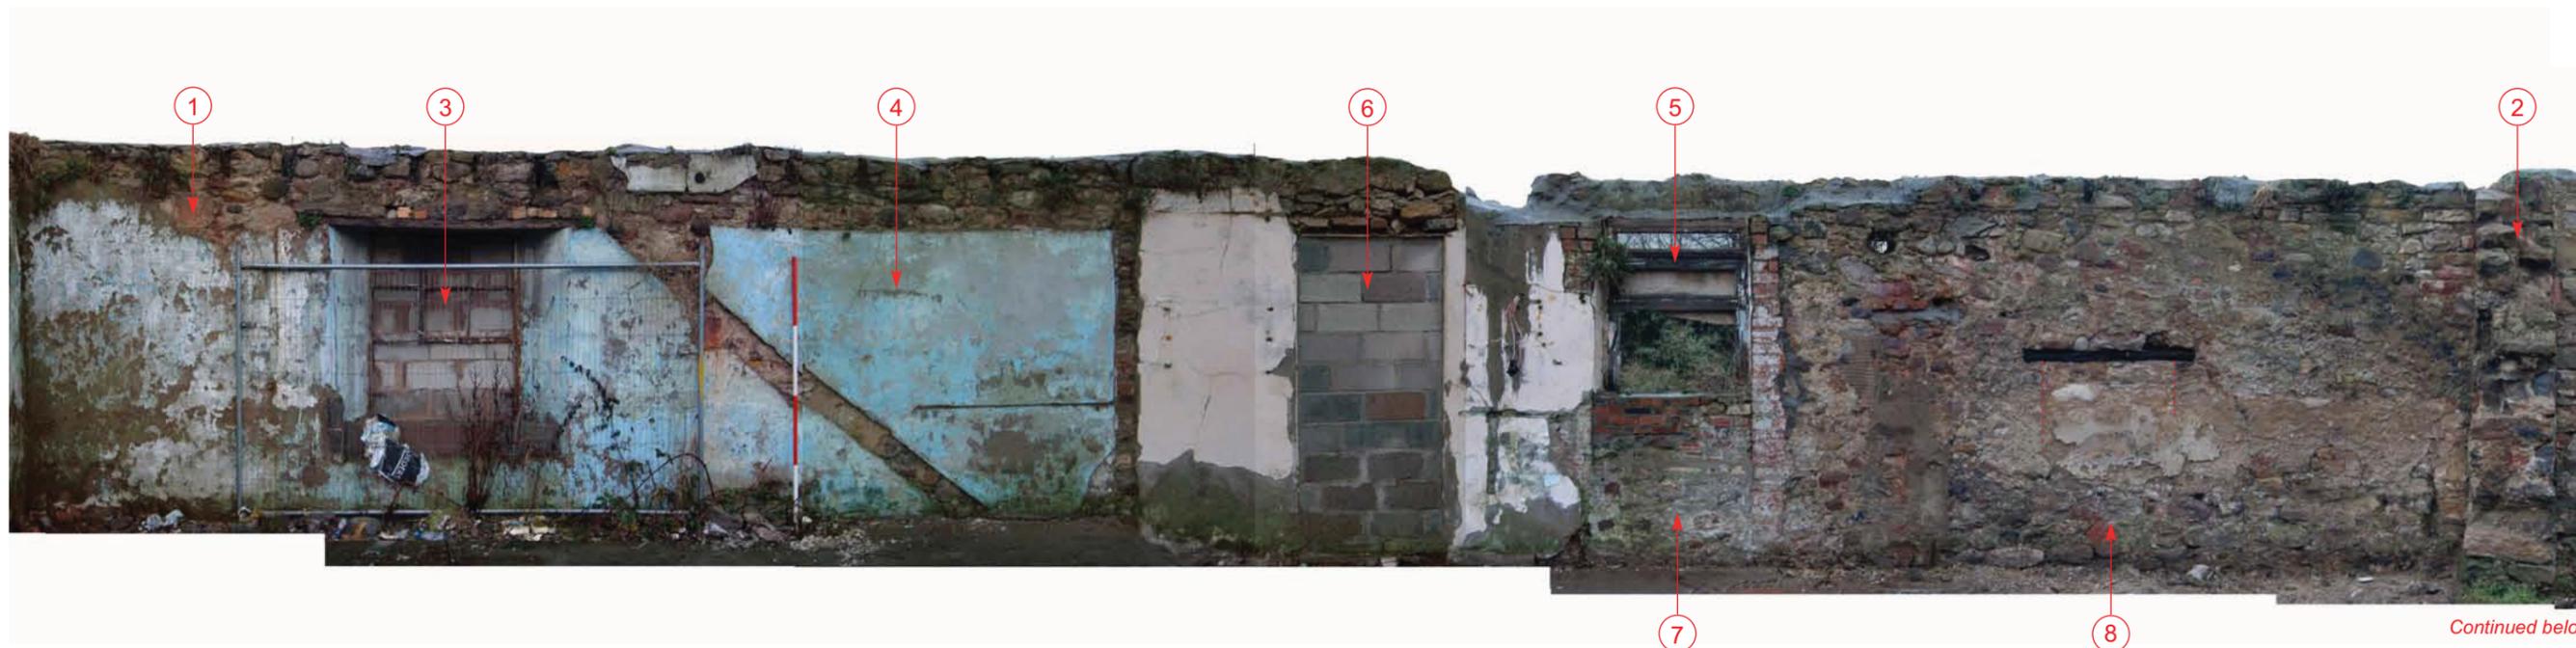
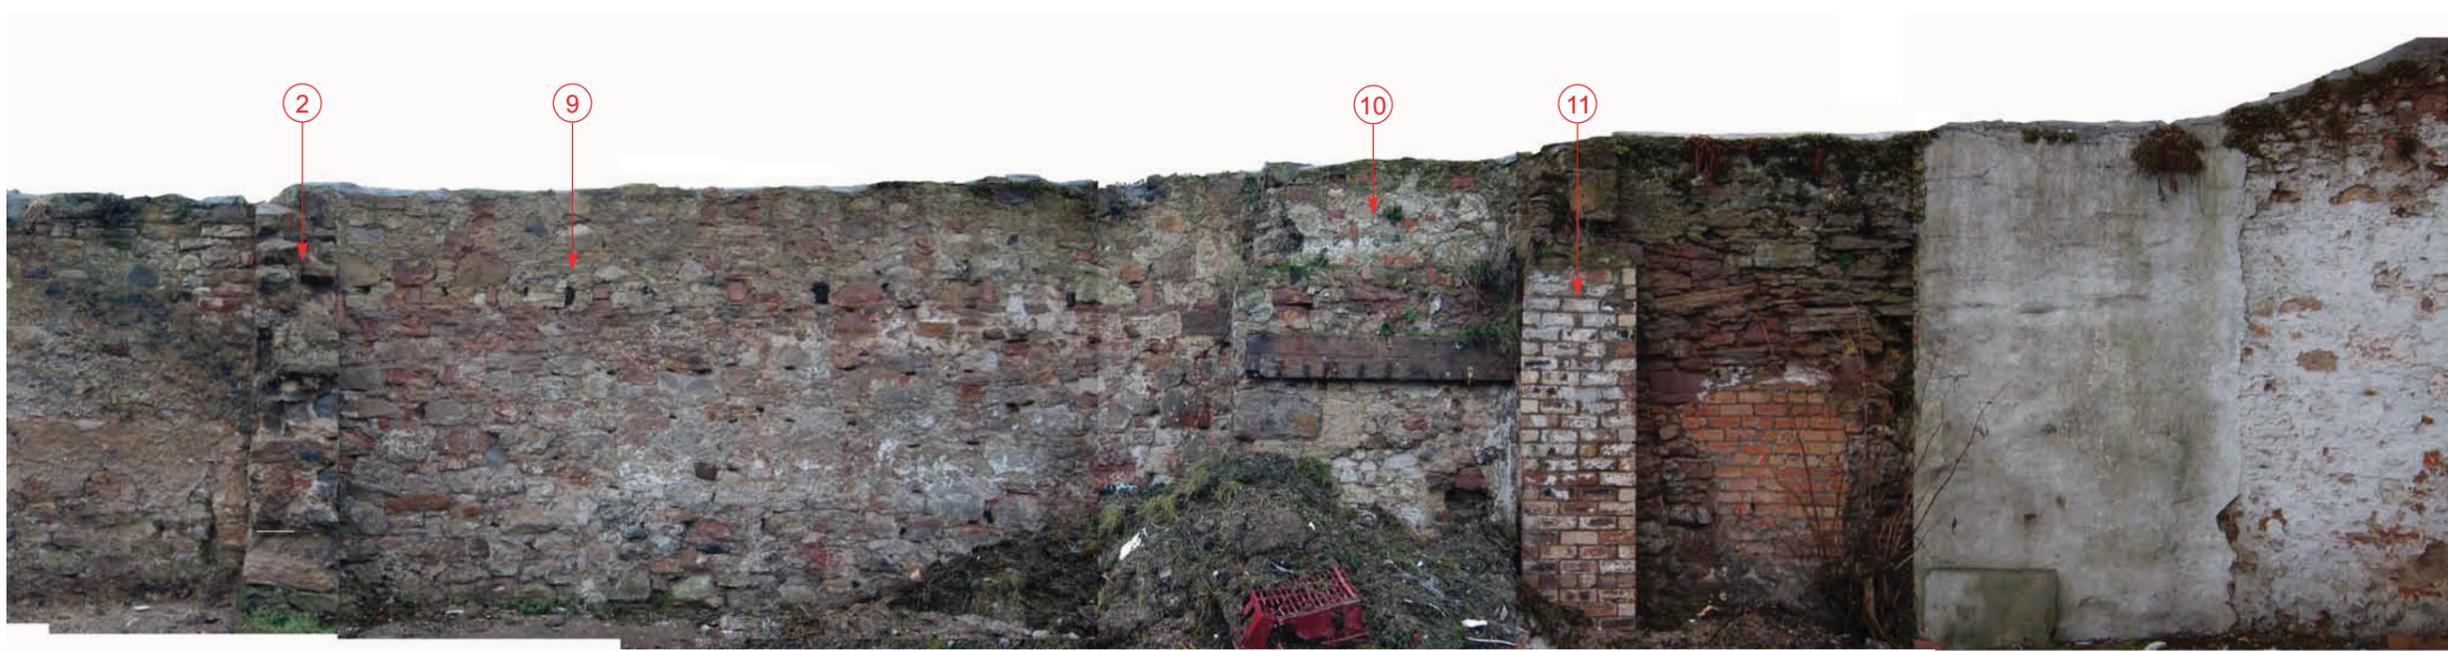
Fig. No: **4** Revision: **A**

*Western Boundary Wall (East-facing elevation) (Fig. 4)*

The site's western boundary wall incorporated both the former bakery building's west wall (1) and a continuation wall (9) which linked the building to the rear of the North High Street buildings. It ran between the southern boundary wall (15) which formed the south end of the bakery building, and continued through the covered pend leading to North High Street.

The bakery building wall (1) was rubble built and mortar bonded. It was keyed into the southern boundary wall (15) and the wall stub (2) at its north end, both of which would have formed the gables of the building. It had areas of surviving plaster but was in overall poor condition. A window (3) with a splayed surround was set close to its south end.

The remains of a stair raggie (4) was visible as a mark on the surviving plaster, ascending right to left and ending just above the level of the top of the window (3), indicating that the building had at least two storeys.

A brick wall stub (5) of an internal dividing wall survived. Two doors occupied the centre of the wall, the southern of which (6) was closed with breeze blocks. The northern door (7) had been converted into a window at some point in the past by blocking up the lower half with bricks. Part of a timber sash and case window survived in the window frame and the door frame itself had been remodelled using bricks.

A blocked window (8) was set towards the north end of the wall. It had a timber lintel and was blocked with mortar bonded stone.

The elevation continued with a wall (9) abutting the gable stub (2) at its south end, and leading into the the pend at its north end. This wall (9) was in poor condition and was built of rubble coursed sandstone. It had a line of joist sockets at its south end indicating that the wall would have once formed part of a building with either a substantial roof or upper floor.

The wall incorporated a substantial stone built buttress (10) towards its north end, possibly for reinforcement, although it contained a timber batten fitted with stubs of possible hooks. A more recent brick pier (11) was built against the wall as additional reinforcement.

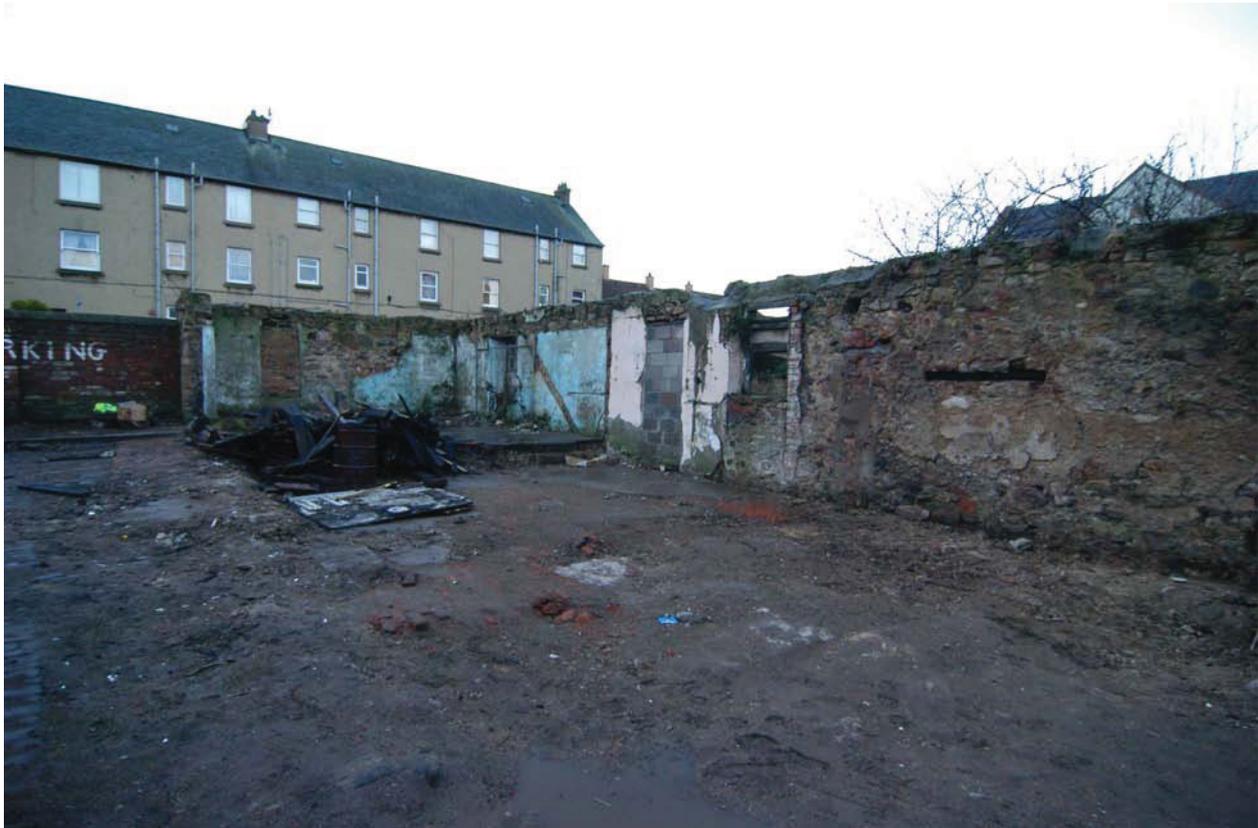
Figure 5: Oblique general view of former bakers

The remains of a single rectangular building defined as a bakery occupied the south-west corner of the site. It was defined by the southern half of the western boundary wall (1), part of the southern boundary wall (15), and the stubs and footings of former upstanding walls (2, 12) (Fig. 5). Two surfaces comprising cobbles (23) and bricks (24) were also associated with the building. No other upstanding building remains were discernible on the site, although the northern end of the western boundary wall would have been part of another building.

The south wall (15) of the bakery building comprised an upstanding wall which had been plastered, but much of this was cracked and weathered off. A vertical gap in the plaster indicated an internal partition. A doorway (16) was situated at the east side, blocked up with bricks. Two ceiling-level windows (17, 18) were located on the west side of the wall, both blocked with rough mortared stone.

The surviving eastern wall (12) of the bakery building comprised an upstanding section of wall 2.7m in length, which continued as a foundation visible at ground level. It was rubble coursed sandstone which had been plastered but now in poor condition. The wall featured a brick wall stub (14) which indicated an internal dividing wall, and a window (13) which had been blocked up with bricks.

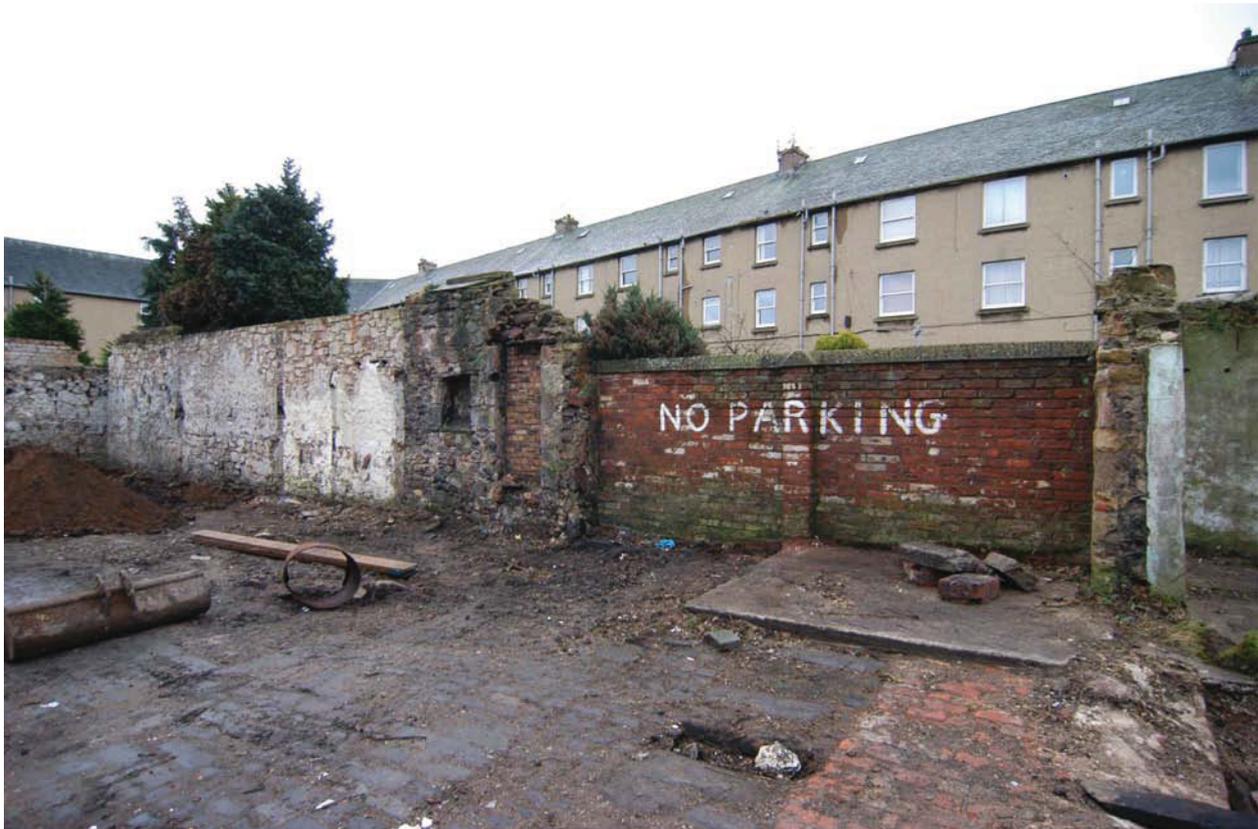
Figure 6: Oblique general view of south boundary wall

The wall bounding the south side of the yard was built of random coursed, mortar-bonded rubble (19) (Fig. 6). It had the remains of thick whitewash although much of this had worn off. Unpainted vertical lines along the wall marked the former locations of timber walls or fences.

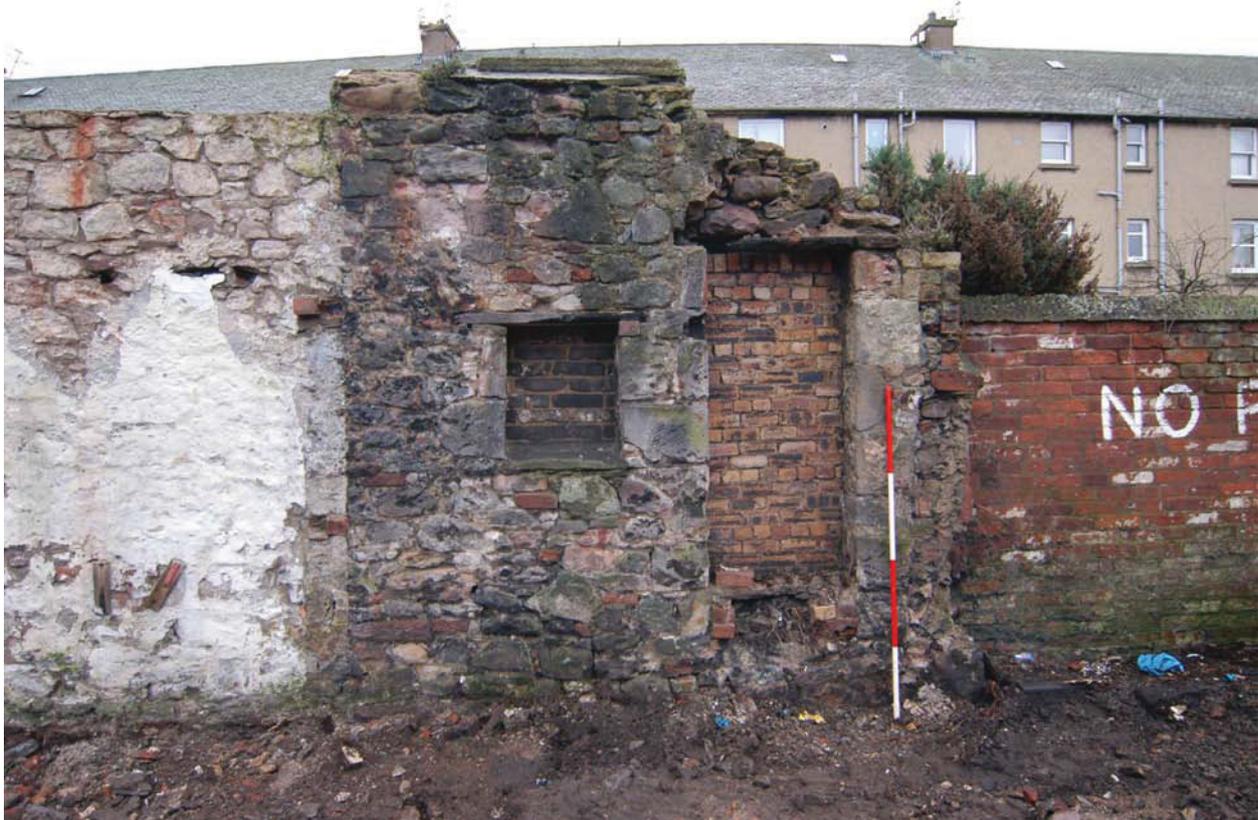
Figure 7: Detail of blocked window and door in south boundary wall

The west end of the wall was unpainted and featured a bricked-up window (20) with a stone lintel and quoins and a sloping stone sill; and a bricked up doorway (21) framed by quoins (Fig. 7). The top of the wall was in poor condition and had partially collapsed so it is unclear whether it was ever high enough to accommodate a second storey. The door and window indicate a permanent building rather than a shed. It is unclear whether this represents the interior or exterior of a building but cartographic evidence suggested that the building lay within the yard rather than in the grounds to the south outwith the yard.

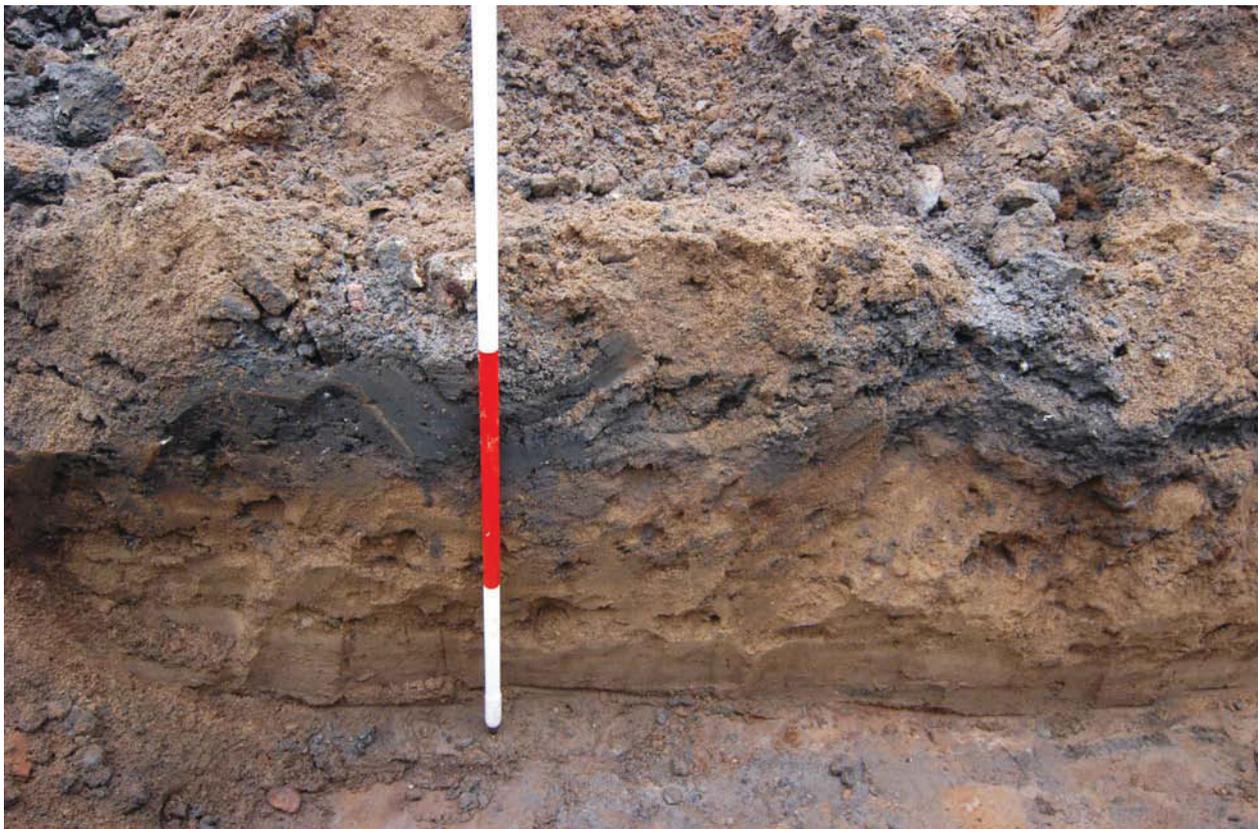
Figure 10: Section of foundation trench

The watching brief was conducted during the excavation of foundation trenches for the proposed building. The site surface was compacted soil up to 0.5m deep. It overlay and merged with compact sand which was 0.3m to 0.5m thick. This overlay natural subsoil which was pale clayey sand with minimal bioturbation or other disturbance (Fig. 10).

No archaeological remains or deposits were identified.
