**Alnwickhill Reservoir, Liberton,
Edinburgh
Boundary Wall Recording
Report No. 1868**

Author	Mike Cressey HND BA MSc PhD FSA Scot MifA
Illustrator	Leeane Whitelaw BSc MAAIS
Editor	Bruce Glendinning BSc Pg Dip MifA
Commissioned by	Black & Veatch Ltd
Date issued	March 2011
Version	0
OASIS Reference	cfaarcha1-94960
Planning Application No	11/00019/LBC
Grid Ref	NT 327185 669158

This report presents the results of a Level 1 photographic survey undertaken by CFA Archaeology Ltd (CFA) in March 2011 on a boundary wall at Alnwickhill Reservoir, Liberton Gardens, Edinburgh (NGR: NT 3271 6691). The work is associated with the Edinburgh Drinking Water Project which requires two sections of the boundary wall to be taken down and reinstated following completion of the works. The survey was commissioned by Environmental Resource management (ERM) on behalf of Black & Veatch Ltd.

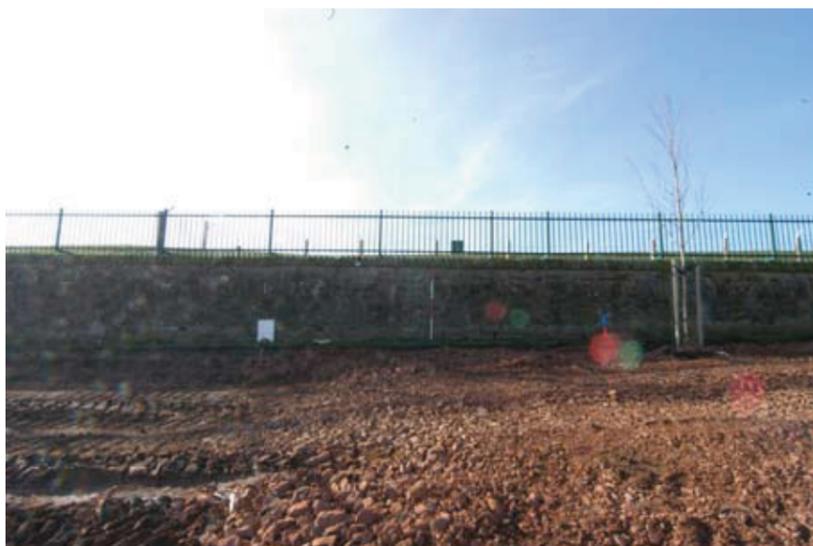
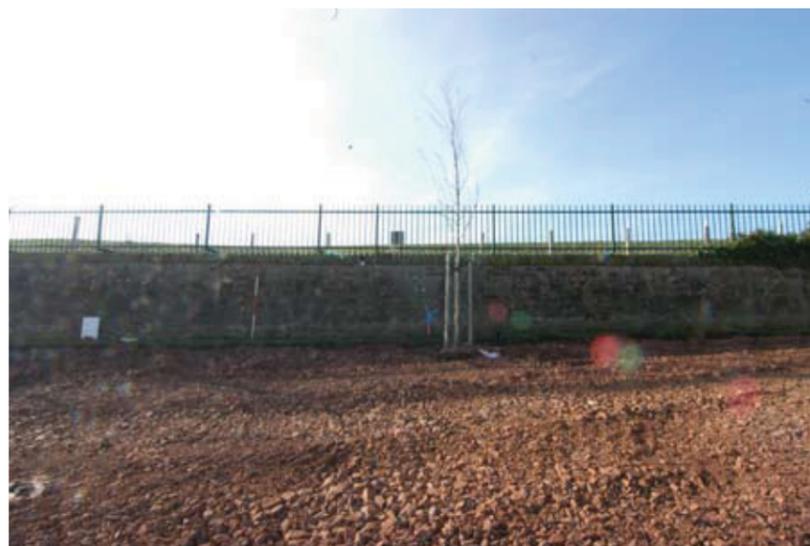
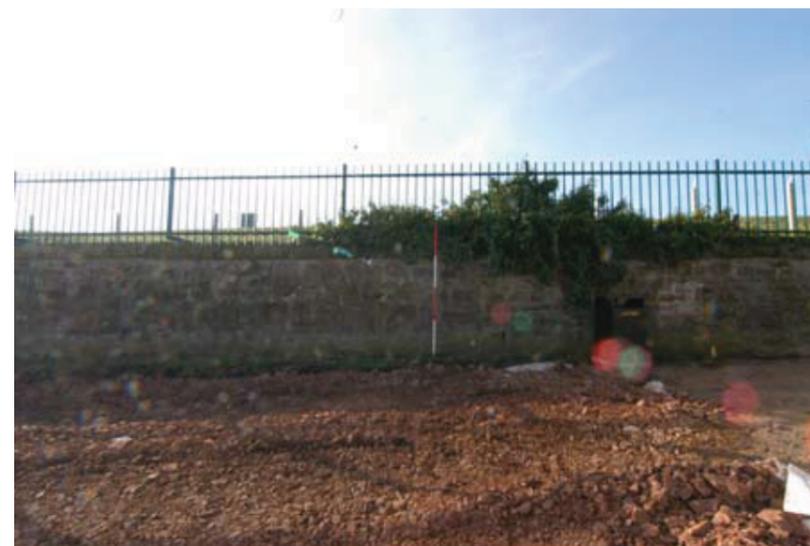
Alnwickhill Road wall section, southwest-facing elevations

The south-west facing elevation of the wall was 1.2m high and the wall fabric had an almost sneaked appearance with square blocks of sandstone being more frequent. The security fence brackets had been fixed to this side of the wall. There were no discernible breaks in build or other features present.

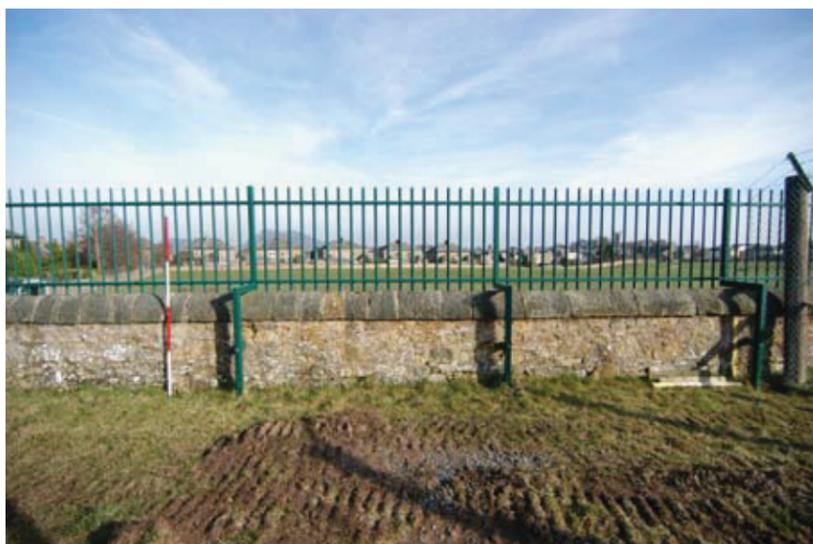
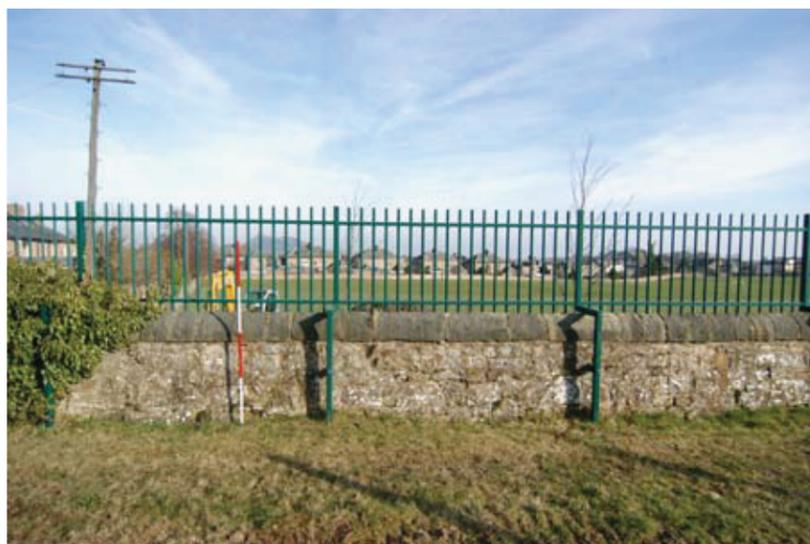
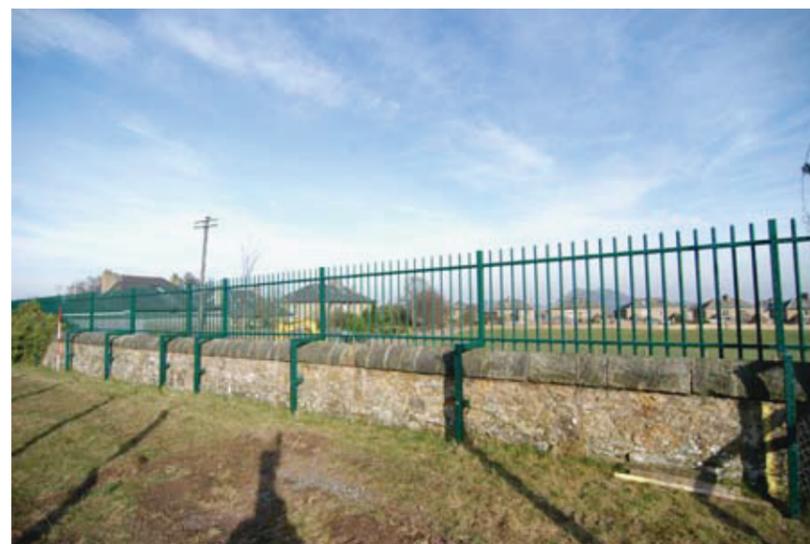
Alnwickhill Road wall section, northeast-facing elevations

The north-east facing elevation of the Alnwickhill Road section faced onto Liberton Public Park. The wall stood to a height of 2.1m and was constructed of coursed sandstone blocks bonded with lime-mortar. The blocks measured on average 0.4m x 0.3m x 0.2m and were laid in regular courses with no discernible break in build. The coping stones varied in size and ranged from between 0.5m to 0.30m long and were slightly elliptical in shape with a hand-tooled 'stugged' finish. The wall was 0.5m thick below the coping stones. The wall was surmounted by a c.1.5m high green-painted steel security fence.

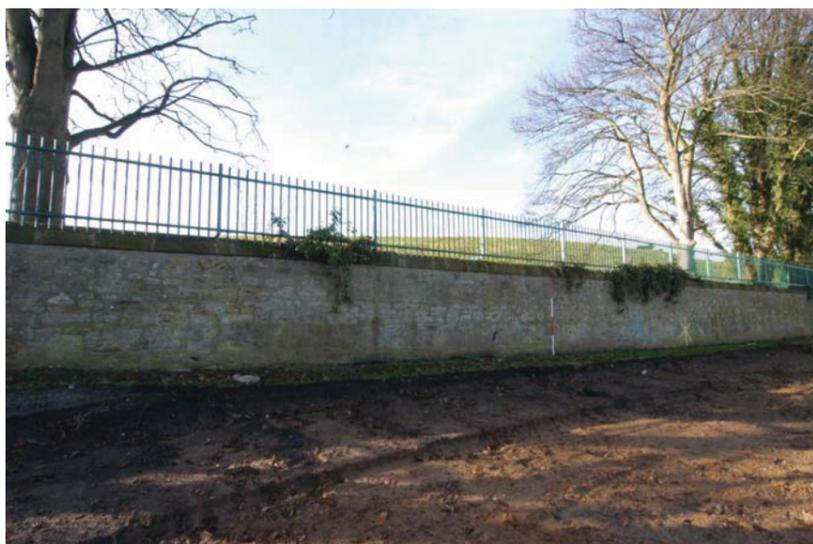
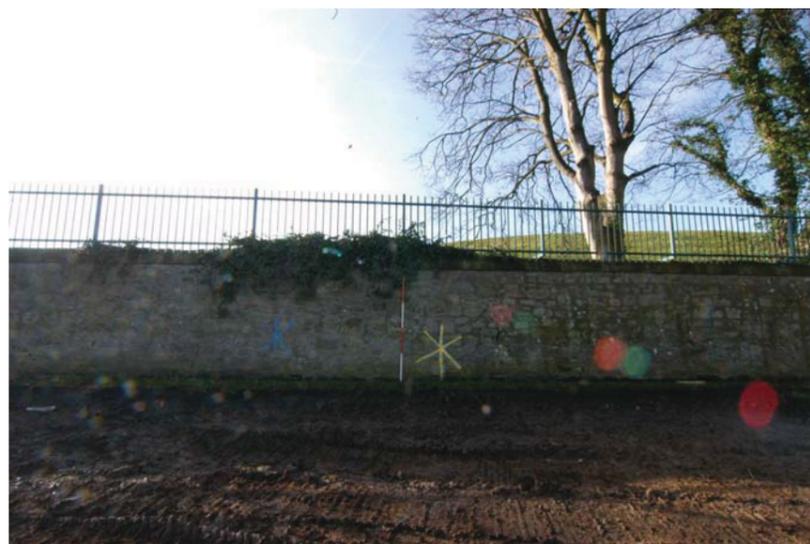
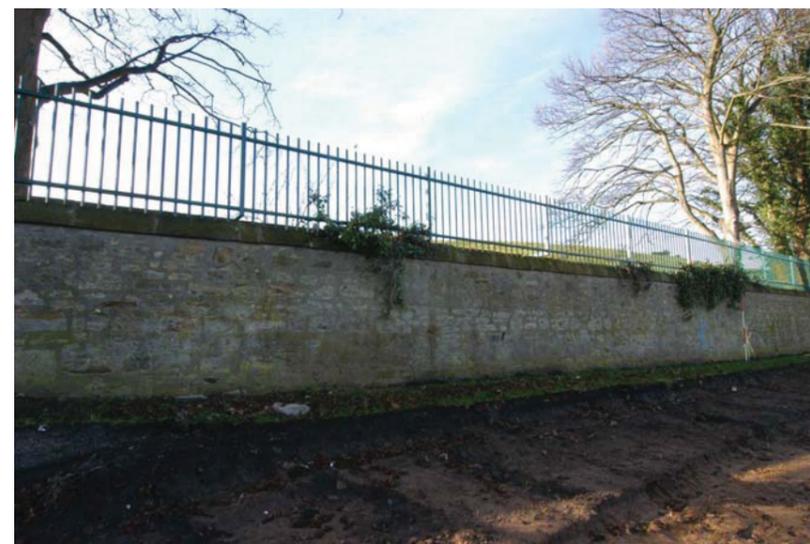
Liberton Gardens wall section, southwest-facing elevations

The south-east facing elevation measured 1.5m high and was 0.4m wide below the coping stones. The sandstone blocks were the same dimension as those on the north-facing elevation and were bonded with lime mortar. The stanchions supporting the steel security fence were fixed to this side of the wall.

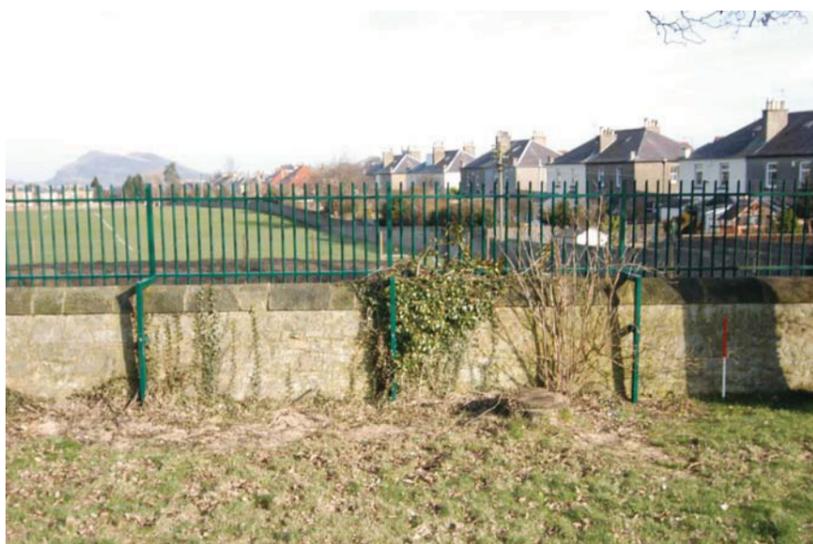
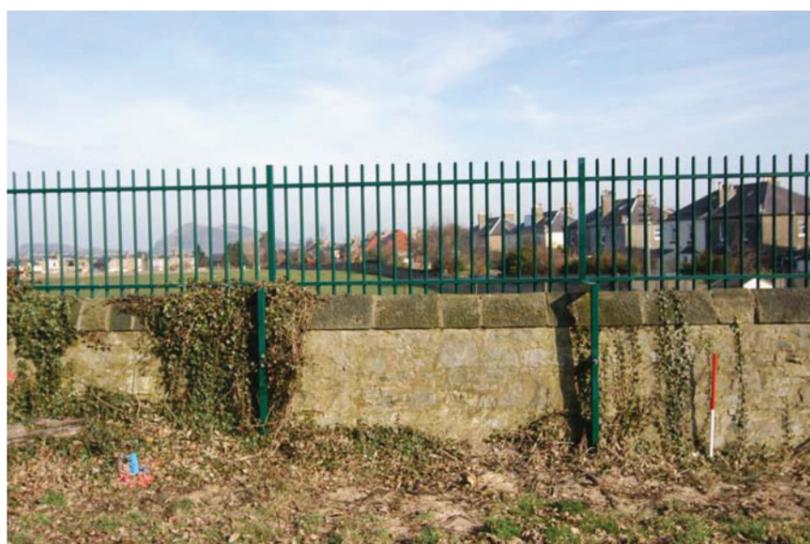
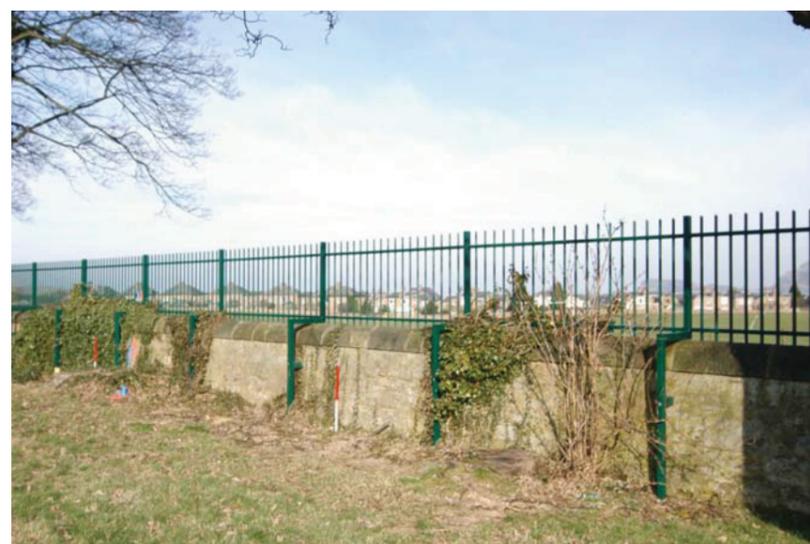
Liberton Gardens wall section, northeast-facing elevations

The north-facing elevation of the Liberton Gardens section measured 2.3m high and was 0.40m wide. The wall incorporated both random and coarsely laid sandstone blocks bonded with lime-mortar. The blocks were on average 0.2m x 0.2m x 0.1m,

with occasional smaller levelling stones. The wall had noticeable banding which probably reflects the different quality of stone and its resistance to weathering rather than a seasonal break in build. The coping stones varied in size but were 0.5m to 0.2m long and slightly elliptical in shape with a hand-tooled 'stugged' finish. The wall had been heavily pointed with grey cement. The wall was surmounted by the steel security fence.
