**Archaeological Building Recording at
the former Blurton Farm Depot
Church Road
Blurton
Stoke-on-Trent
Staffordshire
NGR SJ 89845 41935**

Site Code: BFM 09

Report No. 257

September 2009

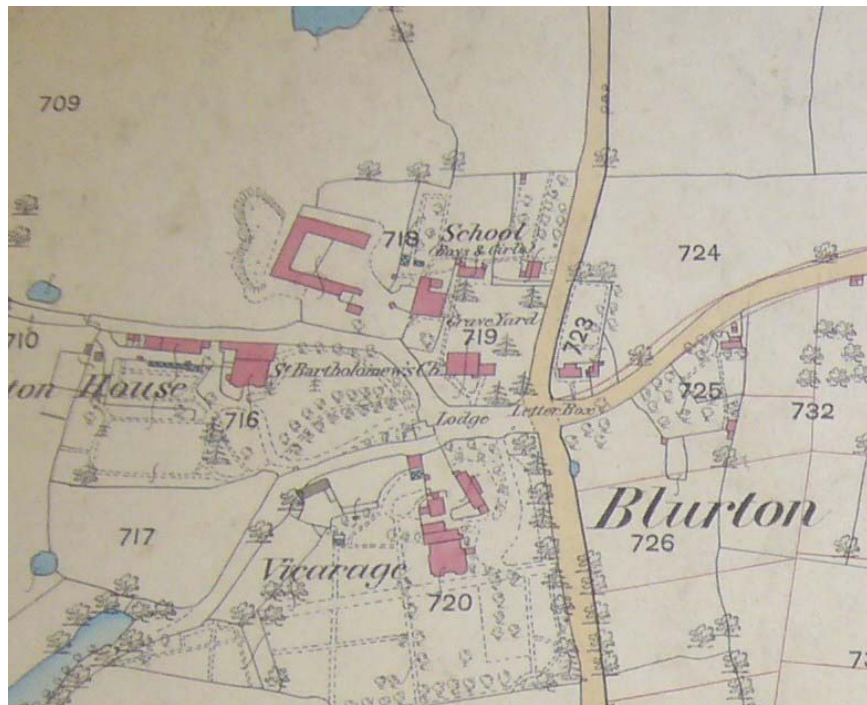
FIG. 7

1878 OS map, showing Blurton Farm as the NW-SE aligned 'U'-shaped farmstead just to the north west of St. Bartholomew's Church.

3.6 The 1878 OS map shows a small building of uncertain function at the eastern end of the southern range. The site of this structure is presently occupied by a modern extension.

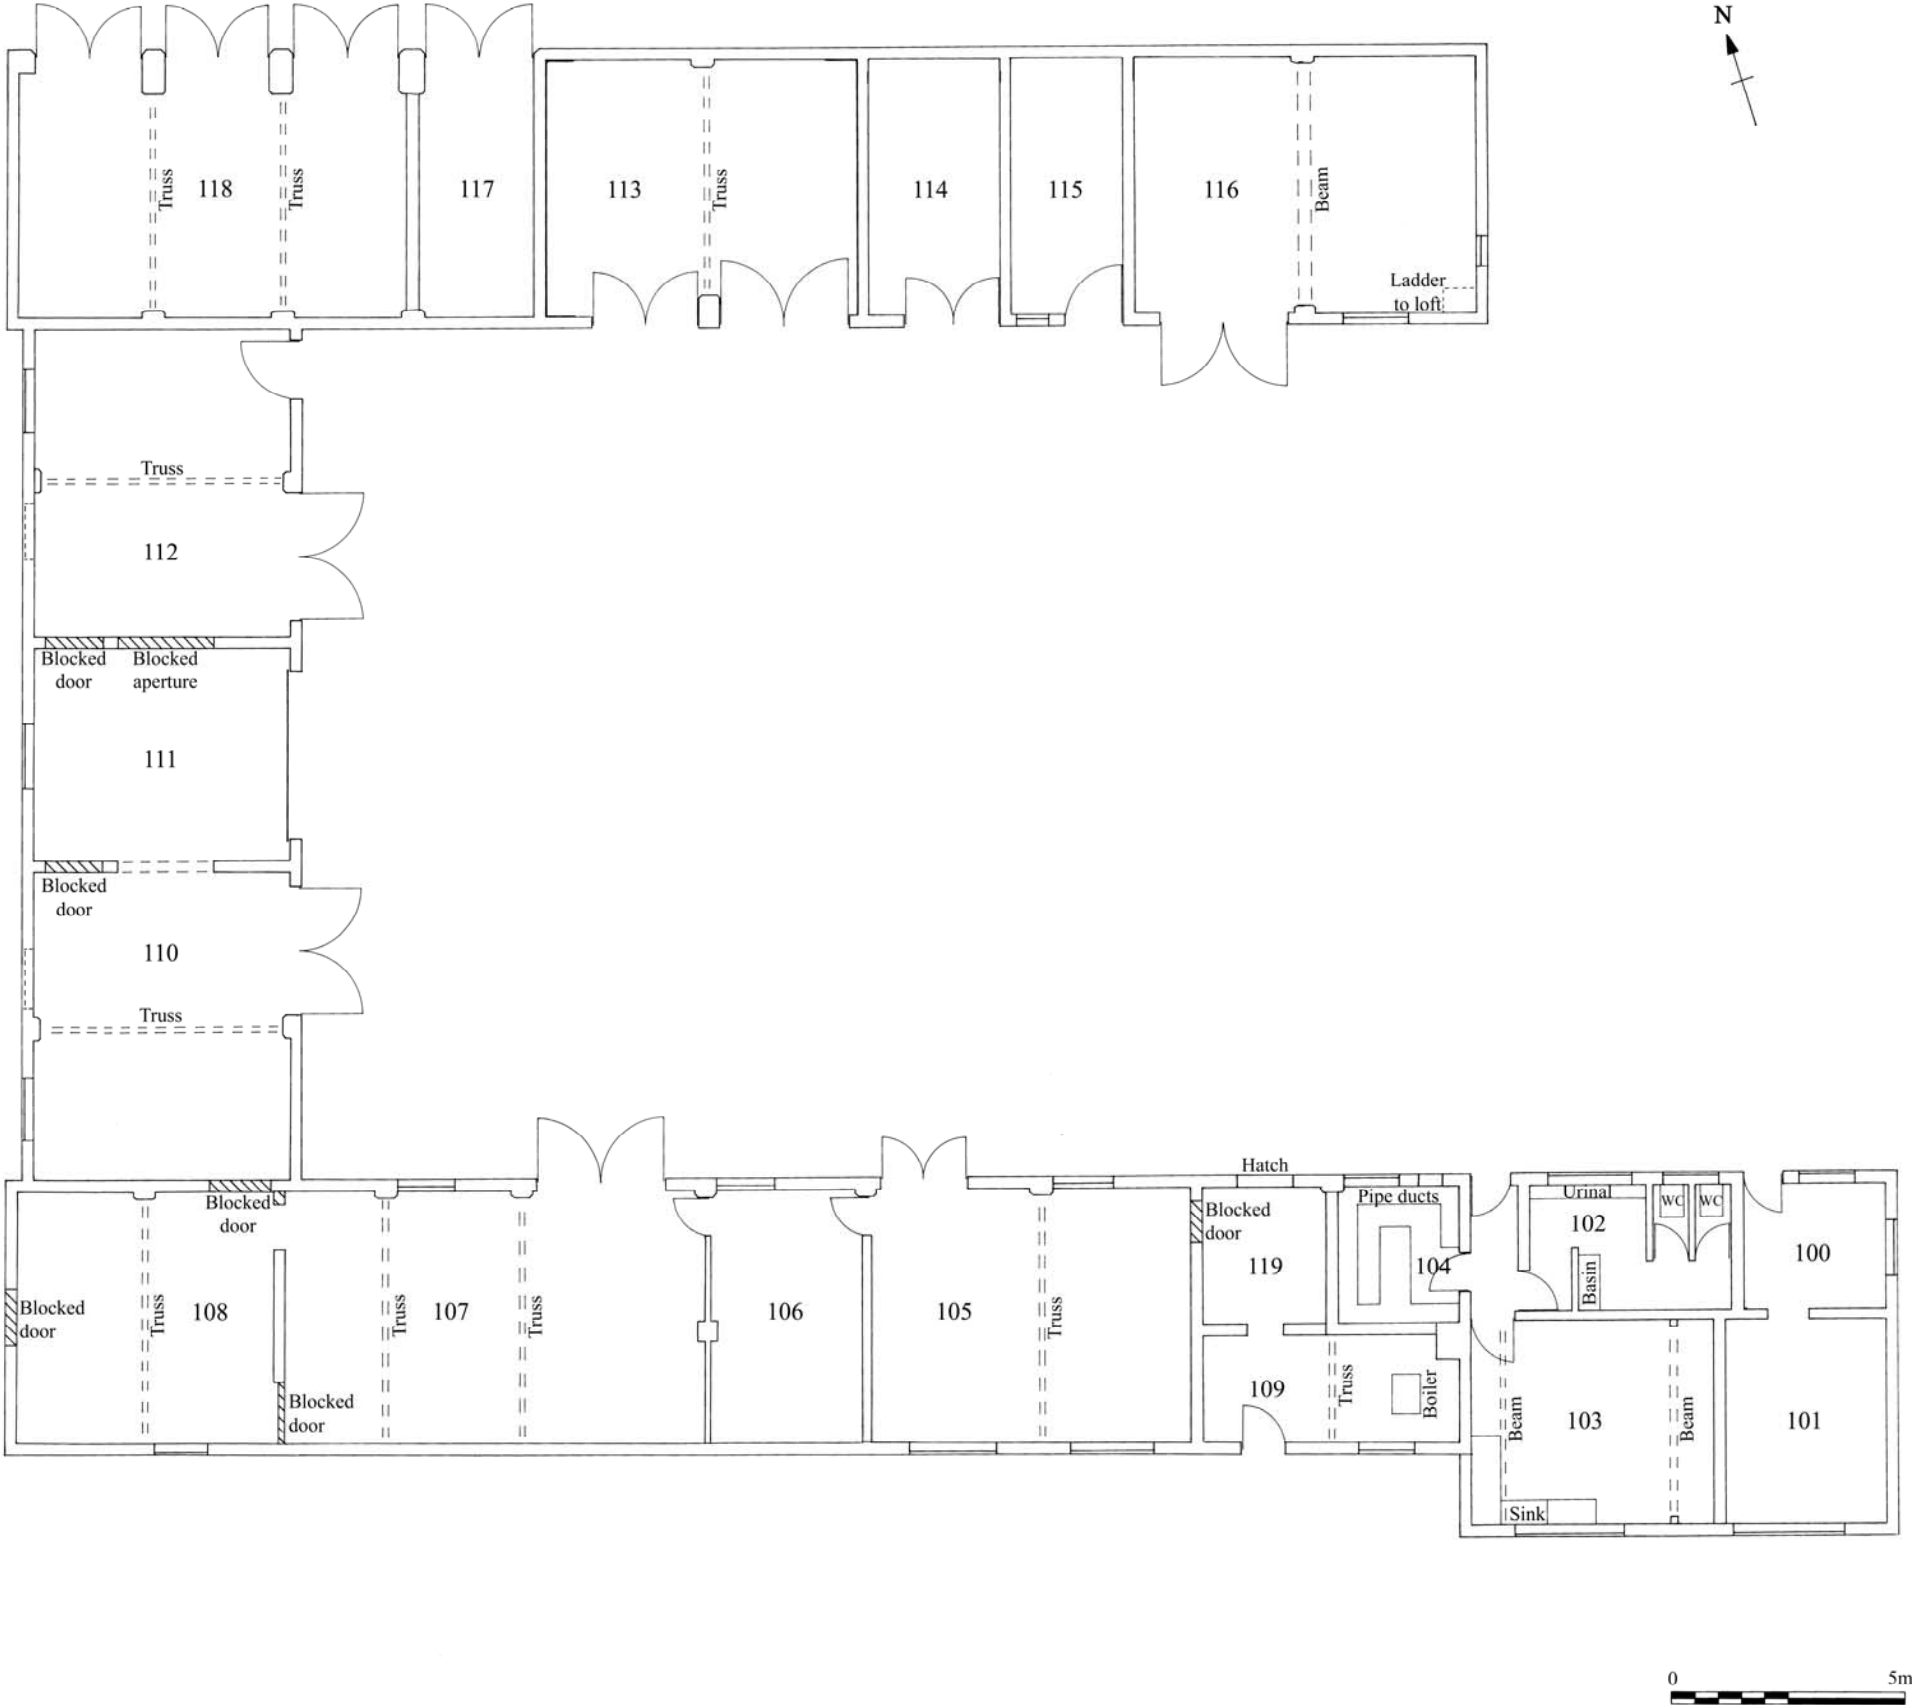
FIG. 10
Ground floor plan

4.2 During the survey, each room or area was assigned a unique reference number (100+ for the ground floor and 200+ for the first floor). These numbers are used in the descriptions below and are reproduced on the floor plans provided by Figs. 10 & 11.

5.1.1 The Blurton Farm complex comprises a range of outbuildings forming three sides of a square and enclosing a yard with open access to the south east (Figs. 2 & 10). The buildings are all single storey with the only second-storey area found at the eastern extreme of the northern range (rooms 200-201) (Fig. 11). A single-storey brick extension

6.7.4 The threshing process progressed from north to south through the bays (Fig. 10). After removal from the northern bay (112), the grain was threshed from the stalk in the central bay (111) upon a specially constructed brick threshing floor. The threshed straw was then stored in the southern bay (110), where a doorway in the southern wall provided access to the adjoining fodder bay (108) in the southern range. The position of the corn hole entrance shown on the architect's plan appears to correspond with the location of the now blocked pedestrian door in the wall between 111 and 112. The presence of a corresponding door in the wall between 111 and 110 may suggest that an additional corn hole once featured in the southern bay, to allow faster threshing. A corn hole was a small room designed to store grain after threshing, but before winnowing (Peters 1969, 65). The presence of a corn hole at Blurton Farm suggests that threshing was undertaken by flail, as mechanised threshing machines also included apparatus for winnowing that made corn holes unnecessary. Such machinery was available after 1850, and, as such, the corn hole at Blurton Farm appears somewhat old-fashioned (Peters 1969, 98). Finally, the central threshing barn (111) featured two opposing doors in the eastern and western walls, positioned to provide a through-draft to aid winnowing. The threshed and winnowed corn may have been stored in bins, or sacks within the barn. No evidence, however, remains to indicate which part of the barn was used for this purpose.

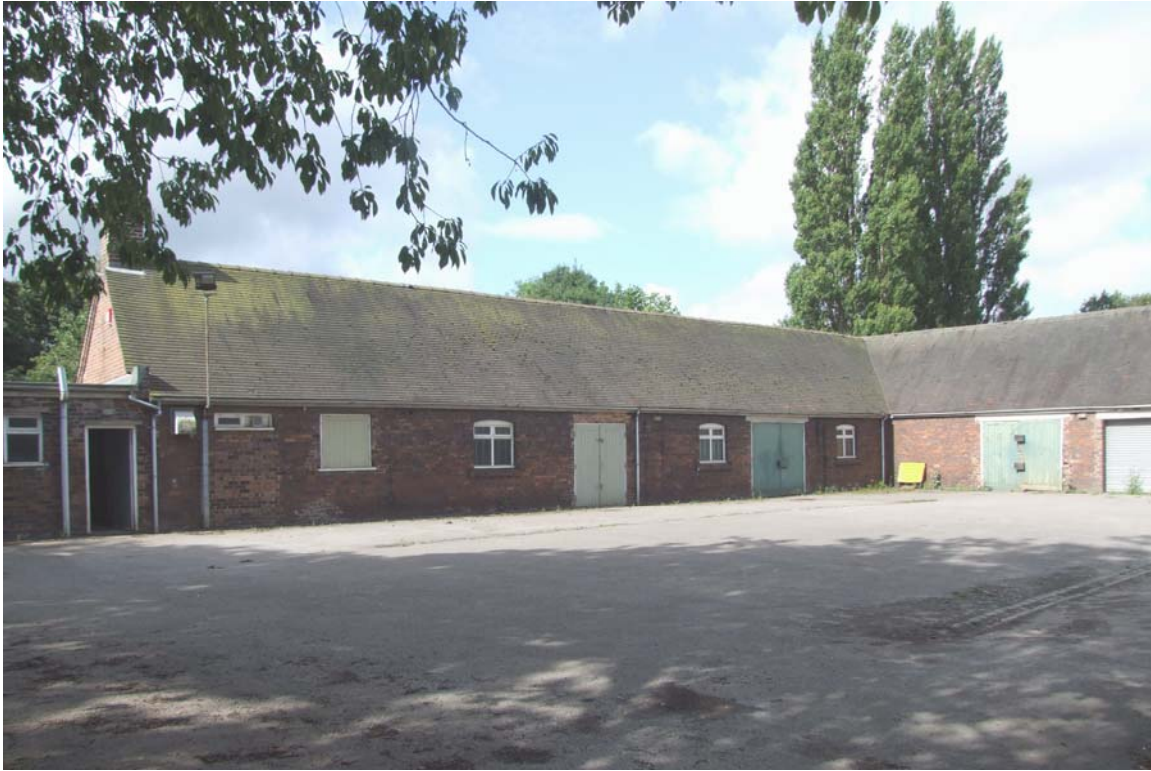
PLATE 1

The southern and western ranges, looking south west.

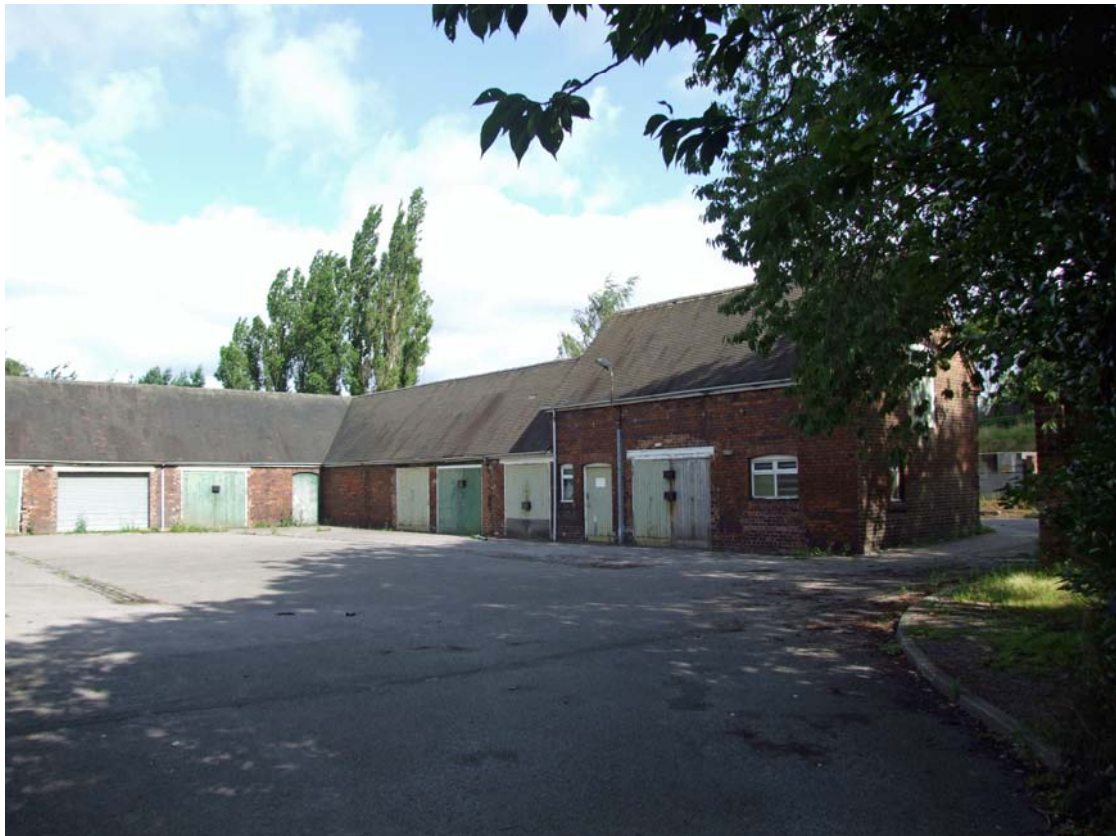
PLATE 2

The northern & western ranges, looking north west.

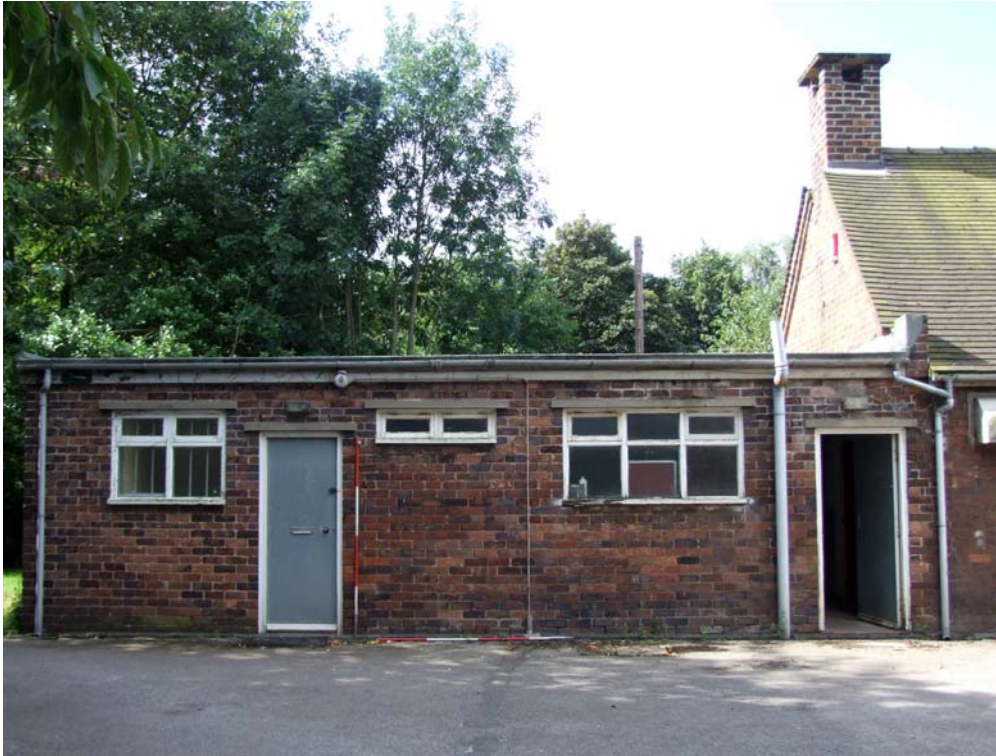
PLATE 3

5.3.1 This eastern extension to the southern range is a brick-built rectangular structure constructed in stretcher bond. The building has a flat concrete roof covered in bituminous felt. The extension contains four rooms, previously used as offices (100 and 101), male toilets (102), a kitchen/canteen (103) and changing area (104). The extension is split into two halves, with rooms 100 and 101 to the east and 102 and 103 to the west. There is no internal access between the two halves, with both accessed separately through doors in the northern elevation. The western half of the extension provides access to room 104 in the southern range. All windows and doors within the extension have concrete lintels. The windows have wooden frames and sills, similar to most of those present in the rest of the complex. It seems probable, therefore, that the majority of windows were replaced when the extension was built. Floors within the area are concrete and, in the case of rooms 100 and 101, are carpeted.

North-facing elevation of the extension to the southern range

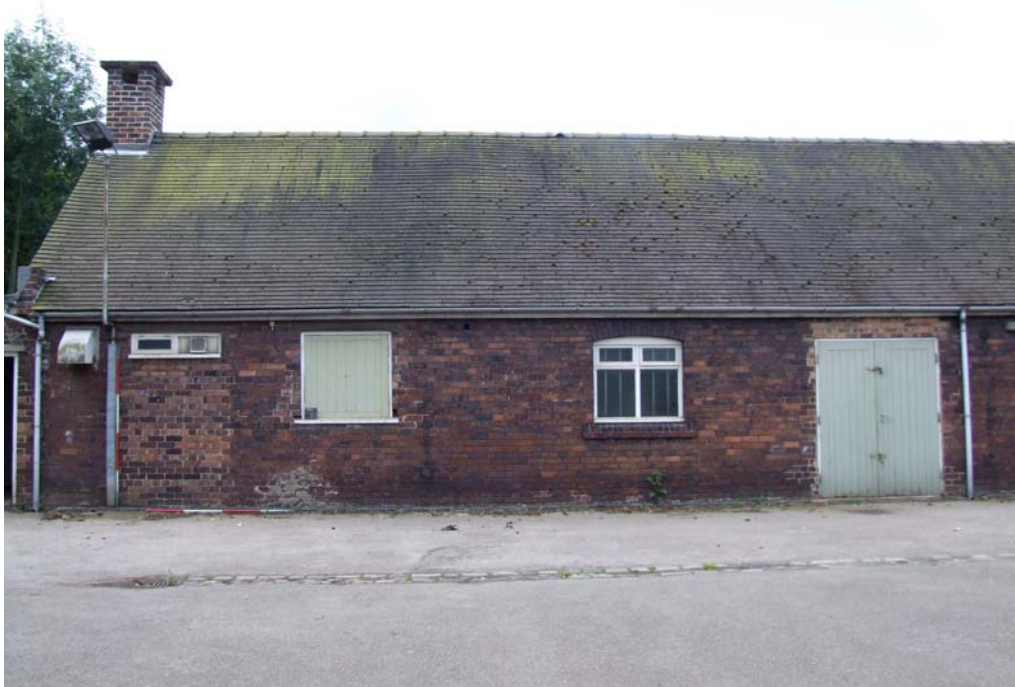
PLATE 4

5.2.4 At the eastern end of the range, a now blocked doorway in the eastern wall of 105 would have originally facilitated internal access between the central and end rooms. Internal access between these areas is not possible in the present layout. Of the rooms located at the eastern end of the range, 109 is accessed via an inserted doorway in the southern elevation and leads into 119 to the north. Room 109 has most recently been used to house a boiler, which appears to have utilised an earlier, possibly original chimney flue positioned between rooms 104 and 109 (Plate 9). Room 104 is presently entered through the extension, although evidence of a blocked external doorway indicates that it was once possible to enter this area from the central courtyard. This doorway had been bricked up and a small window and vent placed across the top of the aperture (Plate 4). Room 104 is isolated from the other two spaces within this area. The ceiling of 104 is of the same material and set at the same height as those within the eastern extension, suggesting contemporaneous construction. The low ceiling of 104 has effectively created an open loft space above the room, which is accessible from 119.

North-facing elevation of the southern range,
showing the blocked door at the eastern end.

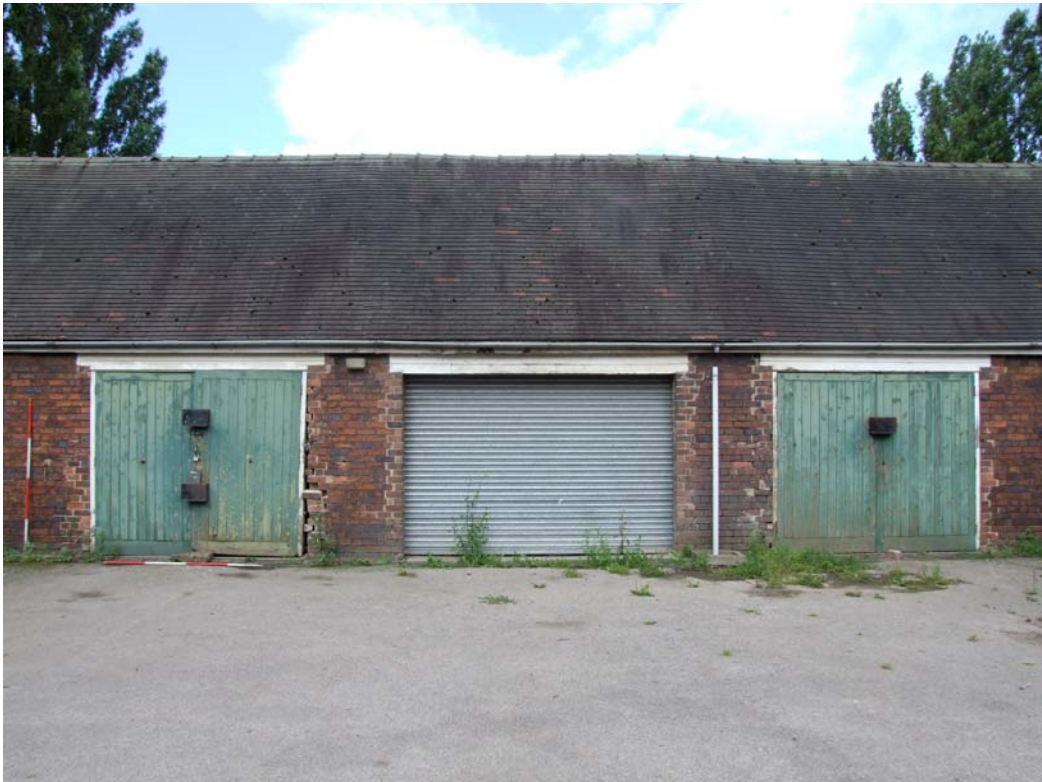
PLATE 5

5.4.2 The original layout of the range is preserved in the present configuration, with a central room (111), flanked by two larger spaces (110 and 112). Three large external entranceways feature in the eastern elevation, providing direct access from the courtyard to rooms 110, 111 and 112 (Plate 5). The entranceways to 110 and 112 are closed with wooden double doors, whilst that to 111 features a metal roller shutter. These doorways, however, have either been modified or are later insertions, with the only original entrance in the eastern elevation being the pedestrian doorway located in room 112. External access through the western elevation was originally made through a doorway in room 111, but this has since been blocked and converted into a window. Internal access is possible between 110 and 111, but 112 can only be accessed externally from the central courtyard. Originally doorways were located at the western end of both the southern and northern walls of the central bay, but both of these have been subsequently bricked up. The northern and southern walls of 111 also originally each featured a large, 3.0m high,

The modified or inserted doorways in the east-facing elevation of the western range.

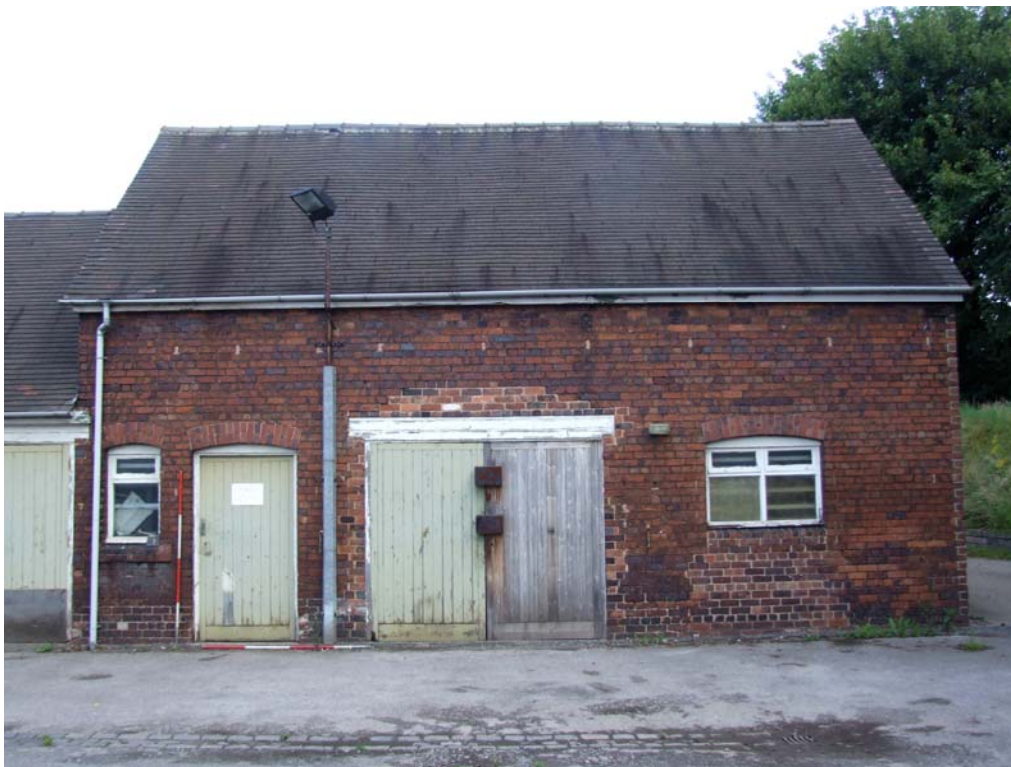
PLATE 6

South-facing elevation of the stable and loft in the northern range

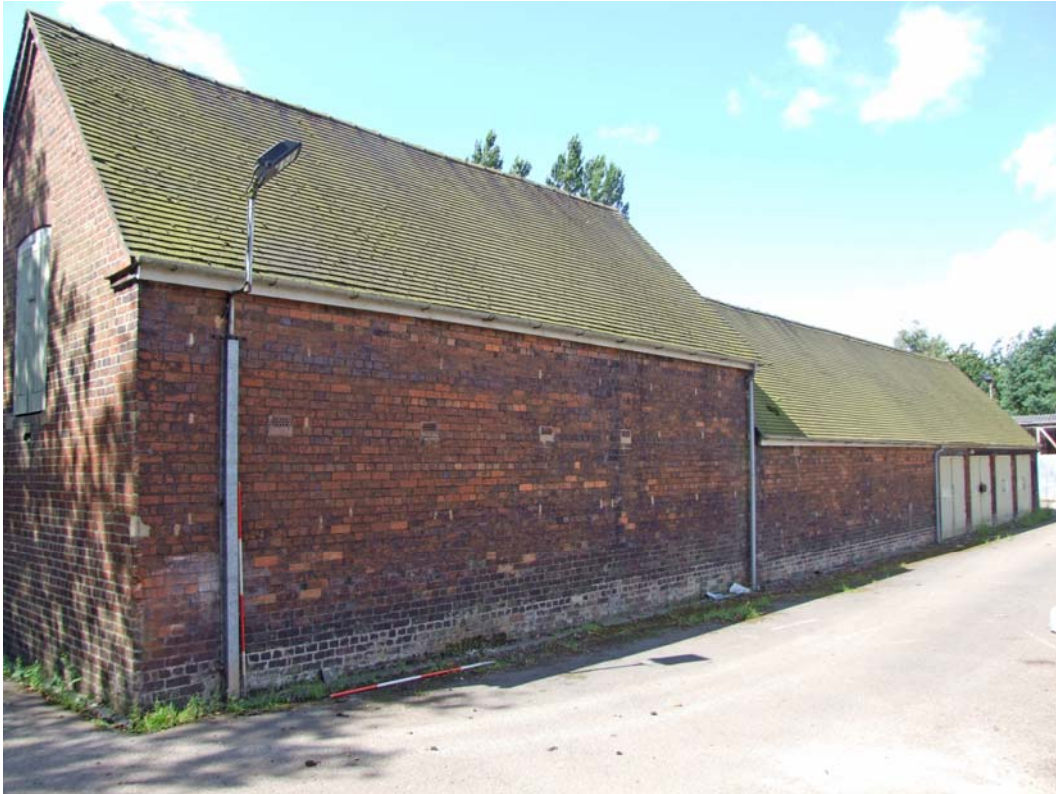
PLATE 7

North-facing elevation of the northern range.

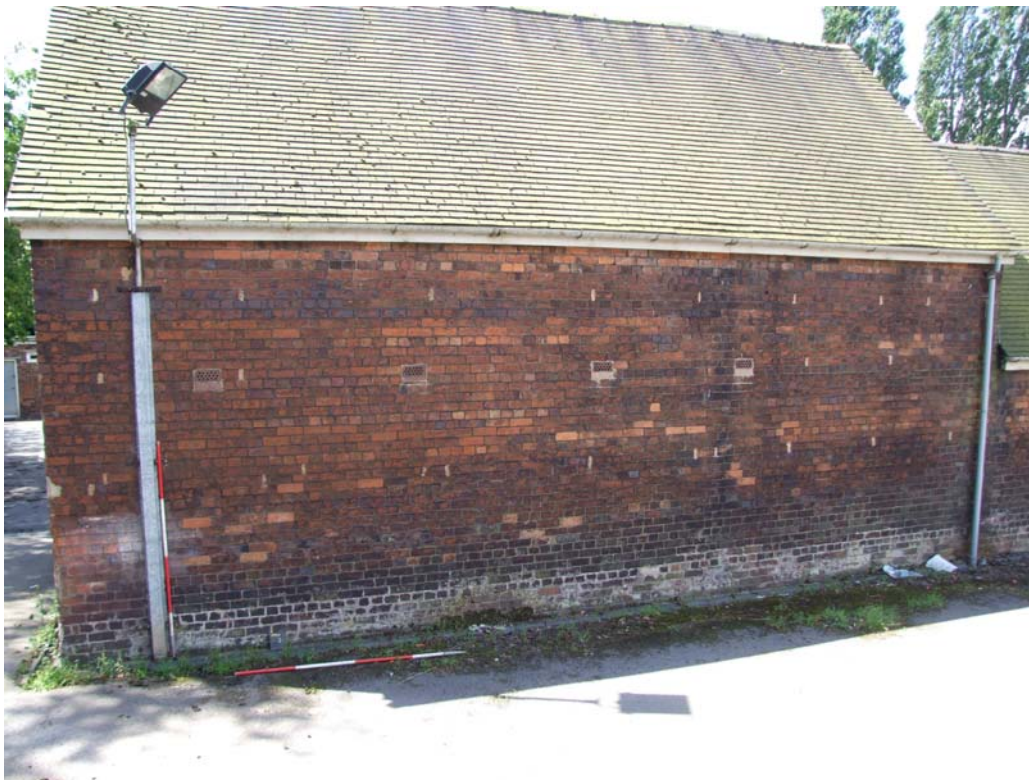
PLATE 8

North-facing elevation of the stable, showing blocked ventilation slots.

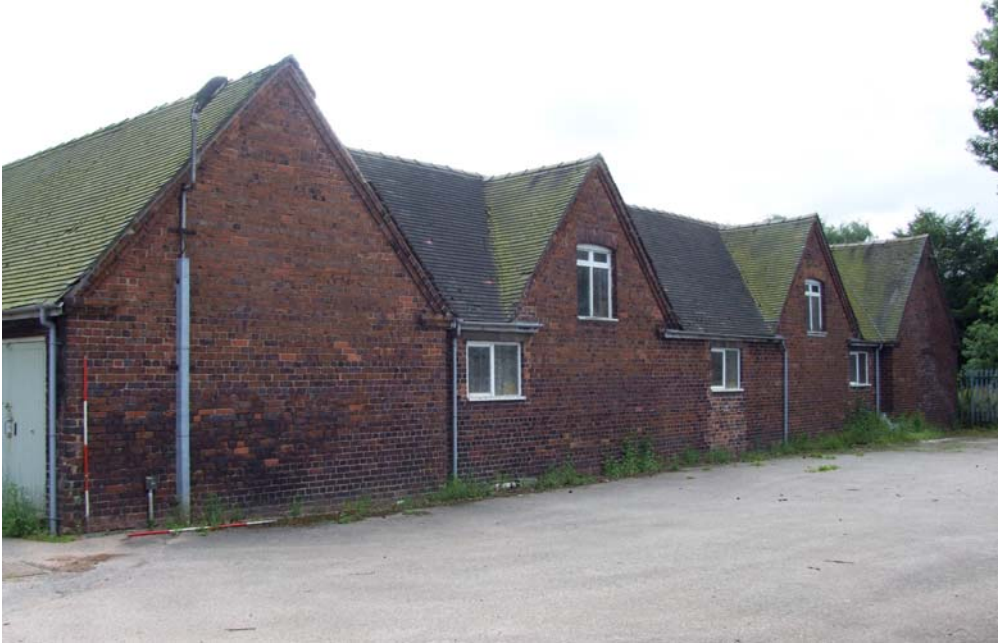
PLATE 9

West-facing elevation of the western range

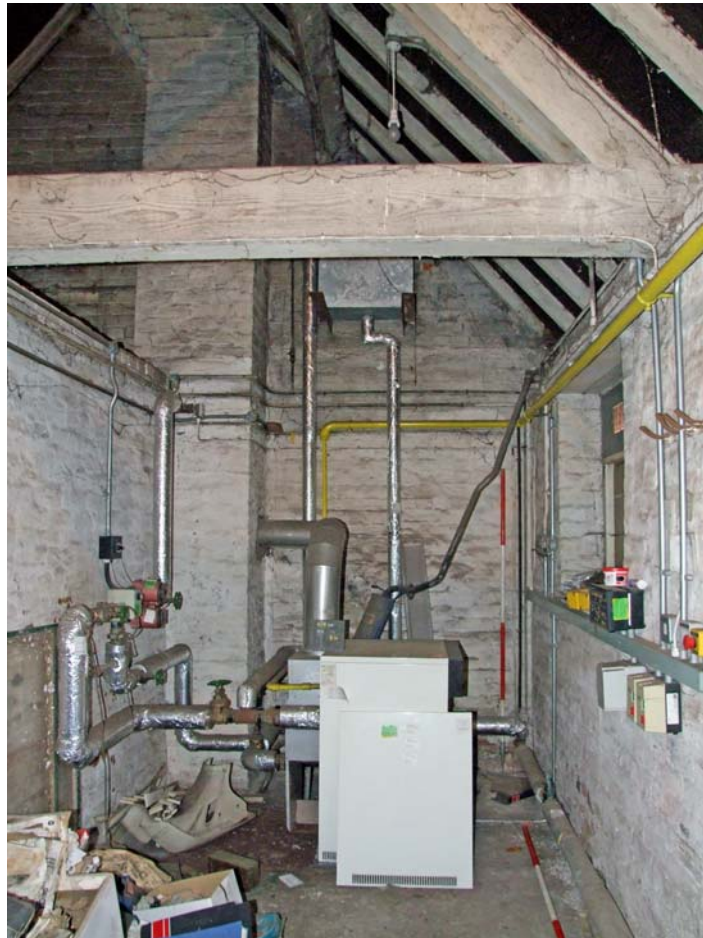
PLATE 10

5.2.1 This NW-SE aligned range comprises seven rooms latterly used as workshops and stores. A small extension has been constructed on the eastern end of the range (Plate 3) (see below section 5.3). All walls are brick, with whitewashed interior elevations. All internal doorways have straight timber lintels with no arching or decoration. In terms of the roof truss supports, the northern and southern walls of the range differ; in the former, the timber roof trusses sit upon brick pilasters and along the south are supported by a stepped brick arrangement (Fig. 13, Plate 10). Floors within the range are concrete.

Room 109, looking east

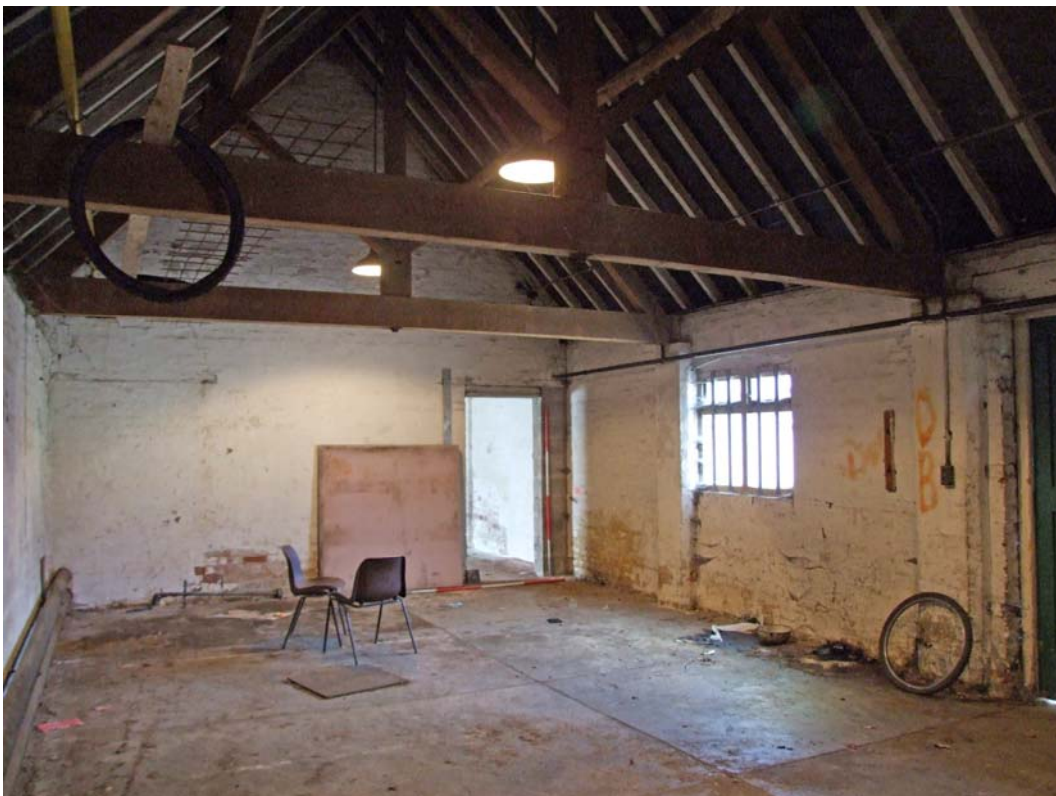
PLATE 12

Room 107, looking north west.

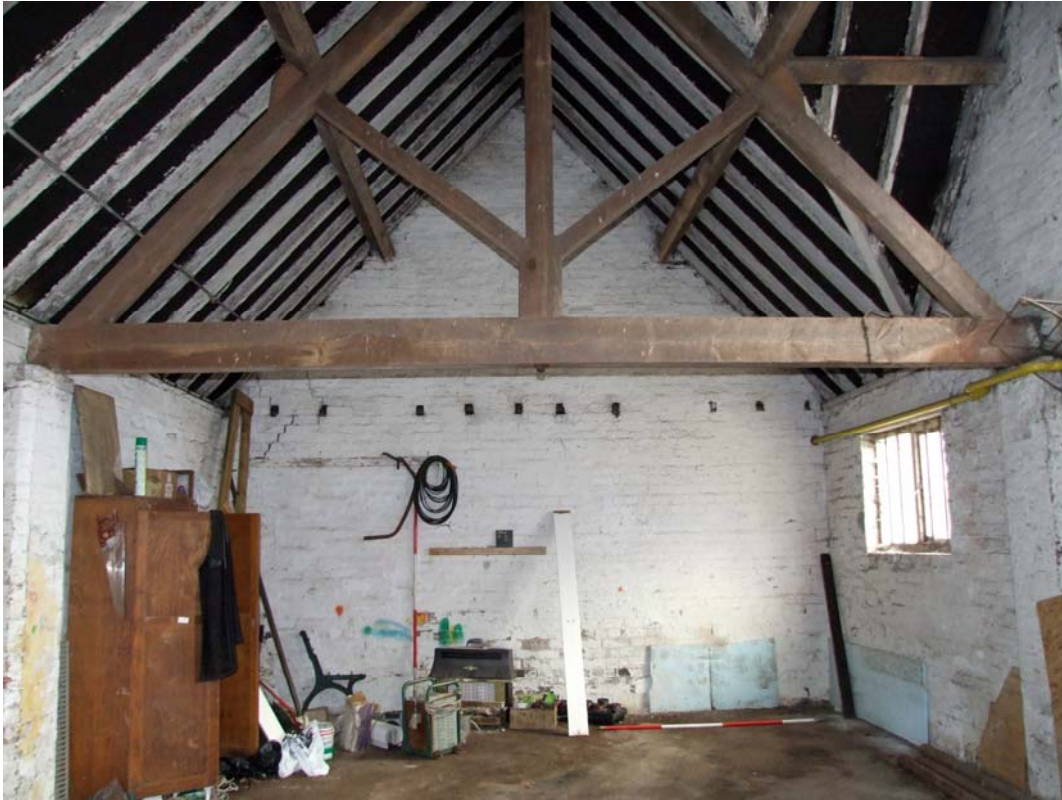
PLATE 13

(room 111) flanked to the north and south respectively by a straw (110) and corn bay (112) with a corn hole. The unthreshed corn was probably stored in a separate rickyard and in the corn bay (112), into which it must have been loaded via the central barn (111), through the large aperture in the dividing wall (Plate 13).

Room 110, looking south.

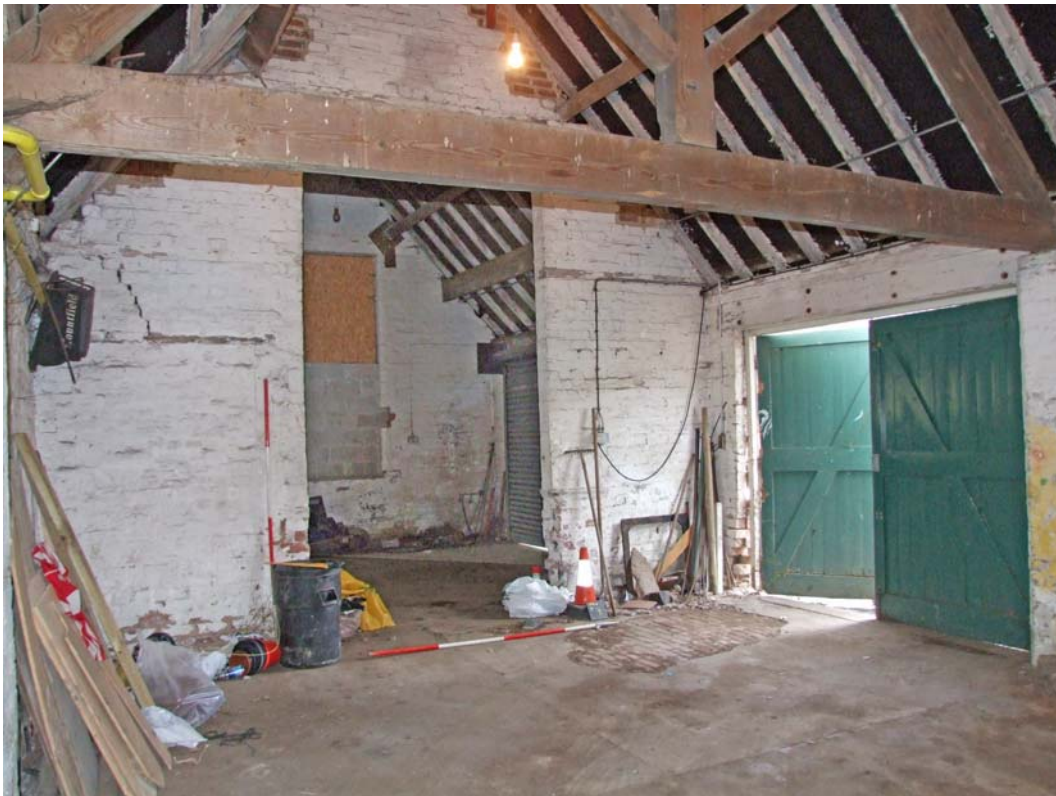
PLATE 14

Room 110, looking north into room 111

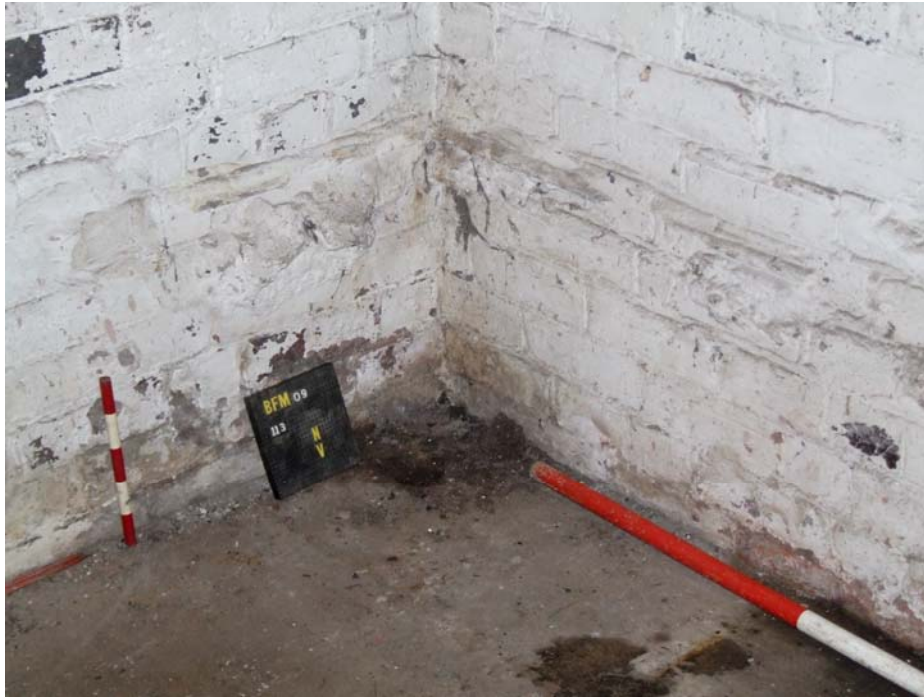
PLATE 15

5.5.4 Some of the rooms within this range feature indicators of their original functions. In room 113 scarring, observed approximately 0.50m from ground level along the whole of the eastern and western walls, suggests that troughs for livestock once stood here (Plate 14). Similarly, opposing 2.20m high scars on the eastern and western walls of room 114, indicate the former presence of a hay-rack (Plate 15). Comparable scarring was observed on the eastern and western walls of room 116. Within 116, scarring on the pilasters that support the central ceiling beam, indicate the position of a former partition, the installation of which would have divided the space into two similarly-sized units. It is not clear if this represented a later modification of the space, or an original feature to temporarily partition the room.

Detail of the scars indicating the presence of a trough in room 113.

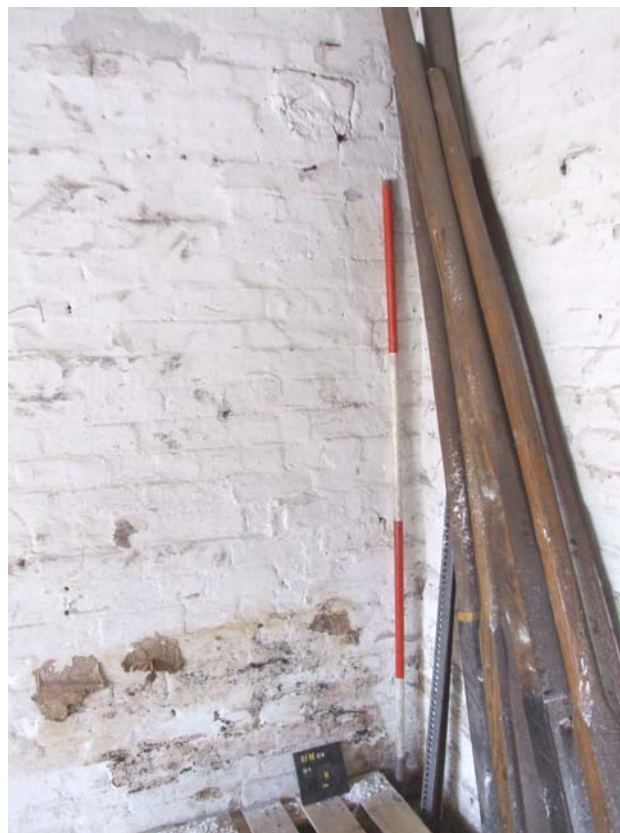
PLATE 16

Scars indicating the presence of a manger or rack in room 114.

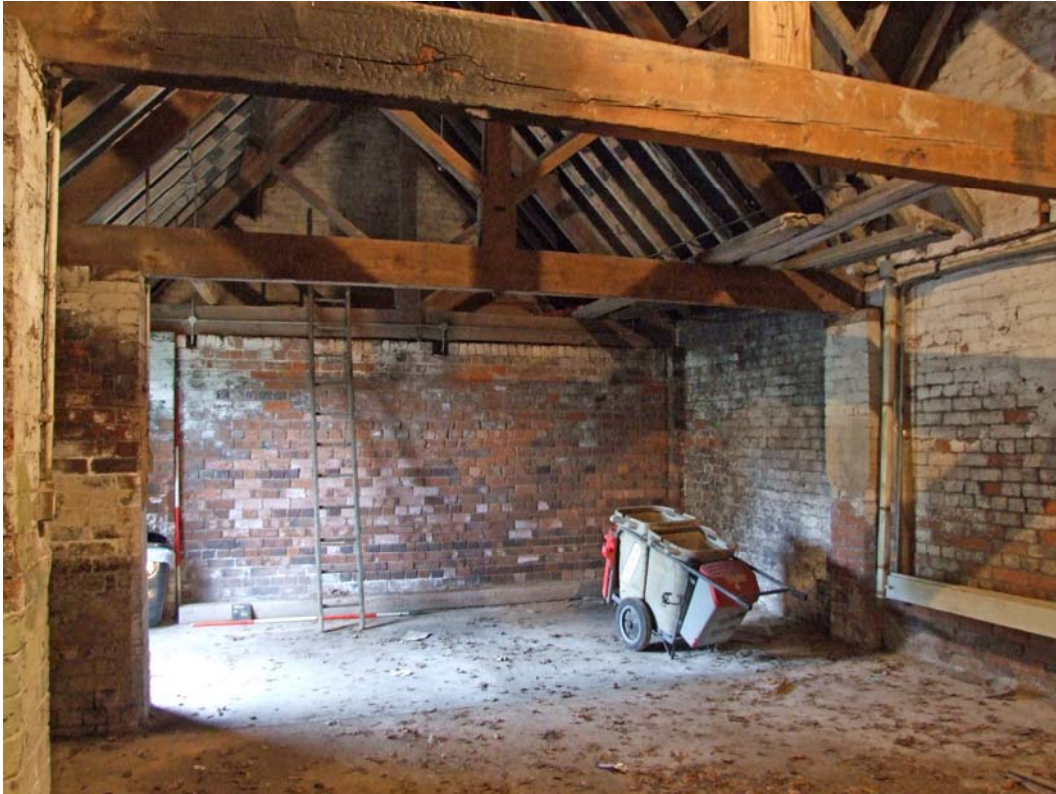
PLATE 17

Room 118, looking east

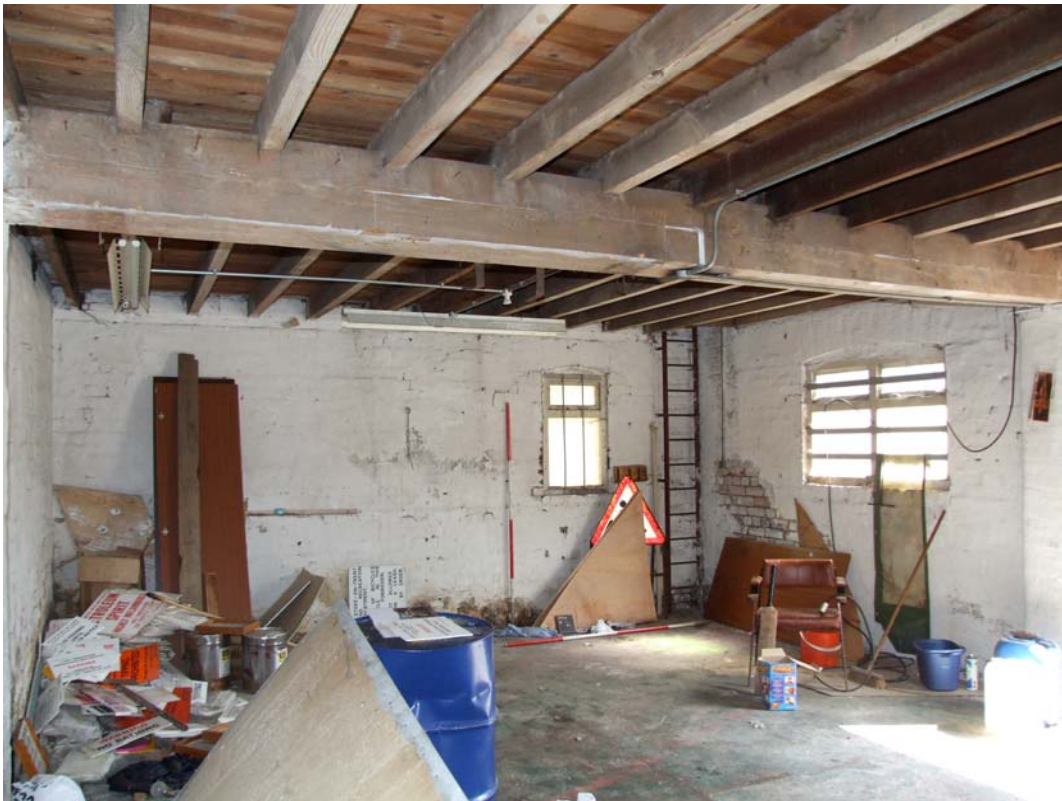
PLATE 18

5.5.5 The loft at the eastern end of the range is accessed via a fixed metal ladder in room 116 (Plate 17). The loft comprises a main area (200), situated above 116, connected to a second smaller space (201), positioned above 115, to the west. The loft includes an external loading/pitching door, located in the eastern gable (Plate 18). Ventilation for the loft was originally provided by three rows of slots, visible at first-floor level in the northern elevation of the range (Plate 7). Similar slots are also present at ground-floor level and would have offered a means of ventilating rooms 113-116. All slots, on both ground- and first-floor level, are now blocked with plaster, and ventilation, at least for rooms 115 and 116, seems to have been subsequently provided by a series of ceramic grilles.

Room 116, looking south east

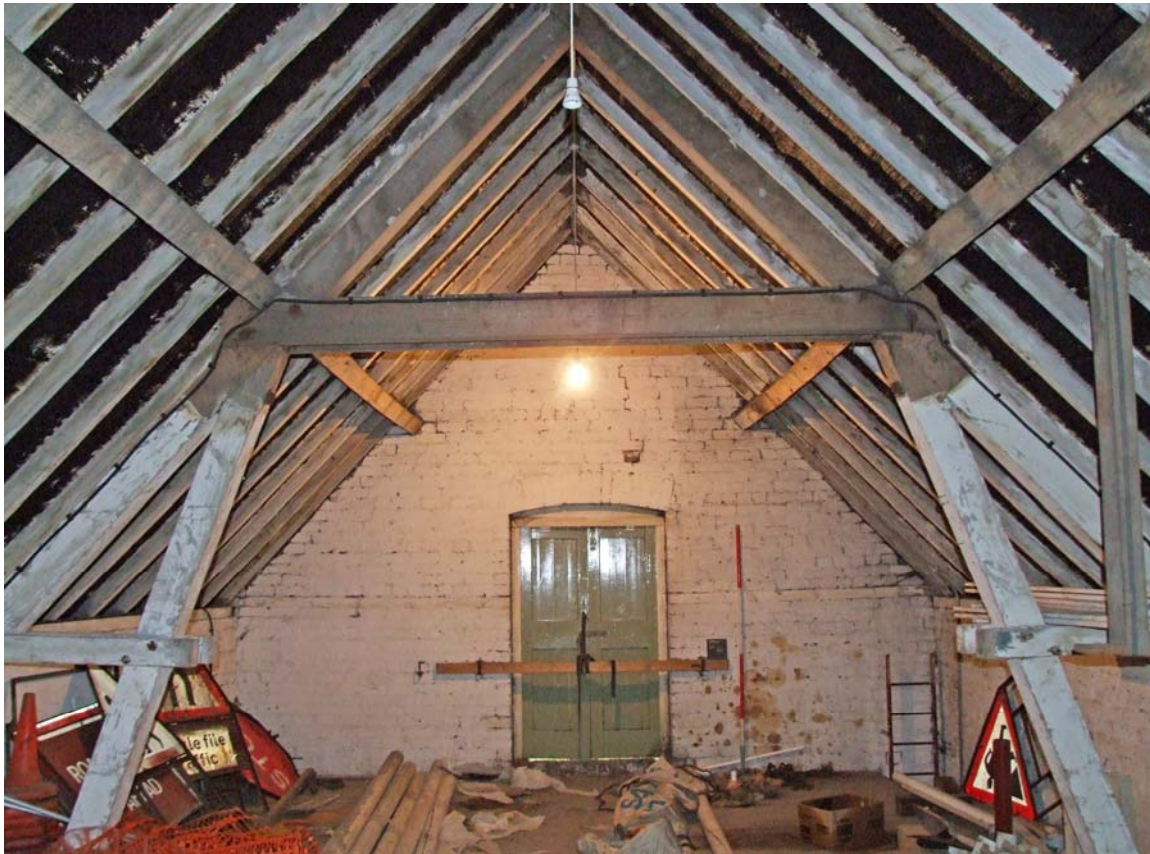
PLATE 19

Room 200, looking east
