Dalton Old Church Archaeological Evaluation

Data Structure Report

An archaeological evaluation was carried out between 28th October and 1st November 2013 at Dalton Old Parish Church, Dumfries (HER ref.12202; NMRS ref. NY17SW 1) by Andrew Nicholson, Dumfries and Galloway Council, on behalf of Neighbourhood Services, Dumfries and Galloway Council in advance of proposed engineering works on the northern boundary wall of the graveyard at the former Dalton Parish Church. The old parish church, churchyard and wall are A-Listed structures (Historic Scotland ref: 3455). In addition the church and a surrounding area, including the churchyard wall to the north, is a Scheduled Monument (Historic Scotland ref: 8676).

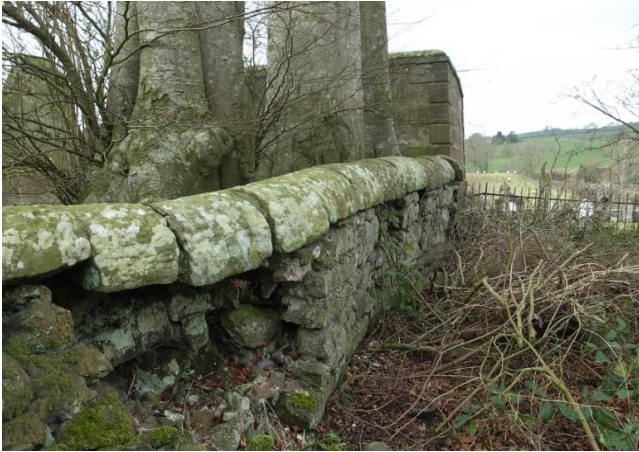
After discussion with Historic Scotland it was agreed that the first trench (A) would be placed within the boundary wall as close as possible to the large beech trees that are causing wall collapse, on their eastern side.

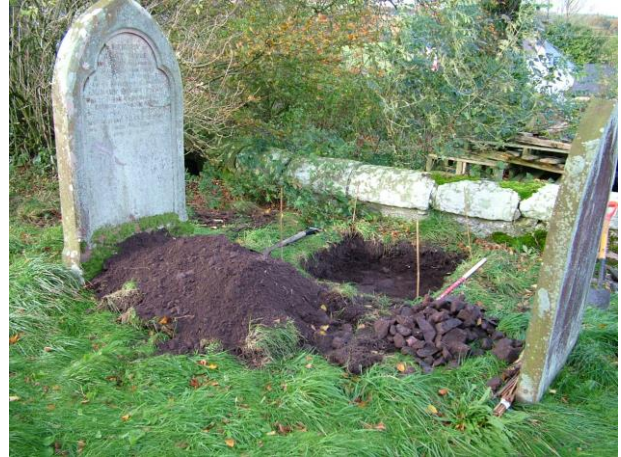
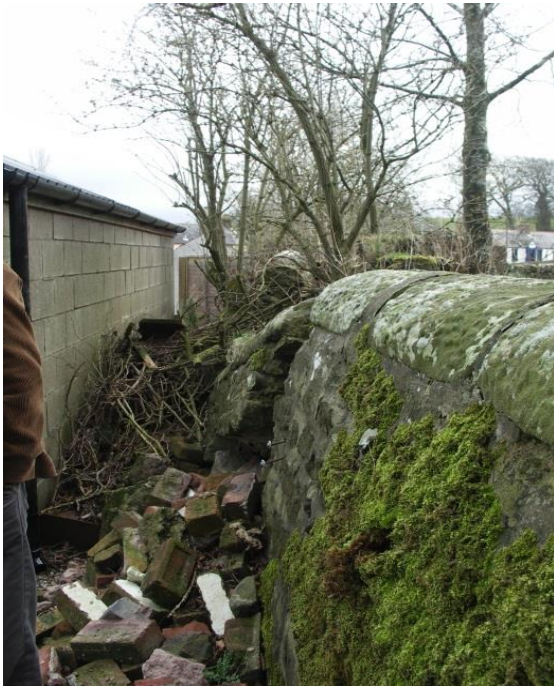
The second trench (B) was located as close as possible to the boundary wall where there is significant collapse adjacent to an external garage.

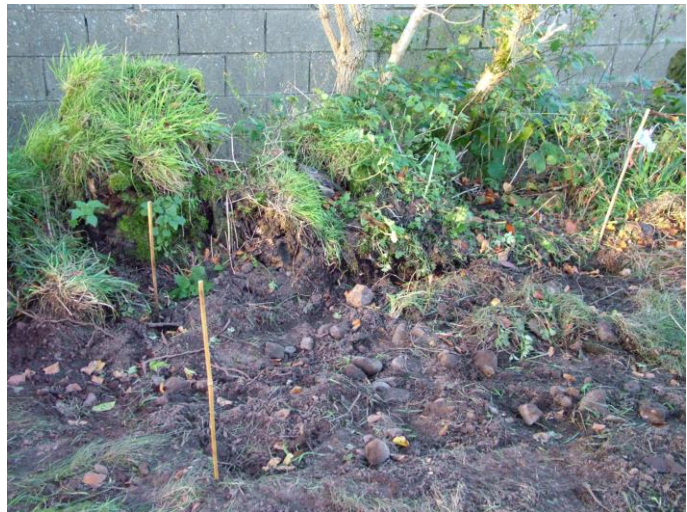
The third trench (C) was located just to the west of the entrance to the graveyard, to determine the nature of a raised mound at that location.

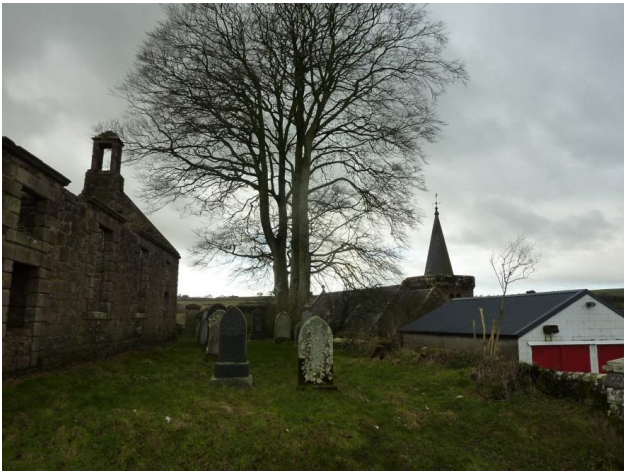
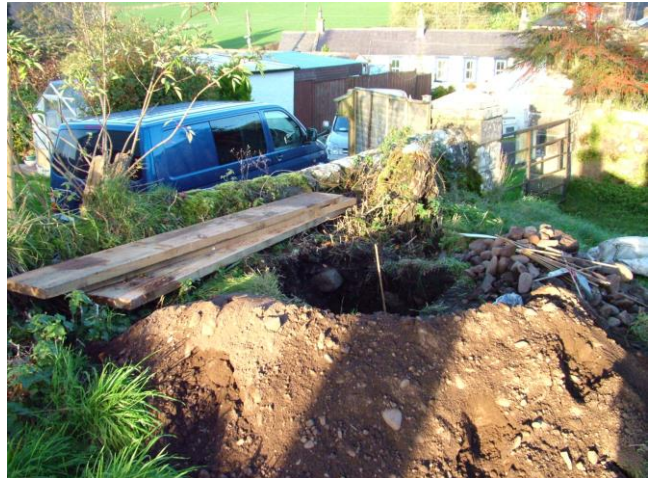
The presence of a path from the gateway to the western entry to the church, shown on the Ordnance Survey maps, raised the possibility that there would be fewer burials between the path and the wall, and no headstones were visible other than at the western end where two headstones stand between the route of the path, now grassed over, and the boundary wall.

At the eastern end of the wall, around the gateway and the raised mound to the west, the evidence from Trench C indicates that in situ archaeological deposits, including disarticulated human remains, could extend right up to the boundary wall. An archaeological watch brief would be recommended during the downcutting phase of works in this area, to record any features uncovered and to deal with any associated finds.

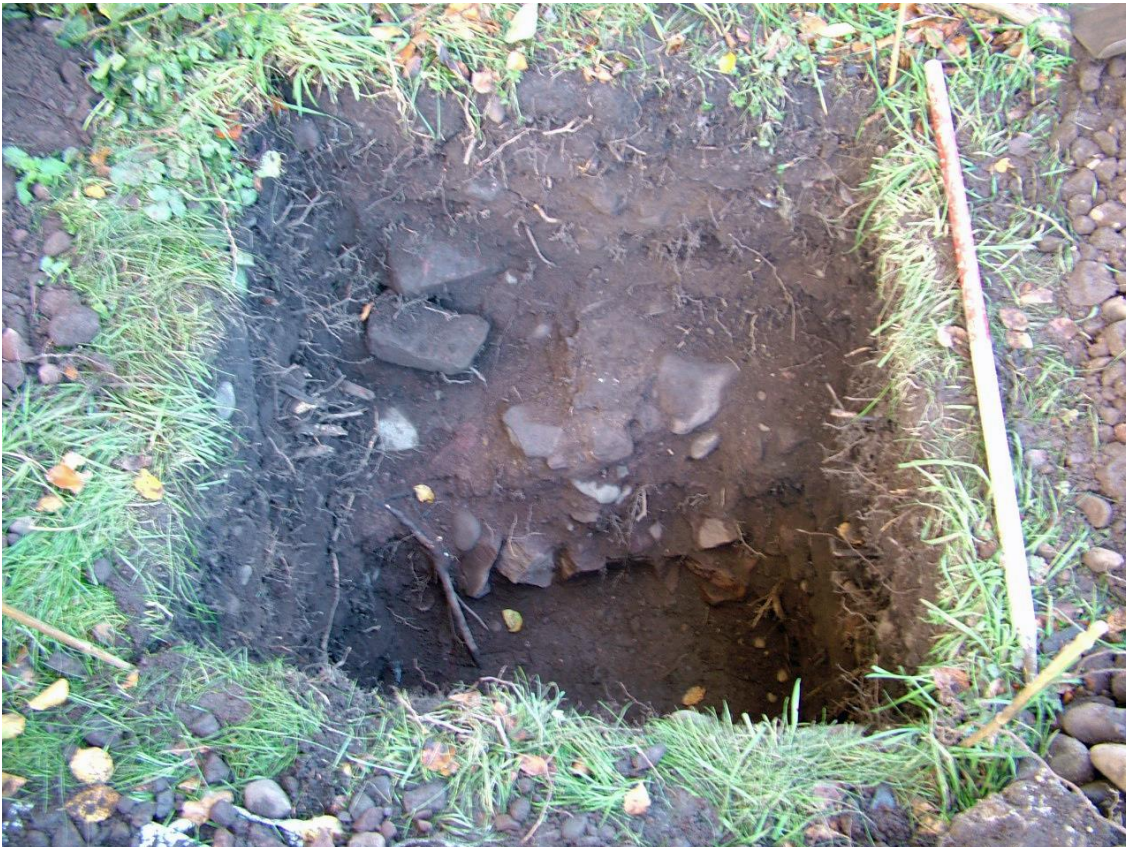
Removal of the turf revealed a mid-brown subsoil, with larger stones in the northern half of the trench (002). Four pieces of disarticulated bone, possibly human, were uncovered during turf removal. The subsoil extended to a depth of 0.5m in the northern half of the trench, and about 0.35m in the southern half, where a lens of compacted red-brown gravel intruded (003). Below the lens was a similar matrix to the layer above it. The interface between the layers in the southern half of the trench and the more rubble-filled north was hard to determine, as the soil matrices were very similar, and the whole was laced with fibrous roots. At a depth of 0.65m below the surface the two halves of the trench were clearly distinguished, with a compacted rubble layer in the northern half (004), and a much looser soil with only small stones in it in the southern half (005). The looser soil appeared to be the fill of a near-vertical cut through the rubble layer, conforming to the shape of the stones, so in some places undercutting the stone, on others lying over it. The looser soil became siltier as excavation proceeded, and at a depth of 1.05m linear remains of decaying timber were noted (007), along with a coffin fitting from close to the southern edge of the trench, confirming that the cut (008) was for a 19th century grave, and that the timber staining and friable pieces were the remains of the side-wall of a coffin. Careful excavation of the silty soil within the timber staining eventually uncovered an in situ mandible and skull (006) in the south-western corner of the excavation continuing under the sections. In the northern half of the trench the rubble layer (004), which contained redeposited chunks of bedrock with evidence of plough-scores, continued down at least as far as the coffin, so was left unexcavated.

Trench A looking north, showing northern rubble (004)

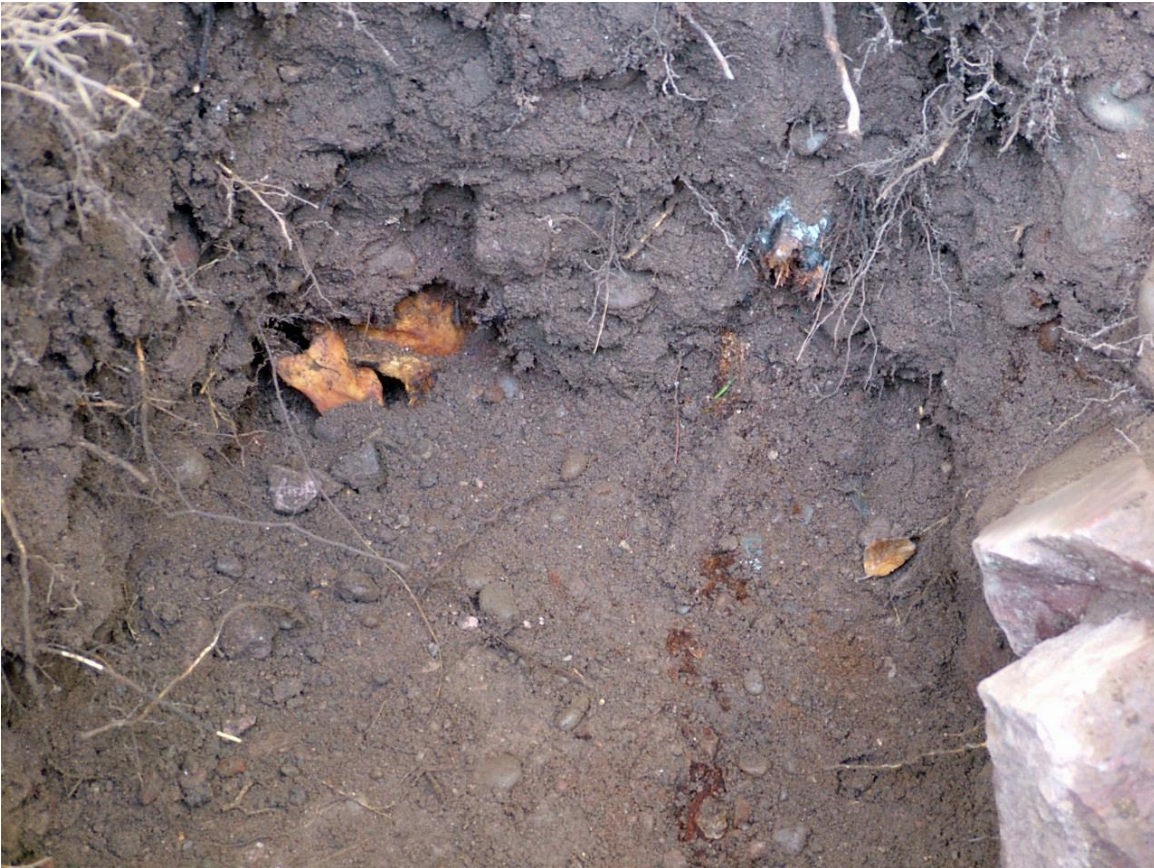
Trench A looking west, showing skull (006) under south-western section and wood staining from the coffin (007).

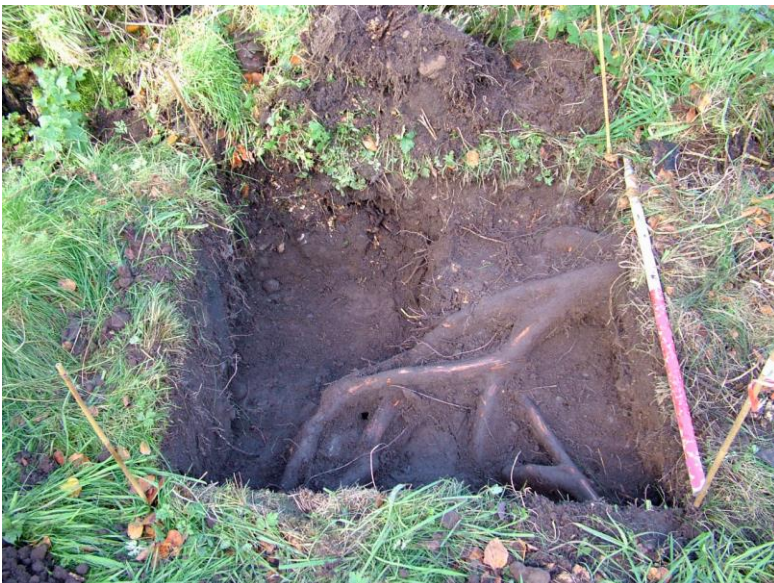
Cleaning up of the subsoil (011) below the turves revealed that the eastern half of the trench was seriously compromised by the presence of tree roots from an adjacent stump. The decision was taken to offset the trench 0.5m to the west to avoid the worst of the problem and enable a useful depth to be reached. The subsoil includes fragments of Welsh slate and modern brick.

Trench B looking north, showing tree roots below topsoil. The trench was extended half a metre to the west, and work abandoned in the eastern 0.5m.

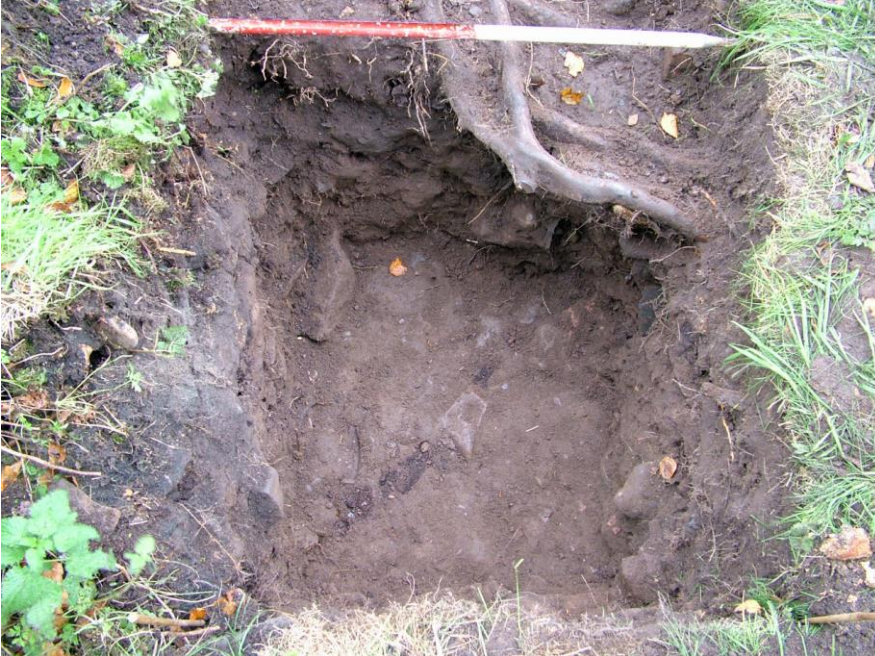
Trench B looking east, after removal of (012), showing the stony deposit (013). Note the line of a former tree root shown as a dark silty band.

Below the soil layer lay a stony rubble deposit (013), again riddled with decomposed root channels, presumably from earlier trees along the boundary. Under the rubble the soil matrix took on a redder hue, becoming considerably less stony and with fewer finds (014). A single lead alloy button with a broken copper alloy attachment loop at the rear was found at the interface between 013 and 014, and can be dated to the later half of the 18th century.

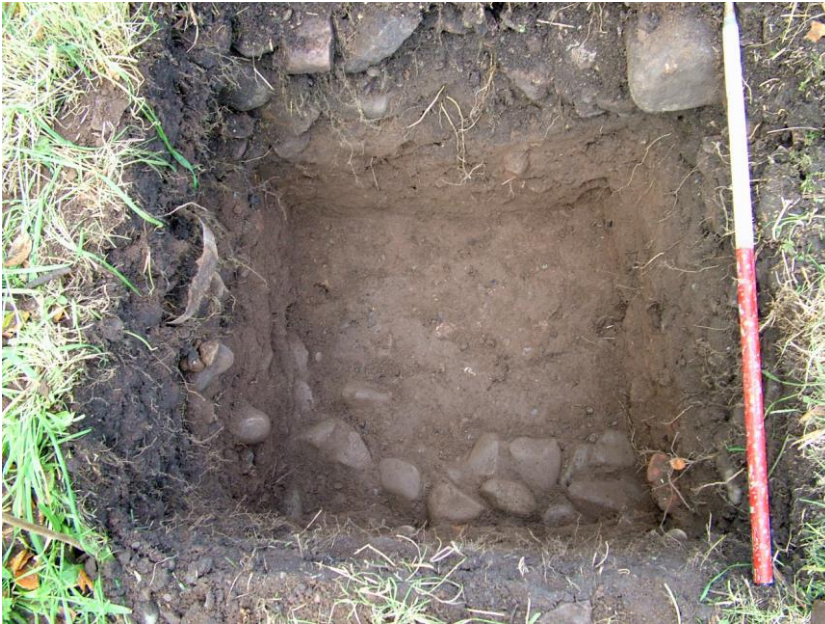
A band of rounded cobbles (019) appeared in the southern part of the trench, with a distinct, arcing northern edge. However the silty soil to the north (020) appeared to be identical to layer 018 that overlay the cobbles, and continued downwards.

Trench C looking north, showing cobble layer (019) with silty soil (020). Note the loose stone (016) in the upper part of the north section.
