Watching Brief

Littleferry Pilots House

Sutherland

Report No.	HAS070301
Site Code	HAS/ LPH06
Client	A Hoare
Planning Ref	
Report Date	02 March 2007
Authors	John Wombell and John Wood

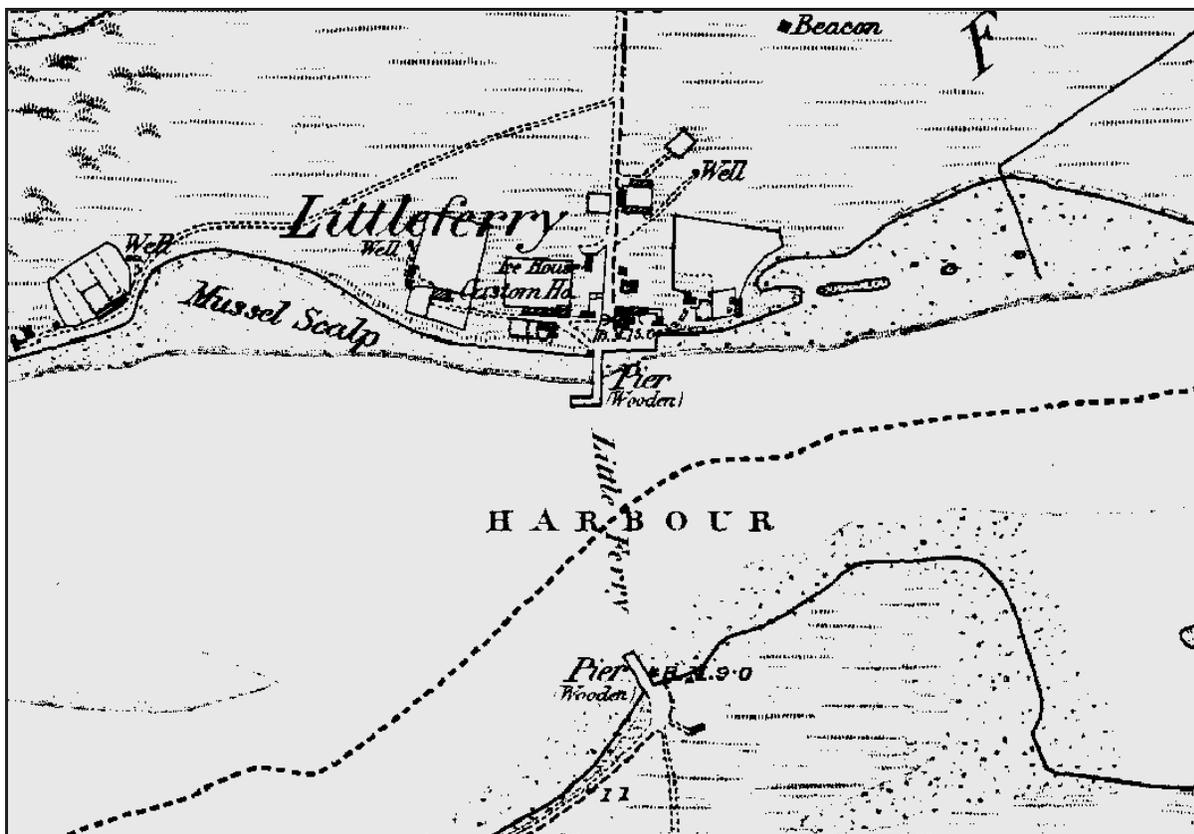
Figure 2 1st Edition OS 1:10560 map 1879 (not to scale)

A check of all relevant archaeological / historical records, maps and aerial photographs was undertaken. An online check was made of the Statistical Accounts, National Library of Scotland Map collection, National Monuments Record and Highland Sites and Monuments Record (SMR). The SMR was also checked for updates in the Council offices in Inverness, where the RAF 1947 aerial photographs were also examined. Historic Ordnance Survey mapping was also checked; the First Edition 1:10560 (6 inch) map of 1878 is reproduced above (Fig 2). However, no archaeological features were found within or adjoining the proposal area.

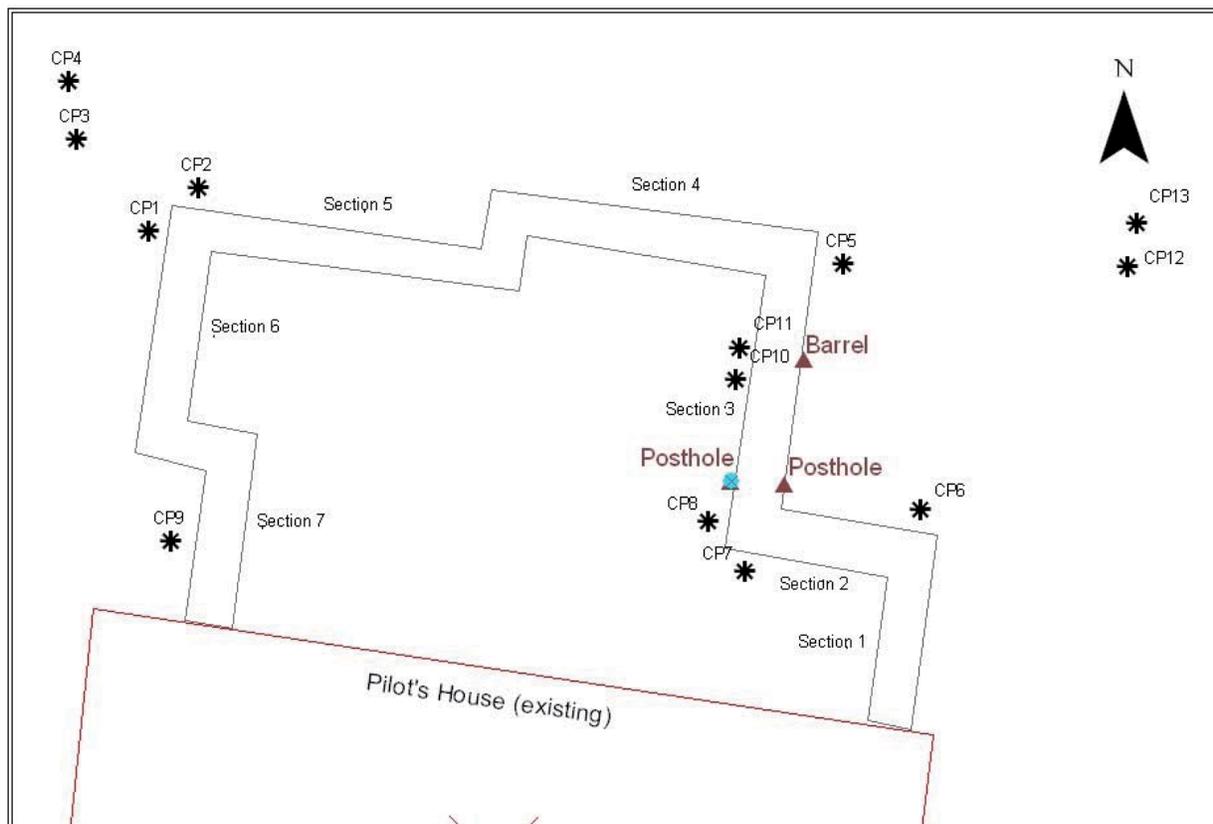
Figure 3 Site plan (from sketch: not to scale)

The works consisted of the formation of a single continuous trench approx 450mm deep and 600mm wide, with a number of 90 degree angle changes. For convenience this trench has been divided into 7 sections (See Fig 3 above). The 2 x 0.9m long trench sections have been ignored and not numbered as in practice they appeared on the ground as overlaps between the longer sections of trench.

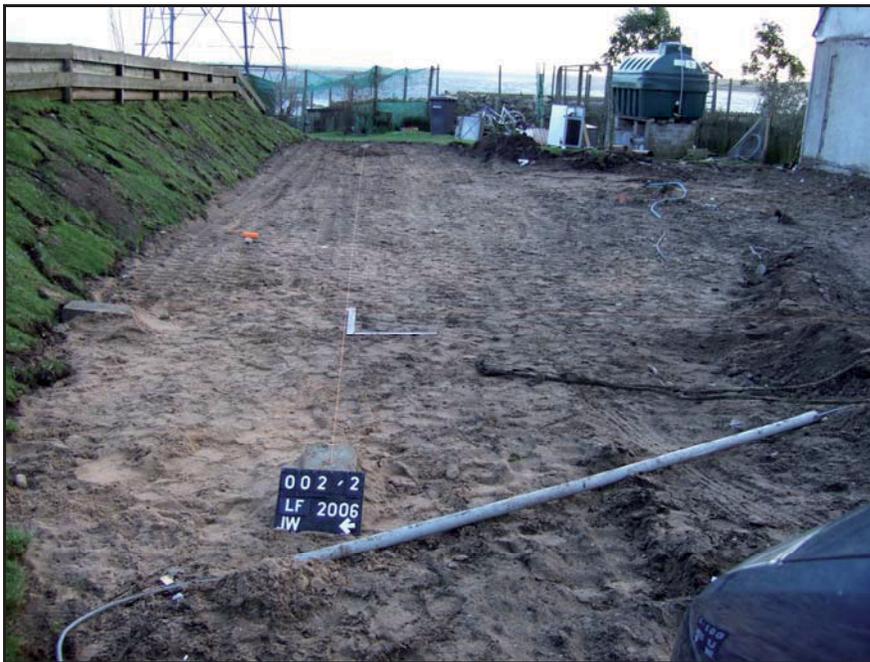
Beyond the limits of the old extension the natural fine turf had been roughly stripped by machine, and an additional strip of ground levelled, as the new extension is to be somewhat larger than the old one. It appears that the levelling works had cut into a natural gravel bank but to what extent it was impossible to judge, as the turf had been re-laid on the exposed bank surface and the extension to the level area smoothed off. The ground surface of this additional strip of levelled ground was seen on the day as clean natural yellow/orange sand. It is unlikely that any disturbance to the bank was of any archaeological significance (See Fig 4 and photos 001-1, 001-2, 002-1 and 002-2).

Figure 4 The site at the outset of the watching brief, showing bank to N

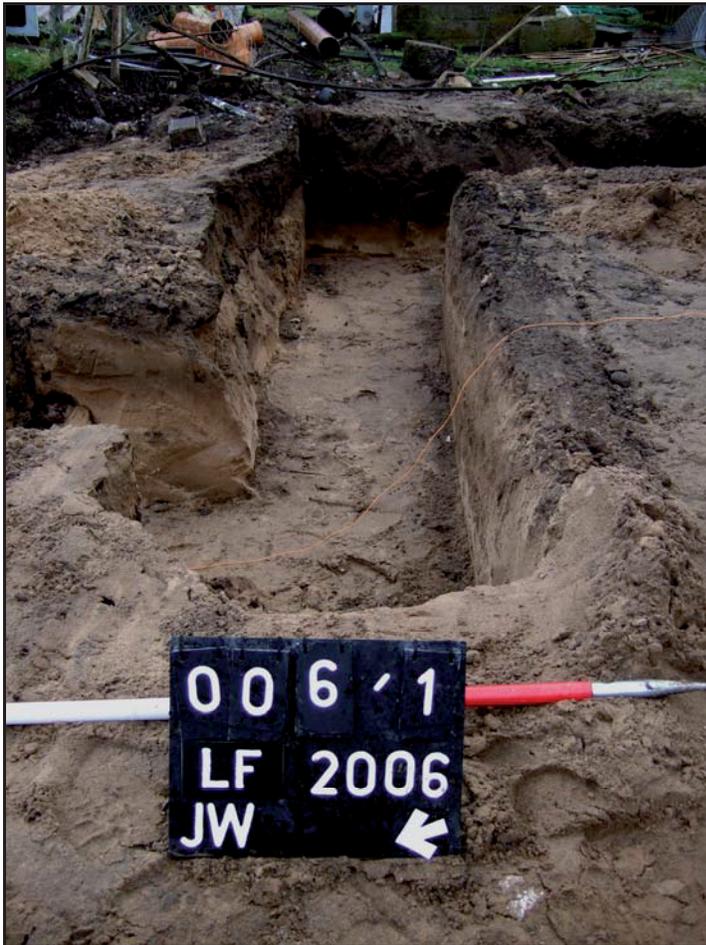
Figure 5 View E from CP8. Post or stakehole in section on extreme left.

This lay at right angles to section 2. About half way along this section the old garden soil faded out and the trench went into natural, mostly undisturbed mixed gravel and sand. Two (apparently modern) post or stake holes were cut by the trench about 1m from the S end of this section. They lay one on either side of the trench. These post holes are more or less in line with a present day chicken run, one post of which can just be seen top left in Fig 6 above behind some old plastic sewer pipe connectors. At c 1.8m from the N end of the trench on the E side, the bucket scraped past the buried remains of a wooden barrel with iron hoops, set vertically on end (See Fig 7, and photos 003/1, 003/2 and 004/1). The barrel was entirely outwith the foundation trench and was not investigated further. One find came out of the clean gravel at the bottom of the trench, possibly a fossilised tooth.

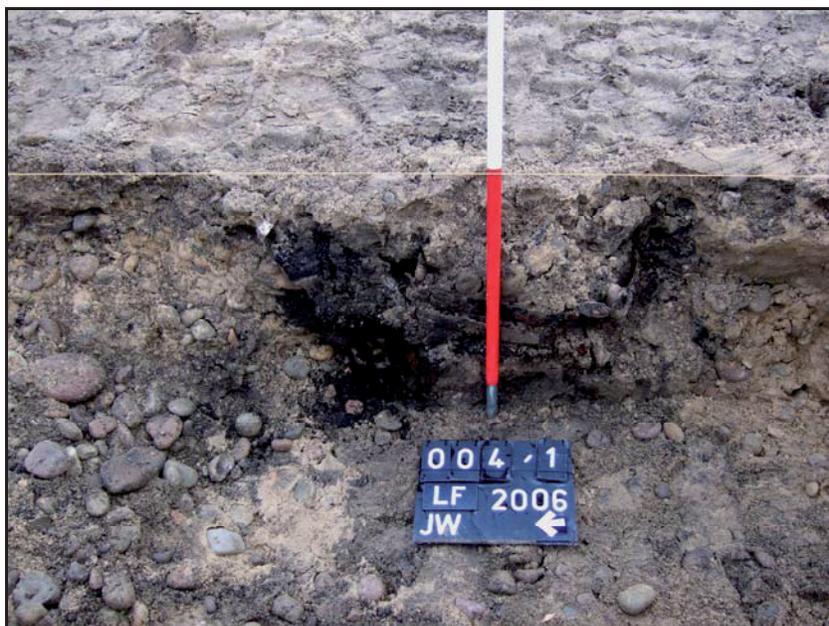
Figure 6 Barrel showing in E Section
