Wester Moy Ross and Cromarty

Archaeological Watching Brief

Report No.	HAS100603
Site Code	HAS-WMY10
Grid Ref	NH 480 553
Client	SSE
Planning Ref	N/A
OASIS	highland4-78136
Date/ revision	08/06/2010
Author	Lynn Fraser

An archaeological watching brief was undertaken on 25th and 26th May 2010 during works in advance of cable undergrounding at Wester Moy, near Marybank, Ross-shire. There were no significant features or finds uncovered.

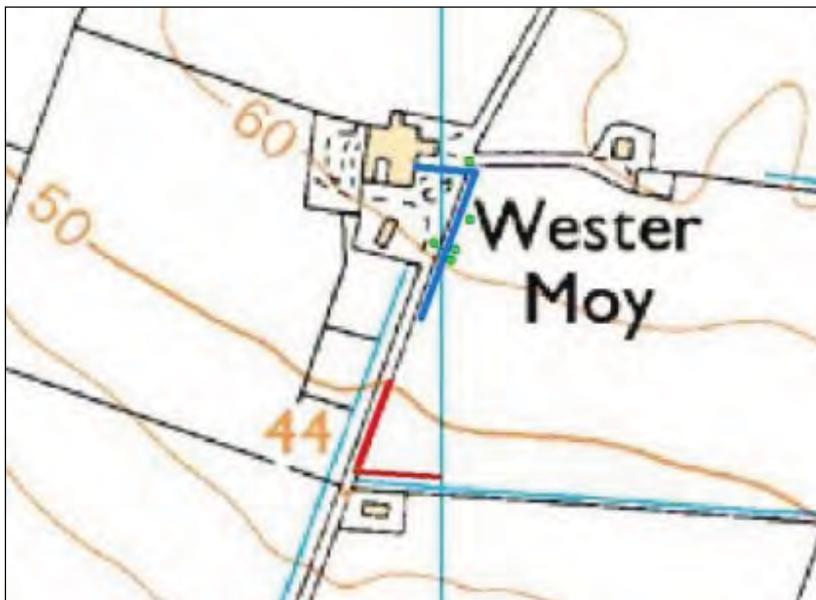
Figure 2 Locations of observed trench areas

Blue: Trench 1; Red: Trench 2. Trench one was not observed across the farmyard.
 Maps reproduced from Ordnance Survey under licence. Not to scale.

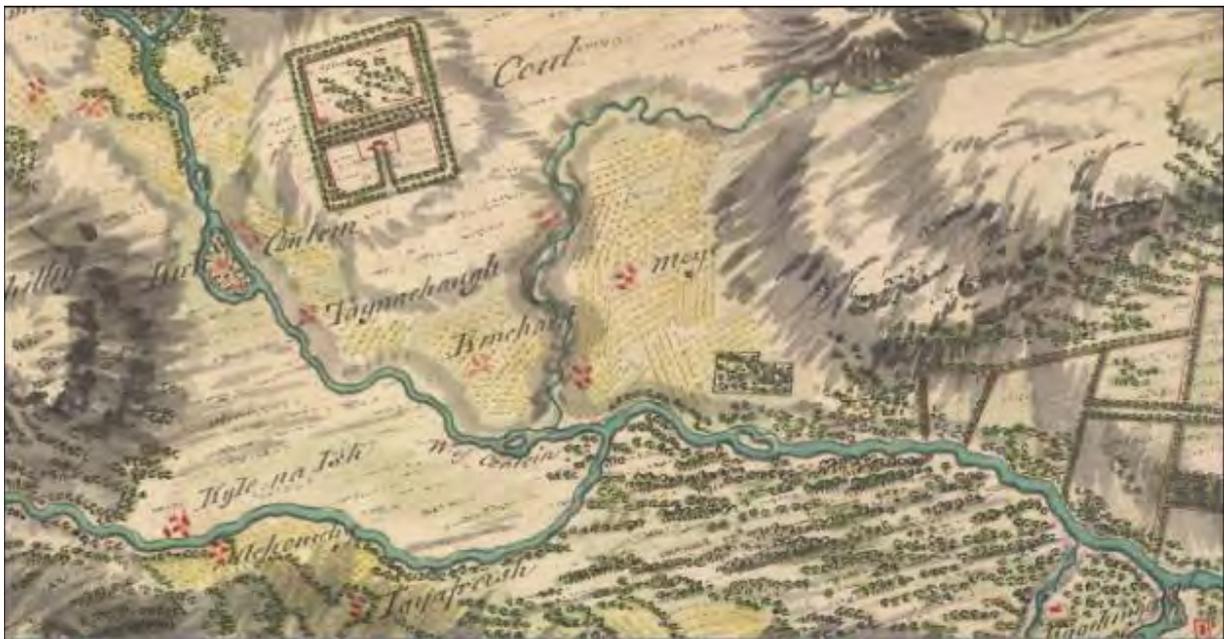
Figure 5 Roy's Map

Extensive cultivation is shown between the north bank of the River Contin, the west bank of Allt Drioghinn and to the base of the hill to the east. There is a settlement in the vicinity of Wester Moy marked 'Moye' with further scattered settlement along the River Contin¹⁰. See Figure 5 below.

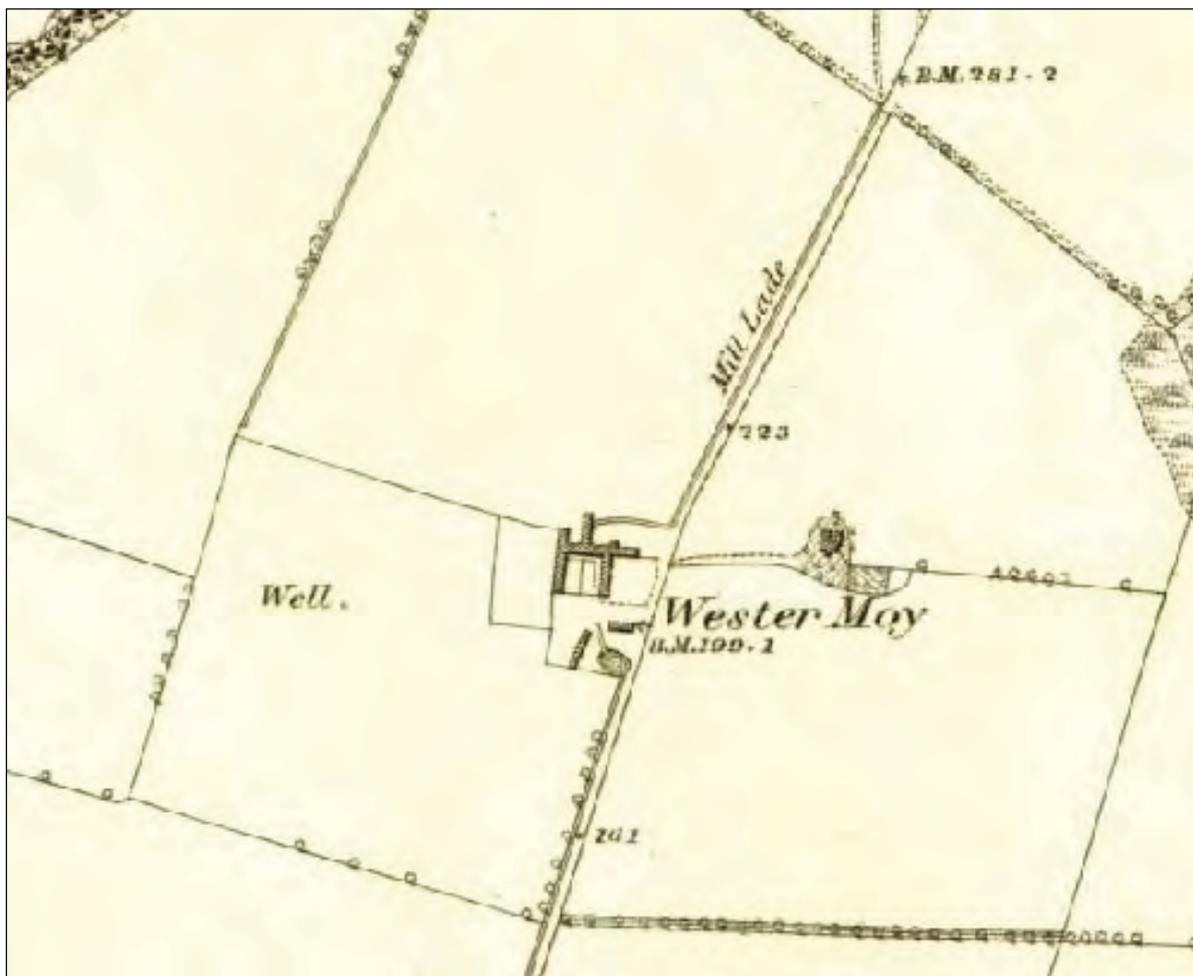
Figure 6 Extract from Ordnance Survey 1st Edition 6"/>" data-bbox="112 750 686 765"/>

Ross and Cromarty Shires (Mainland), Sheet LXXXVII (not reproduced to scale). Image: National Library of Scotland

The farm steading area was inspected for signs of the mill lade shown on the 1st edition Ordnance Survey map. It is possible to see on the most northerly building the position of the waterwheel, which would have been associated with the mill lade (Plate 2). There is no sign of the mill lade in this area.

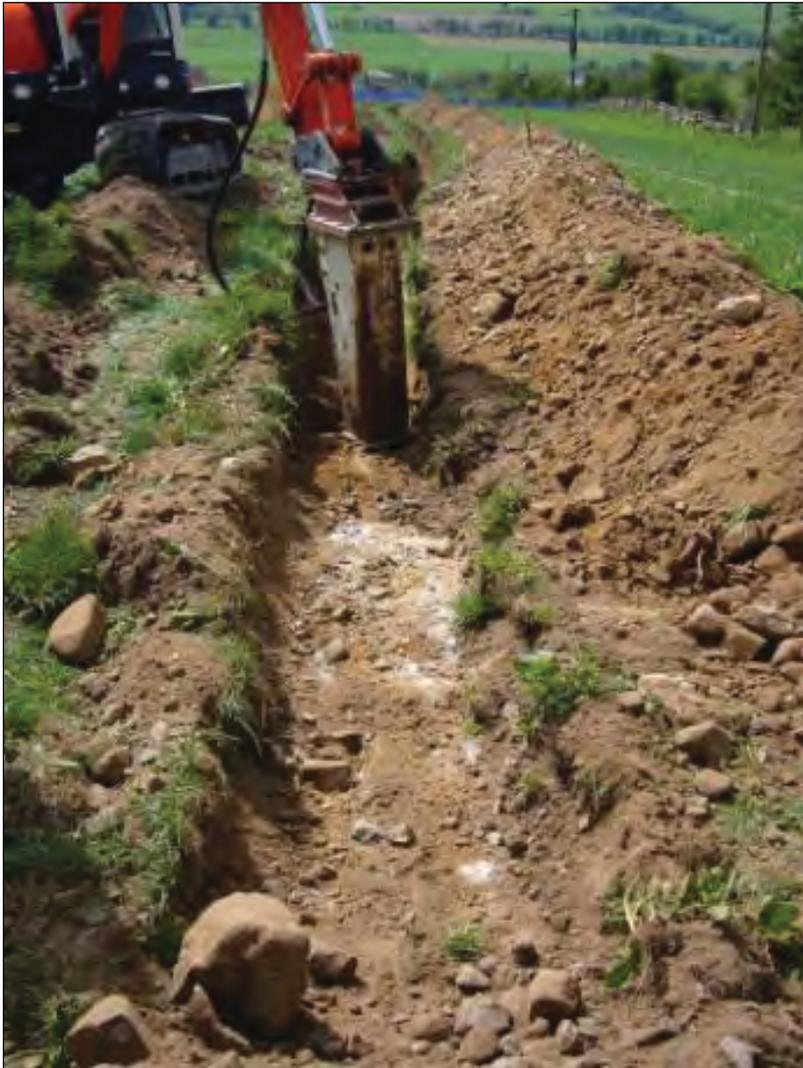
Plate 1 View S showing the 'pecker' breaking up underlying bedrock in the vicinity of pole 19.

As mentioned above, the northern part of the cable trench was cut through bedrock and the farmyard where shallow, redeposited material overlay bedrock. Neither of the trenches produced any archaeological features; there was very little midden material uncovered during the excavations.

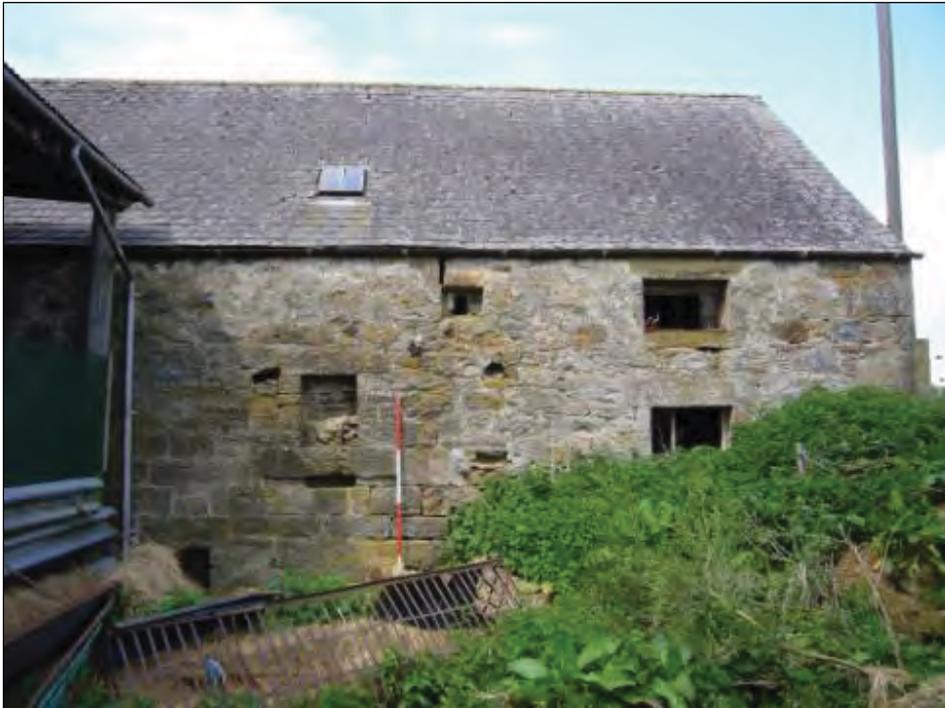
Plate 2 Northern farm building showing the possible position of the waterwheel associated with the mill lade shown on the 1st edition Ordnance Survey map.

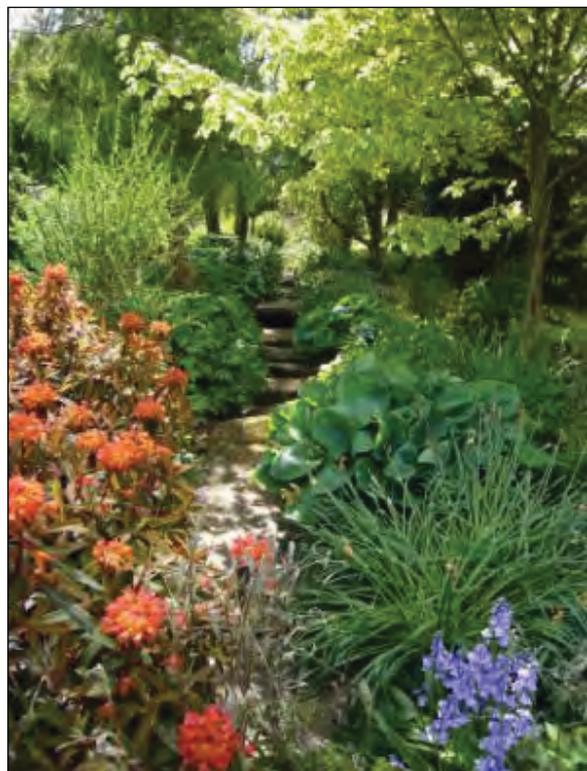
However, it is possible to pick it up on the north side of the boundary between the farm yard and the farm cottage's garden. The mill lade is still in situ in the farm cottage garden (Plate 3).

Plate 3 The mill lade running through the farm cottage garden.
